Tree Condition Report

Somerset Avenue,
Wilpshire,
BB1 9JD

08/11/2024

13/11/2024

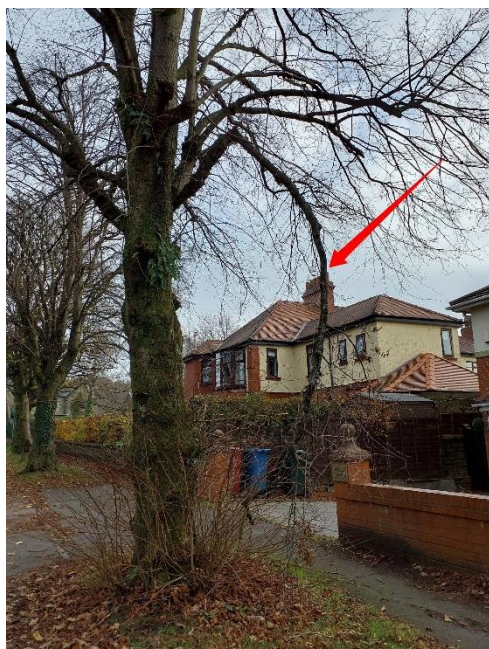
T10 – prune snapped branch

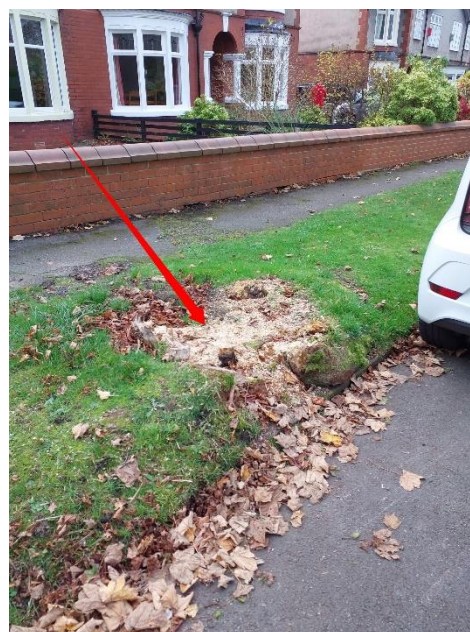
- 18.5. T14 has recently failed during a storm resulting in the tree being removed, as the tree was covered under a TPO, and to keep the ongoing aesthetics of the tree lined avenue, a replacement tree will be required once the stump has been removed / ground out.

T14 – stump requiring grinding

Stump	T014	Unknown Species (<i>Unknown Species</i>)	1	70	0.1	N:0.1 E:0.1 S:0.1 W:0.1	Dead	Good	Good	Dead	_ Tree removed. _ Storm damage.	No significant visible fungus present at the time of inspection.	No significant visible Pests or Disease present at the time of inspection.	Owned by the client. Roadside tree. Target # - Footpath - highway	YES	_ Stump grind. _ Replacement tree planting required.	08-May-2025 (6 Months)	2 Years	
Tree	T015	Lime (<i>Tilia sp.</i>)	1	40	10	N:4 E:4 S:4 W:4	Mature	Good	Good	40+ Years	_ Seasonal leaf drop has occurred. _ Low branching. _ Epicormic growth at base.	No significant visible fungus present at the time of inspection.	No significant visible Pests or Disease present at the time of inspection.	Owned by the client. Roadside tree. Target # - Road Target # - Footpath - highway Target # - Garden	YES	_ Epicormic removal up to 1st limb. _ Crown lift to 5.2 m for highway clearance.	08-May-2025 (6 Months)	2 Years

- 18.4. There are 2 tree stumps in the grass verge, T14 and T62, these are a trip hazard, and the stumps need grinding below ground level and the grass reinstating.

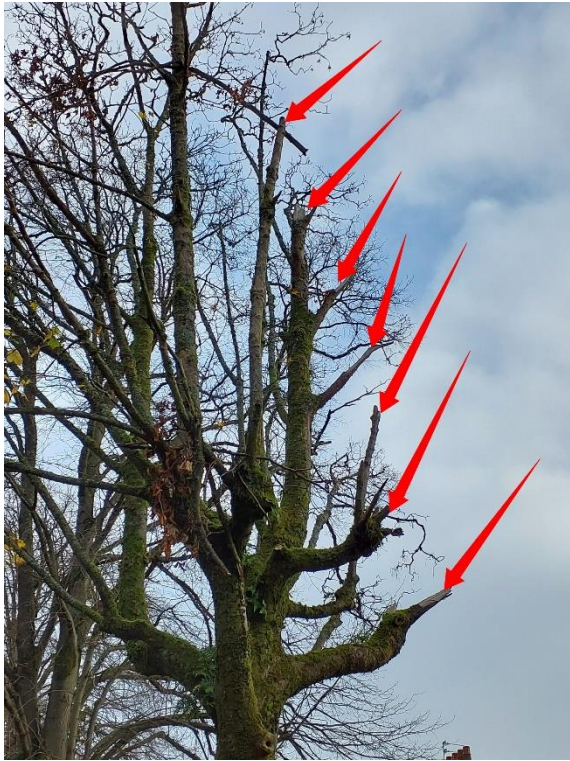
T12 – snapped stubs requiring target pruning and hung-up branches for removal

Tree	T012	Sycamore (<i>Acer pseudoplatanus</i>)	1	40	12	N:4 E:4 S:4 W:4	Mature	Good	Good	40+ Years	_ Low branching. _ Previous branch damage due to neighbouring tree failure. _ Hung up branch.	No significant visible fungus present at the time of inspection.	No significant visible Pests or Disease present at the time of inspection.	Owned by the client. Roadside tree. Target # - Road Target # - Footpath - highway Target # - Garden Target # - Parking / driveway	YES	_ No work required at time of inspection.	No Action	2 Years

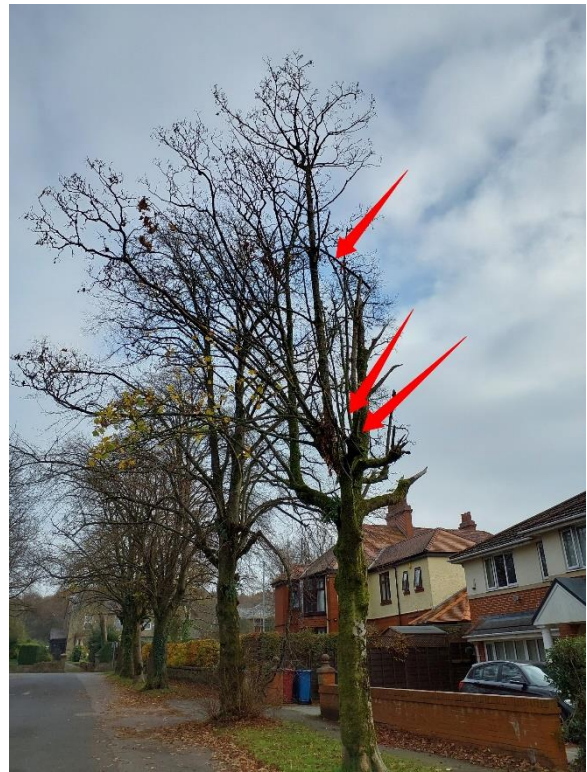
T27 – prune to clear street light

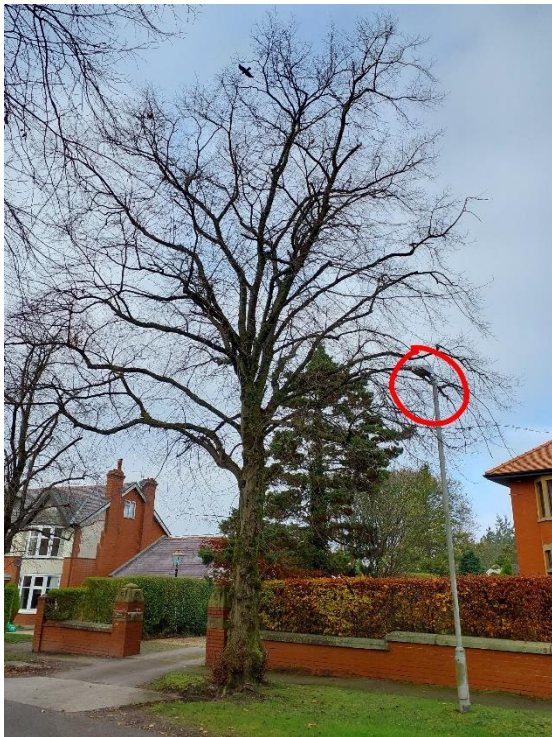
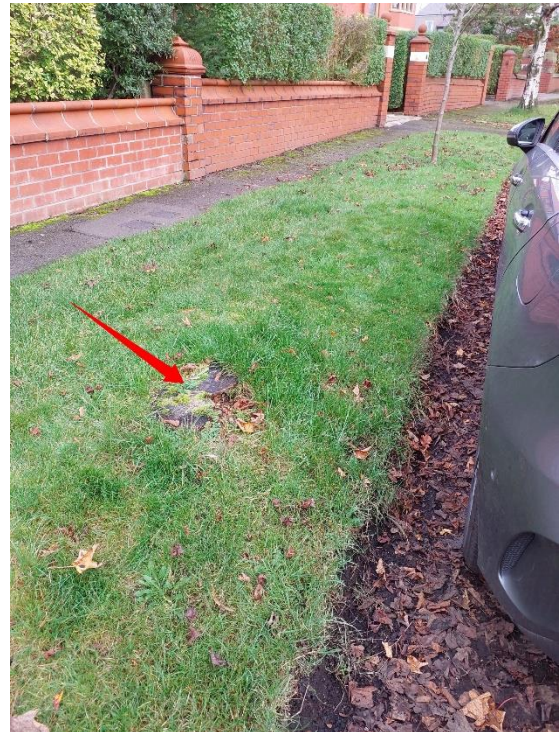
T62 – stump requiring grinding
