Ref: S1 Bonstone Brook

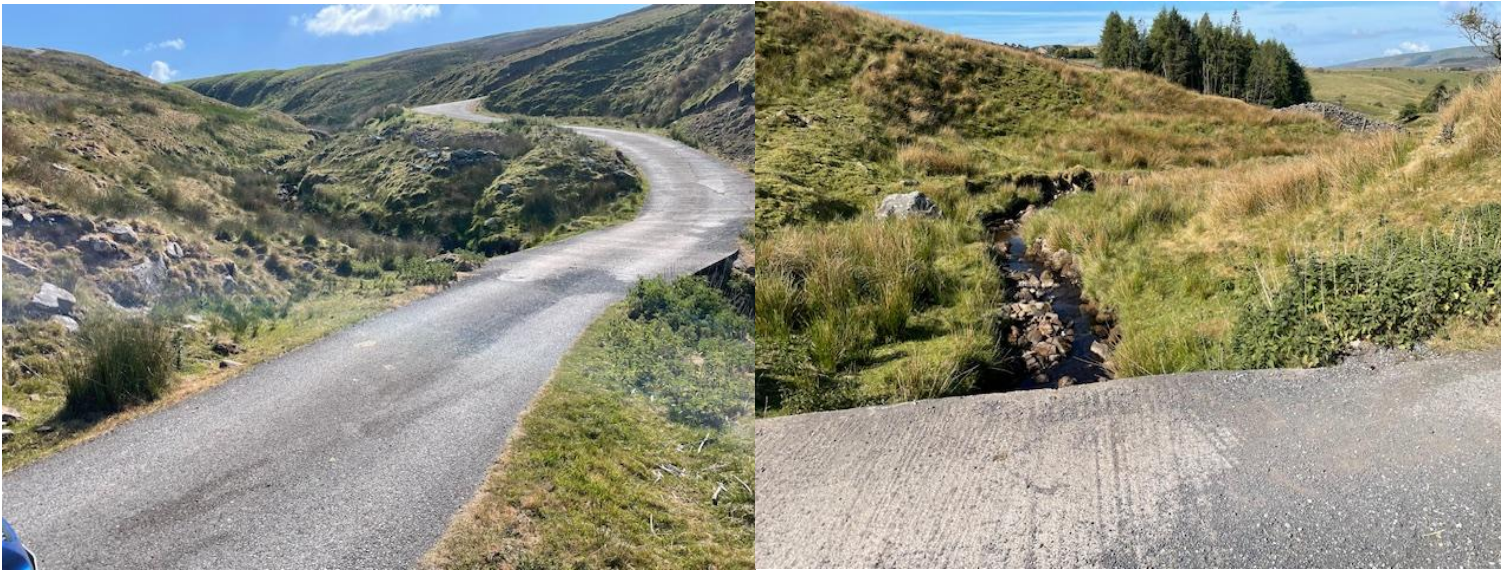
Upstream and downstream images. The land falls significantly to the downstream. The applicant and residents at Stone Fold have never witnessed flooding. No flooding in Storm Desmond.

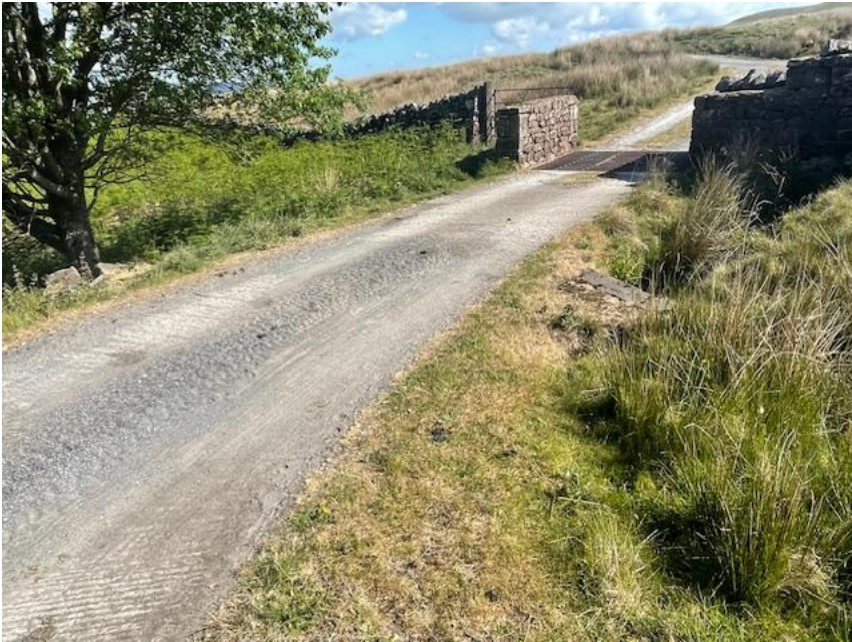
Ref: S2

Minor drainage culvert. Downstream land falls approx. 4 metres within 10 metres of the culvert. No flooding of road ever recorded.

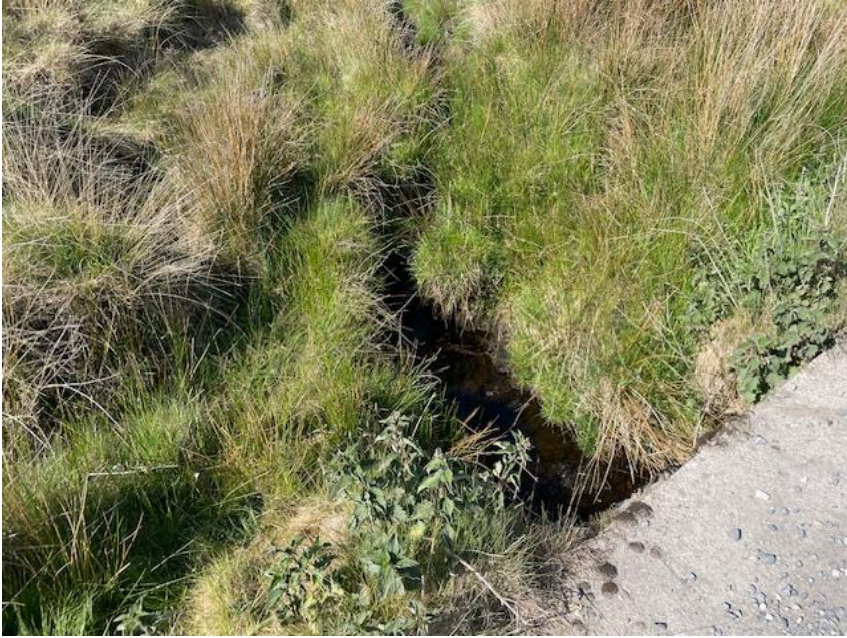
Ref S3

Minor drainage culvert. Land level falls steeply downstream. No history of flooding ever recorded.

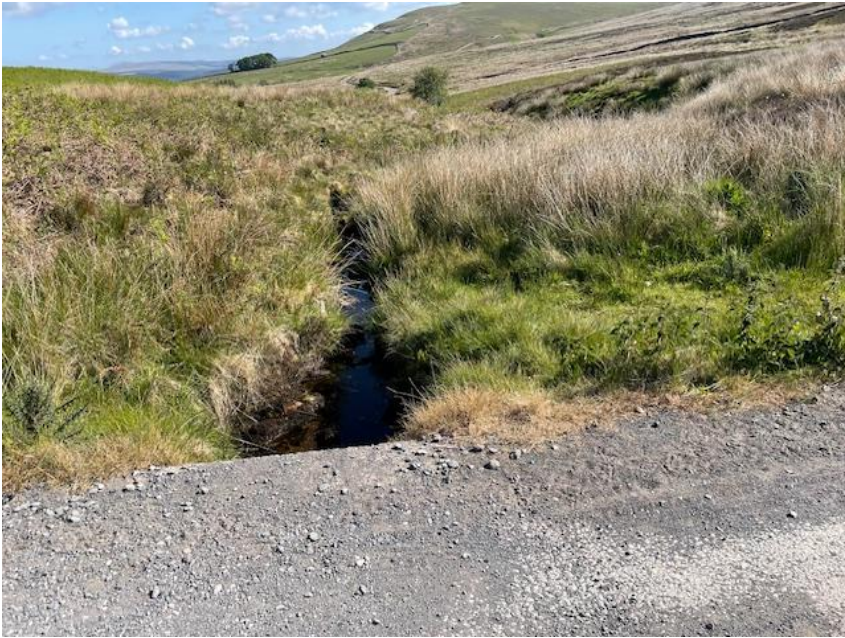
Ref S4

Un-named stream. Land falls sharply downstream. Site has experienced flooding to approx. 10mm in storm events.
