Preliminary Roost Assessment

21 Berry Lane
Longridge
Preston
PR3 3JA

For
Alex Dewhurst

Gritstone Ecology

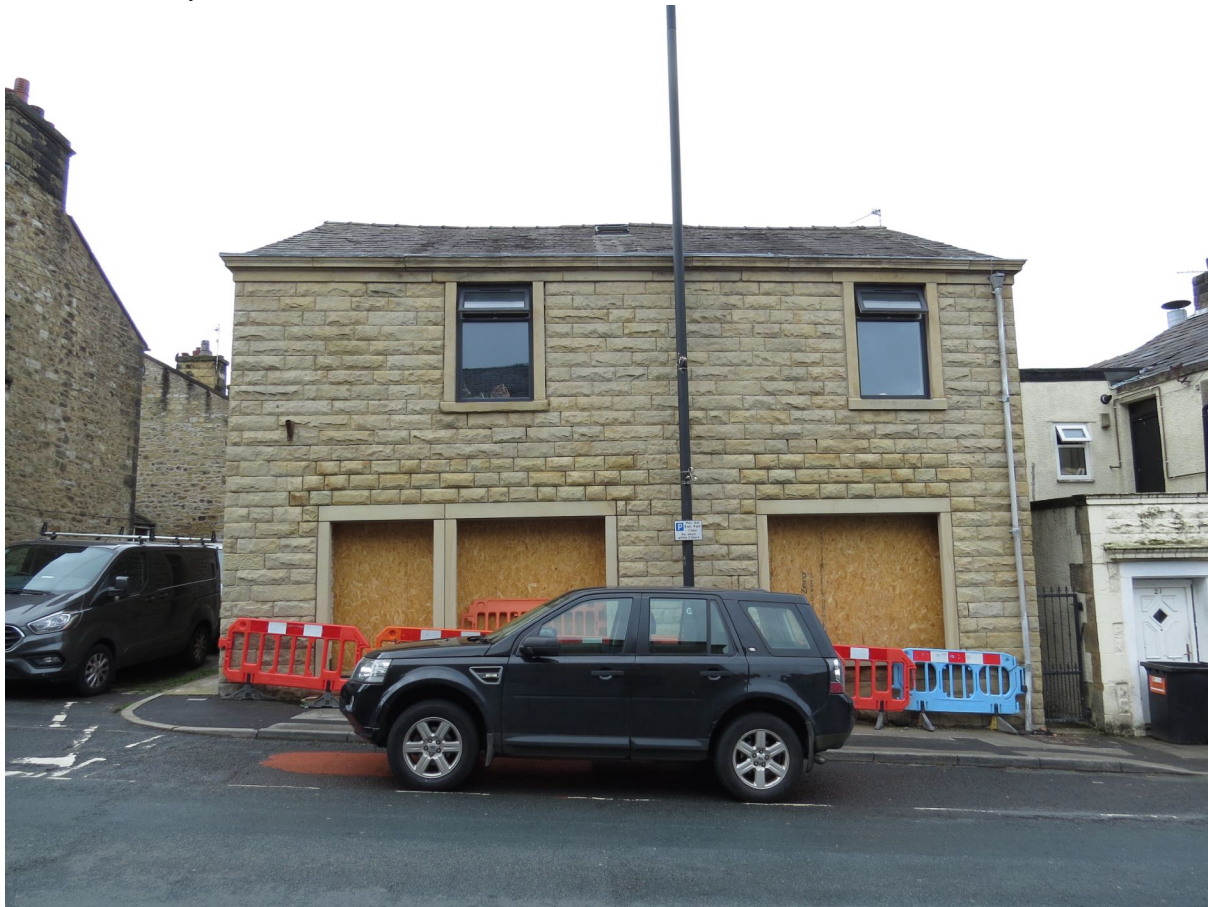
3.1a – The front of the building from Berry Lane.

The building is well maintained, and in good condition. Ridge tiles are fixed tightly, there are no damaged or missing ridge tiles. There are no missing roof tiles. Roof tiles are tightly fitted, with no viable gaps between tiles. Lead flashing is fitted tightly against stonework with no viable gaps. Stonework is in good condition, with no missing mortar or cracks.

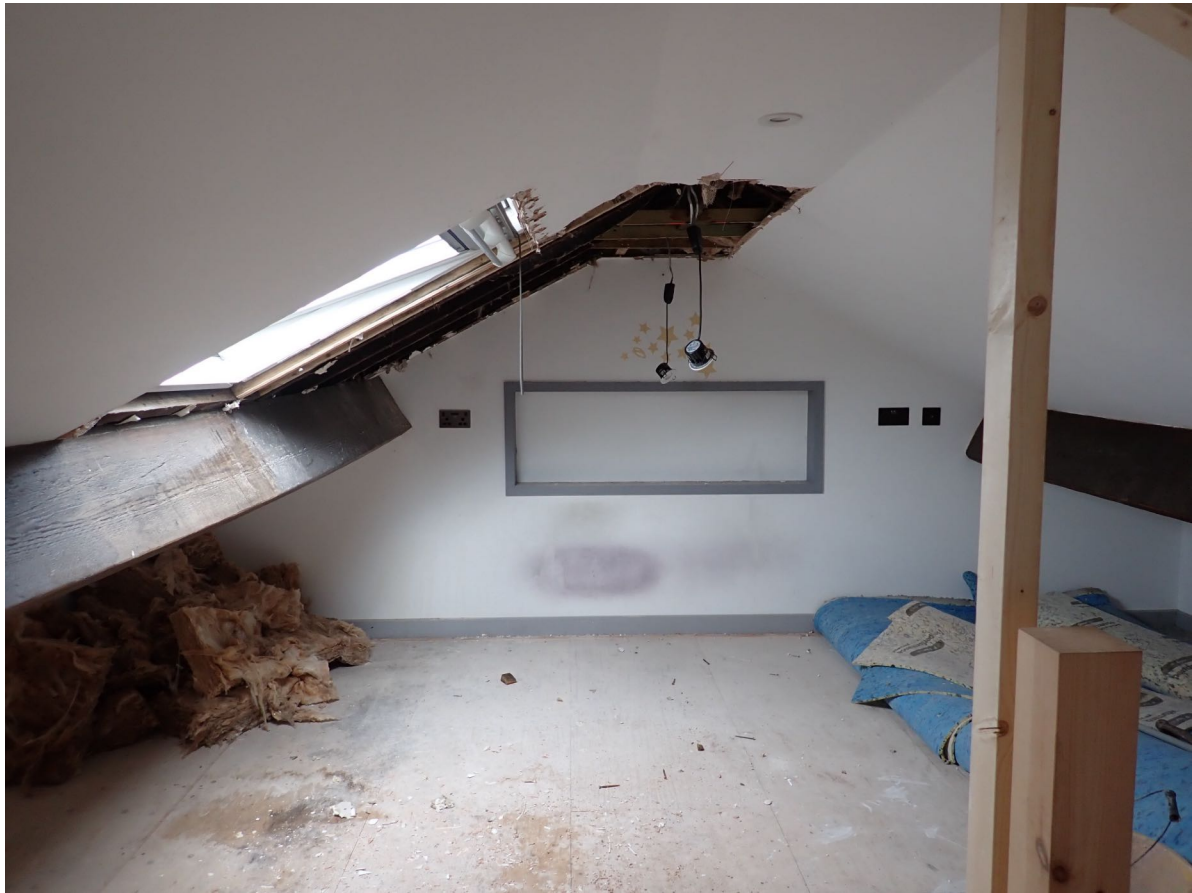
3.2a – The roof void.

The roof has a timber rafter and purlin structure, lined with bitumen felt, and insulated with mineral wool between the rafters. A small area of the plasterboard had been removed to allow inspection. The roof lining is in good condition with no tears, or gaps.

There are no gaps at the eaves or gables; and there are no gaps which give direct access to the building from the outside.

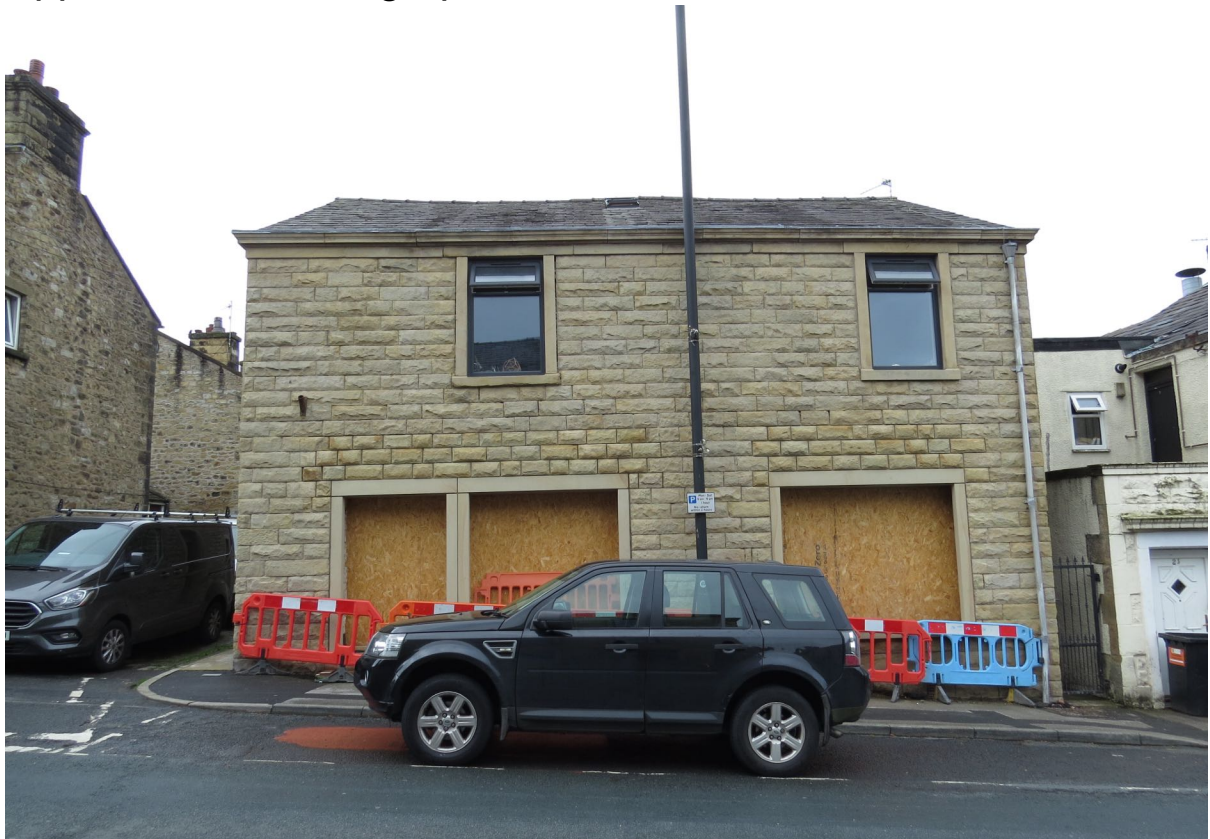
1 – The front of the building.

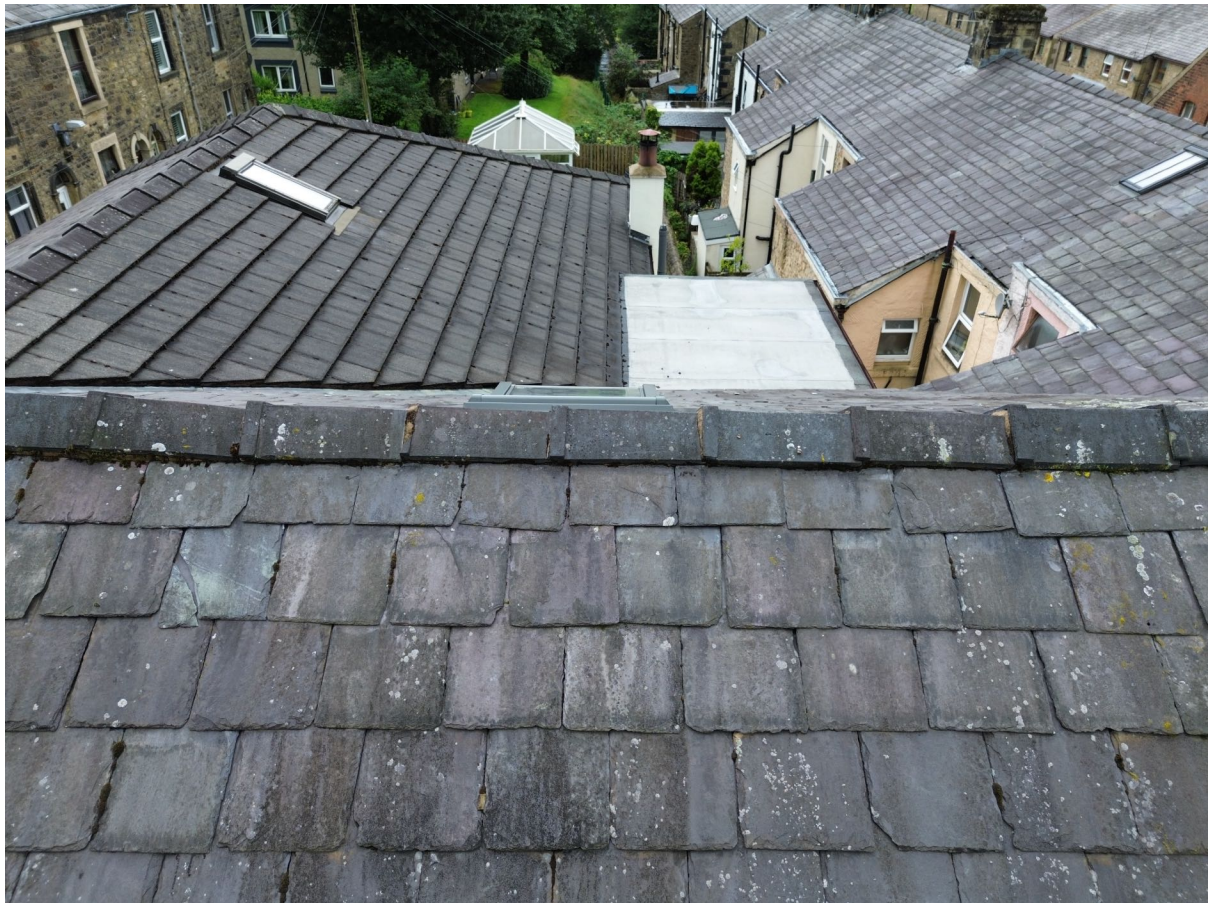
Roof and ridge tiles are in good condition; tiles at the gable end verges are sealed with cement. There are no gaps between roofing materials which could be used by roosting bats.

2 – Roof and ridge tiles are in good condition with no suitable gaps.

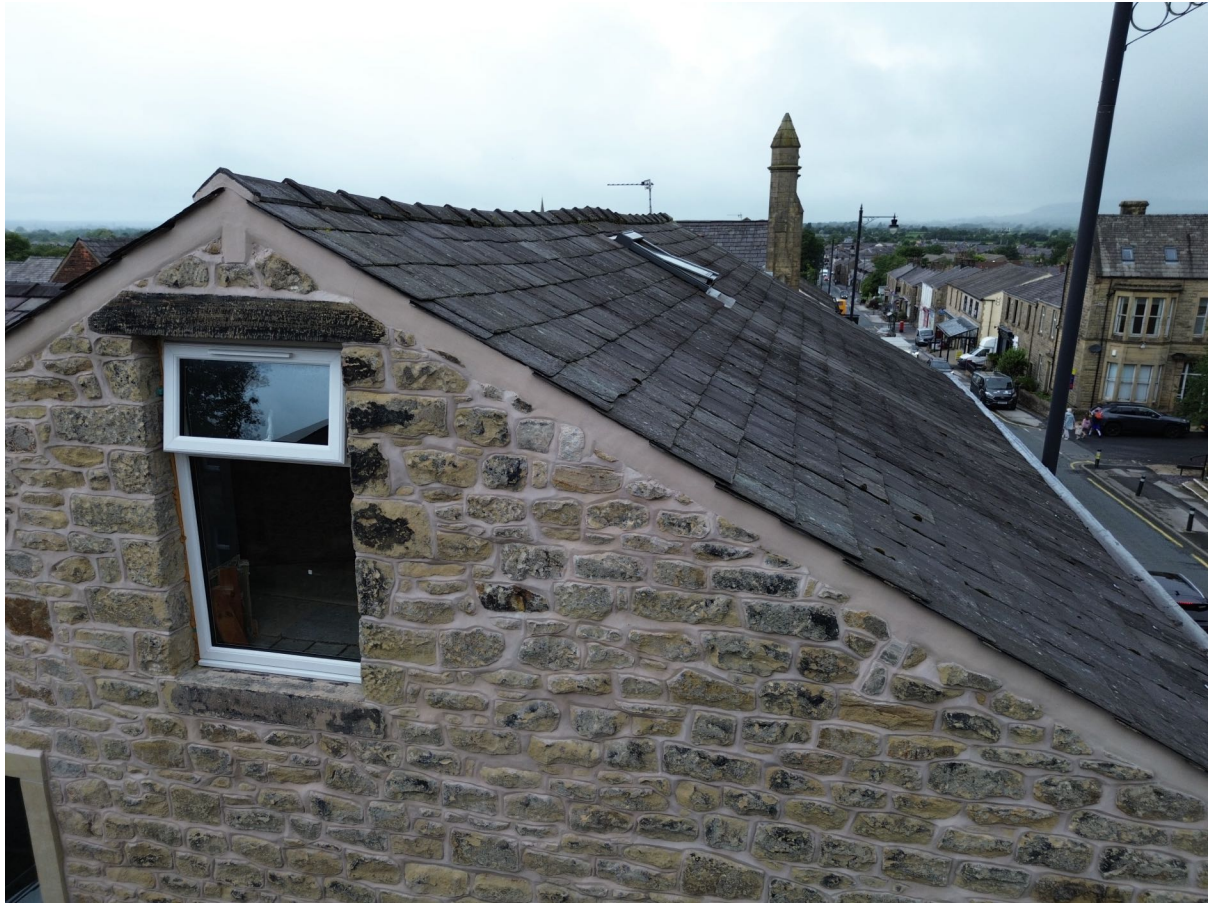
3 – Cement at the gable end verges is in good condition with no viable gaps.

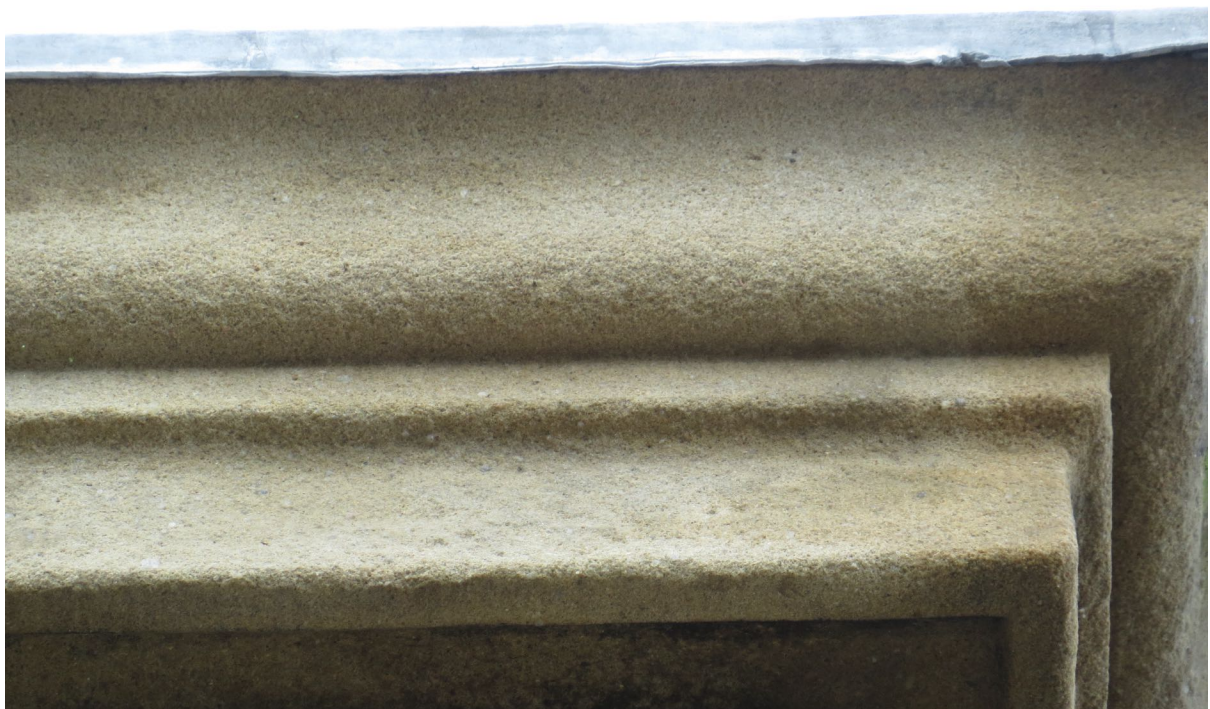
Lead flashing in the hidden gutters and in roof valleys and chimneys is fixed tightly against tiles and stonework, with no suitable gaps.

4 – Stonework and hidden gutters at the eaves are in good condition with no viable gaps.

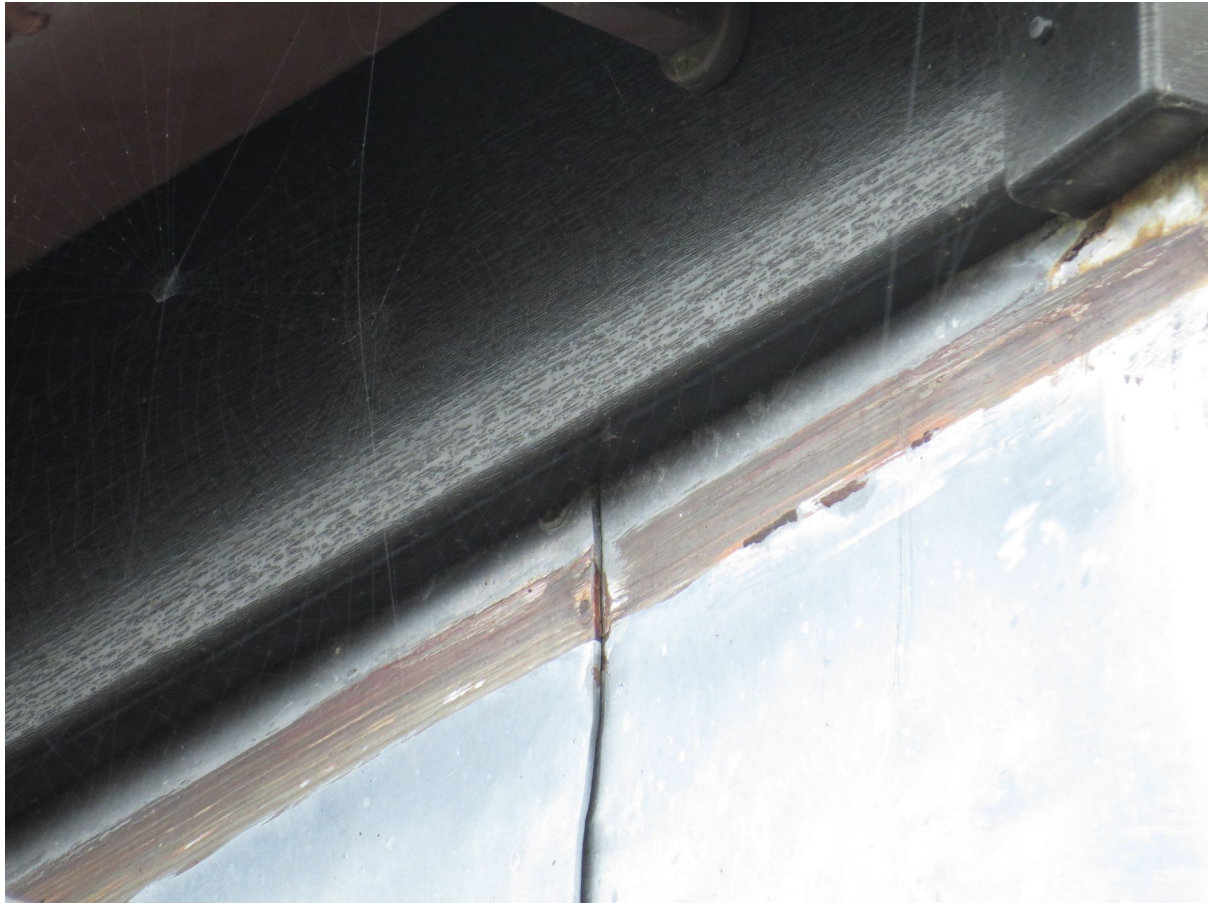
5 – Where present, fascia, and lead flashing are fitted tightly with no suitable gaps.

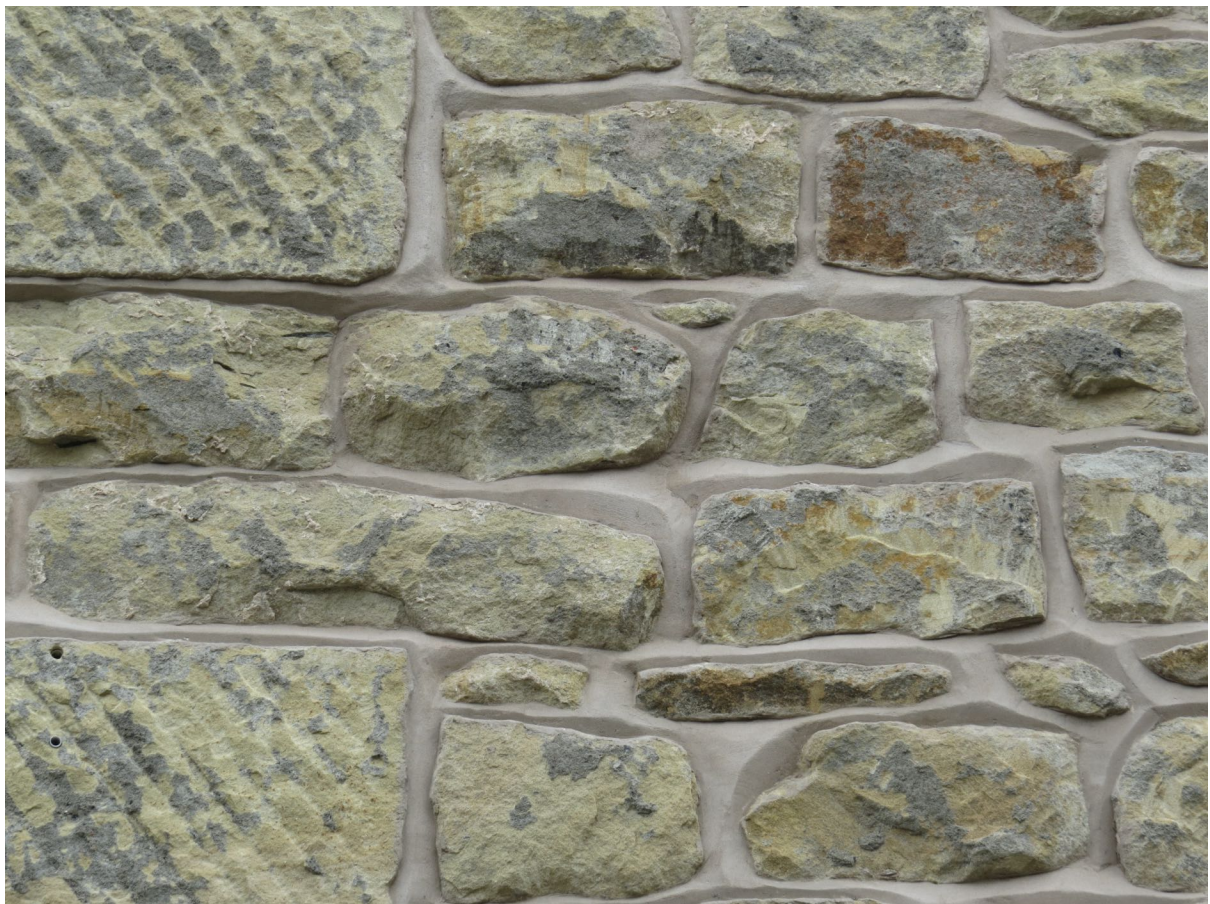
Walls are solid stone blockwork with no insulating cavity. Walls are in good condition, with no cracks, or missing mortar which could be used by crevice dwelling bats.

6 – Stonework and mortar are in good condition with no suitable gaps.

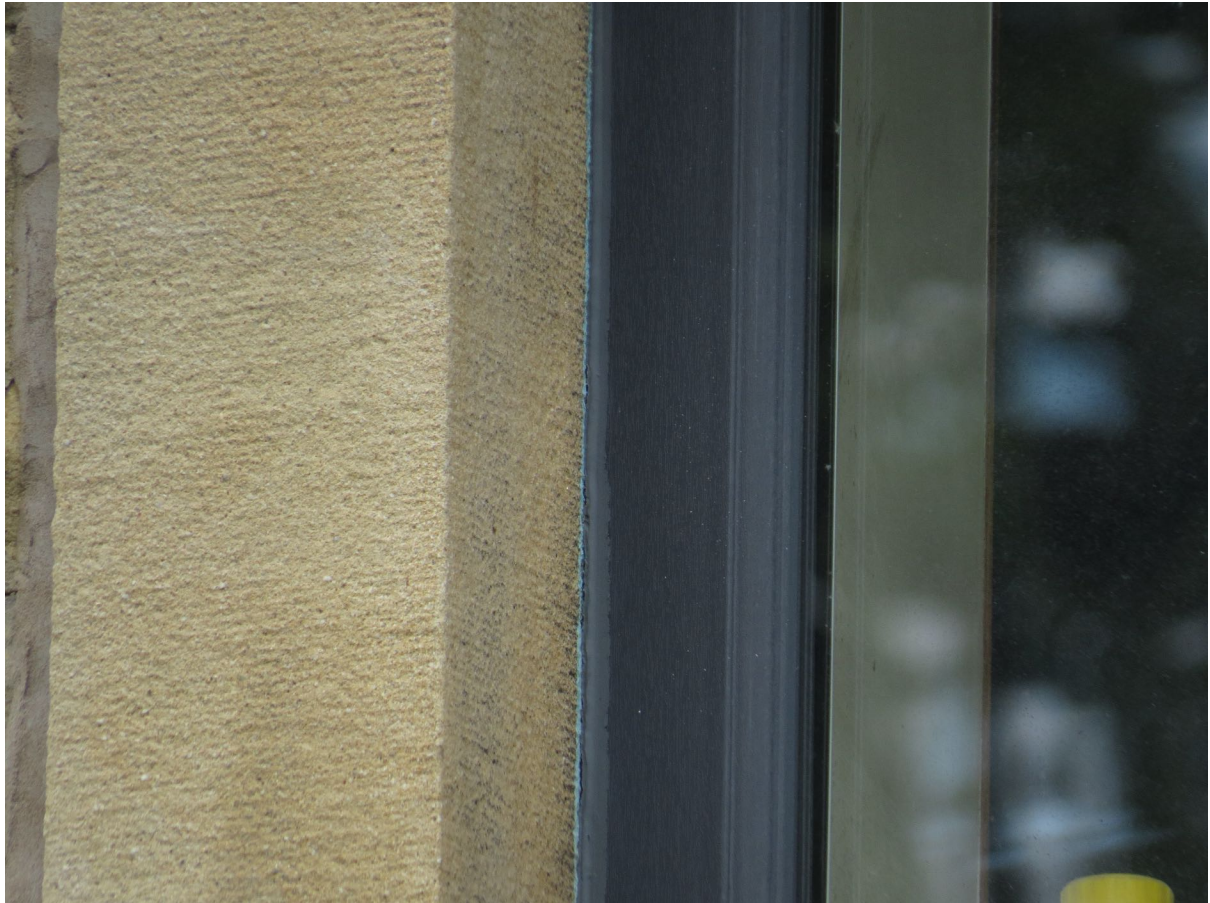
Window and door frames are fixed into the brickwork, gaps are filled with sealant, and offer no suitable roosting opportunities.

7 – Window and door frames are tightly sealed into stonework with no suitable gaps.

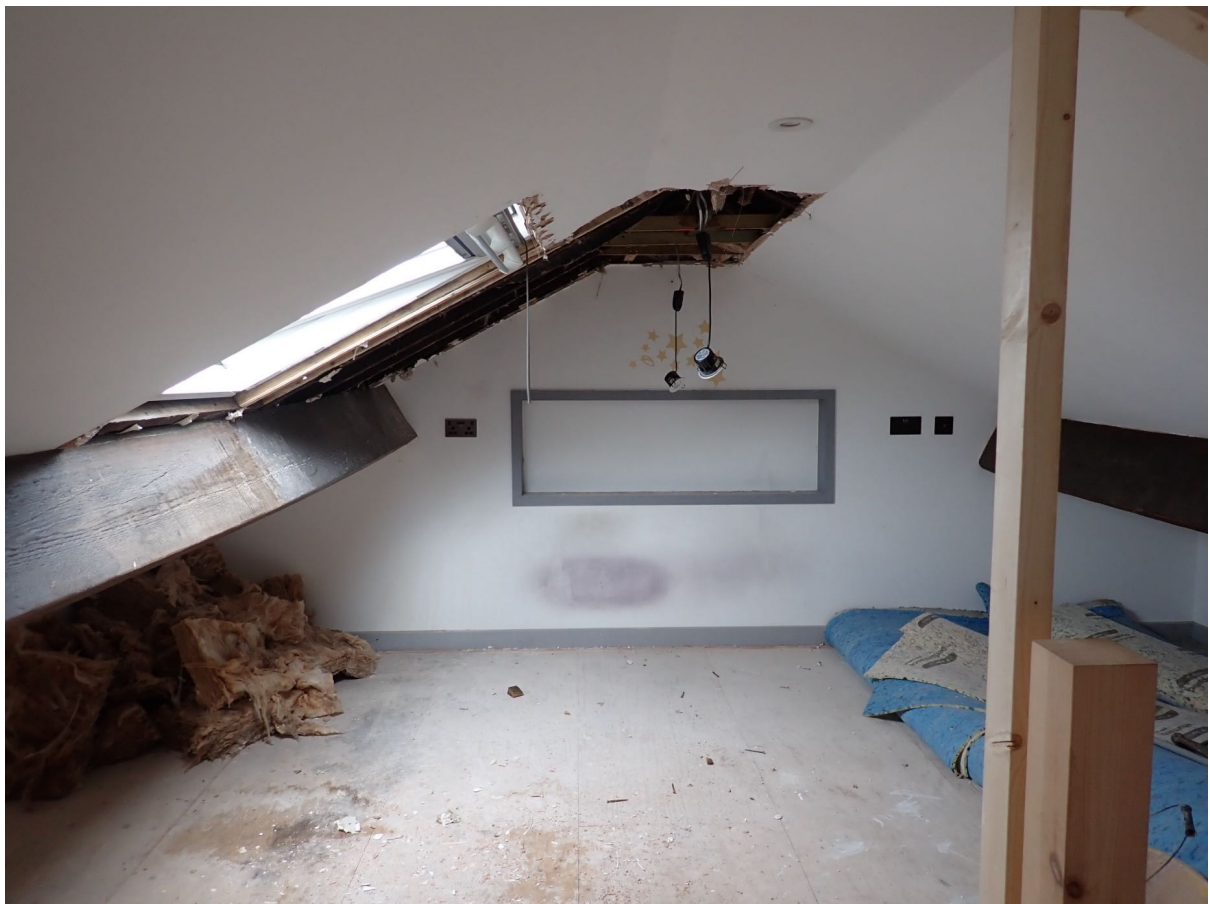
The building has a single roof void, which has been converted into habitable space, with plastered walls and ceilings.

8 – The roof void of the building has been converted to habitable space.
