# Tree Condition Survey

Survey Location: Pendle Hill View  
BB7 9XS

Client: Estate Management  
Solutions

Ref: TS\_PHV\_EMS\_V1

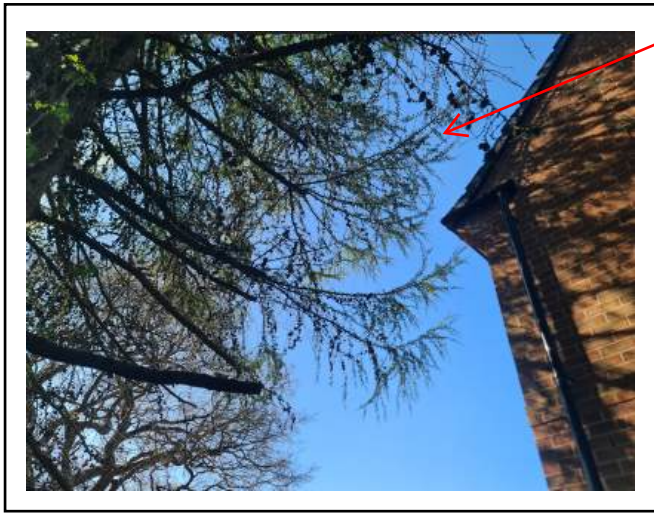
Larch (T1)

To rear of 15 Sheepfold Close.

Rear of 15 Sheepfold Cres – Larch – Lateral reduction to create 2m clearance with property.

Lateral reduction to create 2m clearance with property.

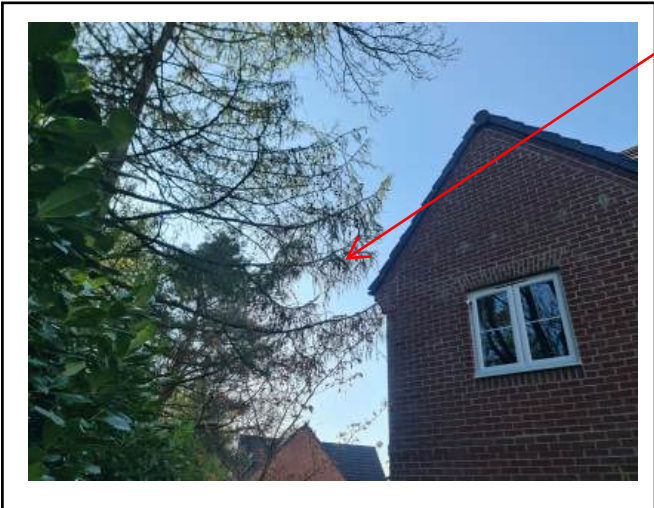
Larch (T2)

Affecting 28 Sheepfold Close.

Opposite 28 Sheepfold Cres – Larch – Lateral reduction to create 2m clearance with property.

Lateral reduction to create 2m clearance with property.

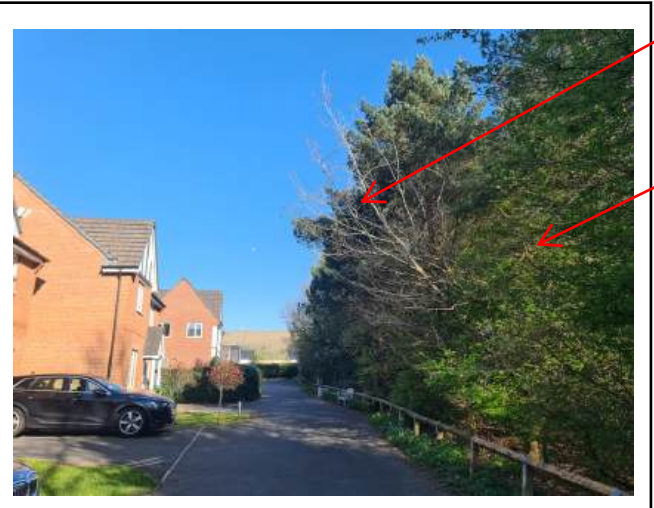
Oak (T4)

Opposite 22 Sheepfold Close  
Minor lateral reduction to reduce encroachment.

Opposite 24 Sheepfold Close  
Prune back to boundary.

Opposite 24 Sheepfold Cres 1 x hawthorn

Opposite 22 Sheepfold Cres – Early mature oak – Lateral reduction of 2m where extending towards property.

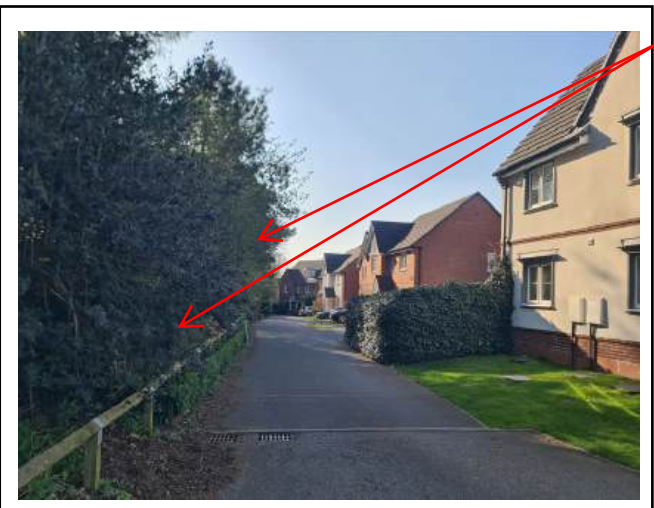
2 x Elder (G1A)

Opposite 18 Sheepfold Close

Opposite 18 Sheepfold Cres 2 x elder

Prune back to boundary

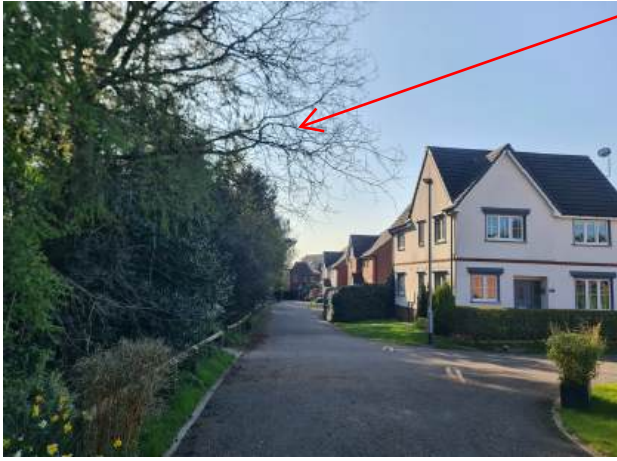
Oak (T5)

Opposite 29 Sheepfold Close

Opposite 29 Sheepfold Cres – Early mature oak. Crown lift to 4m over road by lateral reduction of lowest branches.

Crown raise to 4m over road by lateral reduction.

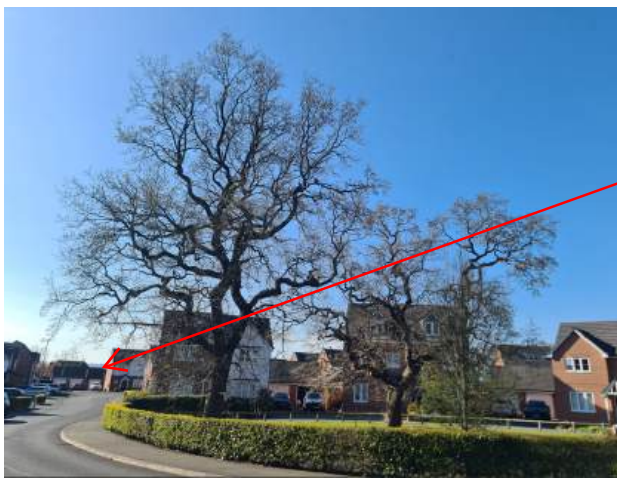
Oak (T171)

Crown raise of lowest drooping branches.

2.4m over pavement and 5.2m over road.

Minor pruning where canopy extending over pavement and road to maintain clearance of 2.4m over pavement and 5.2m over the road.

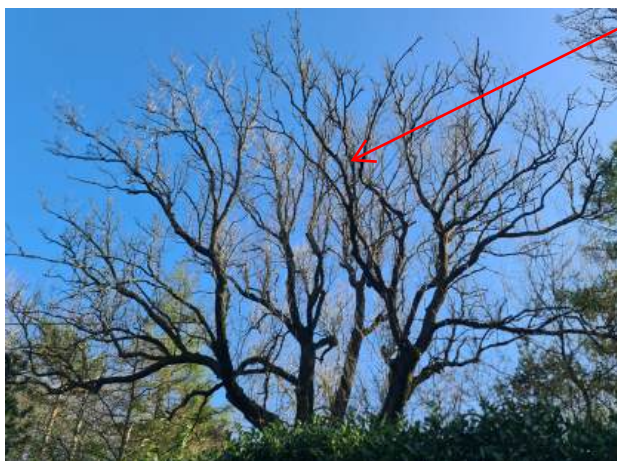
T169 was previously considered as a **Tolerable** risk at the time of the previous inspection. Approval was granted for removal of the canopy to retain a section of stem for habitat (see appendix 5). At present it remains a **Tolerable** risk.

The risk level will likely increase to **Not Tolerable** at the time of the next inspection in 2028.

T169 - Advanced ash dieback.

Crown made up entirely of epicormic growth.

This tree is displaying signs of advanced ash dieback and is estimated to be cat 3/4 with in the region of 25-50% remaining live crown which is mostly made up of epicormic growth.

Whilst it is currently a tolerable risk consideration needs to be give to the safety of contractors that may need to dismantle this tree in the future as the risk increases.

**It is recommended that this work is carried out prior to this date in the interests of contractor safety and to reduce the risk of harm to people or damage to property as the tree continues to decline.**

Previously approved for remedial works to create a monolith for habitat (see appendix 5).

Permission expires on 9/11/25

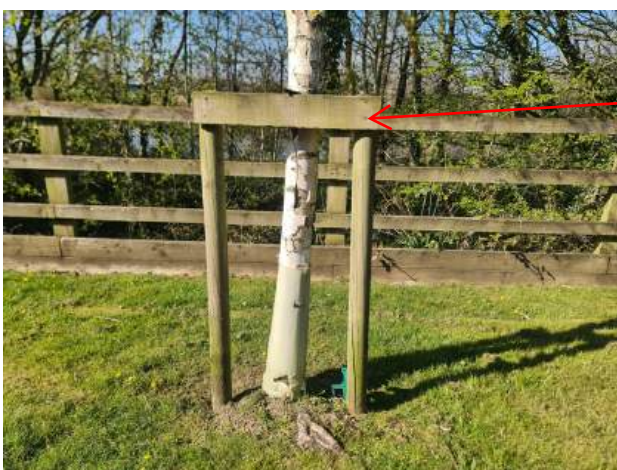
As recommended in the tree schedule (appendix 1) and identified in the 2022 tree survey the remaining stakes and supports to the trees within G3 require removal to stop the potential for damage to the stems. Damage to the cambium layer can lead to decay, loss of vitality or failure of these trees.

Remaining tree supports still require removal to avoid damage to stems.

Strimming around the base of trees is not to take place as this results in damage to the cambium layer, exposing sap wood which can lead to decay and dysfunction.

Wherever the control of grasses and weeds around tree stems is required the use of herbicide or a geotextile membrane topped off annually with wood chip mulch is recommended.

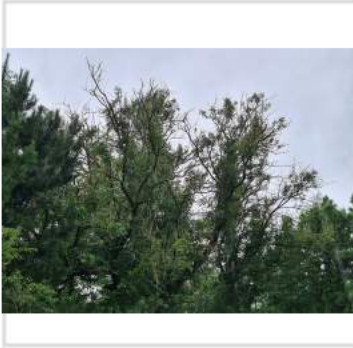
### Ash (T169)

The highest risk is failure of secondary limbs.

As this tree is in terminal decline it is recommended that an application to fell this tree is submitted for felling as soon as a decision notice is received.

If desired, the main stem could be retained (at a height no greater than the distance from the nearest target) to create a habitat feature in the interests of biodiversity.
