BOWLAND SURVEYORS LTD.

Window condition schedule and proposed intervention

Reference: 2025-21 | Version 2.0

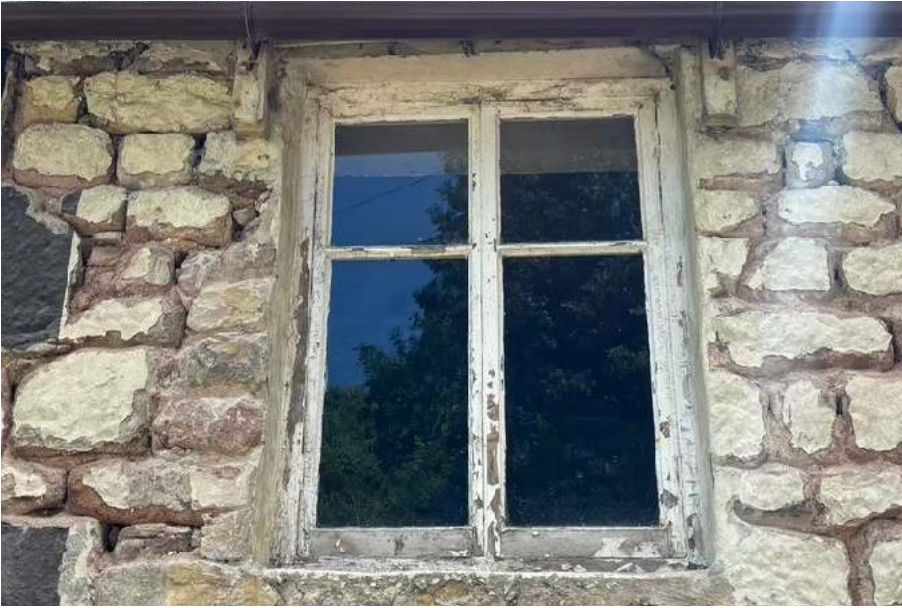
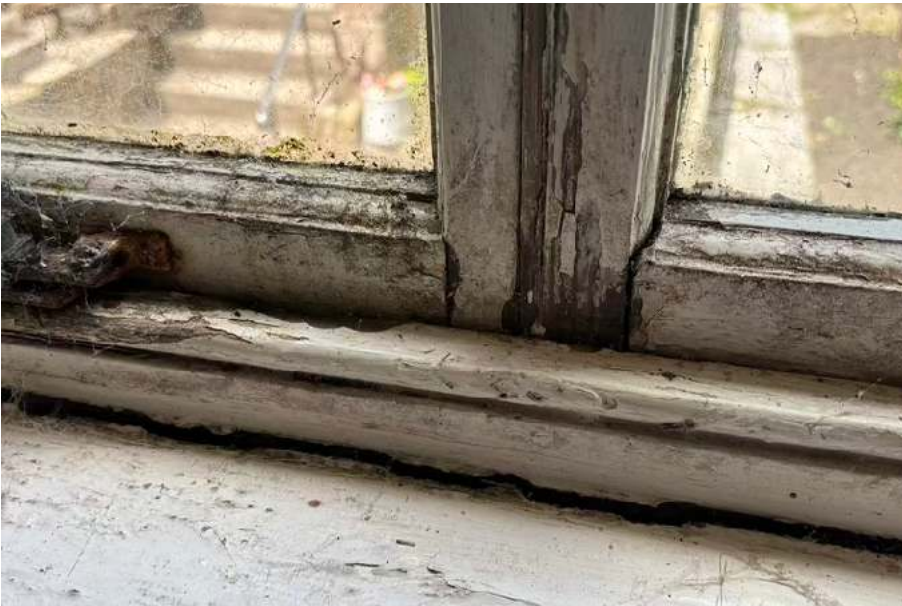
WINDOW 1

Casement window dating to the mid C20th. Poor quality with failure to tenons apparent. Poor condition throughout with decay to cill, frame legs, rails and beads.

Replace like-for-like. Hardwood frame, painted white with narrow profile double glazing.

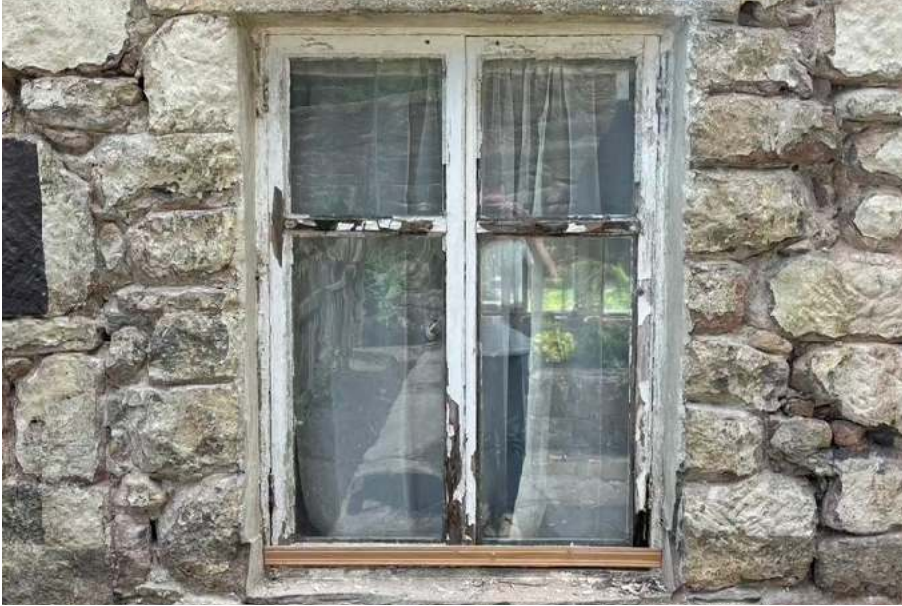
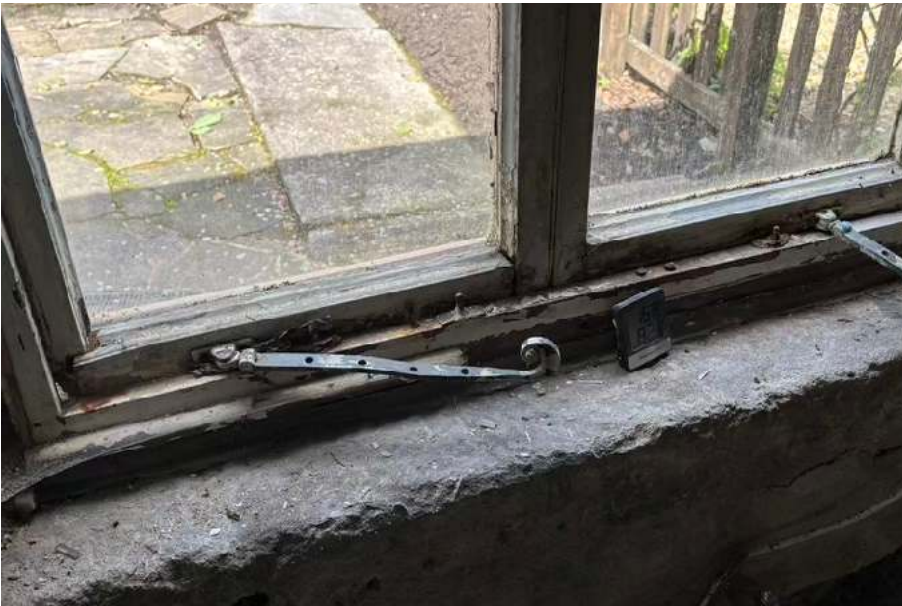
WINDOW 2

Casement window dating to the mid C20th. Poor quality with failure to tenons apparent. Poor condition throughout with extensive decay to cill, frame legs, rails and beads.

Replace like-for-like. Hardwood frame, painted white with narrow profile double glazing.

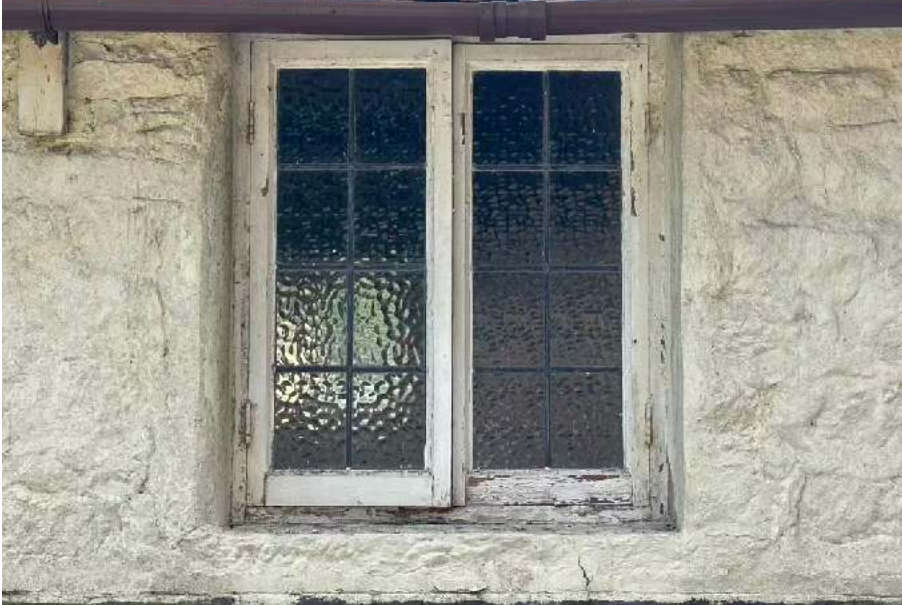
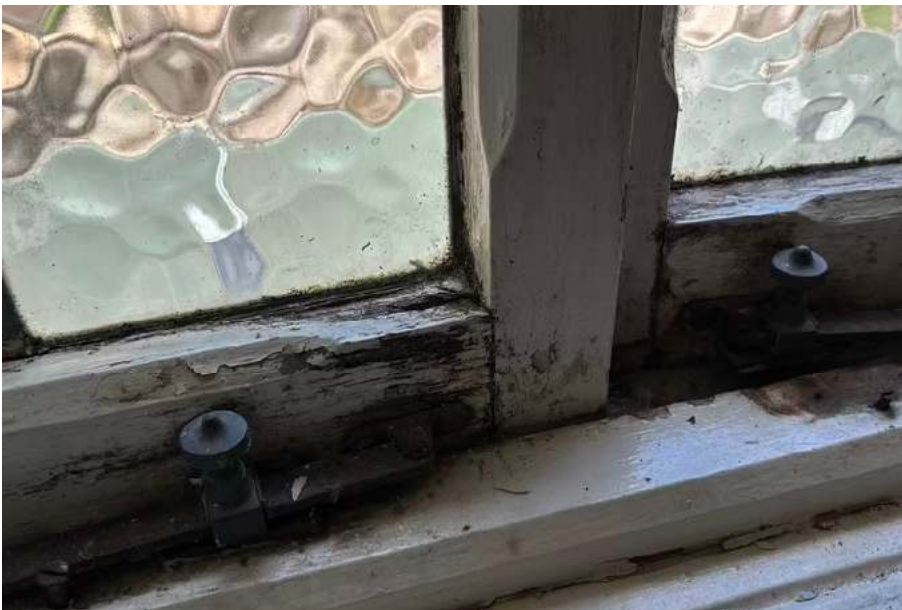
WINDOW 3

Casement window dating to the mid C20th. Poor quality with failure to tenons apparent. Poor condition throughout with decay to cill, frame legs, rails and beads.

Replace like-for-like. Hardwood frame, painted white with narrow profile double glazing. Without the obscured glass or lead detailing.

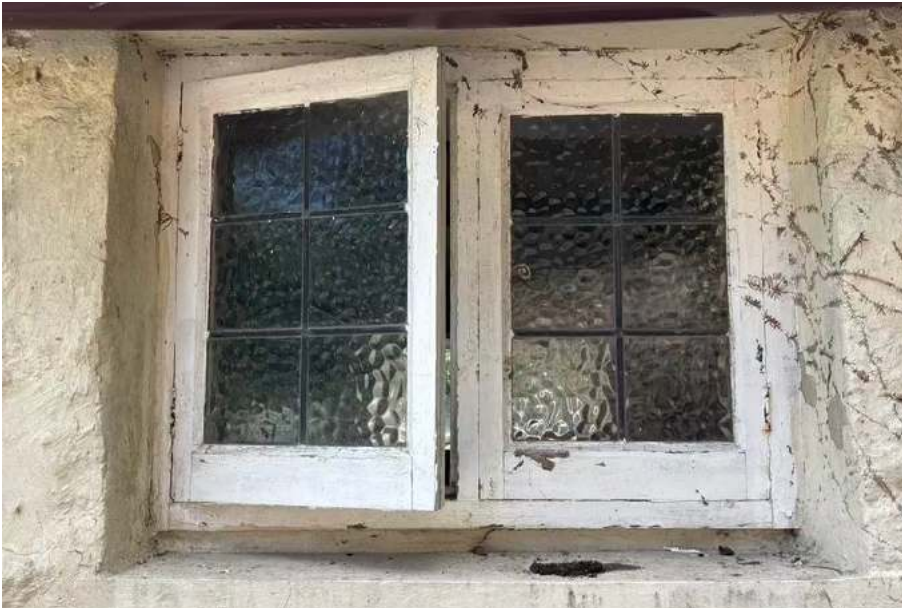
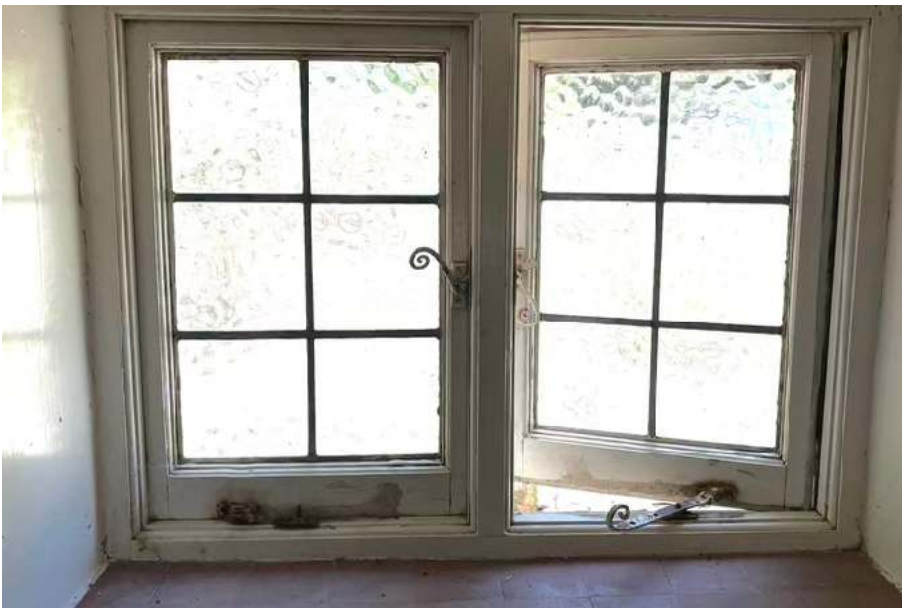
WINDOW 4

Casement window dating to the late C20th. Poor quality and poor condition throughout.

Replace like-for-like. Hardwood frame, painted white with narrow profile double glazing. Without the obscured glass or lead detailing.

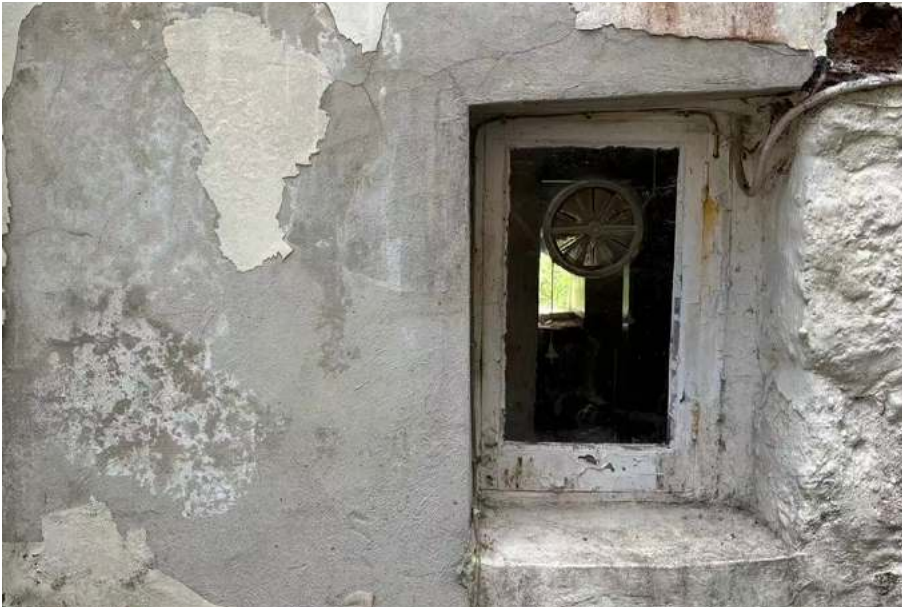
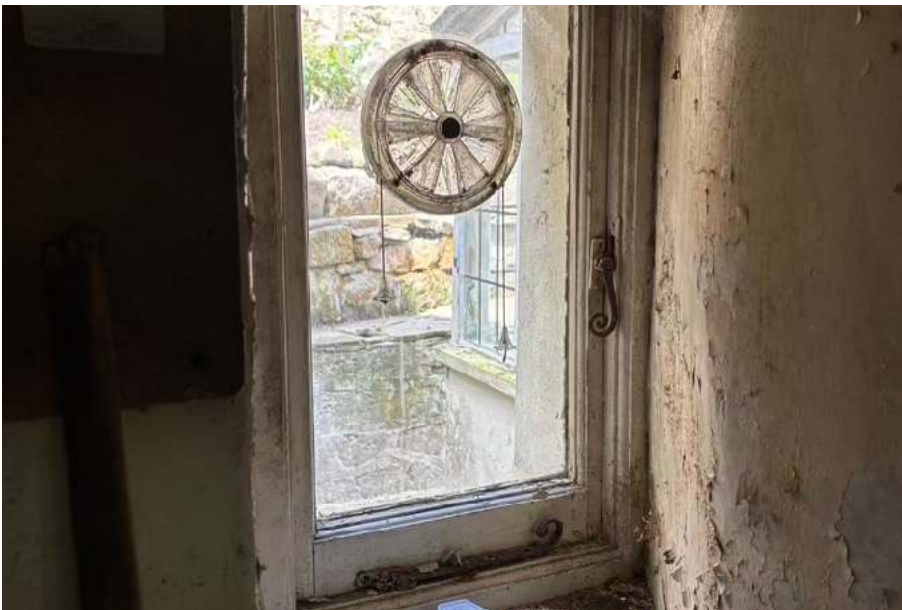
WINDOW 5

Casement window dating to the mid C20th. Poor condition throughout.

Reinstate original window opening, replace rotten lintel and fit hardwood frame, painted white with narrow profile double glazing.

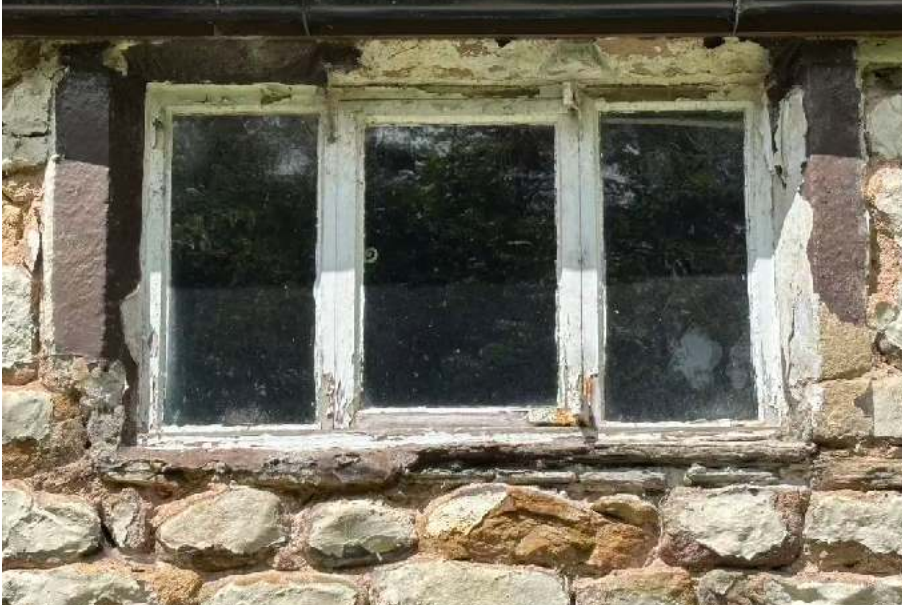
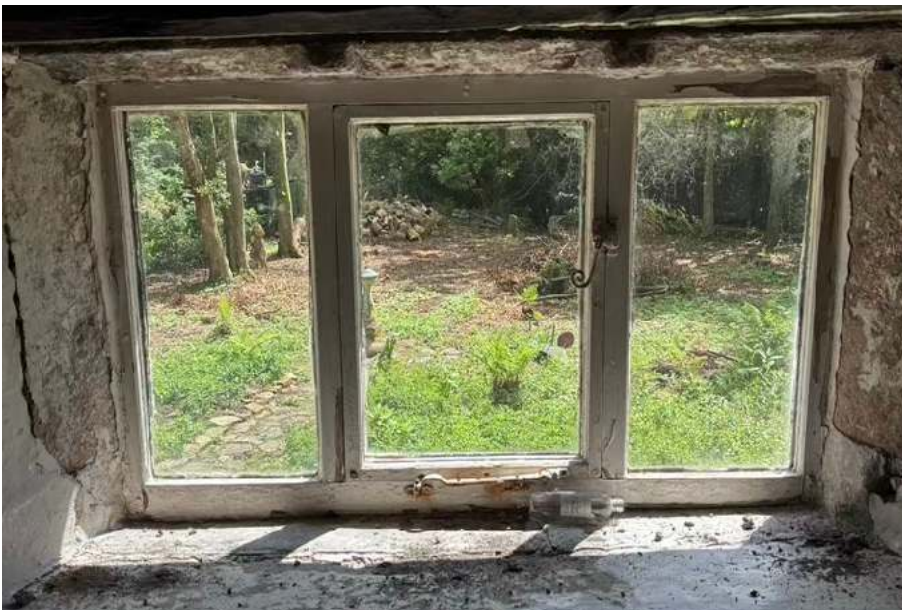
WINDOW 6

Casement window with fixed panes either side, dating to the late C20th. Poor quality with failure to tenons apparent. Poor condition throughout with decay to cill, frame legs, rails and beads.

Replace like-for-like. Hardwood frame, painted white with narrow profile double glazing.

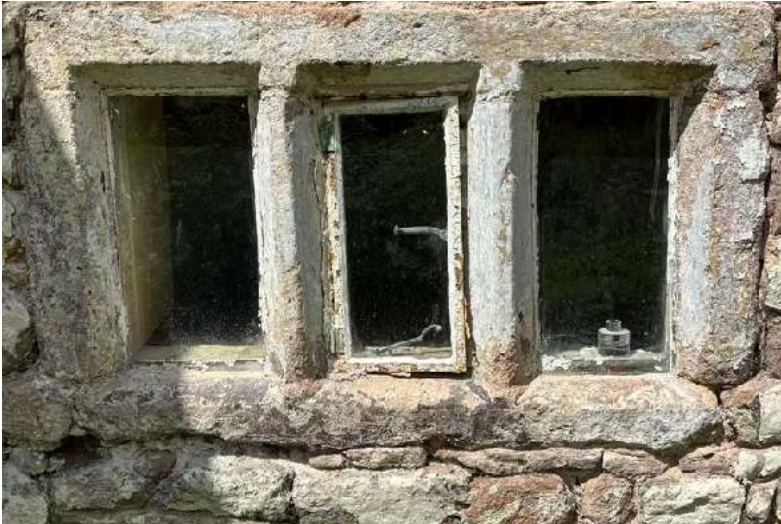
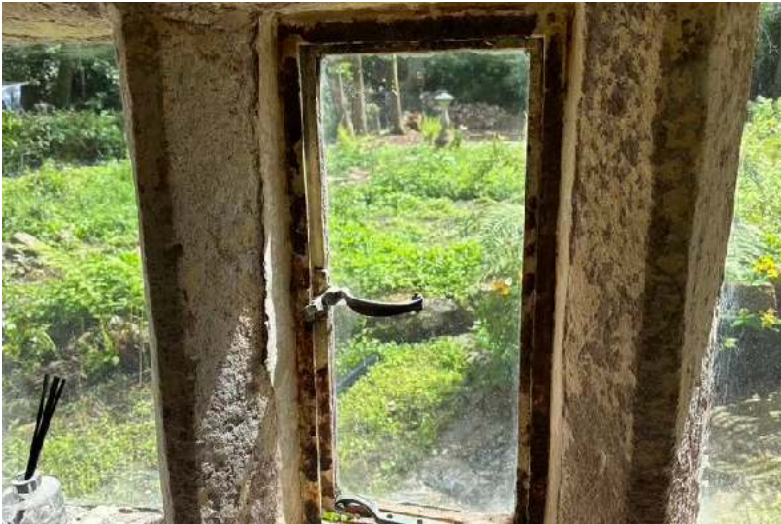
WINDOW 7

Central opening; iron framed casement, mid-C20, seized, deflected, corroded and beyond practical repair. Replace with hardwood frame, side-hung casement, single light, painted white with narrow profile double glazing.

Side openings: existing glass seated within stone with putty. Replace with narrow profile double glazing, no frame as existing.

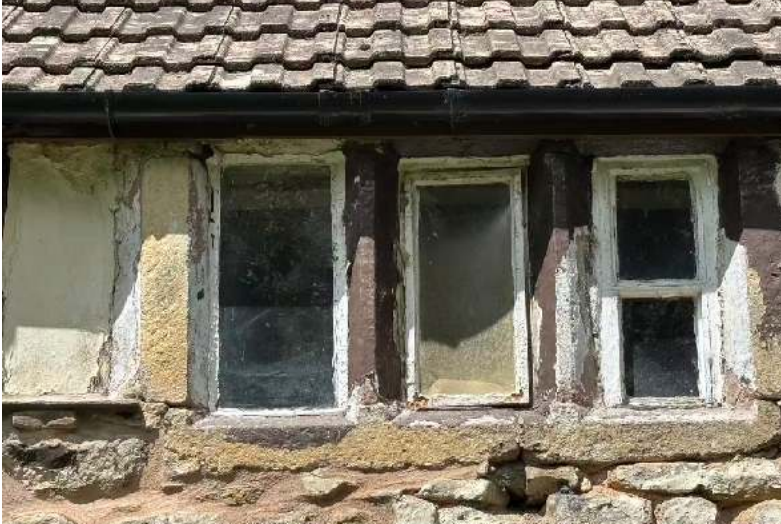
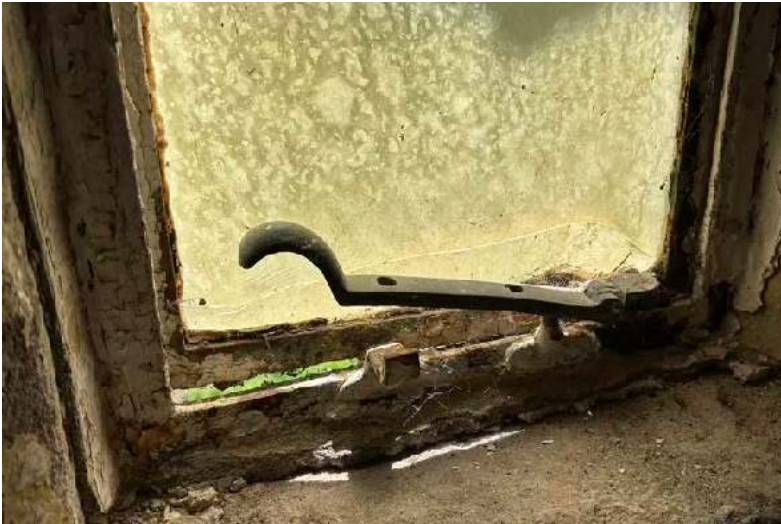
WINDOW 8

Central opening; Iron framed casement, mid-C20, seized, deflected, corroded and beyond practical repair. Replace with hardwood frame, side-hung casement, single light, painted white with narrow profile double glazing.

Side openings: Left - existing glass seated within stone with putty. Replace with narrow profile double glazing, no frame as existing. Right - Mid C20th timber frame,, two light fixed window, poor condition throughout. Replace with narrow profile double glazing, no frame.

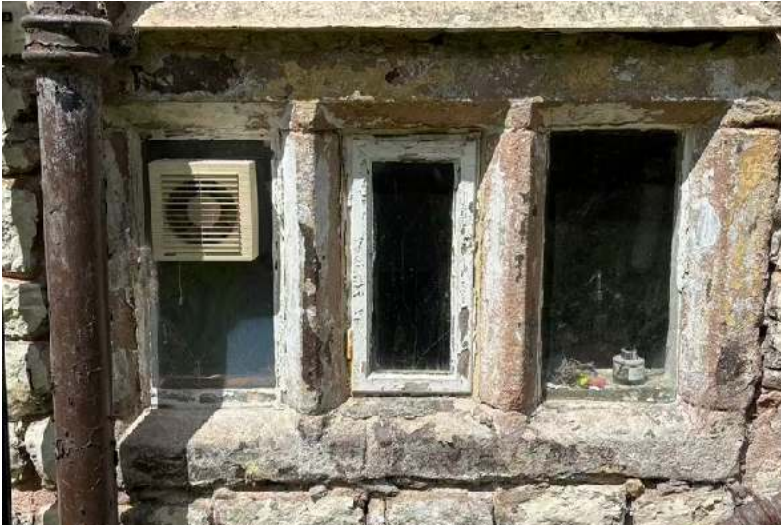
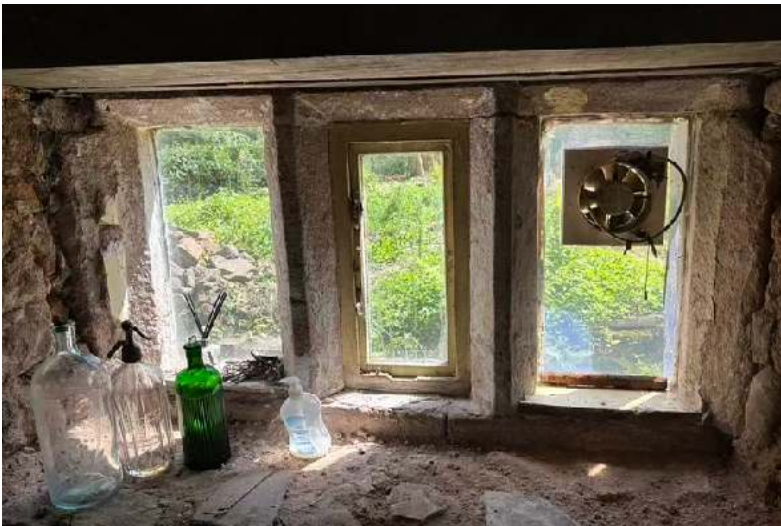
WINDOW 9

Central opening; Timber framed casement mid C20, poor quality and in poor condition. Replace like-for-like with hardwood frame, side-hung casement, single light, painted white with narrow profile double glazing.

Side openings: Existing glass seated within stone with putty. Replace with narrow profile double glazing, no frame as existing.

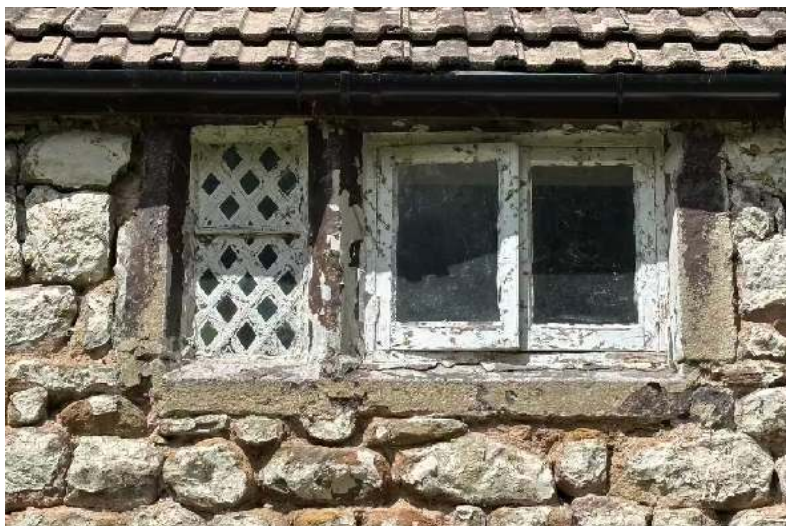
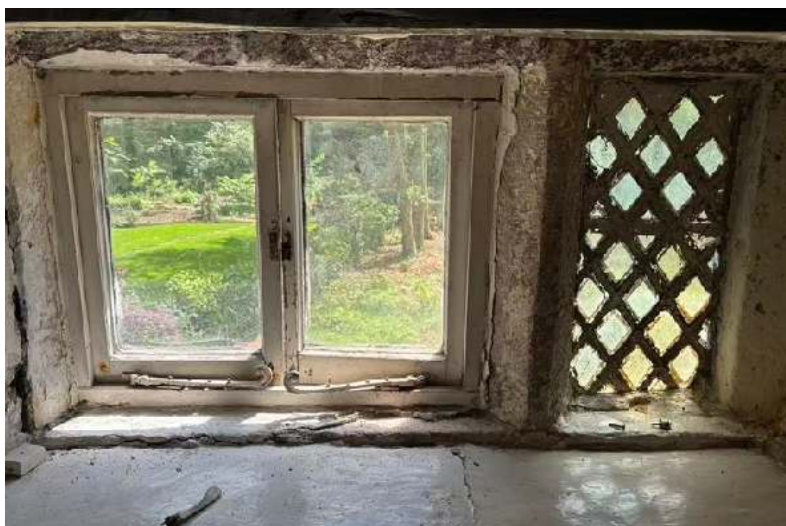
WINDOW 10

Right window mid/late C20th timber-framed casement. Poor quality and poor condition throughout with decay to cill, frame legs, rails and beads. Replace like-for-like. Hardwood frame, painted white with narrow profile double-glazing.

The diamond-patterned pane is in poor condition and comprises a mixture of glass pieces, some of which are broken, along with plastic repair pieces. There also appears to be some lead in situ which has been covered over with tape and paint. This pane will be retained for assessment by a specialist glazier and refurbished if possible. To be secured by condition as discussed.

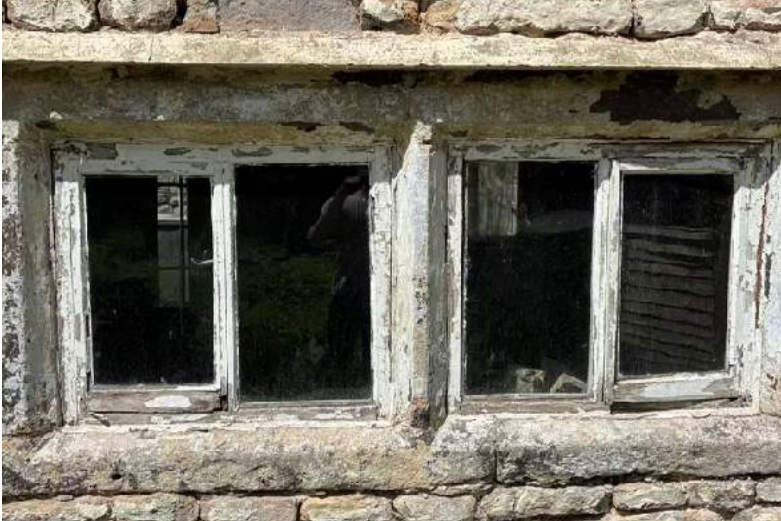
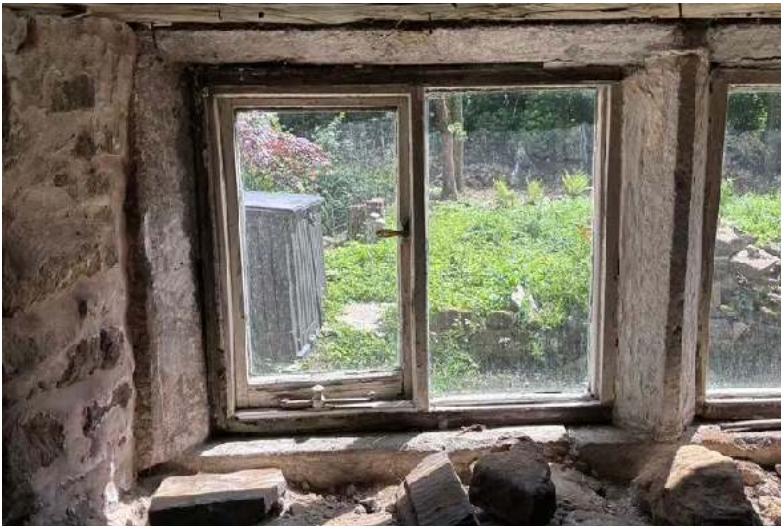
WINDOW 11

Mid C20th timber-framed casement. Poor quality and poor condition throughout with decay to cill, frame legs, rails and beads. Replace like-for-like. Hardwood frame, painted white with narrow profile double glazing.
