## BOWLAND SURVEYORS LTD.

Window condition schedule and proposed intervention

9 July 2025

Reference: 2025-21 | Version 1.0

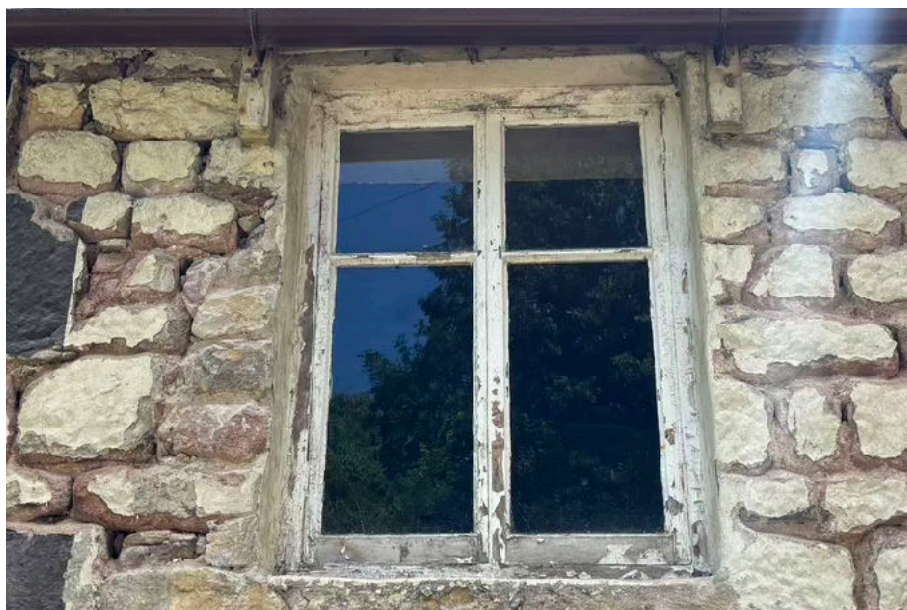
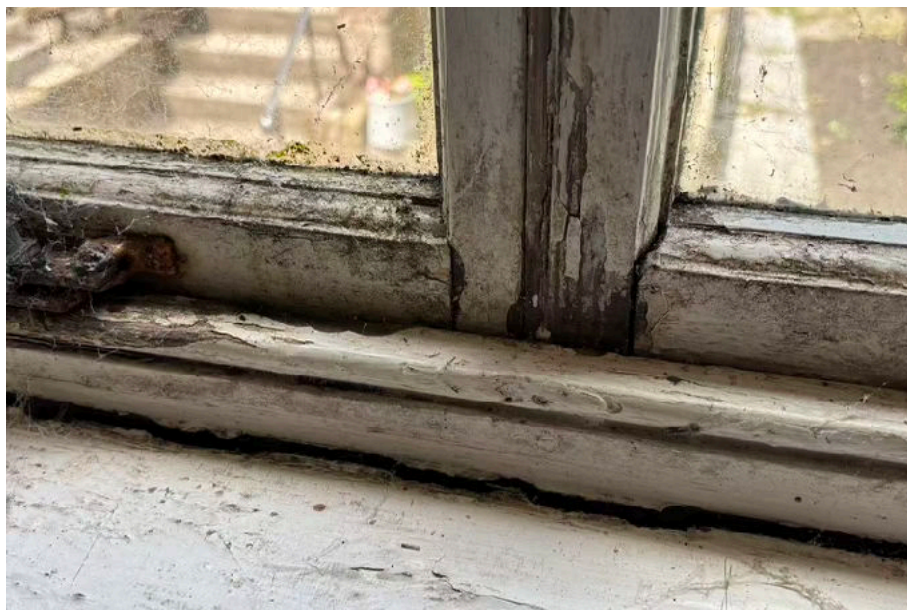
## WINDOW 1

Casement window dating to the mid C20th. Poor quality with failure to tenons apparent. Poor condition throughout with decay to cill, frame legs, rails and beads.

Replace like-for-like. Hardwood frame, painted white with narrow profile double glazing.

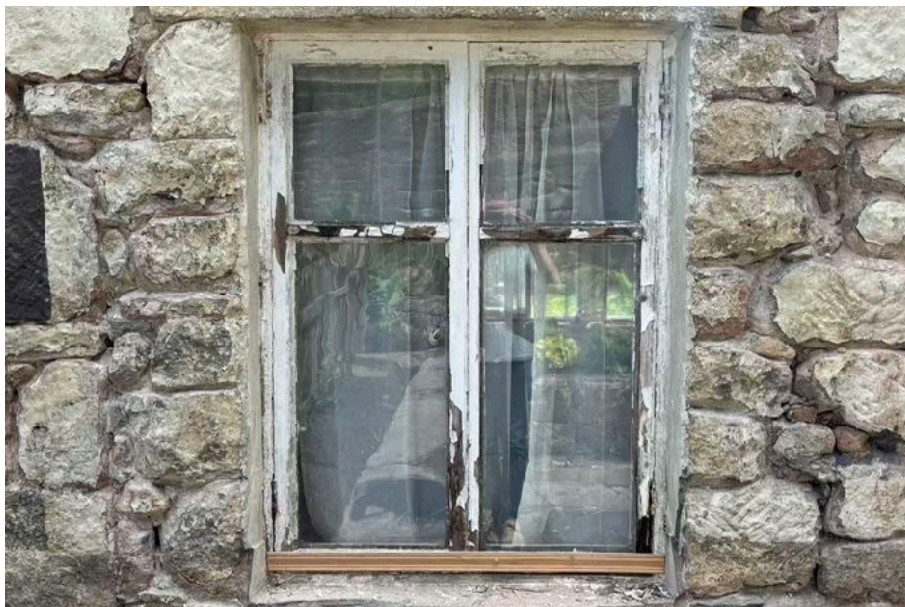
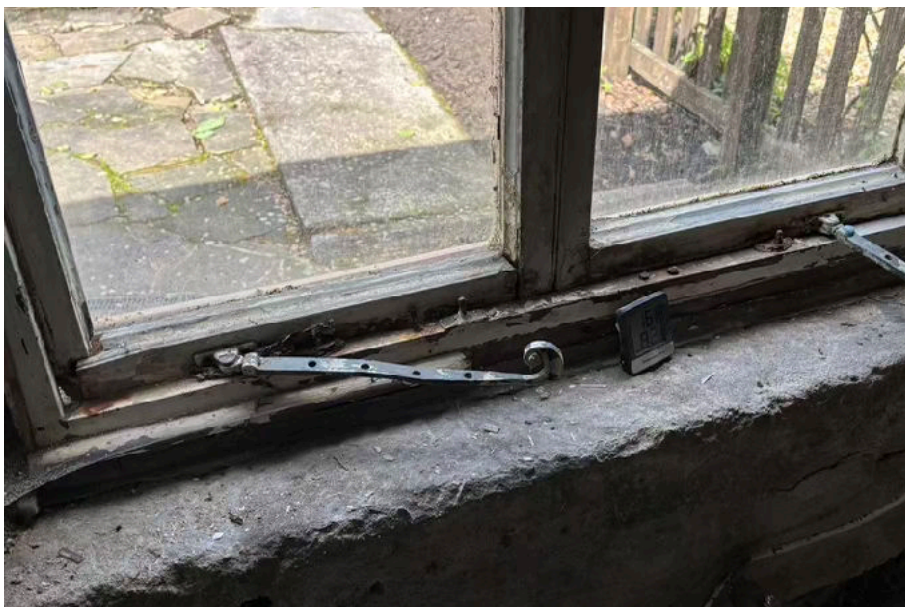
## WINDOW 2

Casement window dating to the mid C20th. Poor quality with failure to tenons apparent. Poor condition throughout with extensive decay to cill, frame legs, rails and beads.

Replace like-for-like. Hardwood frame, painted white with narrow profile double glazing.

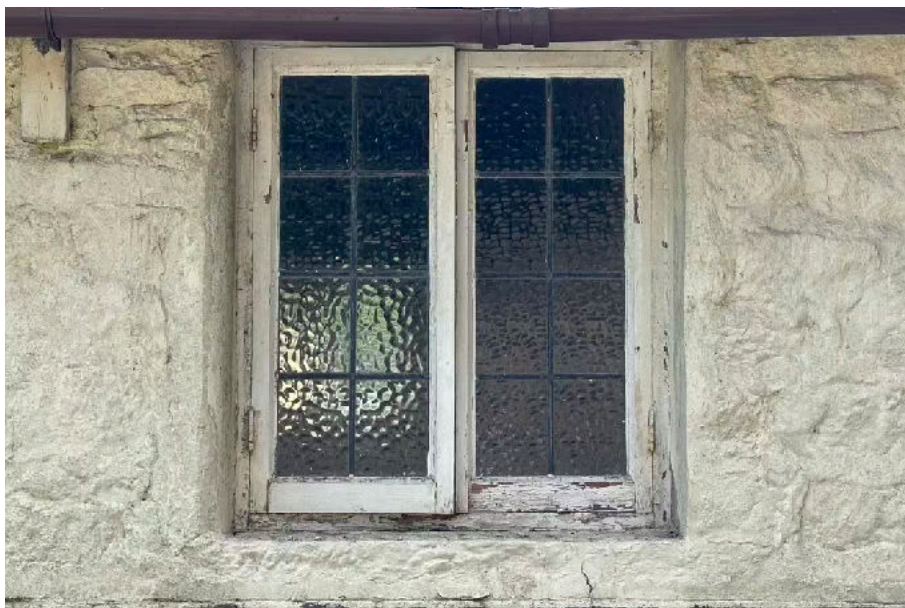
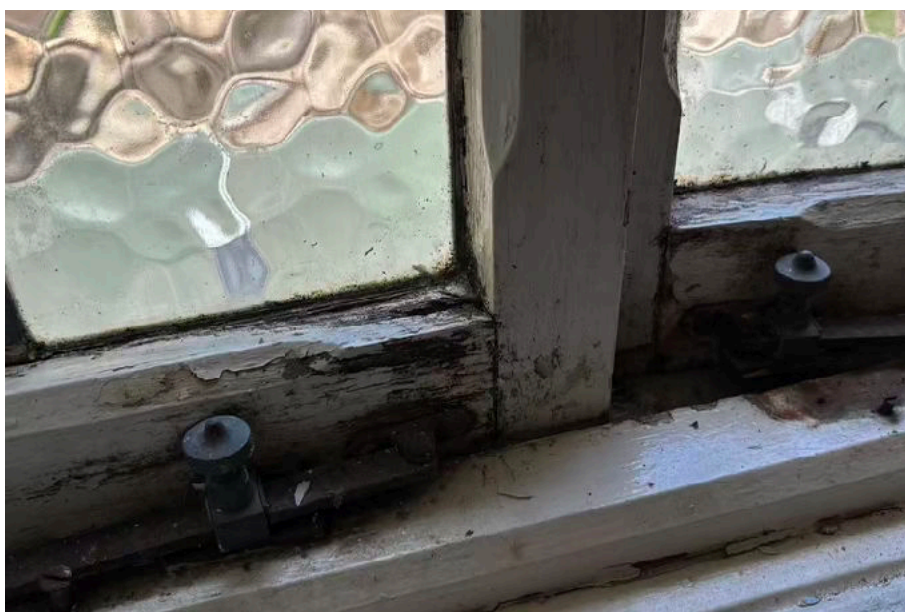
### WINDOW 3

Casement window dating to the mid C20th. Poor quality with failure to tenons apparent. Poor condition throughout with decay to cill, frame legs, rails and beads.

Replace like-for-like. Hardwood frame, painted white with narrow profile double glazing. Without the obscured glass or lead detailing.

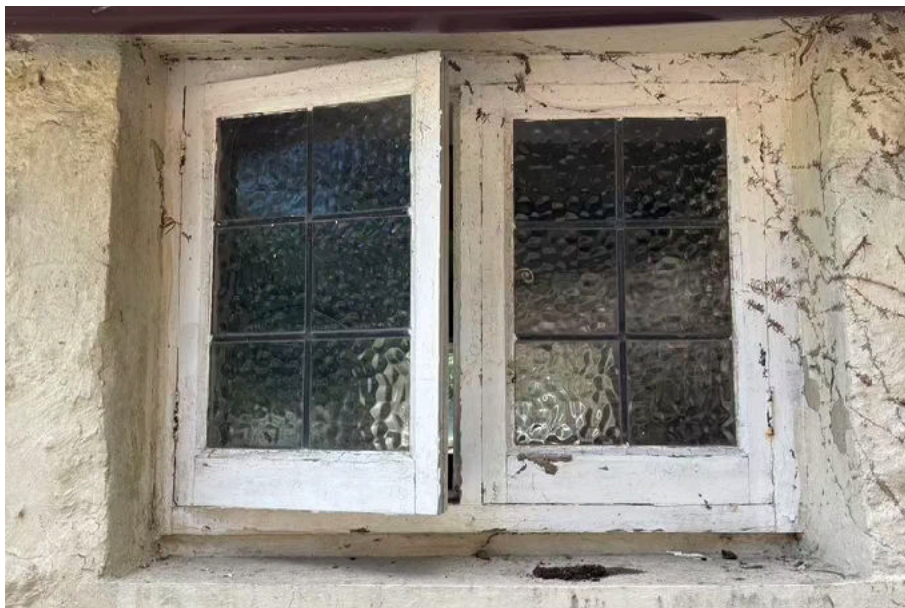
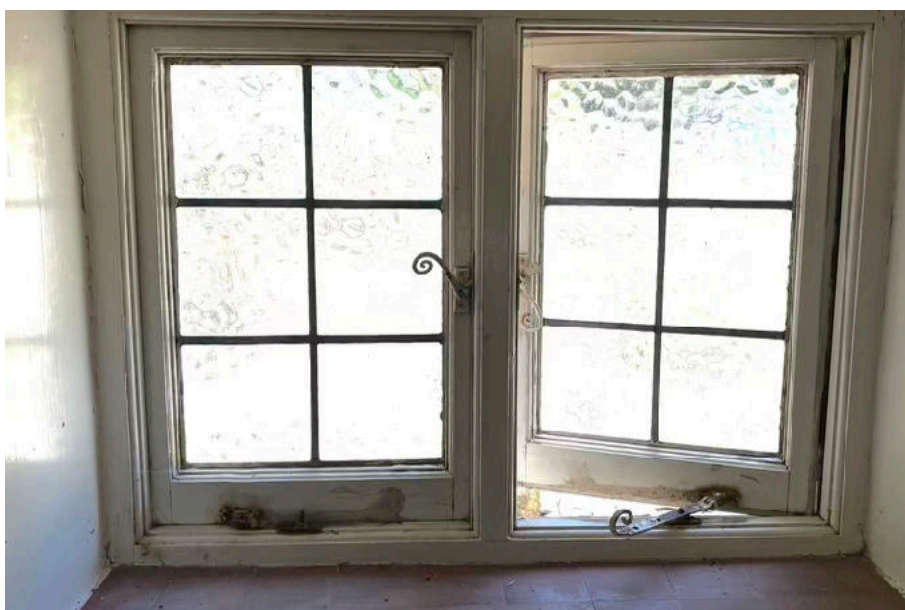
## WINDOW 4

Casement window dating to the late C20th. Poor quality and poor condition throughout.

Replace like-for-like. Hardwood frame, painted white with narrow profile double glazing. Without the obscured glass or lead detailing.

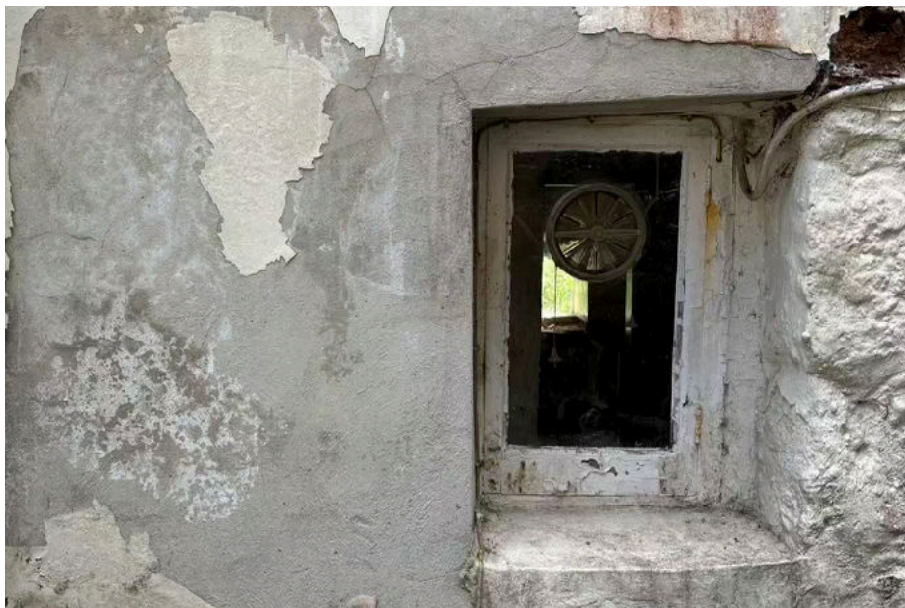
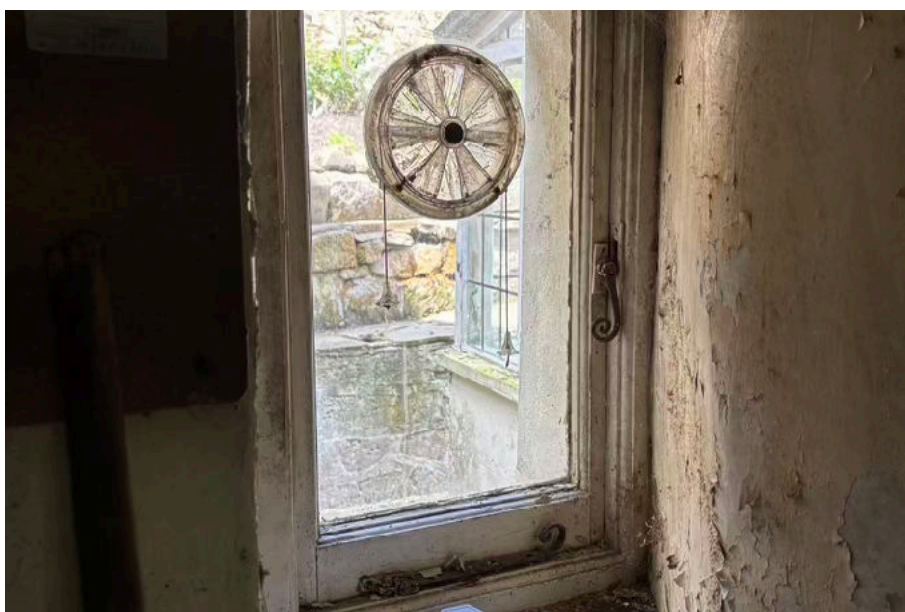
## WINDOW 5

Casement window dating to the mid C20th. Poor condition throughout.

Reinstate original window opening, replace rotten lintel and fit hardwood frame, painted white with narrow profile double glazing.

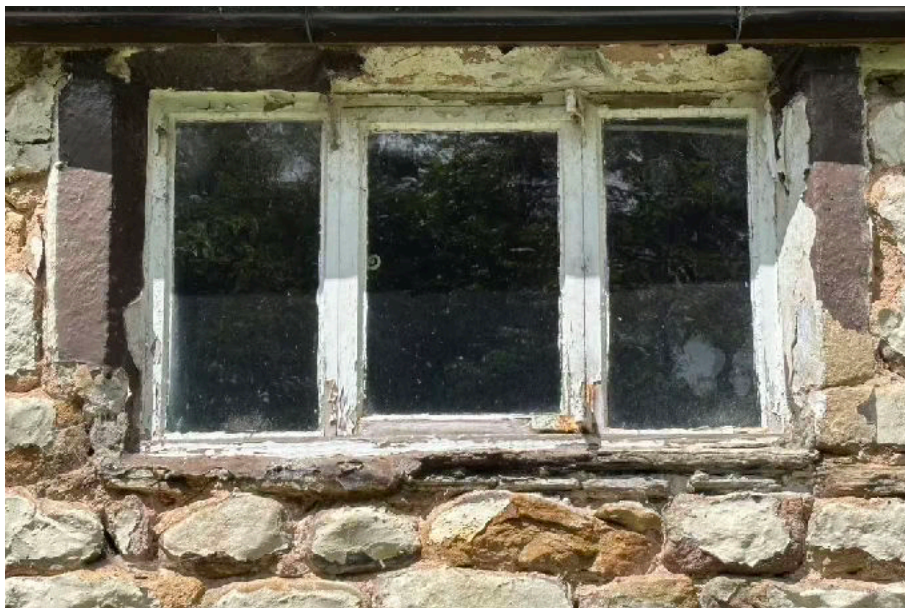
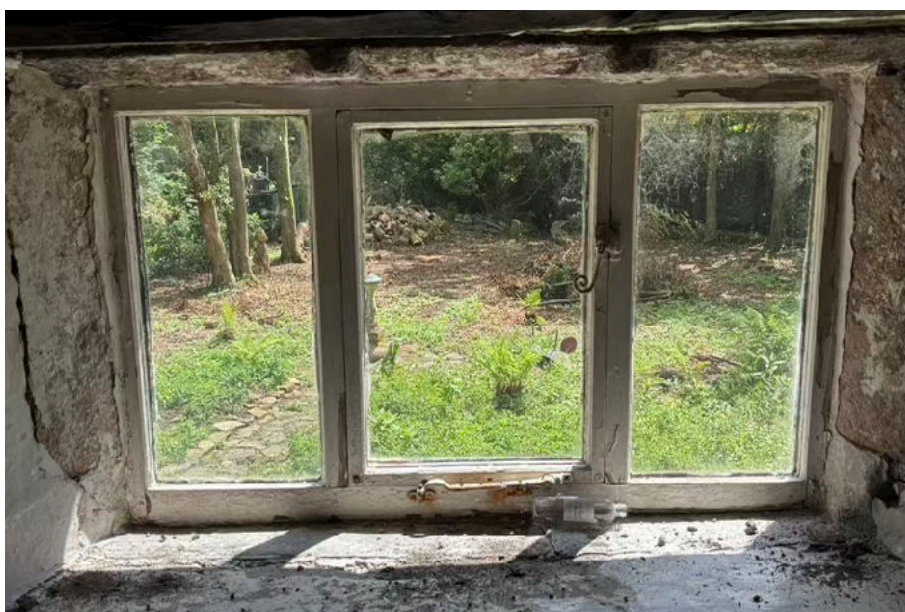
## WINDOW 6

Casement window with fixed panes either side, dating to the late C20th. Poor quality with failure to tenons apparent. Poor condition throughout with decay to cill, frame legs, rails and beads.

Replace like-for-like. Hardwood frame, painted white with narrow profile double glazing.

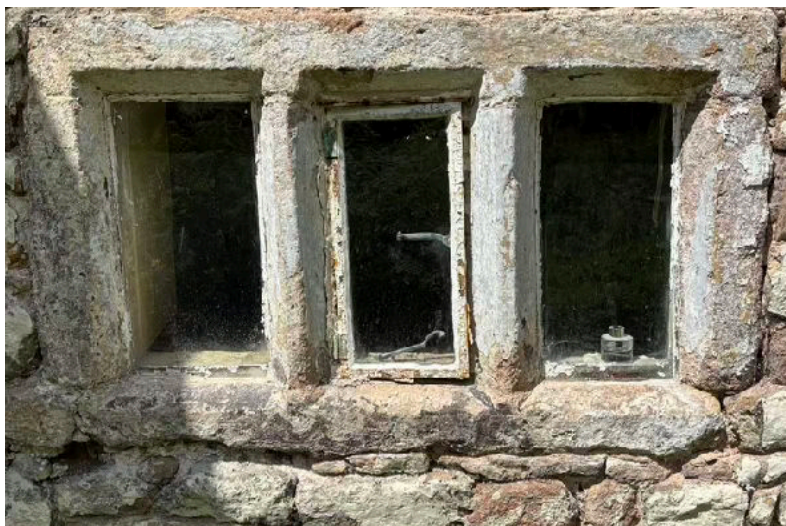
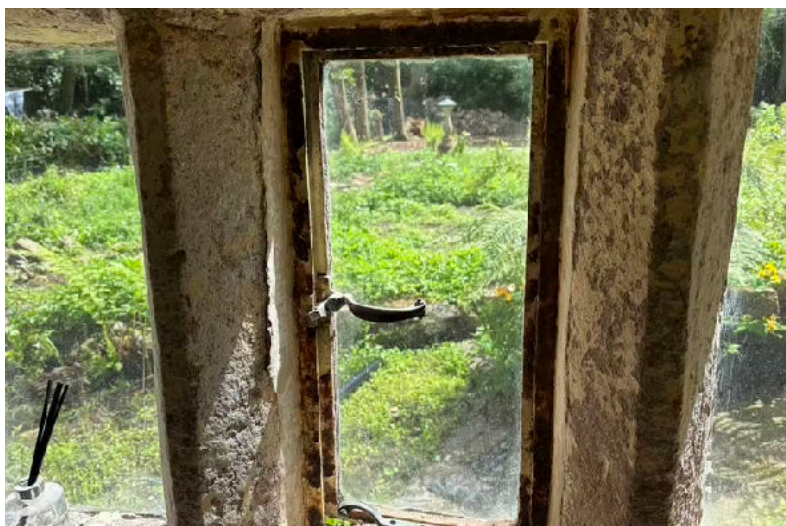
## WINDOW 7

Central opening; iron framed casement, mid-C20, seized, deflected, corroded and beyond practical repair. Replace with hardwood frame, side-hung casement, single light, painted white with narrow profile double glazing.

Side openings: existing glass seated within stone with putty. Replace with narrow profile double glazing, no frame as existing.

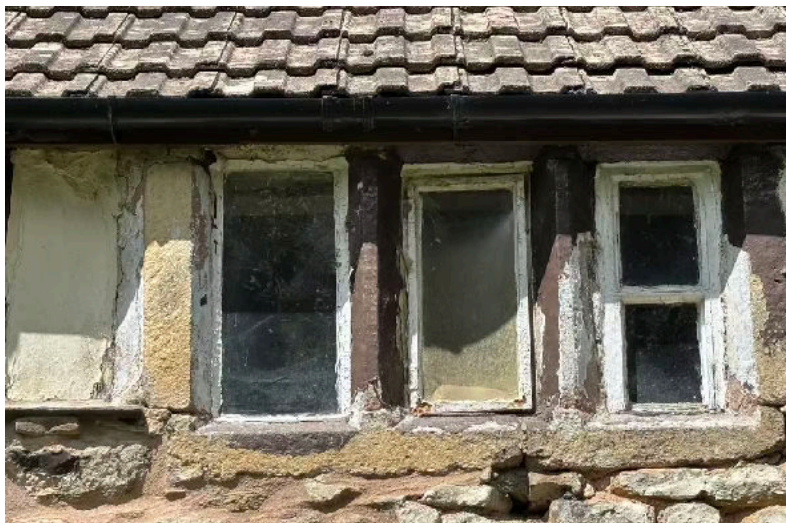
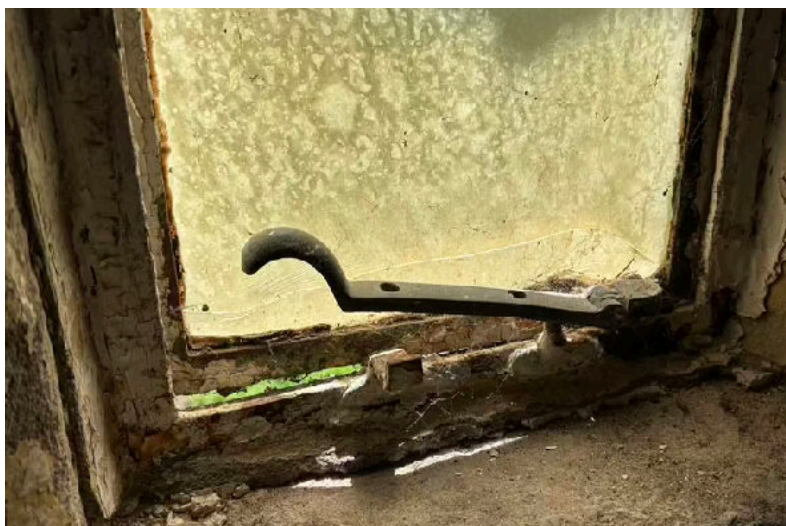
## WINDOW 8

Central opening; Iron framed casement, mid-C20, seized, deflected, corroded and beyond practical repair. Replace with hardwood frame, side-hung casement, single light, painted white with narrow profile double glazing.

Side openings: Left - existing glass seated within stone with putty. Replace with narrow profile double glazing, no frame as existing. Right - Mid C20th timber frame,, two light fixed window, poor condition throughout. Replace with narrow profile double glazing, no frame.

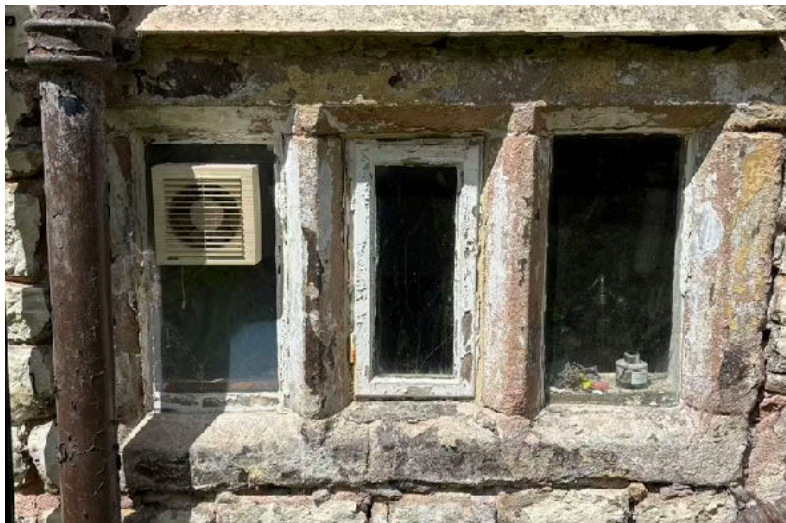
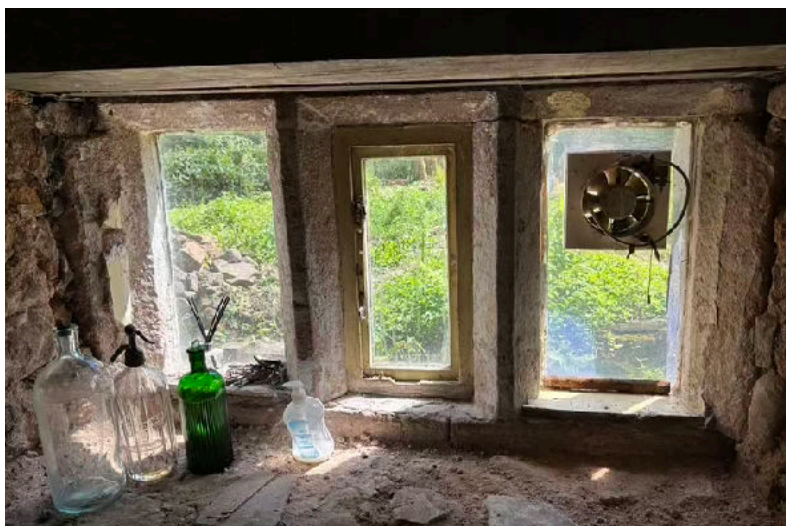
## WINDOW 9

Central opening; Timber framed casement mid C20, poor quality and in poor condition. Replace like-for-like with hardwood frame, side-hung casement, single light, painted white with narrow profile double glazing.

Side openings: Existing glass seated within stone with putty. Replace with narrow profile double glazing, no frame as existing.

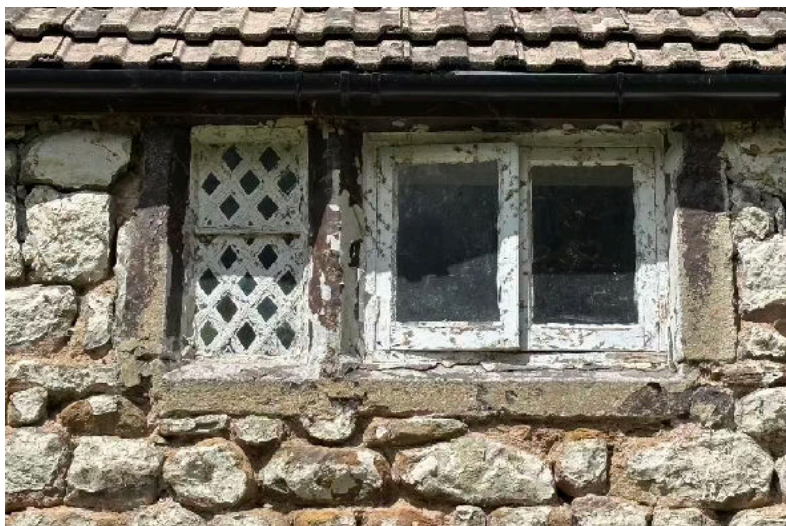
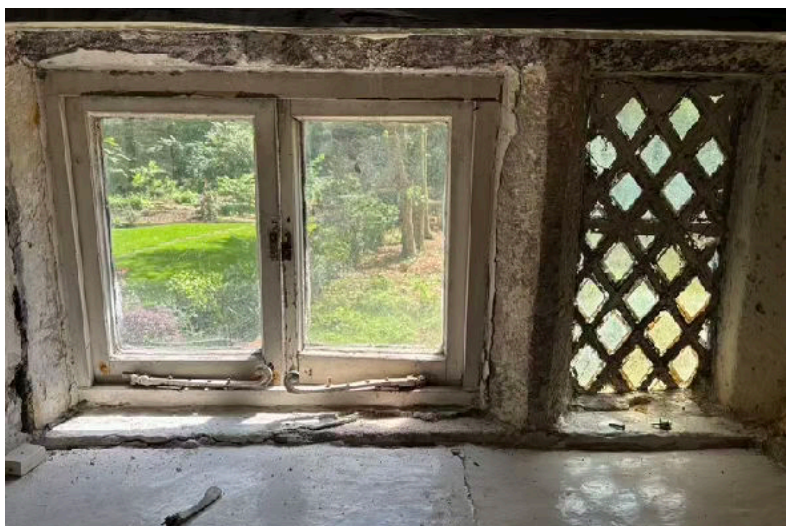
## WINDOW 10

Left window formed with plastic sheet. Replace with narrow profile double glazing and putty.

Right window mid/late C20th timber framed casement. Poor quality and poor condition throughout with decay to cill, frame legs, rails and beads. Replace like-for-like. Hardwood frame, painted white with narrow profile double glazing.

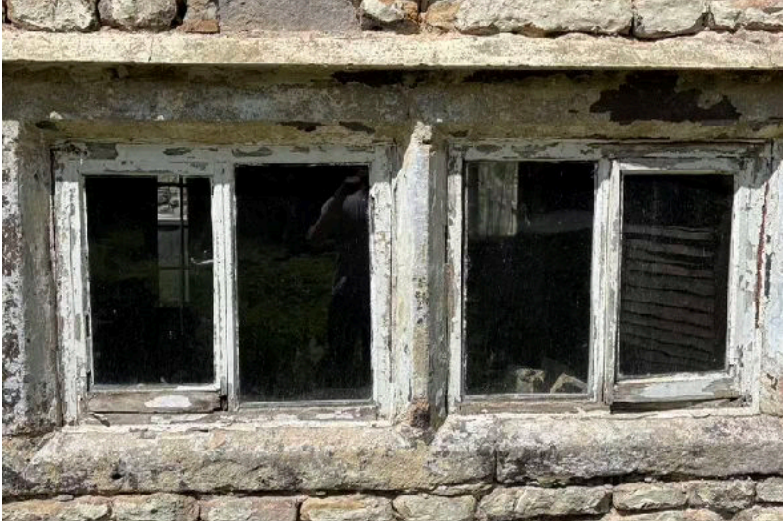
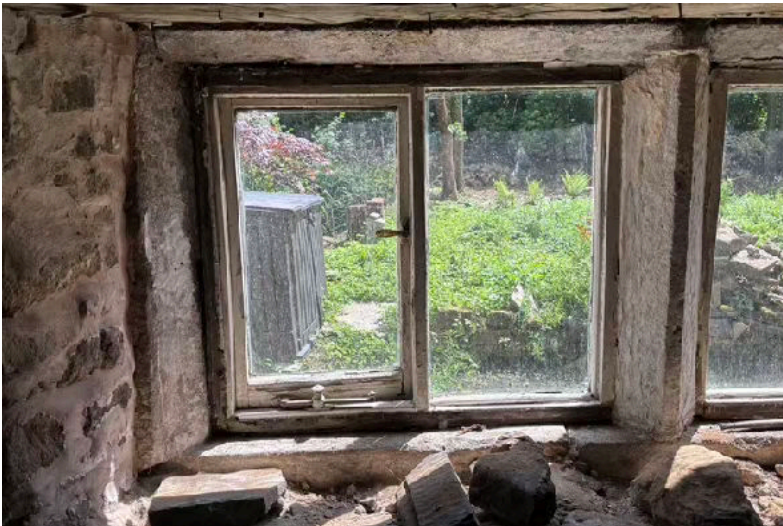
## WINDOW 11

Mid C20th timber framed casement. Poor quality and poor condition throughout with decay to cill, frame legs, rails and beads. Replace like-for-like. Hardwood frame, painted white with narrow profile double glazing.
