Contaminated Land Phase One Desk Study for proposed conversion of storage building to Holiday Cottage at Beacon Fell View Holiday Park, 110 Higher Road, Longridge, PR3 2TF.

Graham Anthony Associates,
2 Croston Villa,
High Street,
Garstang,
Preston,
PR3 1EA.

July 2025

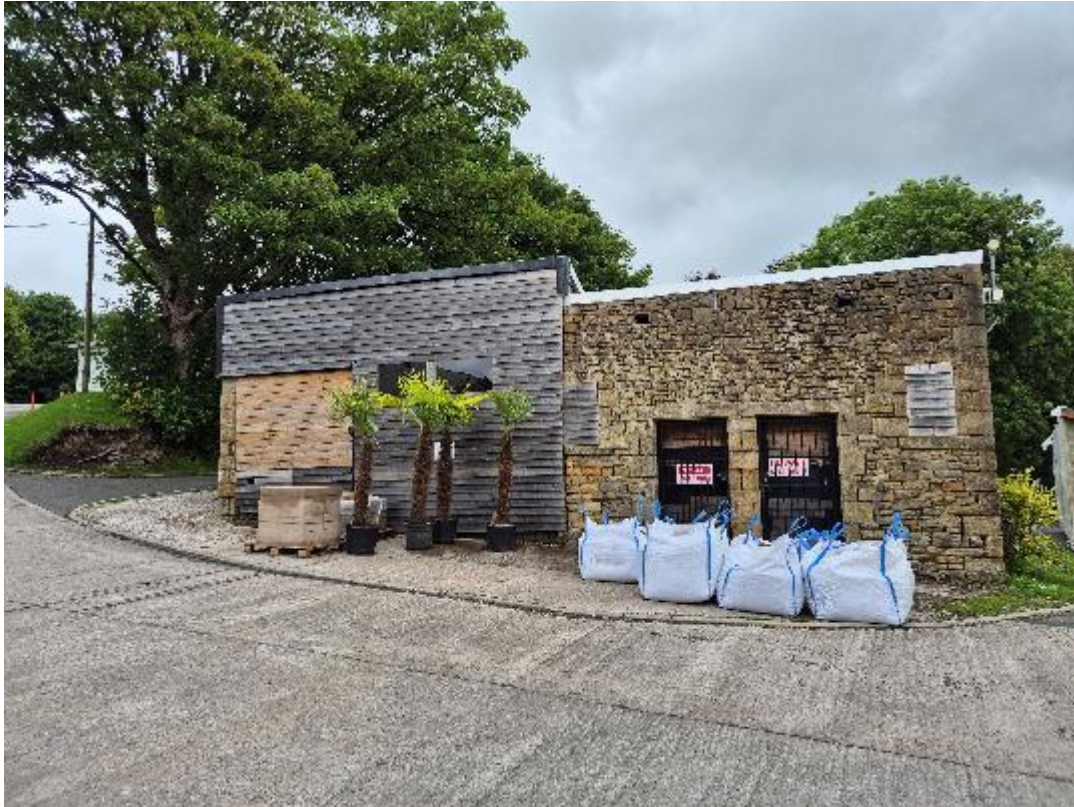
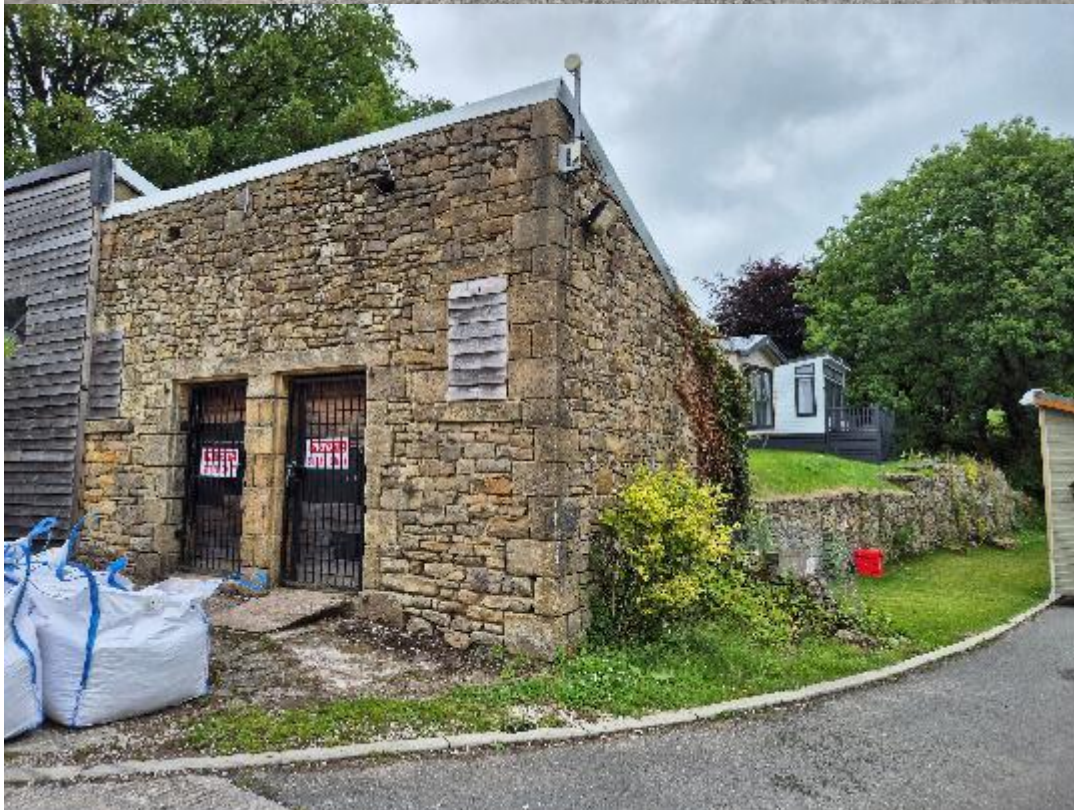
Southwest façade with roadway in front.

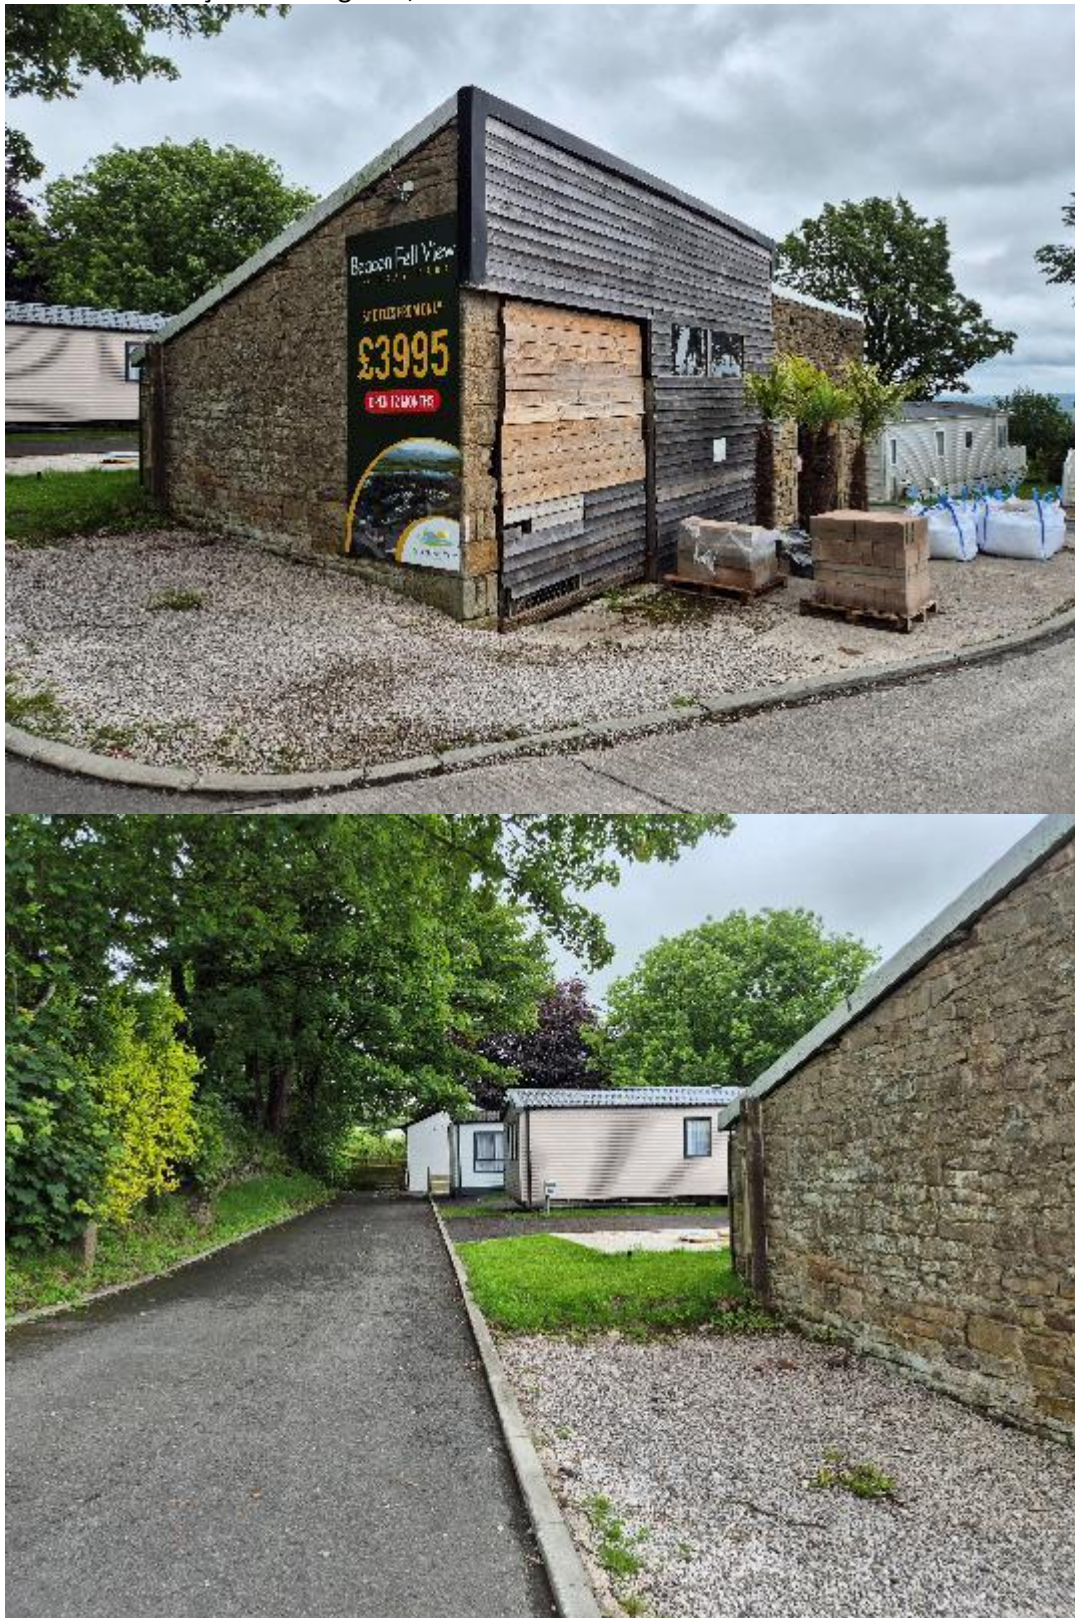
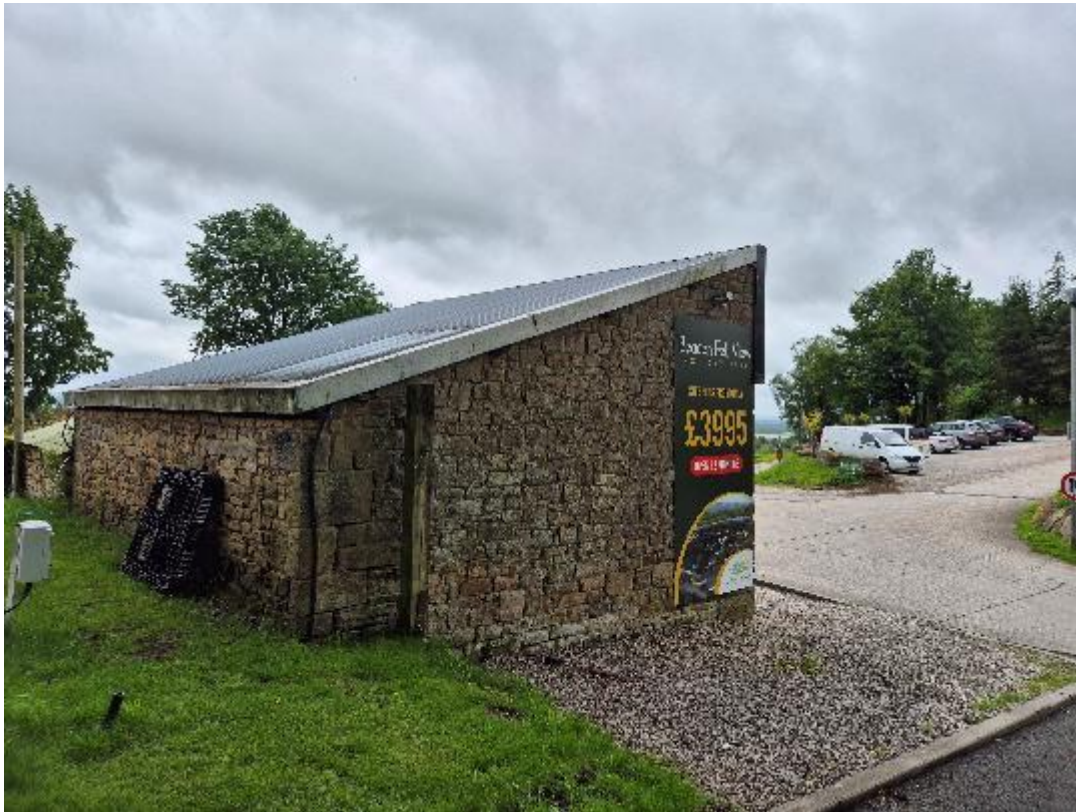
Northwestern façade looking east, then west

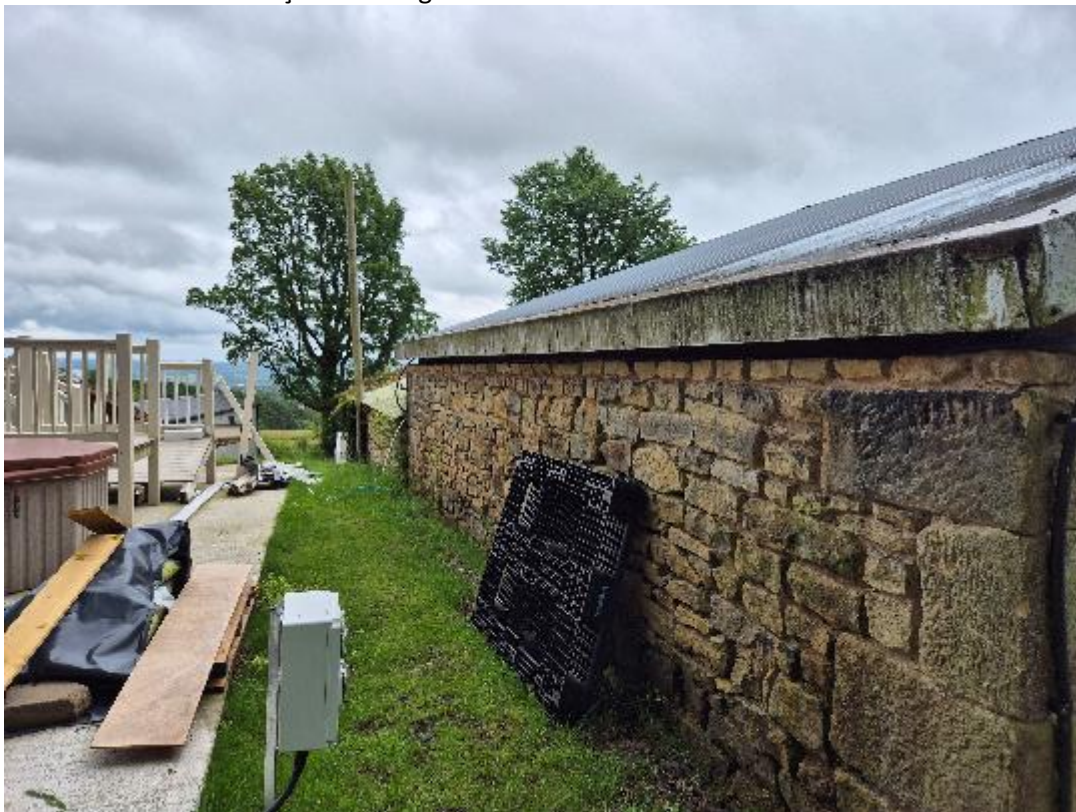
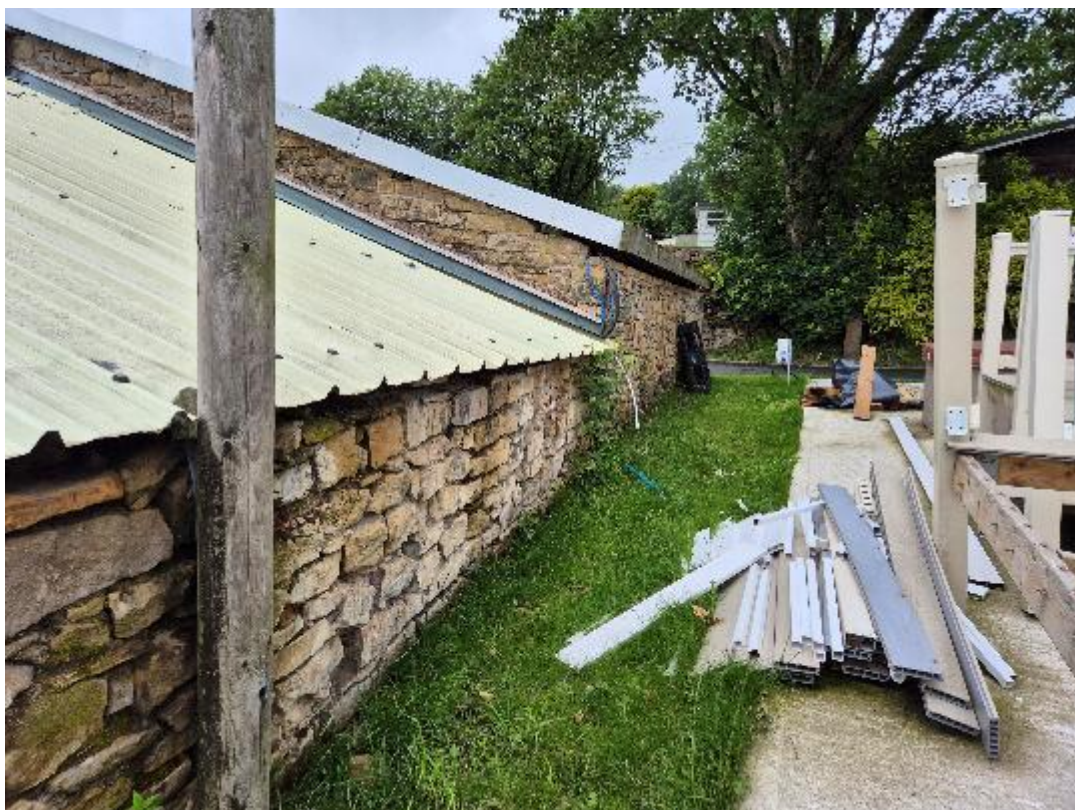
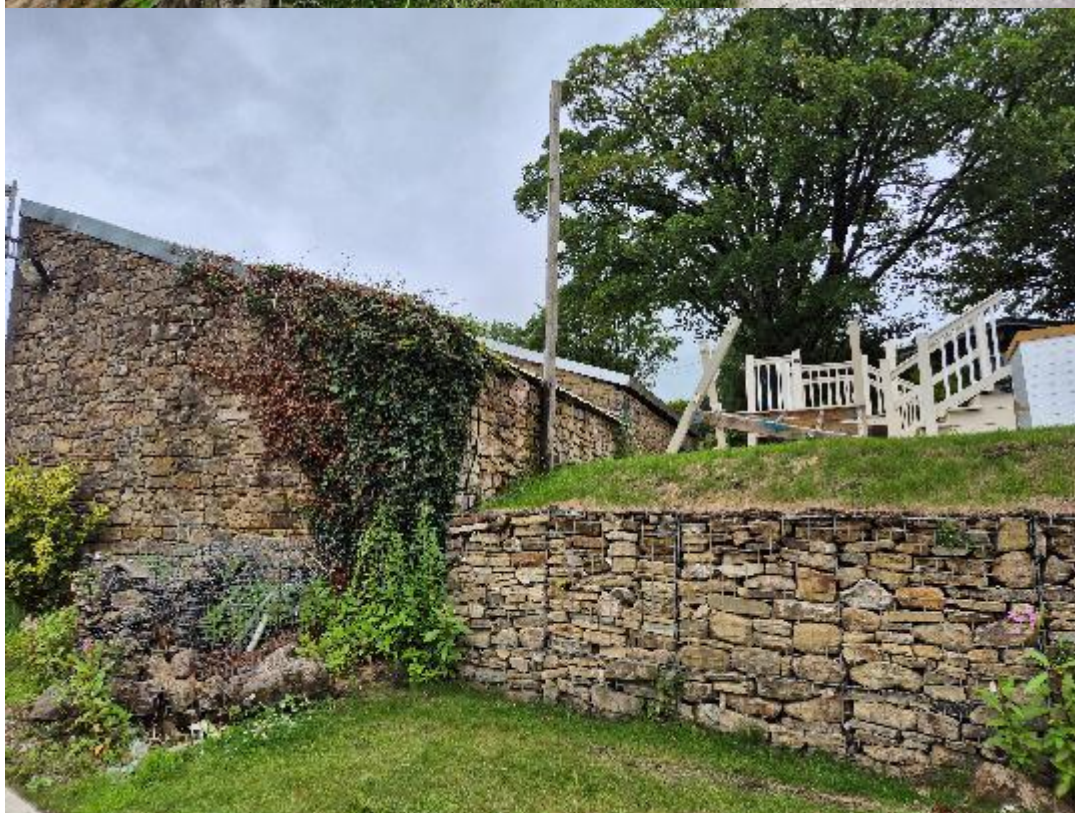
The rear and eastern façade looking south then north

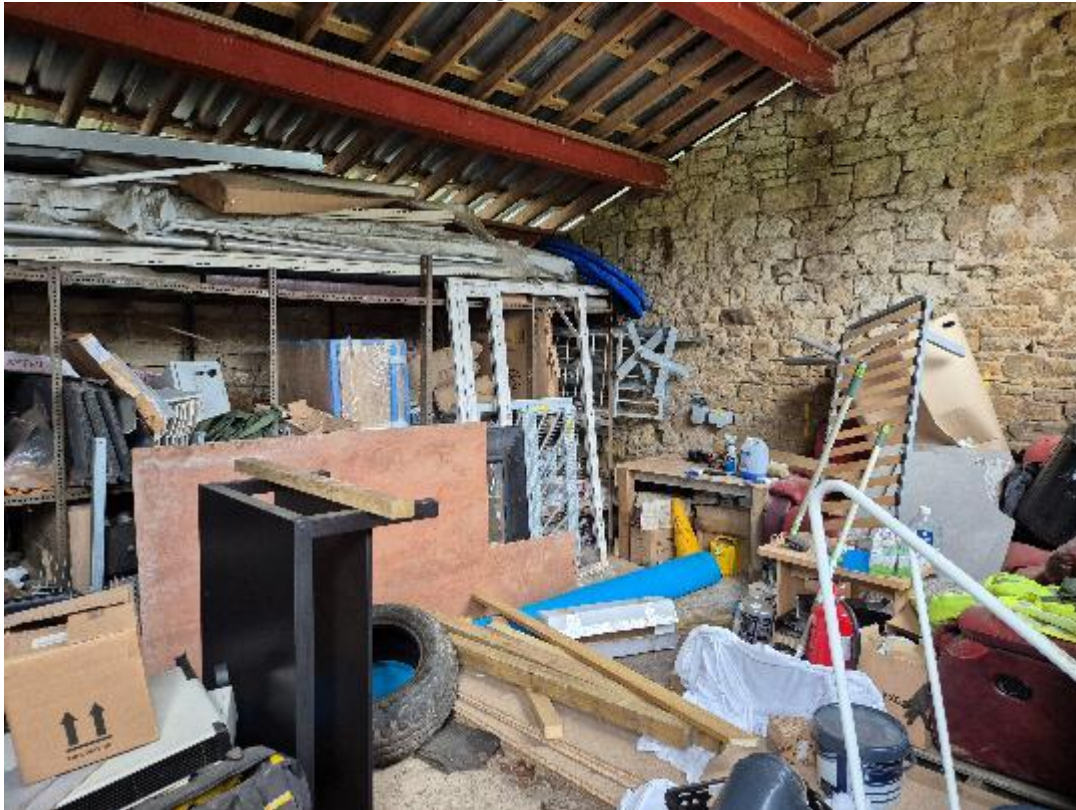
The buildings are currently used for storage of general DIY equipment. No staining was identified on the flooring of the building, which is to be removed and replaced as part of the development.

Inside the northern section of the building

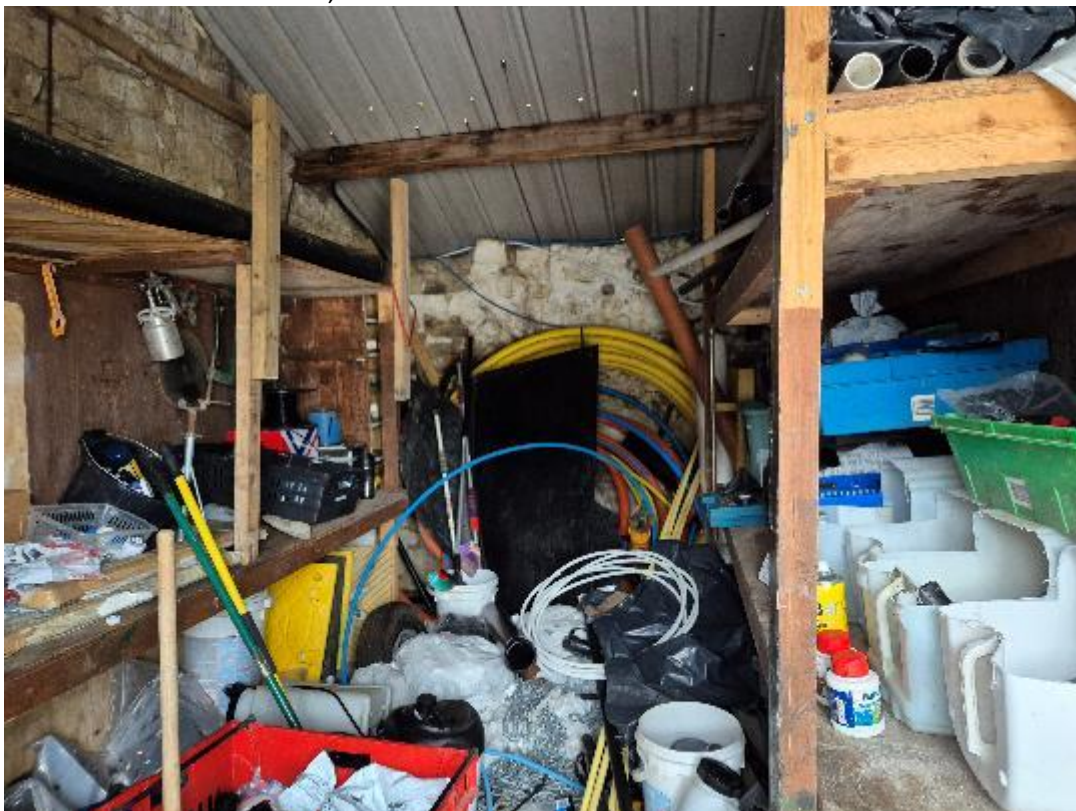
Inside the southern section, middle door

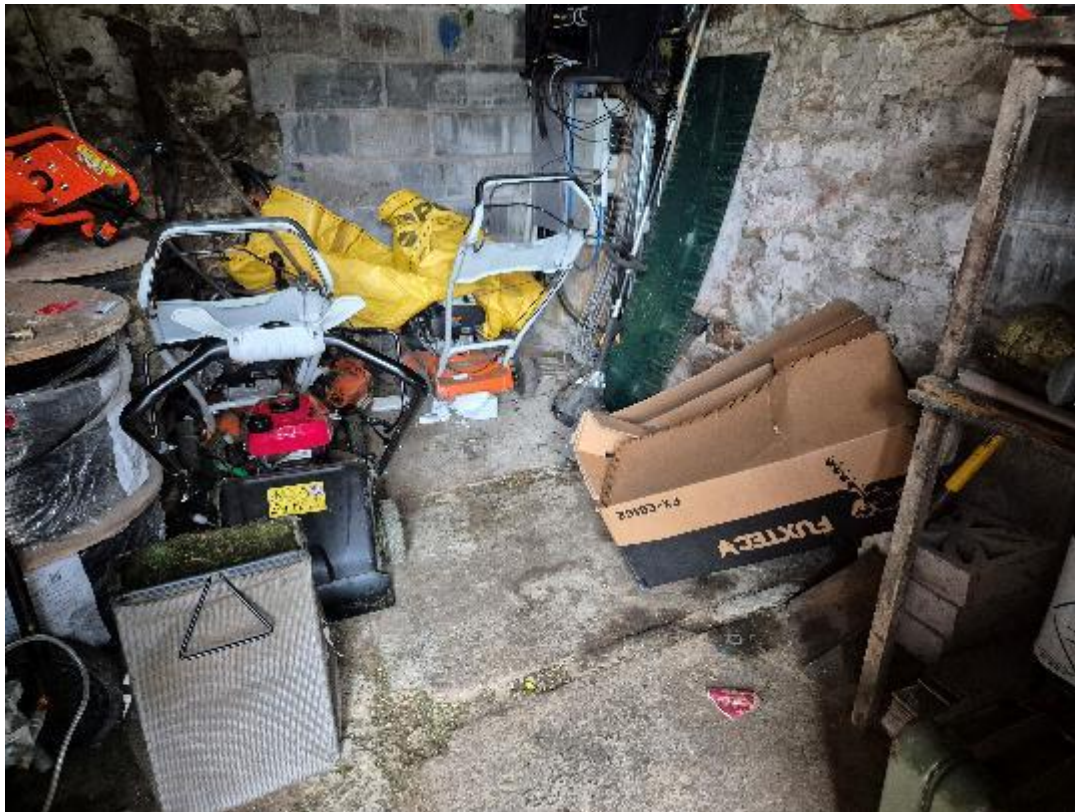
Southern door.
