Structural Statement –Existing workshop

Beacon Fell View Holiday Park, 110 Higher Road, Longridge, PR3 2TF

This is a statement in support of the planning application, Proposed conversion of existing workshop to holiday cottage in association with Beacon Fell View Caravan Park. Proposed works to include creation of first floor and balcony, alterations to roof and insertion of new windows

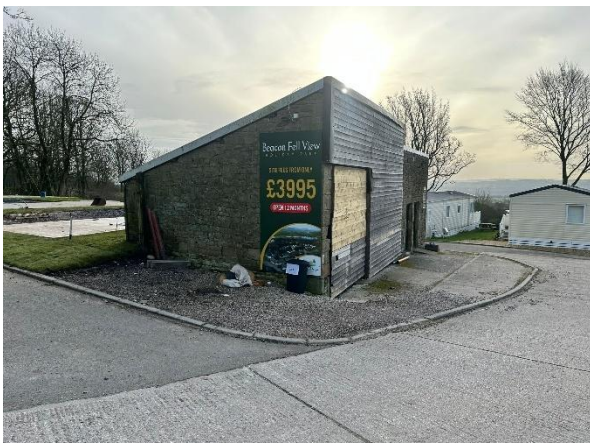
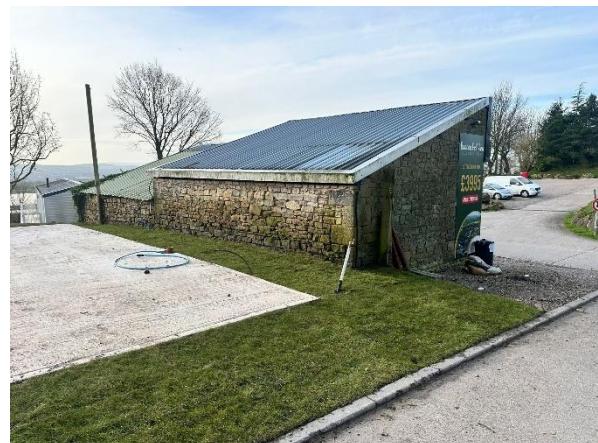
External Structure

- The building is built of traditional stone masonry with a partial retaining wall on the north side.
- External walls show no signs of significant settlement, bowing, or structural cracking.
- Roof ridgeline appears straight and stable from multiple angles, supporting structural soundness of the building.
- The metal roof sheeting and green profiled metal roof on the rear extension appear modern and intact, though some flashing and guttering work may be required.

- **Wall Repointing:** As part of the conversion, repointing of masonry walls is recommended to ensure structural continuity and weather protection.
- **Roof Refurbishment:** The roof covering should be removed and replaced with a breathable membrane, new battens, insulation, and either reused or new slates/tiles, depending on condition.
- **Purlins/Trusses:** Full inspection of timber or steel trusses and purlins is required to confirm suitability and address any end-bearing deterioration.
- **Insulation and Lining:** Internal timber/metal stud frames can be introduced to external walls to carry insulation and comply with thermal standards without compromising structural integrity.
- **Floor:** Existing slab appears sufficient to support residential loads. A new insulated slab or screed with damp proof membrane can be laid over the existing floor.

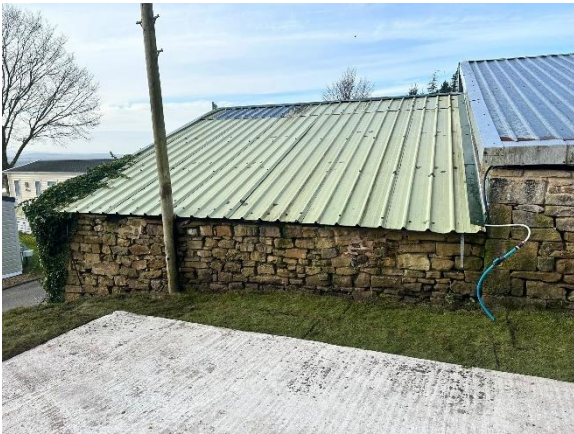
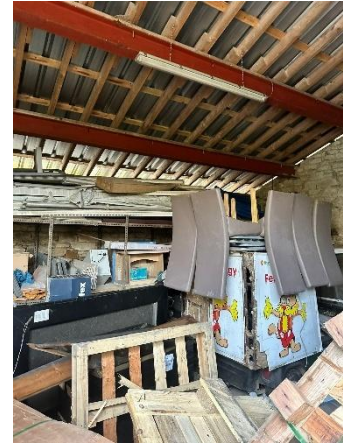
3.2 Roof Structure

- Internally, the roof is supported by steel I-beams and timber purlins. These span longitudinally across the structure.
- The steel beams are in sound visual condition with no visible corrosion or deflection.
- Timber purlins and battens appear aged but serviceable; minor rot may exist at bearing ends
- of cladding is metal sheeting, potentially non-original and installed for durability rather than insulation.

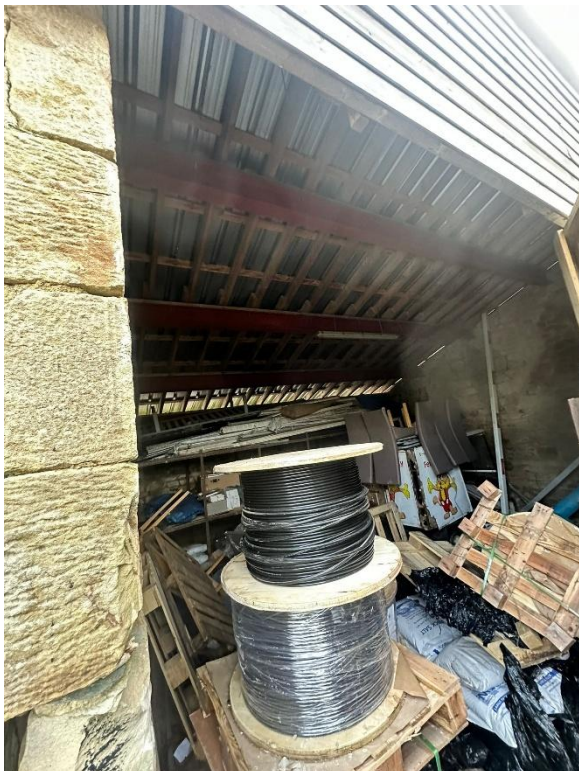
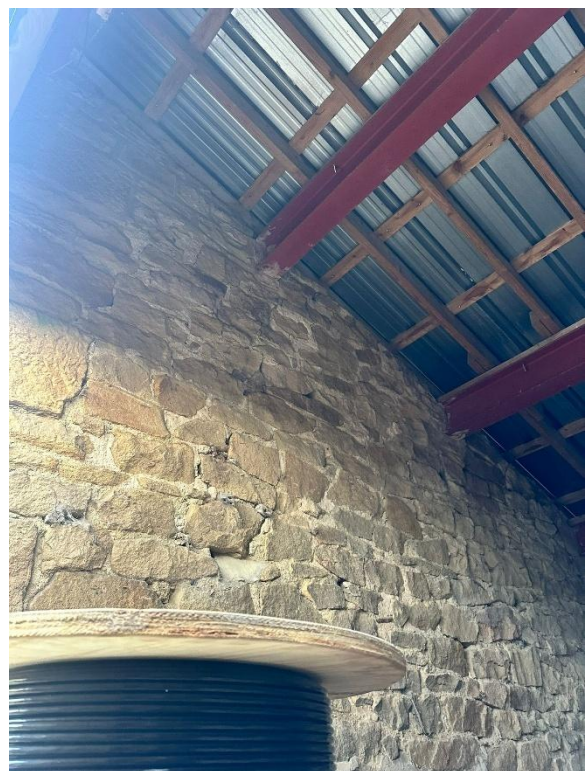
3.3 Interior Condition

- The internal area is cluttered with construction materials and storage items, limiting full inspection.
- Stone walls appear plumb and stable internally, consistent with external observations.
- Floor is solid concrete and seems structurally competent, with no visible spalling or cracking.
- No signs of water ingress through the roof or major damp issues on internal walls
