Application 3/2025/0471 - Houlikers Farm, Read

Report on the Two Ground-Floor Front Sash Windows

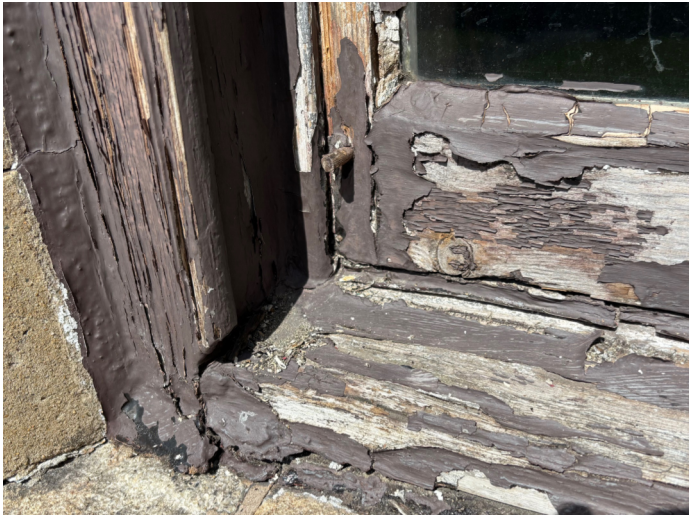
Photograph 1. Rot at the junction between sash box and sill.

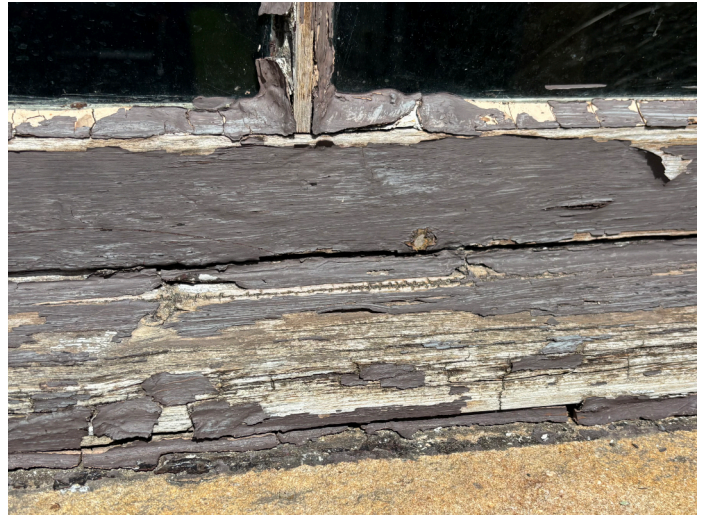
Photograph 2. Loose putty and rot in sill.

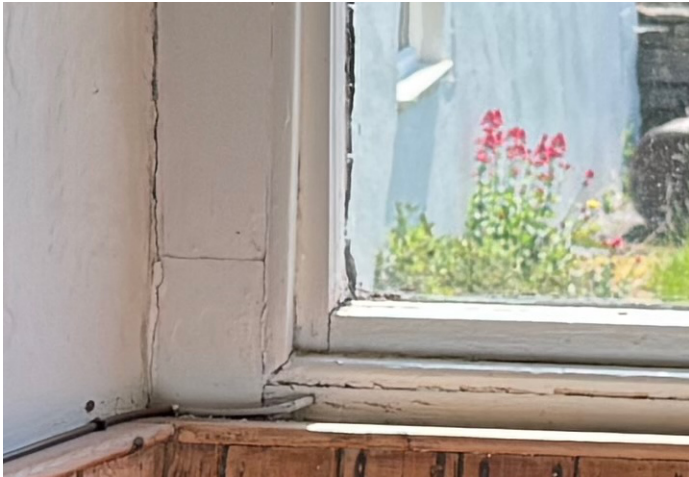
Photograph 3. Repair to sash box.

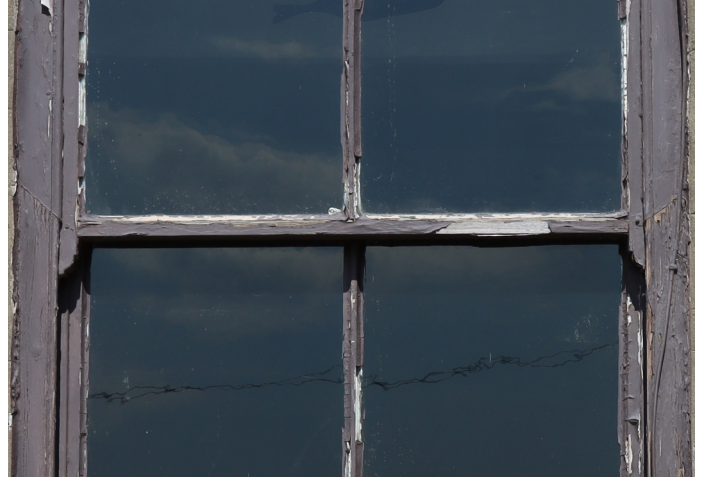
Photograph 4. Repairs to sash boxes.
