STRUCTURAL INSPECTION

45 & 47 WHALLEY ROAD, CLITHEROE

STANTON ANDREWS

Project No.: 12175				
Issue Date	Revision	Status	Issued By	Checked By
10.07.2025	---	First Issue	SJ Reid	T Fryars

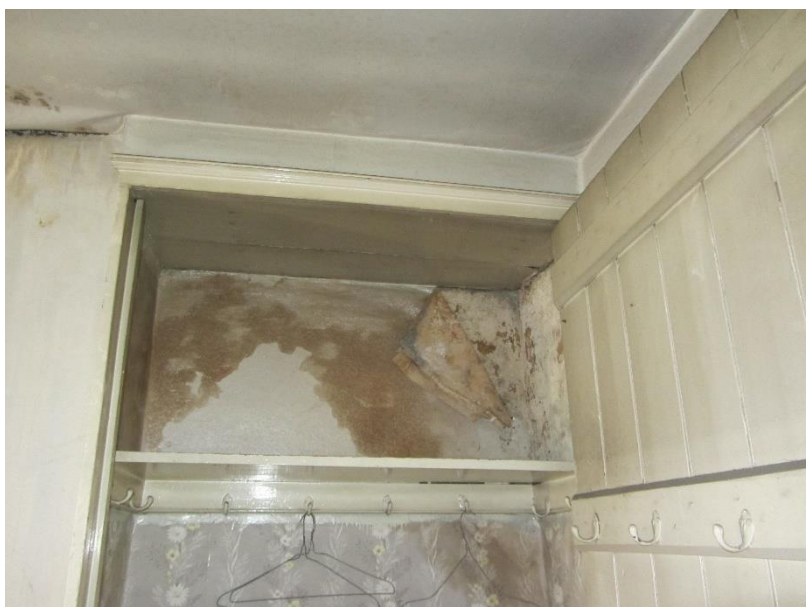
- Damp was noted on the north wall of No.45, at ceiling level near the chimney breast (photo 4). Penetrating damp was noted on the east and west walls (photos 5, 6 & 7). The original ceiling of the rear (east) bedroom had been removed and replaced with plasterboard, with insulation above (photo 6).
- A horizontal crack was noted in an internal wall between two bedrooms on the west (photo 8).
- Signs of water ingress were noted at the rear re-entrant corner, with damage to the plaster wall finish and decay in the timber floor evident (photos 9 & 10).
- Penetrating damp was noted in the walls of the main function room (photos 11 & 12).
- The roof structure could be viewed where part of the ceiling had been removed. No signs of decay in the central part of the trusses could be seen (photo 13).

Photo 4 – Damp around chimney breast

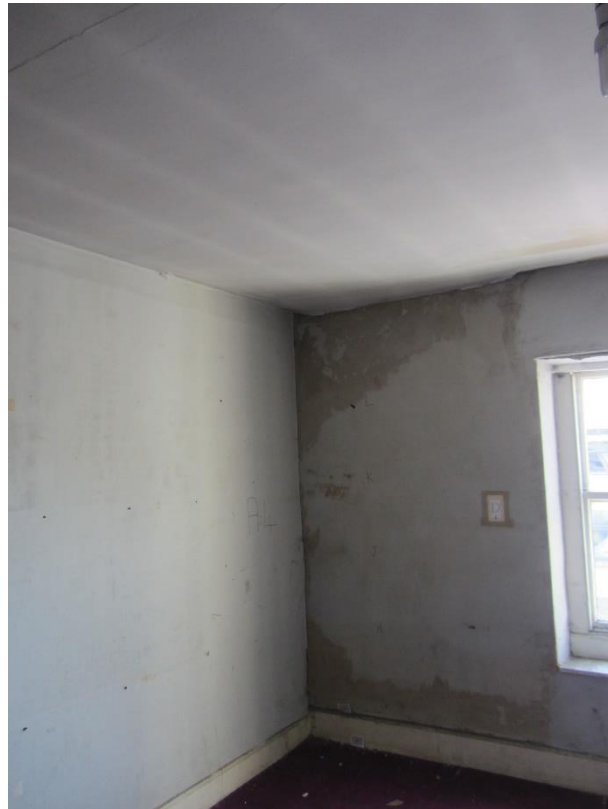
Photo 5 – Penetrating damp

- Penetrating damp through the external walls should be prevented by providing new waterproof costings or linings. Consideration should be given to removing modern cement-based pointing, then re-pointing with natural hydraulic lime mortar and allowing the stone walls to breathe.
- The outward movement of the west wall could be arrested by providing additional ties between the wall and the existing first floor. Tying the proposed mezzanine floor to the walls will also improve the overall robustness and stability of the building.
- The stonework should be consolidated and repaired where required, and the gap along the roof verge filled.
- Timber lintels in the external walls should be removed and replaced with new stone items.

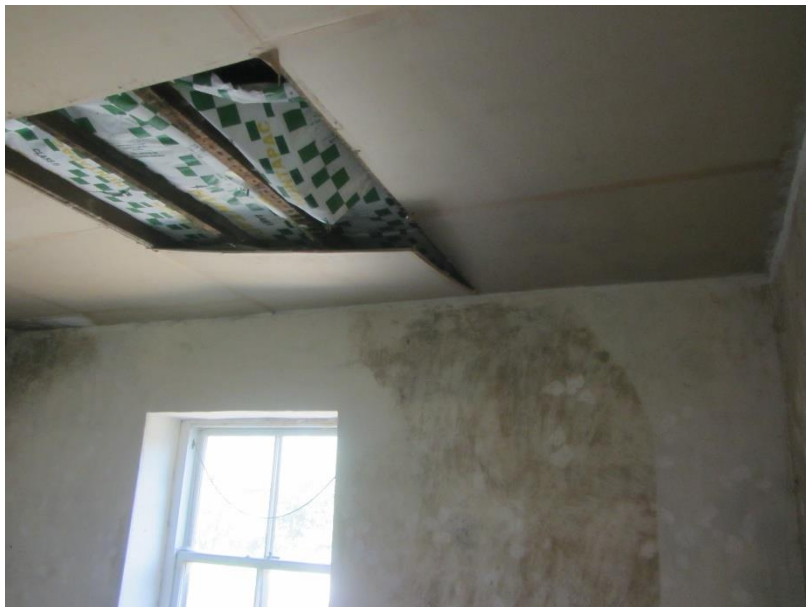
Photo 6 – Penetrating damp; ceiling replaced

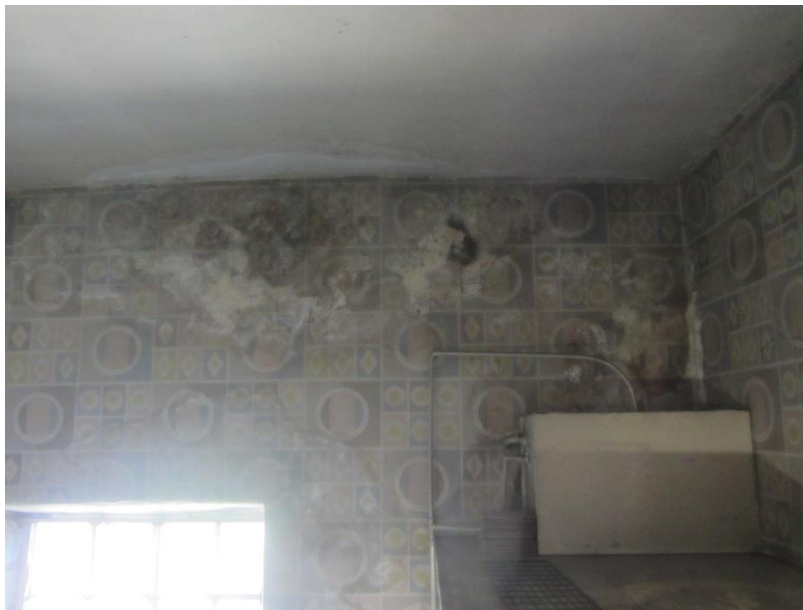
Photo 7 – Penetrating damp

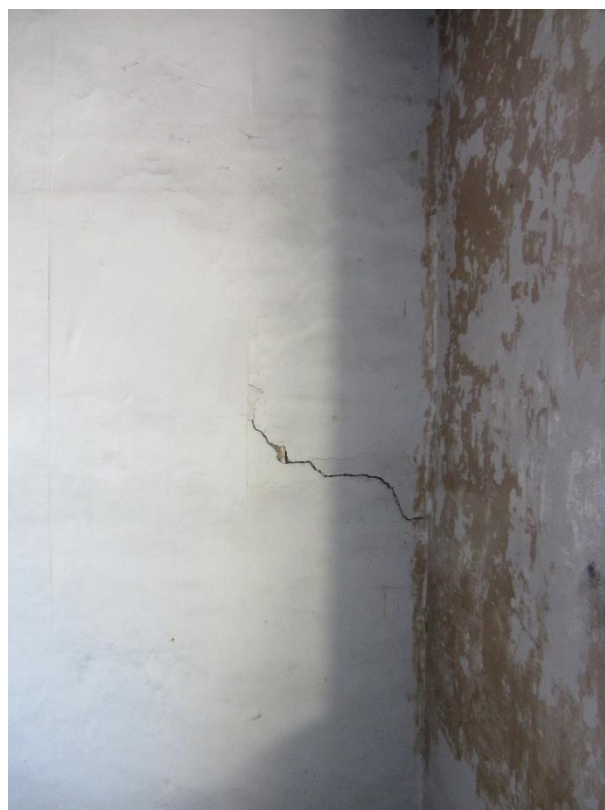
The crack in the bedroom wall is due to it being built off the timber first floor, which has moved. Similarly, the cracked toilet wall at ground floor has most likely been built off the stone slab ground floor.

Photo 8 – Crack in internal wall

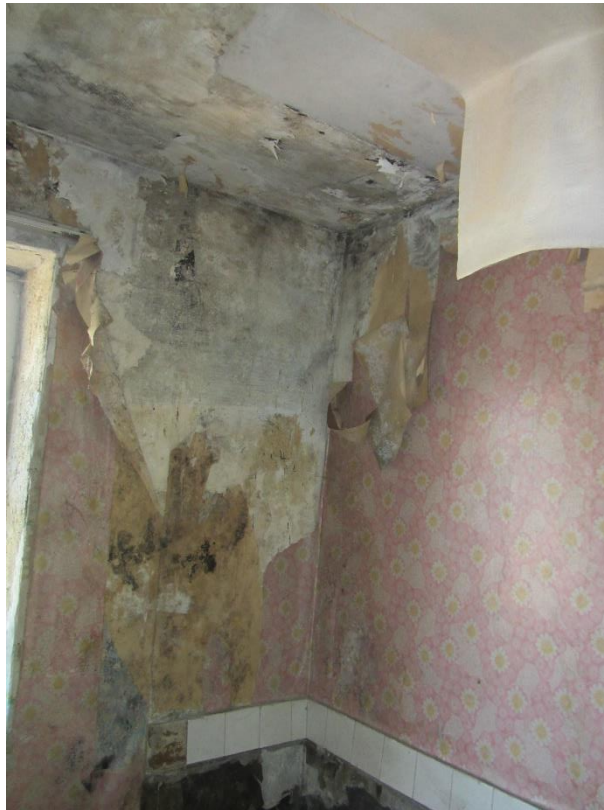
The building is in reasonably good structural condition. The problems noted were in the main caused by water ingress through blocked or failed gutters and flashings, or dampness penetrating through the solid stone walls.

Photo 9 – Water ingress at internal corner

- The roof covering may be original and should be removed and replaced. This will give opportunity to make a full inspection of the structural roof timbers. Timber members which have decayed should be repaired or replaced.
- The existing first floor joists to the function room should be checked for new loadings.
- The gutters and other rainwater goods should be repaired or replaced, along with all flashings.

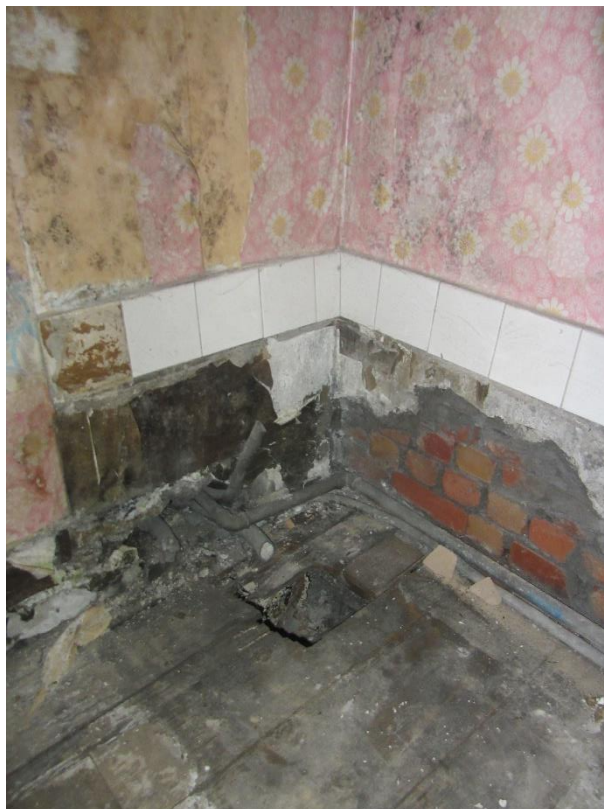
Photo 10 – Decayed floor timbers

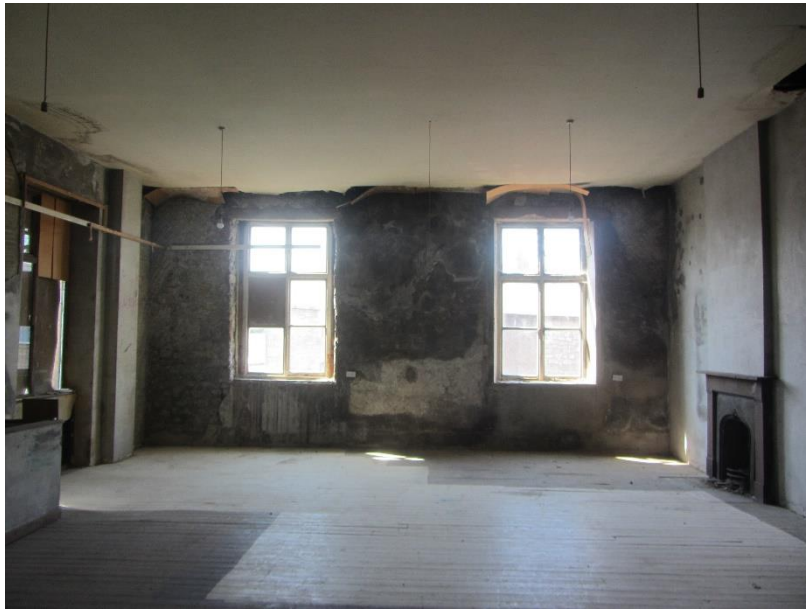
Photo 11 – Penetrating damp

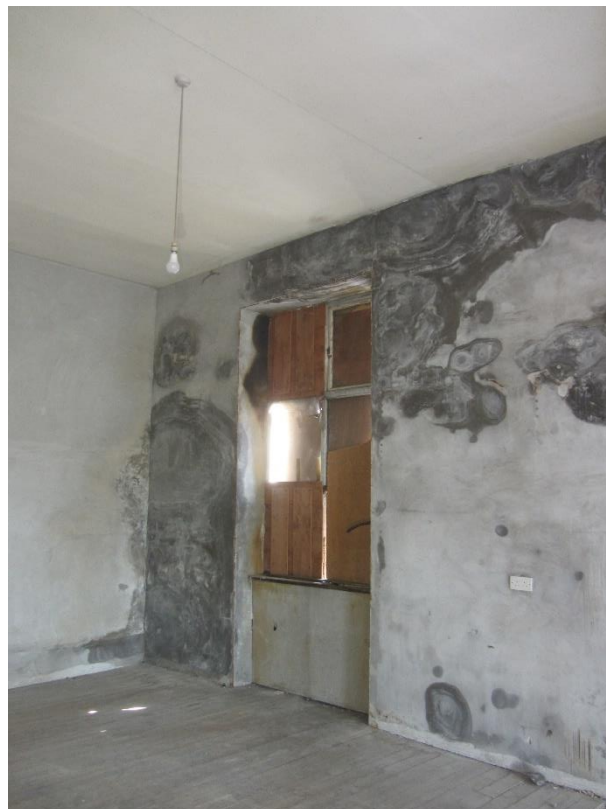
Photo 12 – Penetrating damp

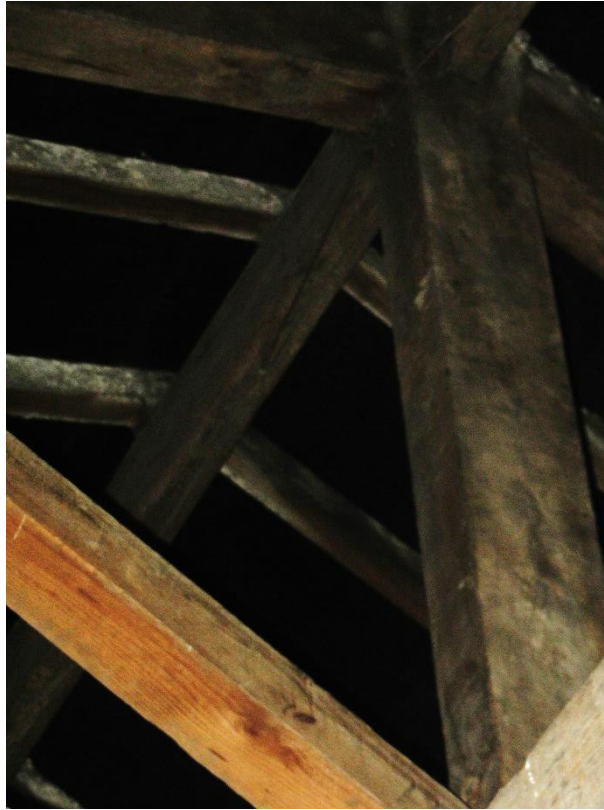
The roof structure could not be fully inspected. There may be decay at the ends of the timber trusses, purlins and rafters in contact with damp external walls and close to blocked perimeter gutters.

Photo 13 – Roof structure over function room

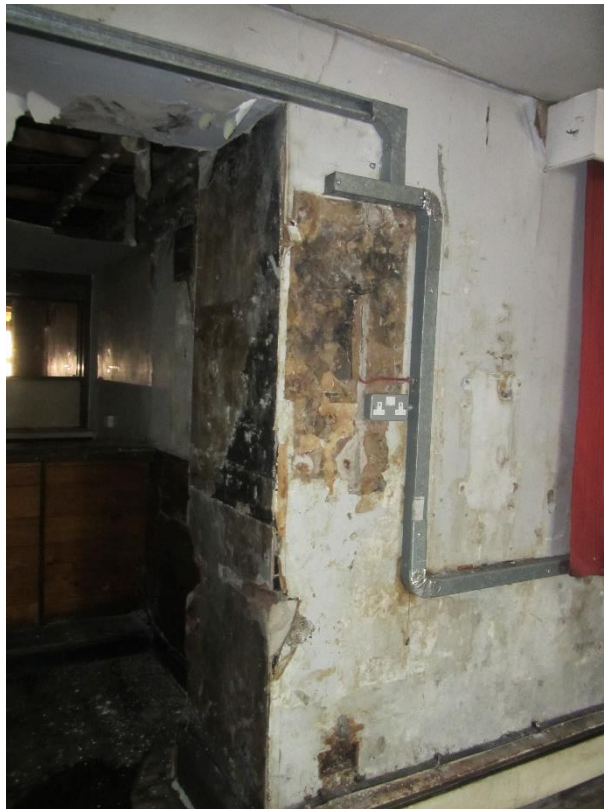
- Water ingress was noted at the re-entrant corner between No.45 & No.47 (photo 14). The first floor joists and boarding were decayed and the plaster damaged (photo 15).
- There is a crack in a wall in the toilets on the west side of No.47 (photo 16).
- Penetrating damp was noted on the west wall of No. 45 (photos 17 & 18).

Photo 14 – Ground floor – water ingress

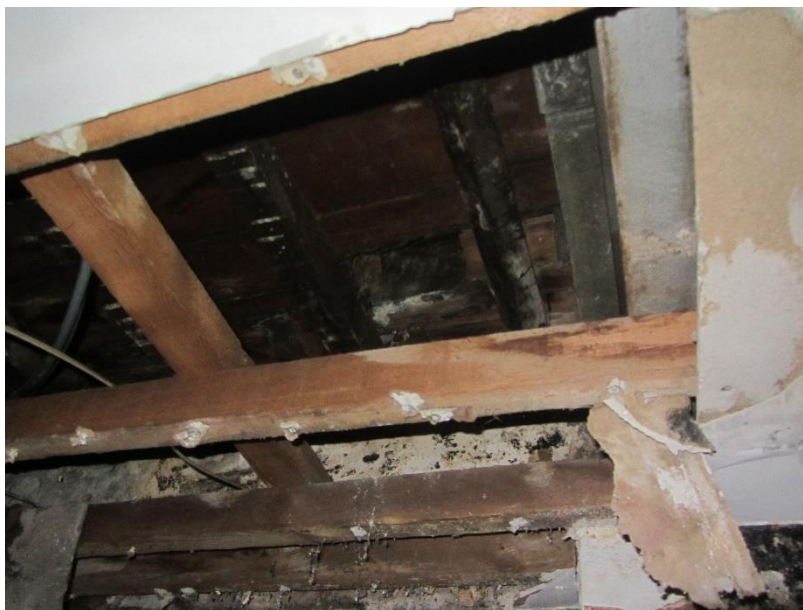
Photo 15 – Ground floor – decayed first floor timbers

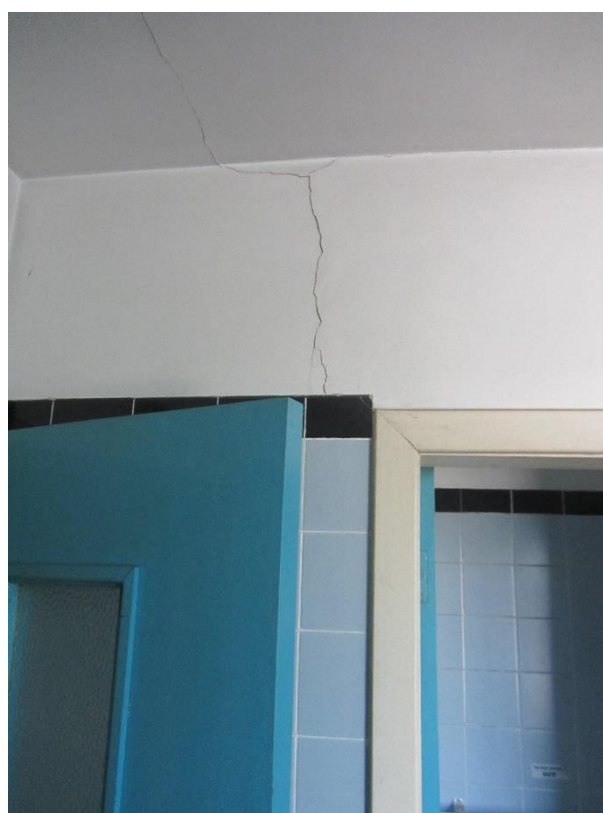
Photo 16 – Ground floor toilets – crack in wall

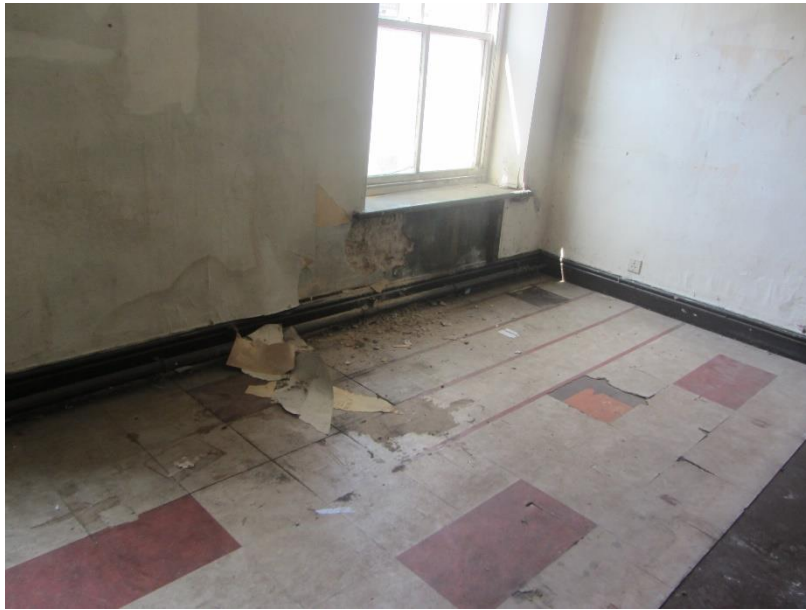
Photo 17 – Ground floor – penetrating damp in west wall

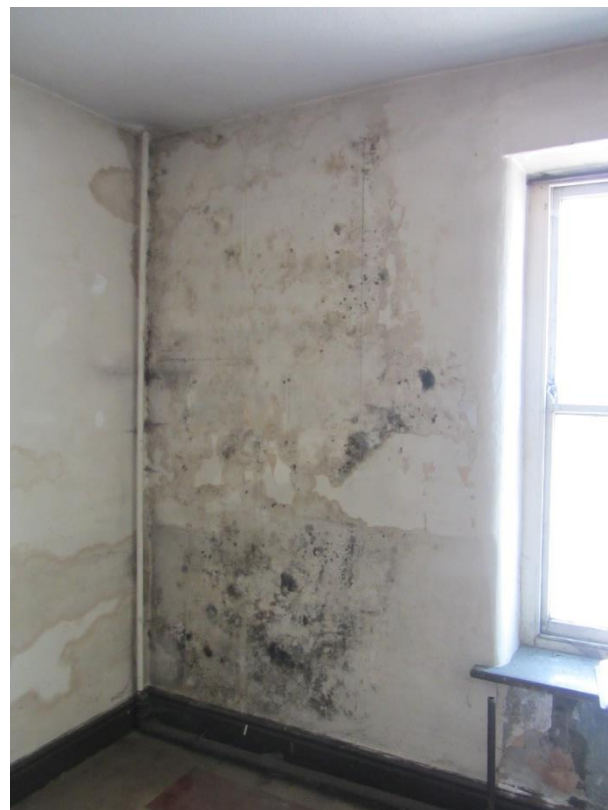
Photo 18 – Ground floor – penetrating damp in west wall

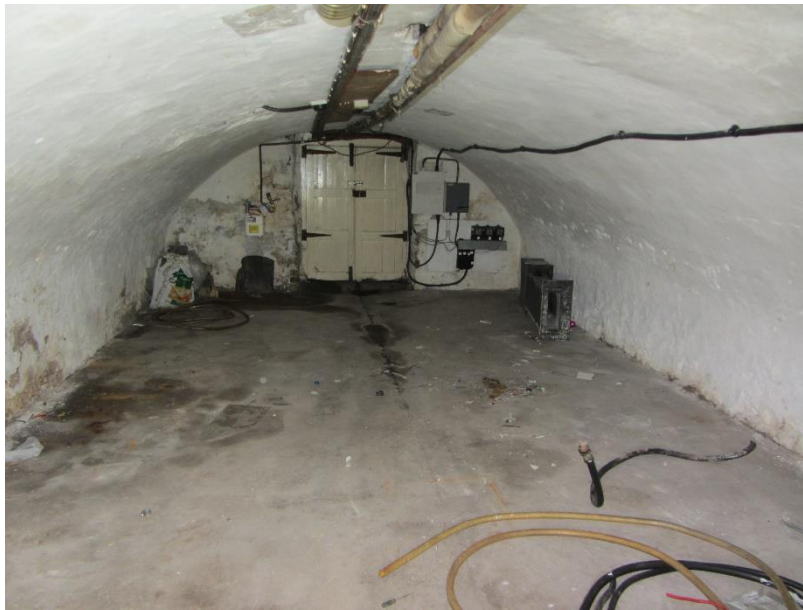
- Some damp patches were noted on the floor and at the bottom of the walls (photo 19).

Photo 19 – Cellar – damp patches on floor and walls

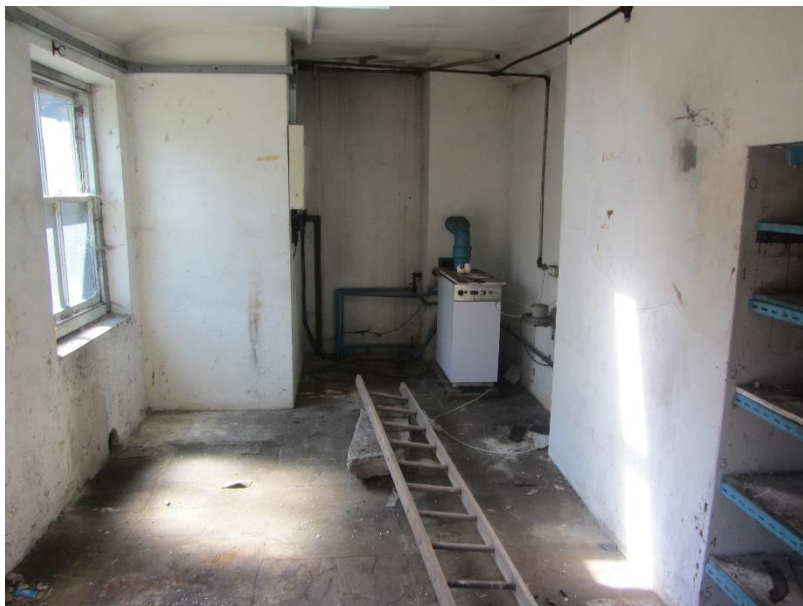
- No defects of structural significance were noted (photo 20).

Photo 20 – External store room

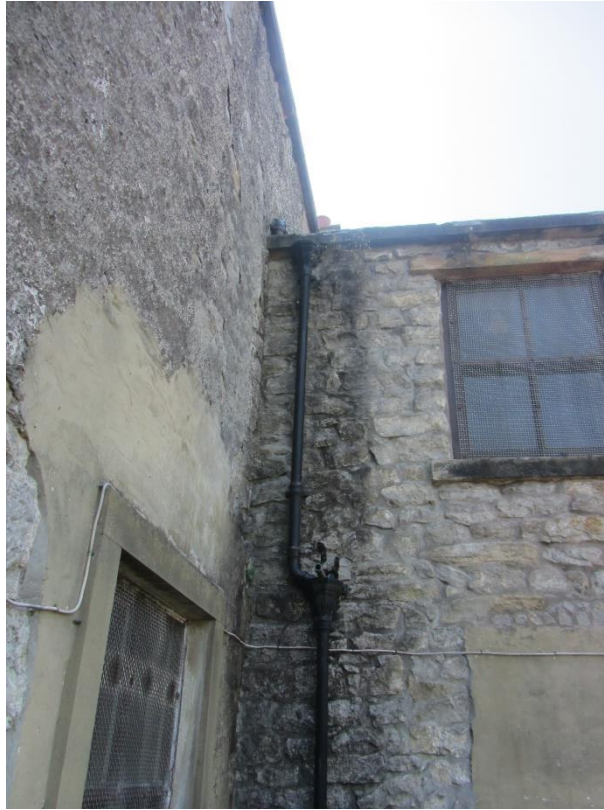
- Water staining from leaking rainwater goods was noted at the re-entrant external corner (photo 21).
- The south wall of No.47 shows a slight outward bulge at around first floor level (photo 22). A single tie-bar and pattress plate has been installed at approximately ground floor window head height.
- There is a gap between the top of the stone wall and the edge of the roof along the verge line to the east wall of No.47 (photo 23).
- Some exposed timber lintels have decayed.

Photo 21 – Leaking gutters and downpipes

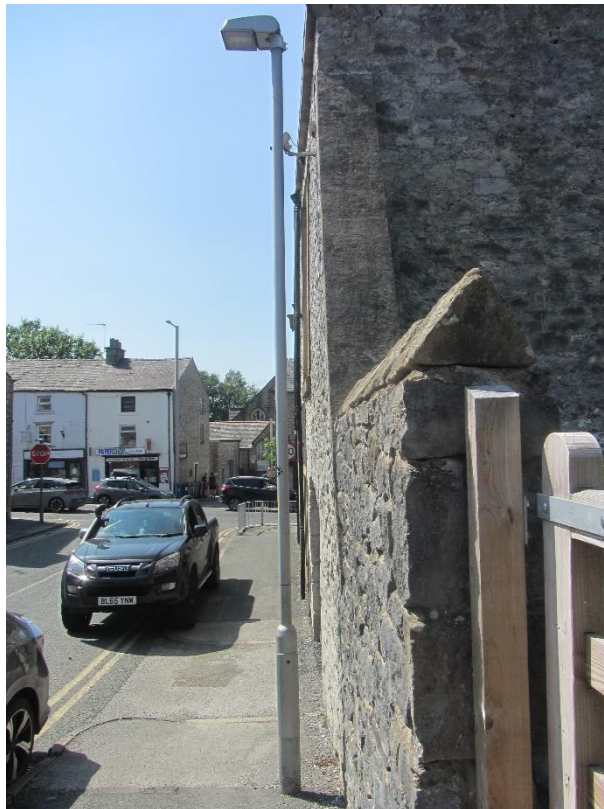
The south wall of No.47 shows a slight outward bulge at around first floor level. The tie bar may be ineffective in arresting this movement, as it is at a level lower than the floor.

Photo 22 – Outward bow to south wall

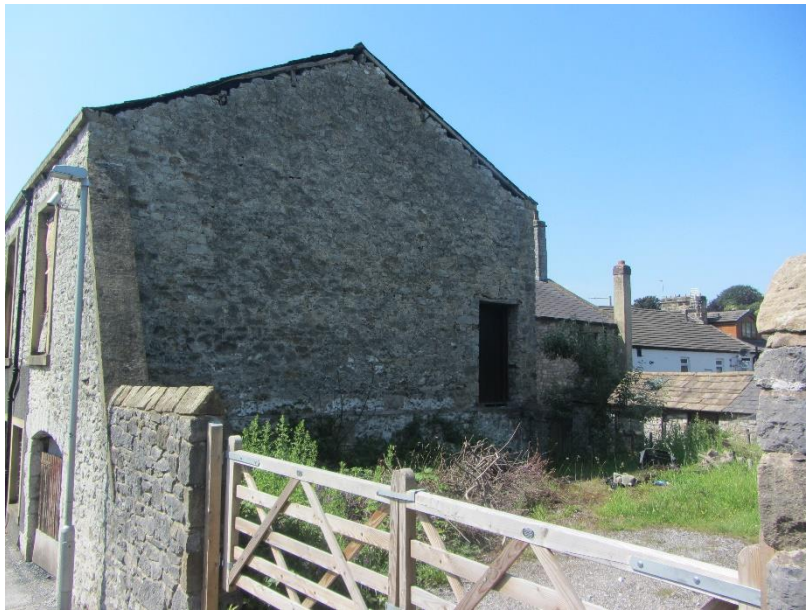
Photo 23 – East wall – gap along roof verge
