REFURBISHMENT/DEMOLITION ASBESTOS SURVEY REPORT

Site Name: 45-47 Whalley Road
(Wheatshaf Hotel)
Clitheroe
Lancashire
BB7 1EE

Date of Survey: 5th February 2025

Survey Type: Refurbishment and Demolition Survey

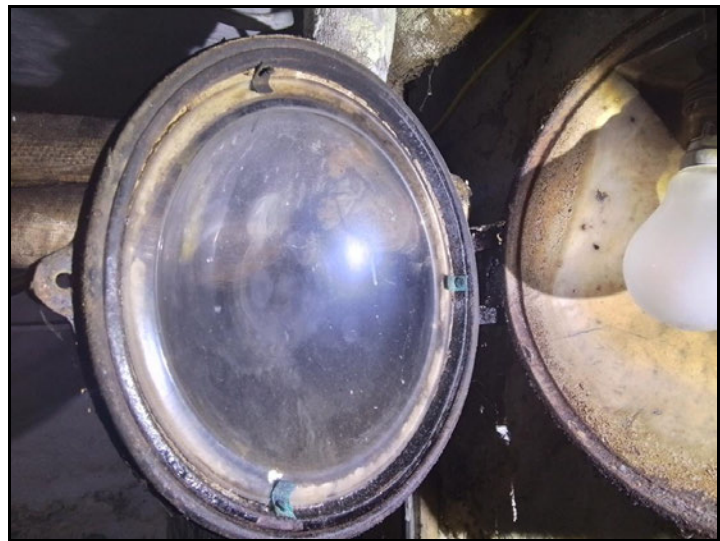
Site ID 28400
 Location ID 001
 Building/Unit 45-47 Whalley Road
 Floor -1 (Basement)
 Room / Area Cellar
 Description Putty to Light Cover
 Surveyed Yes
 Source of Information Luke Poston
 Last Inspection Date 05/02/2025
 Lab Reference P-58707/001
 Survey Type Refurbishment
 Demolition
 Sample Number 28400/S01

Action	Priority	Notifiable	Licensed
Additional Comments	No asbestos was identified within the sample analysed.		
Recommendations

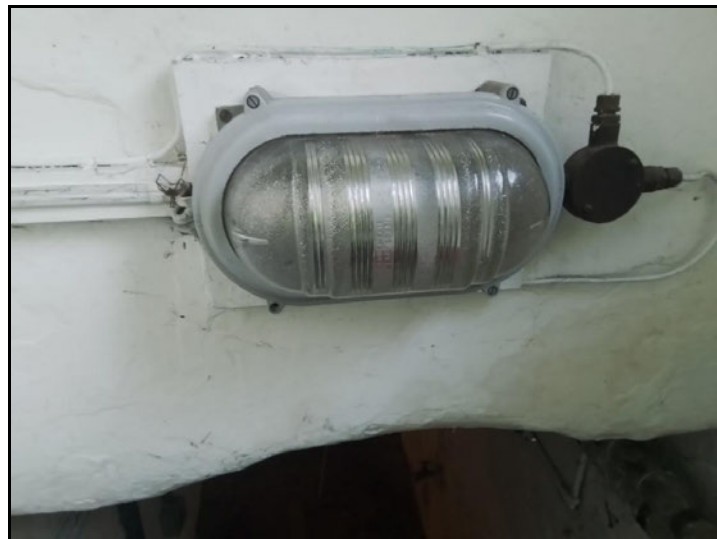
Site ID 28400
Location ID 001
Building/Unit 45-47 Whalley Road
Floor -1 (Basement)
Room / Area Cellar
Description Seal to Light Cover
Surveyed Yes
Source of Information Luke Poston
Last Inspection Date 05/02/2025
Lab Reference P-58707/002
Survey Type Refurbishment
 Demolition
Sample Number 28400/S02

Action	Priority	Notifiable	Licensed
Additional Comments	No asbestos was identified within the sample analysed.		
Recommendations

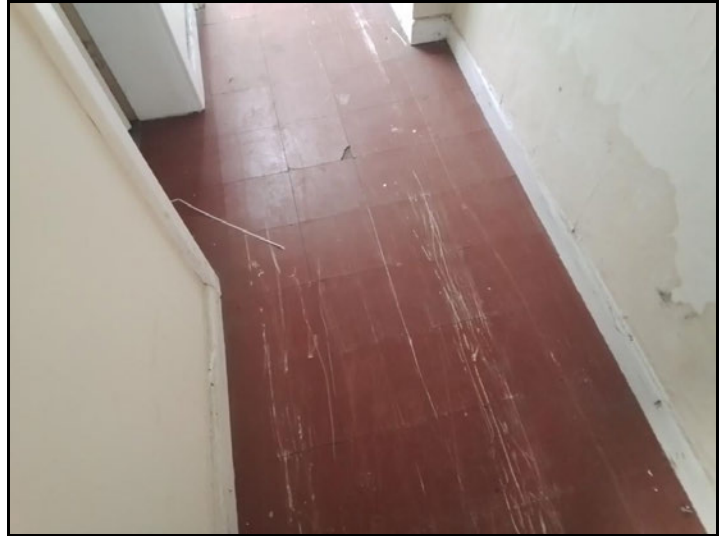
Site ID 28400
 Location ID 003
 Building/Unit 45-47 Whalley Road
 Floor 0 (Ground)
 Room / Area Foyer
 Description Floor Tiles
 Surveyed Yes
 Source of Information Luke Poston
 Last Inspection Date 05/02/2025
 Lab Reference P-58707/003
 Survey Type Refurbishment
 Demolition
 Sample Number 28400/S03

Action	Priority	Notifiable	Licensed
Additional Comments	No asbestos was identified within the sample analysed.		
Recommendations

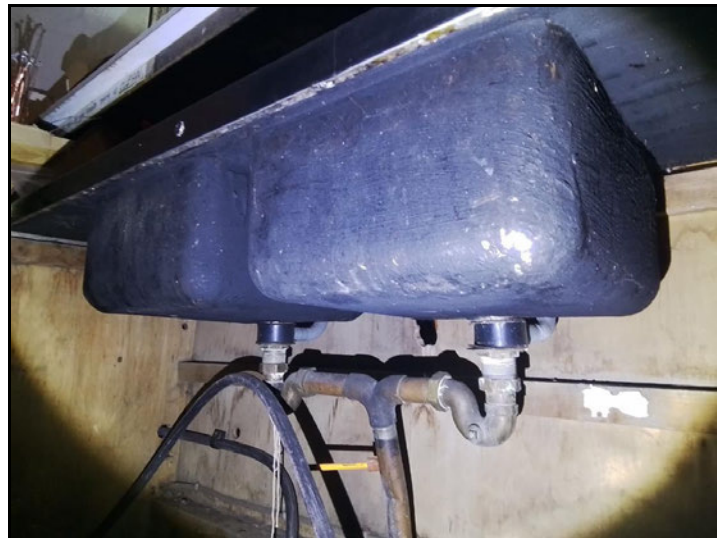
Site ID 28400
 Location ID 006
 Building/Unit 45-47 Whalley Road
 Floor 0 (Ground)
 Room / Area Stores
 Description Bitumen Coating to Sink
 Surveyed Yes
 Source of Information Luke Poston
 Last Inspection Date 05/02/2025
 Lab Reference P-58707/004
 Survey Type Refurbishment
 Demolition
 Sample Number 28400/S04

Action	Priority	Notifiable	Licensed
Additional Comments	No asbestos was identified within the sample analysed.		
Recommendations

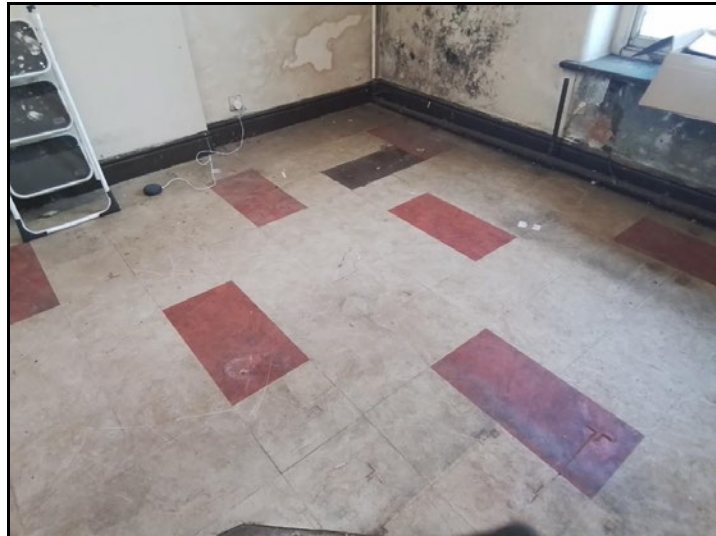
Site ID 28400
Location ID 008
Building/Unit 45-47 Whalley Road
Floor 0 (Ground)
Room / Area Store
Description Floor Tiles
Surveyed Yes
Source of Information Luke Poston
Last Inspection Date 05/02/2025
Lab Reference P-58707/005
Survey Type Refurbishment
 Demolition
Sample Number 28400/S05

MATERIAL ASSESSMENT = 3

Material	Vinyl Tiles (1)	Surface Treatment	Composite, reinforced or bonded (0)
Condition	Low Damage (1)	Sample Result	Chrysotile
Location	Room(s) up to 100m ²	Amount	35 m ²
Accessibility	Easily Disturbed

Recommendations **The floor tiles need to be removed by suitably trained persons under controlled conditions using HSE Guidelines, prior to the commencement of any works.**

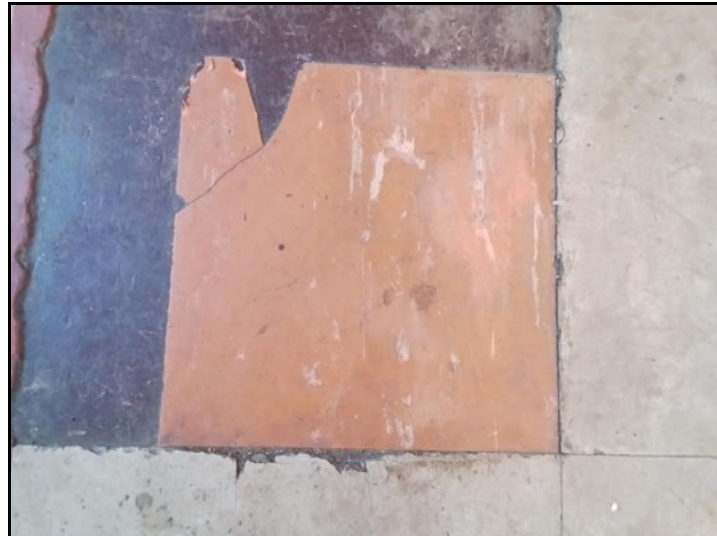
Site ID 28400
Location ID 008
Building/Unit 45-47 Whalley Road
Floor 0 (Ground)
Room / Area Store
Description Floor Tile
Surveyed Yes
Source of Information Luke Poston
Last Inspection Date 05/02/2025
Lab Reference P-58707/006
Survey Type Refurbishment
 Demolition
Sample Number 28400/S06

MATERIAL ASSESSMENT = 3

Material	Vinyl Tiles (1)	Surface Treatment	Composite, reinforced or bonded (0)
Condition	Low Damage (1)	Sample Result	Chrysotile
Location	Room(s) up to 100m ²	Amount	1 floor tile
Accessibility	Easily Disturbed

Recommendations **The floor tile needs to be removed by suitably trained persons under controlled conditions using HSE Guidelines, prior to the commencement of any works.**

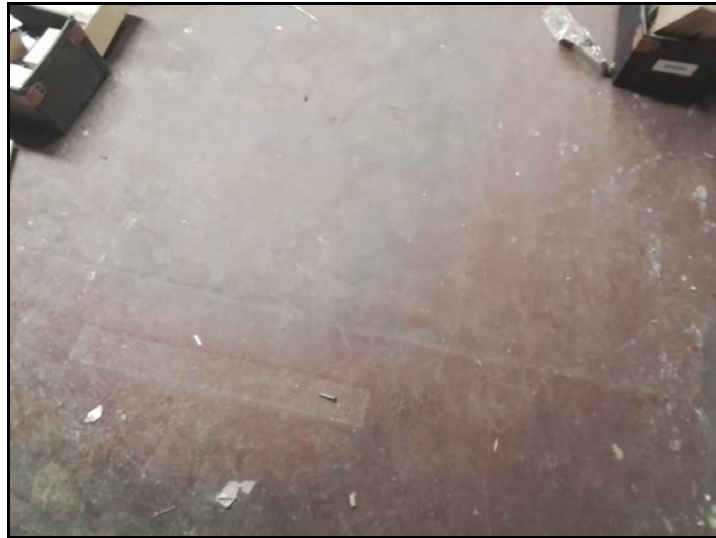
Site ID 28400
 Location ID 013
 Building/Unit 45-47 Whalley Road
 Floor 0 (Ground)
 Room / Area Throughout
 Description Magnesite Floor
 Surveyed Yes
 Source of Information Luke Poston
 Last Inspection Date 05/02/2025
 Lab Reference P-58707/008
 Survey Type Refurbishment
 Demolition
 Sample Number 28400/S08

Action	Priority	Notifiable	Licensed
Additional Comments	No asbestos was identified within the sample analysed.		
Recommendations

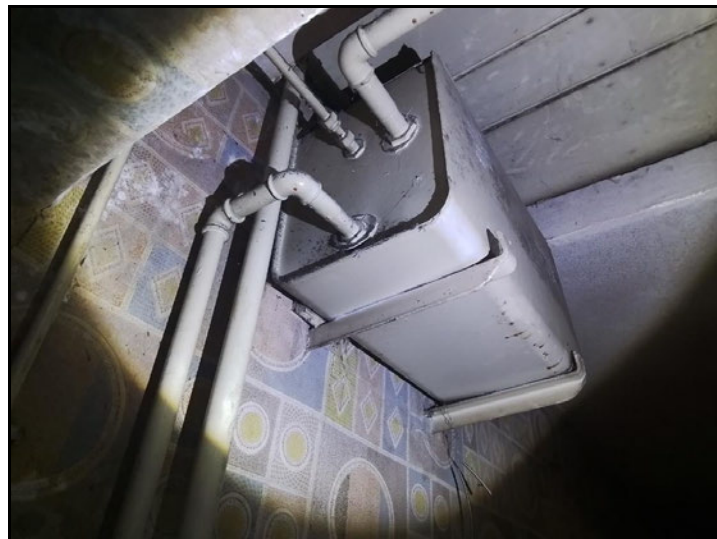
Site ID 28400
 Location ID 014
 Building/Unit 45-47 Whalley Road
 Floor 1 (1st Floor)
 Room / Area Landing
 Description Putty to Tank
 Surveyed Yes
 Source of Information Luke Poston
 Last Inspection Date 05/02/2025
 Lab Reference
 Survey Type Refurbishment
 Demolition
 Sample Number 28400/X09

Material	Surface Treatment	
Condition	Sample Result	No Asbestos Detected
Location	Amount	
Accessibility

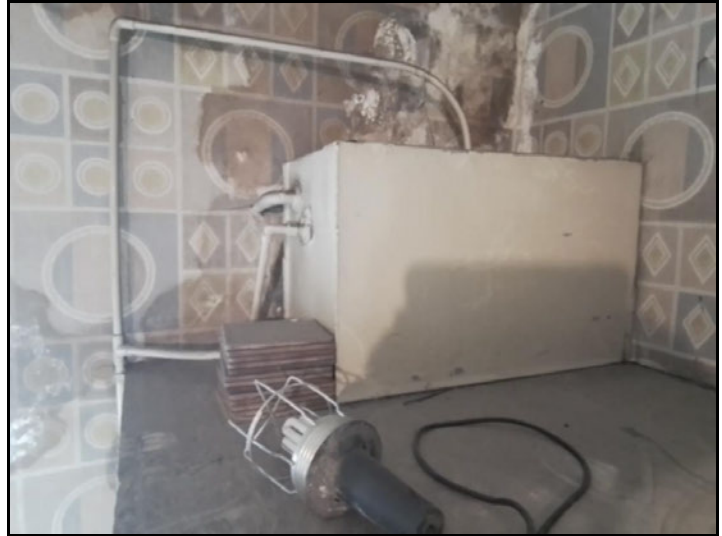
Site ID 28400
 Location ID 014
 Building/Unit 45-47 Whalley Road
 Floor 1 (1st Floor)
 Room / Area Landing
 Description Putty to Tank
 Surveyed Yes
 Source of Information Luke Poston
 Last Inspection Date 05/02/2025
 Lab Reference P-58707/009
 Survey Type Refurbishment
 Demolition
 Sample Number 28400/S09

Action	Priority	Notifiable	Licensed
Additional Comments	No asbestos was identified within the sample analysed.		
Recommendations

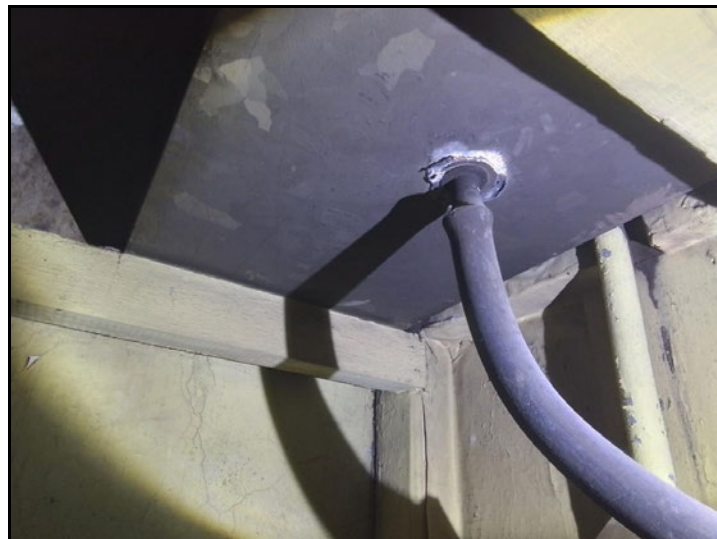
Site ID 28400
 Location ID 020
 Building/Unit 45-47 Whalley Road
 Floor 1 (1st Floor)
 Room / Area Old Bathroom
 Description Seal to Metal Tank
 Surveyed Yes
 Source of Information Luke Poston
 Last Inspection Date 05/02/2025
 Lab Reference P-58707/011
 Survey Type Refurbishment
 Demolition
 Sample Number 28400/S11

Action	Priority	Notifiable	Licensed
Additional Comments	No asbestos was identified within the sample analysed.		
Recommendations

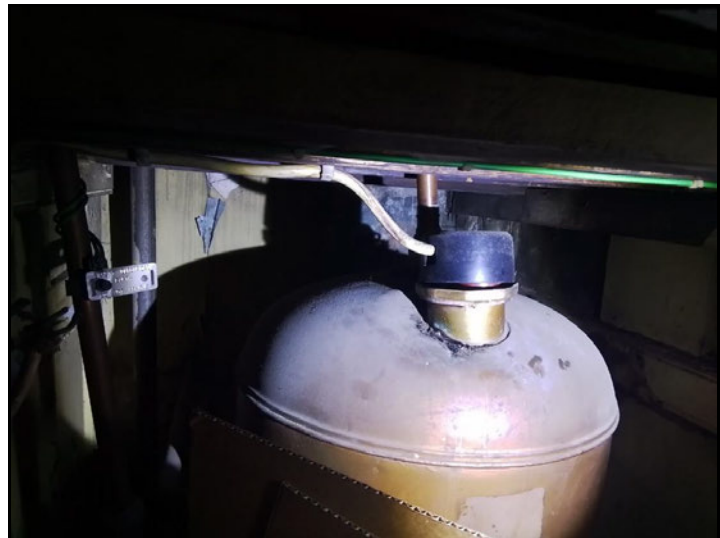
Site ID 28400
Location ID 020
Building/Unit 45-47 Whalley Road
Floor 1 (1st Floor)
Room / Area Old Bathroom
Description Gasket to Copper Tank
Surveyed Yes
Source of Information Luke Poston
Last Inspection Date 05/02/2025
Lab Reference P-58707/010
Survey Type Refurbishment
 Demolition
Sample Number 28400/S10

MATERIAL ASSESSMENT = 4

Material	Gaskets (Compressed) (2)	Surface Treatment	Unsealed cement / Enclosed lagging or spray / Encapsulated board (1)
Condition	Good Condition (0)	Sample Result	Chrysotile
Location	Room(s) up to 100m ²	Amount	
Accessibility	Easily Disturbed

Recommendations **The gasket to the tank needs to be removed by suitably trained persons under controlled conditions using HSE Guidelines, prior to the commencement of any works.**

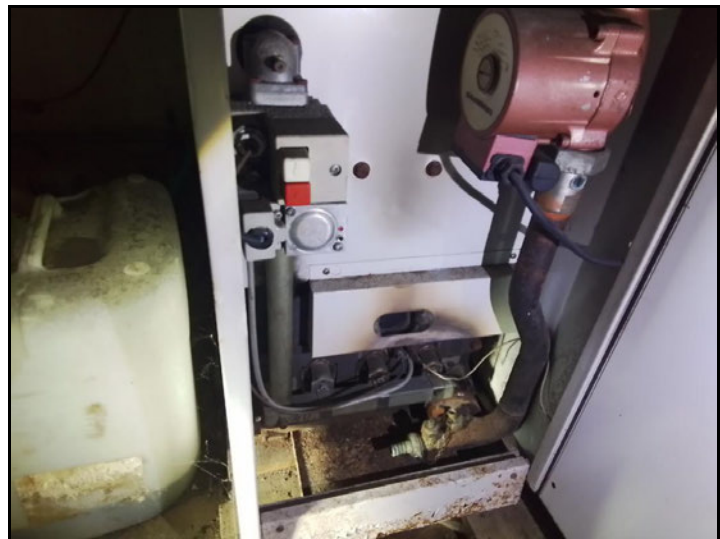
Site ID 28400
 Location ID 024
 Building/Unit 45-47 Whalley Road
 Floor 0 (Ground)
 Room / Area Old Stable
 Description Gaskets within Boiler
 Surveyed Yes
 Source of Information Luke Poston
 Last Inspection Date 05/02/2025
 Lab Reference P-58707/012
 Survey Type Refurbishment
 Demolition
 Sample Number 28400/S12

MATERIAL ASSESSMENT = 4

Material	Gaskets (Compressed) (2)	Surface Treatment	Unsealed cement / Enclosed lagging or spray / Encapsulated board (1)
Condition	Good Condition (0)	Sample Result	Chrysotile
Location	Room(s) up to 100m ²	Amount	
Accessibility	Easily Disturbed

Recommendations **The boiler needs to be removed complete without any disturbance to the internal materials by suitably trained persons prior to the commencement of any works.**

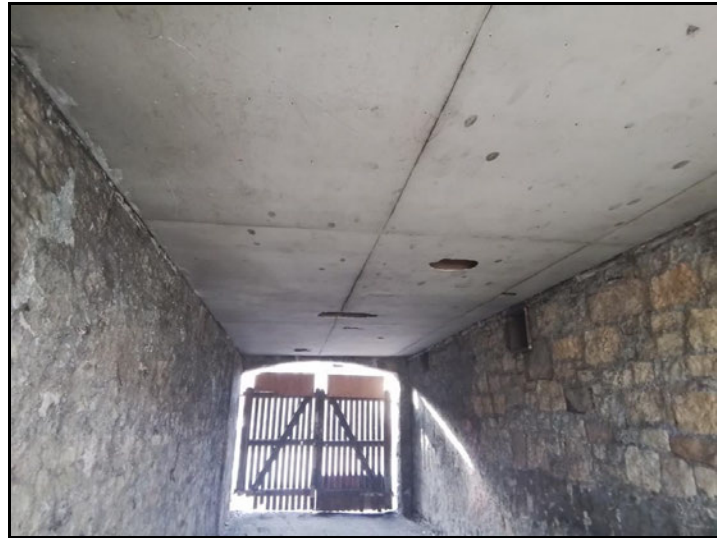
Site ID 28400
Location ID 025
Building/Unit 45-47 Whalley Road
Floor 0 (Ground)
Room / Area Canopy
Description Ceiling Boards
Surveyed Yes
Source of Information Luke Poston
Last Inspection Date 05/02/2025
Lab Reference P-58707/013
Survey Type Refurbishment
 Demolition
Sample Number 28400/S13

MATERIAL ASSESSMENT = 10

Material	Insulating Board (2)	Surface Treatment	Unsealed lagging or spray (3)
Condition	High Damage (3)	Sample Result	Amosite/Chrysotile
Location	Outdoors	Amount	25 m ²
Accessibility	Usually inaccessible

Action	REMOVE (AIB)	Priority	1	Notifiable	Yes	Licensed	Yes
Additional Comments							
Recommendations	The ceiling boards need to be removed by a licensed removal company prior to the commencement of any works.

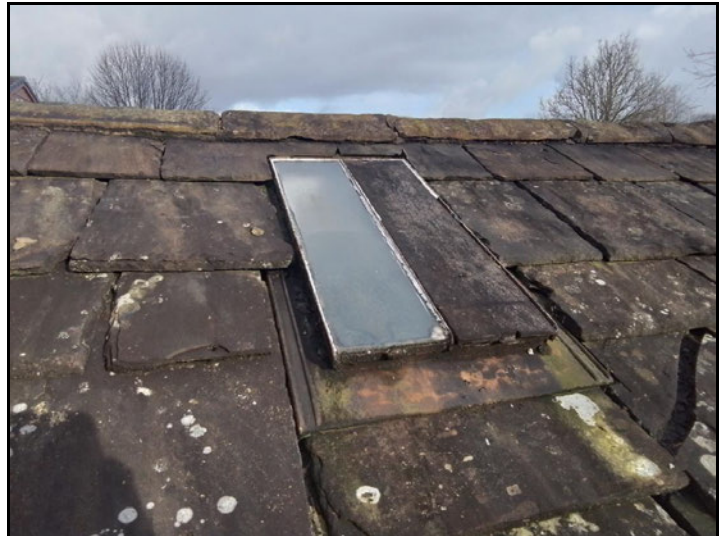
Site ID 28400
Location ID 026
Building/Unit 45-47 Whalley Road
Floor 0 (Ground)
Room / Area External Areas
Description Putty around Skylight
Surveyed Yes
Source of Information Luke Poston
Last Inspection Date 05/02/2025
Lab Reference P-58707/015
Survey Type Refurbishment
 Demolition
Sample Number 28400/S15

Action	Priority	Notifiable	Licensed
Additional Comments	No asbestos was identified within the sample analysed.		
Recommendations

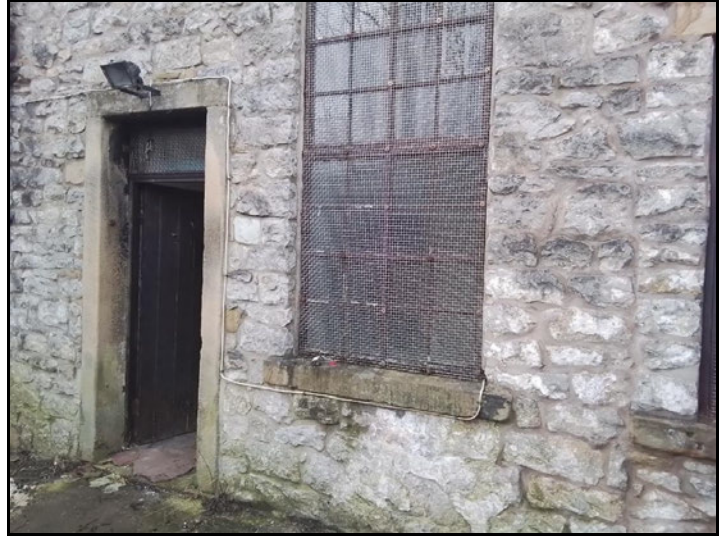
Site ID 28400
 Location ID 026
 Building/Unit 45-47 Whalley Road
 Floor 0 (Ground)
 Room / Area External Areas
 Description Putty around
 Windows & Doors
 Surveyed Yes
 Source of Information Luke Poston
 Last Inspection Date 05/02/2025
 Lab Reference P-58707/014
 Survey Type Refurbishment
 Demolition
 Sample Number 28400/S14

Action	Priority	Notifiable	Licensed
Additional Comments	No asbestos was identified within the sample analysed.		
Recommendations
