# **Barn at Holmes Farm, Higher Commons Lane, Balderstone BB2 7LR**

## Structural Condition Survey for Conversion to Dwellings

PSC-949 Rev A

July 2025

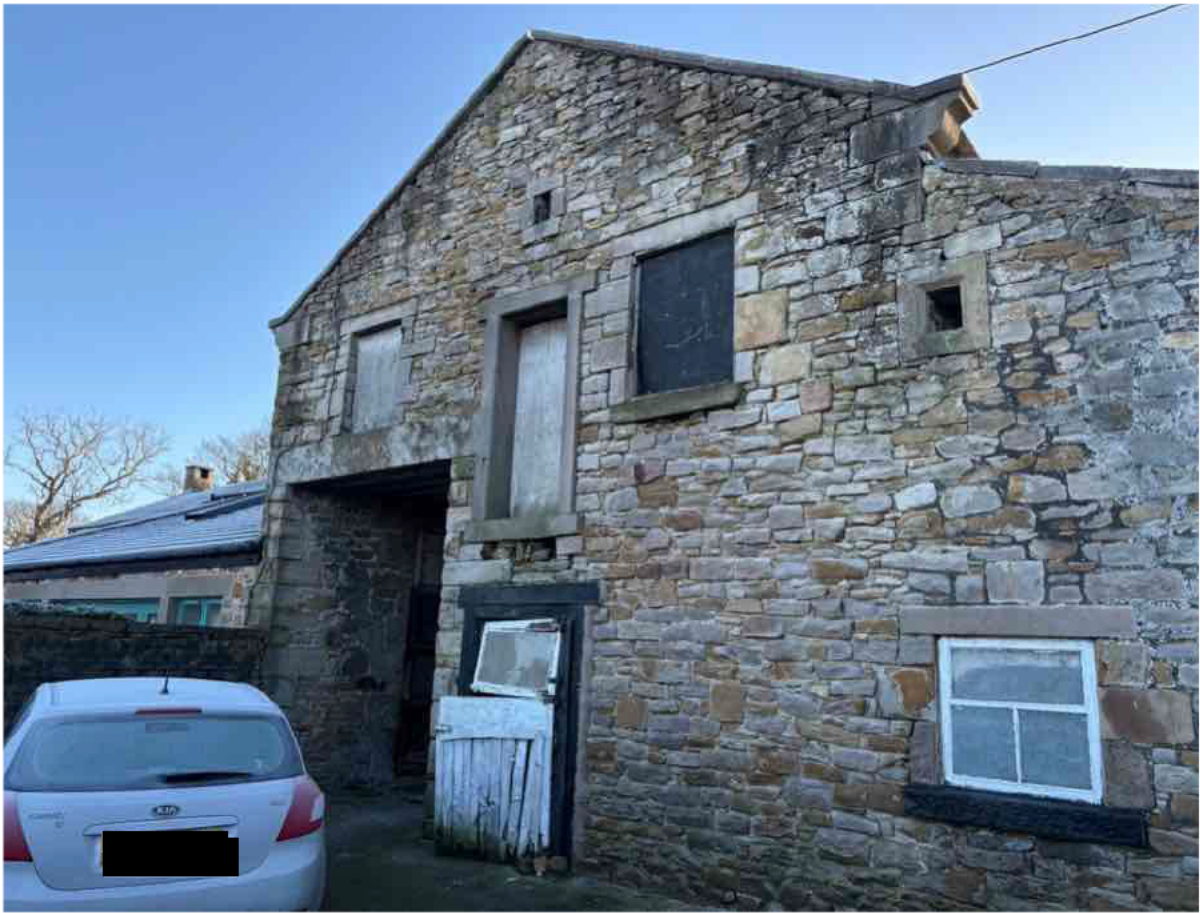
Photo 1 - North West Elevation

The North-West Elevation is built in random sandstone with a large barn door at the west end (photo 1) which has timber doors set back as indicated on the existing plan. The wall is in good condition. It is plumb and reasonably pointed with a mixture of lime and cement mortar. There are no signs of previous or ongoing movement. The photos indicate that the roof has copings to the gable edge which are all in place. In addition to the main barn door there are two further door openings and one window opening at ground floor level plus a door and two window

openings at first floor level. There are two further small vents at the upper levels (photo 1). The timber to the doors and windows is in poor condition.

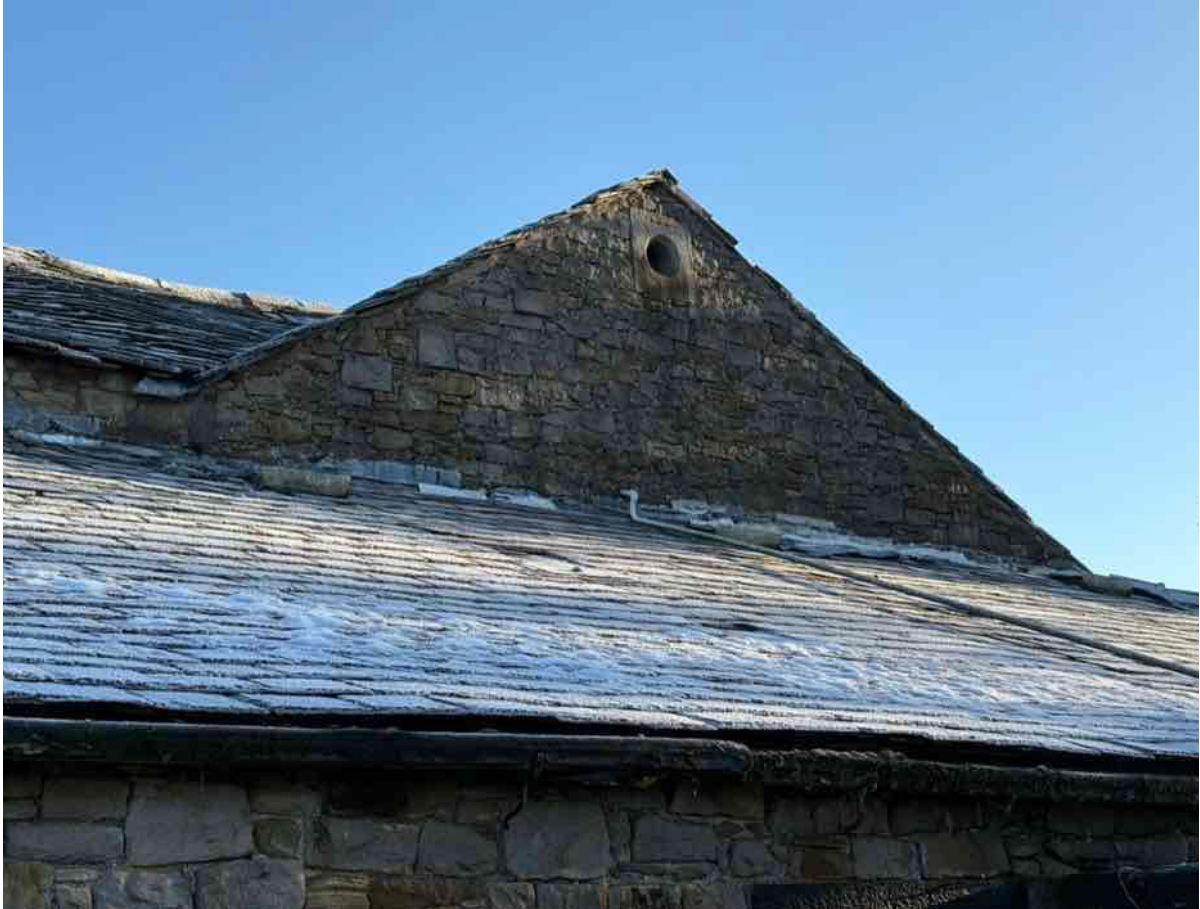
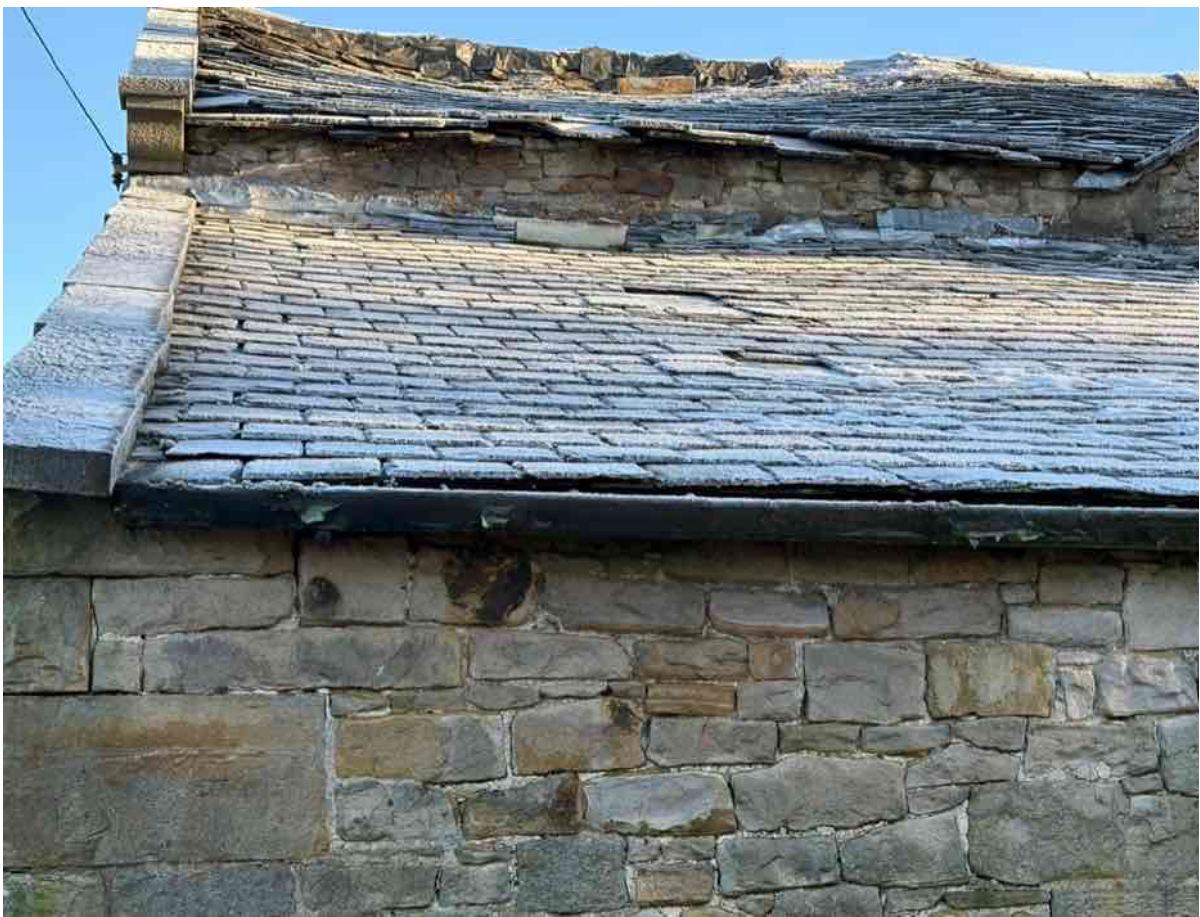
This single storey wall to the stable area is built in random sandstone and there is a small two room storage area at the south end (photos 9 & 10). Part of the elevation is obscured by a large, rendered tank (photo 8). The gable of the main barn is visible above the roof (photos 6 & 7). The walls are all in good condition. They are plumb and reasonably pointed with a mixture of mainly lime and some cement mortar. There are no signs of previous or ongoing movement. Photo 7 indicates some slight movement to the gable copings on the roof. There are 3 door openings and 3 window openings and the timber to these is in poor condition. This elevation has some sections of gutter but they are in poor condition with no downspouts.

Photo 6 – South West Elevation

Photo 7 – South West Elevation

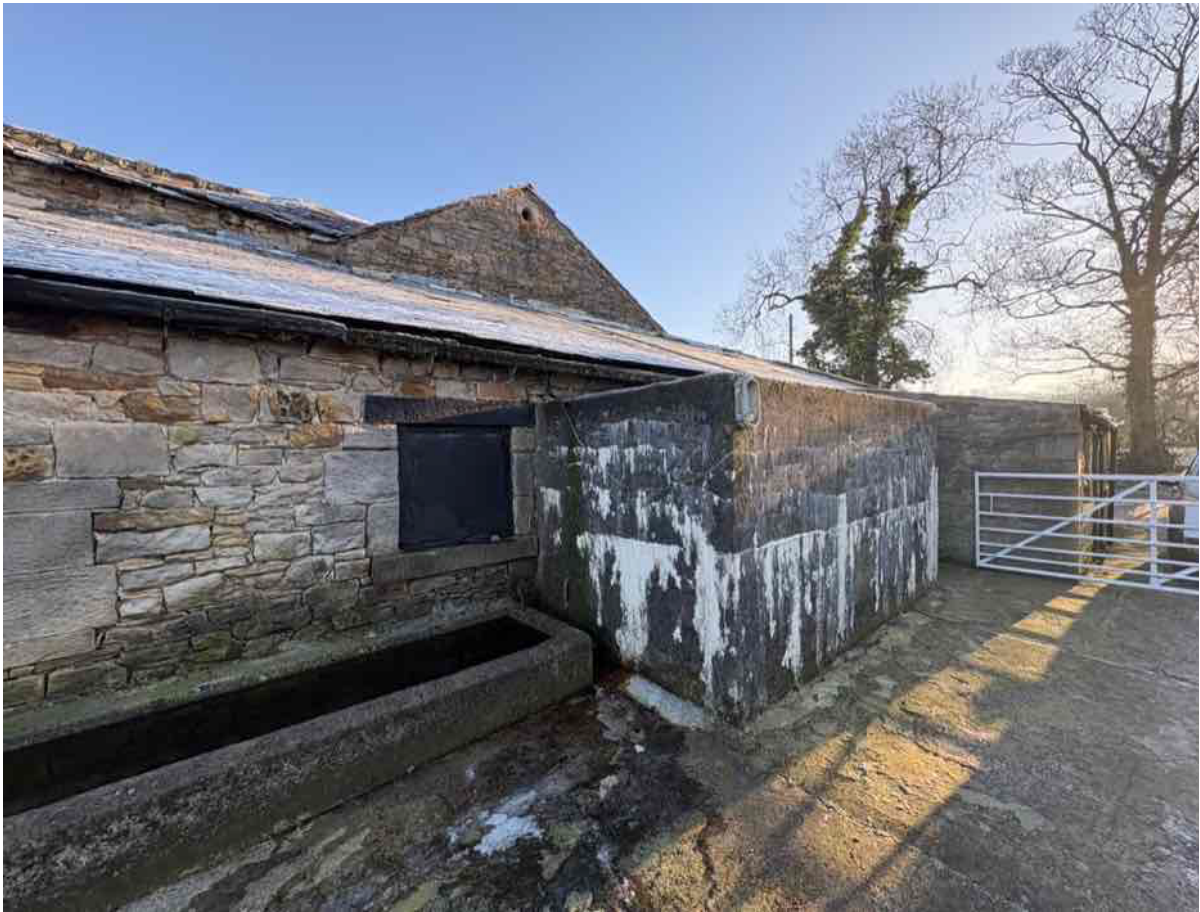
Photo 8 – South West Elevation

When converting barns, it is essential that the construction techniques and sequence are carefully considered. The proposals are for two dwellings, one occupying the main barn and the other occupying the single storey lean-to section to the south west. In the main barn some internal walls will be removed or openings made but given the condition of the barn this should not affect the overall stability and structural integrity of the building. In the stable the individual stable layout will be replaced by new walls forming the rooms and it is advised that these are formed in masonry to maintain the stability and integrity of the structure. The tank and two small rooms on the south west elevation are to be removed/demolished.

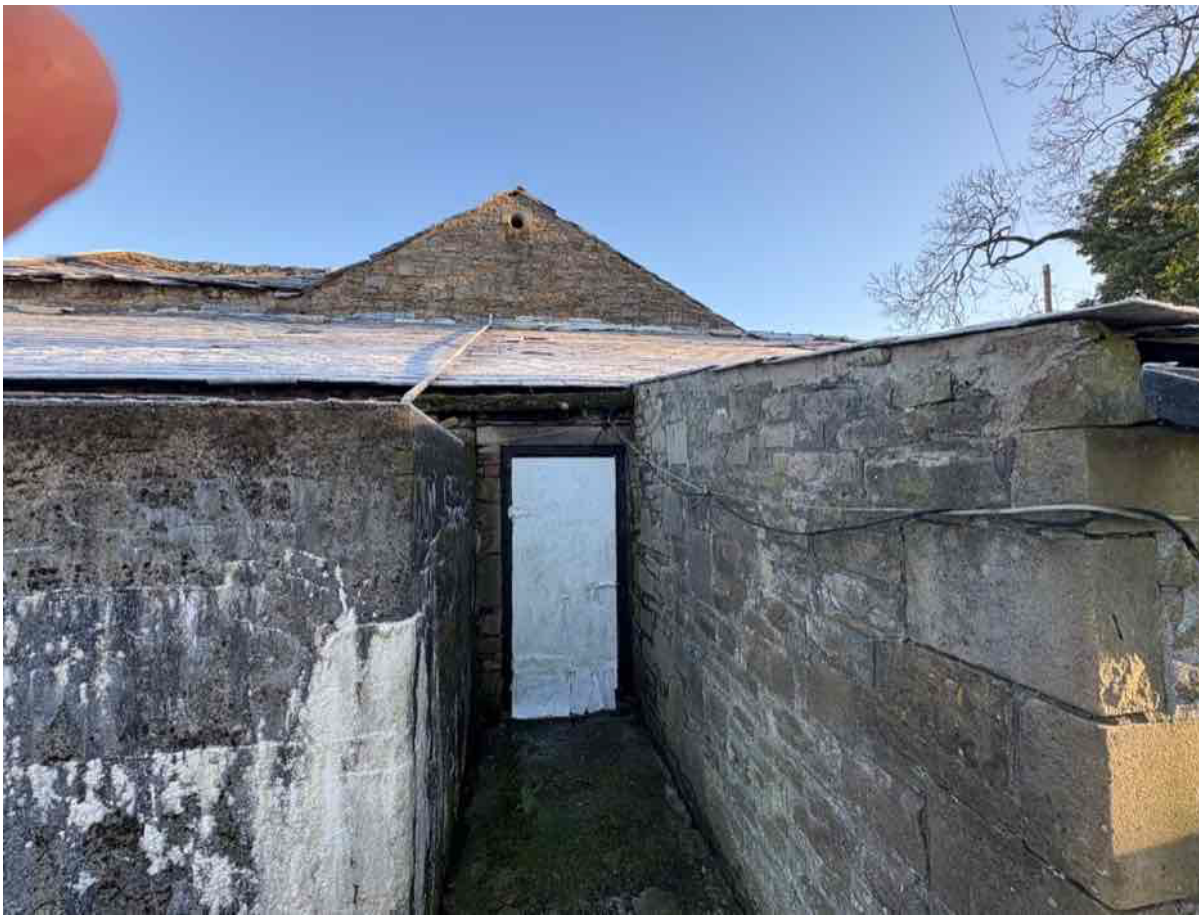
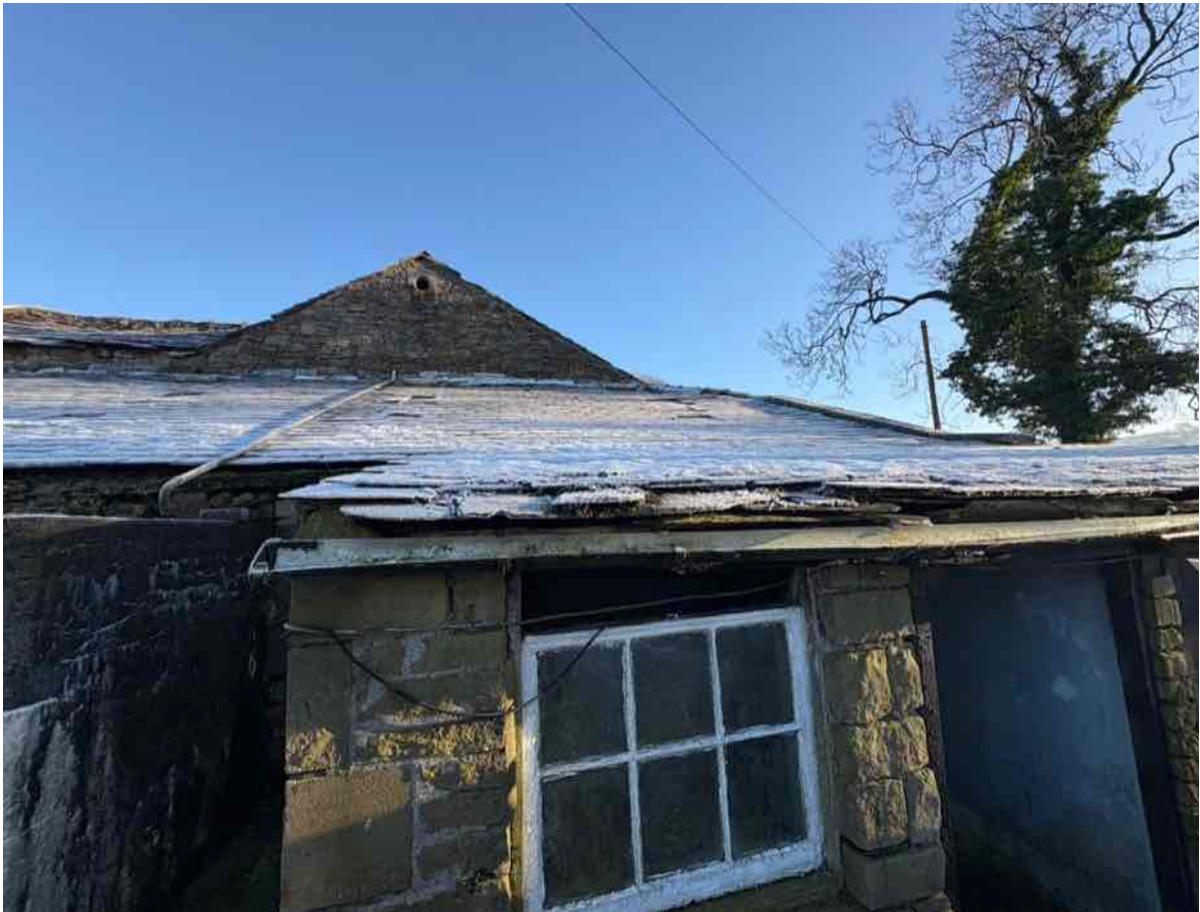
Photo 9 – South West Elevation

Photo 10 – South West Elevation

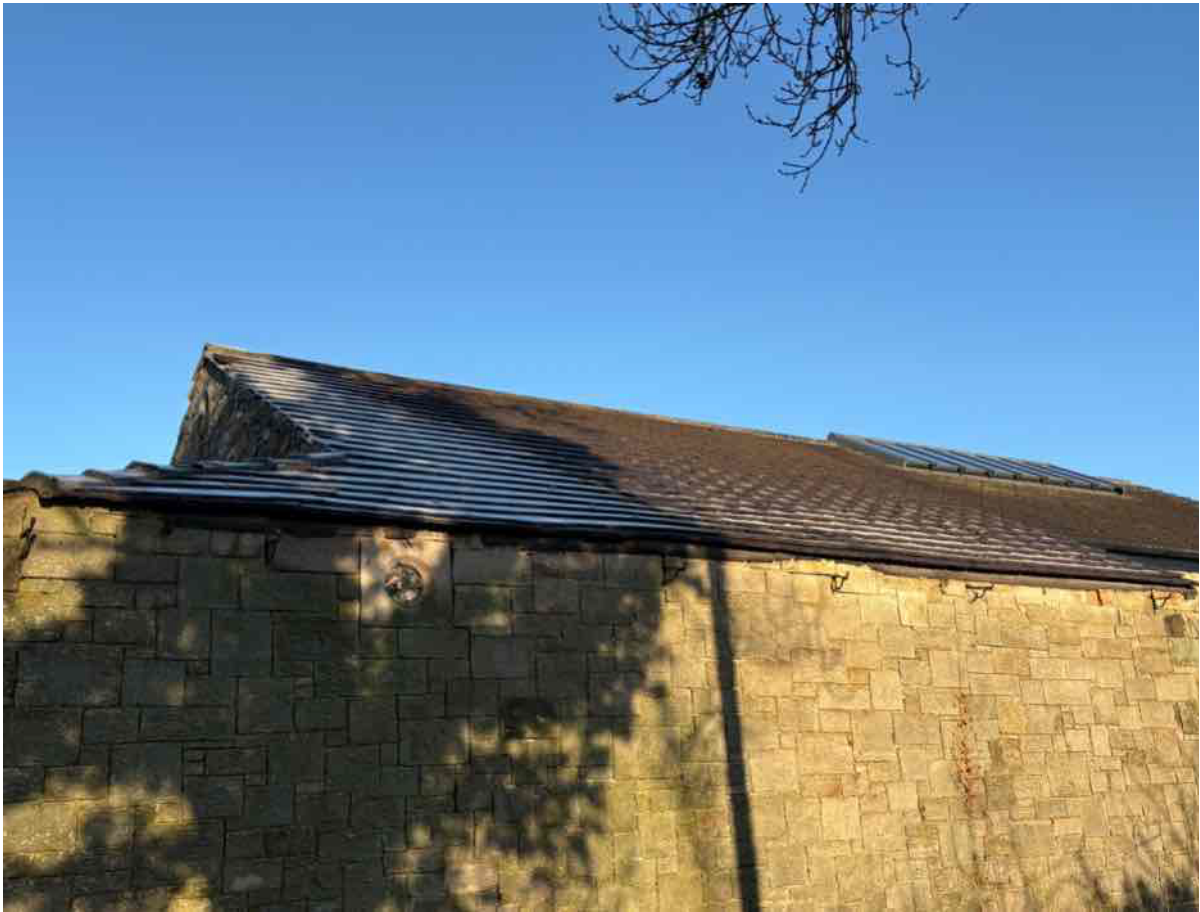
The roof to the main barn is original to the rear (north-west) with slate on timber rafters and purlins. This is in poor condition and is badly deflected and failing. The internal inspection below illustrates this more clearly. The roof to the south-east has had the slates replaced with clay tiles and this is in reasonable condition (photos 12 & 13) as detailed in the internal inspection.

Photo 12 - South East Elevation

It is expected that the barn is to be re-roofed with a traditional timber and slate roof as the current roof is in a poor condition. The timber purlins and rafters to the front elevation are likely to be able to be retained together with the felt. The clay tiles could be retained unless slate is thought more appropriate. The trusses in the lean-to stable may be able to be retained to suit the proposed layout. Any timber retained should be assessed by a timber specialist, with regard to rot and infestation. All retained timber should be treated against rot/infestation and an indication of residual section given for structural purposes. All retained timber to be used structurally should be checked for structural adequacy. The new roof construction, including any insulation, should be assessed to ensure additional loading is not added to any roof structures retained. The new roof will also accommodate several velux windows which will require suitable timber trimmers to the rafters.

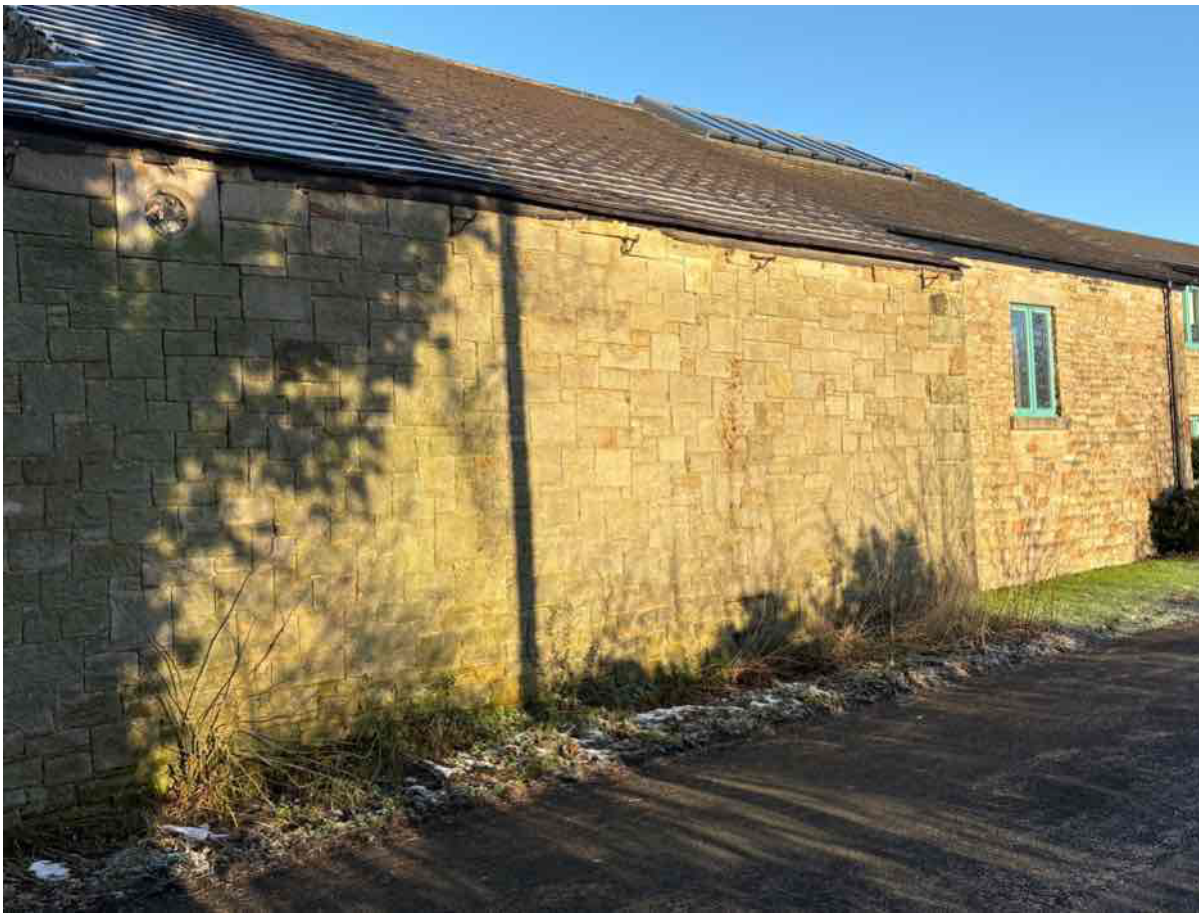
This elevation runs along Higher Commons Lane and is built in dressed, randomly coursed sandstone. This elevation has no openings except for a small circular vent at a high level (photo 13). The wall is in good condition. It is plumb and reasonably pointed with a mixture of mainly lime and some cement mortar. There are no signs of previous or ongoing movement. The guttering is missing from this elevation with only brackets remaining.

Photo 13 - South East Elevation

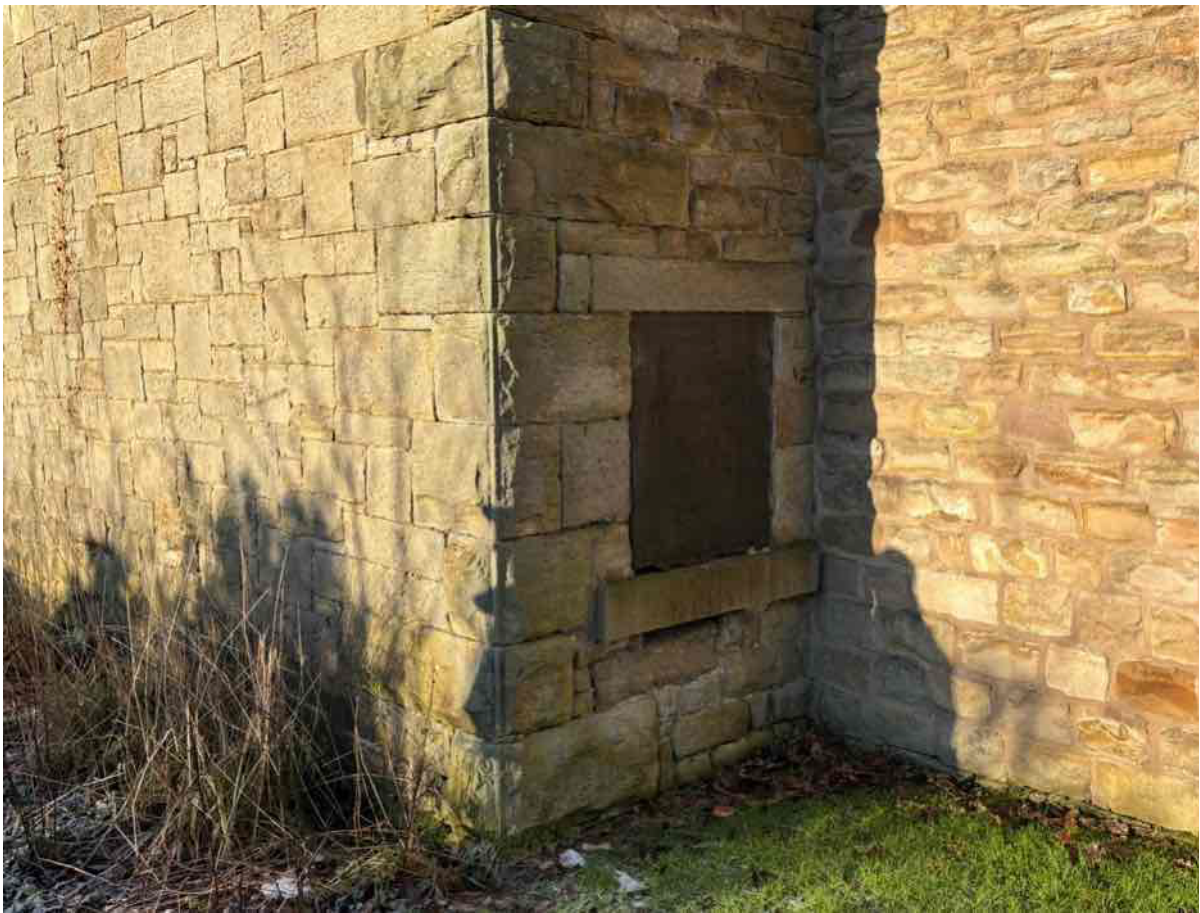
This short return is built in dressed, randomly coursed sandstone. There is single window opening at ground floor level (photo 15). The wall is in good condition. It is plumb and reasonably pointed with a mixture of mainly lime and some cement mortar. There are no signs of previous or ongoing movement. The window is boarded over.

Photo 15 - South East Elevation and return on North East Elevation

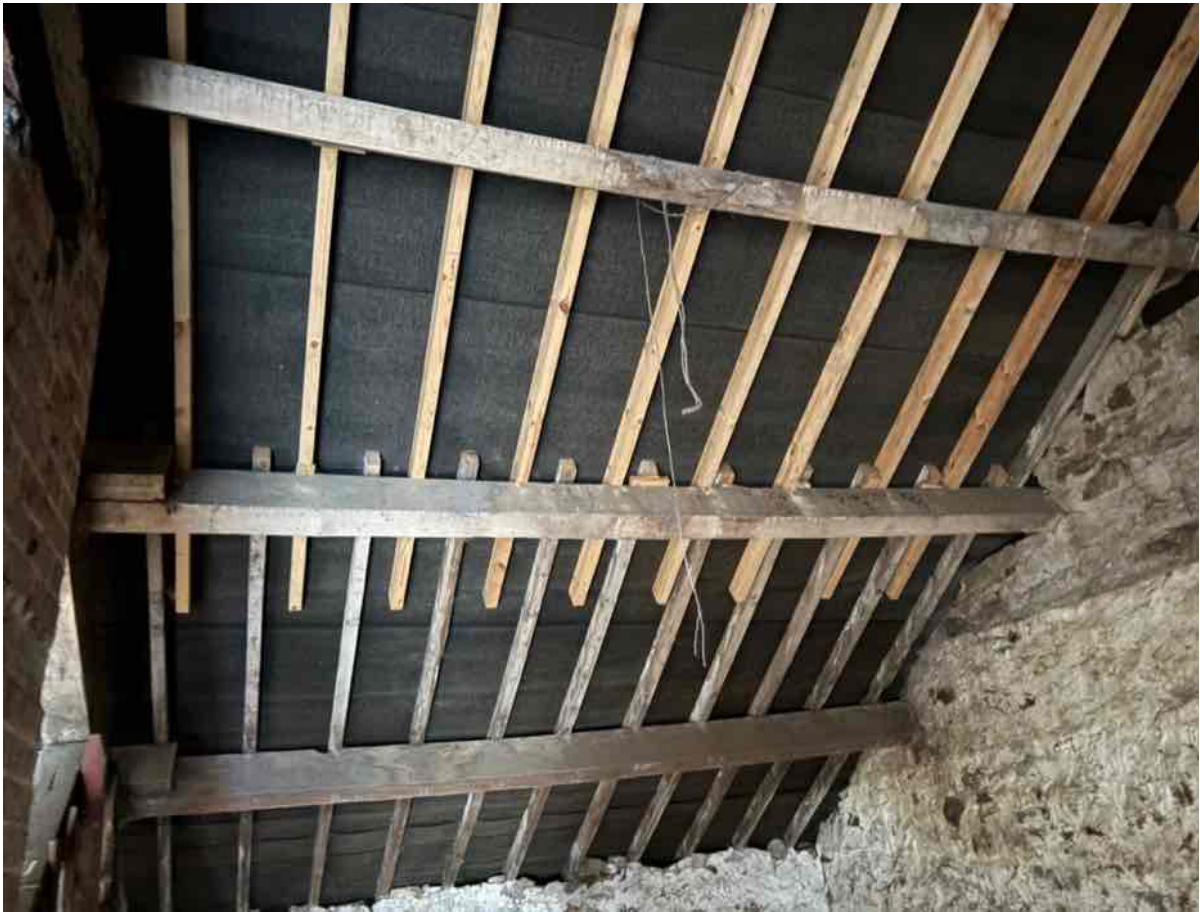
The timber beams and boards to the loft areas are in poor condition (photo 31). As discussed above the original roof to the rear is in poor condition with deflected timber which has been damaged by water and rot (photos 21 & 22). Photo 18 illustrates the re roofing to the front

elevation with new purlins, rafters and felt below the clay tiles noted externally. Photos 20 & 25 illustrate a large tank supported by steel beams below the ridge area.

Photo 18 – Internal new roof to south east

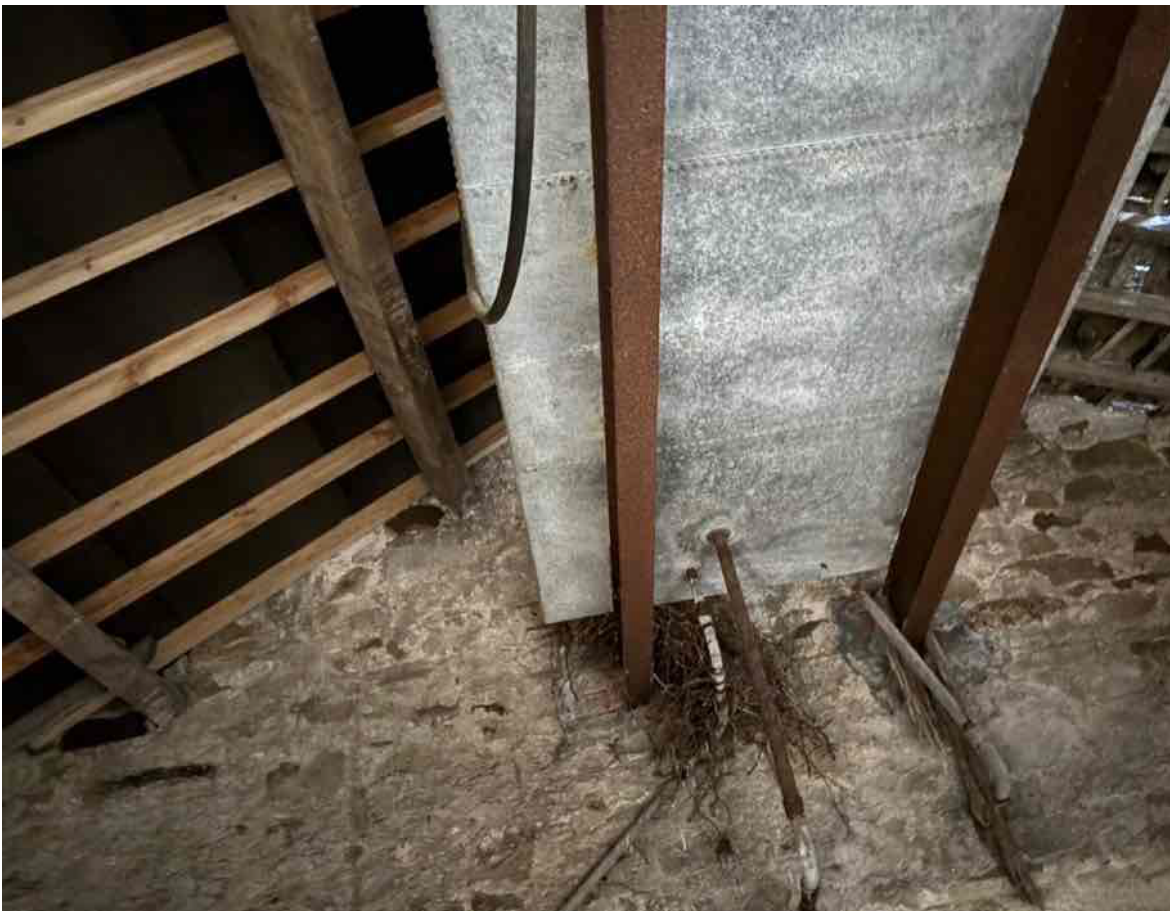
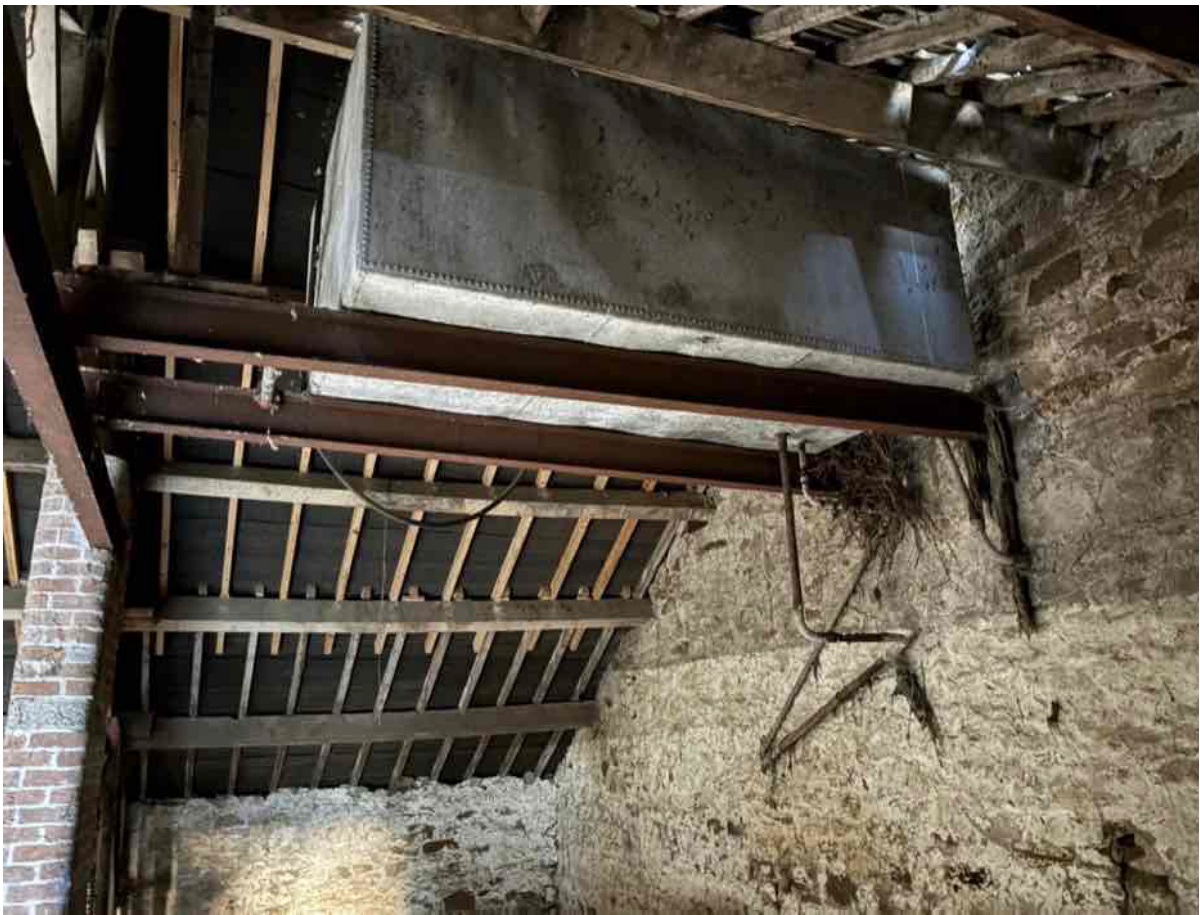
Photo 20 – Internal – tank and steel supports over loft

Photo 25 – Internal – tank and steel supports over loft

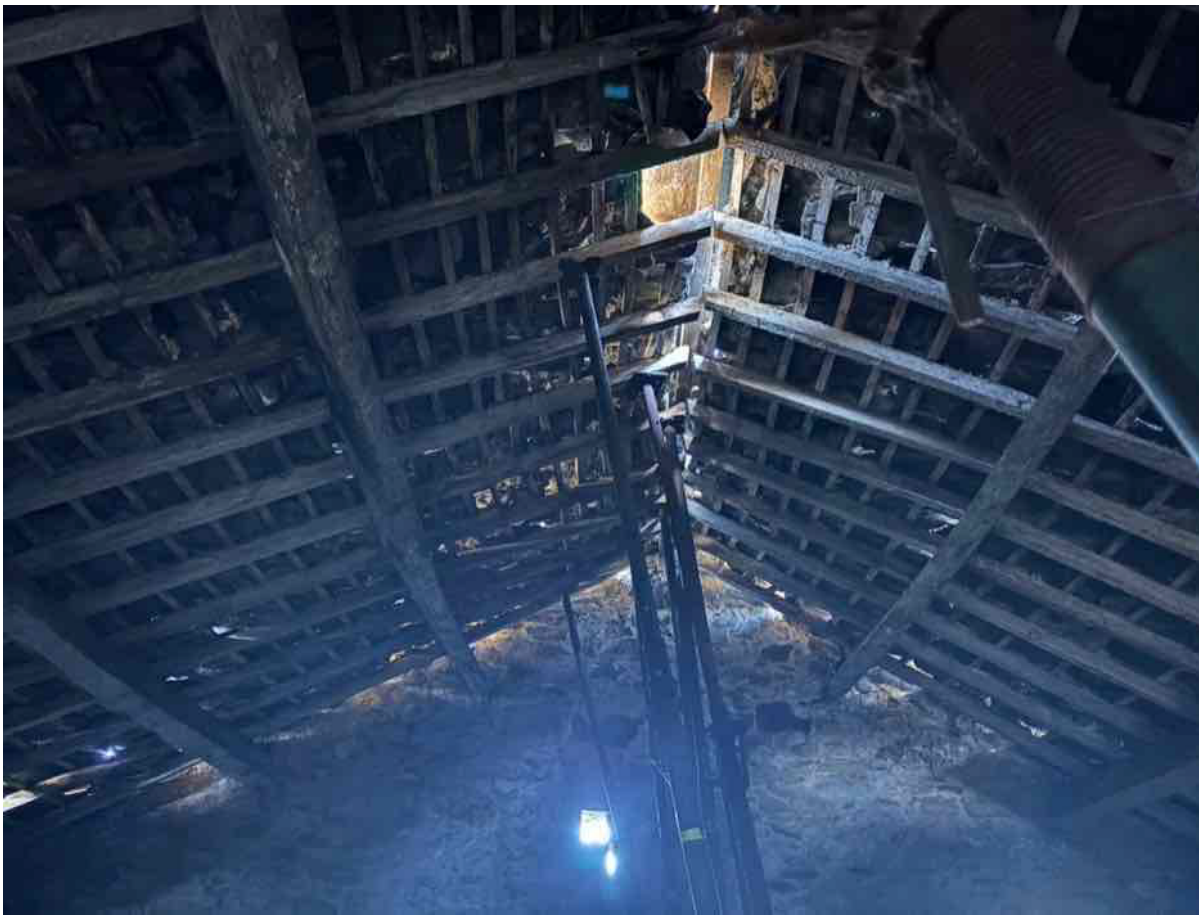
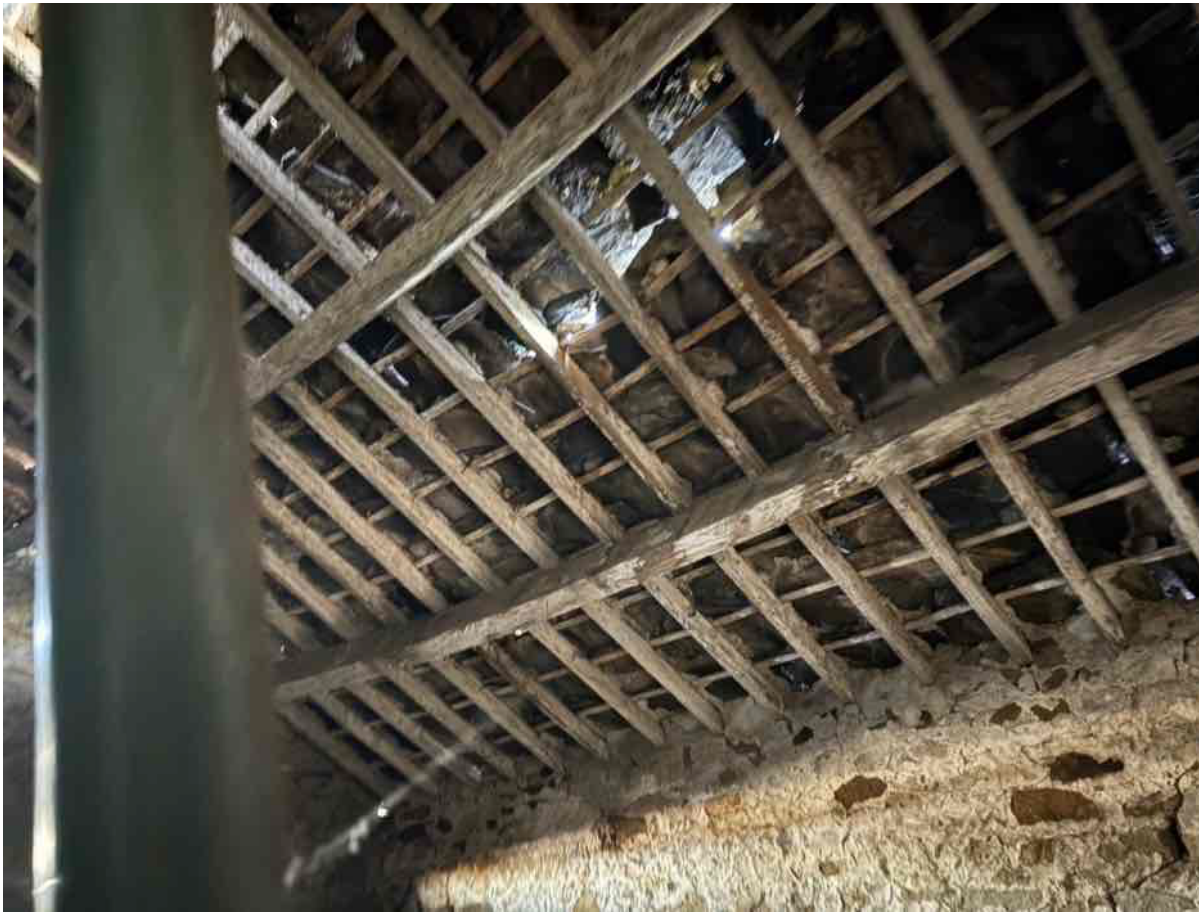
Photo 21 – Internal – original roof over rear (north west) area

Photo 22 - Internal – original roof over rear (north west) area

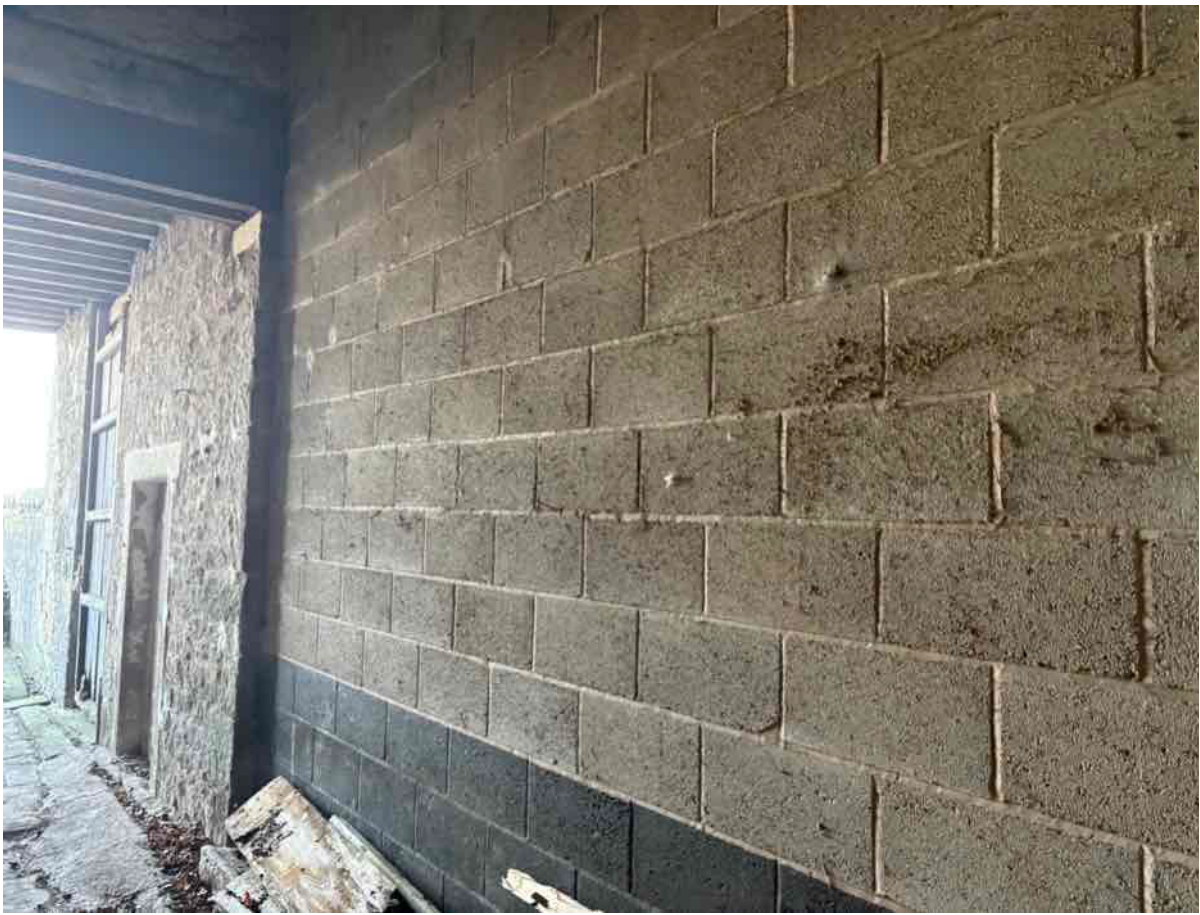
The main section of the barn is split into several rooms as detailed on the plans. Apart from the entrance area, these rooms have loft areas above, supported on timber beams. Internal inspection indicated that all the internal walls were in good condition with no sign of previous or ongoing movement. The walls are well pointed with lime mortar and the majority are lime washed. There are some areas of walls built with red brick (photos 30 & 33). The gable wall to the adjoining property has been re-built in blockwork (photo 29) and this is in excellent condition.

Photo 29 – New party wall to adjacent property on north east elevation

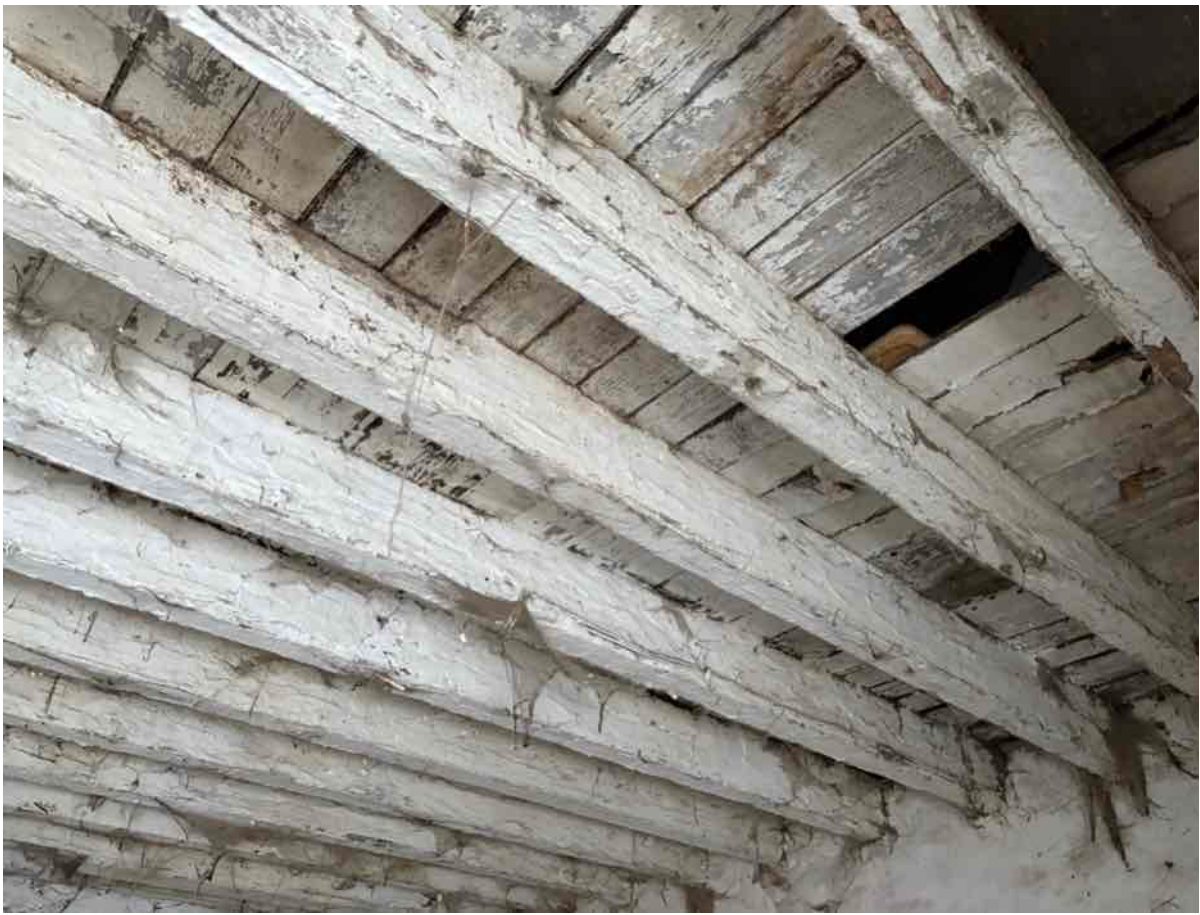
Photo 31 – Timber to loft area

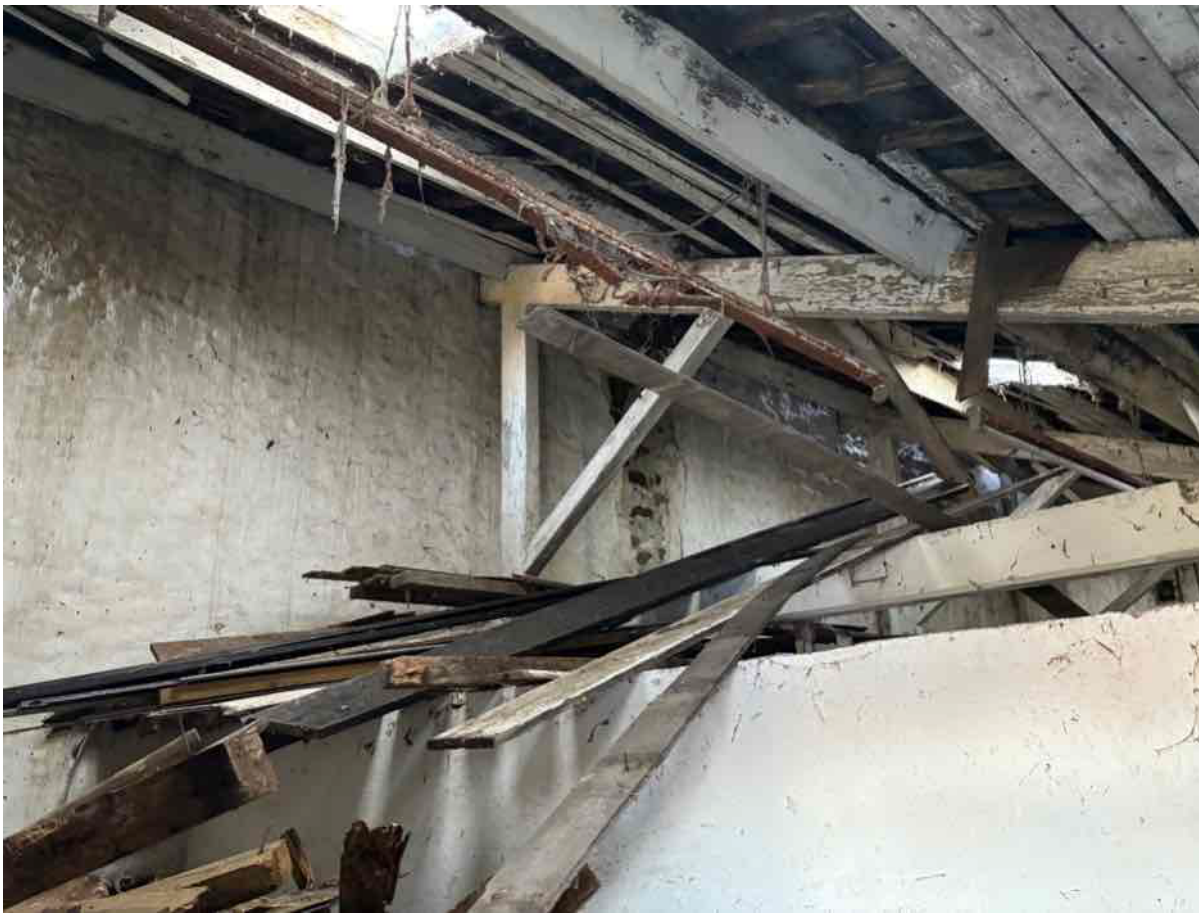
The large lean to stable area is shown on photos 37 to 40. Again, the walls are in good condition with no sign of previous or ongoing movement. The stalls are in place below the mono span trusses and purlins supporting the roof. The timber is in poor condition with some signs of deflection, rot and/or infestation. Timber under boarding has fallen from the rafters (photo 37).

Photo 37 – Lean to stable area to south west elevation
