# **Barn at Holmes Farm, Higher Commons Lane, Balderstone BB2 7LR**

## Structural Condition Survey for Conversion to Dwellings

PSC-949 Rev A

July 2025

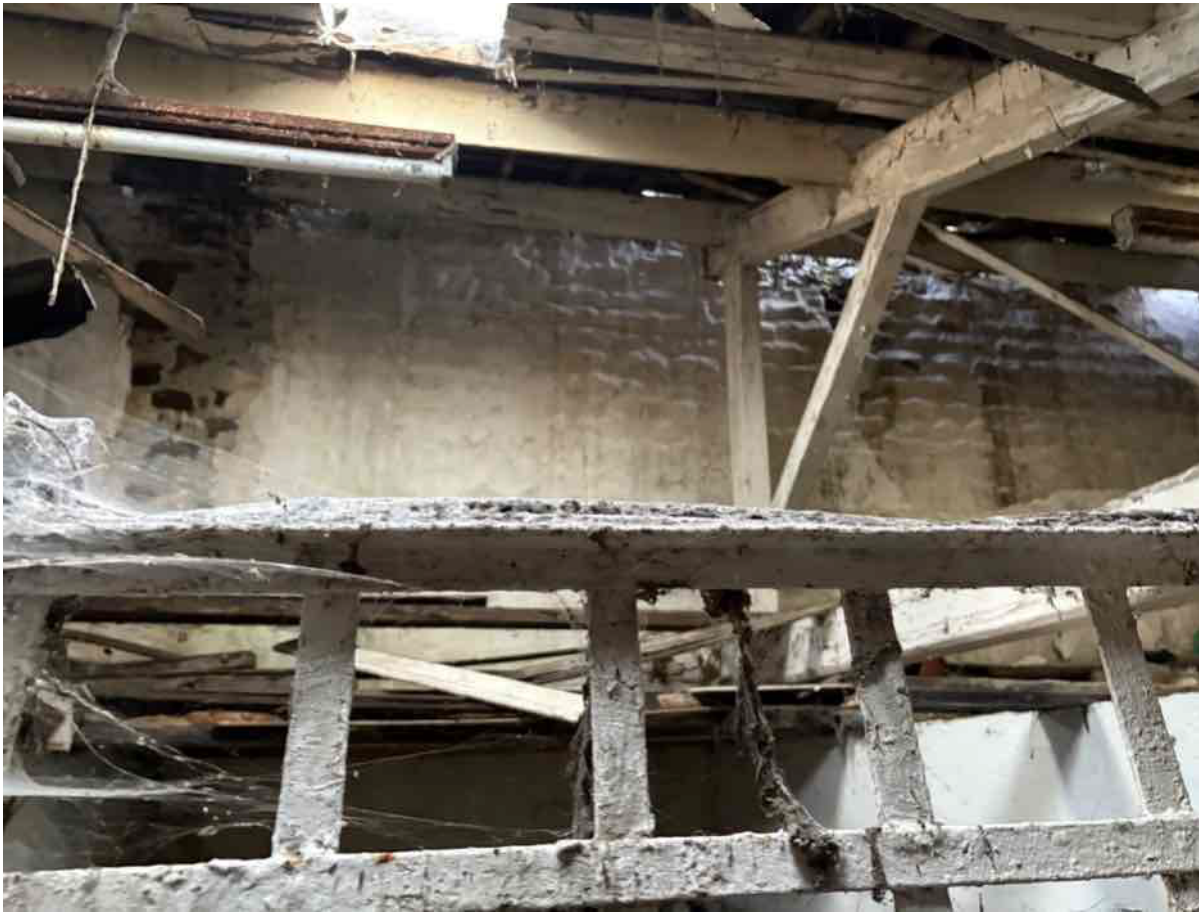
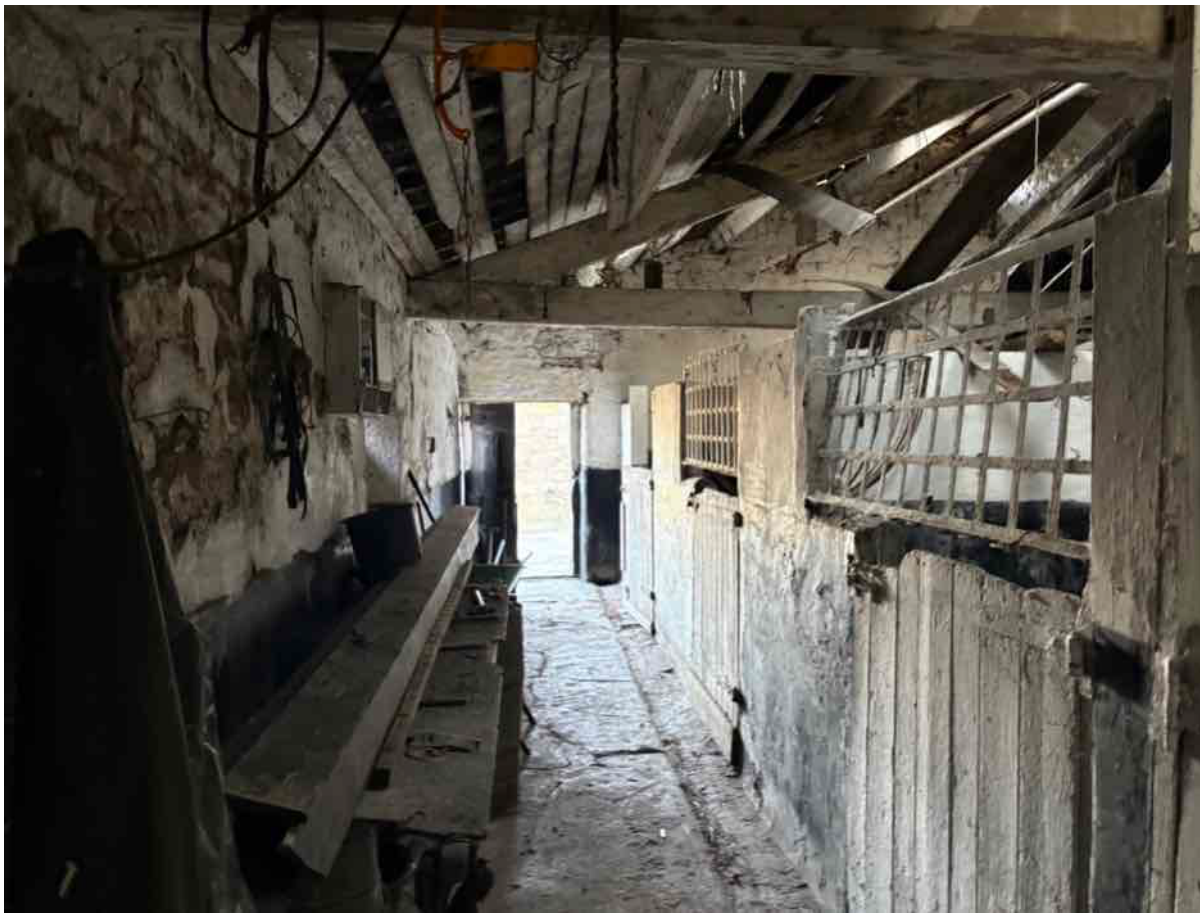
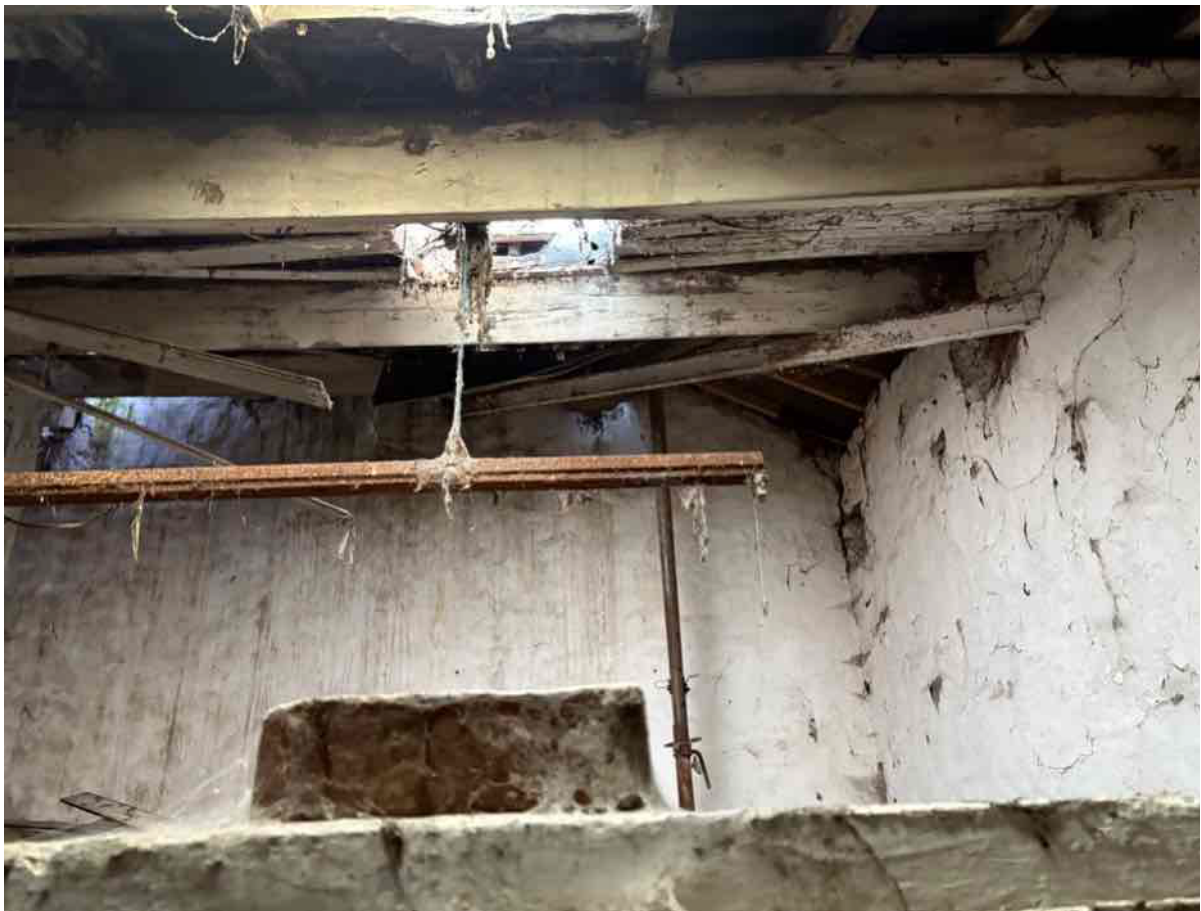
The large lean to stable area is shown on photos 37 to 40. Again, the walls are in good condition with no sign of previous or ongoing movement. The stalls are in place below the mono span trusses and purlins supporting the roof. The timber is in poor condition with some signs of deflection, rot and/or infestation. Timber under boarding has fallen from the rafters (photo 37).

Photo 38 - Lean to stable area to south west elevation

Photo 39 - Lean to stable area to south west elevation

Photo 40 - Lean to stable area to south west elevation

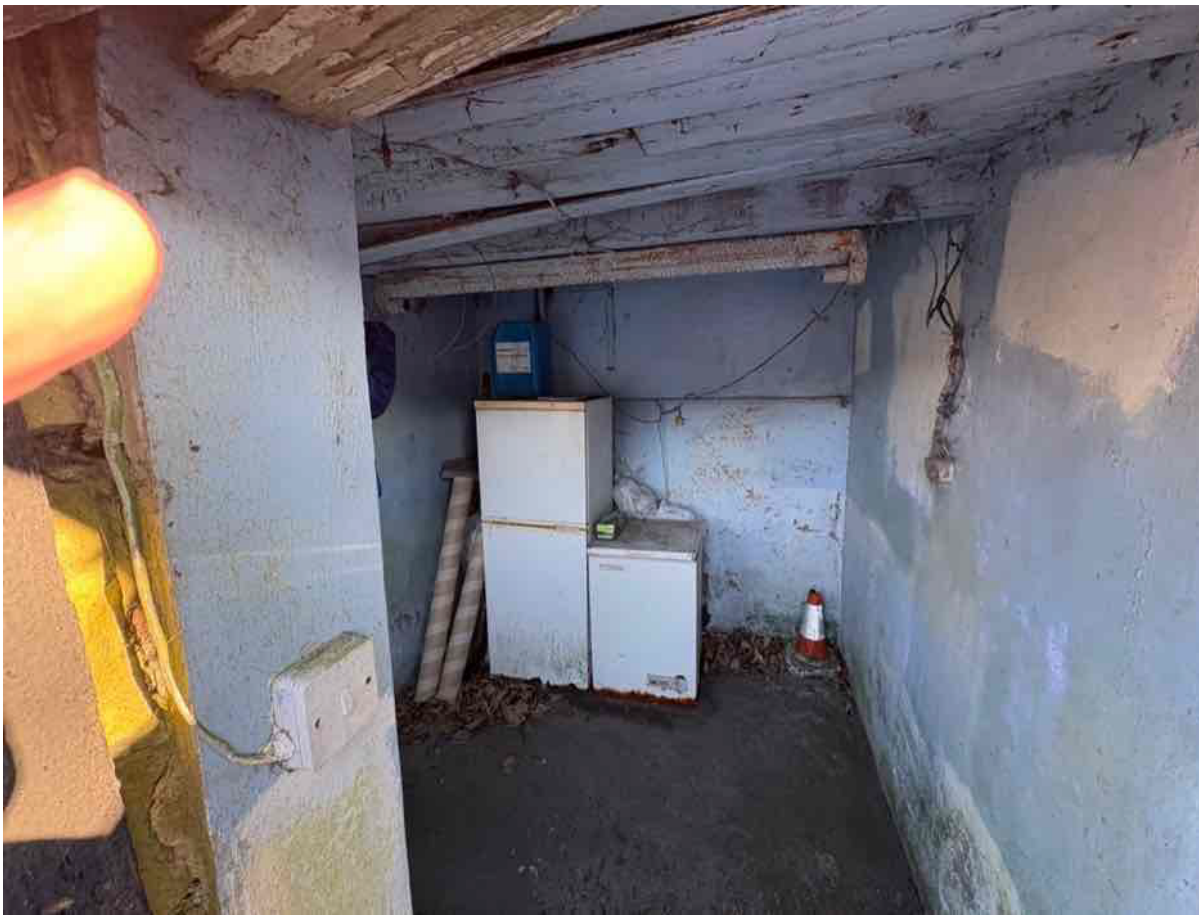
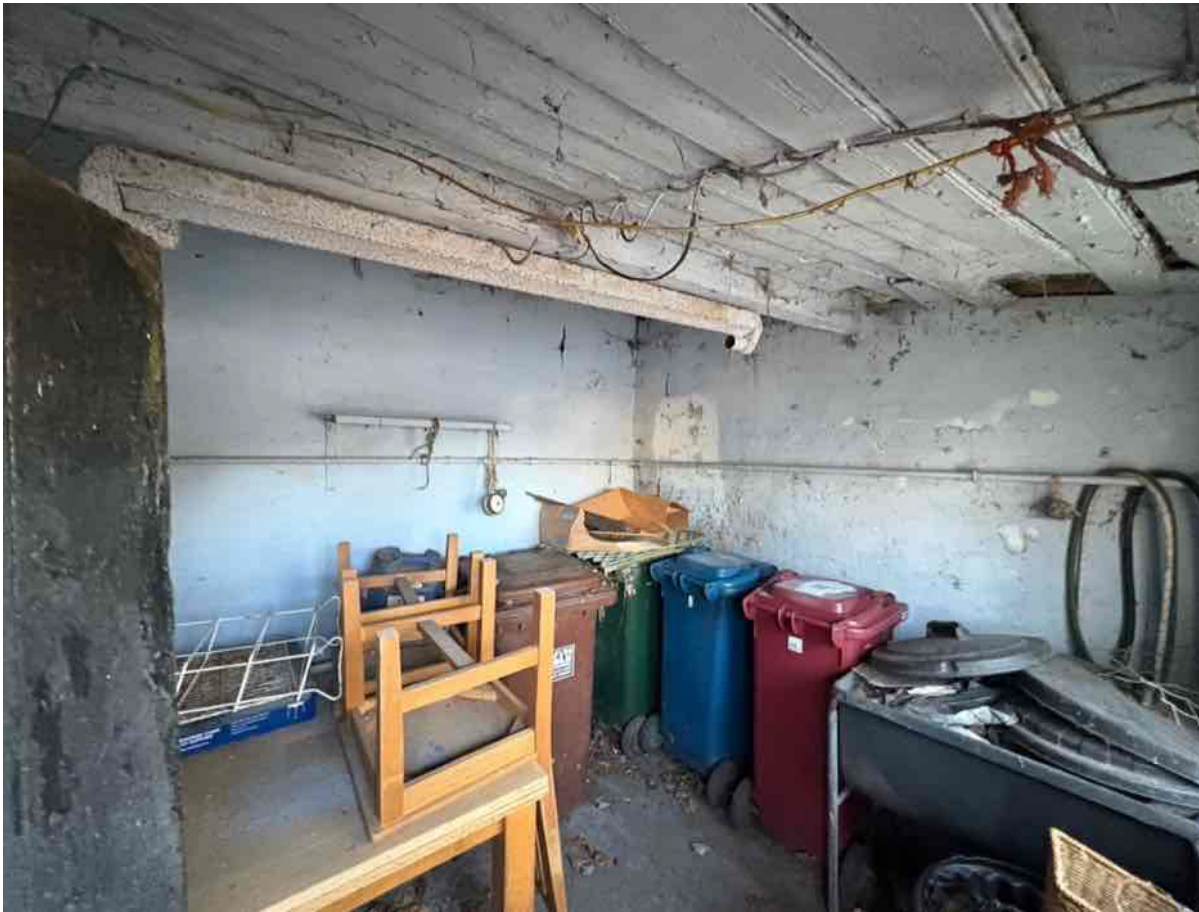
As noted above, there are two small buildings at the south end and these are shown in photos 41 and 42. These have no signs of previous or ongoing movement.

Photo 41 – Outbuilding on south west elevation

Photo 42 - Outbuilding on south west elevation

When converting barns, it is essential that the construction techniques and sequence are carefully considered. The proposals are for two dwellings, one occupying the main barn and the other occupying the single storey lean-to section to the south west. In the main barn some internal walls will be removed or openings made but given the condition of the barn this should not affect the overall stability and structural integrity of the building. In the stable the individual stable layout will be replaced by new walls forming the rooms and it is advised that these are formed in masonry to maintain the stability and integrity of the structure. The tank and two small rooms on the south west elevation are to be removed/demolished.
