HERITAGE STATEMENT

ALMSHOUSES

Flat 1-4

STYDD LANE

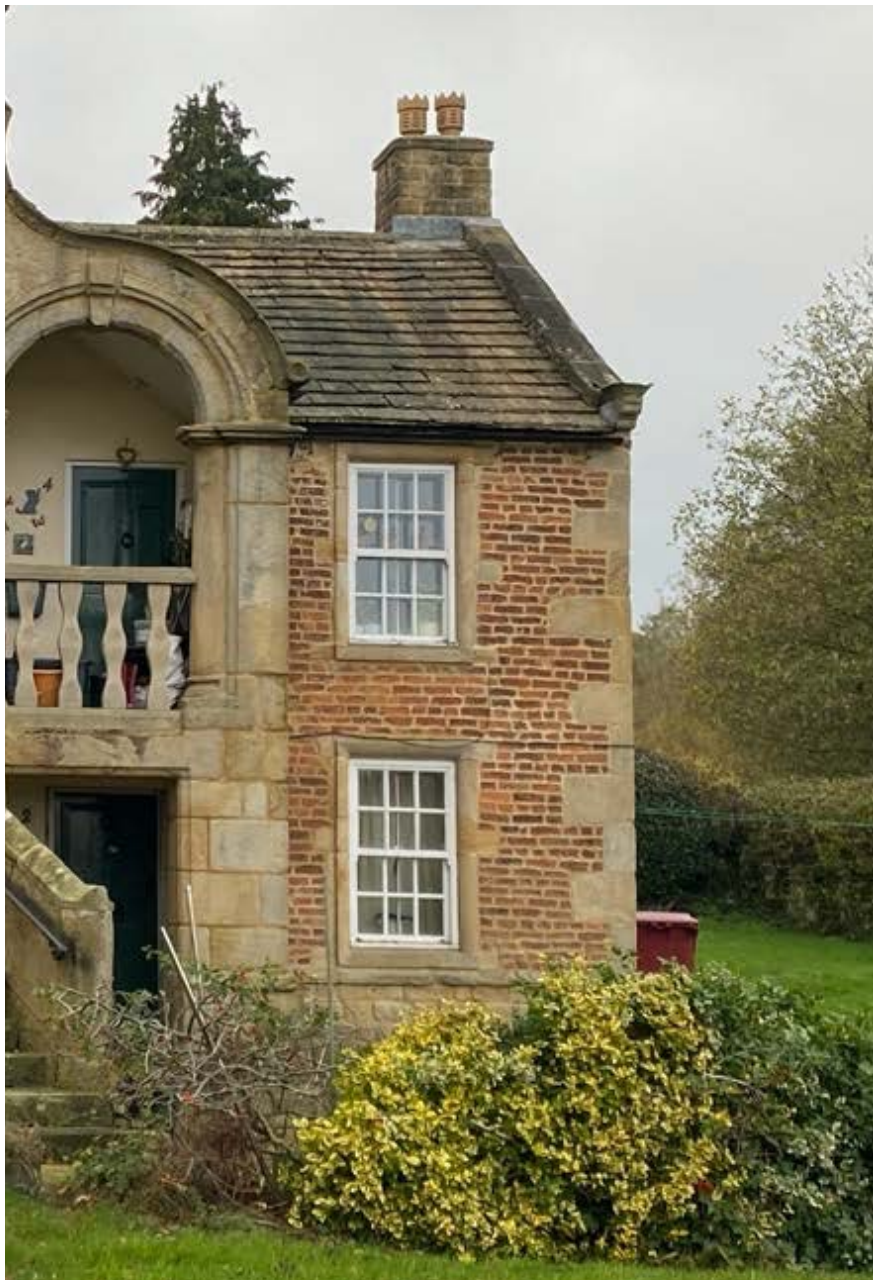
Photo 01: Front elevation brickwork

The front elevation is prominently facing brick with stone features. Facing brick is believed to be original.

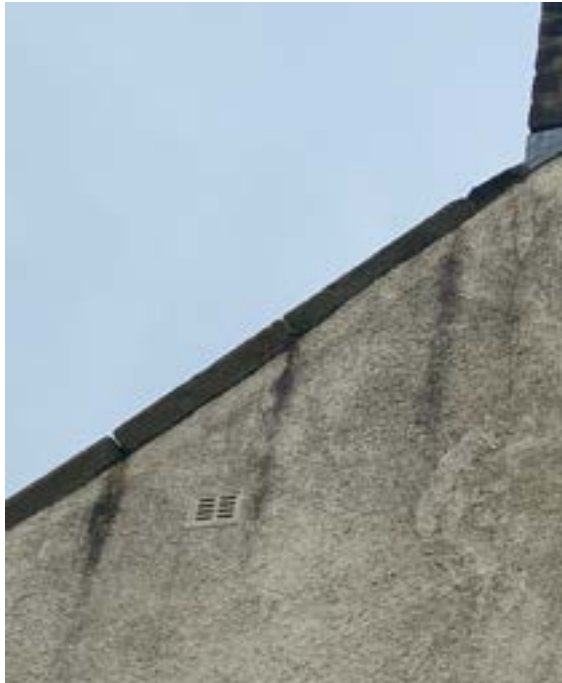
Photo 02: Gable copings:

Photo showing open joints to gable copings, with resulting running water down and behind render and poor condition of coping where abuts chimney.

- The condition of copings to gable is poor in areas, with gaps and irregular stone faces.
- The poor overhang and poor condition of copings generally has resulted in water tracking behind render causing render cracks and moisture ingress to habitable rooms within.

- Removal and reinstatement of gable copings.
- fitting of lead flashing under copings lapped with lead soakers and turned down over gable wall to protect upper edge of render from water ingress.
- The repair of render on a like for like basis and decorate or replace render with lime render with a breathable paint system. Whilst the latter is obviously the preferred option it is costly and was not enforced as part of the approval.
- To repair and seal the junctions between render and quoins where due to render being set proud allows water to track behind and into property.
- To replace plaster internally where damaged
- To fit bathroom extract fan venting through a terracotta airbrick

- To address source of water ingress (Attend to verge copings, lead flashings and where applicable soakers, repair render).

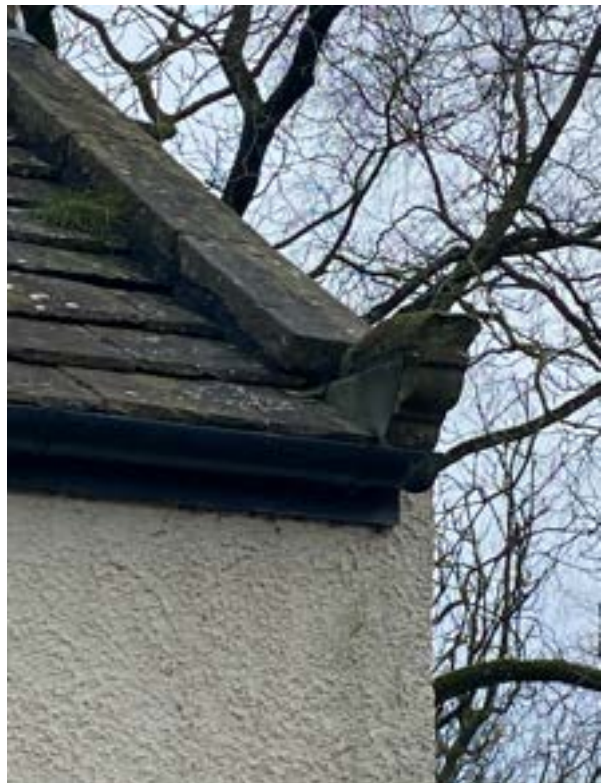
Photo 03: Stone Kneeler stone

Photo showing kneeler stone to rear elevation and poor pointing and lead soakers where meets slate

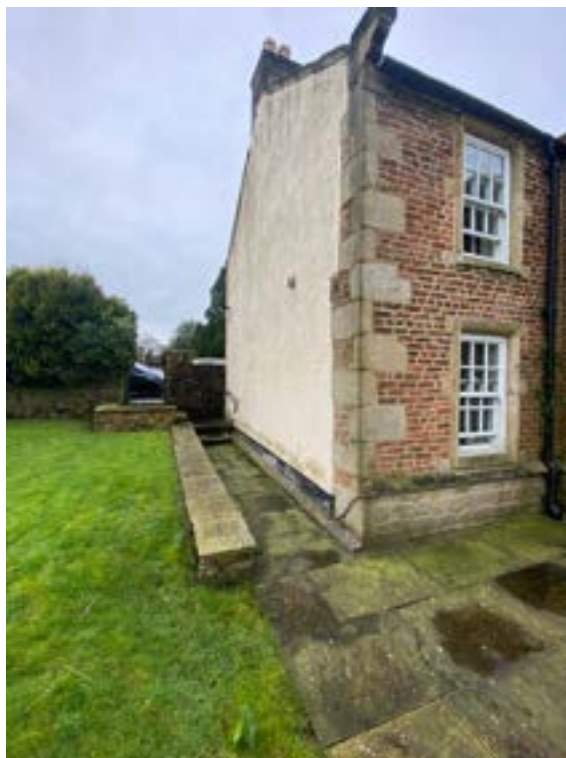
Photo 4: Gable to flats number 1 and 3

Render stopped short of stone quoins, risk of water penetration behind.

Poor pointing to resulting exposed brickwork

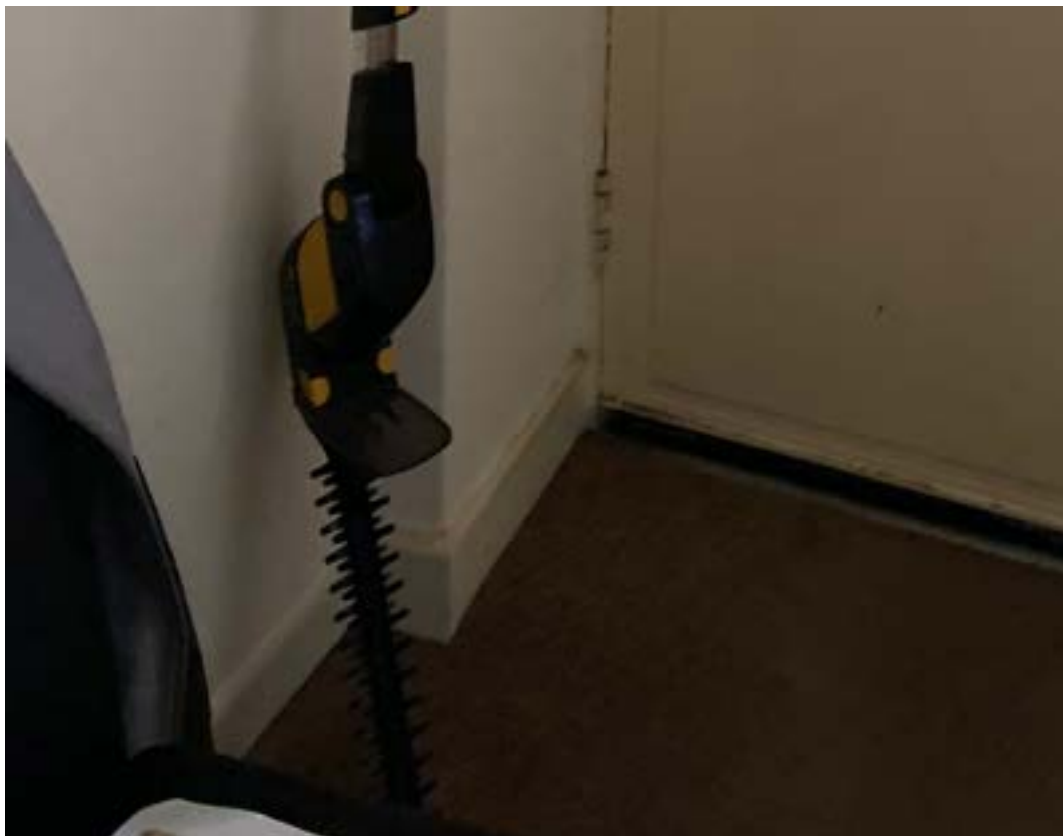
Skirtings appear to be modern painted softwood of simple design being bull nosed rounded approximately 94x19mm. Skirtings do not appear to be original.

Photo 05: Typical skirting

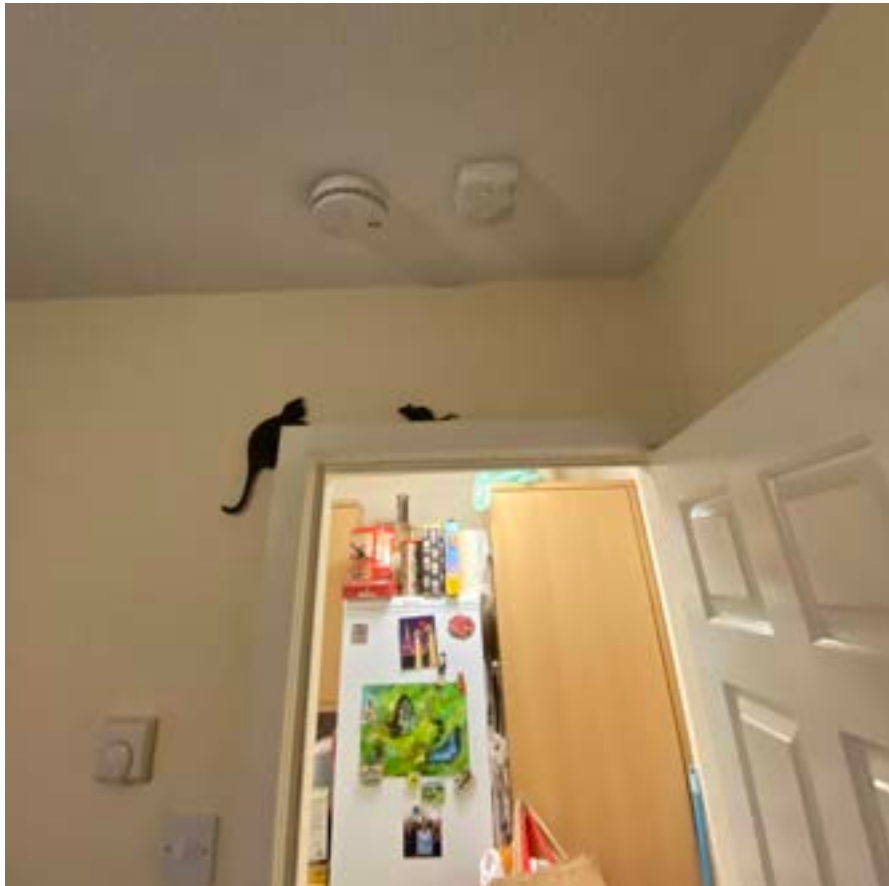
Doors appear to be modern pressed panelled doors with a paint finish. Doors do not appear to be original

Photo 06: showing typical modern door, absence of coving cornice, dado and picture rails

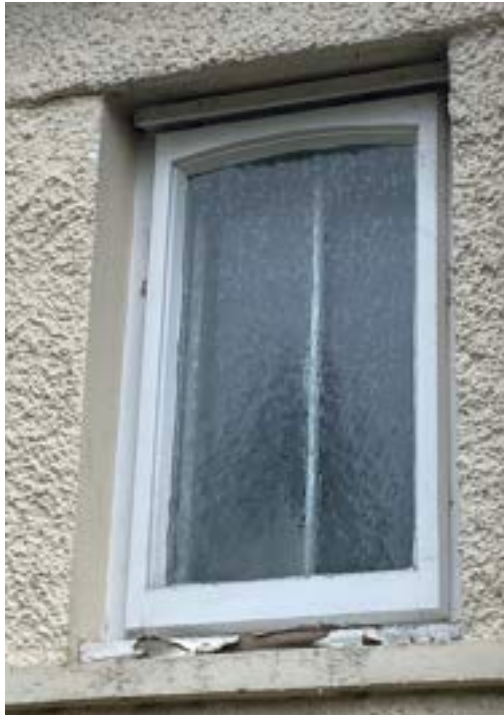
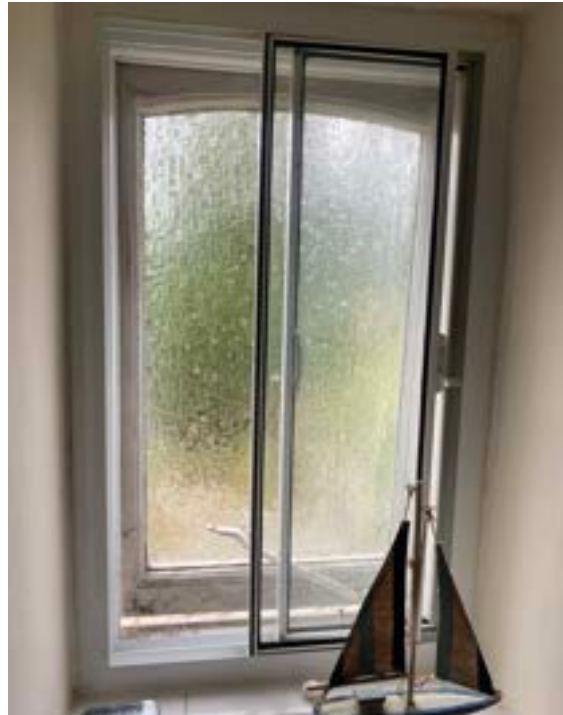
Rear elevation windows are painted timber casement single glazed type windows with modern painted casement stay.

The arises to window frames and casement appear to be clearly defined and not softened as may be expected from old repeatedly decorated windows.

Rear elevation windows therefor do not appear to be original.

Photos 7 and 8: Typical external and internal view of rear elevation window

-Rear elevation windows, some have square heads others arched and are of modern timber casement profile. It is proposed to replace with double glazed units (greater thermal efficiency and suitable for residents to use), a more traditional flush casement design with constant arched heads.

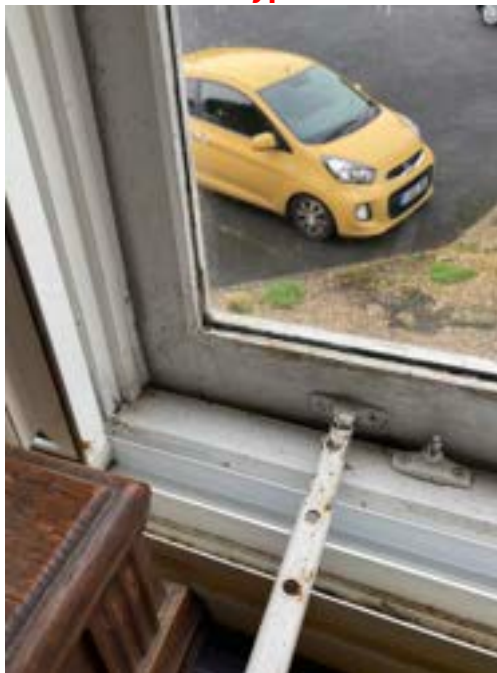
Photo 09: Typical rear elevation casement stay

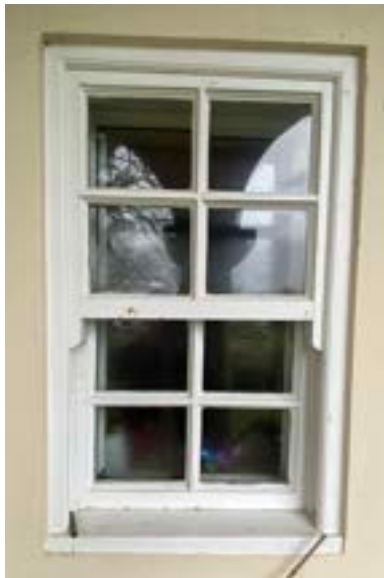
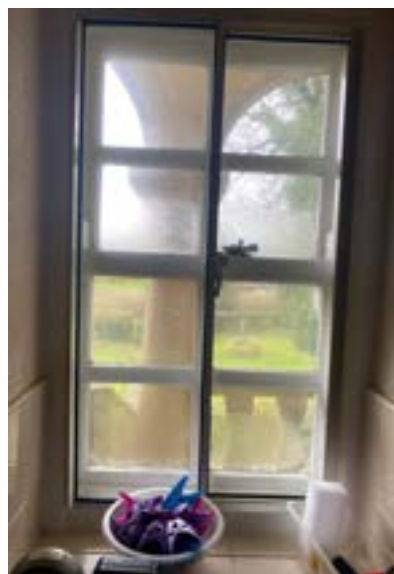
The frames appear “chunky” in comparison to historic frames and the proportion being oblong but “squat” is not consistent with historic sliding sash proportions.

Front elevation windows do not appear to be original.

Photo 10 and 11: Typical external and internal view of front elevation kitchen window

- Front elevation windows within the property, they are not original, are in poor condition, thermally inefficient (single glazed) and do not appear to be of the proportions that would be expected of traditional sliding sash windows. The kitchen window glazing proportions are also not consistent with what would be expected of traditional sliding sash windows. Heritage slim double glazed units with integral draught seals will improve thermal performance whilst allowing more accurate sectional proportion to timber members. Replacing kitchen glazing configuration from 4 over 4 to 2 over 4 will restore the original glazing proportions.

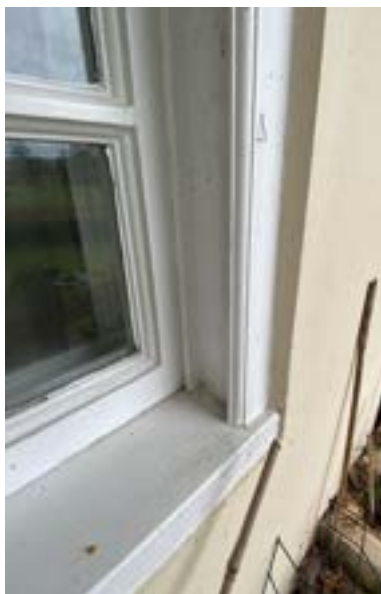
The frame does not appear to be recessed behind brickwork, set back from render approximately 30-50mm. We assume operation is spiral balance sprung.

Photo 12: Typical external view of kitchen window proximity to front render face.

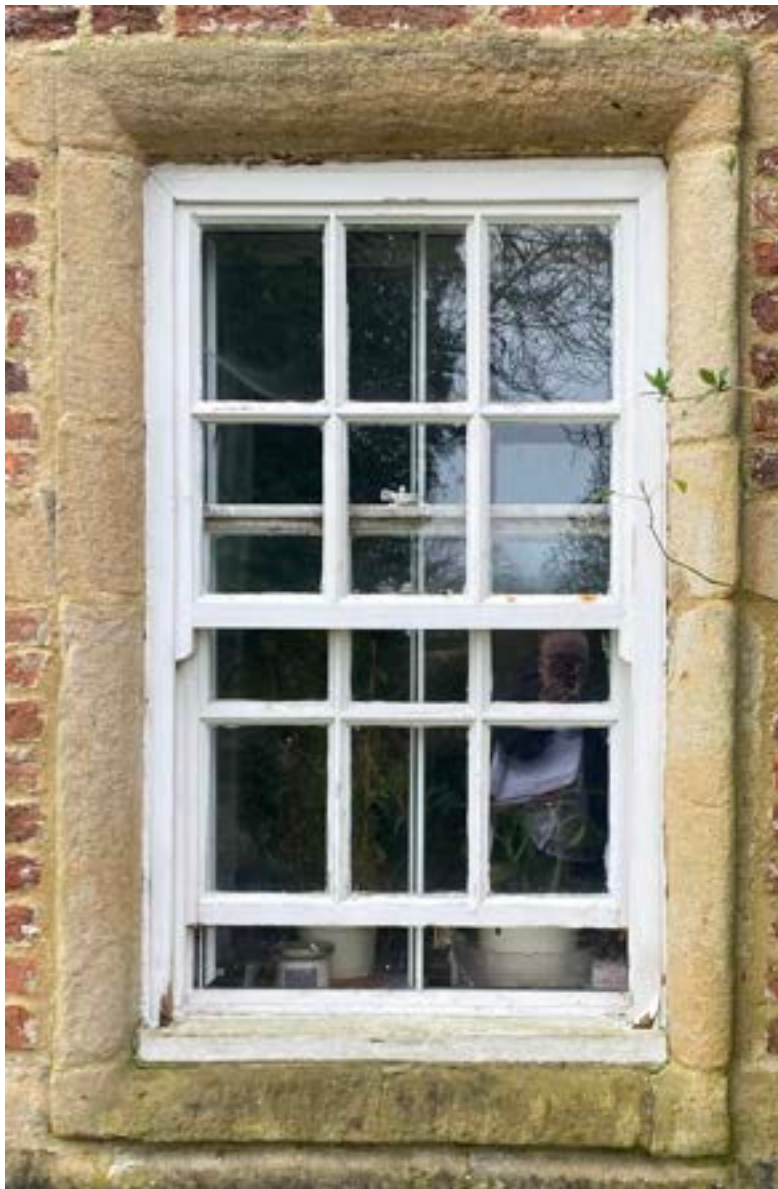
Photo 13: External view of typical Livingroom window

The frames appear “chunky” in comparison to historic frames. The proportion appears to be consistent with a sliding sash window.

Front elevation windows do not appear to be original.

Front elevation windows are supplemented with internal secondary glazing. These do not align with main frames.
