Specific Defect Report
on
Damp

at
1, 2, & 3 Stydd Almshouses

Executive summary

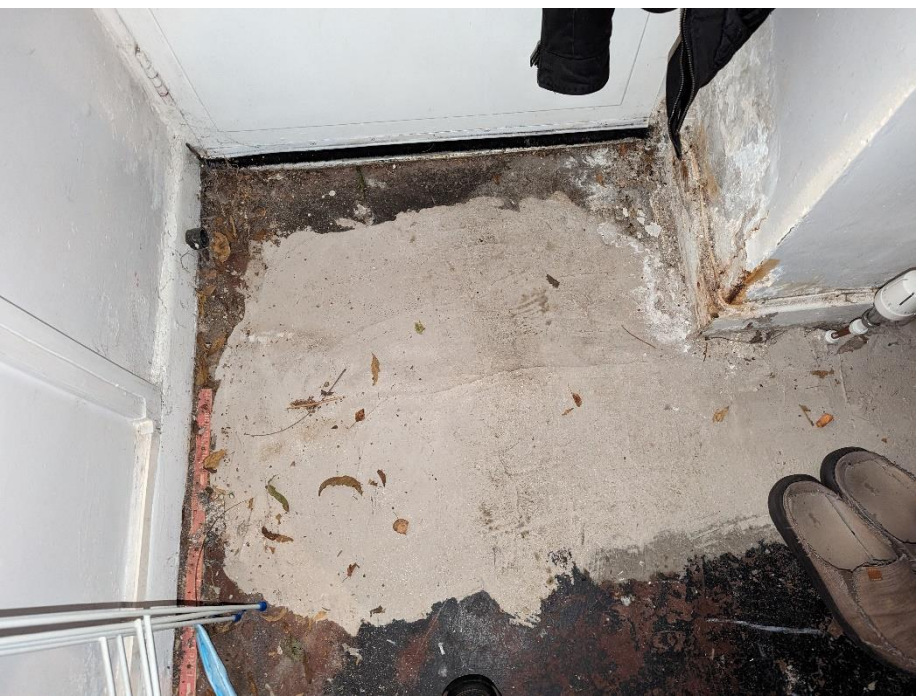
<p>Photograph: 3.</p>

<p>Location: Living room.</p>	
<p>Damp affected plaster due to leakage from adjacent radiator.</p>

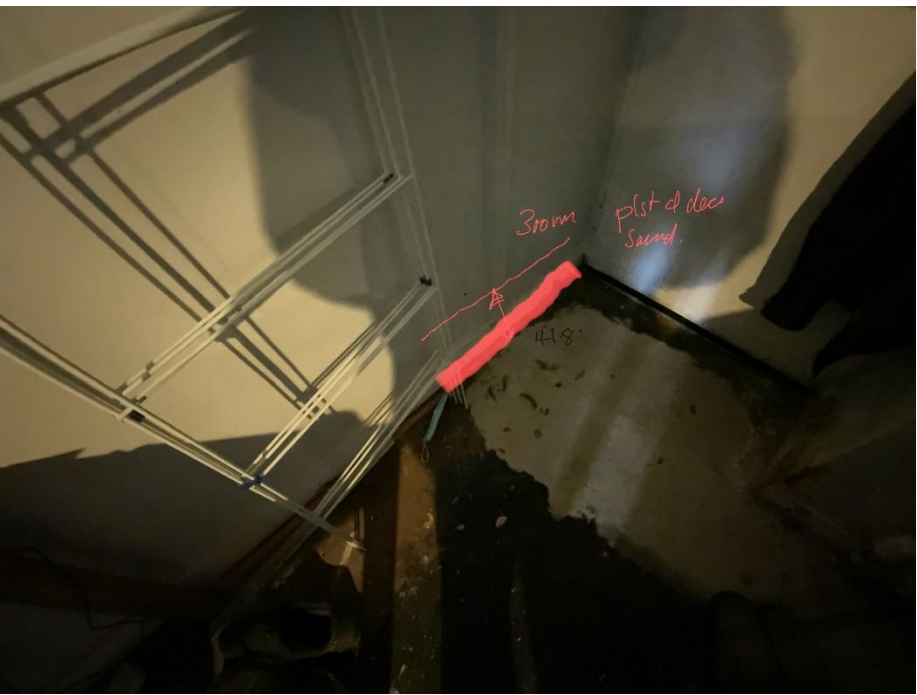
Photograph: 8.

Location: Living room.	
High damp reading to right hand wall And within door opening. No damage to decoration or to plasterwork.

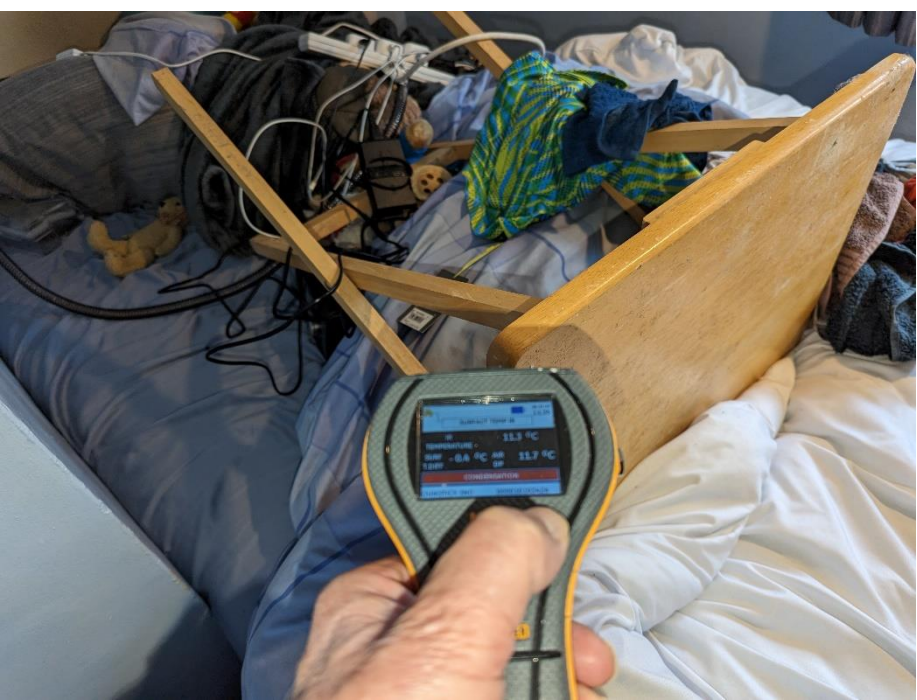
<p>Photograph: 11.</p>

<p>Location: Bedroom</p>	
<p>Surface temperature of the rear wall show is condensation taking place at the time of inspection.</p>

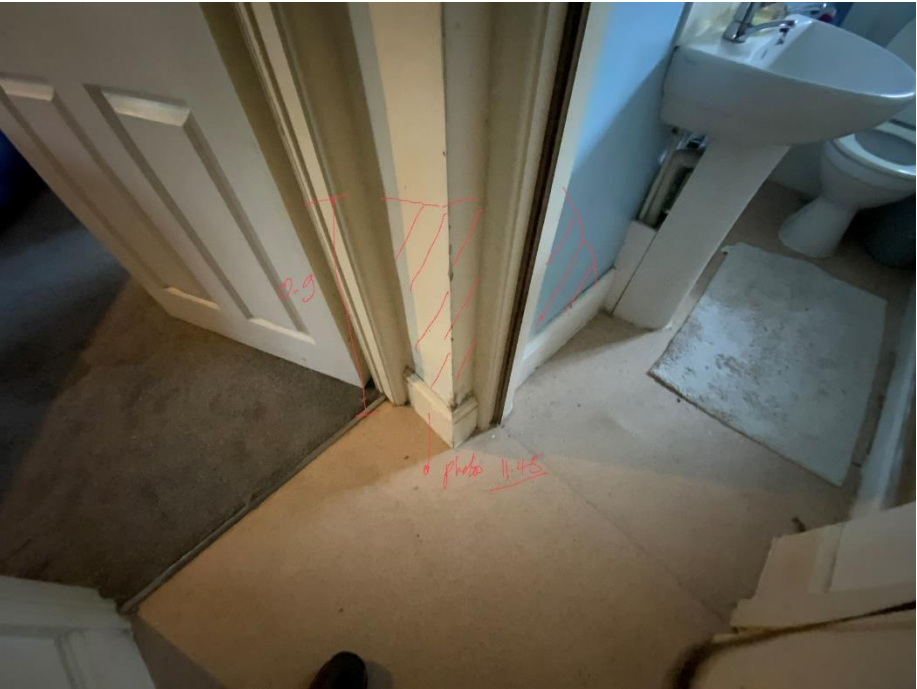
Photograph: 14.

Kitchen
Findings
When subjected to moisture profiling high readings were recorded at each side of the door opening to the living room (Photos 12 -21). There is no damage to plaster or decoration.
Cause
On the balance of probability, the raised moisture content of the skirtings is due to condensation on the surfaces of both wall and floor.
Repair
No repair is necessary currently.

Location: Kitchen.	
Damp in wall at door opening to living room.

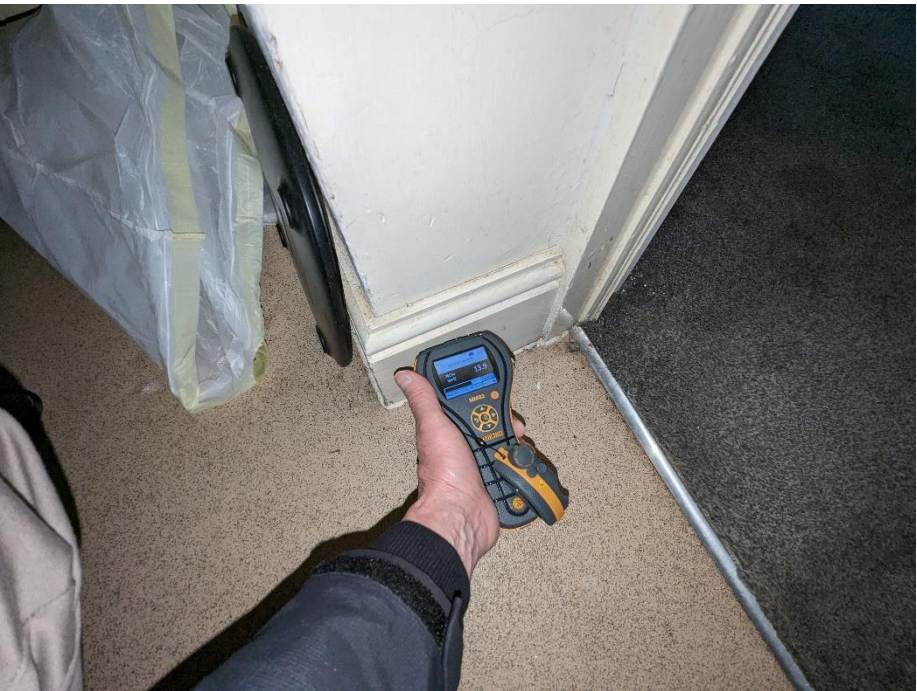
<p>Photograph: 18.</p>

<p>Location: Kitchen.</p>	
<p>Moisture content normal to skirting board.</p>

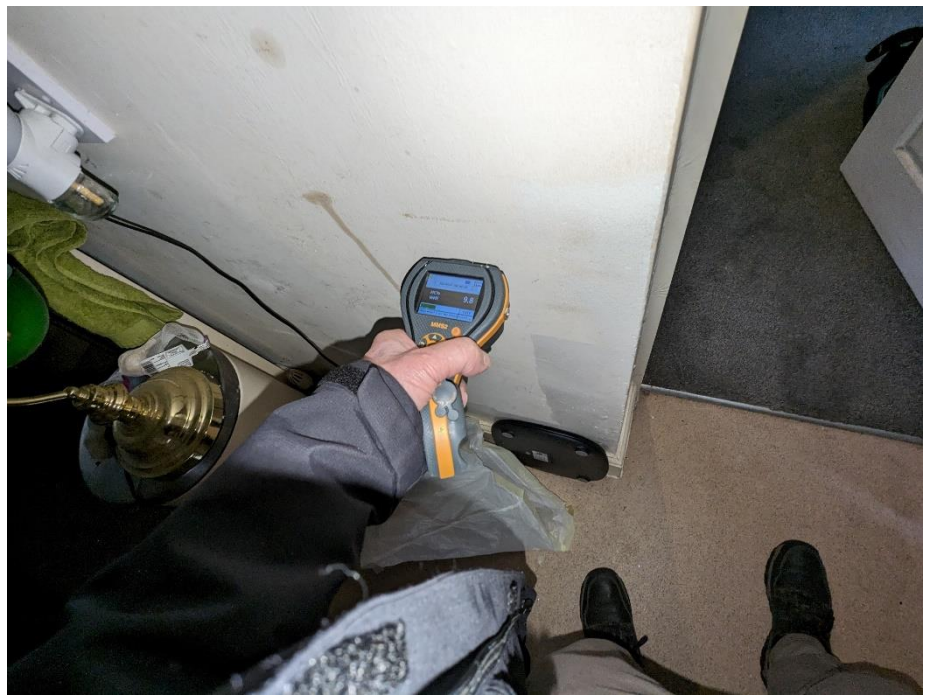
Photograph: 21.

Normal readings in plasterwork slightly above damp readings taken in photo 20.

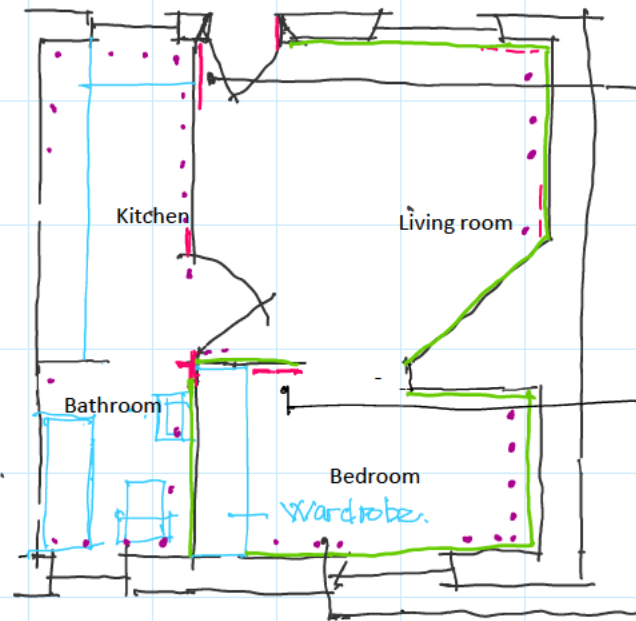
Plan - 1 Stydd plan

Damp readings to 310 mm.
No damage to plaster or decoration.

Damp in the plaster to a height of 400 mm. no damage to plaster or decoration.

Intermittent, damp in the skirting

Condensation taking place
-

Damp in plaster

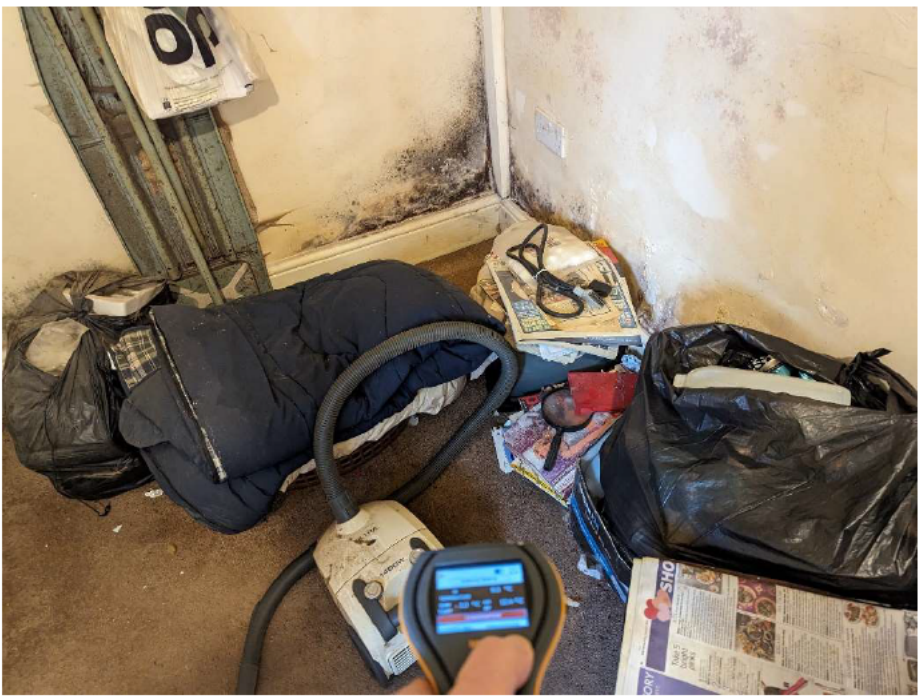
Photograph: 8.

Bedroom
Findings
<p>When subjected to moisture profiling high readings were recorded in most of the surfaces to all walls extending from floor to ceiling level (Photo 7).</p> <p>Black spot mould and staining was also present to all walls and is particularly severe at low level where areas of plaster are denatured (Photos 8, 9 & 10).</p> <p>Using infra-red thermometer, it was established condensation was occurring on front, rear, and right walls (Photo 11).</p> <p>The left wall is largely concealed by a fitted wardrobe. There a section containing the central heating boiler where the wall is exposed, damp and mould were present at low level. Near the boiler conditions were normal.</p> <p>The decoration is damaged and there are indications of salt contamination on the front wall.</p> <p>The room is unfurnished as the tenant is sleeping in the living room. The timber window is single glazed and provided with a secondary glazing system (Photo 12).</p>

Cause
<p>The mould is due to condensation, caused by an imbalance in the heating, ventilation, and moisture control within the room, it is not attributable to a failure by the landlord to carry out its repairing obligations.</p>
Repair
<p>Sanitise the room using mould cleaning solution. When the mould has been eradicated, it is important to keep the surface dry to prevent the mould from returning. Given the intermittent use of heating this will be very difficult to achieve.</p>

Location: Bedroom	
Condensation taking place on the right exterior wall.

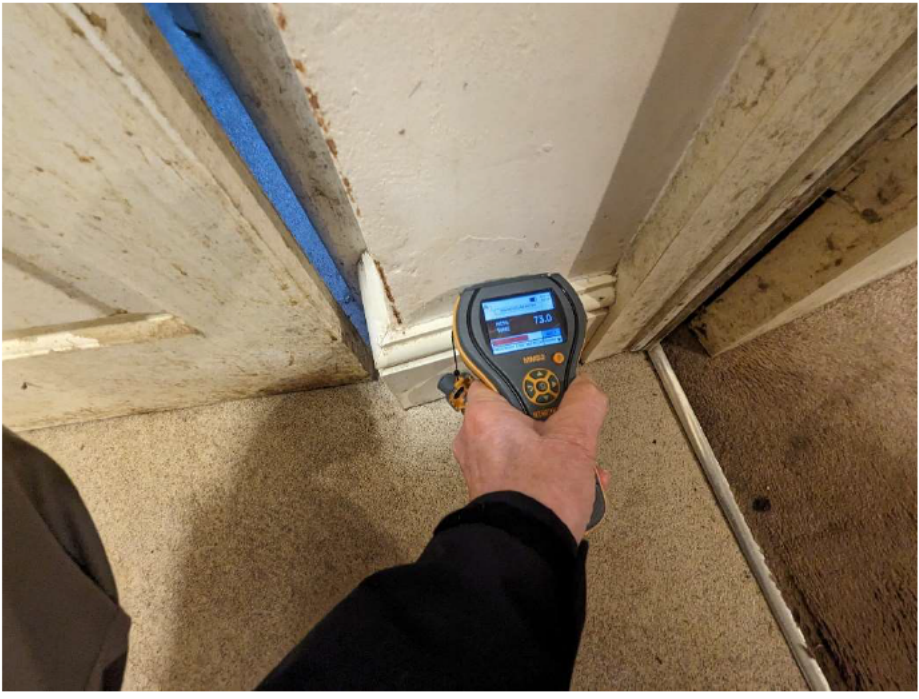
Photograph: 15.

Kitchen
Findings
<p>The rear right reveal to the door opening was damp when tested, the other exposed walls were dry when tested (Photos 13 – 15).</p> <p>The timber window is single glazed and provided with a secondary glazing system.</p>
Cause
<p>The damp readings at the door reveal are assessed to be due to contamination of the plaster by salts.</p>
Repair
<ol style="list-style-type: none">1. Remove the door frame and set aside.2. Remove the skirting and set aside.3. Hack off the plaster to a height of 1.1m and replaster, 13mm thick two-coat Thistle Driccoat water resistant cement-based plaster. Skim with Thistle Board finish.4. Terminate the wall plaster a minimum of 25mm above the floor level.5. Reinstall the door frame and skirting board.6. Allow for consequential redecoration.

Location: Kitchen	
Damp in reveal to living room door.

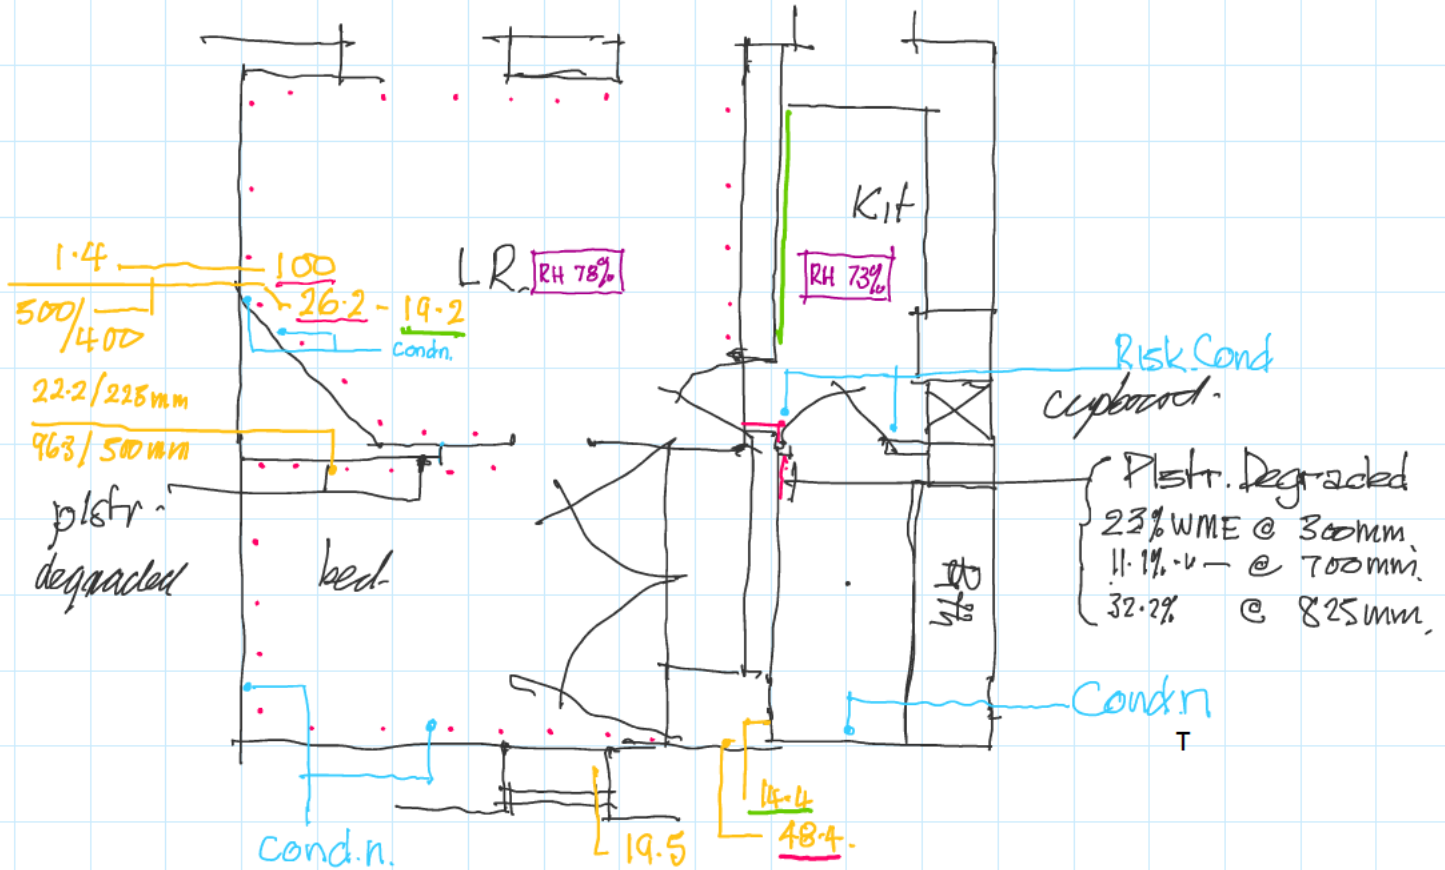
Number 2 - Ground floor Plan

- Condensation taking place at time of inspection.
- Damp readings & Height above floor level.
- ... High damp readings due to condensation.
- High damp readings.

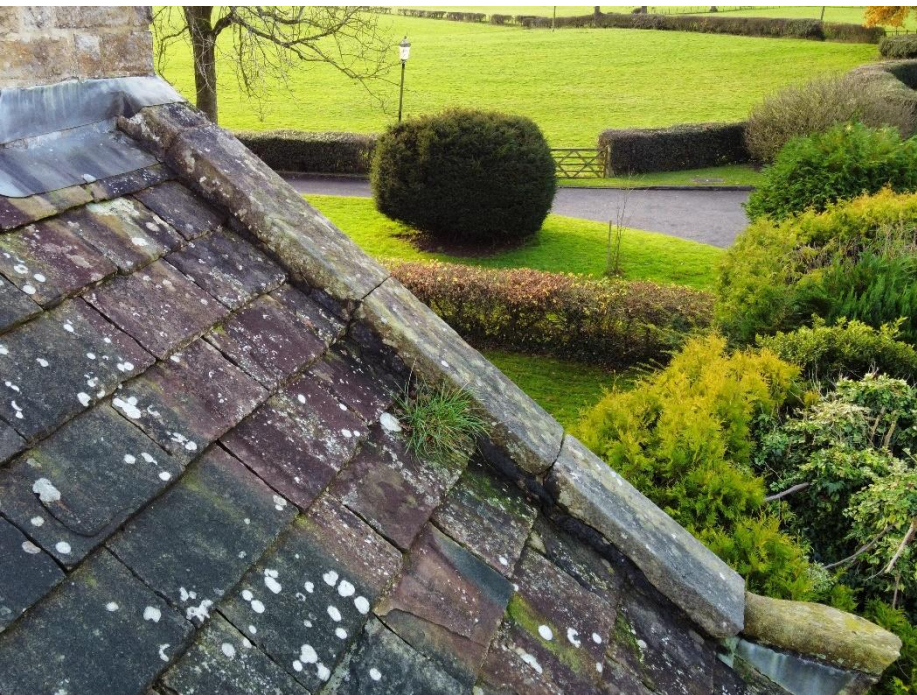
Photograph: 4.

Bedroom
Findings
When subjected to moisture profiling elevated, damp reading were recorded in the left wall. The wall plaster is soft and the decoration spoiled (Photos 2 & 3).
External inspection showed vegetation growing at the junction of the roof and gable capping (Photo 4).
There are gaps at the joint between capping stones Which will allow rainwater to enter the head of the gable wall (Photo 5).
There are cracks in the spar-dash and painted render, particularly at the head of the wall (Photo 5).
Cause
The damp internally is assessed to be rain penetration through the defects in the render and the joint between the slate roof covering and the stone carving.
Repair
<u>Internal</u>
<ol style="list-style-type: none"> 1. Allow for all preparation, making safe electrics, dust sheets etc. 2. Remove the skirting boards and cart away debris. 3. Hack off damp wall plaster to the entirety of the left wall and return 150mm into the front and rear walls. 4. Replaster utilising Thistle Dricoat renovating plaster with Thistle Board Finish skim coat smooth and level with surrounding surfaces. 5. Provide and fix pre-treated replacement skirting boards. 6. Allow for consequential redecoration.

Location: External Rear roof slope.	
Vegetation at junction of the roof covering and capping.

<u>External.</u>
<ol style="list-style-type: none"> 7. Clear the vegetation from the roof. 8. Remove any loose or friable, pointing between the roof covering and capping and seal the junction with a butyl mastic. 9. Rake out all loose and friable mortar from between the capping stones and re-point.
