Stydd Lane Almshouse

Structural survey report

MARCH 2024

Ref. 224-034

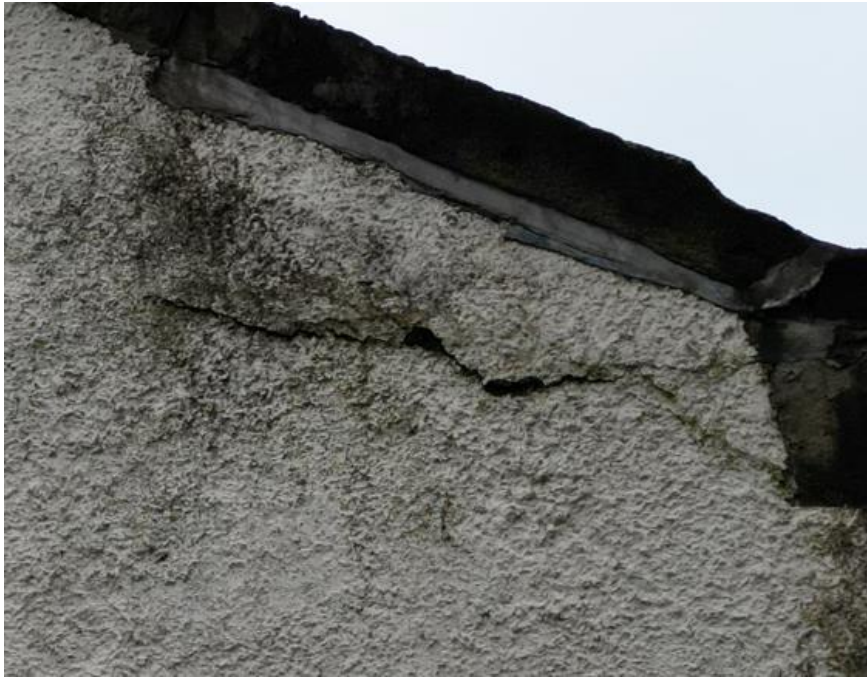
- The rendered surface on both gables is being stained due to cascading water falling between gaps in coping stones. Cracking to the render has occurred at the head of the wall, likely due to thermal/building movement. The North gable is more severely affected. The cracks are large enough to allow water to penetrate fully to the brickwork substrate. Ref photo 1 & 2.

Photo 1 – Cracked render

- D** Remove the render below the coping to expose the probably damp brickwork. Allow the brick to breath/dry whilst improving the condition of the coping (as the previous point) to ensure water does not drain from the roof edge down the wall. The render can be replaced as necessary. *Historic England* should be made aware of these works as the buildings appearance will be affected temporarily and they may wish to comment.

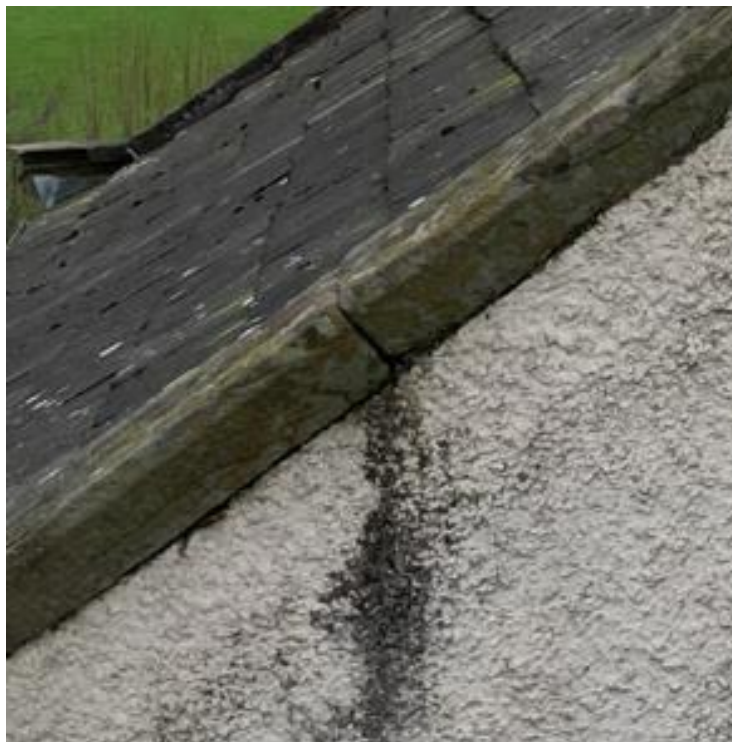
Photo 2 – Staining on render at coping stone joint

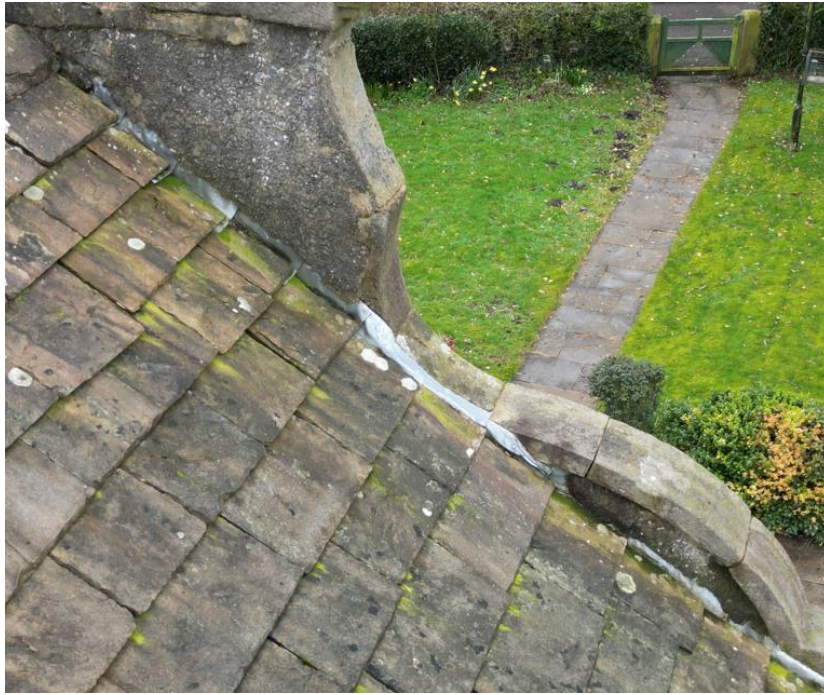
- Parts of the gable above the entrance are becoming soaked due to missing flashing. This is causing staining and will lead to vegetation growth if not dealt with. Refer to photo 3 & 4.

Photo 3 – Poor or missing lead soaker

- The poorly installed/missing lead soakers at the junction between the roof and the gable above the entrance.
 - Slipped and broken tiles which may be leading to water ingress

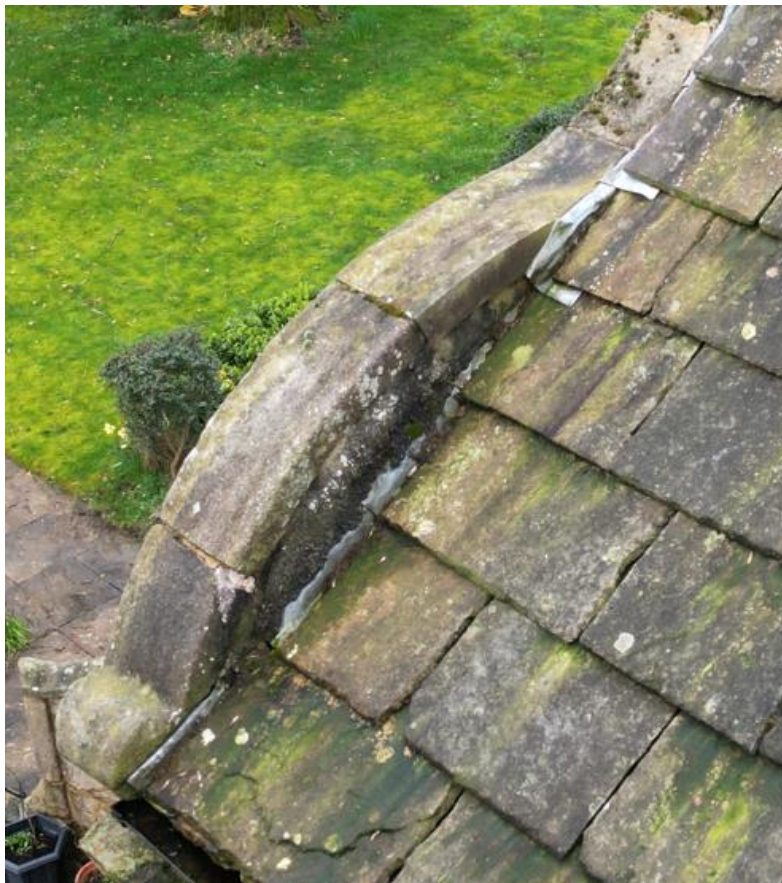
Photo 4 – Poor or missing lead soaker

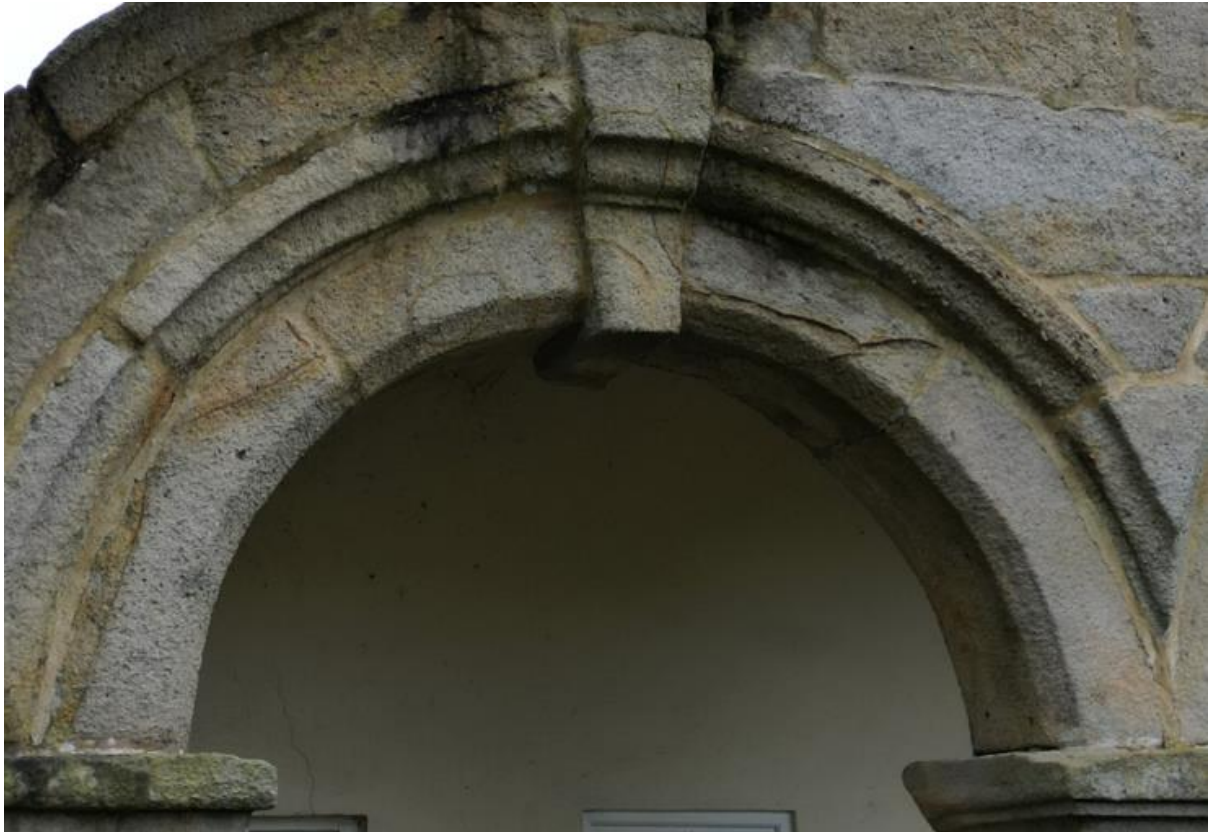
- Fine cracks have propagated through the sandstone arches, particularly near the keystones, potentially due to thermal/building movement. Due to the variation in colour of the sandstone, these cracks appear to be historical and may have been repaired previously as part of the restoration. They do not appear to be structurally concerning at this time. Refer to photo 5.

Photo 5 – Possible previous repairs and discolouration to sandstone

- E** The fine cracks in the sandstone gable, which may just be marks from a previous repair, should be monitored as part of periodic surveys.

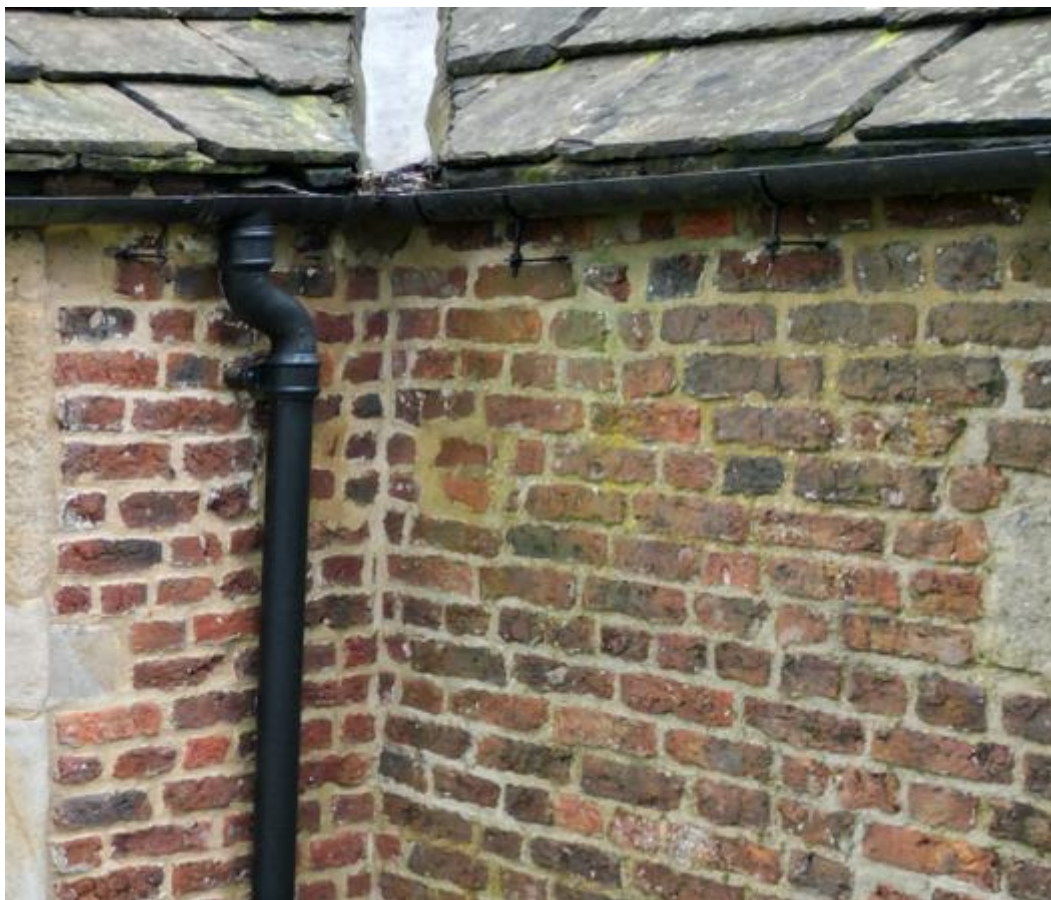
- One brick wall is becoming stained, likely due to the overspilling gutter. Refer to photo 6.

Photo 6 – Stained wall likely due to gutter overspill

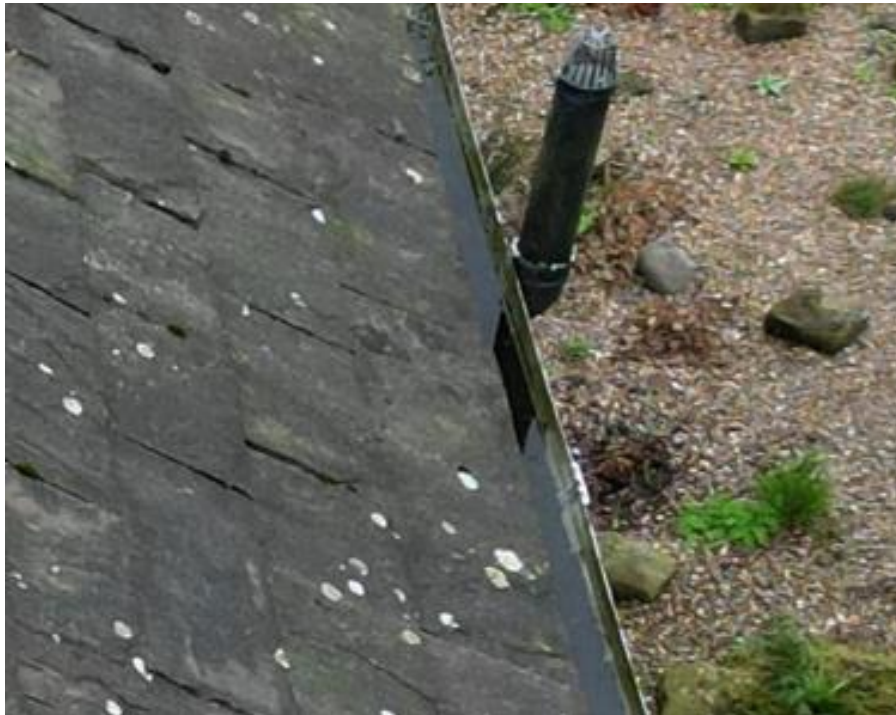
- Due to leaves and other debris, some gutters are holding water and unable to drain effectively. This issue is compounded as the gutter has low points which cause water to pond. The gutters will overspill in heavy rain and cause the bedding beneath flagstones below to wash away. Refer to photos 1, 2 & 3.

Photo 1 – Ponding water in gutter

- A** All items in section 1.6(p2) are to be addressed, completing further surveys where necessary.
- B** Clean all gutters, including at roof valleys, and unblock outlets

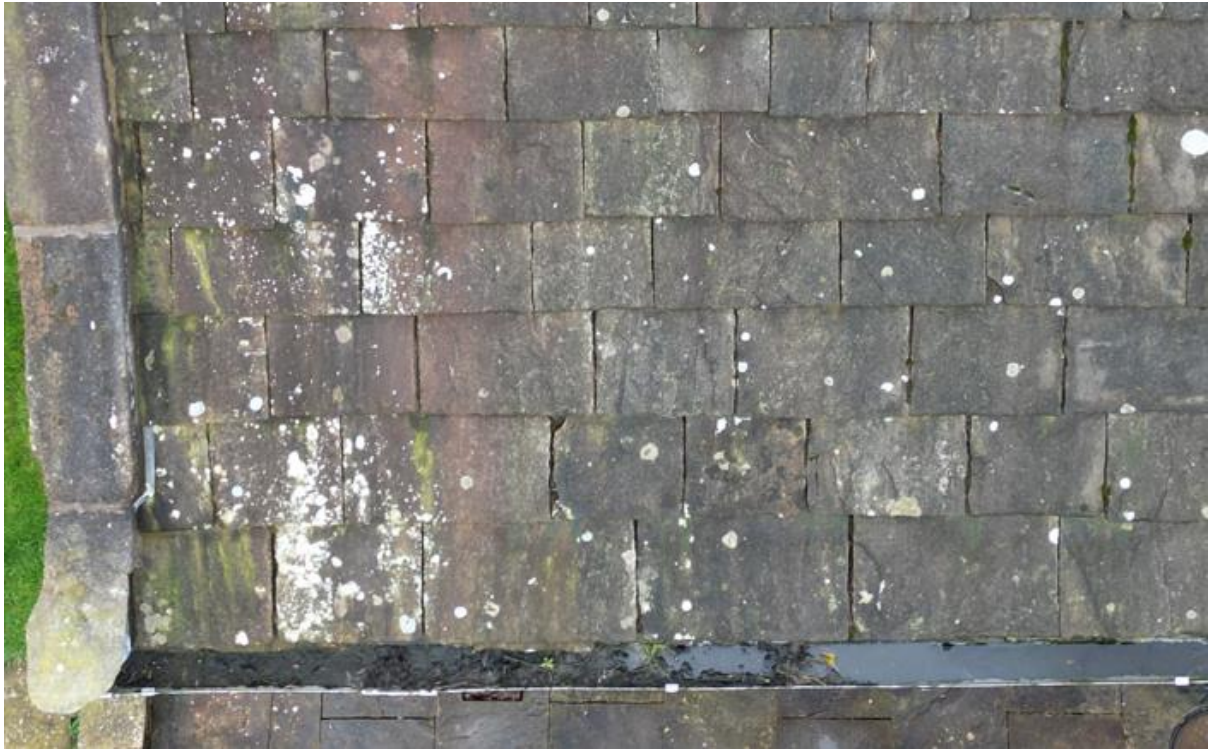
Photo 2 – Completely blocked water outlet in gutter

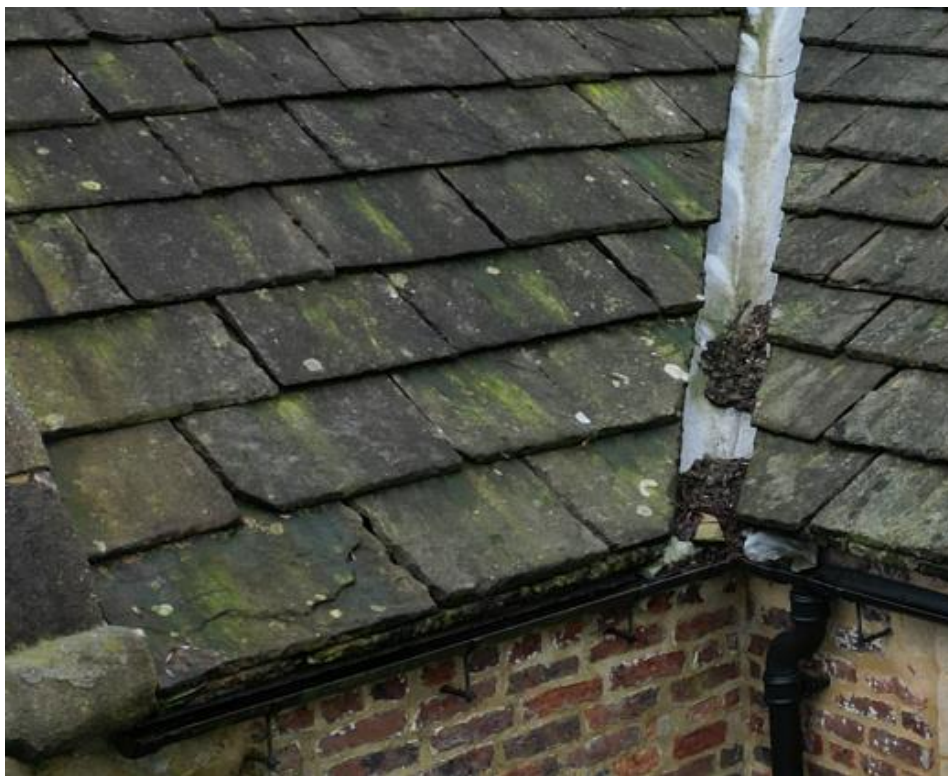
Photo 3 – Blocked valley gutter

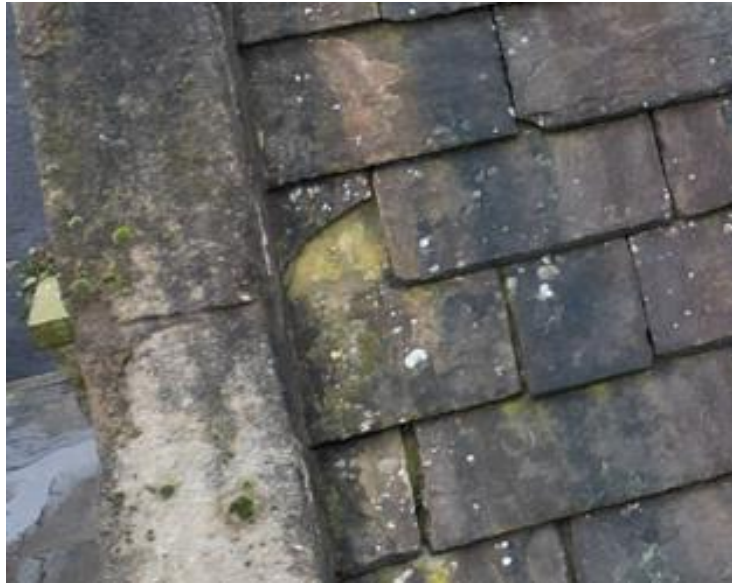
- A small number of tiles have slipped or lost material due to cracking. At least two large tiles at ridge level has a crack in a critical location and may be allowing water ingress. Refer to photo 4 & 5.

Photo 4 – Broken tile

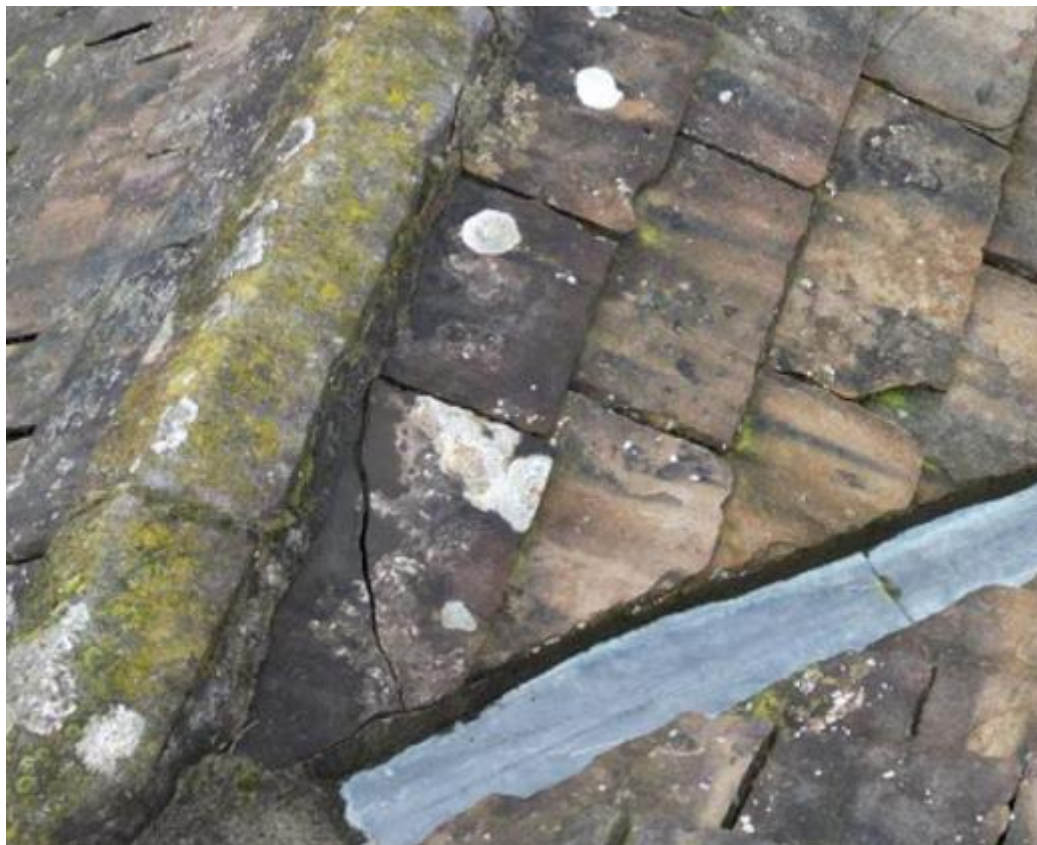
Photo 5 – Broken apex tile.

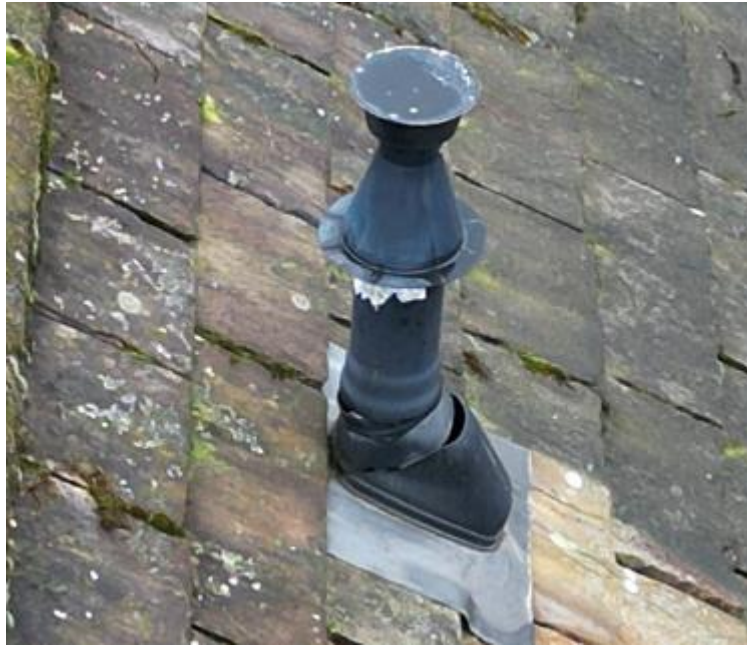
- The protective housing to one of the plastic flues has slipped and will probably be holding water. Refer to photo 6.
- Mortar bedding appears to have been used in lieu of soakers at coping stone locations, the mortar has degraded and is allowing water to penetrate, leading to water ingress and render damage. Refer to photo 7.

Photo 6 – Slipped flue housing

- The deteriorated mortar bed for the coping stones on the side gables
 - The slipped plastic housing around the plastic flue
 - The flashing which appears to terminate beneath the render

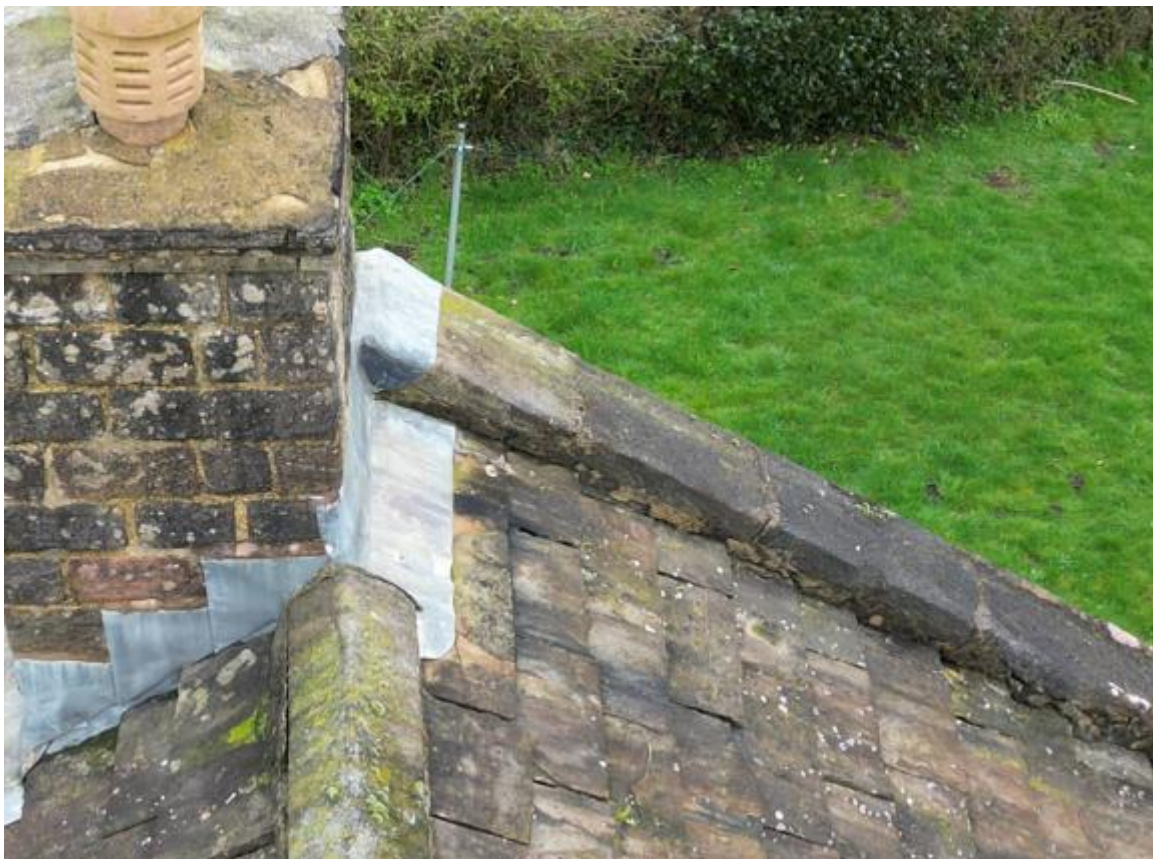
Photo 7 – Poor mortar condition beneath coping stones

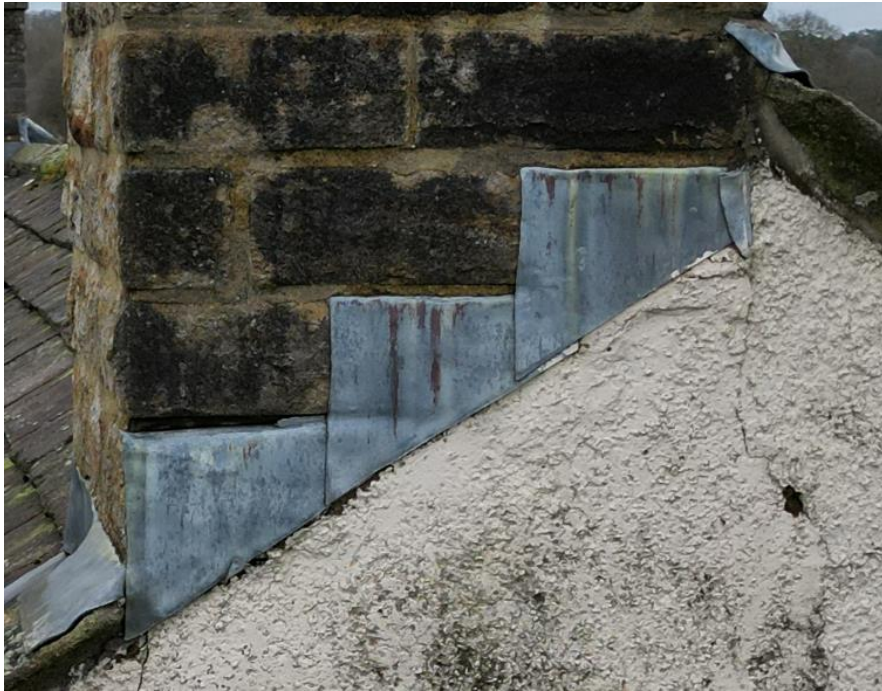
- The chimney flashing does not completely cover the head of the render, potentially allowing water behind the surface and causing cracking etc. Refer to photo 8.

Photo 8 – Render not completely covering head of render

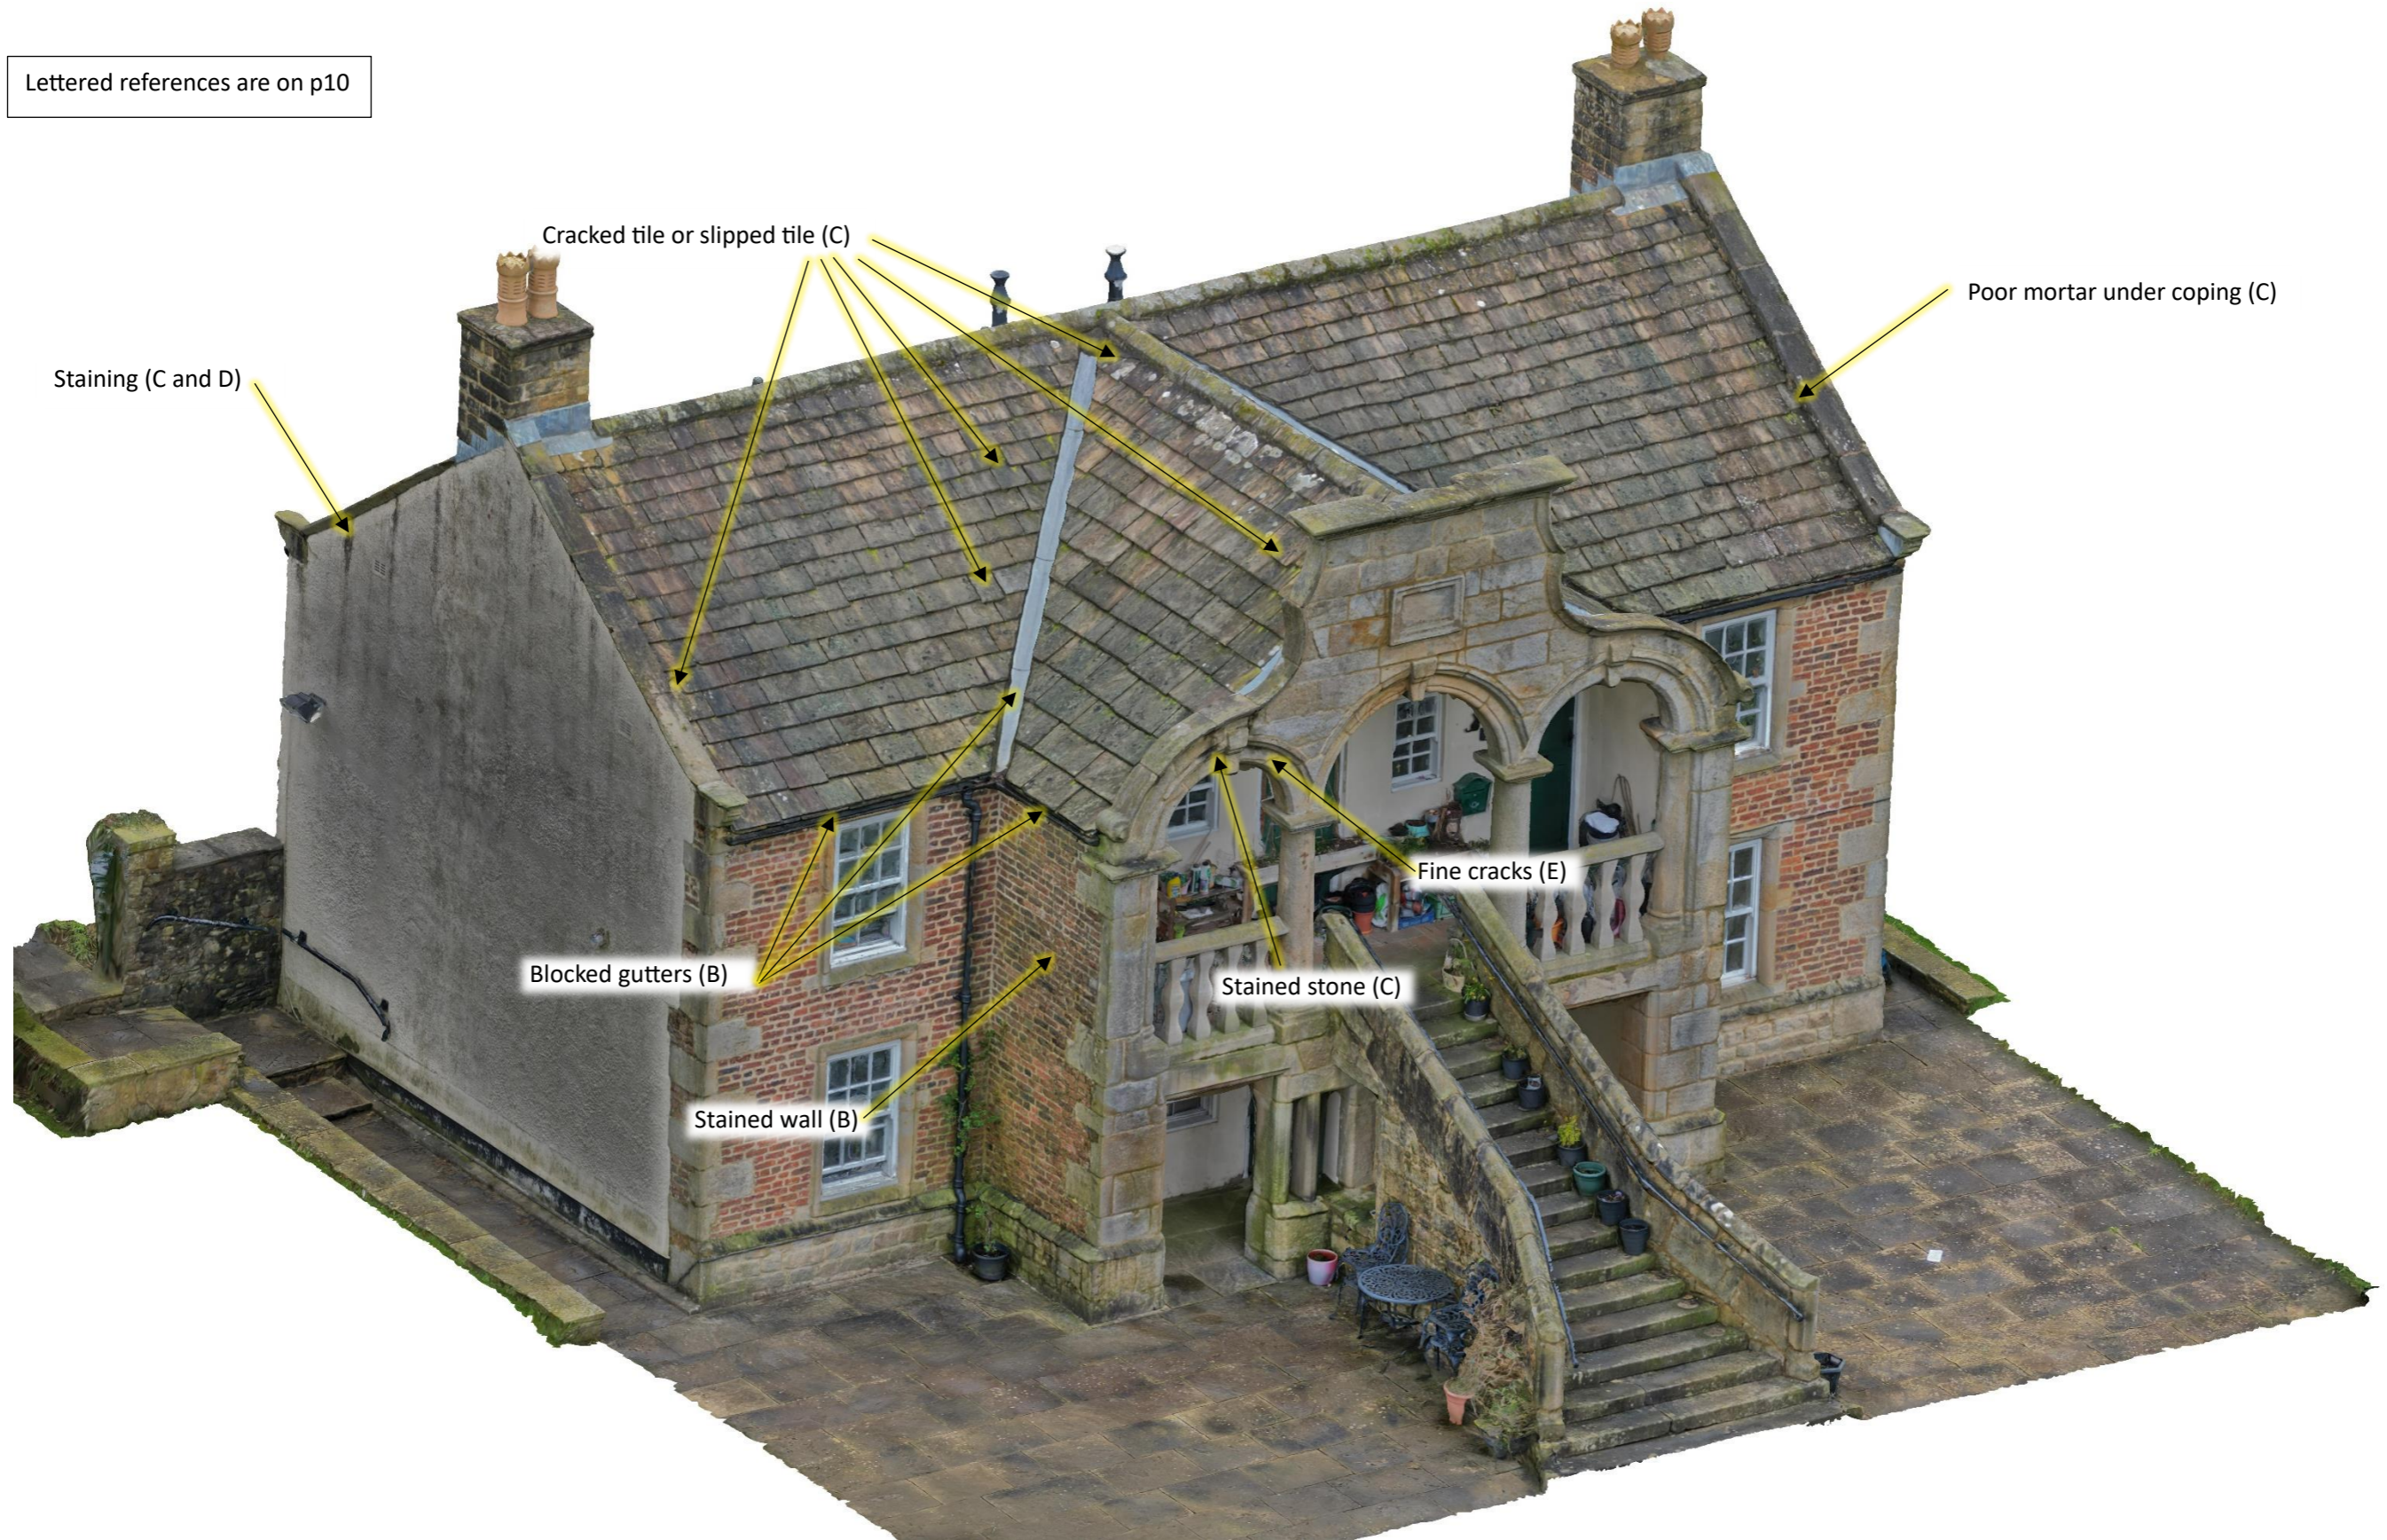
Lettered references are on p10

Photo 9 – Visual summary of defects

- C** Appoint a competent roofing contractor, with experience in dealing with historic slate/timber/lead construction, to advise on various issues including:

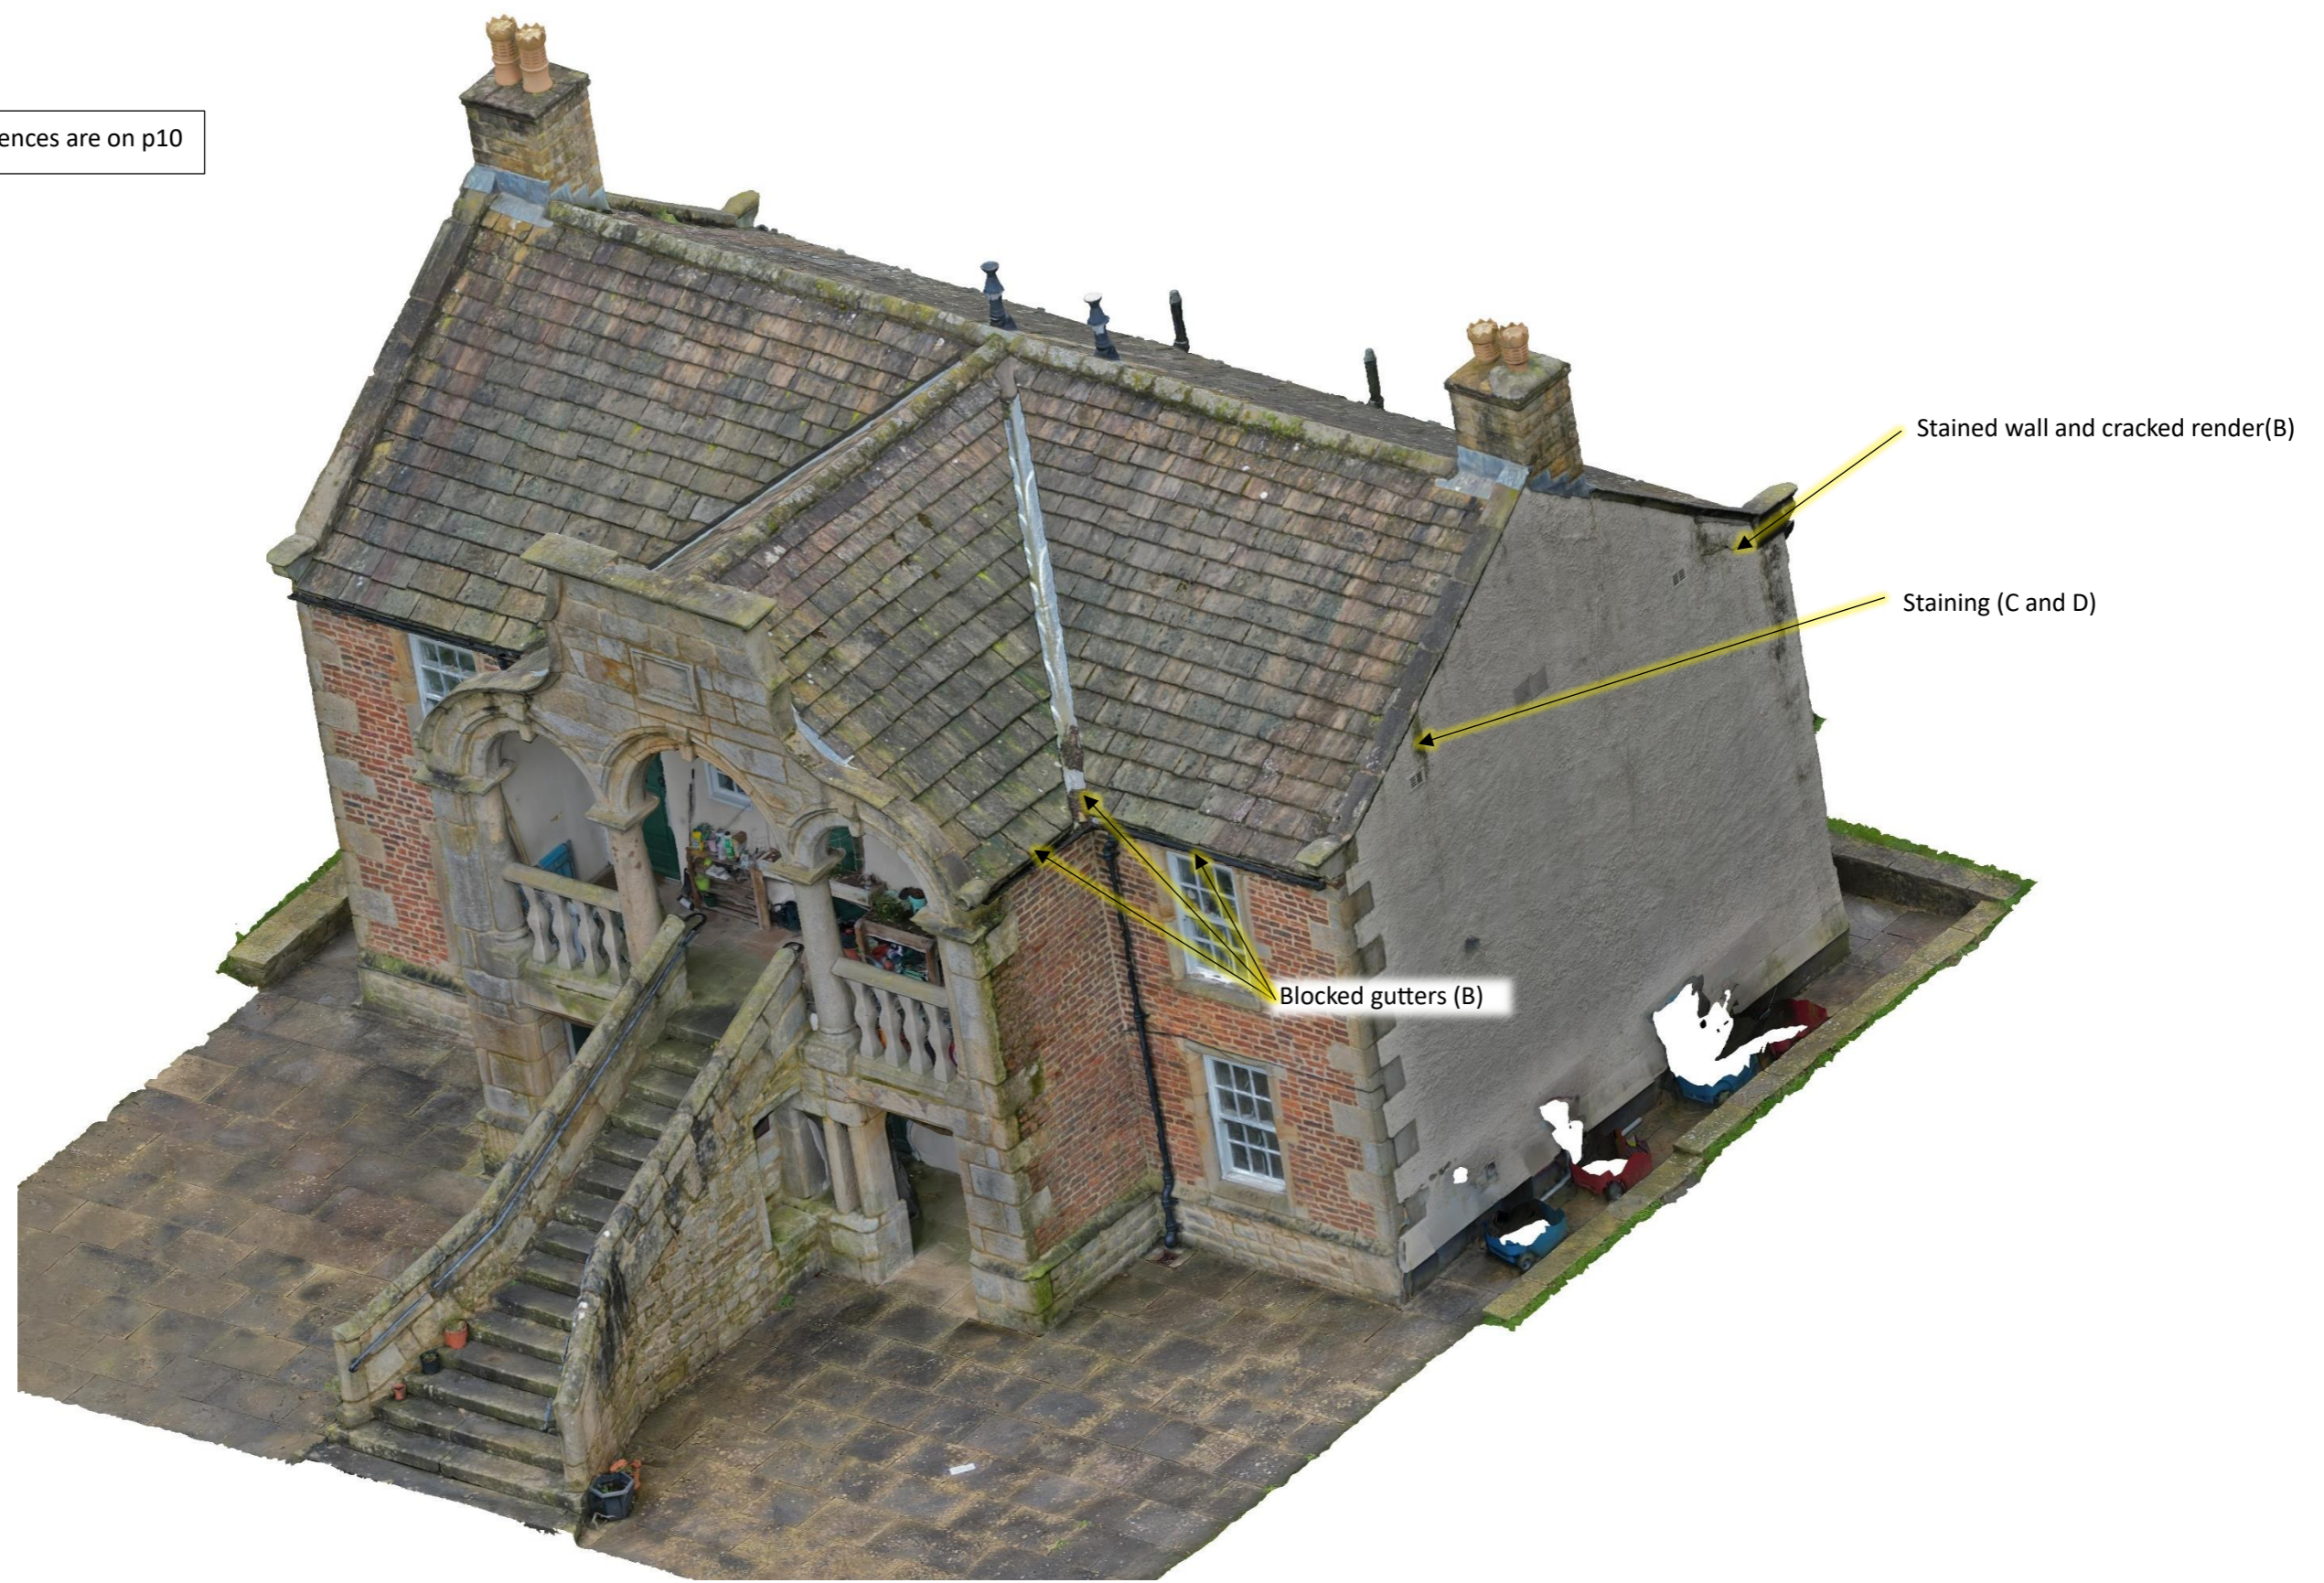
Lettered references are on p10

Photo 10 Visual summary of defects

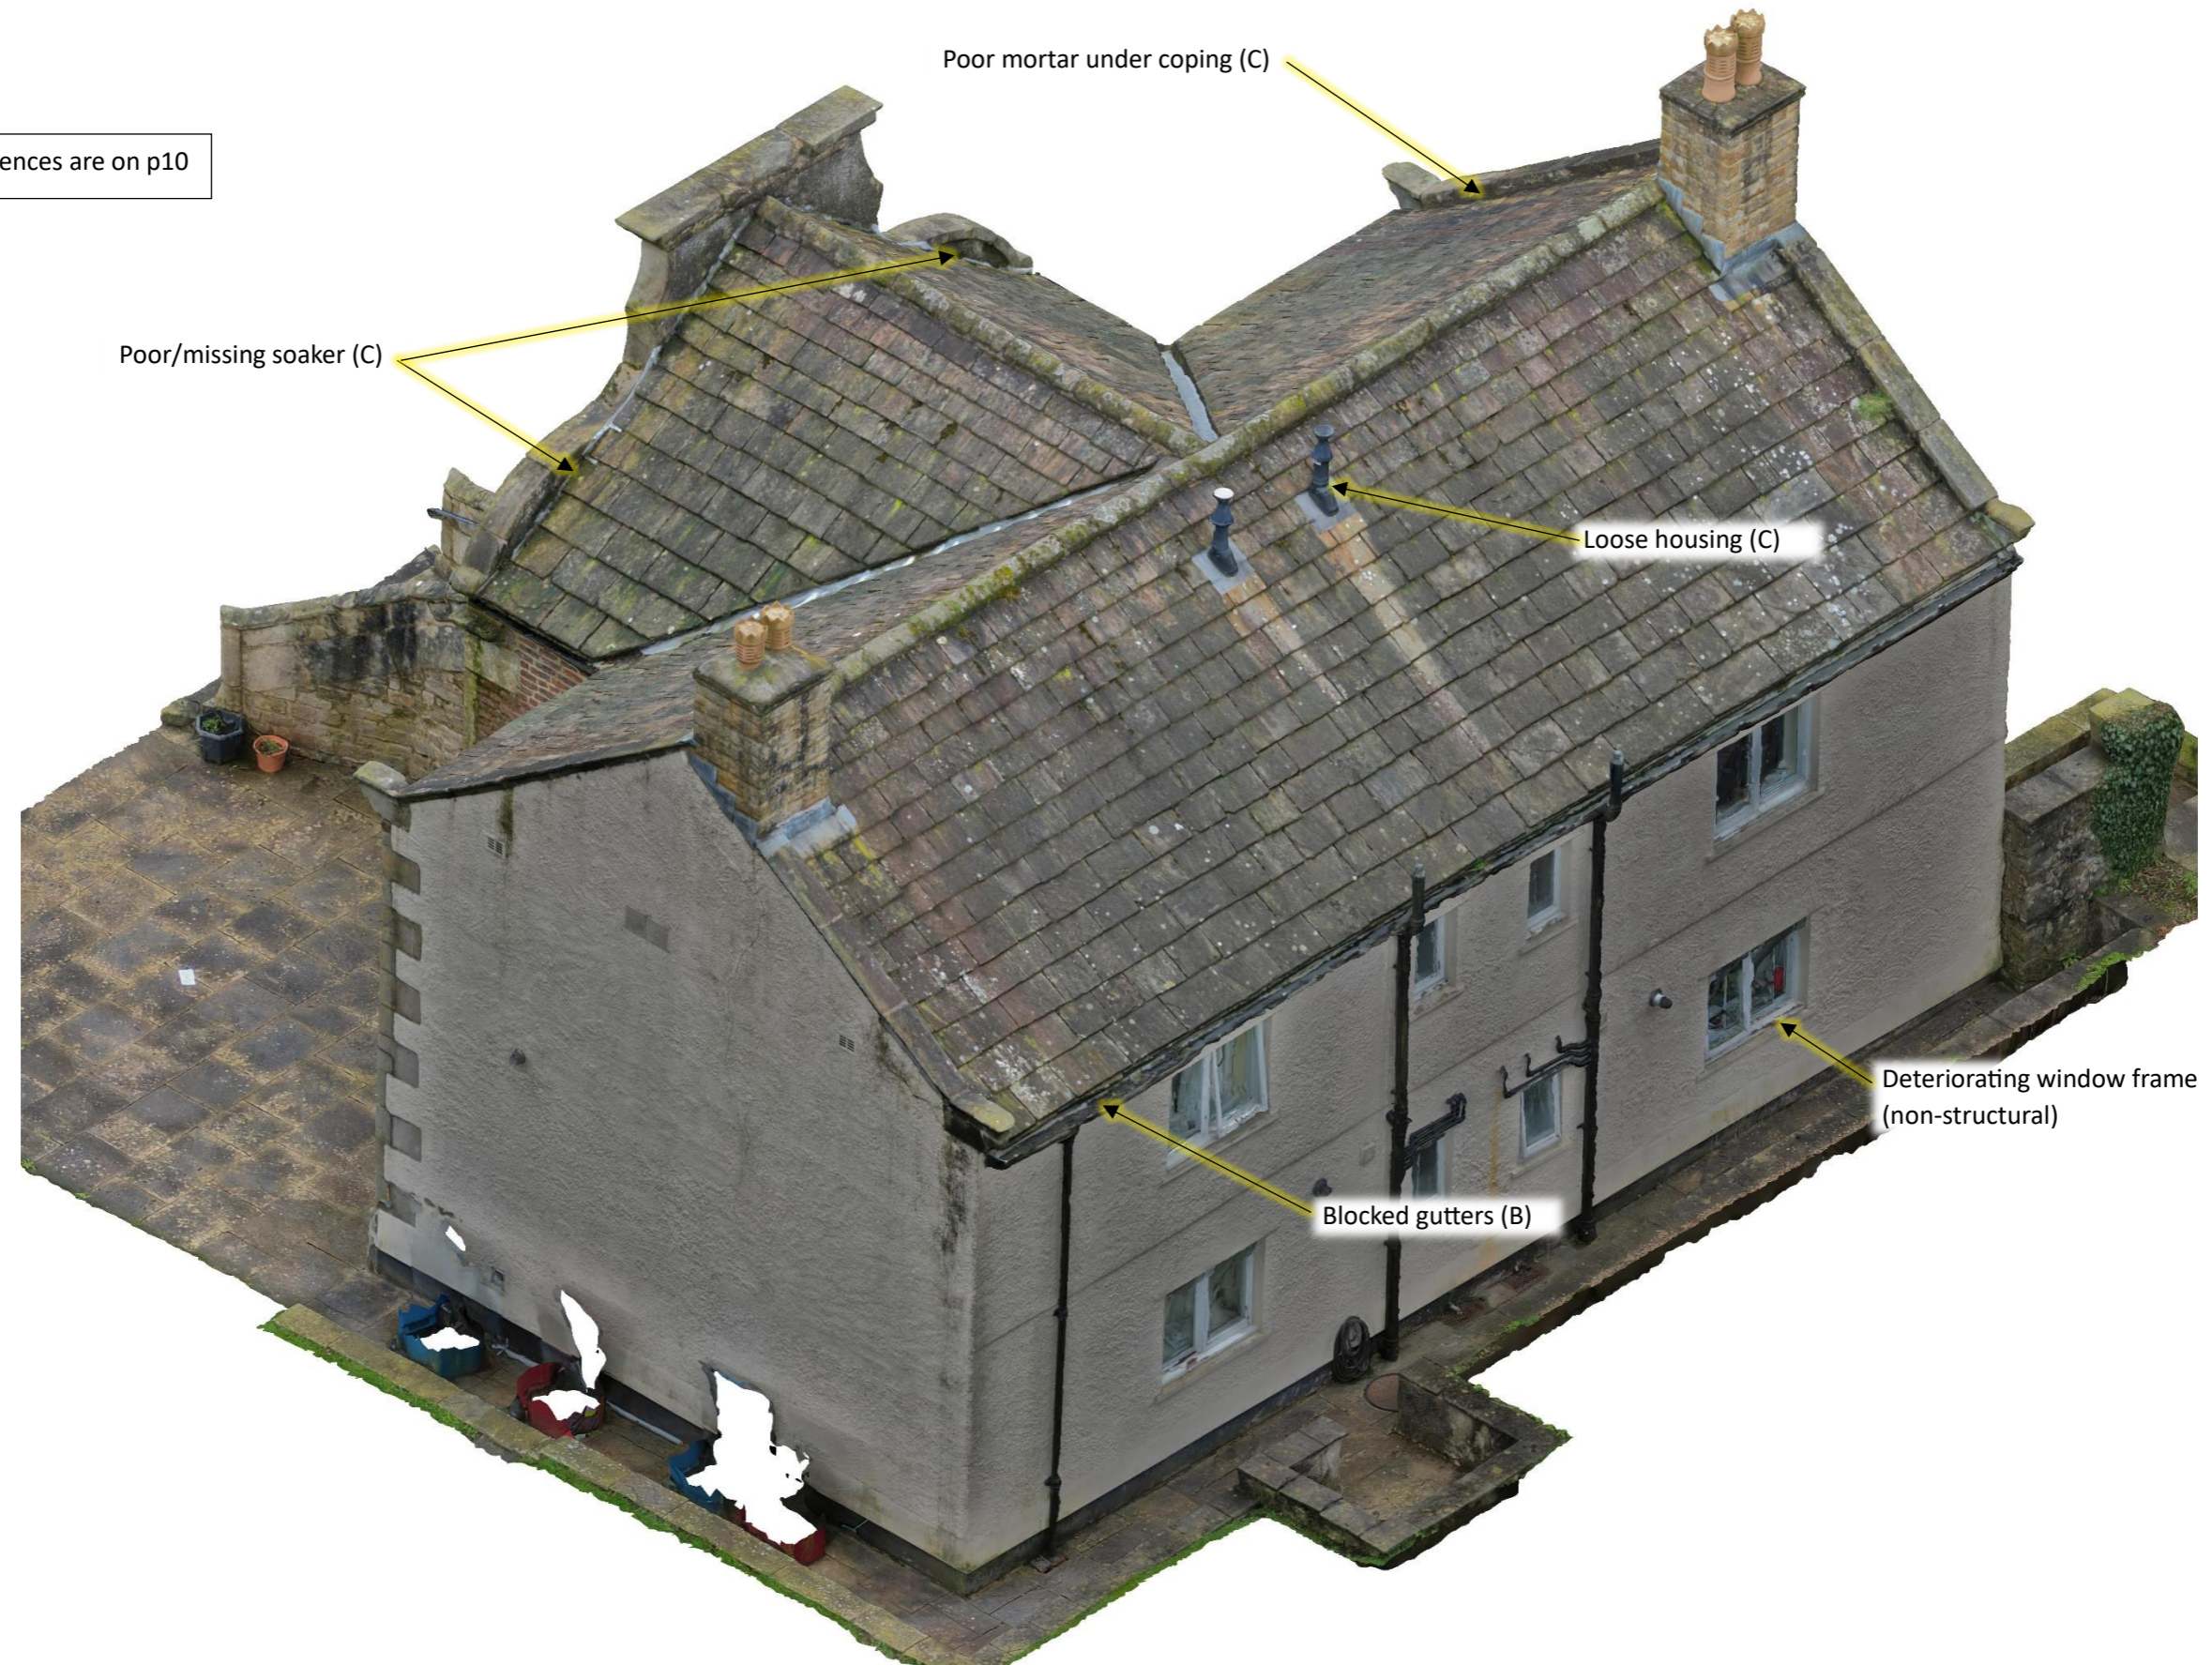
Lettered references are on p10

Photo 11 – Visual summary of defects
