**The Barn, Springwood,  
Hurst Green**

**Level 2-3 Historic  
Building Recording**

AB Heritage Project No: 63086

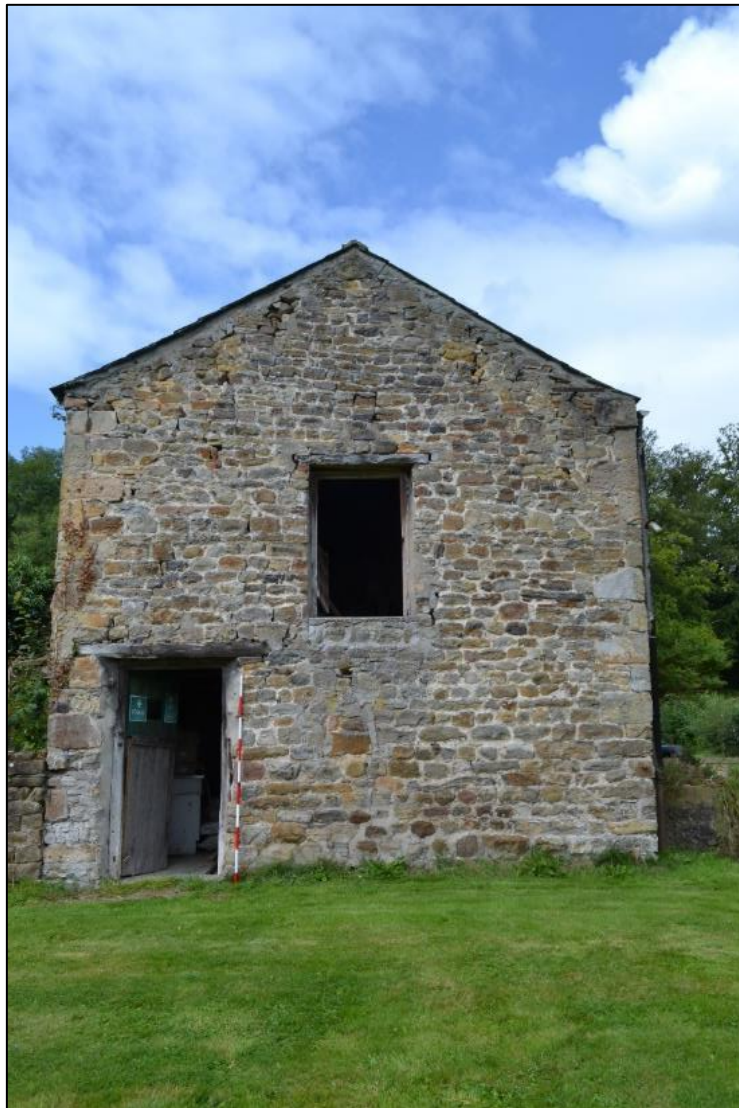
**Plate 9. The east elevation (scale 2m)**

- 4.2.9 The east elevation features a ground floor door under a worn timber lintel. The door itself is of a timber board, stable type. The portal looks to have been adapted to fit the later door, evidenced by the jamb being 'rendered' with cement.

- 4.2.10 At first floor and located just off centre is a loading bay door, again with a worn timber lintel, but with a thin concrete cill, and a timber architrave. This portal does not look like part of the original field Barn, perhaps evidenced by the cementitious pointing around it.

- 4.2.11 As with the north elevation, regular quoins and a change in the quality and pointing of the sandstone rubble indicates where the field Barn has been extended upwards. The present roof is bonded to the eaves by a thick bed of cement. Ridge tiles are in place along the whole length of the roof, suggesting that this arrangement post-dates the chimney inside the west gable.

- 4.2.12 It is apparent on Plate 9 that the ruinous building on the south elevation and the trough on the north elevation are not integral to the build of the Barn.

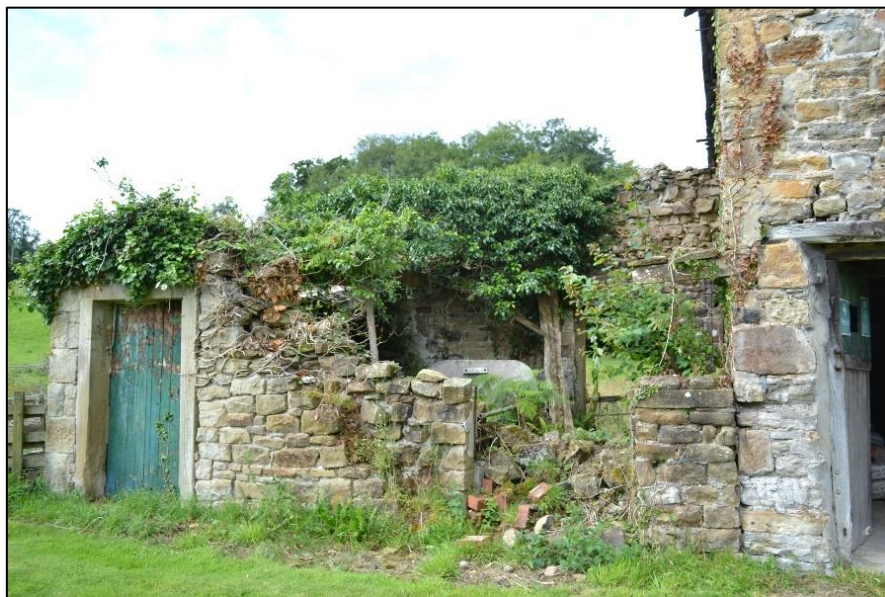
**Plate 23. The ruin from the east**

- 4.3.1 Abutting the Barn on the east side of the south elevation, is the ruined building shown on the 25 Inch OS map of 1932 (Plate 6) so we can assume that the building very much post-dates the original construction of the Barn. The building is almost square in plan, and is a single storey, built of sandstone blocks. The roof was slate and mono-pitched, sloping down from the adjoining Barn (Plate 23).

- 4.3.2 Plate 23 shows the state and condition of the building in 2024. However, it is possible to identify certain key features and to identify the function of building in the past. Plates 13 & 23 show the east and west elevation of the ruin, and they show that the building had opposing doors close to the back of the Barn.
