## **Barn 2 at Writtenstone Farm, Writtenstone Lane, Longridge, PR3 2ZN**

### Structural Condition Survey for Conversion to Dwelling

PSC-859 – B2

February 2024

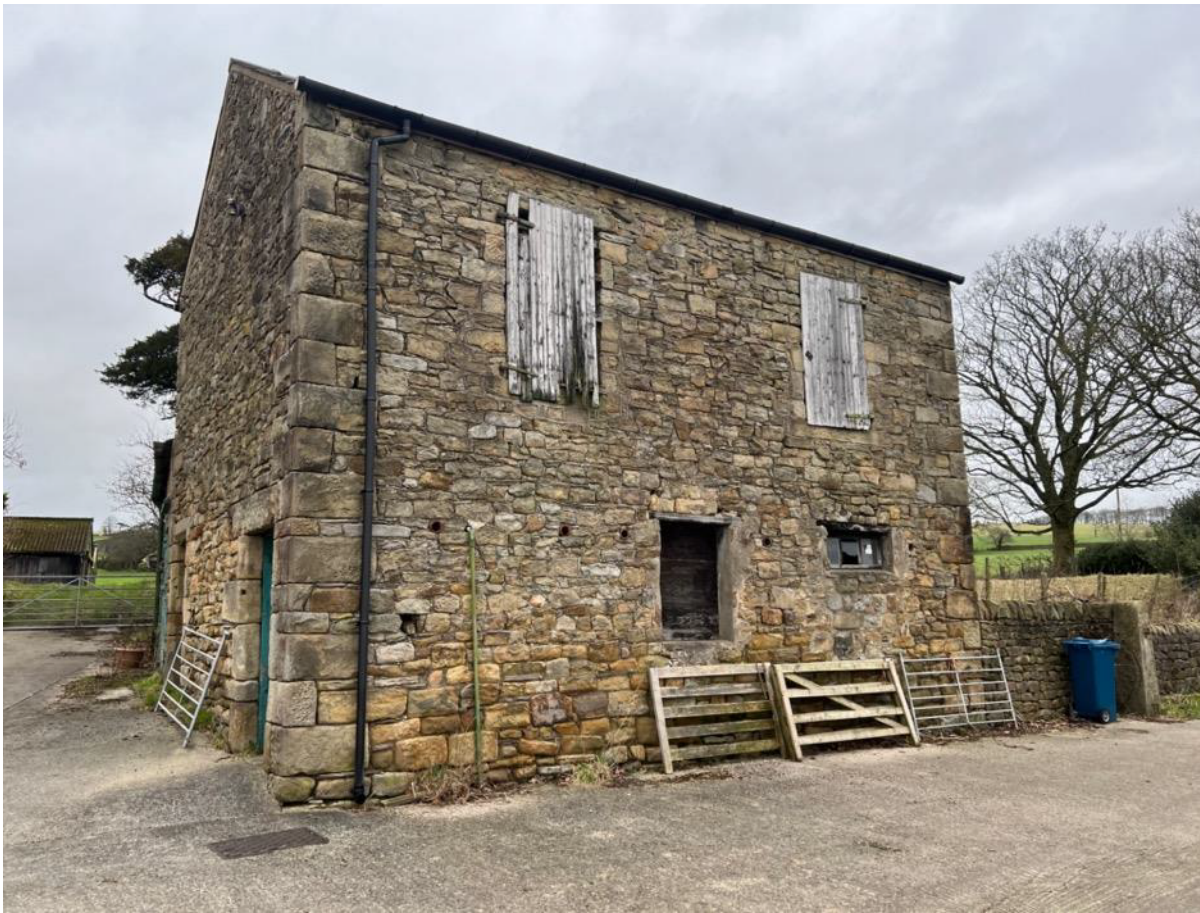
This elevation is built in random sandstone and the wall is 500mm thick. The wall is in reasonable condition. It is plumb and reasonably pointed. There are no signs of previous or ongoing movement. There are two window openings at ground floor level with two larger timber door openings giving access to the loft above (photo 3). Further vents to the building are provided by field tiles through the wall (photos 3 & 4). This elevation has the benefit of guttering and downspouts which are in reasonable condition (photo 1).

Photo 1 - South East Elevation

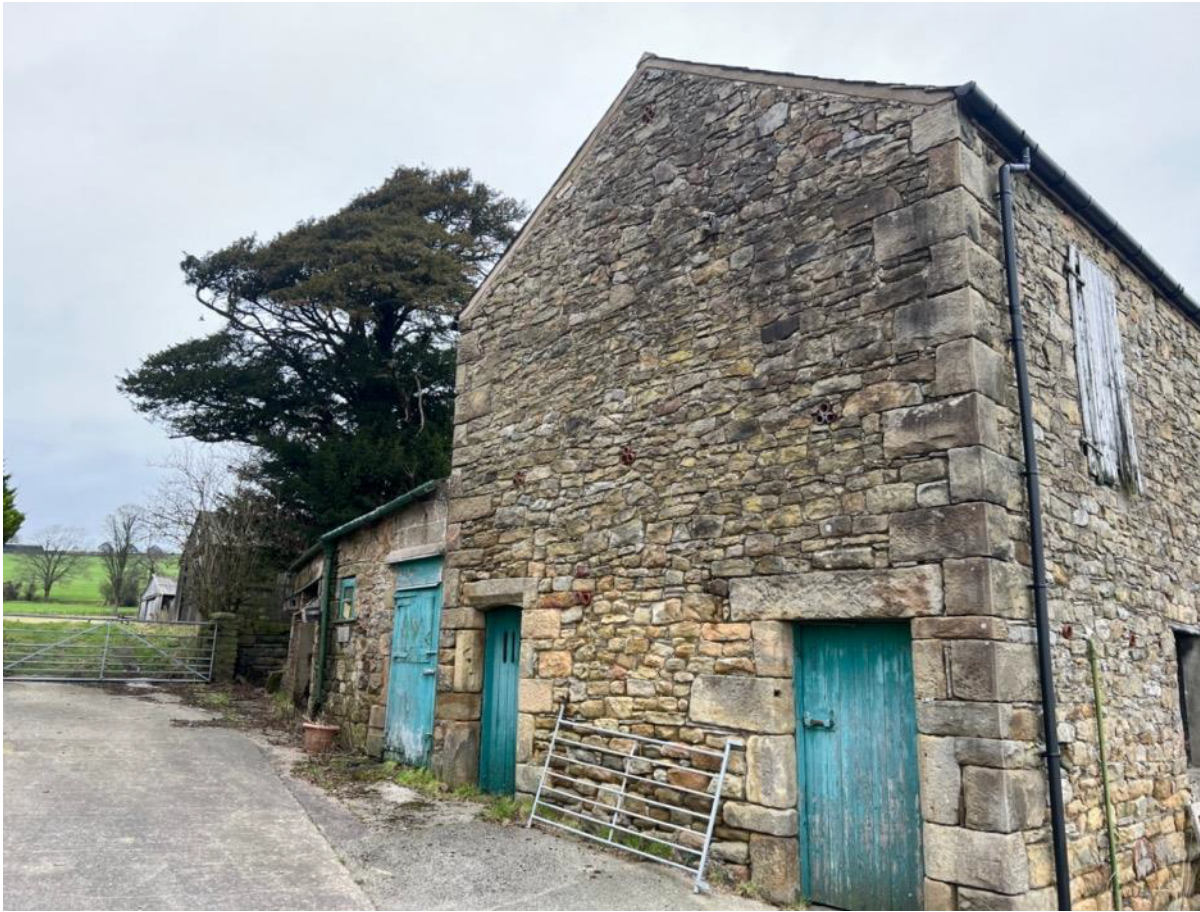
This elevation includes the gable to the main barn and the single storey outrigger to the rear of the barn (photo 2). The gable of the main barn is built in random sandstone and the wall is 500mm thick. The wall is in reasonable condition. It is reasonably plumb and reasonably pointed. There are no signs of previous or ongoing movement. There are two door openings at ground floor level with further vents to the building provided by field tiles through the wall (photo 9). The single storey rear elevation wall has sections of sandstone wall, brick wall and an infill of concrete block. The walls to this section are 400mm thick. There are three openings along this length of wall, a doorway and small window (photo 11) and a larger opening for vehicular access (photo 12). When the larger opening was formed a large steel beam was put in place and a section of wall rebuilt in brick (photo 12 & 16). This section of the elevation has the benefit of guttering and downspouts which are in poor condition (photo 13).

Photo 2 – South West Elevation

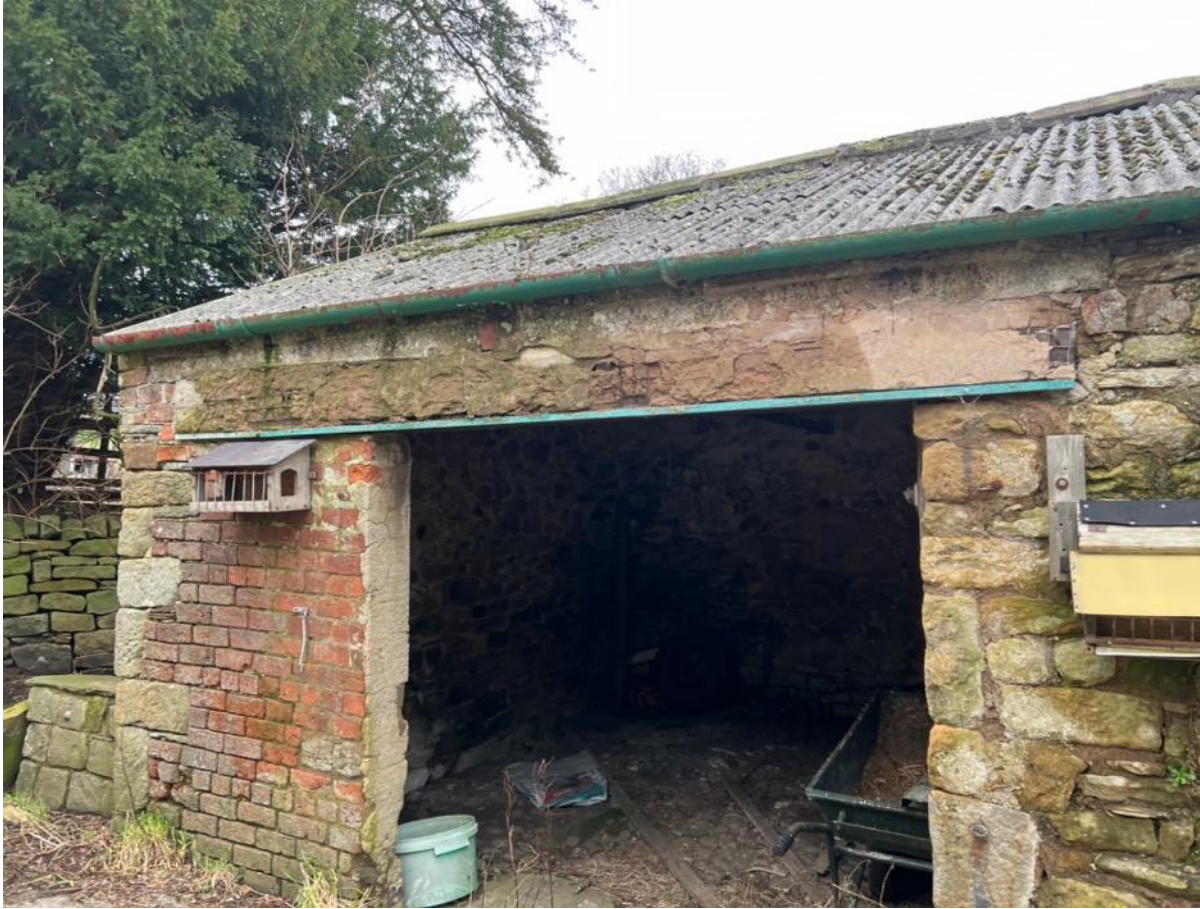
This building has a cobbled floor in the open garage type area and a solid concrete floor in the small storage area. The building shows no sign of previous or ongoing movement to walls or floors.

Photo 12 - South West Elevation outrigger

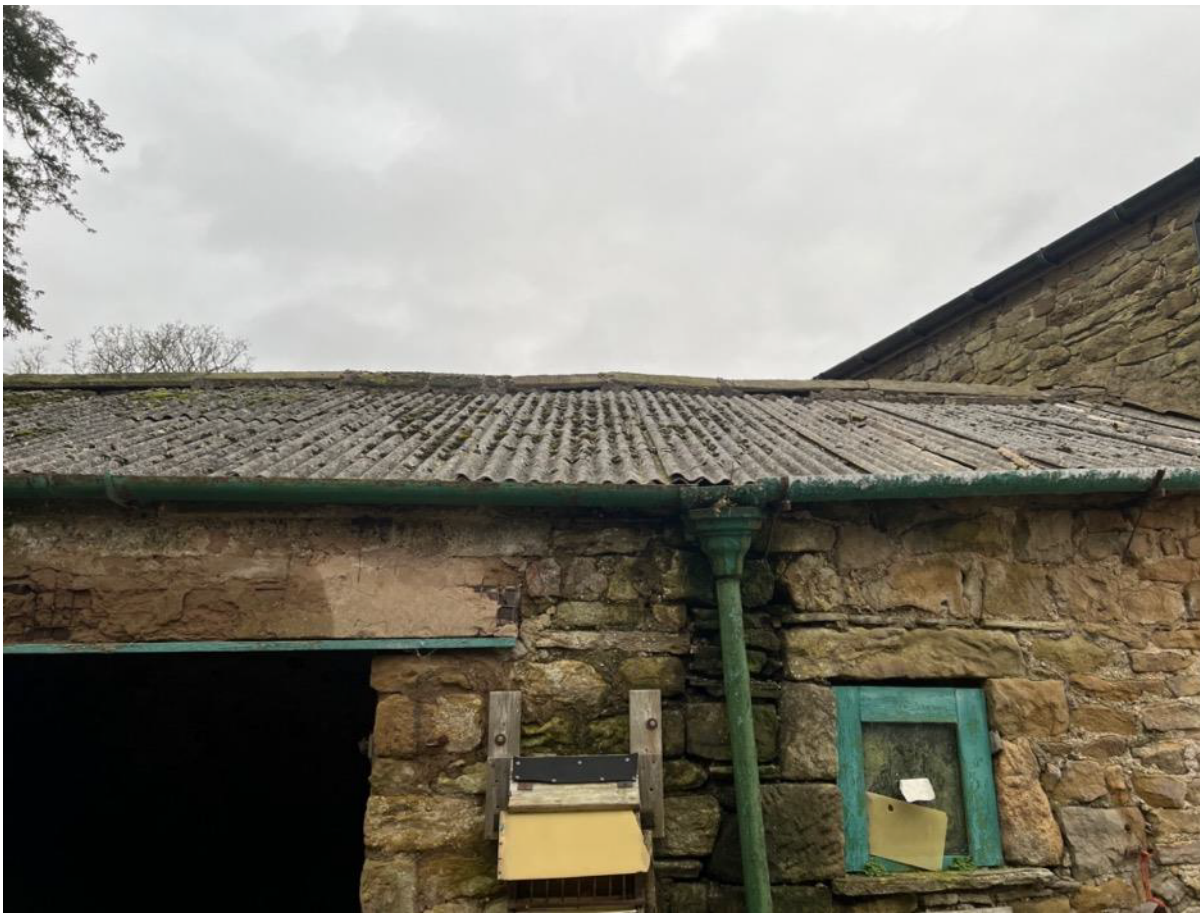
Photo 13 - South West Elevation outrigger and roof

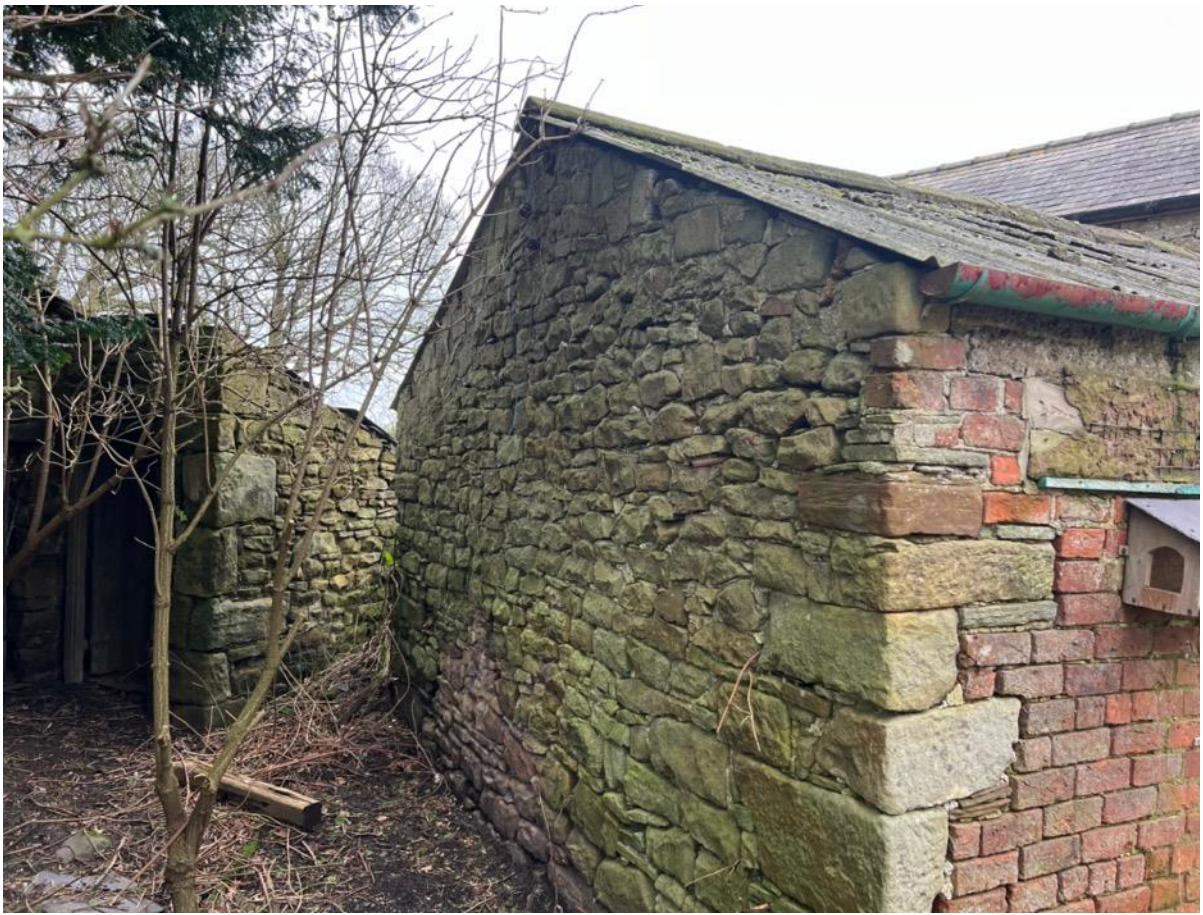
This gable elevation is a 400mm thick random stone wall no openings. The wall is plumb, reasonably well pointed and free from signs of movement.

Photo 15 - North West Elevation - outtrigger

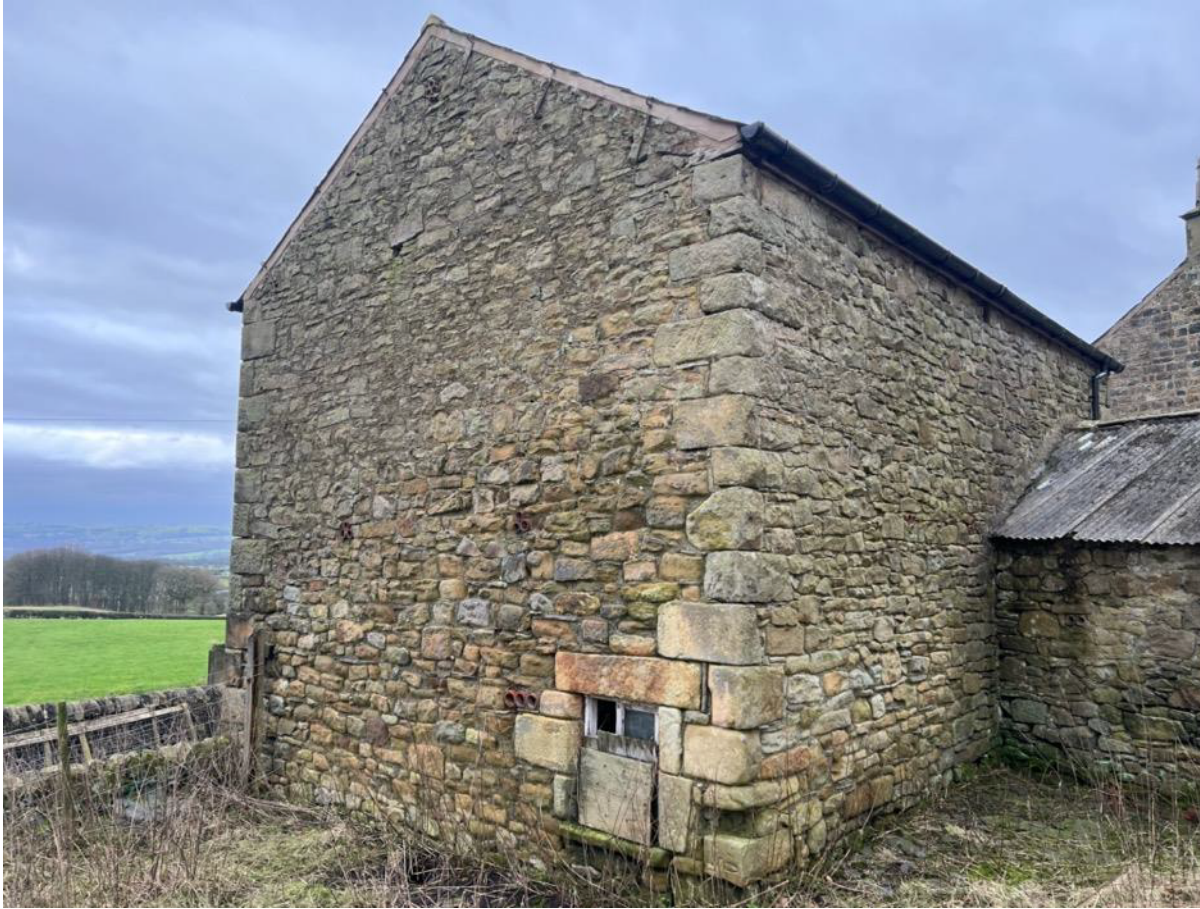
This elevation is a 500mm thick random stone wall no openings. The wall is plumb, reasonably well pointed and free from signs of movement. This section of the elevation has the benefit of guttering and downspouts which are in good condition (photo 18).

Photo 18 – North East Elevation

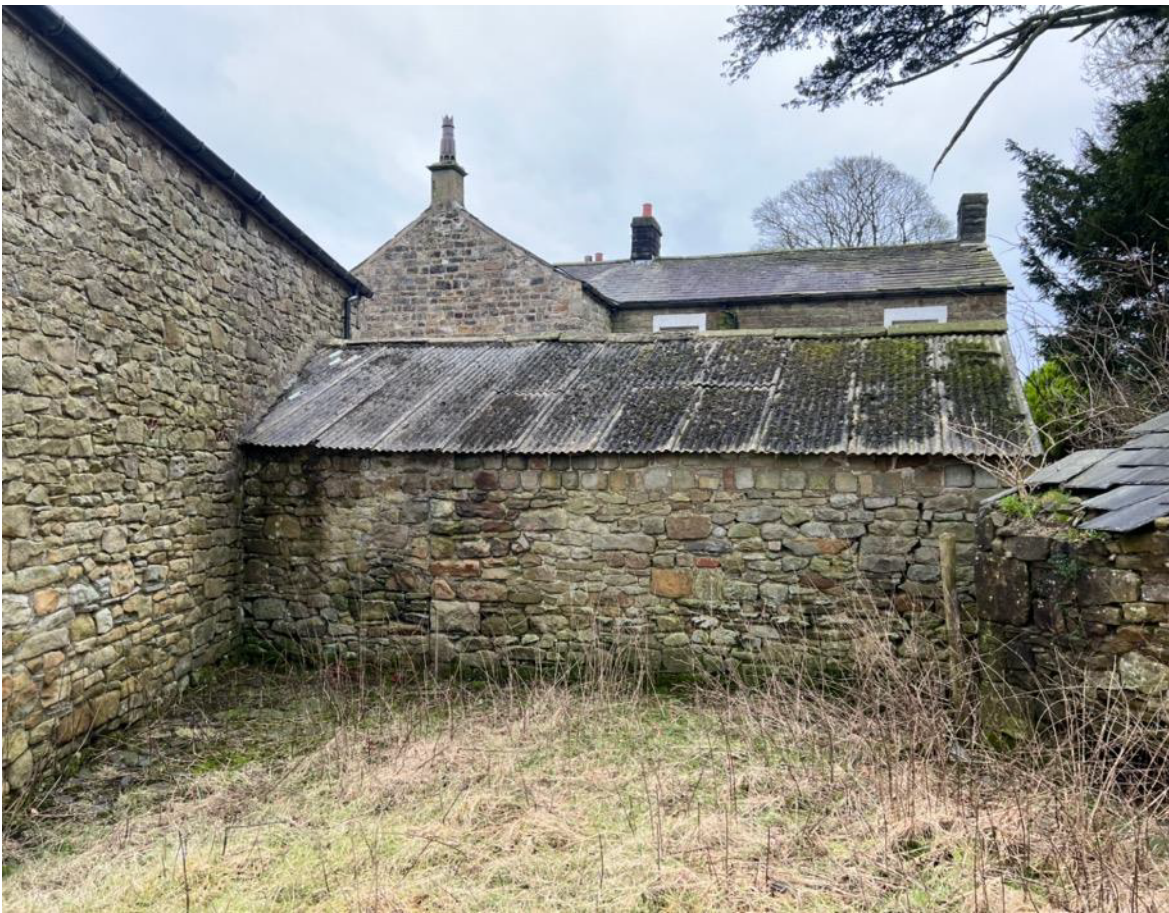
This wall is a 400mm thick random stone wall with no openings. There is a distinct straight vertical joint close to the main barn which indicates this outrigger was originally much smaller and later extended. The wall is plumb, reasonably well pointed and free from signs of movement. This elevation does not have a gutter or downspout.

Viewed externally, the main barn roof appears in very good condition with no sign of damage, slate loss, or deflection. The internal inspection discussed below indicates that the main barn has been re-covered including felt. The outrigger has all the asbestos cement sheets in place and these are in a reasonable condition with ridge tiles in place. There is some moss on the north east face of the roof (photo 19)

Photo 19 – North West of main barn and North East of outrigger with roof

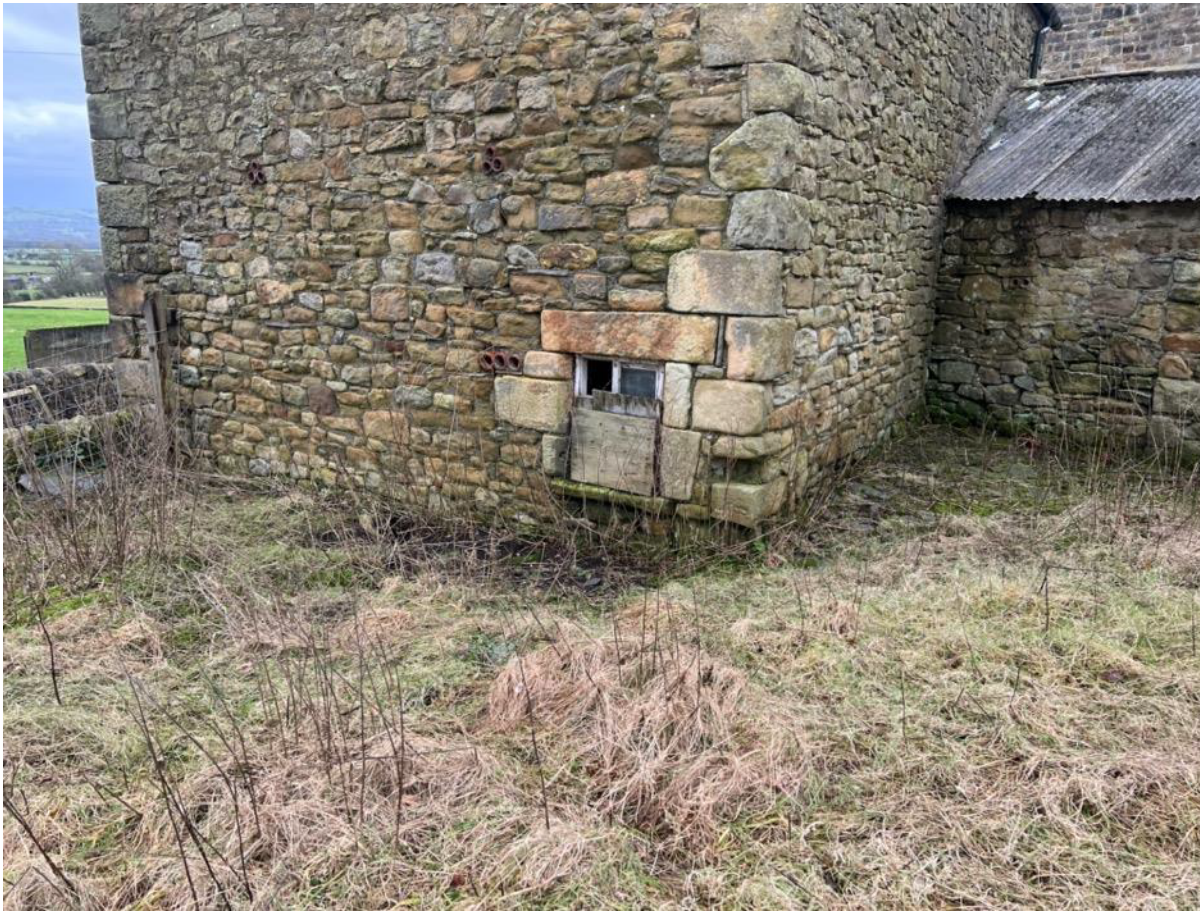
This wall is a 500mm thick random stone wall with one small window opening at the bottom right corner. The wall is plumb, reasonably well pointed and free from signs of movement. There is a single quoin stone missing at the bottom right corner of the building (photo 22) adjacent to the window.

Photo 22 – North East Elevation

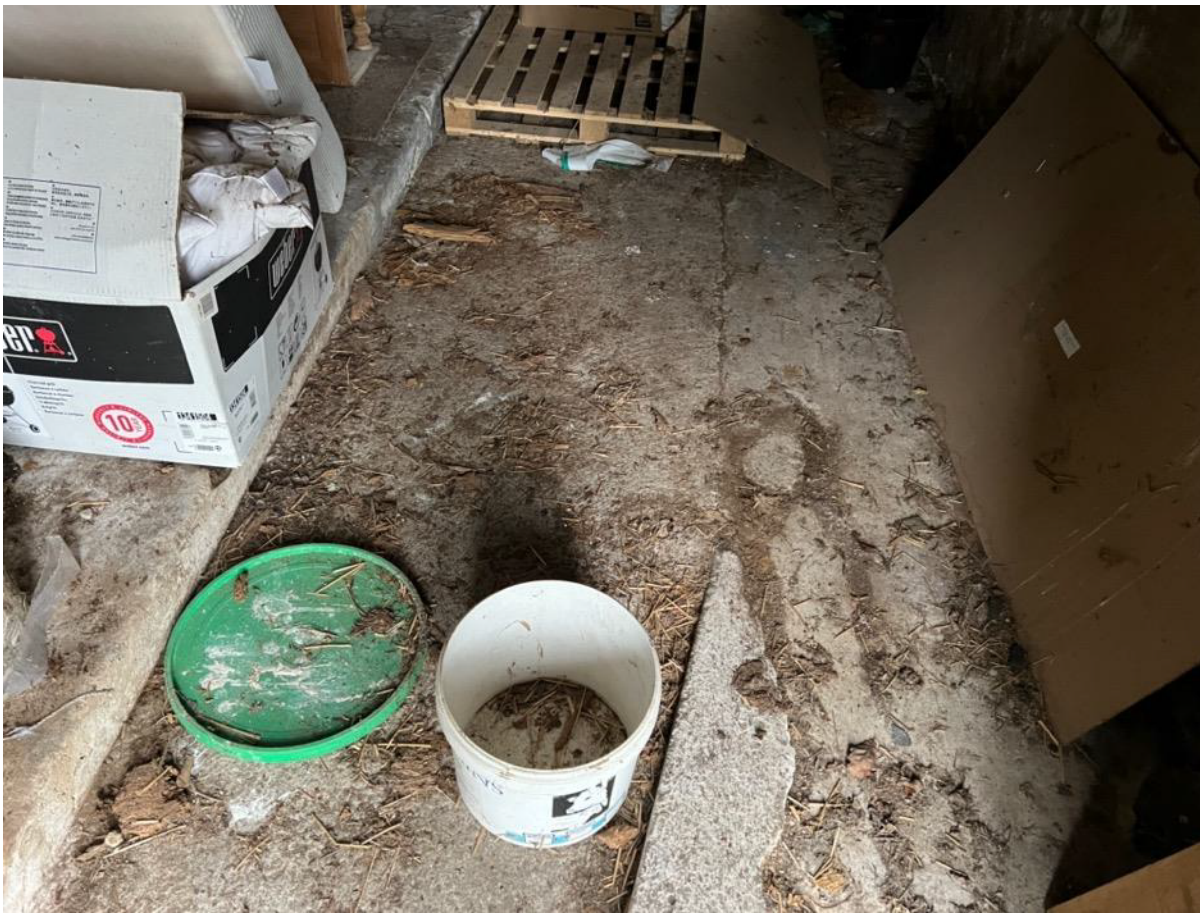
Main section – This section of the building has a shippon area at ground floor level with a loft above. The building shows no sign of previous or ongoing movement to walls or floors. The ground floor is solid concrete (photo 23). The loft floor is of a timber construction with evidence of rot to the floor boards (photo 25) and signs of damp and possible rot in other structural timbers (photos 26 & 27).

Photo 23 – Internal concrete floor

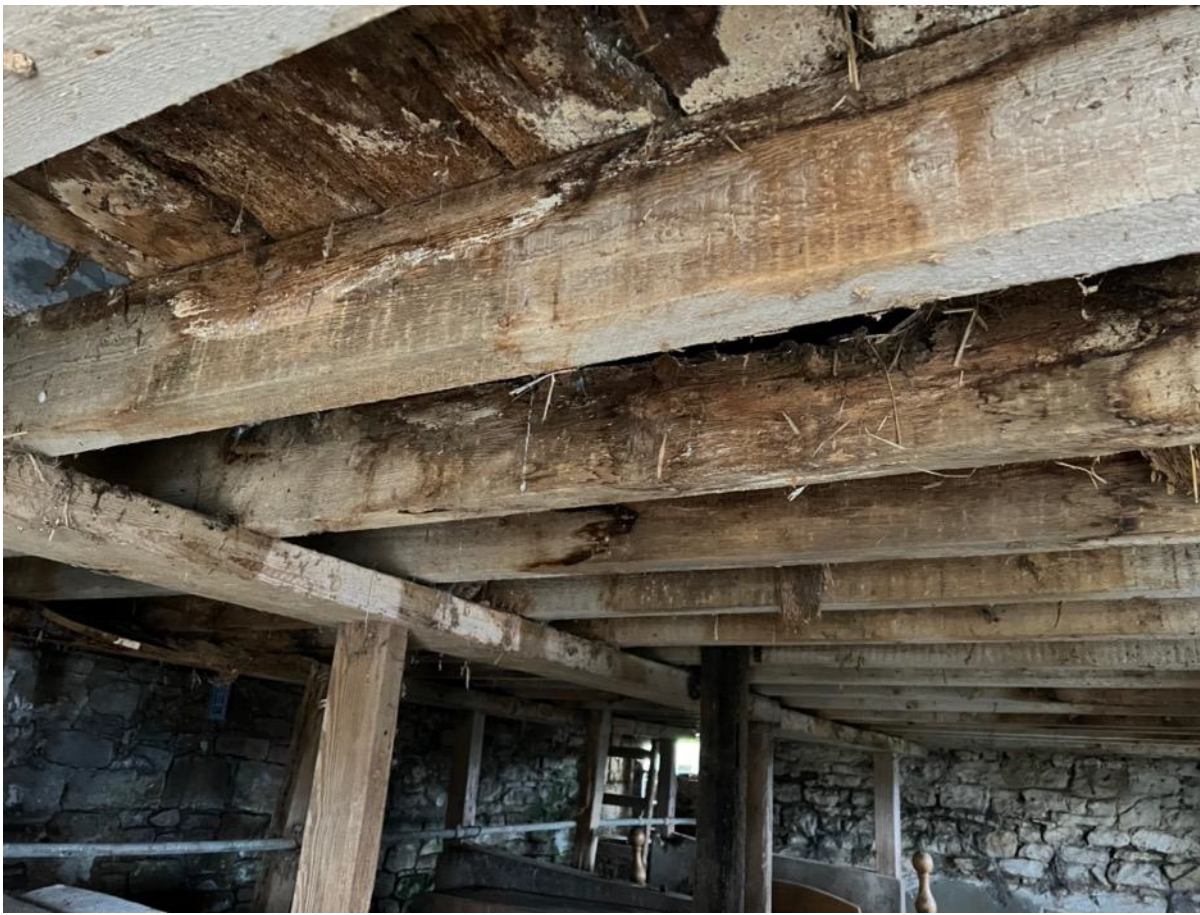
Photo 25 – Intrnal joists to upper loft

The existing truss and purlins appear to be in good condition with little sign of rot or infestation. Any timber retained should be assessed by a timber specialist, with regard to rot and infestation. All retained timber should be treated against rot/infestation and an indication of residual section given for structural purposes. All retained timber to be used structurally should be checked for structural adequacy. The roof to the outrigger is currently covered with cement sheets or asbestos cement sheets. These should be investigated further to ascertain the exact material. If this is found to be asbestos sheeting it should be removed and disposed of to current Health & Safety Guidelines.

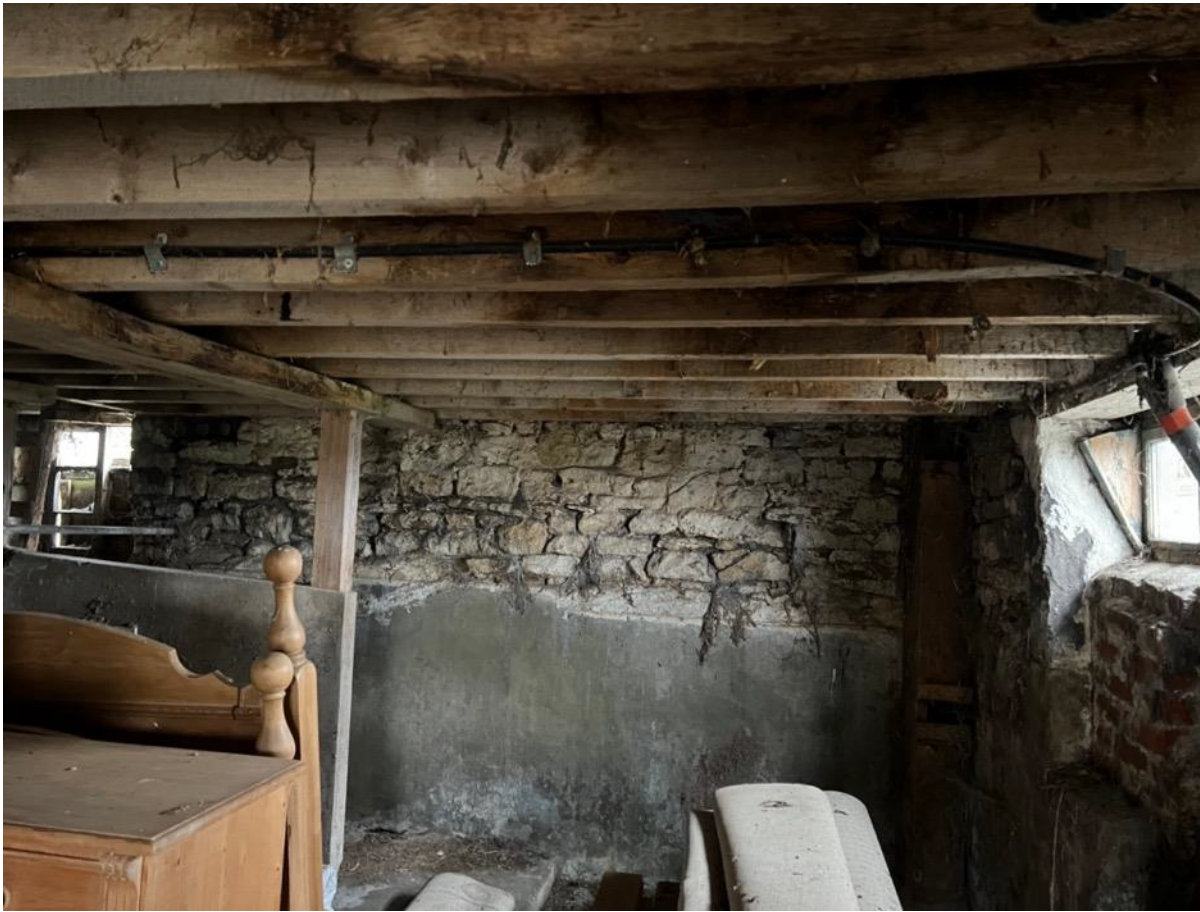
Photo 26 – Internal looking North East

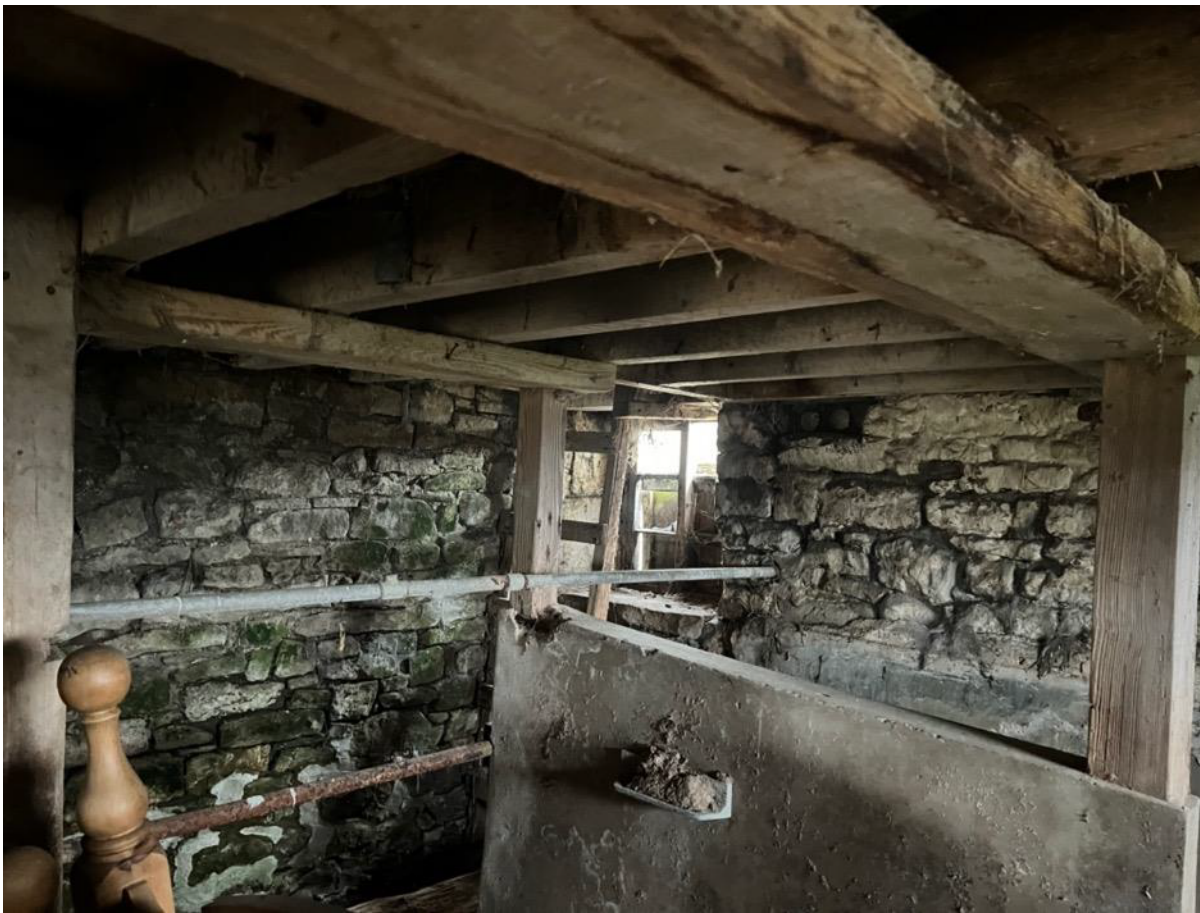
Photo 27 – Internal looking North East

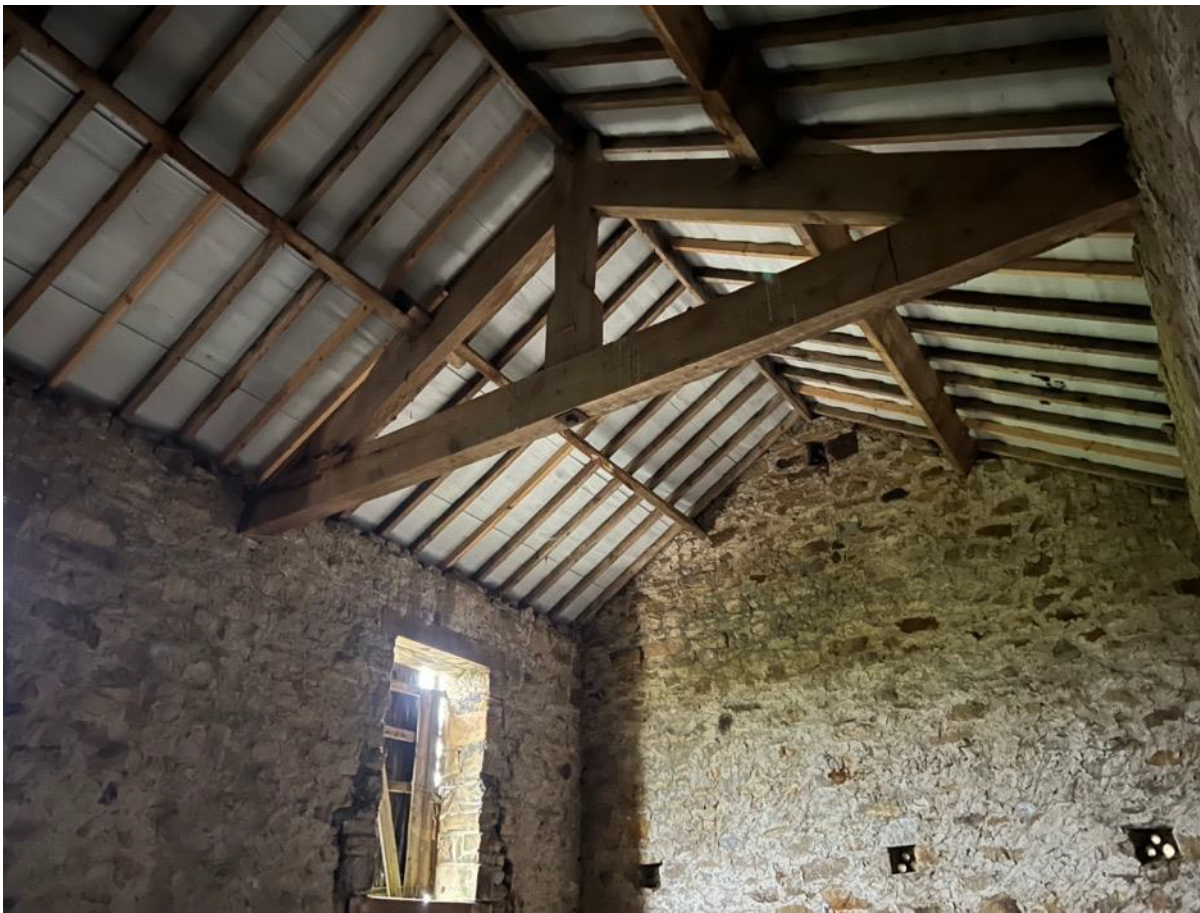
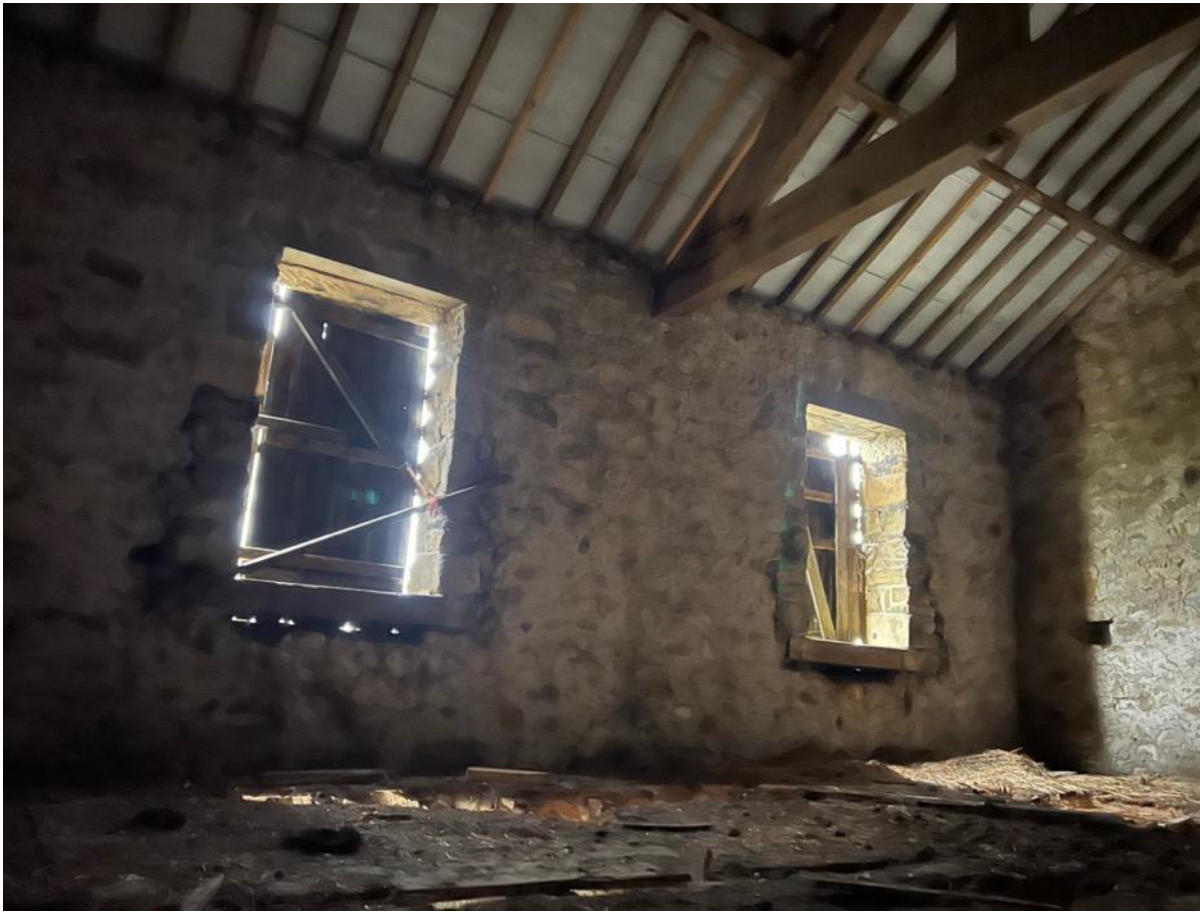
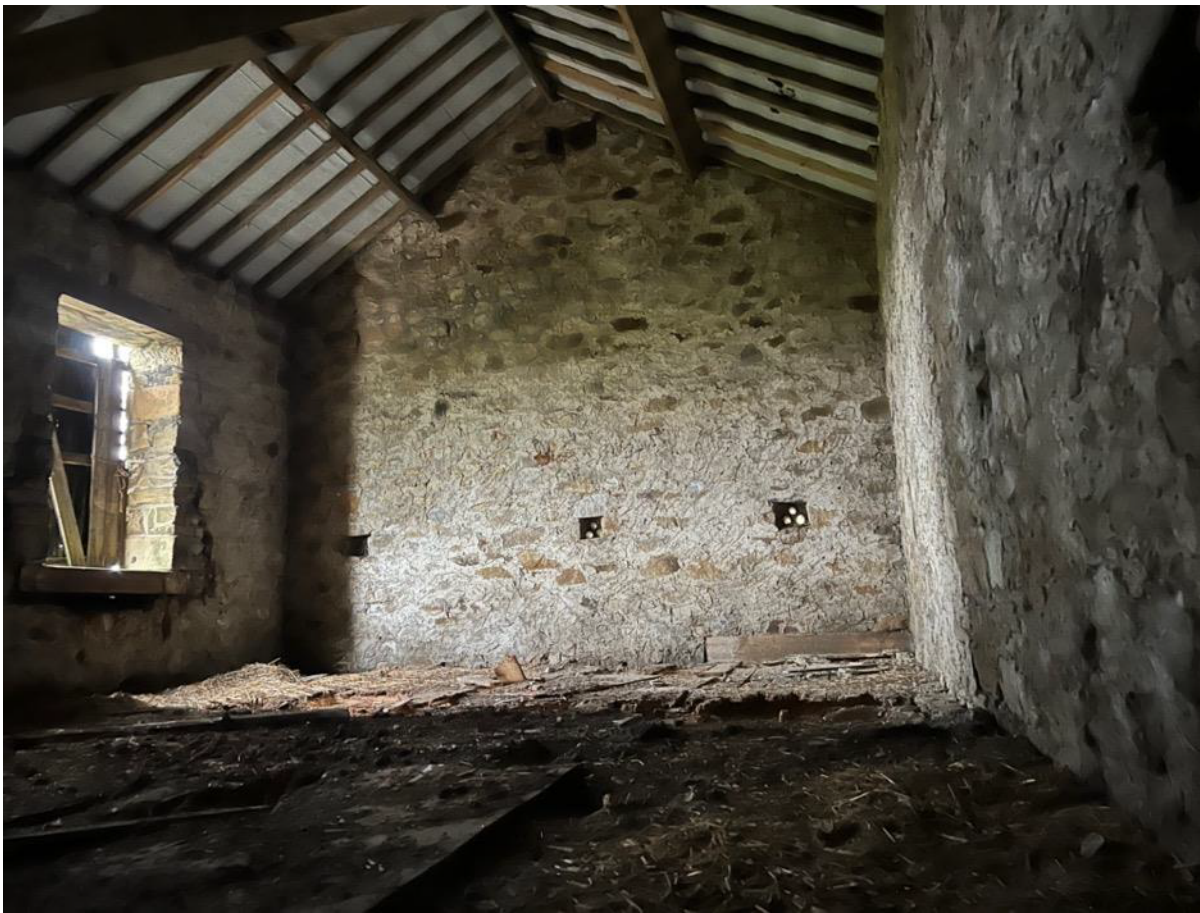
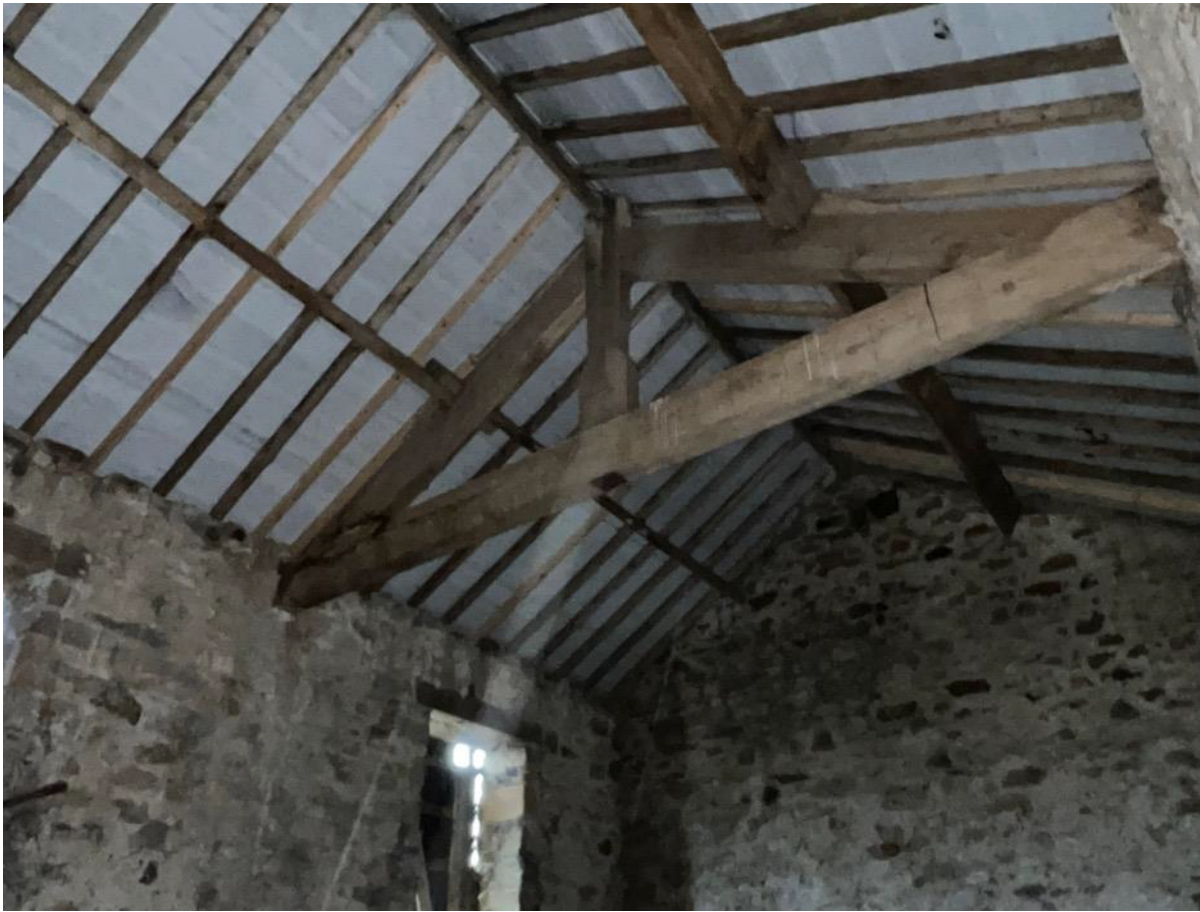
The upper loft is shown in photos 29 to 32. This indicates the good condition of the walls which are well pointed with little or no sign of movement. As noted above, the barn has been recovered and has felt in place. The timber trusses, purlins and rafters appear in reasonable condition with no clear signs of extensive rot or infestation.
