# BS5837 Tree Survey

Parsonage Farm  
Church Street  
Ribchester  
PR3 3YE

August 2025

<b>Job no.</b>	LTC374
<b>Site</b>	Parsonage Farm, Church Street, Ribchester, PR3 3YE
<b>Client</b>	Drs. Gray
<b>Agent</b>	Sunderland Peacock and Associates Ltd.
<b>Arboriculturist</b>	Jennie Keighley PhD MSc MArborA
<b>Local authority</b>	Ribble Valley Borough Council
<b>Issue date</b>	29 August 2025

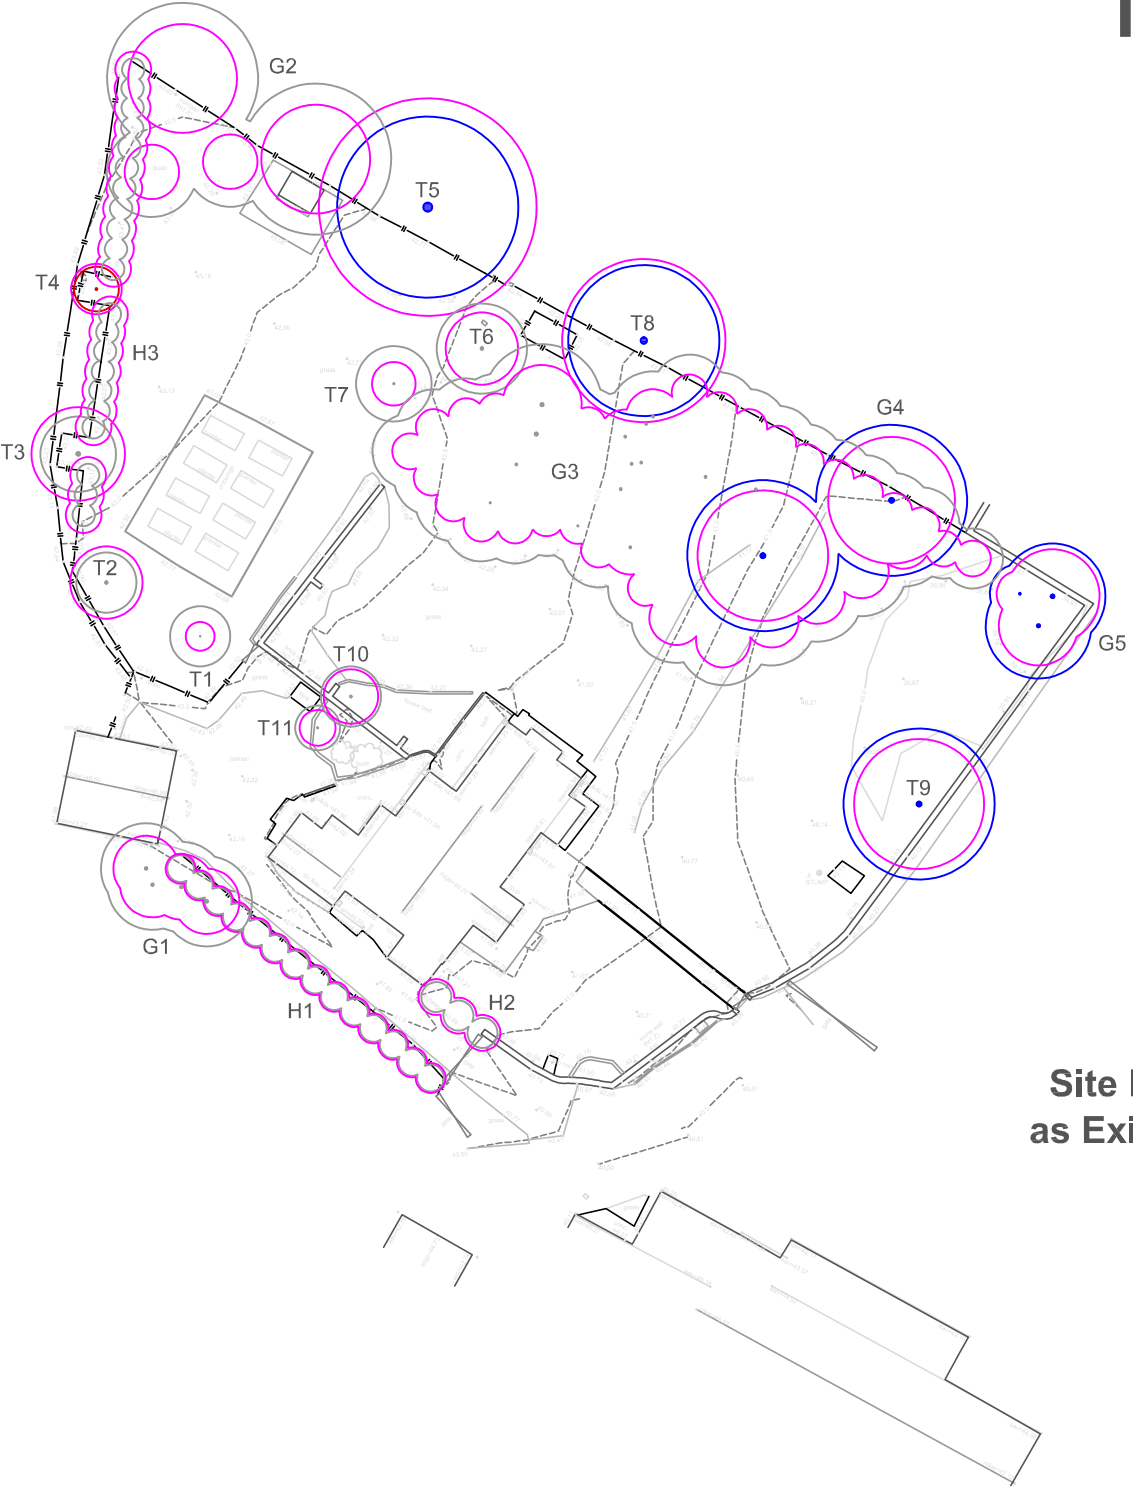
# Tree Survey Plan

ID	Species	Cat.
T1	Pear	C
T2	Cypress	C
T3	Oak	C
T4	Cedar	U
T5	Oak	B
T6	Cherry plum	C
T7	Sweet gum	C
T8	Oak	B
T9	Keaki	B
T10	Damson	C
T11	Cypress	C
G1	4no. birch	C
G2	4no. cherry, magnolia	C
G3	Damson	C
G4	2no. beech	B
G5	3no. birch	B
H1	Hawthorn	C
H2	Cypress	C
H3	Cypress	C
