**Crane Wood Farm Barn
PHOTOGRAPHIC RECORD 2025**

For Robbie Taberner and Hannah Grummett

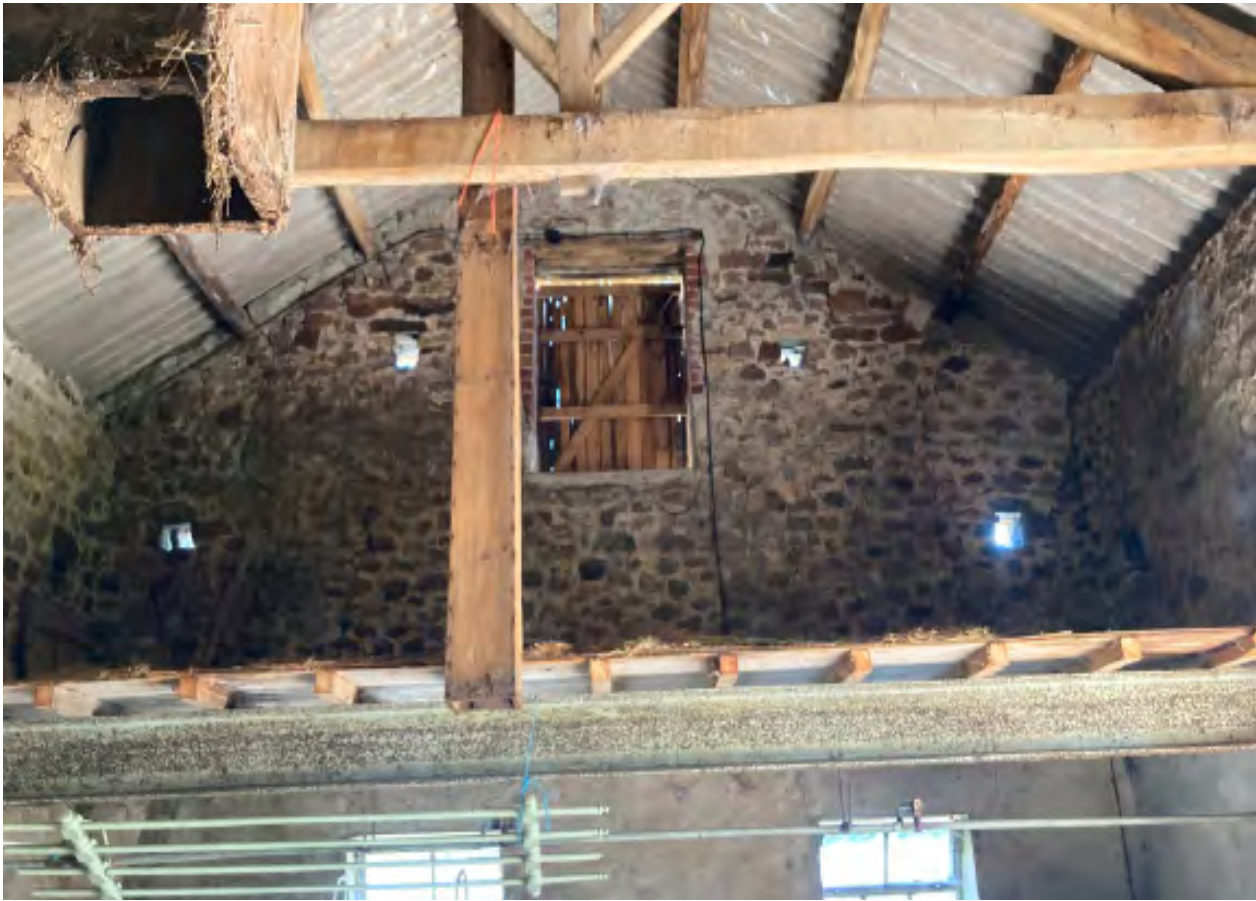
View to east side of the main barn from the central threshing floor. C20th hayloft over on steel beam. Note C20th plasterwork to the walls of the byre and exposed rubble work above, with diagonal crack to upper left hand side reflecting crack externally.

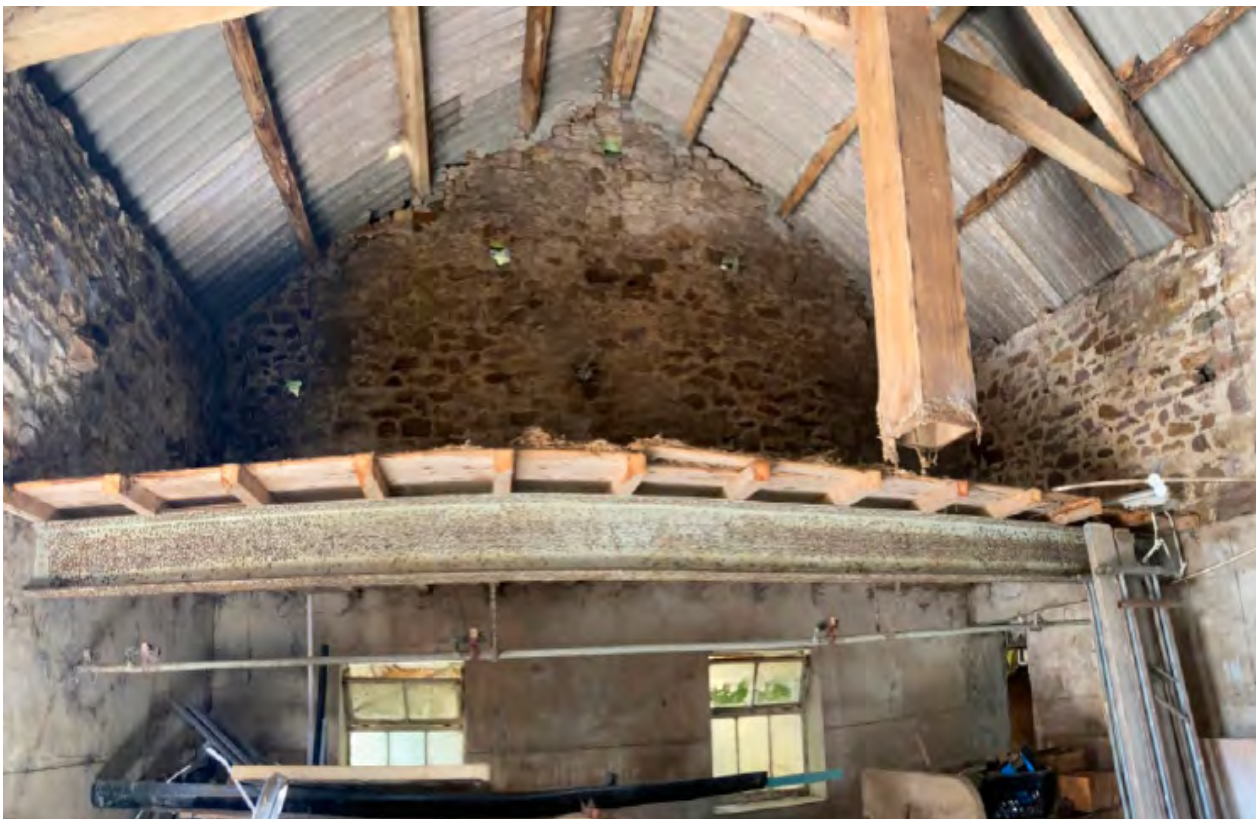
View to west side of the main barn from the central threshing floor. C20th hayloft over on steel beam. Note C20th plasterwork to the walls of the byre and exposed rubble work above with cracking towards verge to upper left and right hand sides. Also note water damage and split to right hand / north bearing of the west truss.

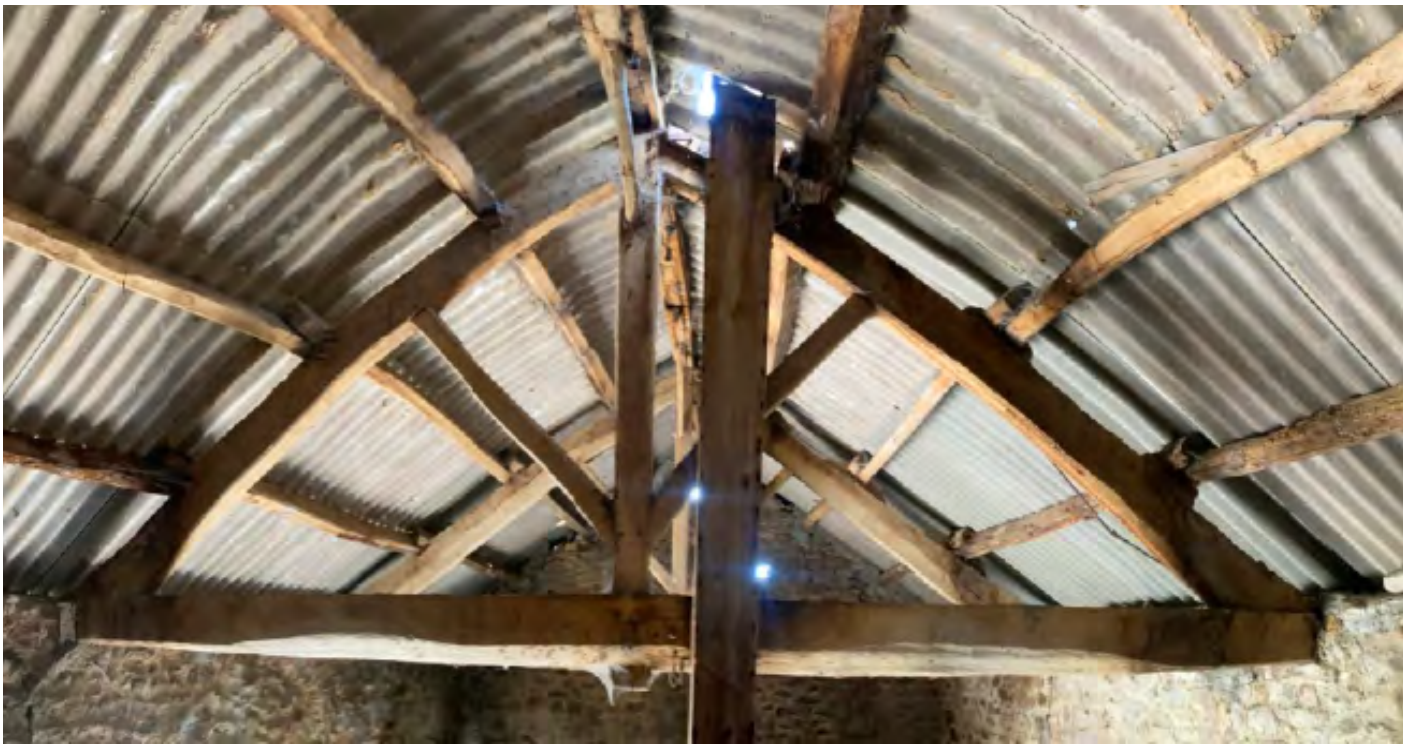
East and west king post trusses viewed from the east with remaining purlins and asbestos and fibre cement sheet roofing over.

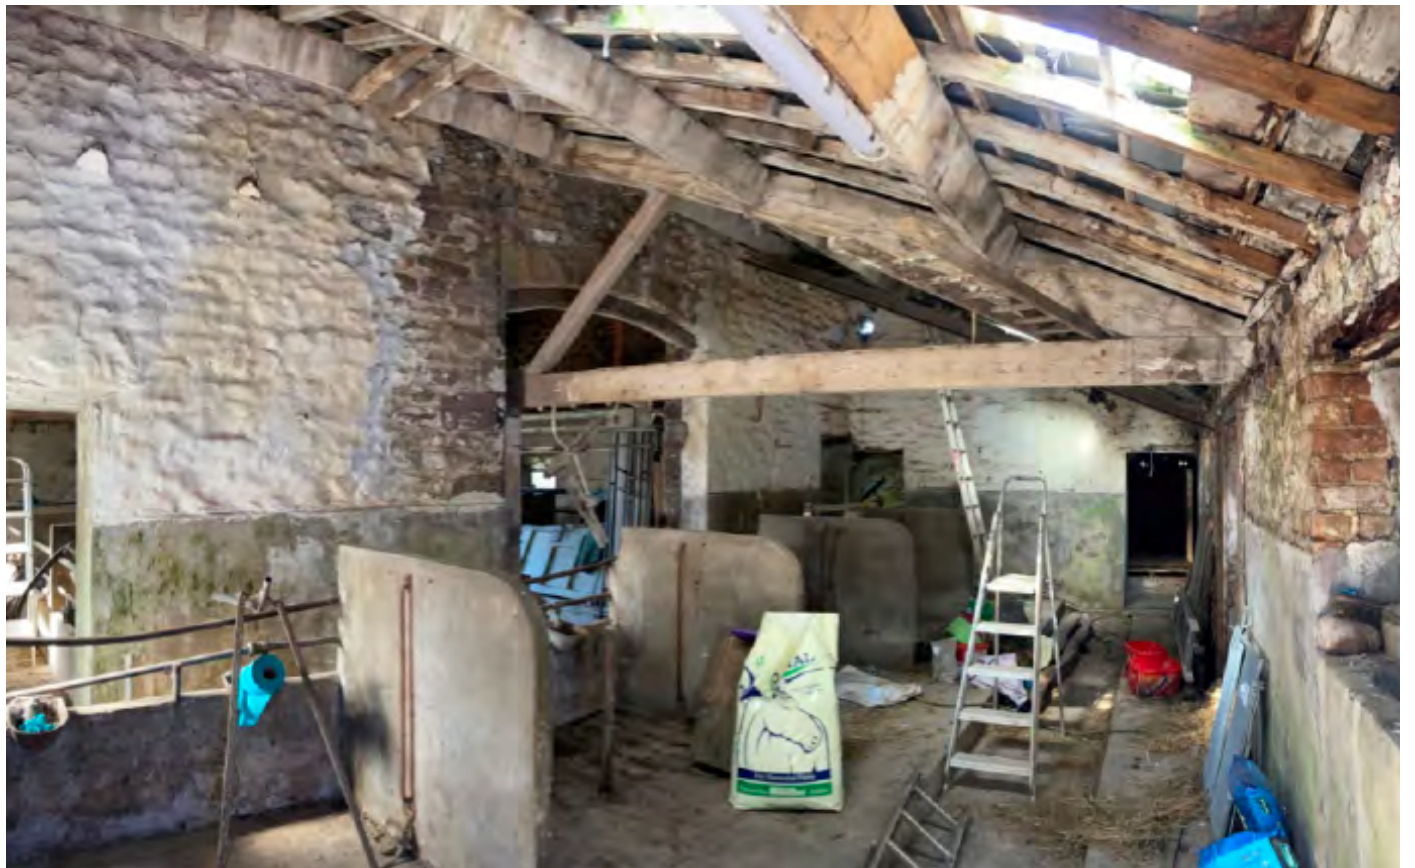
View of lean-to shippon from the east door showing threshing door through into the main barn to the left. Note timber half truss to the front and replacement steel beyond.

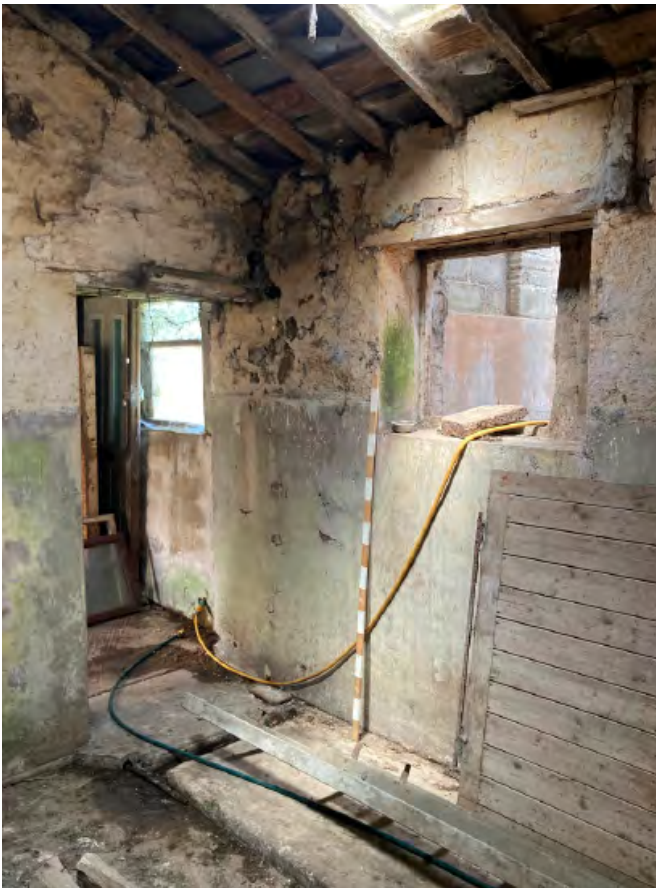
Northwest corner of north shippon, with doorway to C20th shippon to left and window opening to modern barn to the north. Note mix of cementitious plaster and earlier layers of limewash to the walls.

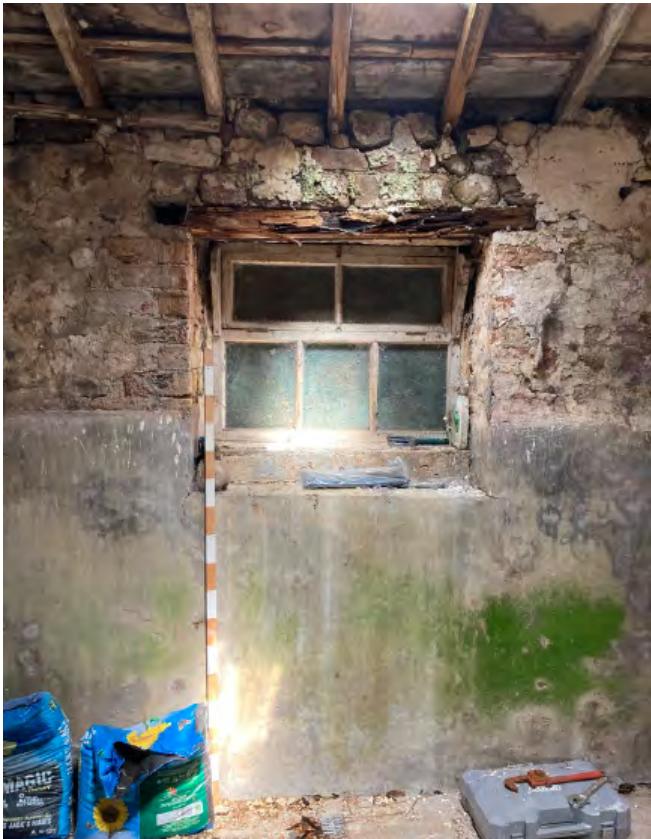
Window to north wall of north shippon with lower cementitious plaster and limewash above. Also note decay to the timber lintel.

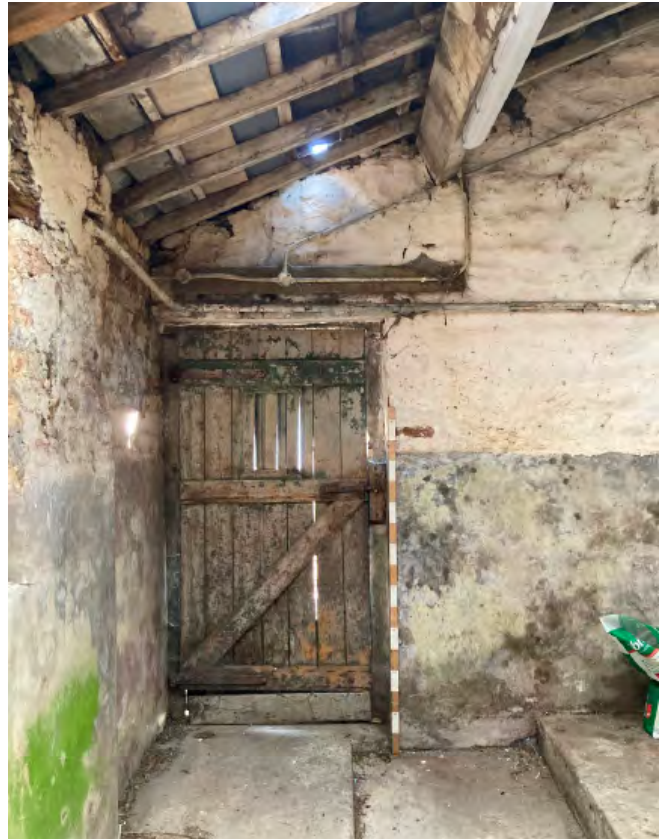
Doorway to east side of north shippon.
