Site Inspection Report

Project: Crane Wood Barn

Job No: B53

Report No:
01

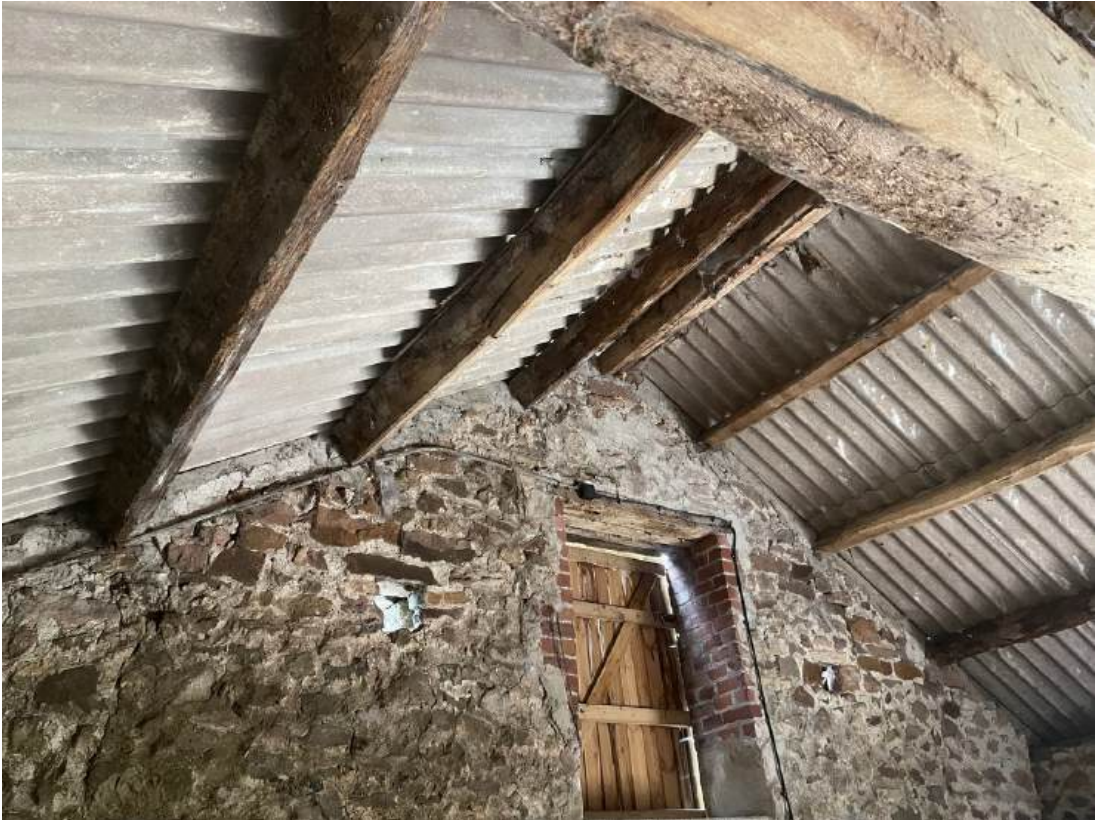
The roof of the main barn has a number of defective purlins, probably dating from before the replacement of slate with sheeting, and although they are adequate for a lightweight sheet roof some need to be replaced if they are to carry slate. These are identified on the accompanying plan drawing.

Photo One: Main Barn - Righthand Side of Roof

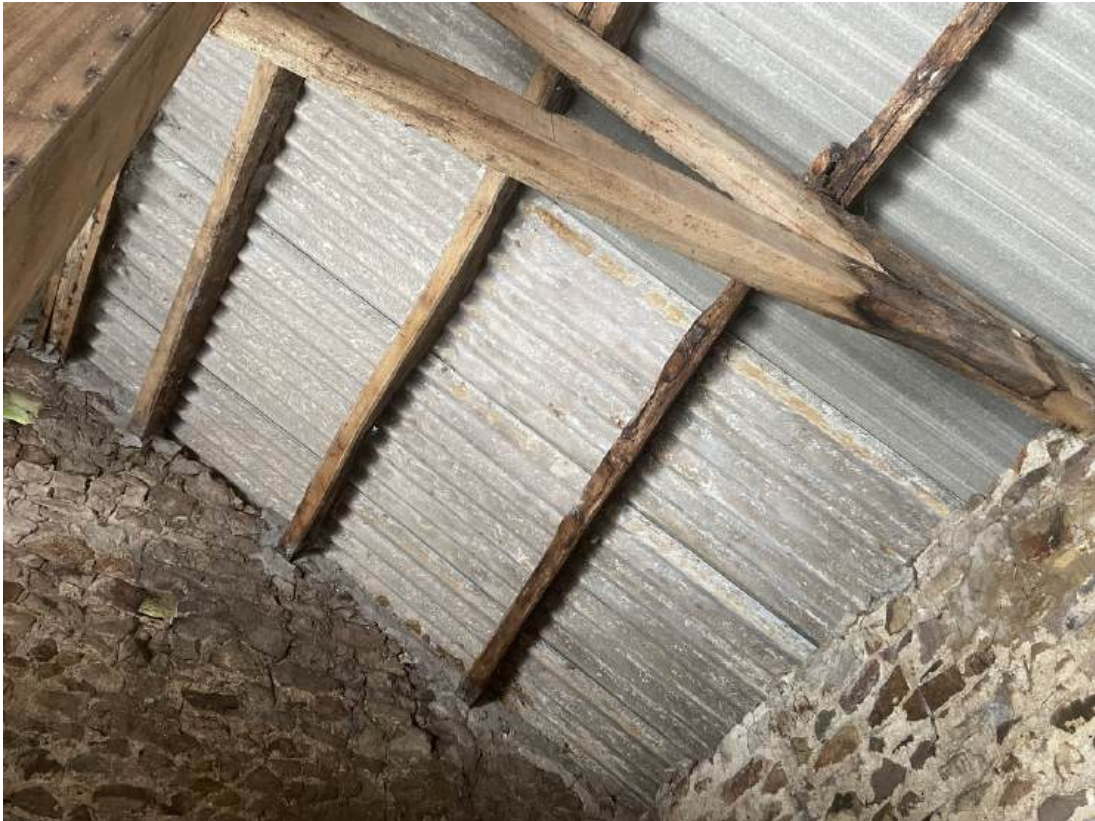
Photo Two: Main Barn – Lefthand Side of Roof

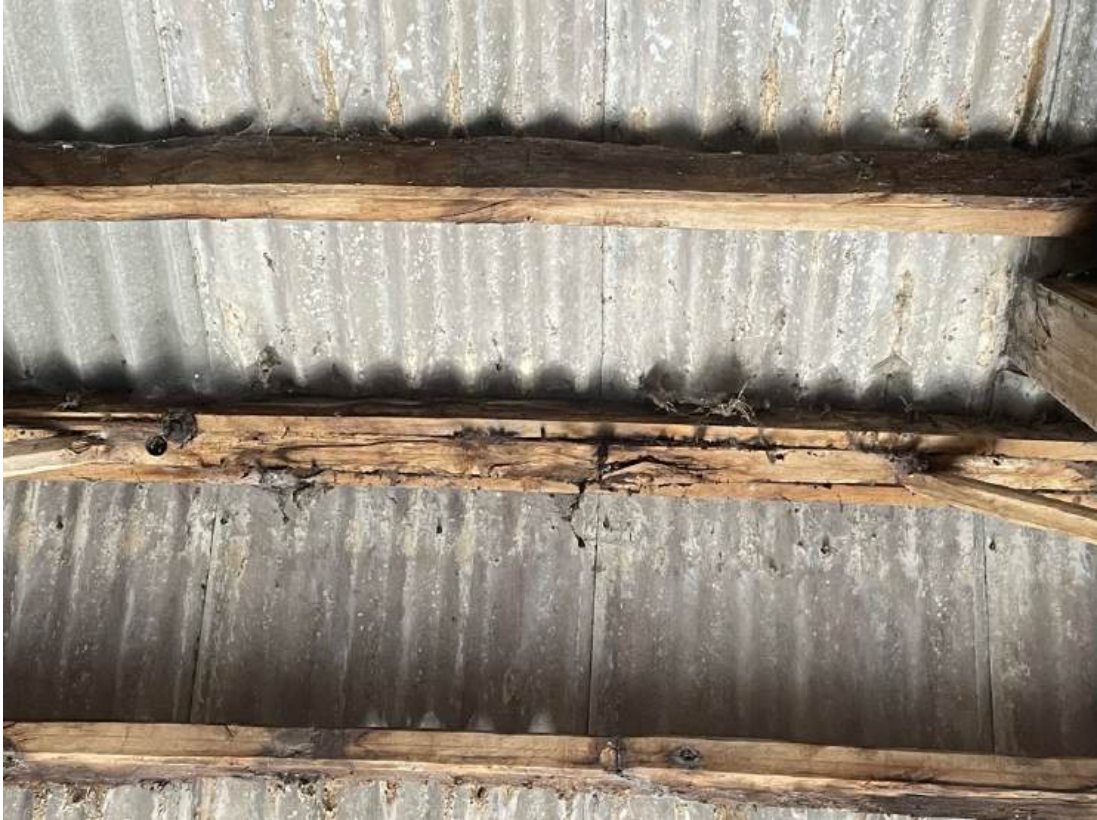
Photo Three: Main Barn – Rotten Ridge

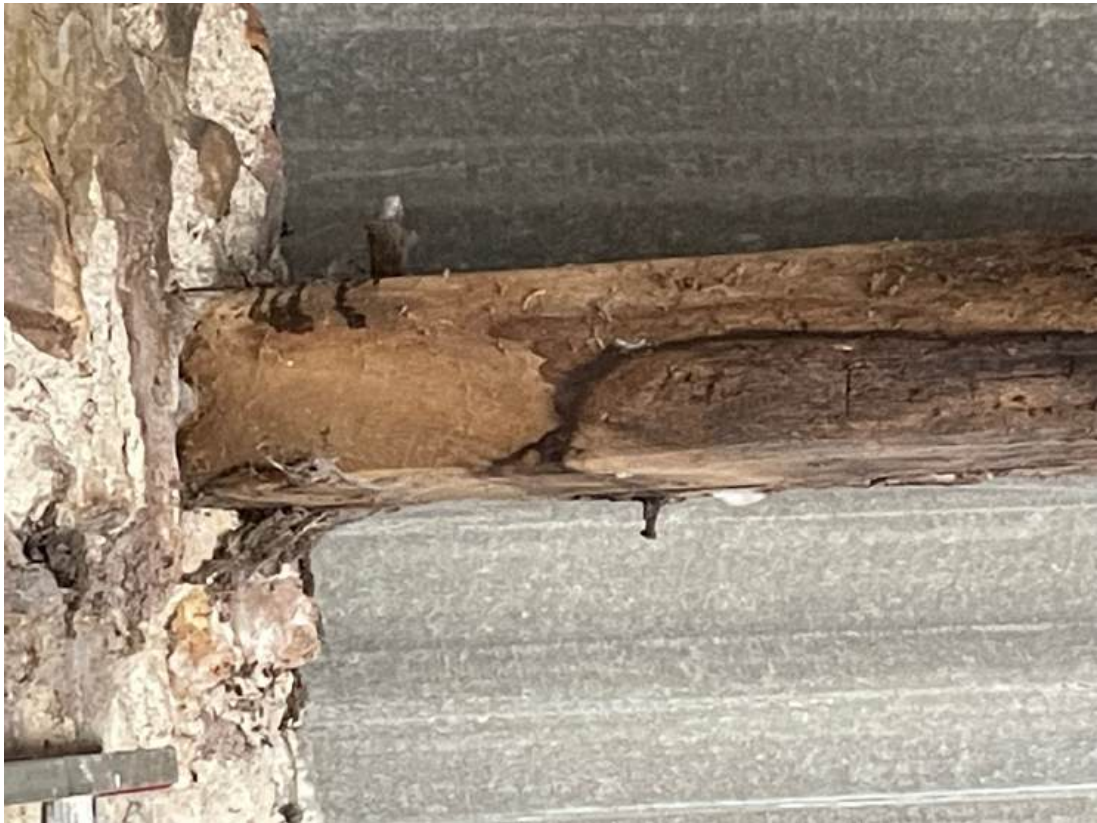
Photo Four: Main Barn – Split in Oak Truss

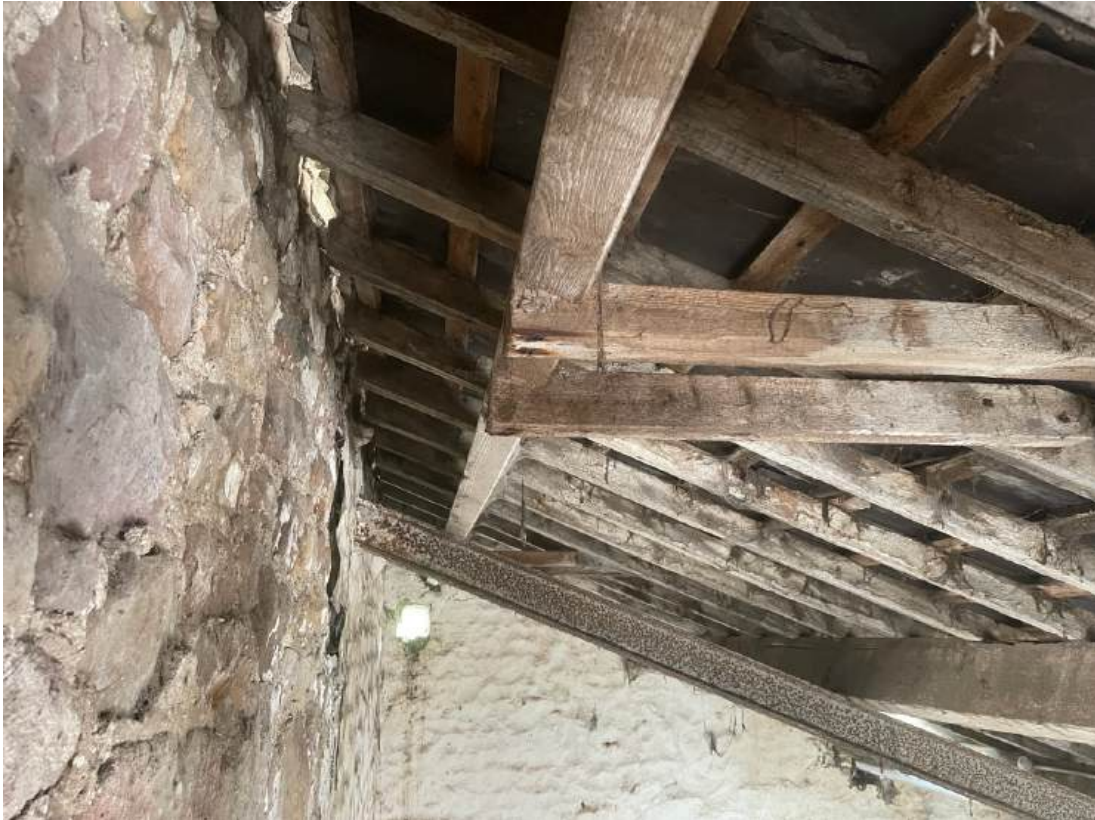
Photo Five: Shippon – General Roof Structure

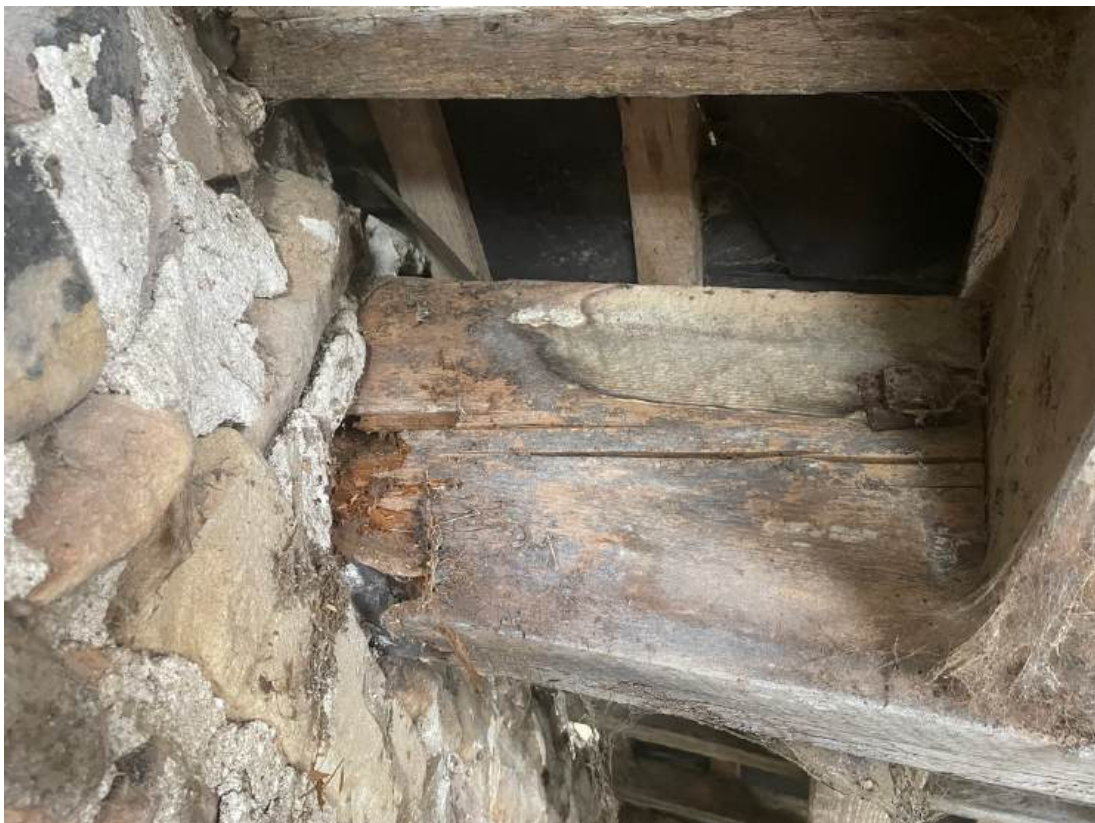
The remaining timber truss in the rear outshut has wet rot at its upper end where it is built in to the rear wall of the main barn. This needs a timber repair as shown on the drawing.

Photo Six: Shippon – Rotten End of Truss
