STRUCTURAL INSPECTION REPORT

**ALDER HOUSE FARM,
BOLTON BY BOWLAND,
BB7 4LZ**

REF: 223532 - NOVEMBER 2023

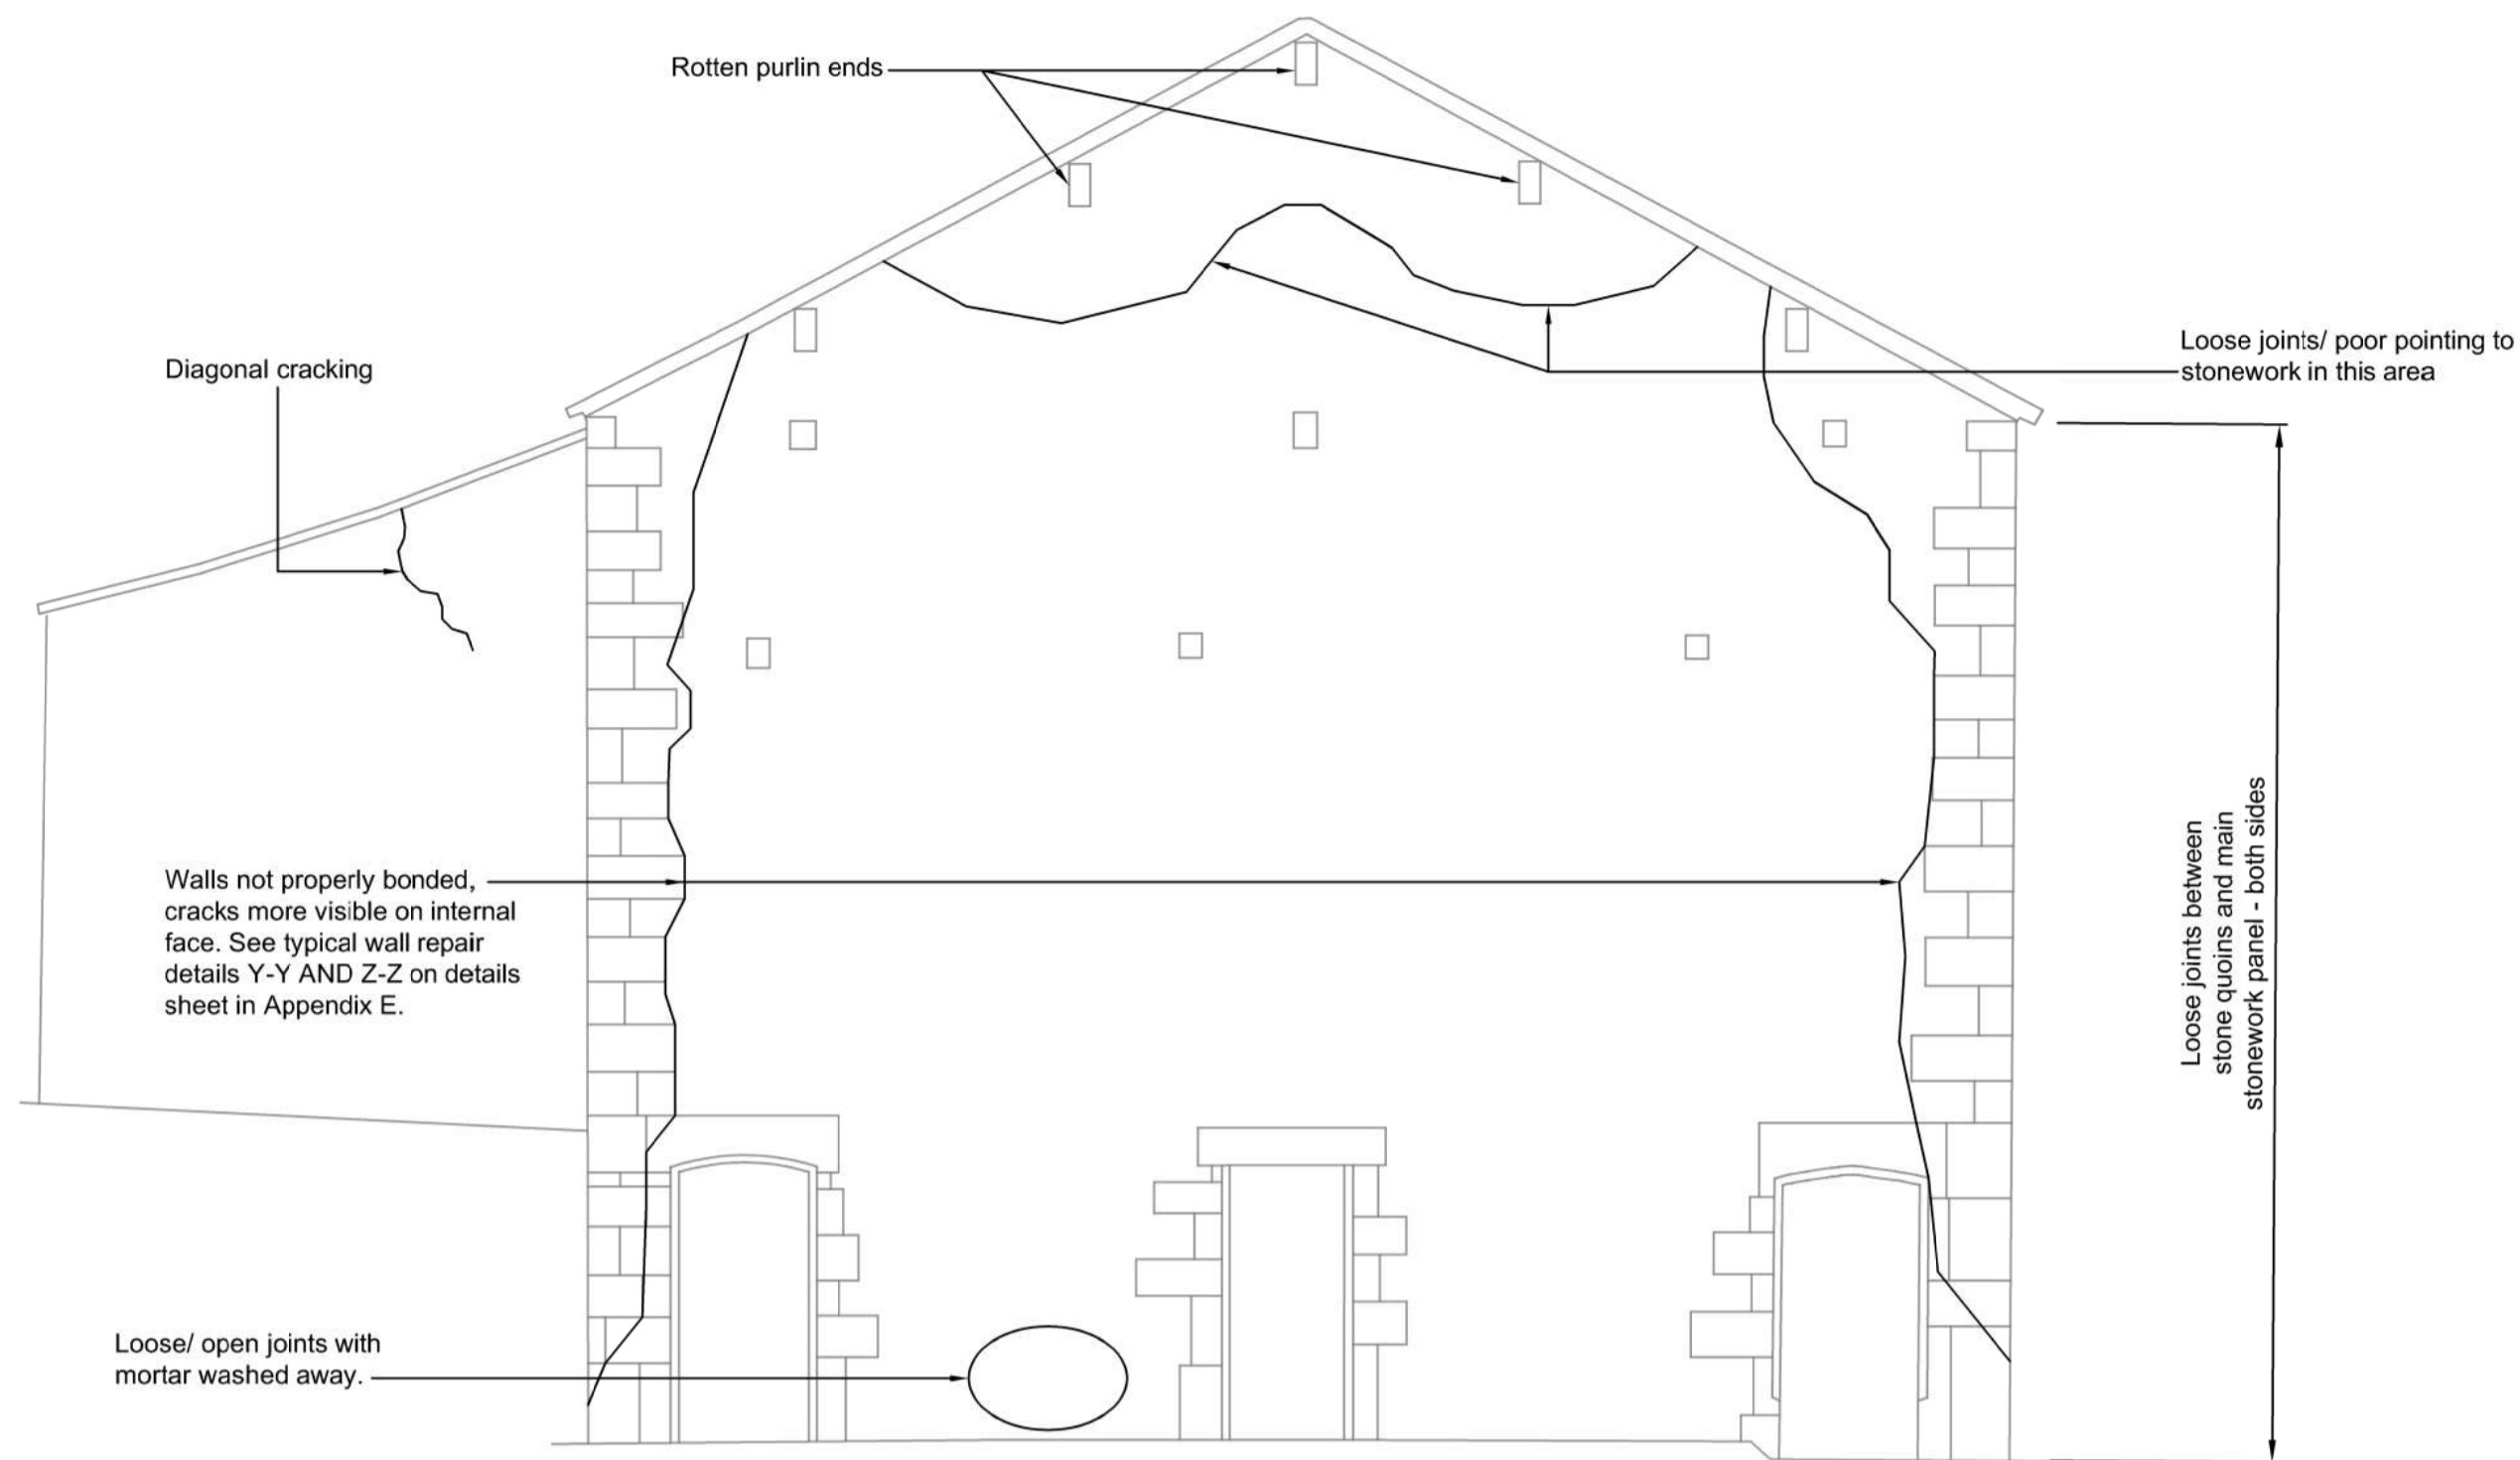
Elevation D

NOTE: All loose joints will need re-pointing

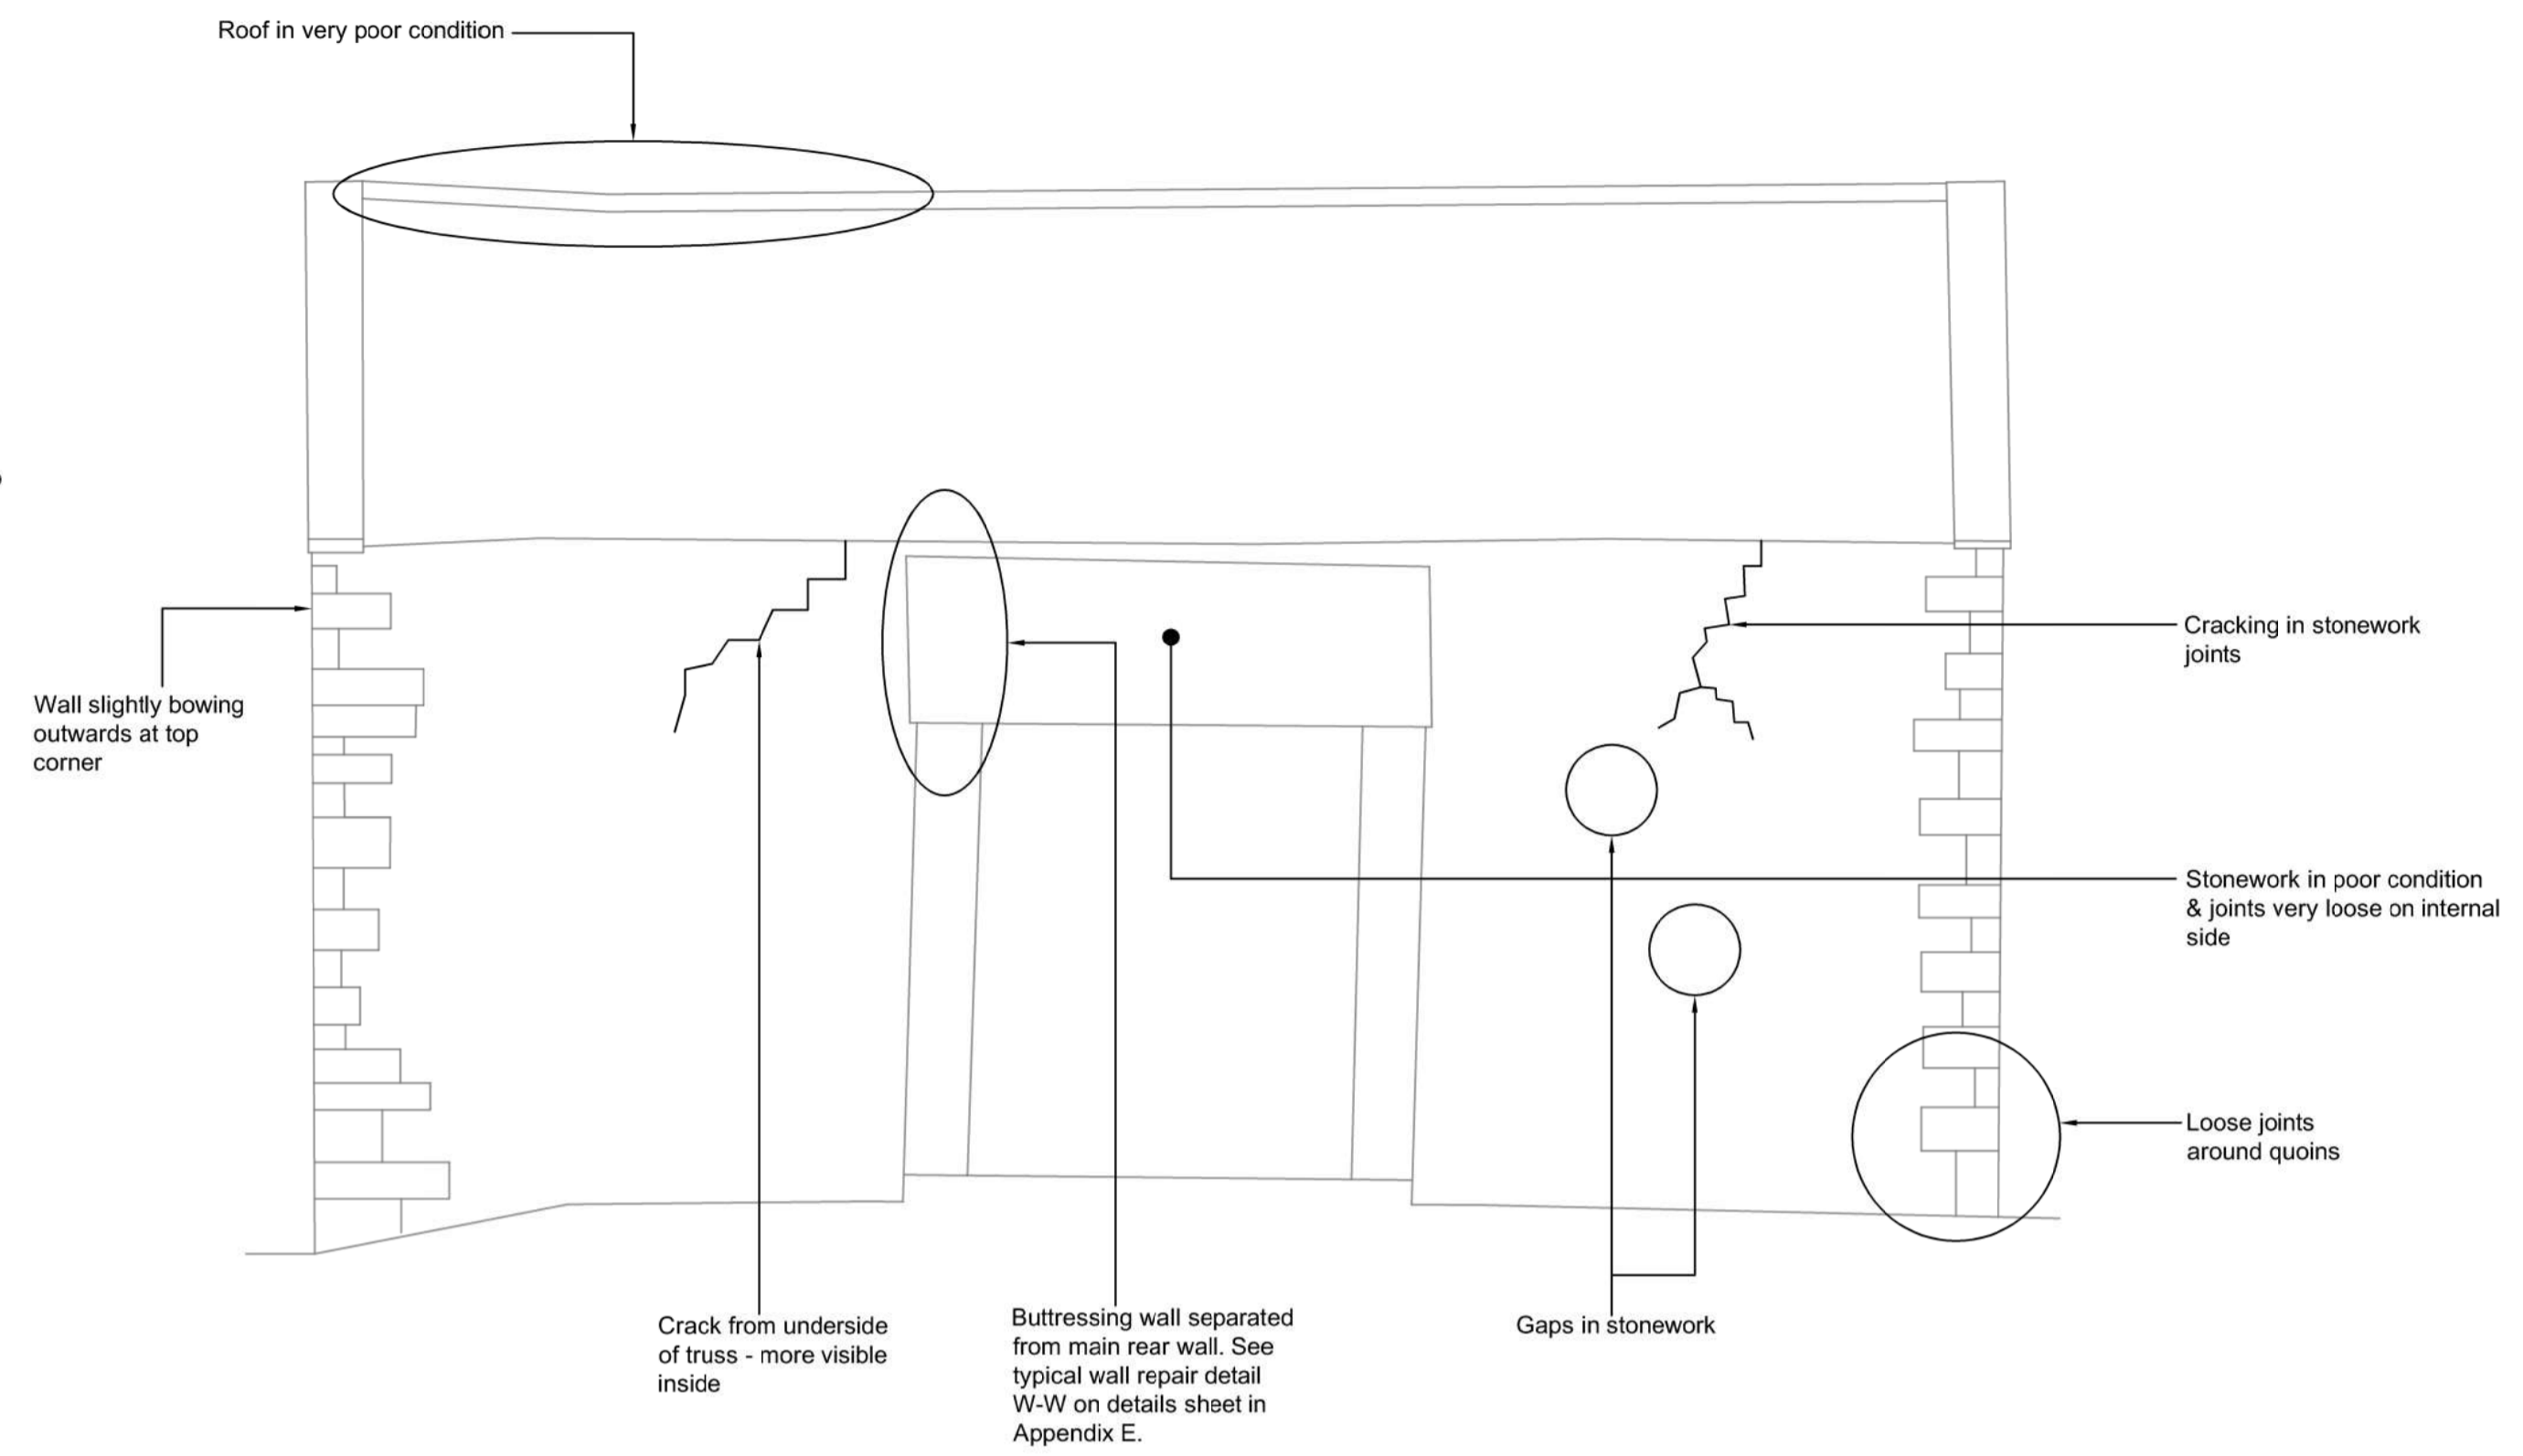
Elevation A

NOTE: Overall the roof is in a poor condition - timber survey required. Slates appeared to be in reasonable condition and can be reinstated.

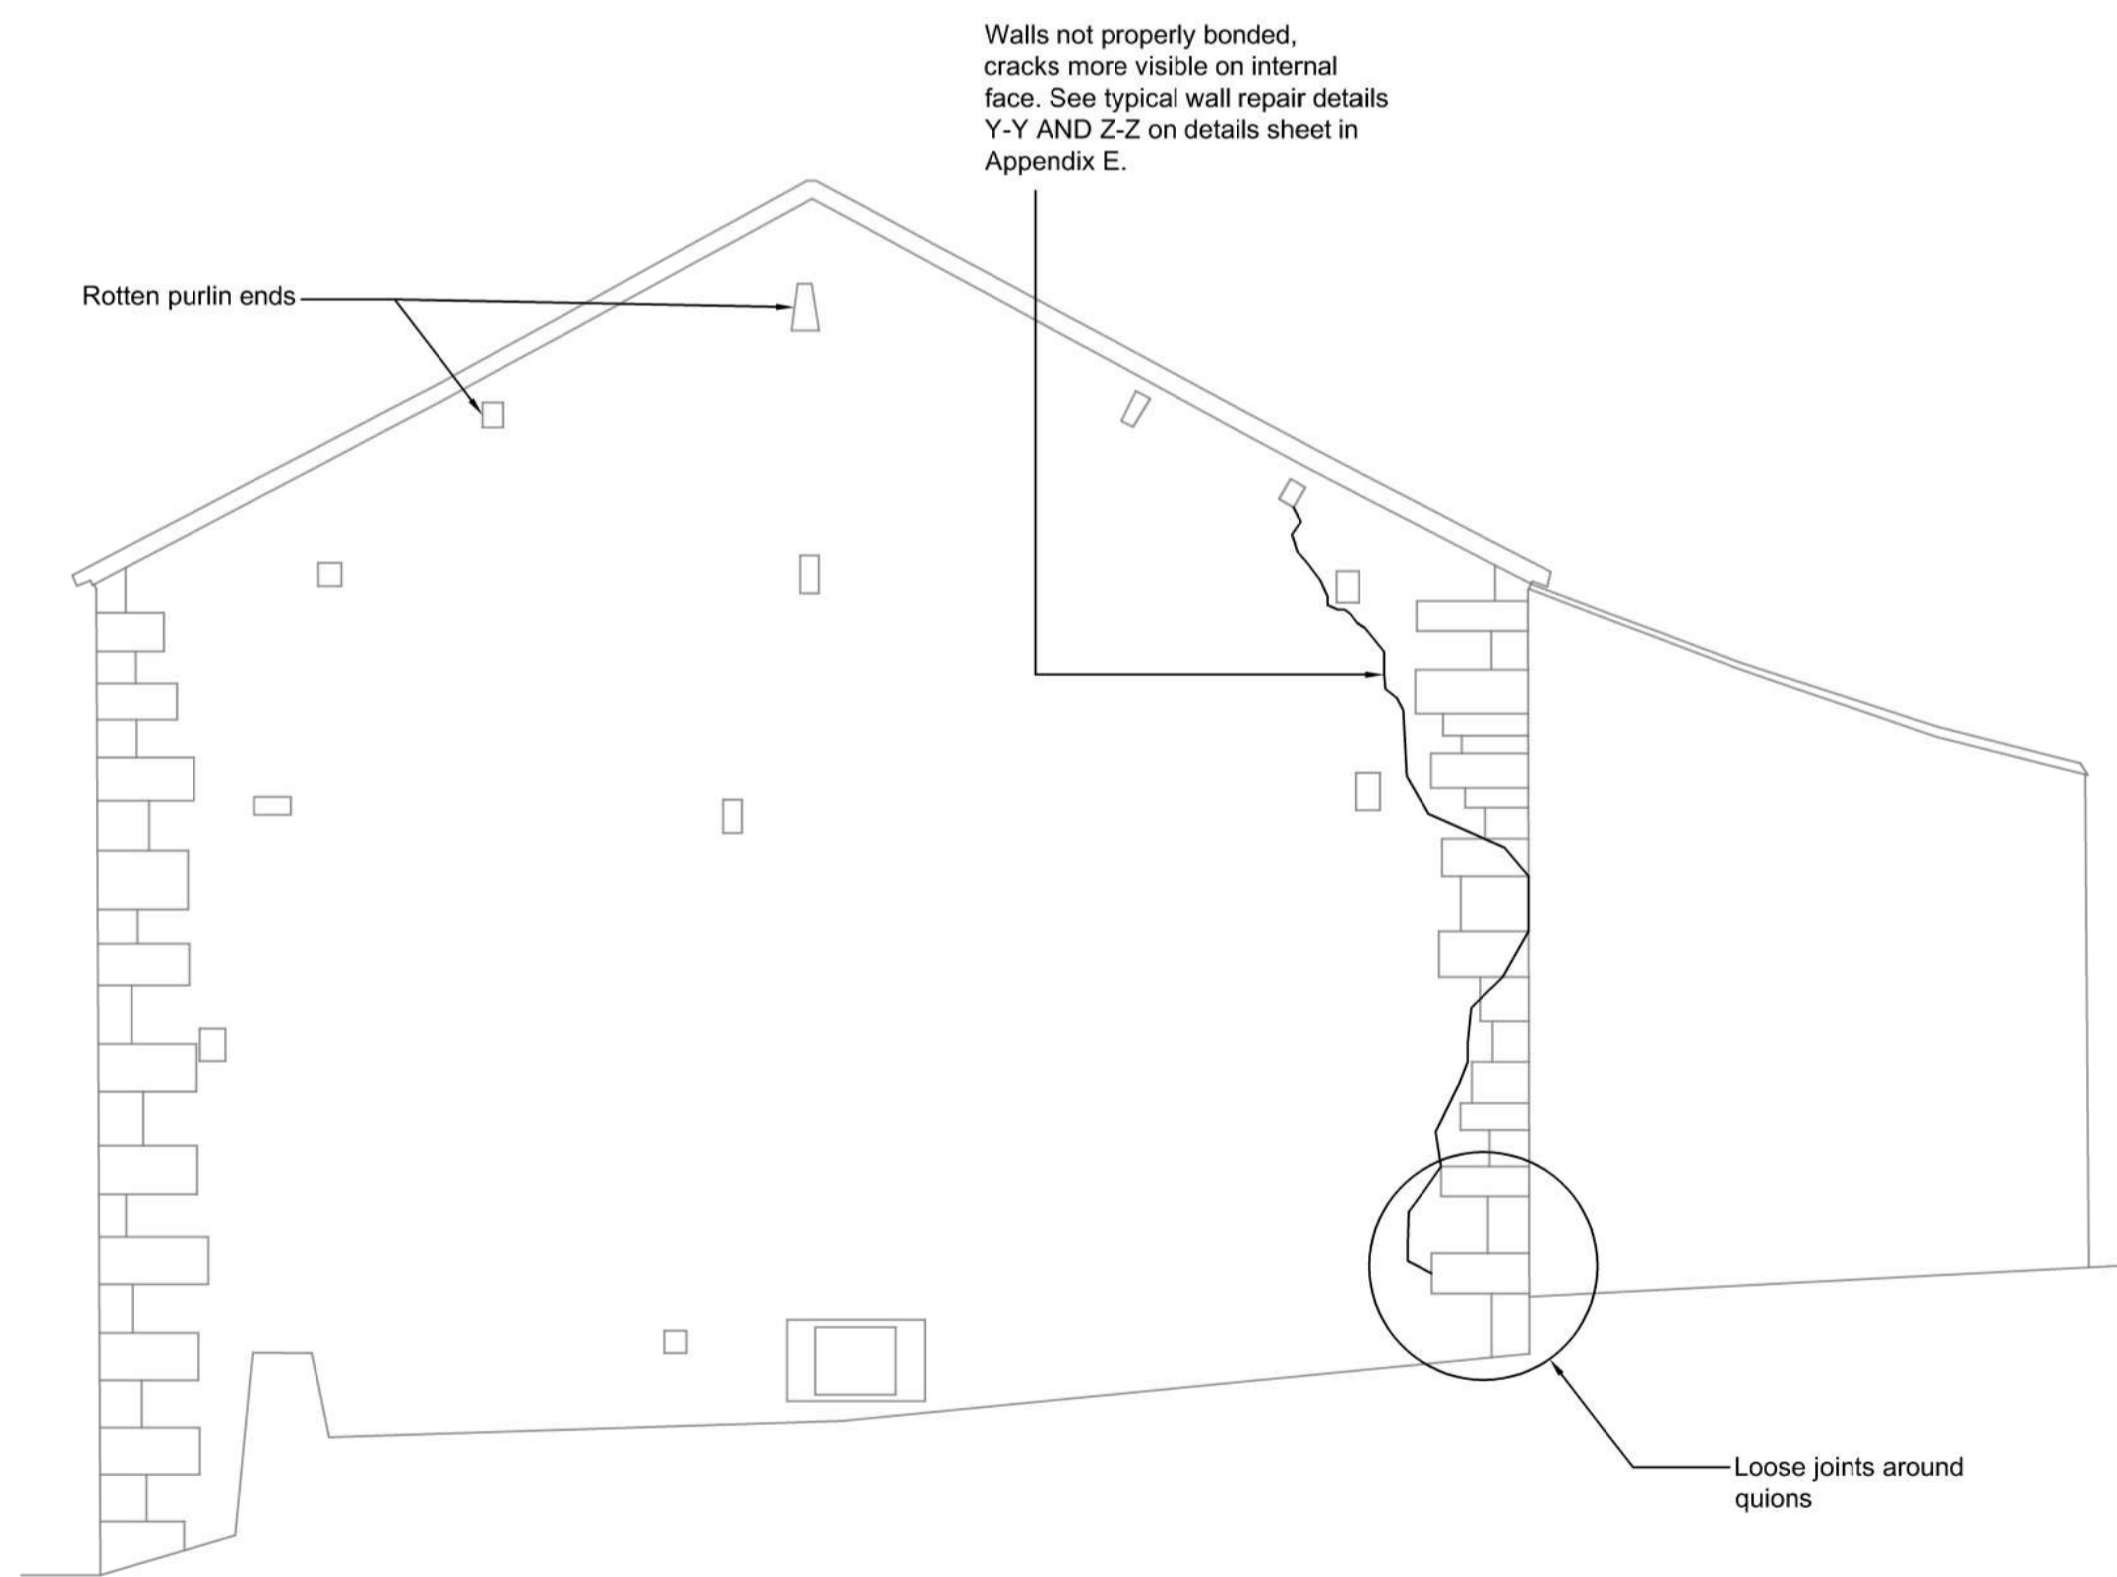
Elevation B

NOTE: Some very loose joints along elevation, majority of wall panel will need re-pointing.

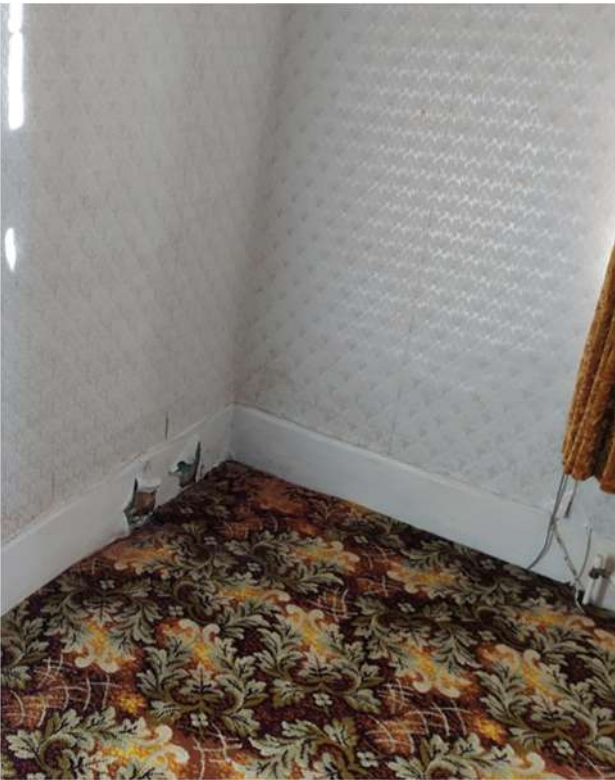
(P-03)

- 3.1.1 Rising damp had started to penetrate through the wall below the window damaging the lime plaster in room 4 (See photograph P-01).
- 3.1.2 A number of the walls were showing signs of damp and water ingress in room 2 (See photographs P-02 & P-03).
- 3.1.3 Crack in the timber beam above living space in room 2. (See photograph P-04).

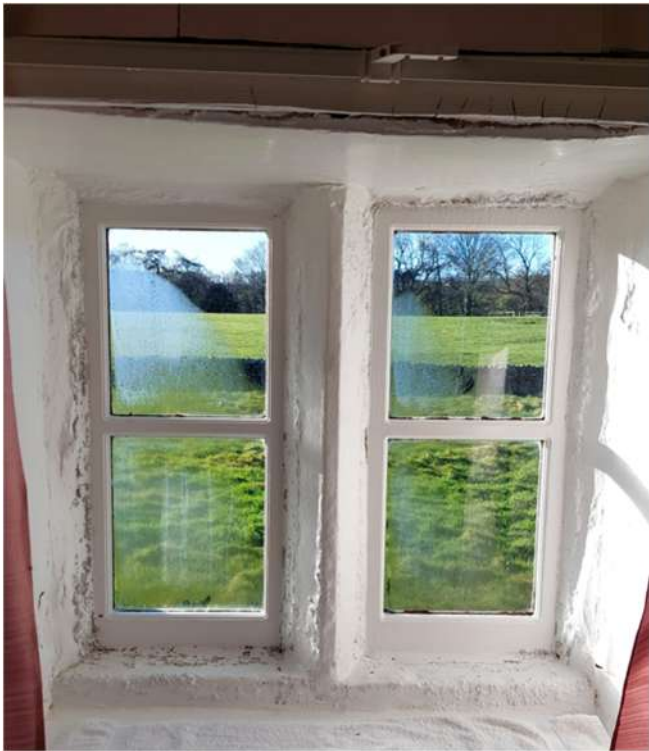
(P-07)

- 3.1.4 Water ingress around window and to side wall panel in room 6 (See photographs P-05 & P-06).
- 3.1.5 Corroded window surround due to water ingress in room 7 (See photograph P-07).
- 3.1.6 Vertical crack in wall under the beam corbel in room 9 (See photograph P-08).
- 3.1.7 Cracking to plaster around beam and mould/ damp indicating signs of water ingress in room 9. (See photograph P-09).
- 3.1.8 Signs of water ingress around window and ceiling in room 9 (See photograph P-10).
- 3.1.9 Cracking under beam/ corbel bearing next to the opening in the wall for the cupboard space in room 8. (See photograph P-11).
- 3.1.10 Damp penetration on the wall above shower in room 10 (See photograph P-12).

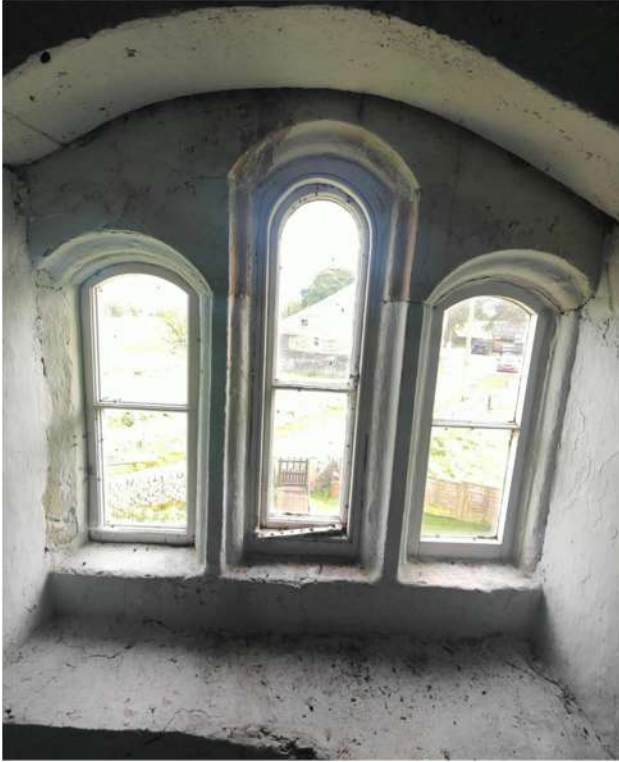
(P-13)

- 3.1.11 Cracking/ de-bonding of plaster around the window in room 11 (See photograph P-13).
- 3.1.12 Water ingress to side of the window and de-bonded plaster to cill in room 12 (See photograph P-14).

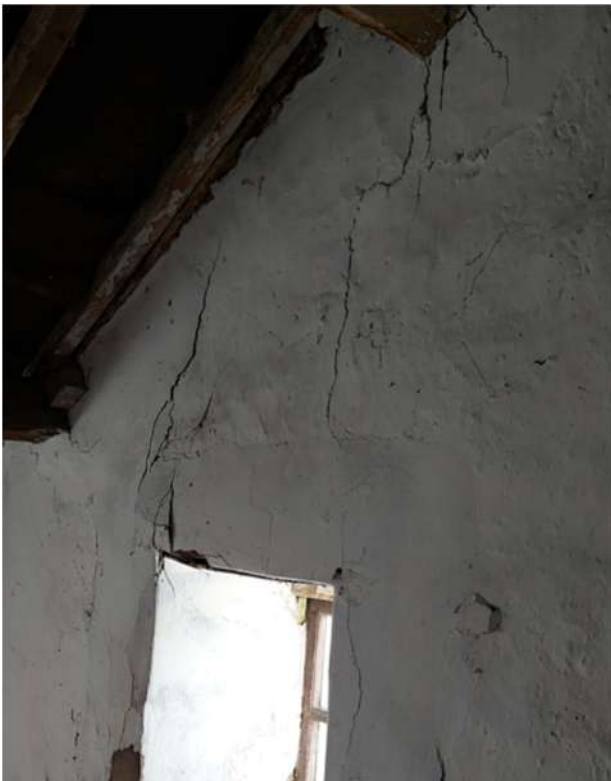
(P-15)

- 3.1.13 Cracking to plaster above the smaller window and signs of water ingress in room 12 (See photograph P-15).
- 3.1.14 Heavy signs of water penetration along the chimney breast in room 12 (See photograph P-16).

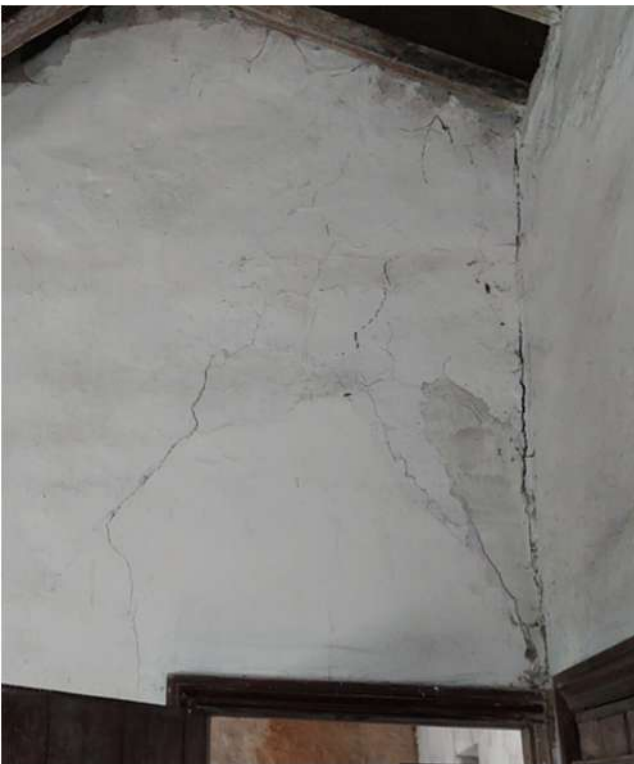
(P-23)

- 3.1.21 Cracking along abutment between wall dividing rooms 12 & 13 and perpendicular wall to landing (See photograph P-23).

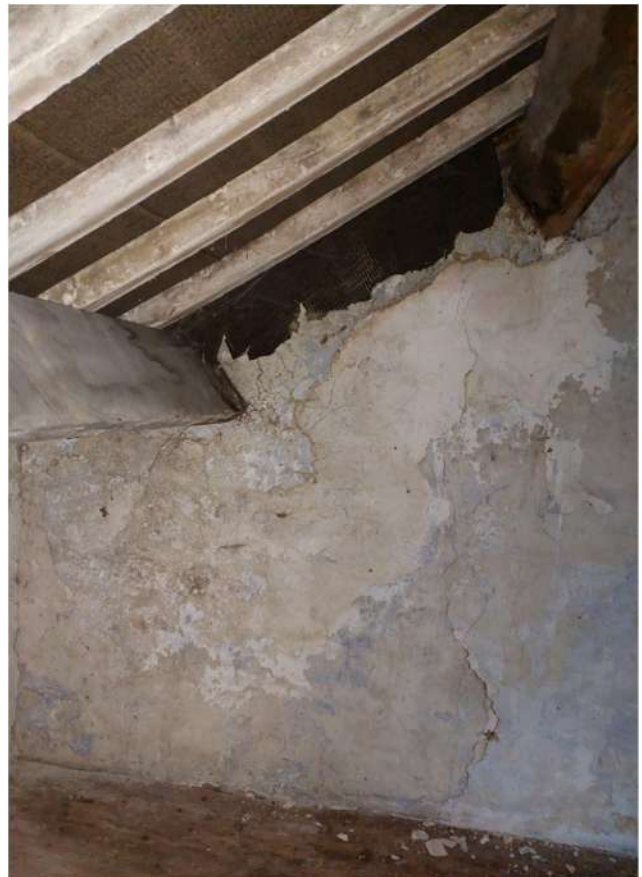
(P-24)

- 3.1.22 Rotting timber purlin ends with damp timber floor boards under, likely due to water ingress in room 14. Plaster damaged and de-bonded along wall panel (See photographs P-24 & P-25).
- 3.1.23 Mould present to top corner of wall and vertical crack along plaster in landing space (See photograph P-26).
- 3.1.24 Water ingress and mould on wall between stair and window (See photograph P-27).
- 3.1.25 Cracking and de-bonding to plaster along all wall panels and end of timber purlin heavily decayed in room 15 (See photograph P-28).

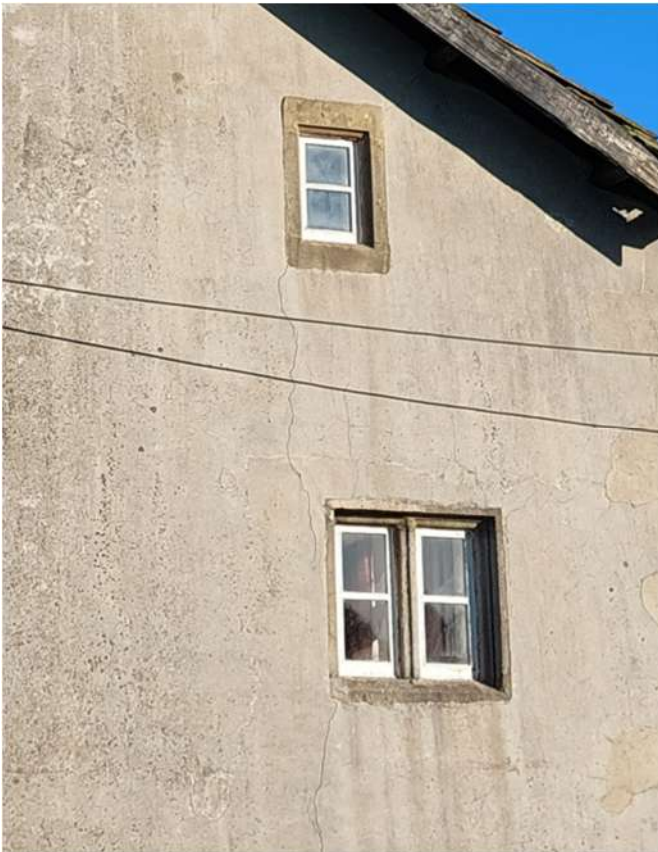
(P-31)

- 3.1.28 Note: this elevation had a full render finish.
- 3.1.29 Vertical cracking to render along full height of wall next to windows (See photograph P-31).
- 3.1.30 Missing barge and soffit board to rear section of gable roof (See photograph P-32).
- 3.1.31 Missing soffit board and decaying barge board to front of gable roof (See photograph P-33).
- 3.1.32 Tiles loose and guttering damaged to roof above front porch (See photograph P-34).

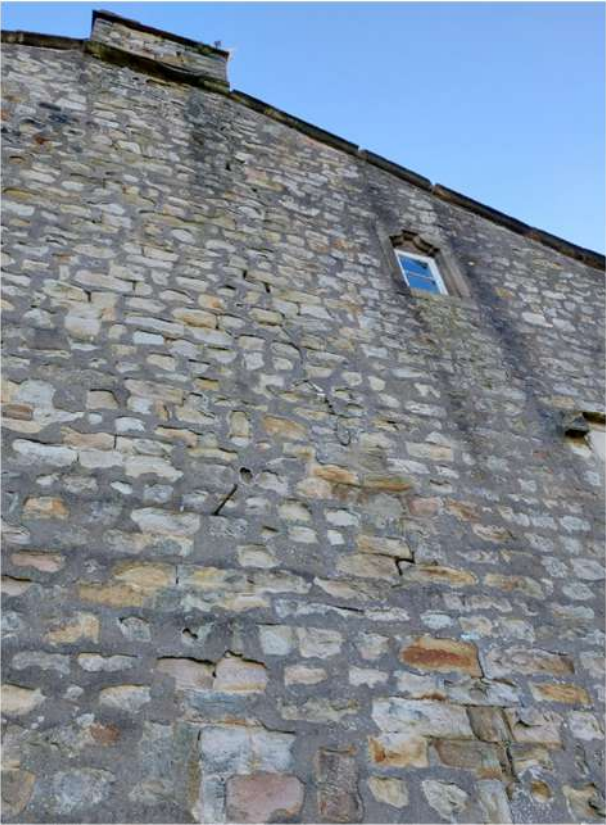
(P-39)

- 3.1.35 Cracking to mortar joints above and below top left window (See photograph P-38).
- 3.1.36 Diagonal crack stemming from corner of chimney/roof abutment to ground floor level (See photograph P-39).
- 3.1.37 Spalled stonework and cracking in the centre of the wall panel due to poor repointing using cementitious mortar (See photograph P-40).
- 3.1.38 Crack in the mortar under the right hand side window (See photograph P-41).

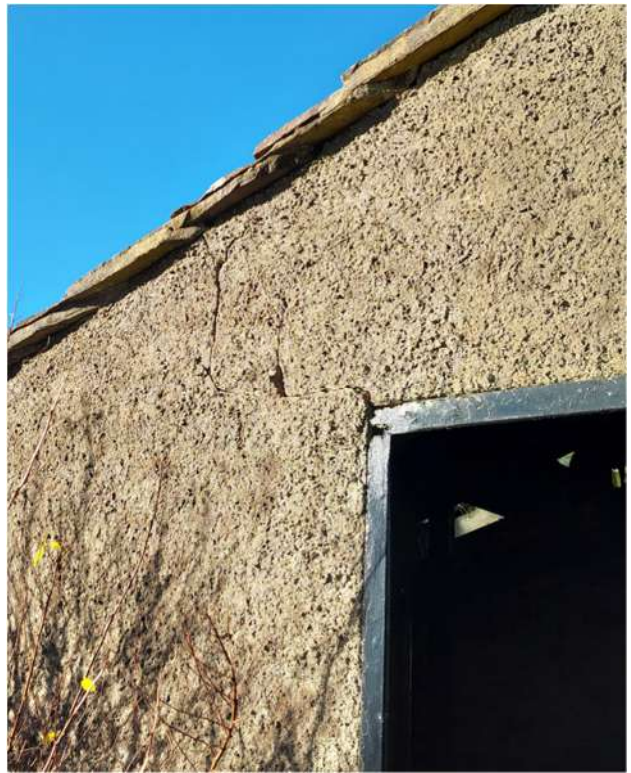
(P-42)

- 3.1.39 Crack leading from the underside of the roof to the corner of door (See photograph P-42).
- 3.1.40 Slate tiles/ ridge tiles & felt in very poor condition, rafters slightly saturated in most areas (See photographs P-43 & P-44).

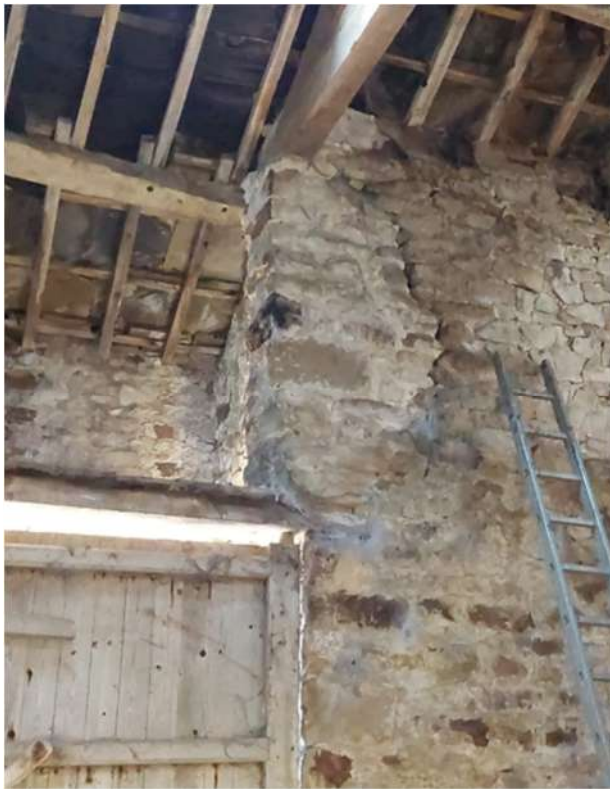
(P-47)

- 3.2.1 Timber roof was in poor condition above room 1, particularly where felt/tiles are loose or missing.
- 3.2.2 Vertical crack to stone wall under both ends of the truss next to openings in room 1, wall beginning to slip under truss bearing (See photographs P-47 & P-48).

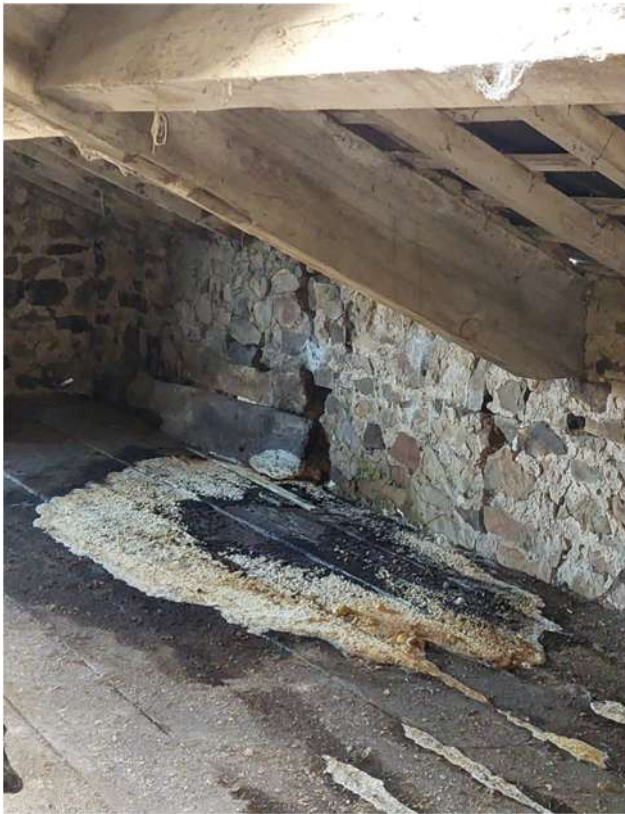
(P-55)

- 3.2.8 Cracking to render around window and centre of the wall panel adjacent in room 3 (See photograph P-54).
- 3.2.9 Timber beams supporting level 01 floor above room 3 appeared to be in acceptable condition, although two of the end beams are showing signs of decay under the heavily saturated/decaying floor boards above. Note: removal of supporting timber posts to any of the existing timber beams could result in beam failure. (See photographs P-54 & 55).

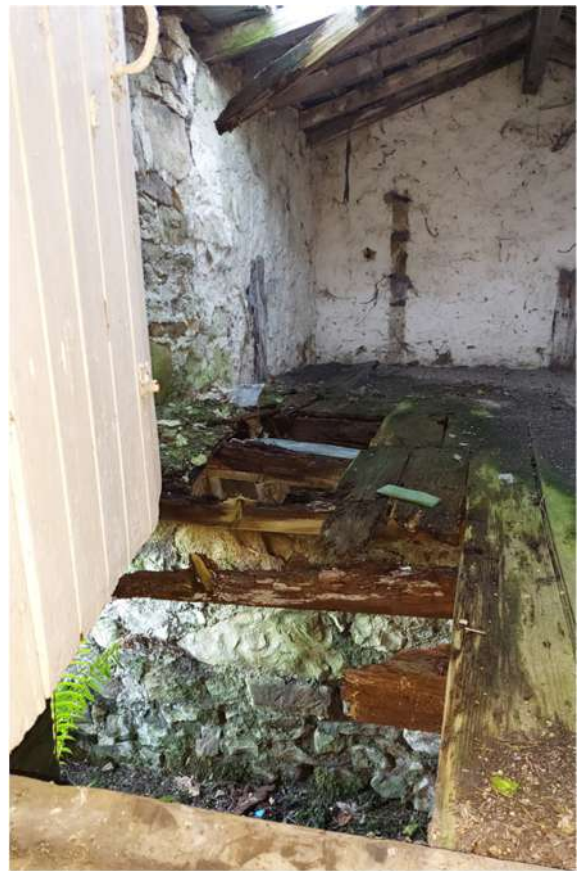
(P-56)

- 3.2.10 The timber floor above pigsty in room 4 was heavily decayed from a hole in the damaged roof above (See photograph P-56).

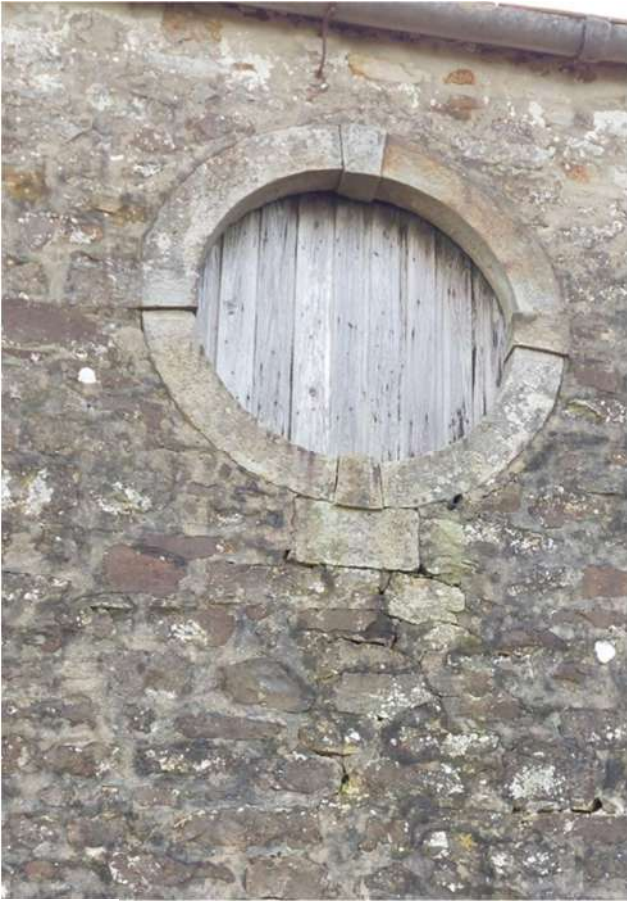
(P-57)

- 3.2.11 Minor cracking and loose joints below the circular window opening (See photograph P-57).
- 3.2.12 Limestone lintel above the main barn door entrance decaying & spalled in areas. Timber joists and boards which form the soffit behind are heavily decayed. (See photographs P-58 & P-59).
- 3.2.13 Buttressing walls to the porch not toothed and bonded into main front wall (See photograph P-60).

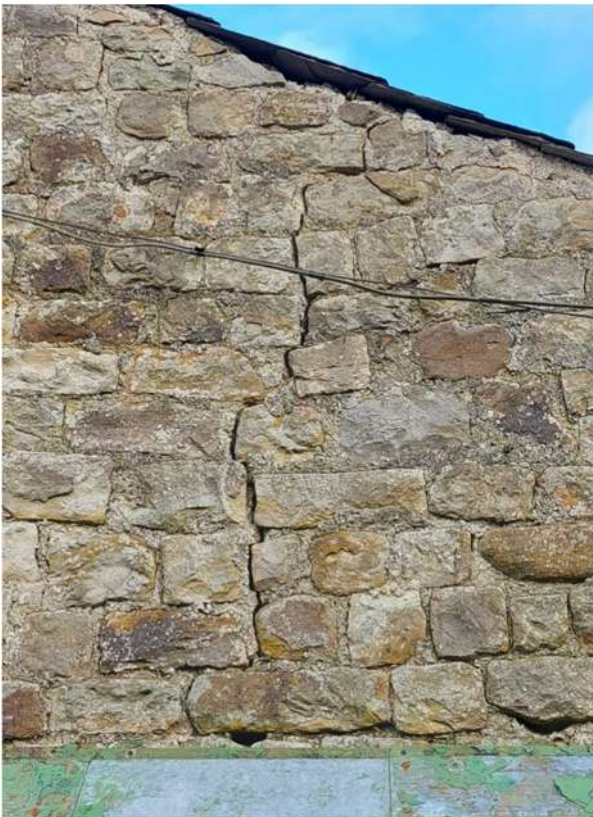
(P-71)

- 3.2.25 Large crack over the door lintel (See photograph P-71).
- 3.2.26 Wall abutment between new lean to extension and original barn was not properly toothed and bonded together. Proof of connection either through wall starters or ties to be established. (See photograph P-72).
- 3.2.27 Previous repointing with cementitious mortar in some areas has caused the original limestone bricks to spall (See photograph P-73).
- 3.2.28 Vertical cracking to joints over the door lintel (See photograph P-74).
- 3.2.29 Poor pointing to the stone soldiers above the window and the stone quoins along the wall edge (See photograph P-75).

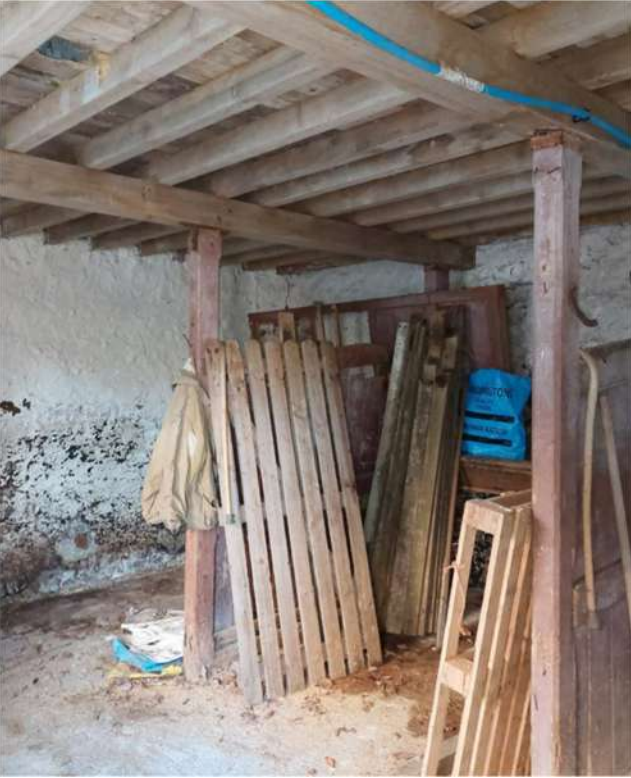
(P-77)

- 3.3.2 Timber beams in room 1 in reasonable condition with the exception of a minor crack forming at the end of one of the beams. The existing timber posts are helping prop and support the joists (See photographs P-77 & P-78).

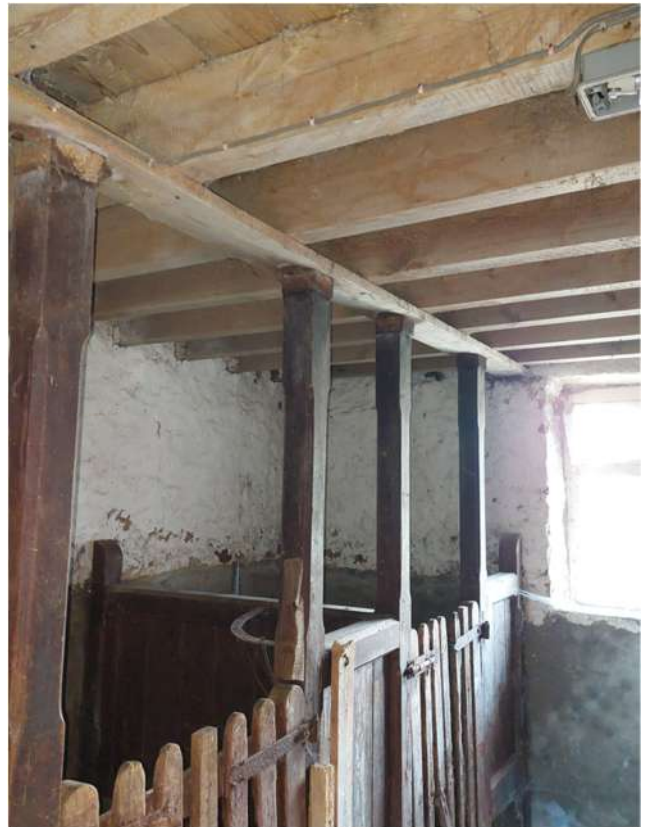
(P-80)

- 3.3.3 Section of timber joist missing near end bearing (See photograph P-79).
- 3.3.4 The walls and timber joists in room 2 were in good condition, the timber posts were providing extra support to the joists. (See photograph P-80).

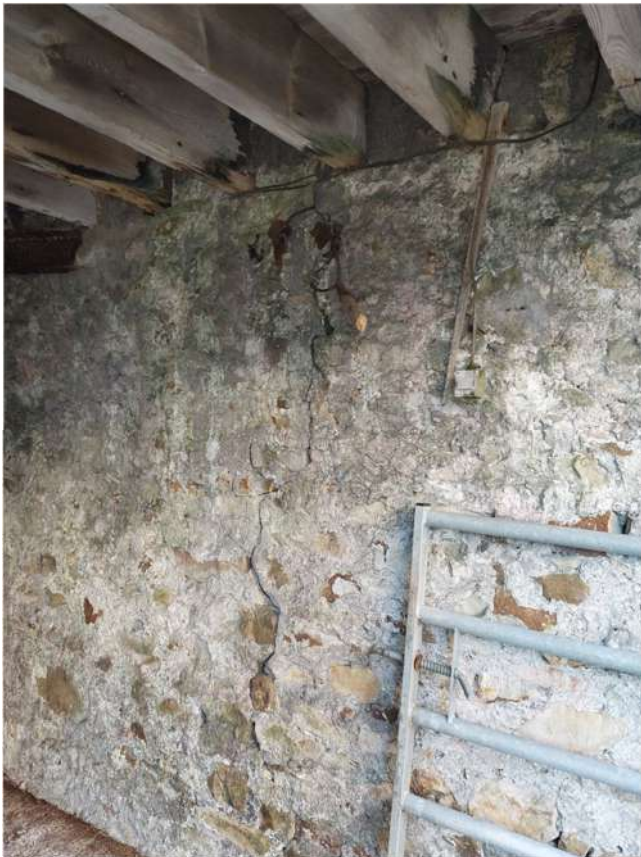
(P-87)

- 3.3.13 Cracking in wall beneath timber joists supporting floor over (See photograph P-87).
- 3.3.14 Steel beam supporting decaying joists is showing heavy signs of rust, delamination doesn't appear to be present (See photograph P-81).

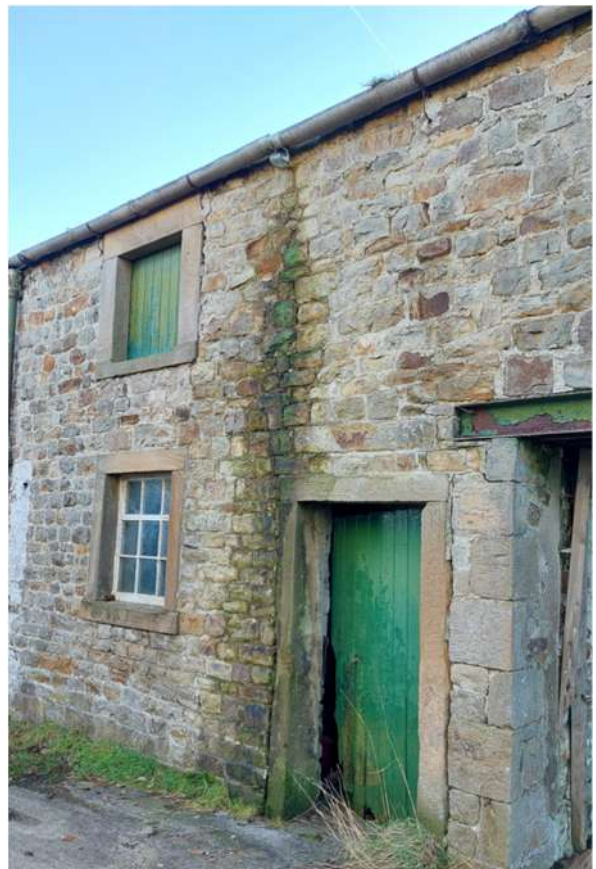
(P-88)

- 3.3.15 Mortar joints washed away and stonework stained due to water ingress from the split in the guttering above (See photograph P-88).
- 3.3.16 Crack forming between the stonework and stone mullion to the side of the top window (See photograph P-89).

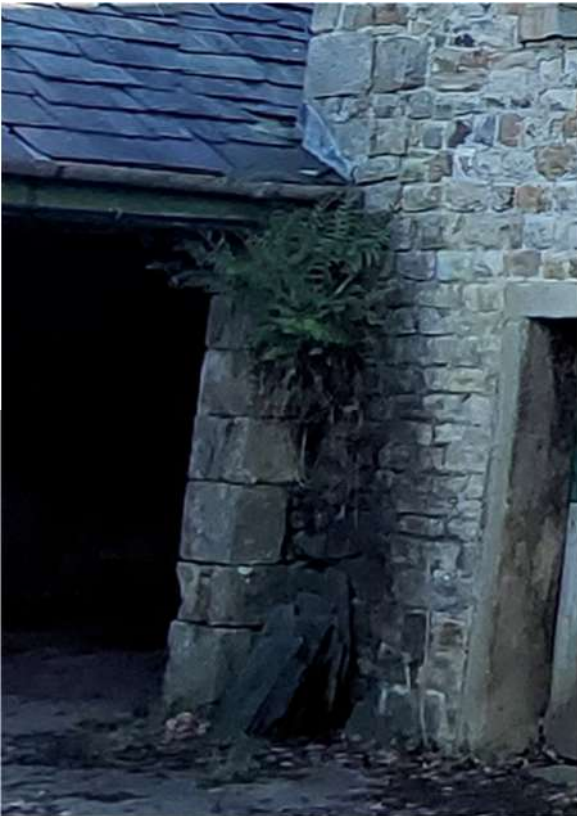
(P-91)

- 3.3.17 Loose stonework joints under the bottom window cill (See photograph P-90).
- 3.3.18 Loose joints in stonework under the roof/wall abutment where mortar has been washed out. Vegetation growth present here too (See photograph P-91).

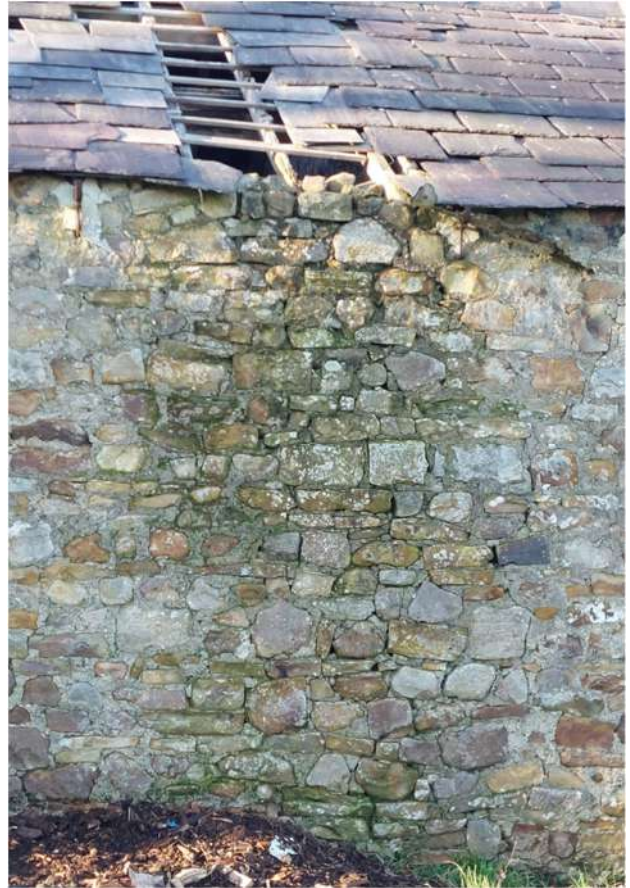
(P-94)

- 3.3.21 Guttering missing along the majority of the wall length.
- 3.3.22 Roof in poor condition, a large number of slate tiles loose and missing.
- 3.3.23 Stonework stained and joints washed away where the slate roof tiles and guttering are missing along the edge and no longer providing protection to the wall (See photograph P-94).
- 3.3.24 Large vertical crack down the centre of the wall panel (See photograph P-95).
