STRUCTURAL INSPECTION REPORT

**ALDER HOUSE FARM,
BOLTON BY BOWLAND,
BB7 4LZ**

REF: 223532 - NOVEMBER 2023

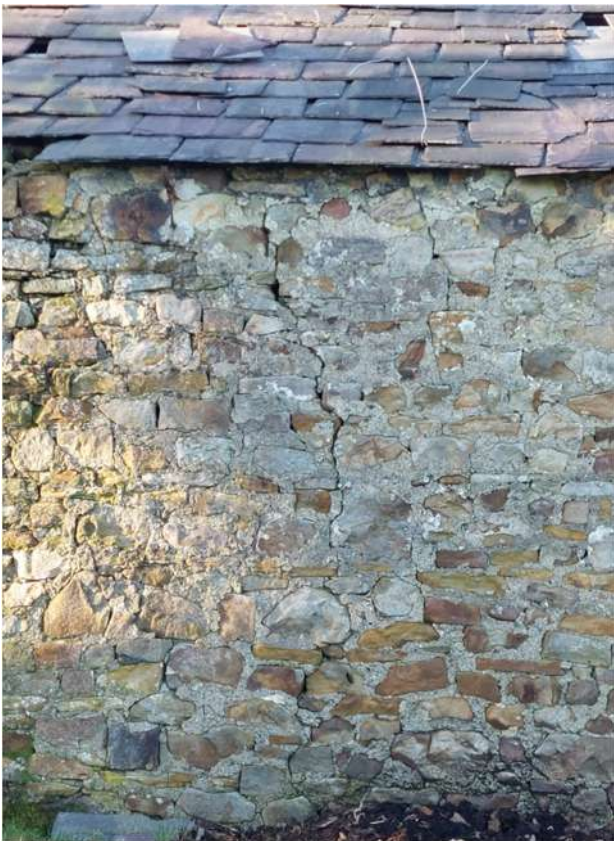
(P-95)

- 3.3.21 Guttering missing along the majority of the wall length.
- 3.3.22 Roof in poor condition, a large number of slate tiles loose and missing.
- 3.3.23 Stonework stained and joints washed away where the slate roof tiles and guttering are missing along the edge and no longer providing protection to the wall (See photograph P-94).
- 3.3.24 Large vertical crack down the centre of the wall panel (See photograph P-95).

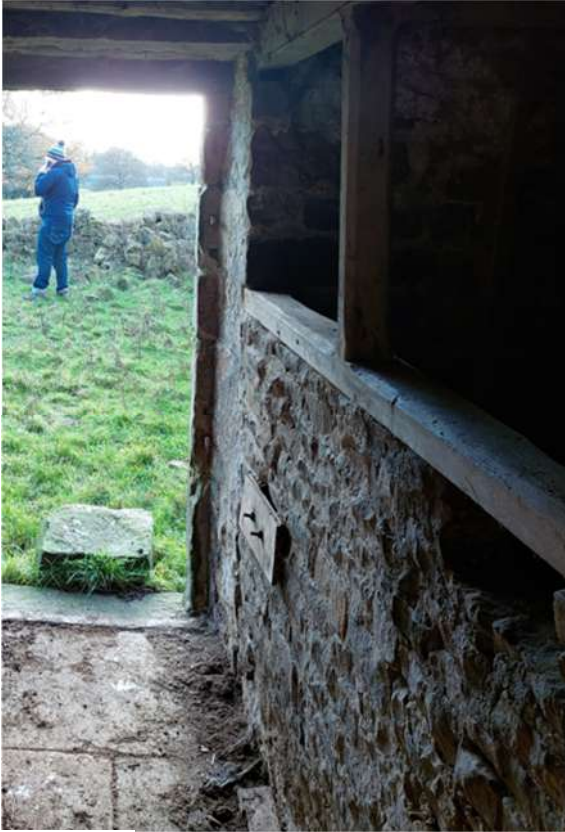
(P-101)

- 3.4.2 Holes from the decay were present in some of the timber floor boards (See photographs P-98 & P-100).
- 3.4.3 The stone walls supporting the timber posts which help prop the floor at midspan were damaged with sections missing in some areas (See photograph P-101).

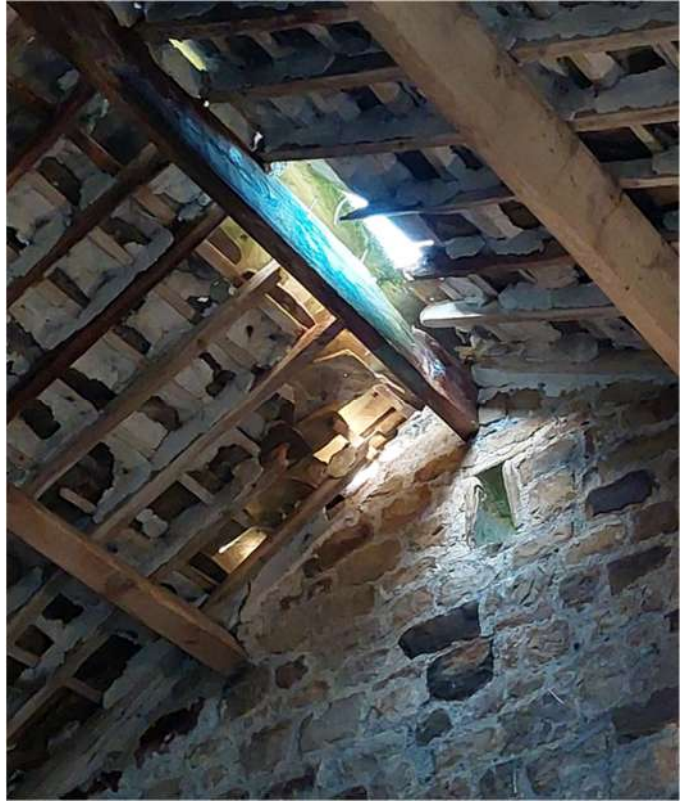
(P-106)

- 3.4.6 A number of the purlins showed heavy signs of decay particularly at the wall bearings (See photograph P-105).
- 3.4.7 Light coming through the roof exposed areas where the roof tiles were damaged or missing, consequently the timber ridge beam and rafters below were showing signs of weathering & deterioration (See photograph P-106).

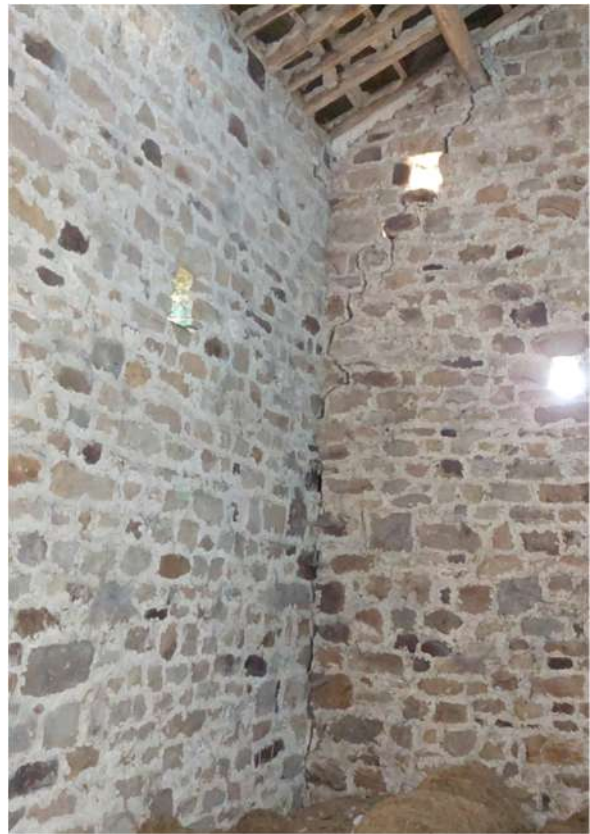
(P-108)

- 3.4.8 The bottom chord to the existing timber truss was heavily decayed (See photograph P-107).
- 3.4.9 Large vertical cracks in the corners of the wall are more prominent internally. This is likely due to differential settlement between the stone quoins and the main stonework panel (See photographs P-108 & P-109).

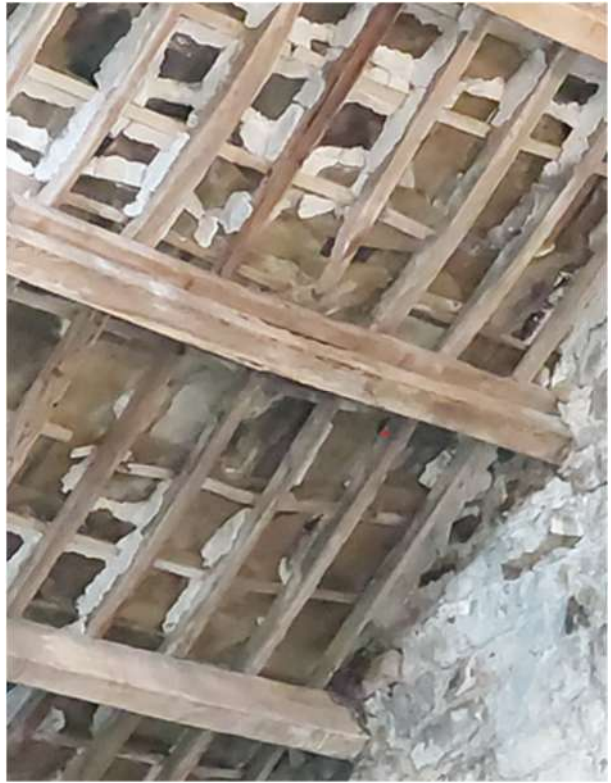
(P-110)

- 3.4.10 Timber rafter damaged (See photograph P-109).
- 3.4.11 Timber purlin showing signs of a fracture (See photograph P-110).
- 3.4.12 Timber purlin with section missing due to deterioration (See photograph P-111).

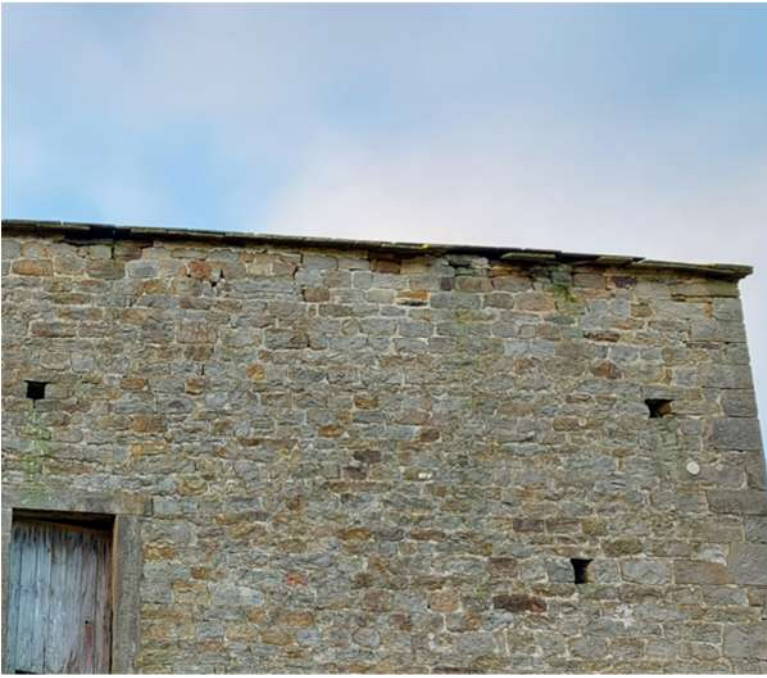
(P-117)

- 3.4.18 Some stonework loose across the top of wall (See photograph P-117).
- 3.4.19 Loose joints to stonework around door opening (See photograph P-118).
- 3.4.20 Stonework local to cantilever stair/ wall abutment stained and vegetation present due to water ingress (See photograph P-119).

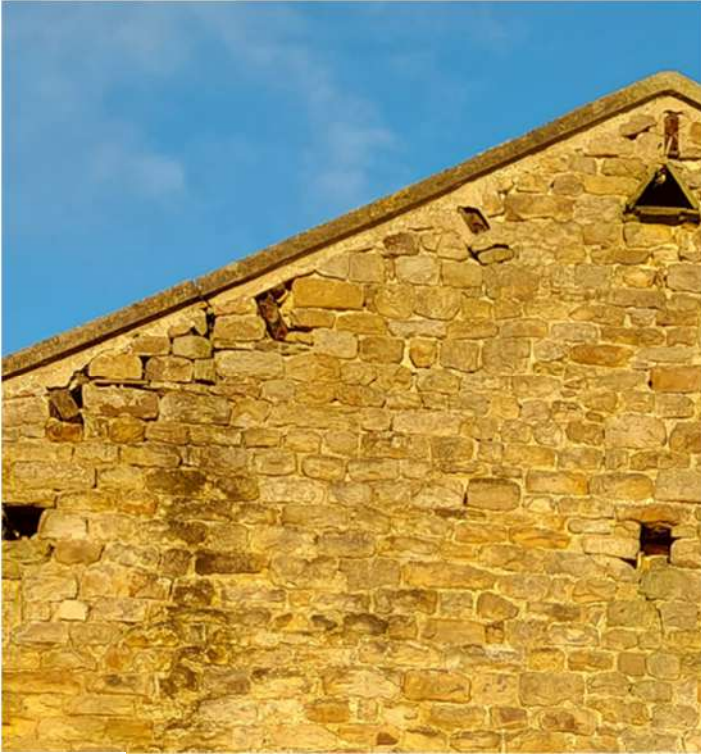
(P-120)

- 3.4.21 Ends of the timber purlins visible and heavily corroded. Stonework loose across the top of the gable wall (See photograph P-120).
- 3.4.22 Large vertical cracks to the corners of the wall are less prominent from external face, please see point 3.4.10.
