**HISTORIC BUILDING SURVEY REPORT:**  
**CUCKOO HALL, HIGHER ROAD, LONGRIDGE, LANCASHIRE**

Planning Reference: 3/2024/0121  
NGR: SD 63896 39018  
AAL Site Code: LOHR 25  
OASIS Reference Number: allenarc1-536093

By  
Allen Archaeology Ltd  
Report Number AAL 2025117

August 2025

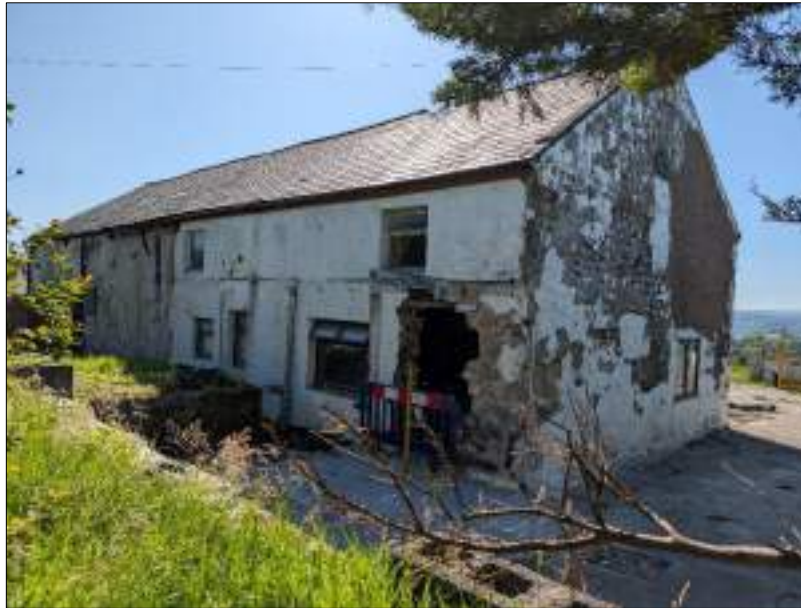
- 6.7 The northwest facing elevation of the farmhouse (Plate 7; Shot 172) was once again finished with limewash. There were two windows at first floor level, and three at ground floor level, along with an opening (Plate 8; Shot 33) which had provided egress between the farmhouse and a modern extension on the western corner of the main range. The extension had been recently demolished, and presumably the damage to the entranceway occurred during the demolition work. The damage revealed the structure of the masonry of the wall, largely comprising roughly squared back-to-back facing stones with no core material, with occasional throughstones tying the faces together (Plate 9; Shot 35). The damaged area also clearly showed the layer of limewashed render on the exterior of the wall.

*Plate 7 (shot 172): Northwest-facing elevation of farmhouse, looking southeast, 2m scale*

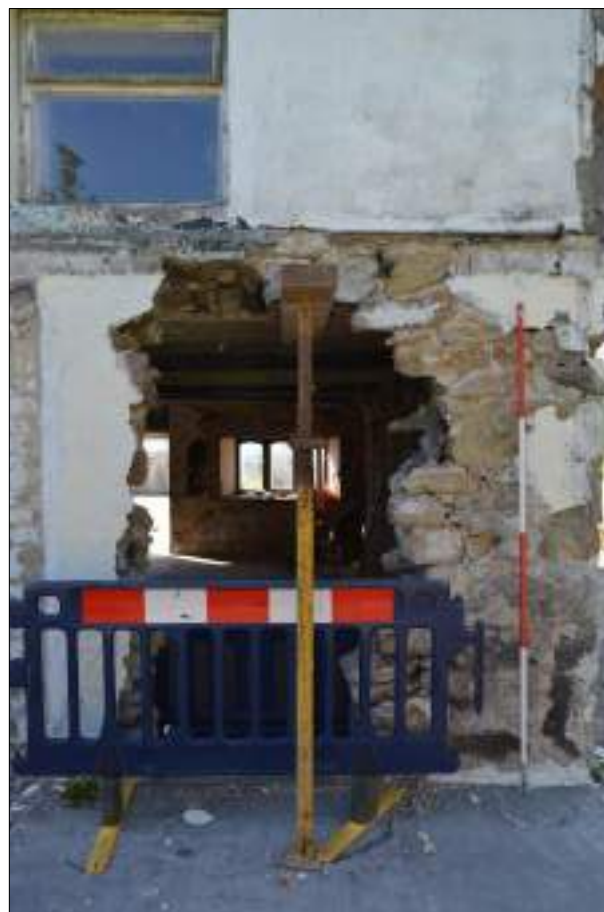
*Plate 8 (shot 33): Damaged entrance in northwest elevation of farmhouse, looking southeast, 2m scale*

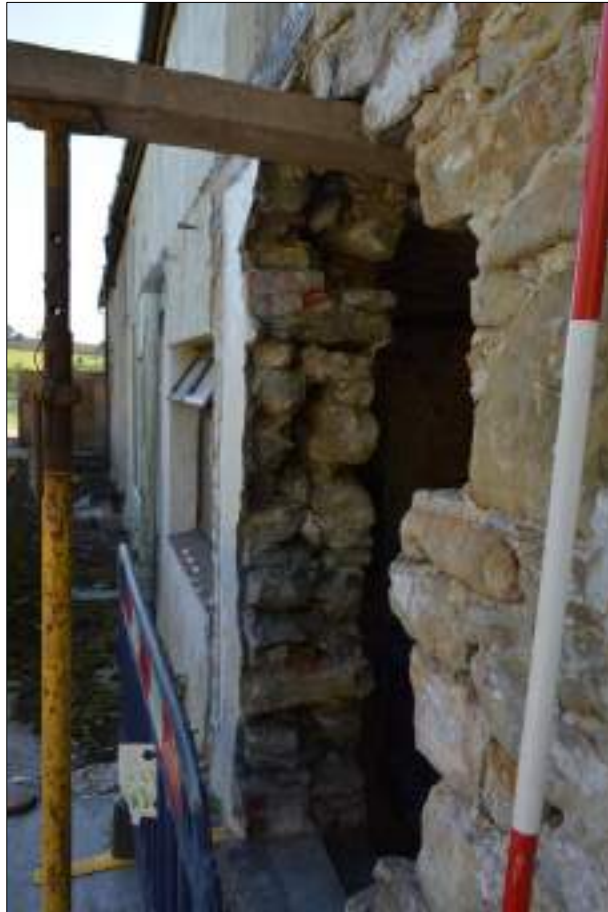
*Plate 9 (shot 35): Damaged entrance in northwest elevation of farmhouse showing structure of masonry, 2m scale*

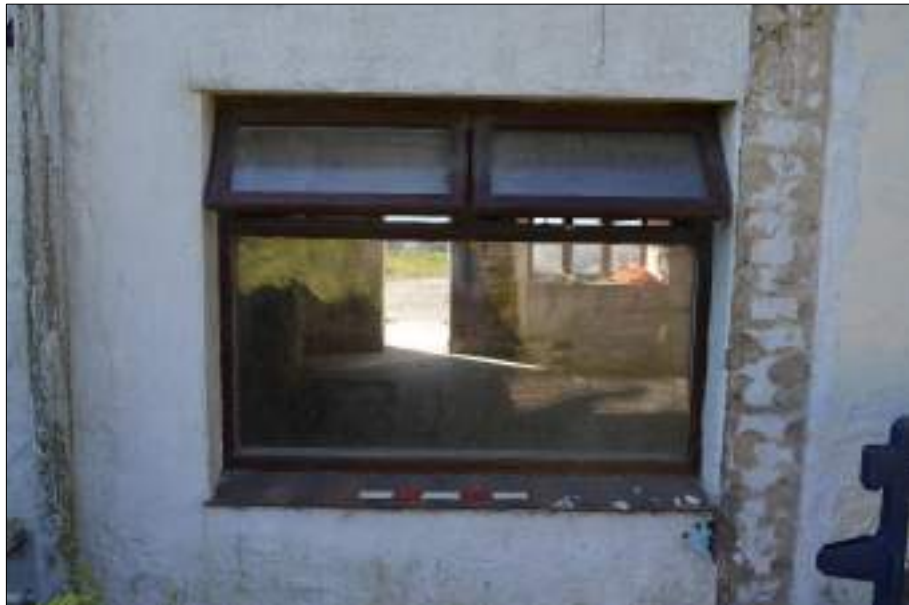
*Plate 10 (shot 31): Detail of ground floor window, northwest elevation of farmhouse, 0.5m scale*

- 6.8 To the northeast of the entranceway a rectangular window (Plate 10; Shot 31) had a large rectangular lower light with two top hung casements above. The window was timber framed and of recent origin. The photograph also shows the wall scar of the demolished extension to the right of the window.
- 6.9 In the northeastern bay of the farmhouse there were two windows (Plates 11 and 12; Shots 30 and 28) with frames and glazing in a similar style, both of which were rectangular with awning hung casements over fixed lights. All three of the ground floor windows were set fairly deeply into the wall, with wide flat reveals.

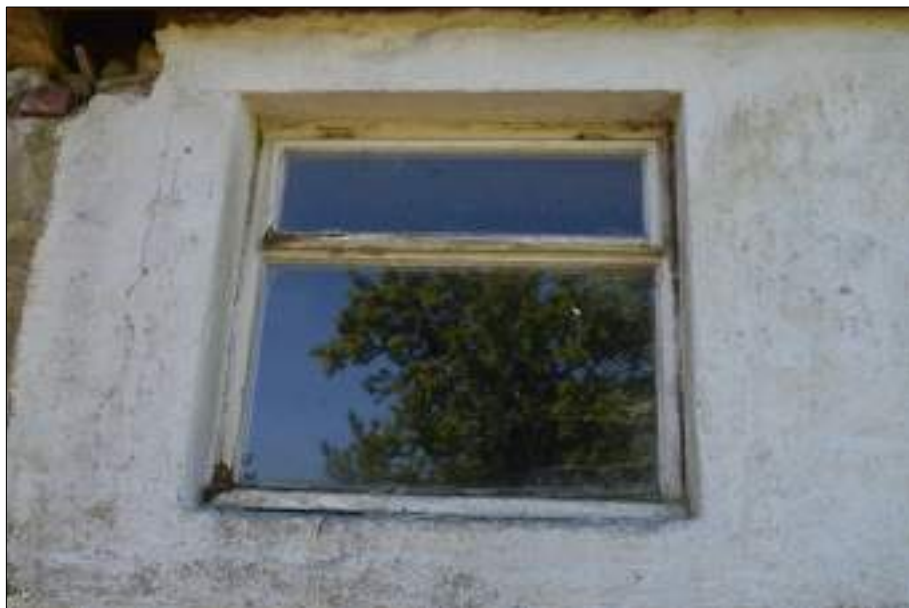
- 6.10 At first floor level there was a single window (Plate 13; Shot 29) in a similar style in each of the two bays, although the wooden frames of the windows were painted white rather than stained.

*Plate 13 (shot 29): Detail of first floor window, northwest elevation of farmhouse, no scale*

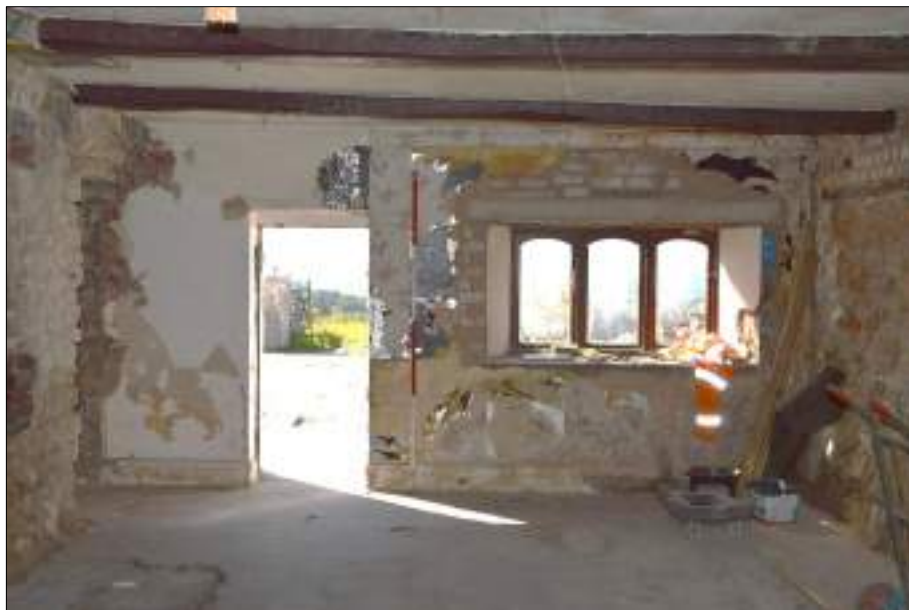
- 6.16 The southeastern wall of Room 1 (Plate 20; Shot 47) largely had the internal render and some wallpaper remaining, so the nature of the fabric was unclear. The rectangular window (Plate 21; Shot 175) had very deep splayed reveals and was surmounted by a concrete lintel with blockwork above, suggesting that the position of the window as well as the glazing represents a relatively late alteration to the fabric of the farmhouse.

*Plate 20 (shot 47): Southeastern wall, Room 1, 2m scale*

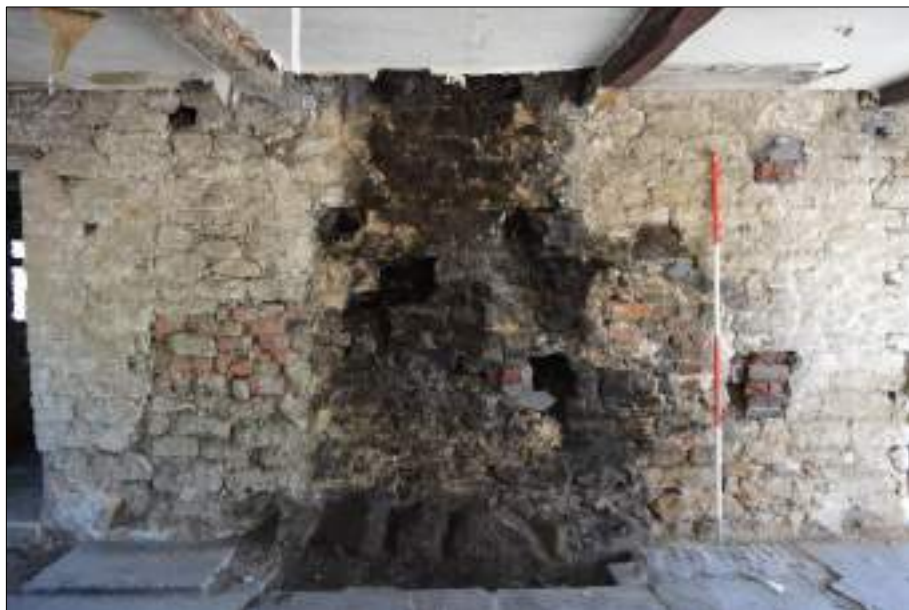
- 6.21 Between the two doorways a fireplace or range in the centre of the northeastern wall had been substantially removed (Plate 26; Shot 50), with evidence of its original extent visible on the floor (Plate 27; Shot 178) and ceiling (Plate 28; Shot 28) of the room, as well as on existing plans of the farmhouse provided by the client. Surrounding the fireplace a number of brick blocked openings in the masonry of the wall are likely to relate to the former presence of a cooking range.

*Plate 26 (shot 50): Detail of demolished fireplace on northeastern wall, Room 1, 2m scale*

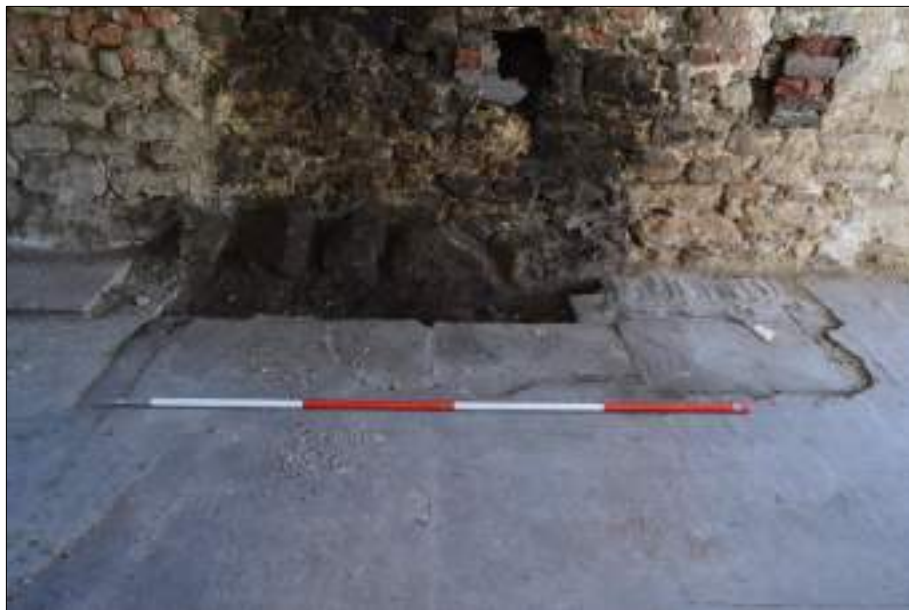
*Plate 28 (shot 53): Base of demolished fireplace, 2m scale*

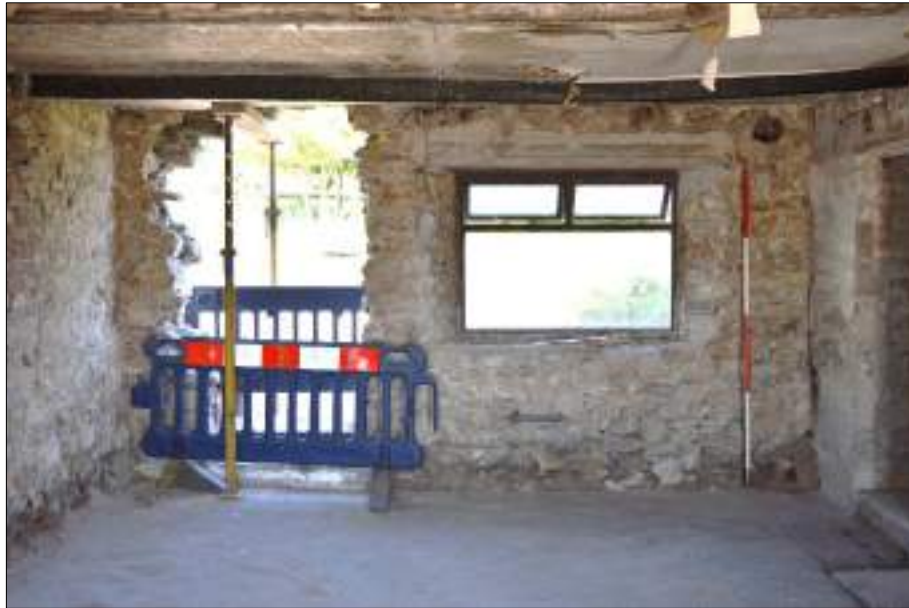
- 6.22 The northwestern wall of Room 1 (Plate 29; Shot 41) was of random coursed sandstone rubble construction, with two openings. That to the southwest was a doorway leading to a demolished modern extension, the doorway had been heavily damaged presumably during the demolition work. To the northeast of the doorway, a rectangular window (Plate 30; Shot 42) with splayed reveals appeared to be in its original position, though some infill above the window suggested that it had been altered later.

*Plate 29 (shot 41): Northwestern wall, Room 1, 2m scale*

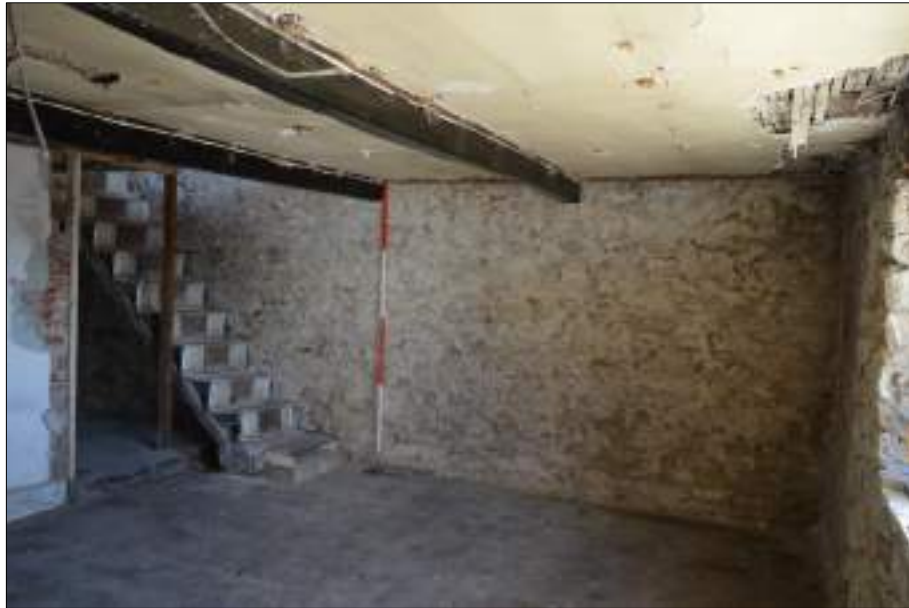
- 6.25 Room 2 (Plate 32) was located to the northeast of Room 1 on the southeastern side of the farmhouse. The ceiling had exposed beams continuing from Room 1, but with a lath and plaster ceiling rather than a plasterboard one, and a concrete floor.

*Plate 32 (shot 55): Interior of Room 2, looking northeast, 2m scale*

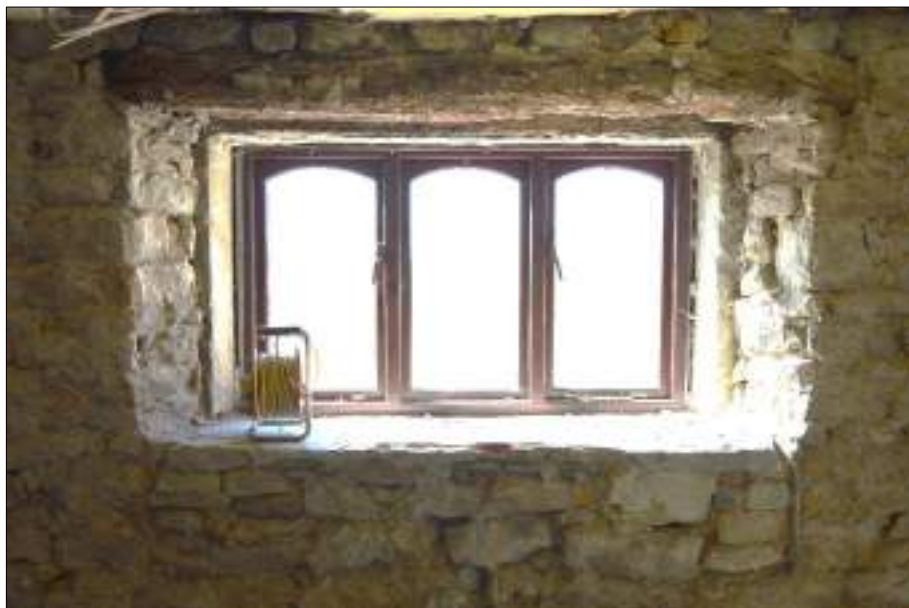
- 6.26 The rectangular window (Plate 33; Shot 57) in the southeastern wall of Room 2 had a timber lintel and a stone surround and appeared to be part of the original fabric of the farmhouse, although the frame and glazing were later replacements.

*Plate 33 (shot 57): Detail of window, southeastern wall, Room 2, 0.5m scale*

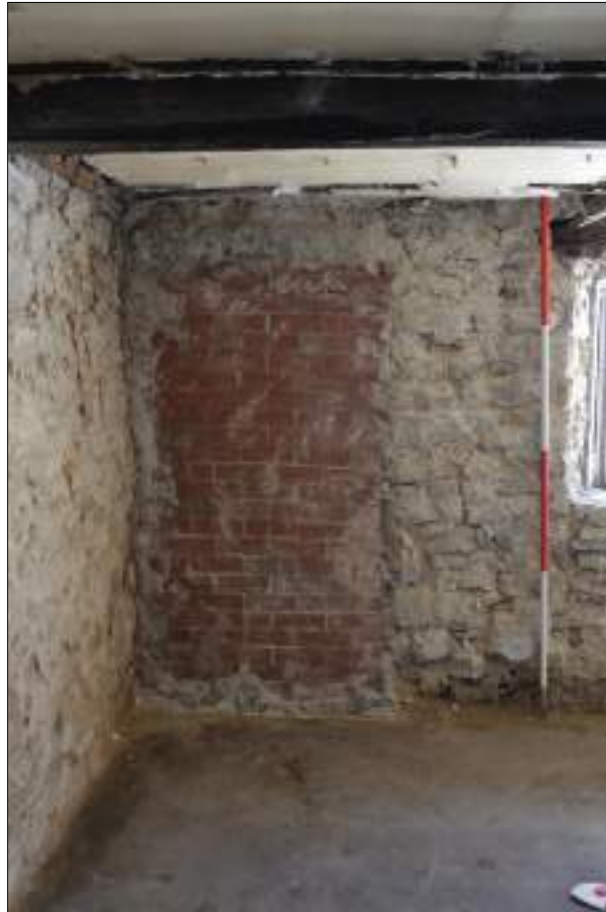
- 6.27 To the northeast of the window a former doorway (Plate 34; Shot 60) was visible, blocked with machine pressed brick laid in stretcher bond. The blocking may have been inserted following the demolition of a southeast projecting extension or outshut depicted as part of the farmhouse on historic mapping from 1844 onwards, and demolished recently due to its unstable condition.

*Plate 34 (shot 60): Detail of blocked doorway in southeastern wall of Room 2, 2m scale*

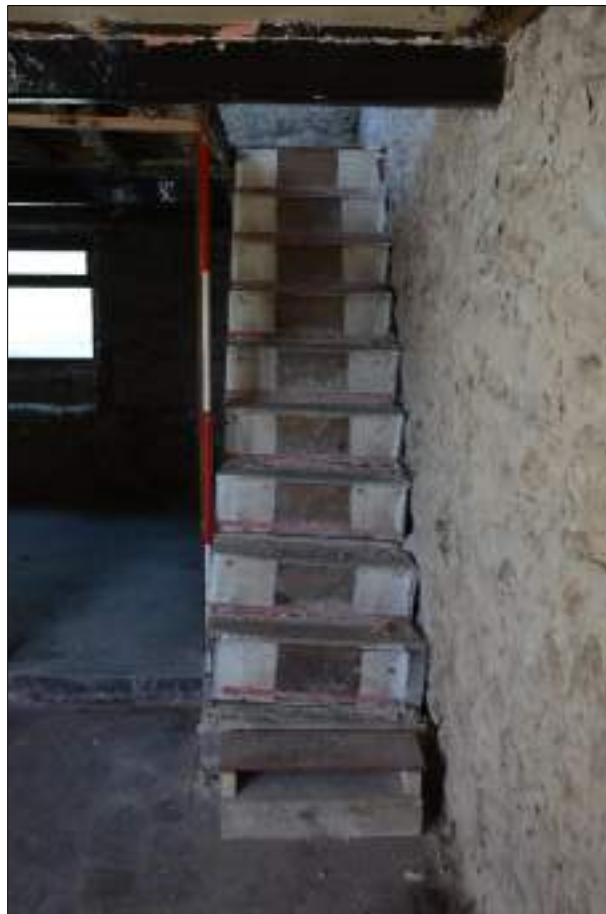
- 6.30 The straight staircase (Plates 38 and 39; Shots 67 and 70) leading from Room 2 to the first floor was of fairly crude construction. The northeastern side of the staircase abutted the northeastern wall of Room 2 and both sides of the staircase rested on diagonal string beams between the ceiling beam and the floor (Plate 40; Shot 69). There was no newel post or handrail. The treads were of timber construction and the painting of the outside edges of the risers indicated that the stairs were carpeted with a runner, although later gripper strips across the full width of the stairs suggest the runner was replaced with a full width carpet.

*Plate 38 (shot 67): Detail of staircase, Room 2, 2m scale*

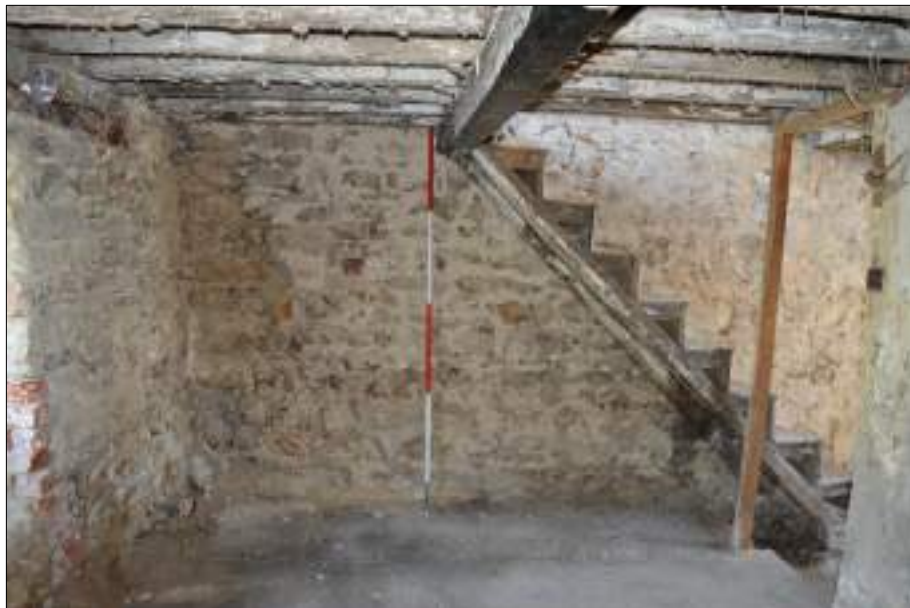
- 6.31 The northeastern wall of Room 2 was of random coursed sandstone rubble construction. There was little evidence of alteration. The wall was abutted by the staircase leading to the first floor.

*Plate 40 (shot 69): Northeastern wall of Room 2, 2m scale*

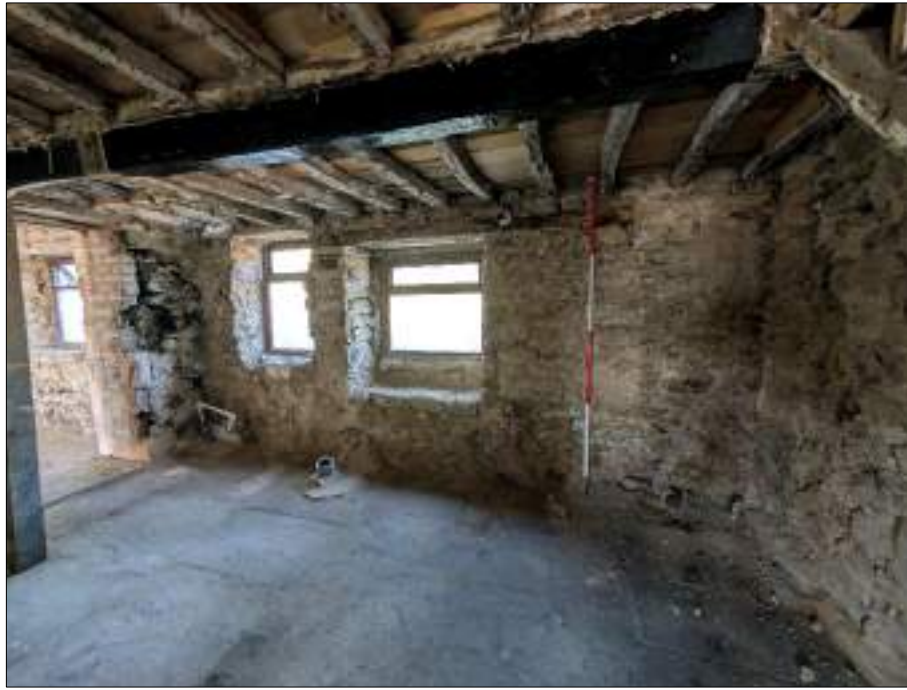
- 6.32 The floor level of Room 3 was at a higher level to that of Room 2. The floor comprised large rectangular sandstone flags (Plate 41; Shot 182). There was no ceiling in Room 3, the underside of the floorboards of the first floor being visible resting on the joists carried by the exposed beam (Plate 42; Shot 75).

*Plate 41 (shot 182): Interior of Room 3, looking northwest, 2m scale*

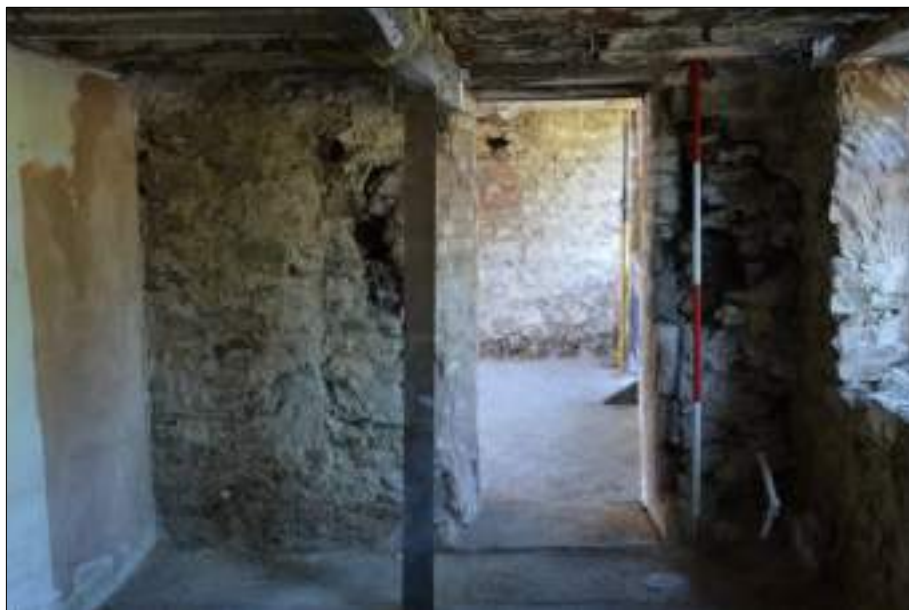
- 6.35 The southwestern wall (Plate 46; Shot 68) of Room 3 was of random coursed sandstone rubble construction and pierced by a doorway leading to Room 1.

*Plate 46 (shot 68): Southwestern wall of Room 3, 2m scale*

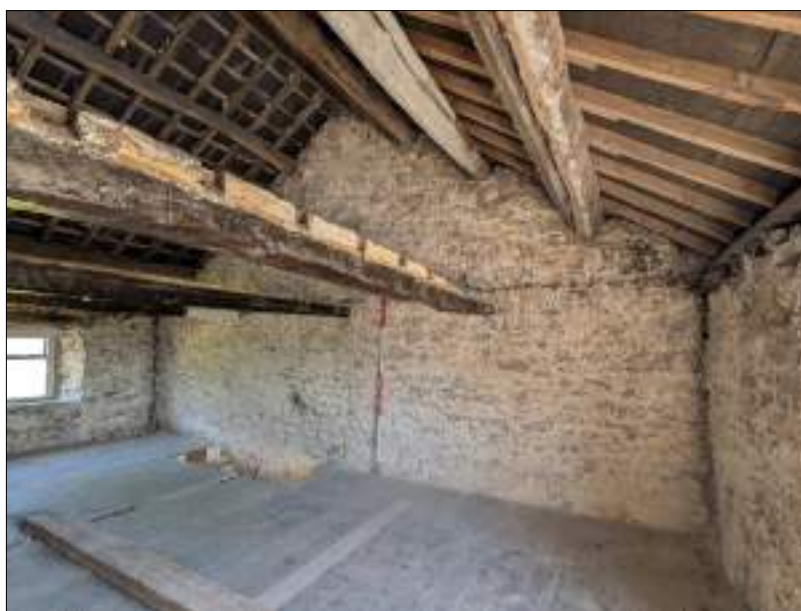
- 6.39 The northeastern wall of Room 4 (Plate 50; Shot 185) was of random coursed sandstone rubble construction, with little sign of alteration. Three beams aligned with the ridge line of the farmhouse were present at the eaves level of the roof, demonstrating that the first-floor rooms had had a ceiling, with a separate loft space above, this floor level having subsequently been removed. Two of the beams were likely to be later replacements, but that to the southeast retained the mortises for the floor joists (Plate 51; Shot 87) and is likely to represent an original member of the building's fabric.

*Plate 50 (shot 185): Northeastern wall of Room 4, 2m scale*

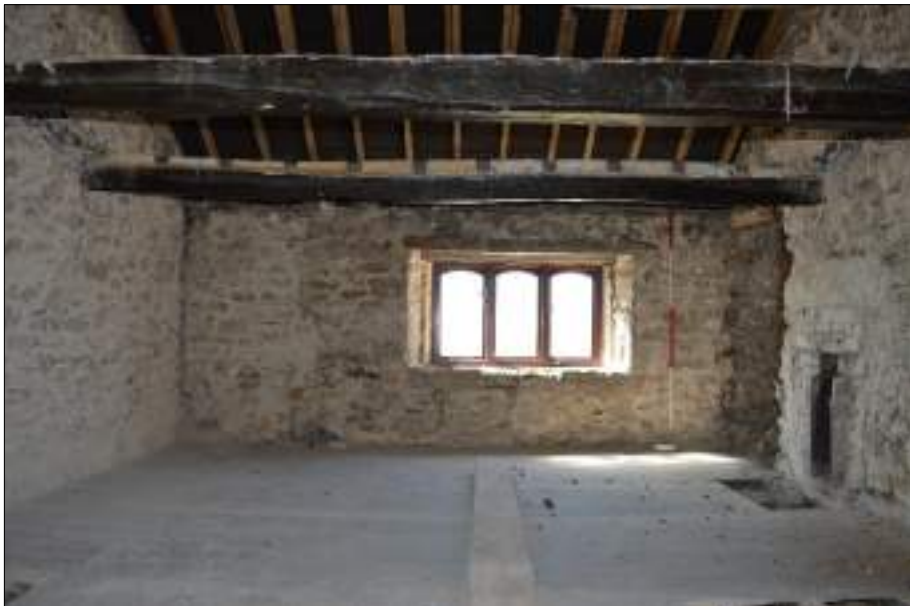
- 6.40 The southeastern wall of Room 4 (Plate 52; Shot 83) was pierced by a landscape rectangular window (Plate 53; Shot 86) with splayed reveals and a timber lintel above. The position of the window opening is likely to be original, although the wooden frame and glazing are later replacements. To the northeast of the window in the corner of the room there was thicker rendering on the wall, although it was not clear whether this was associated with a structural alteration.

*Plate 52 (shot 83): Southeastern wall of Room 4, 2m scale*

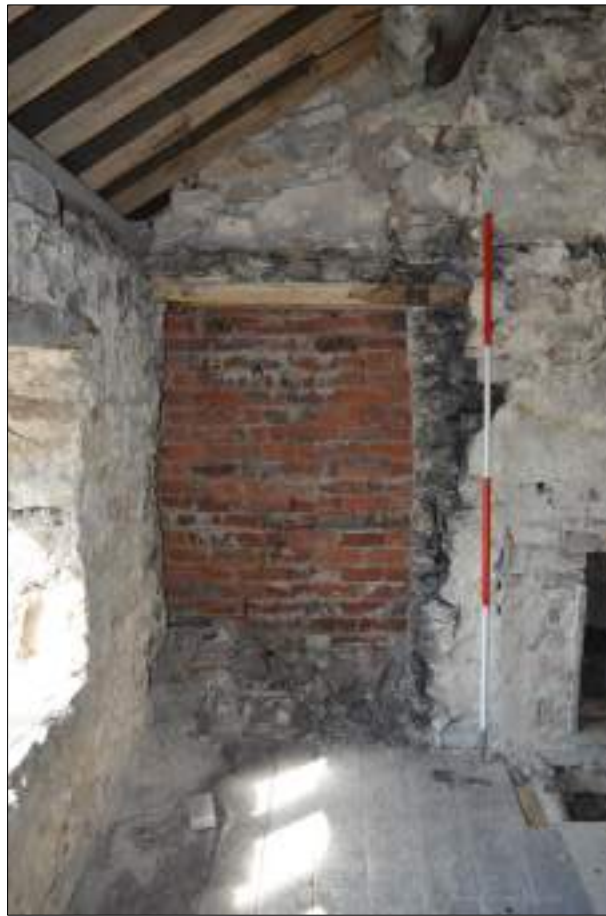
*Plate 55 (shot 82): Detail of blocked doorway, southwestern wall of Room 4, 2m scale*

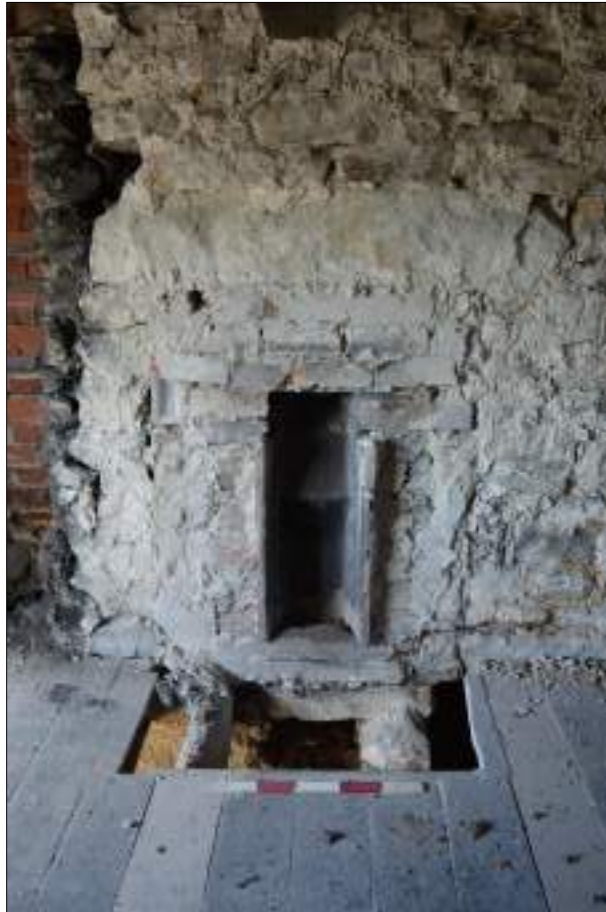
- 6.42 Between the two doorways in the southwestern wall of Room 4 there was a fireplace (Plate 56; Shot 81), which probably shared the same flue as those noted in Rooms 1 and 2 on the ground floor. The original opening has a substantial sandstone lintel above and has largely been blocked with brick contemporary with the insertion of a fireclay fire back. The grate and all other fittings have been removed.

*Plate 56 (shot 81): Detail of fireplace, southwestern wall of Room 4, 0.5m scale*

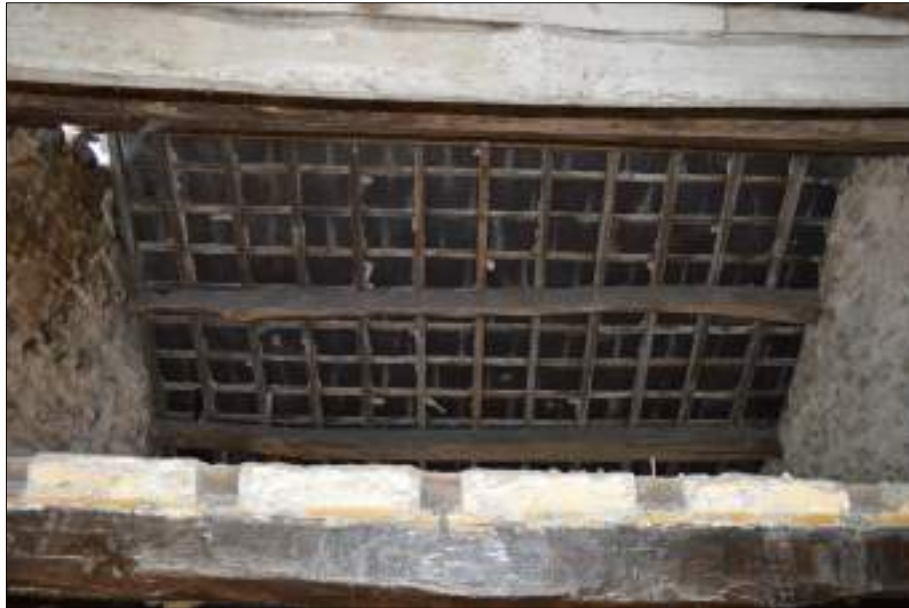
- 6.44 The floor of the room comprised timber floorboards laid parallel to the ridge line of the roof. The roof structure (Plate 59; Shot 77) was visible as the ceiling had been removed and comprised substantial beams resting directly on the slopes of the walls, carrying rafters and purlins on which the roof was laid. Some elements of the roof structure had been replaced but several of the beams were likely to be original.

*Plate 59 (shot 77): Detail of roof structure, Room 4, no scale*

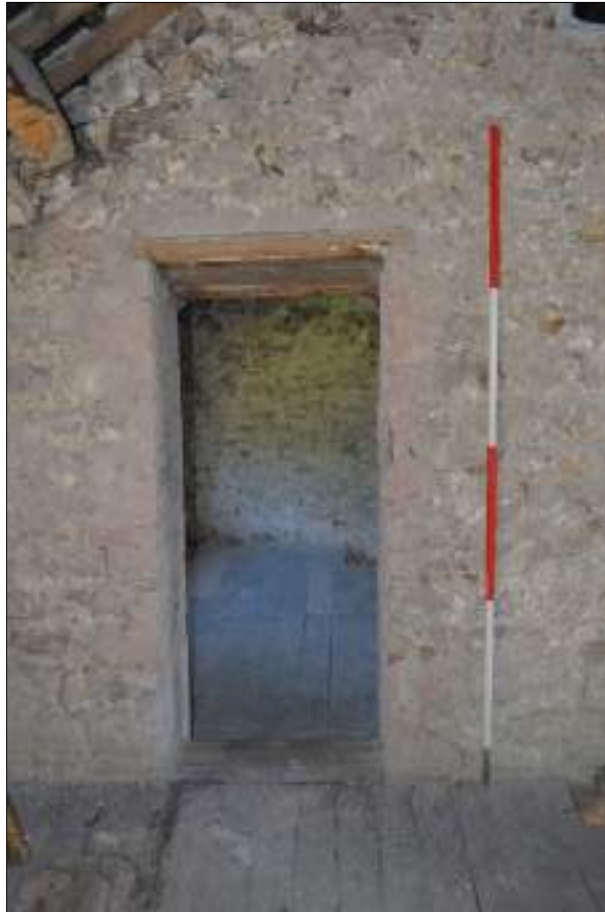
- 6.46 The northeastern wall of the room (Plate 60; Shot 189) was of random coursed sandstone rubble masonry. The doorway between Room 5 and Room 4 (Plate 61; Shot 89) had a timber lintel and brick jambs, as on the opposite side. There was no door hung in the opening.

*Plate 61 (shot 89): Detail of doorway, northeastern wall of Room 5, 2m scale*

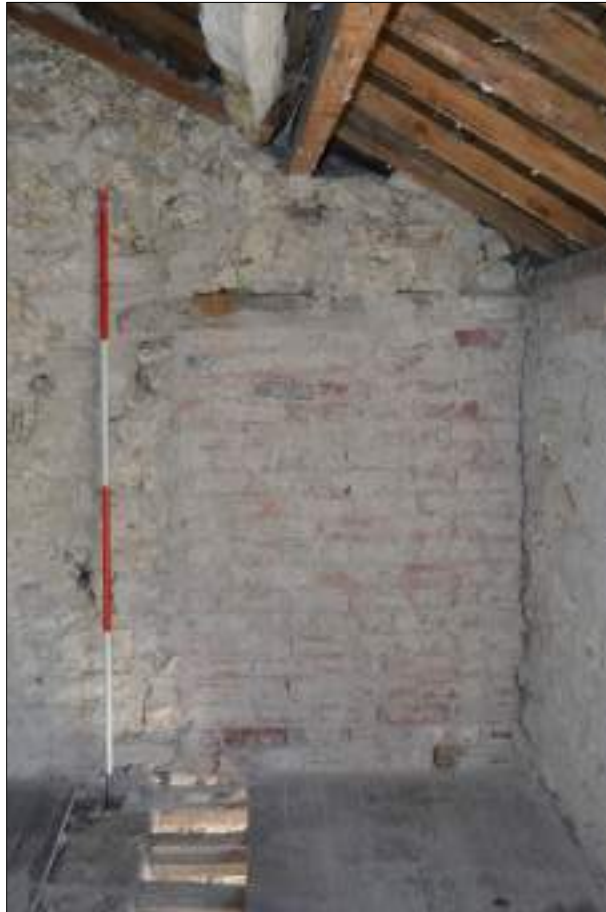
- 6.47 At the southeastern end of the wall the blocked doorway between the first-floor rooms was visible, with brick blocking as before.
- 6.48 Between the two doorways the northeastern wall of Room 5 was stained with soot at the back of the flue of the fireplaces within the farmhouse (Plate 60; Shot 189). A rectangular gap in the floorboards in Room 5 suggests that a fireplace in this room had been removed. Between the flue and the blocked door, a gap in the masonry of the wall (Plate 63; Shot 91) is likely to represent a socket for a ceiling beam, although no beams were *in situ* in Room 5. Between the flue and the open doorway, a small rectangular opening at loft level with chamfered jambs (Plate 64; Shot 90) suggests that there had been a ceiling present in Room 5 with a separate loft above.

*Plate 62 (shot 92): Detail of blocked doorway, northeastern wall of Room 5, 2m scale*

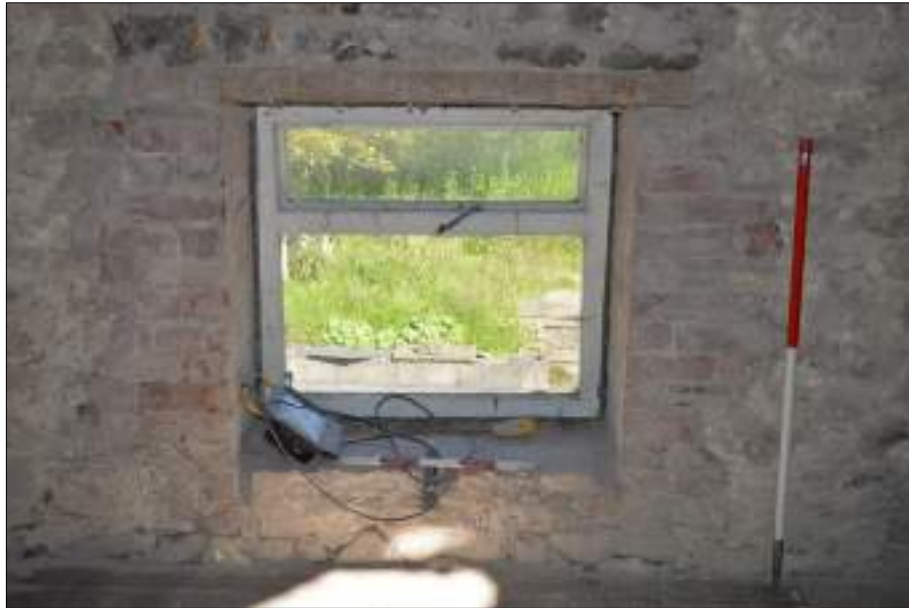
- 6.51 The northwestern wall of Room 5 (Plate 69; Shot 94) was of sandstone rubble construction with a single window (Plate 70; Shot 95). The window was square with a timber lintel and flat reveals formed from brick infill to either side of the window, indicating that the window opening was an alteration to the original fabric of the farmhouse, and that it may have been preceded by a larger window, as noted on other parts of the first floor.

*Plate 70 (shot 95): Detail of window, northwestern wall of Room 5, 1m and 0.5m scales*

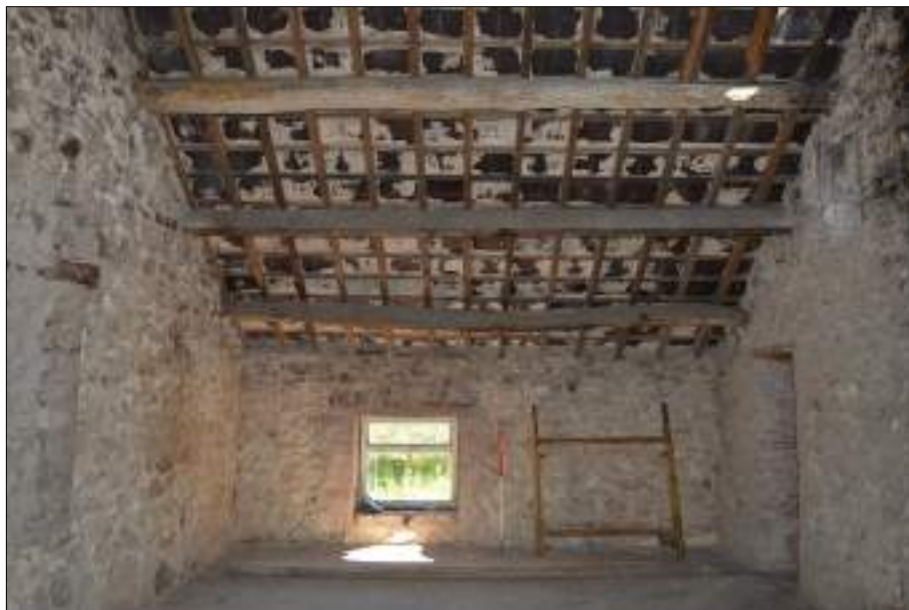
- 6.52 The roof construction was the same as that noted in Room 4, with no trusses and a square grid of rafters and purlins supporting the roof on the northwestern slope (Plate 71; Shot 93), while on the southeastern slope the purlins were not present and the rafters were formed of pairs of overlapping planks (Plate 72; Shot 96). The roof structure showed much alteration, although some of the main beams are probably original.

*Plate 71 (shot 93): Northwest side of Room 5 showing roof construction, 1m and 0.5m scales*

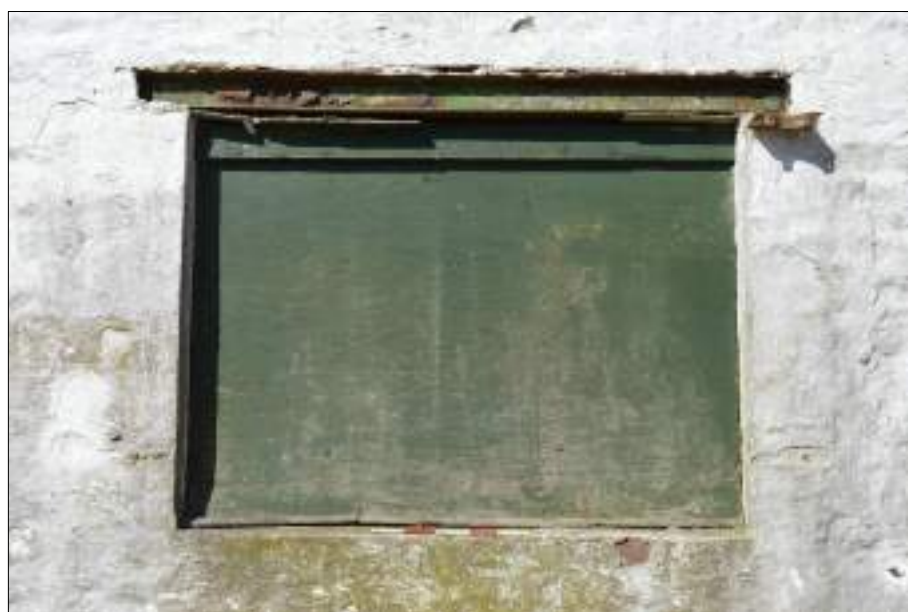
- 6.57 The northwesternmost window (Plate 77; Shot 19) was a landscape rectangular opening surmounted by a lintel comprising a length of steel H-beam. There was no frame or glazing in the opening, which was boarded up with plywood.

*Plate 77 (shot 19): Detail of window in northeast elevation of barn, 0.5m scale*

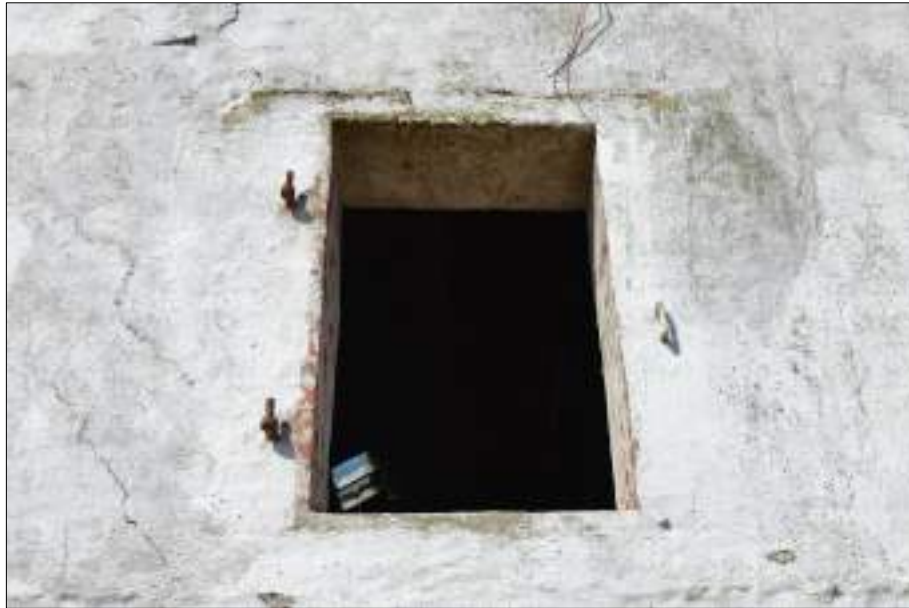
- 6.58 Above this window a doorway (Plate 78; Shot 20) with stone lintel and threshold and brick jambs had presumably given access to load a hayloft above the barn. On the southeast side of the door two cast iron pintles from flag hinges indicate that the door was hung on that side. An iron keep for a locking bar was attached to the wall on the other side of the door.

*Plate 78 (shot 20): Detail of doorway in northeast elevation of barn, no scale*

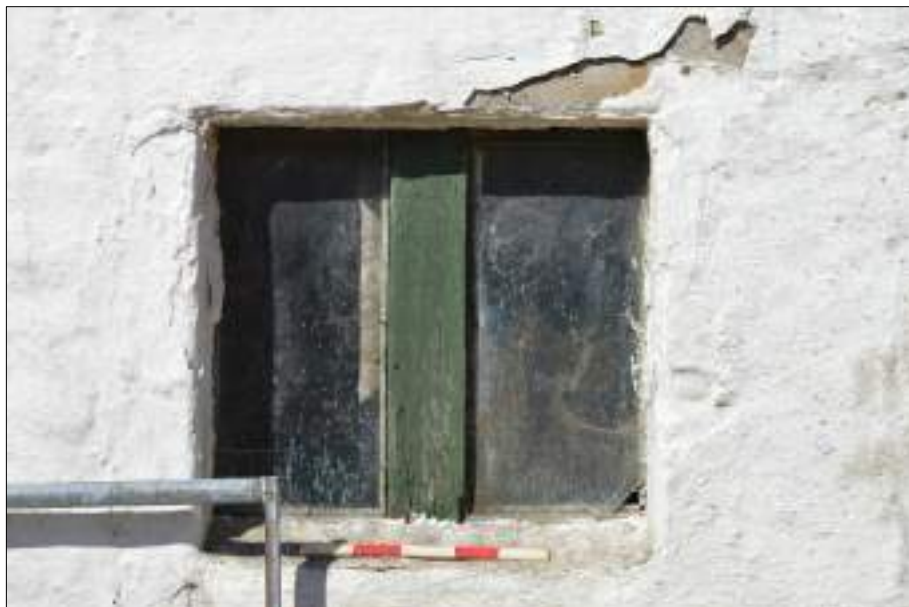
- 6.59 To the southeast of the window and doorway another window (Plate 79; Shot 18) was square in shape and divided into two lights with a wide strip of wood serving as a mullion. To the southeast of this window another (Plate 80; Shot 17) of very similar form was divided horizontally with two panes of glass below and presumably it had a missing awning hung casement above.

*Plate 79 (shot 18): Detail of window in northeast elevation of barn, 0.5m scale*

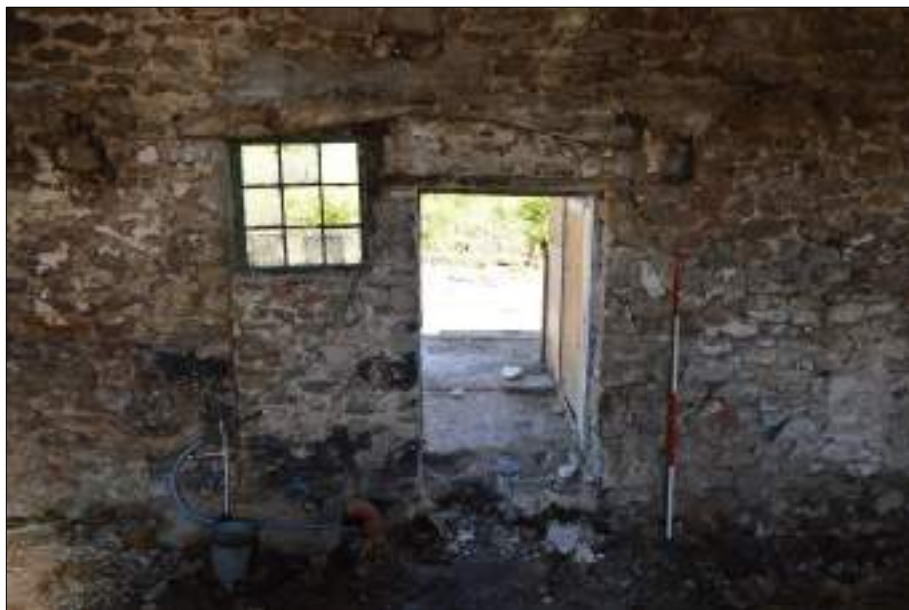
*Plate 93 (shot 102): Remodelled entranceway in northwestern wall of Room 6, 2m scale*

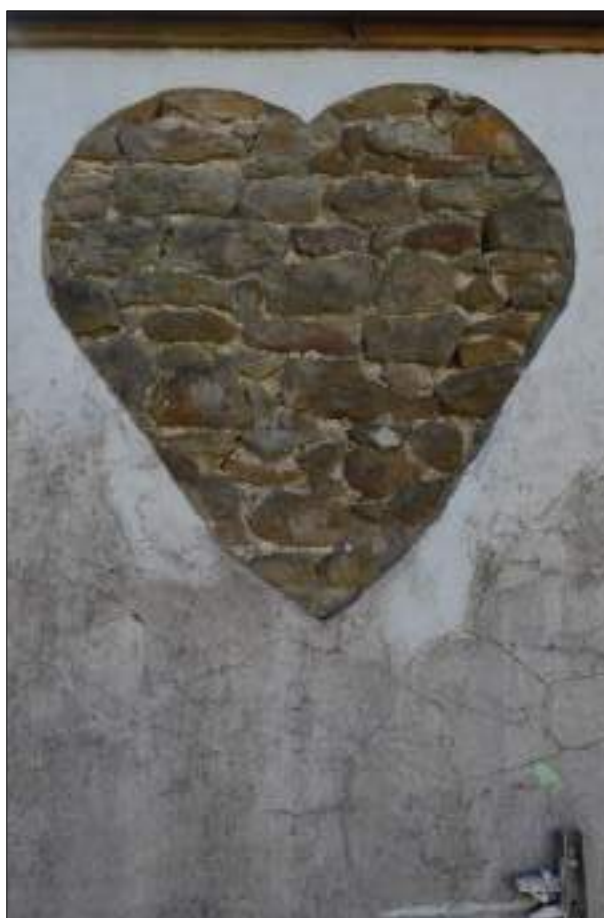
*Plate 110 (shot 136): Heart shaped patch of exposed masonry in northwestern elevation of outbuilding, no scale*

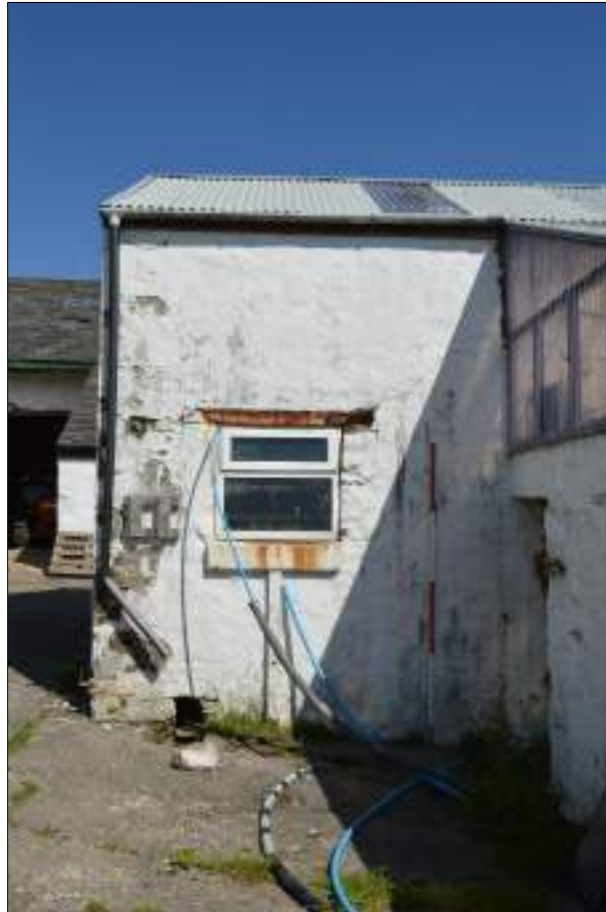
- 6.81 The southeastern elevation of the outbuilding, at the southwestern end (Plate 114; Shot 127) was rendered and limewashed, with a single rectangular window (Plate 115) with a steel joist for a lintel and a concrete sill, representing a later alteration to the original fabric of the outbuilding. The window comprised a uPVC frame with patterned frosted glass in the awning hung casement and plain glass in the lower light.

*Plate 114 (shot 127): Southeastern elevation of outbuilding, southwestern end, 2m scale*

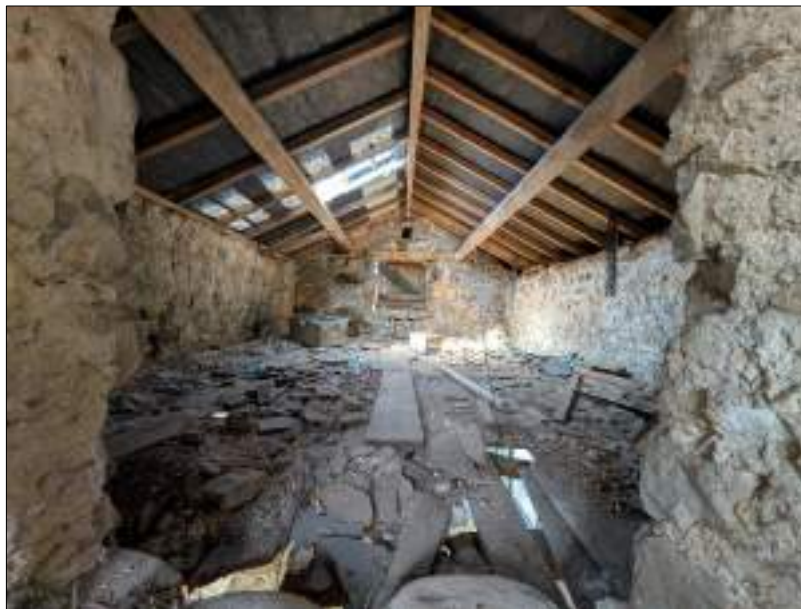
- 6.95 Room 9 had low walls to the northwest and southeast of random coursed sandstone rubble construction (Plate 132; Shot 201). The gable end wall had a square loading door with substantial sandstone lintel and sill, with a plank-built timber door fitted. Above the door there was a partially blocked vent comprising a square gap into the masonry.
- 6.96 The roof structure of Room 9 consisted of timber wall plates, ridge beam and axial beams supporting rafters that carry the roof, which is likely to be a relatively recent replacement of the original.

*Plate 132 (shot 201): Interior of Room 9, no scale*

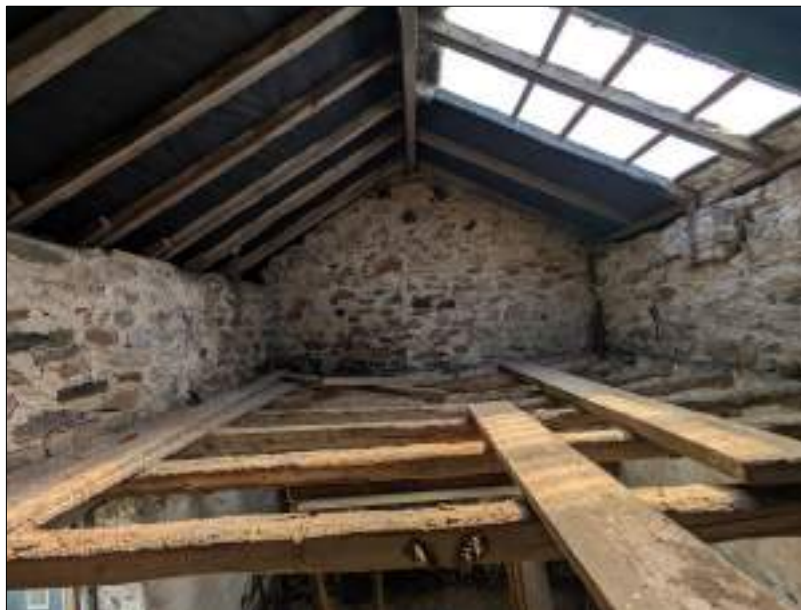
- 6.97 In Room 10 the roof structure was the same, and again the roof is likely to represent a fairly modern replacement. The masonry (Plate 133; Shot 202) was of very similar character and form to that observed in Room 9. Near the apex of the gable at the northeastern end of the room there was a metal fixing, the function of which could not be ascertained, as the exterior of the gable at this end could not be observed.
- 6.98 In the gable of the partition wall between Room 9 and Room 10 there was a rectangular doorway with a lintel formed by two large pieces of timber (Plate 134; Shot 199). There was no door fitted to the opening, nor any evidence that there ever had been.

*Plate 133 (shot 202): Interior of Room 10, no scale*
