# Tree Condition Report

16 The Rydings  
Langho  
BB6 8BQ

02/09/2025

**Job Ref:** 2190

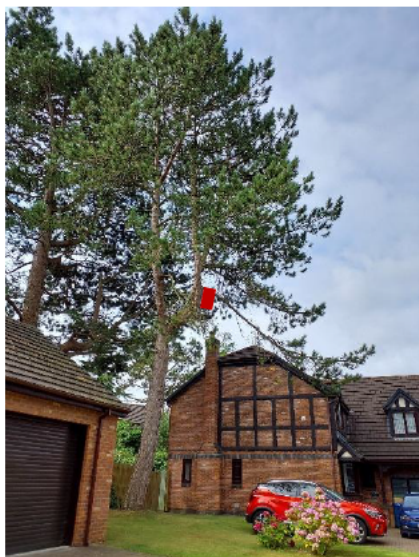
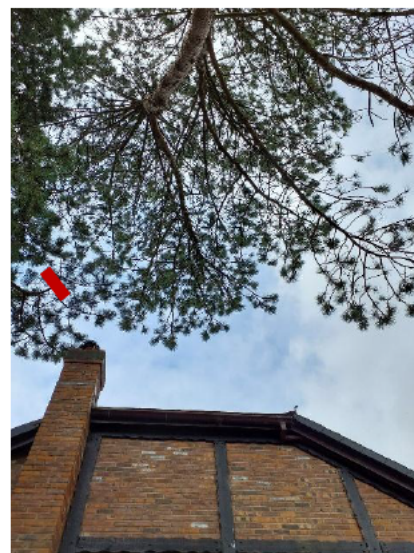
T1 Pine – 2 small branches recommended for removal – see image below and line of pruning point.

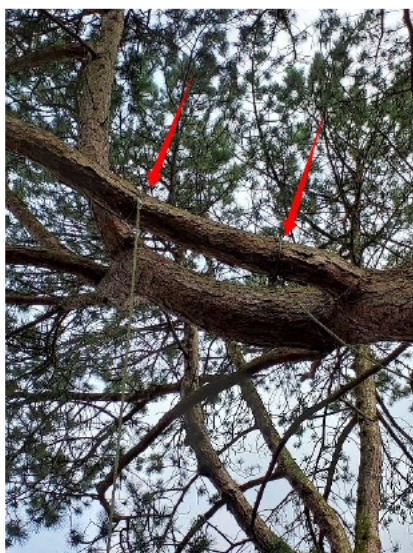
- 19.5. T2 has the rope from an old rope swing still attached to one of the main limbs, due to the growth of the limb the rope is now constricted and is impinging on the bark, the rope is recommended to be cut off to prevent future issues with cambium dieback and branch failure.

T2 Pine – Cut the 2 ropes that are tied onto the limb to prevent construction and bark damage  
**\*\* do not remove the limb \*\***

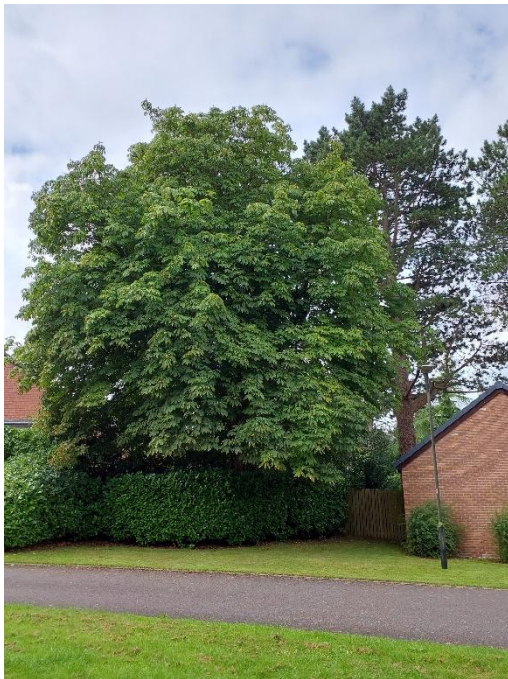
T4 – Horse Chestnut – canopy in full leaf and showing good vitality.

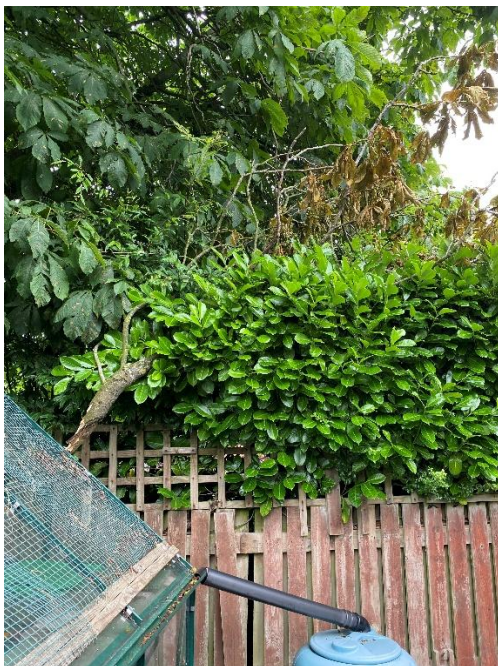
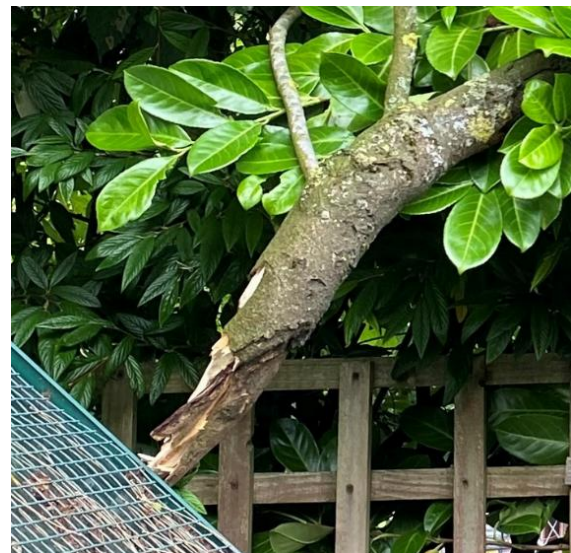
- 19.6. T3 does encroach over the neighbour's boundary line but no pruning is recommended currently.
- 19.7. T4 has recently lost a small branch that landed on the neighbour's hedge, the branch had been removed prior to me attending site so I can not fully comment on the reason for failure. From the photo provided by the neighbour there does seem to be old bark damage at the failure point, this could have contributed to the failure.

Neighbours photo of snapped branch and closeup of failure point.

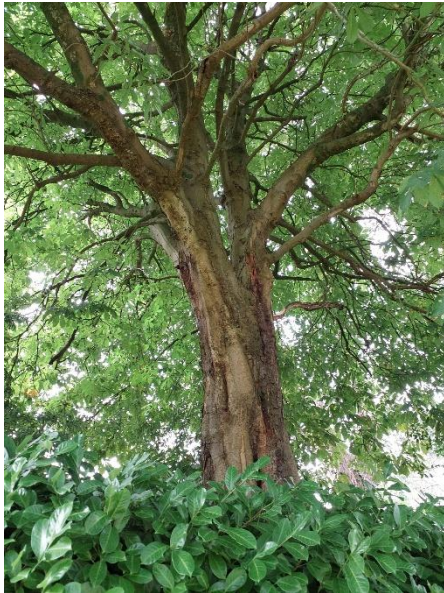
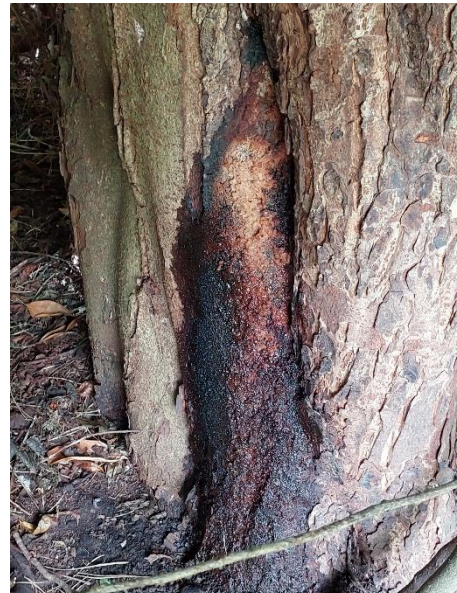
- 19.8. The tree is suffering from Bleeding Canker of Horse Chestnut (*Pseudomonas syringae* pv. *aesculi*), over time this can lead to tree death, but significant numbers of trees do recover. The symptoms are cankers, or lesions, and bark cracks appear on the stem and branches with bleeding of dark fluid.

- 19.9. At the time of the inspection there is some oozing of residue at the base of the stem and bark disfigurement in the upper stem (see photos), but with this the canopy of the tree is still in full leaf and in a healthy condition, this leads me to conclude that the tree is still able to send water and nutrients to and from the roots and leaves allowing it to flourish and the infection has not yet got to a point where it is detrimental to the trees health and structural condition.

Horse chestnut bleeding canker caused by the bacterium *Pseudomonas syringae* pv. *aesculi*, with symptoms of dark, sticky, bleeding lesions on the trunk and branches.

- 19.10. Monitoring of the trees condition over the following years is needed to ascertain if the infection is compromising the tree to a point where removal may be required. In advanced stages, the tree may show yellowing leaves, premature leaf drop, and overall crown decline, but at present there is no work recommended on this tree.

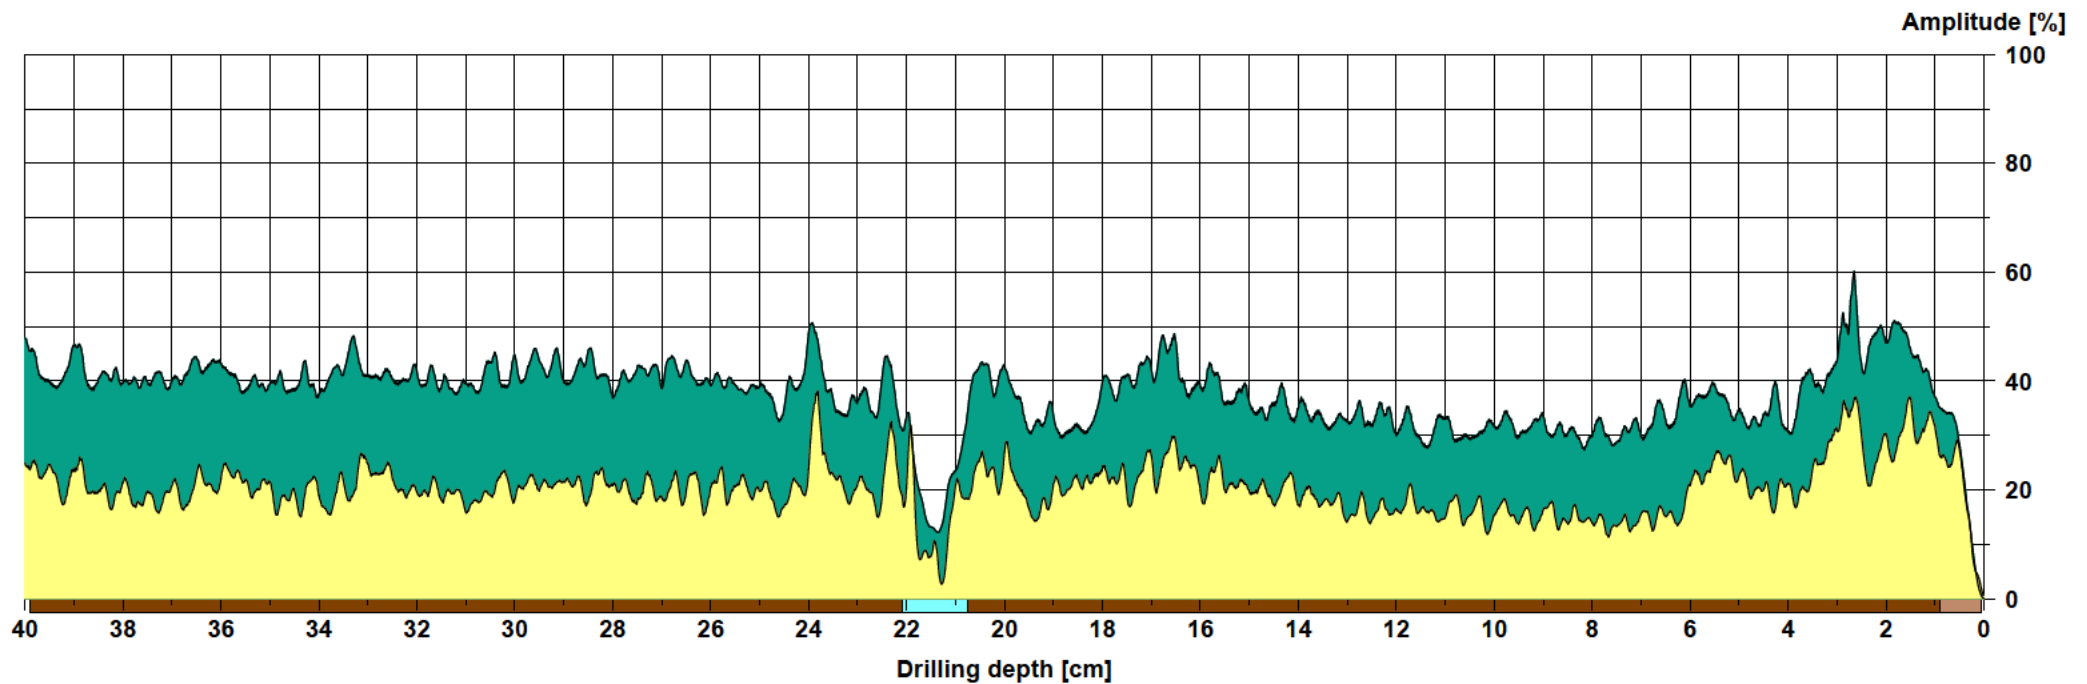
| From | 20.76 cm | to | 22.08 cm | : | Partial decay |
