Re; Application number 3/2025/0738

# HERITAGE STATEMENT

33 & 33a King Street, Whalley, BB7 9SP  
Grade II Listed Building within Whalley Conservation Area

Property: First Floor, 33 King Street, Whalley  
Client: Julie Macfarlane  
Survey Date: 09 June 2026  
Report Reference: Whalley shop first floor

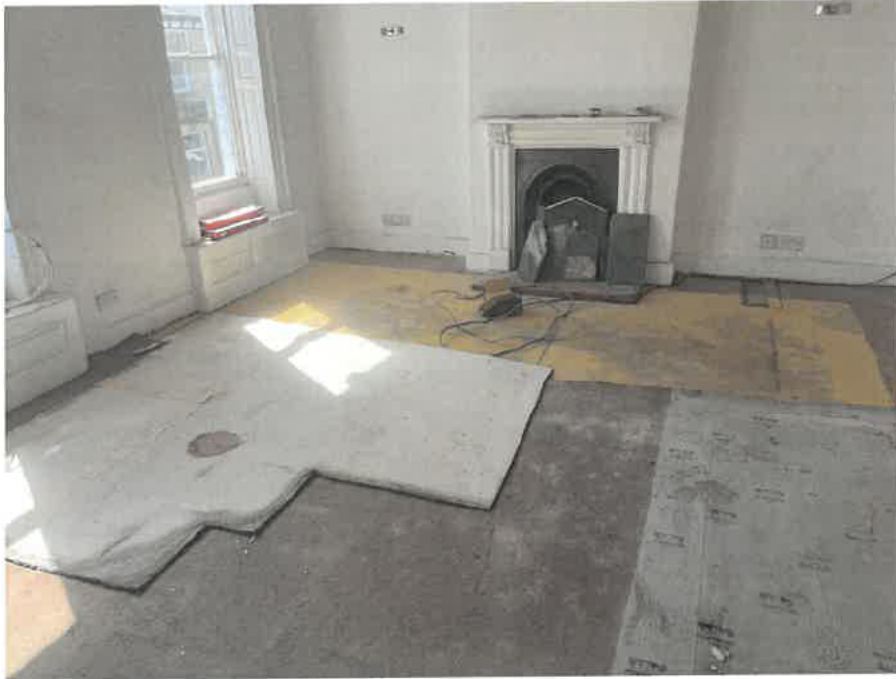
### Photograph 1 – General Floor Condition

Observation: Historic repairs visible together with uneven board alignment and evidence of long-term movement.

1. Secure all loose floorboards.
2. Carry out localised repairs to damaged boards.
3. Install a suitable acoustic isolation layer.
4. Overlay the existing floor with a minimum 18mm structural flooring-grade board.
5. Install final floor finishes in accordance with manufacturer recommendations.

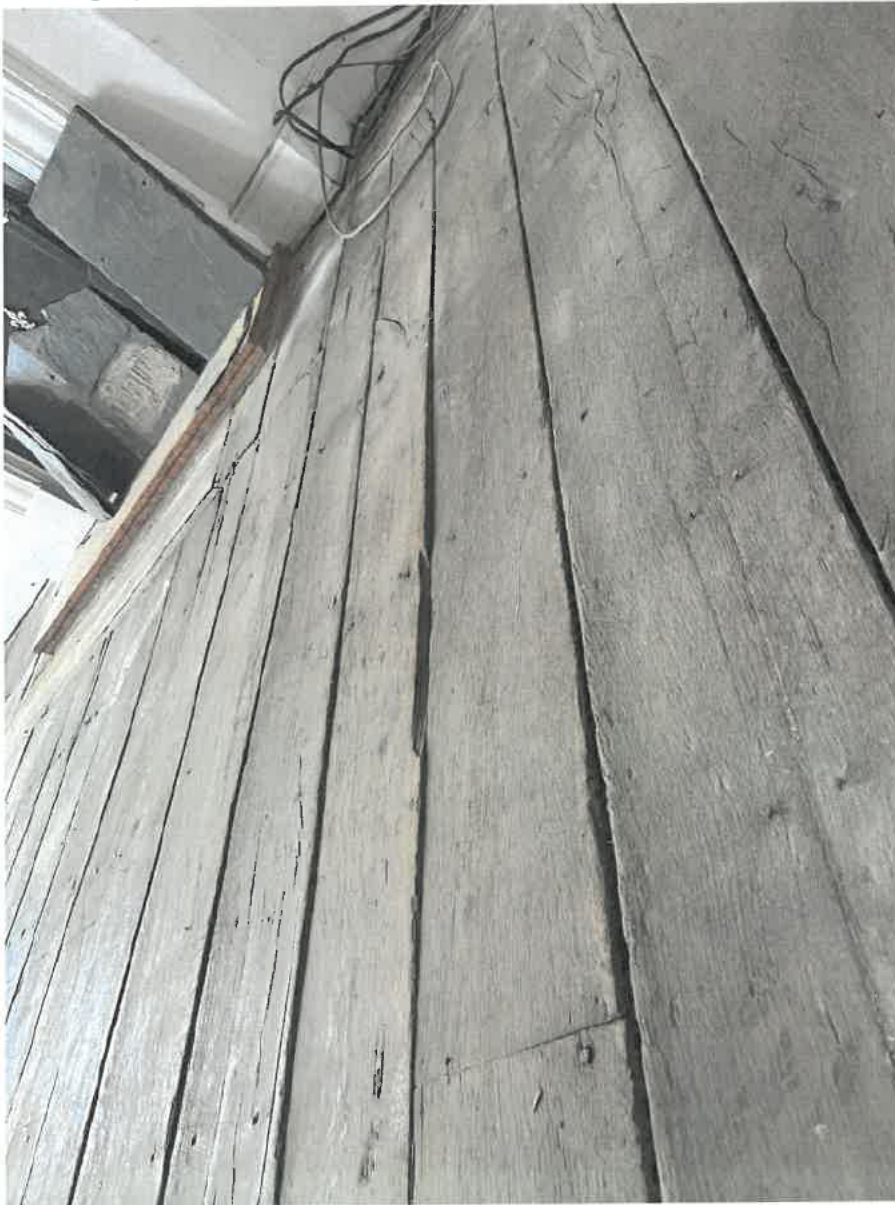
**Photograph 2 – Evidence of Floor Deflection**

**Observation: Low-level view demonstrating significant unevenness and floor movement.**

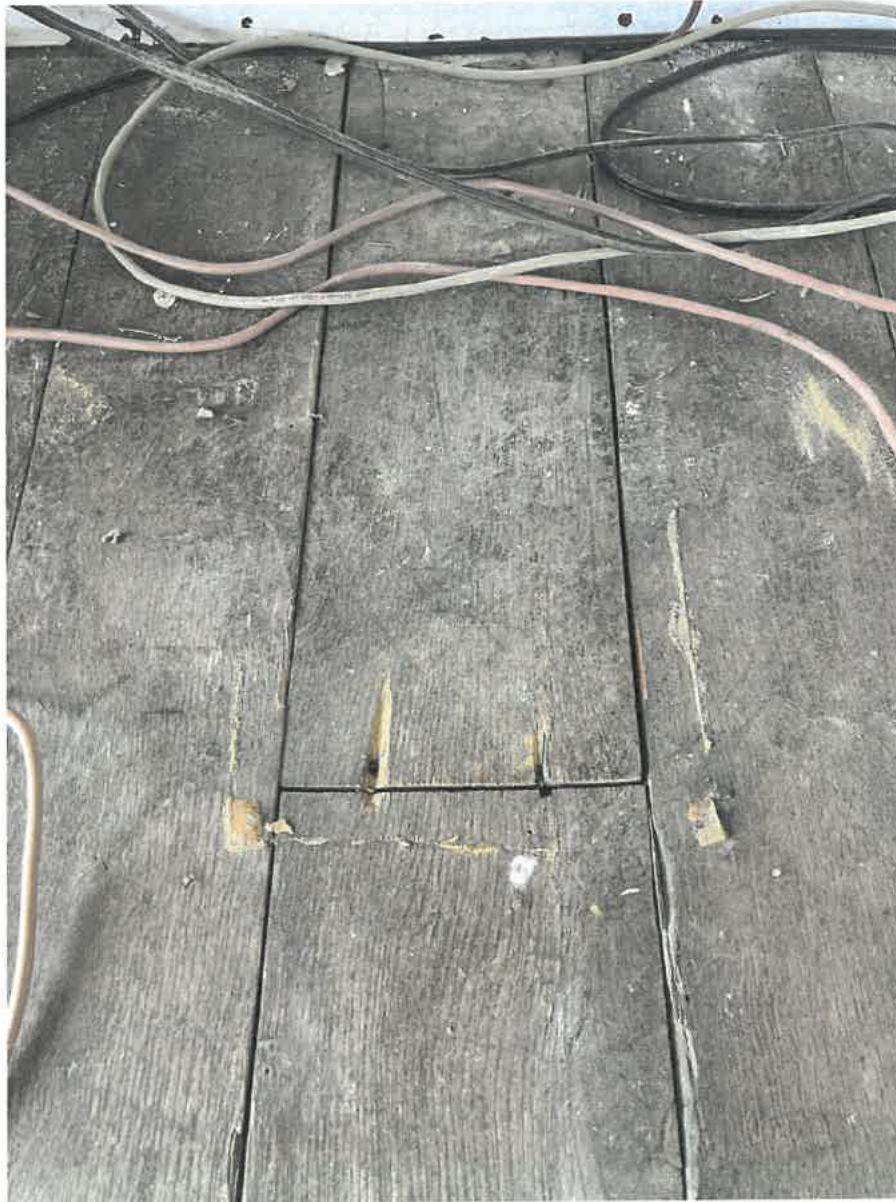
**Photograph 3 – Historic Repairs and Alterations**

Observation: Multiple sections of flooring have been lifted and reinstated over time.

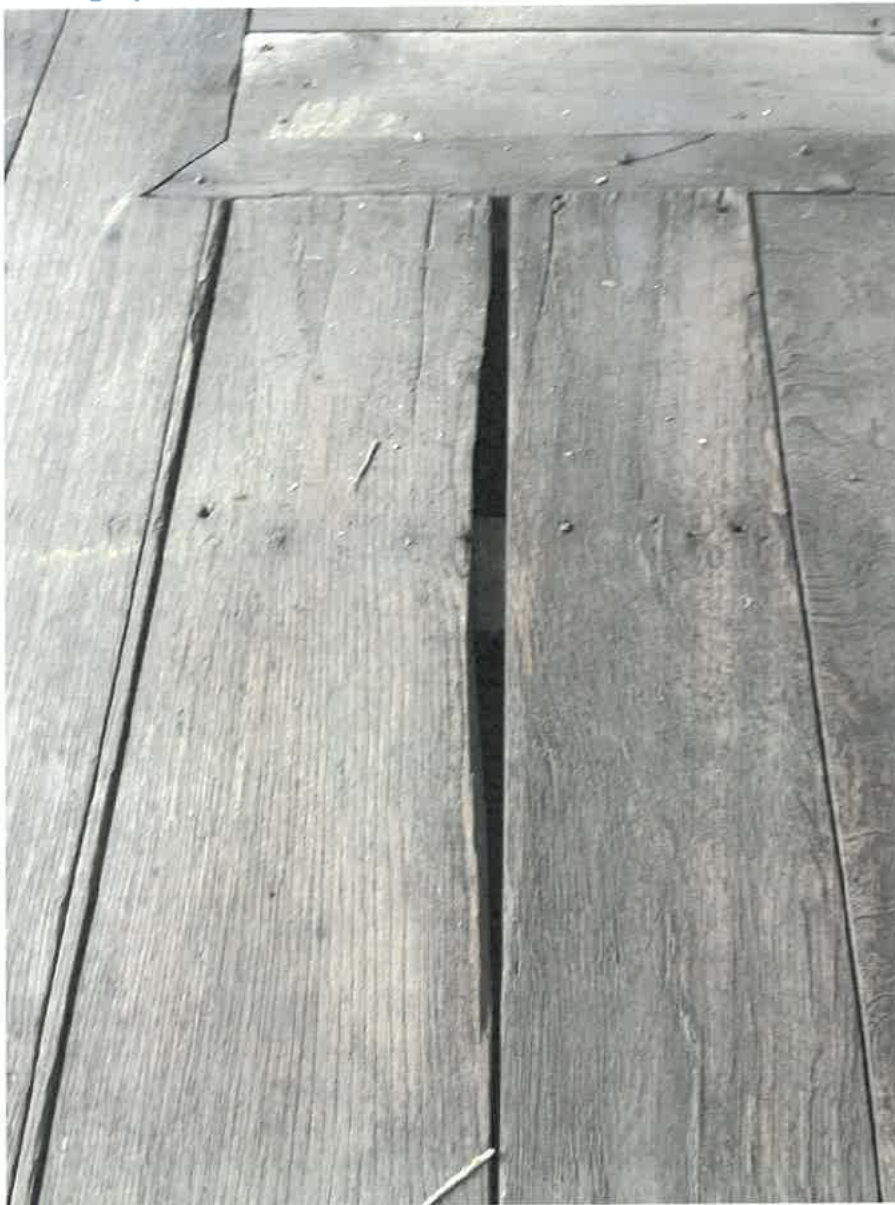
**Photograph 4 – Excessive Gaps Between Boards**

**Observation:** Open joints visible between boards, reducing stability and acoustic performance.

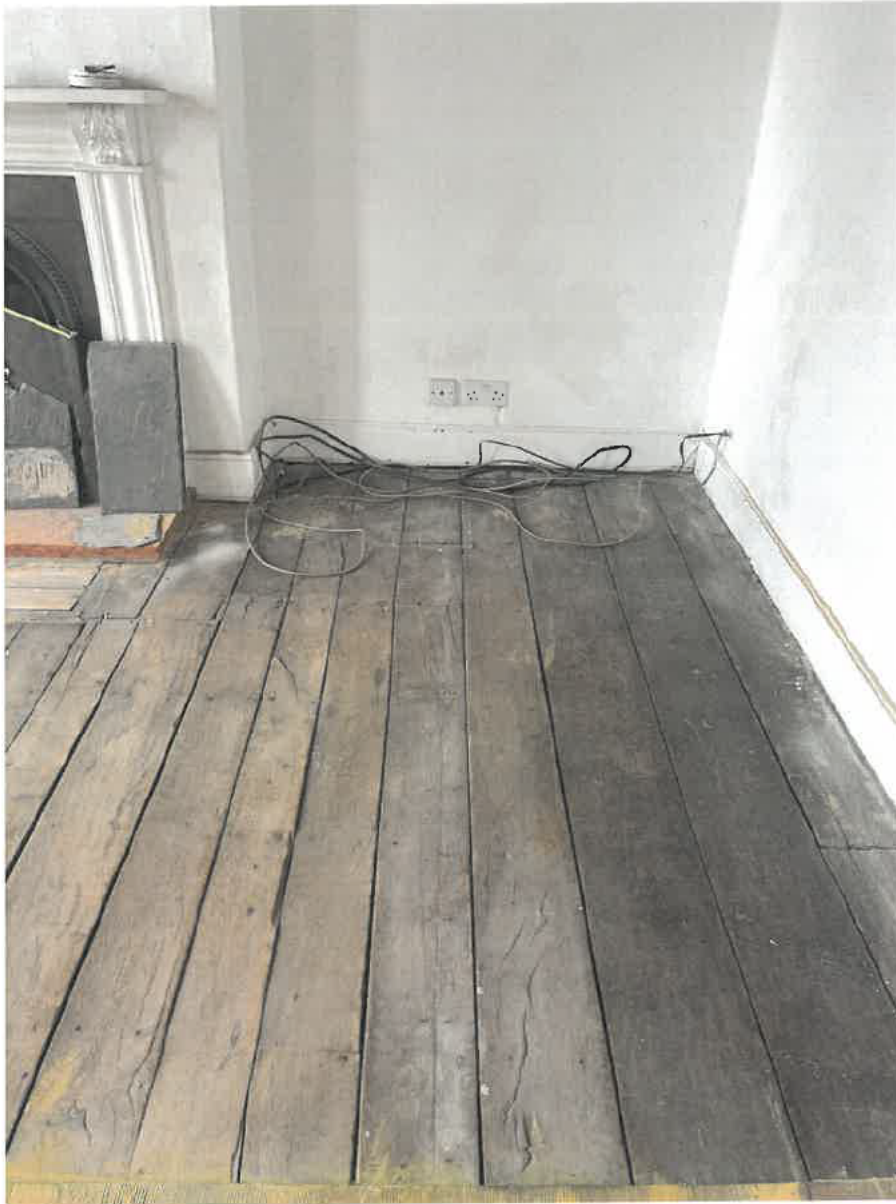
**Photograph 5 – General Room View**

Observation: Illustrates the extent of the floor condition across the room.

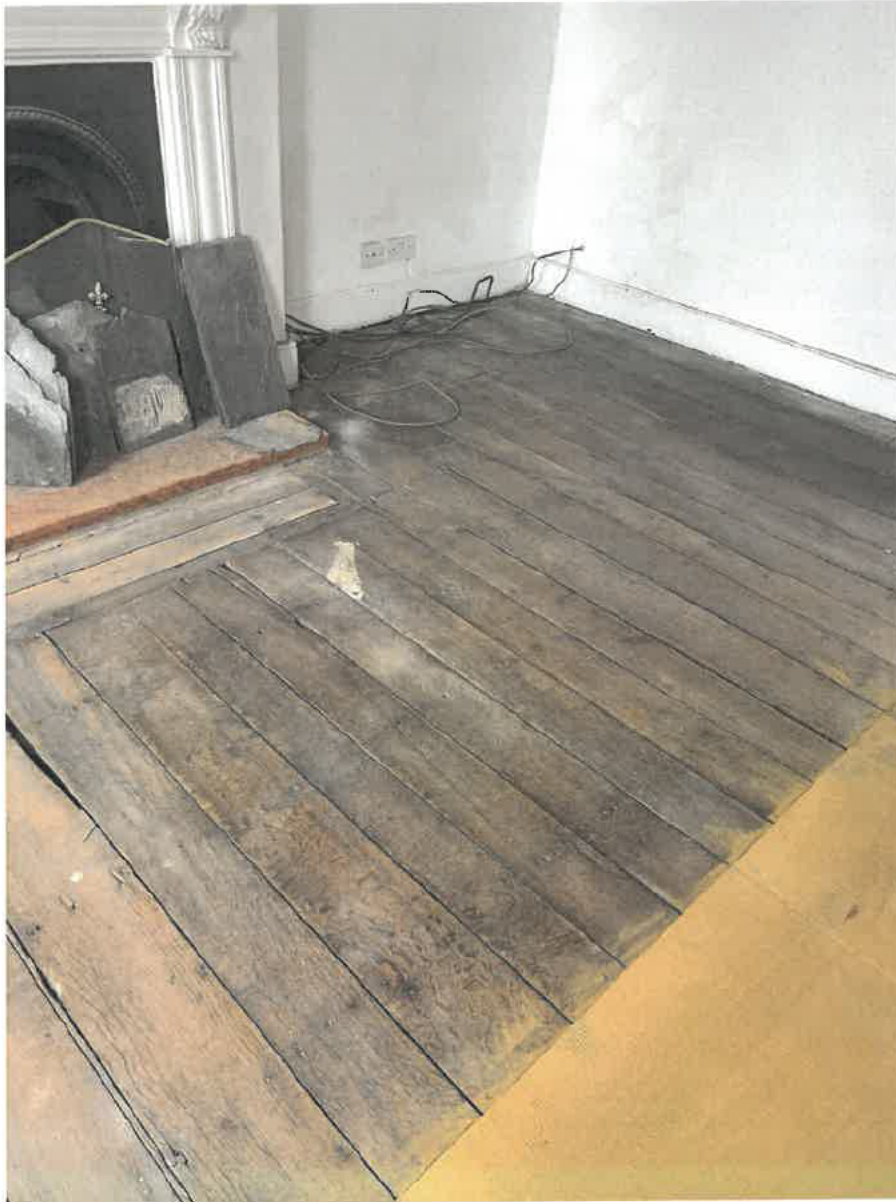
**Photograph 6 – General Condition and Unevenness**

**Observation: Additional view highlighting irregular board levels and settlement.**

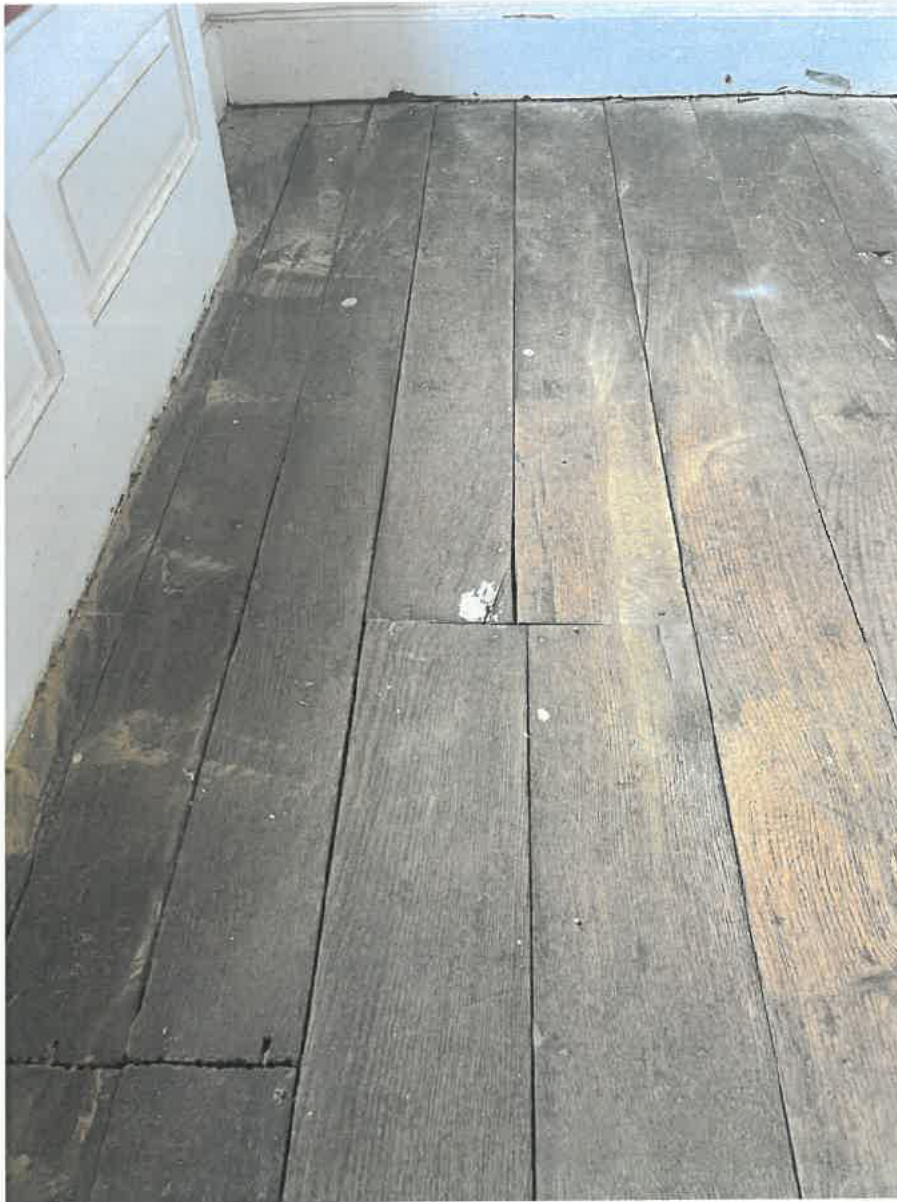
**Photograph 7 – Existing Floor Prior to Exposure**

**Observation:** Provides context to the inspection area before complete exposure of the floorboards.
