**Report No:** AA0491

## **Management Survey Report**

**33 King Street, Whalley, Lancashire, BB7 9QF**

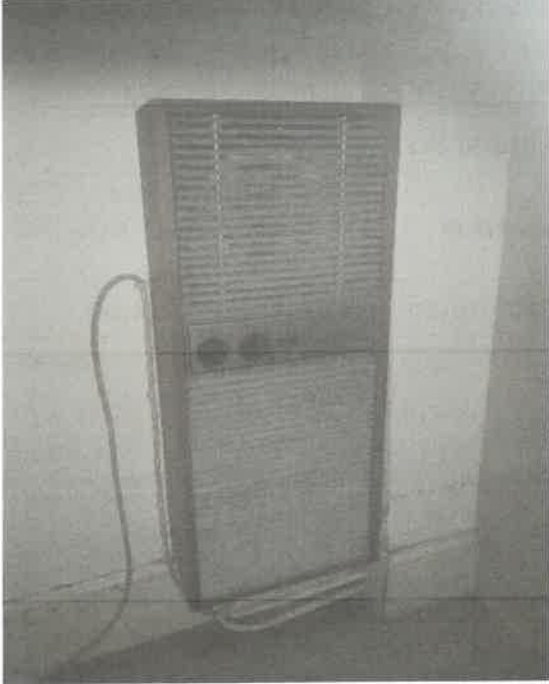
<b>Survey Ref.</b>	AA0491		
<b>ACM Ref.</b>	WOVEN/GASKETS/C/P01		
<b>Location</b>	Ground Floor - G03 - Presumed Asbestos Containing Materials Within Old Heater Fixed to Wall		
<b>Component</b>	Presumed Asbestos Textile, Presumed Asbestos Gaskets or Presumed Asbestos Cement.		
<b>Amount</b>	Small Parts		
<b>Analysis</b>	Presumed Chrysotile		
<b>Comments</b>	Access was not made into the electric heater in the hallway at the time of the survey. It is presumed that asbestos components (cement, textile, or gaskets) may be present within.		
<b>Summary of Findings</b>	The heater should be managed as potentially containing asbestos containing components. If the heater is to be removed, it should be disposed of as asbestos waste.		
<b>Material Risk Assessment</b>	<b>2 + 0 + 1 + 1 = 4 = Very Low Risk</b>		
Material Risk Assessment = PT + ED + ST + AT <span style="color: red;">High (10+)</span> , <span style="color: orange;">Medium (9-7)</span> , Low (6-5), Very Low (<4)

**Access was not made into the electric heater in the hallway at the time of the survey. It is presumed that asbestos components (cement, textile, or gaskets) may be present within. The heater should be managed as potentially containing asbestos containing components. If the heater is to be removed, it should be disposed of as asbestos waste.**

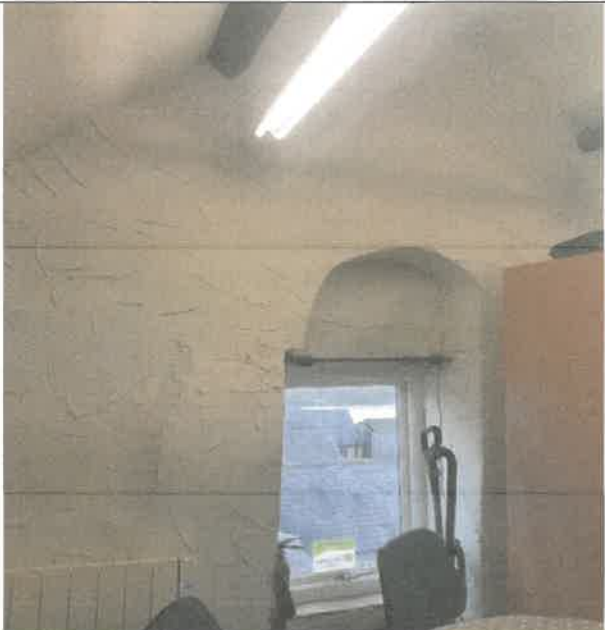
<b>Survey Ref.</b>	AA0491	
<b>Sample No.</b>	TX/01	
<b>Location</b>	Second Floor, Third Floor - 204, 301, 302 - To Walls	
<b>Component</b>	Textured Coating	
<b>Analysis</b>	Non-Asbestos	
<b>Comments</b>	Samples were taken of the textured coating in each of the rooms, and pooled into a single sample, which was analysed for the presence of asbestos.	
<b>Summary of Findings</b>	No asbestos was detected in the sample. No Action Required.

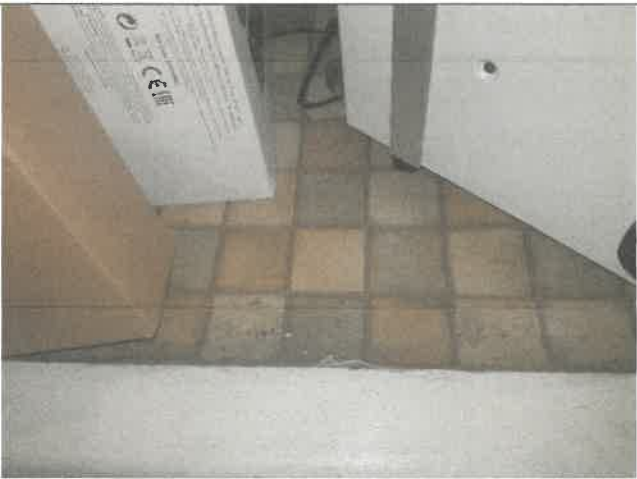
<b>Survey Ref.</b>	AA0491	
<b>Sample No.</b>	LINO/02	
<b>Location</b>	Third Floor - 301 - To Floor in 2 x Eaves Storage Spaces	
<b>Component</b>	Patterned Lino	
<b>Analysis</b>	Non-Asbestos	
<b>Comments</b>	A sample of the material was taken, and analysed.	
<b>Summary of Findings</b>	No asbestos was detected in the sample. No Action Required.

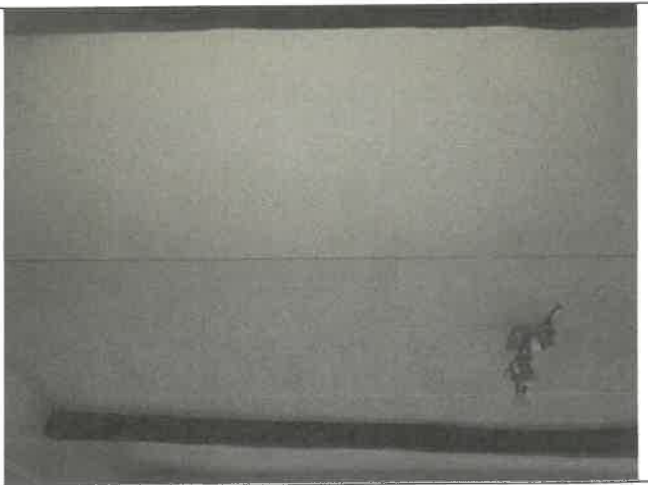
<b>Survey Ref.</b>	AA0491	
<b>Sample No.</b>	TX/03	
<b>Location</b>	Second Floor - 201 - To Ceiling	
<b>Component</b>	Textured Coating	
<b>Analysis</b>	Non-Asbestos	
<b>Comments</b>	A sample of the material was taken, and analysed.	
<b>Summary of Findings</b>	No asbestos was detected in the sample. No Action Required.

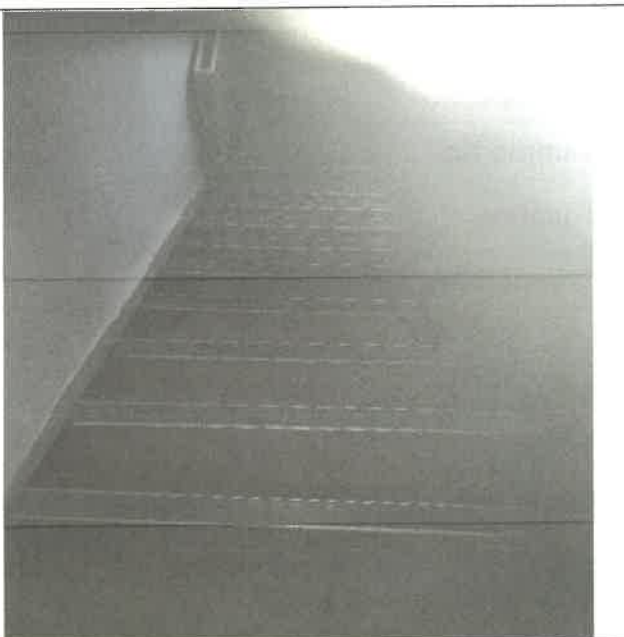
<b>Survey Ref.</b>	AA0491	
<b>Sample No.</b>	NS/04	
<b>Location</b>	Ground Floor>First Floor - G03, 102 - To Stairs	
<b>Component</b>	Brown Stair Nosing	
<b>Analysis</b>	Non-Asbestos	
<b>Comments</b>	A sample of the material was taken, and analysed.	
<b>Summary of Findings</b>	No asbestos was detected in the sample. No Action Required.

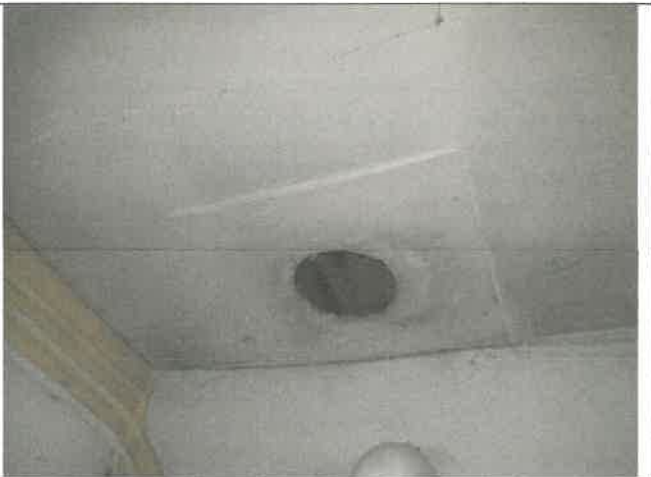
<b>Survey Ref.</b>	AA0491	
<b>Sample No.</b>	IB/06	
<b>Location</b>	Ground Floor - G07 - Board to Ceiling	
<b>Component</b>	Insulating Board	
<b>Analysis</b>	Non-Asbestos	
<b>Comments</b>	A sample of the material was taken, and analysed.	
<b>Summary of Findings</b>	No asbestos was detected in the sample. No Action Required.

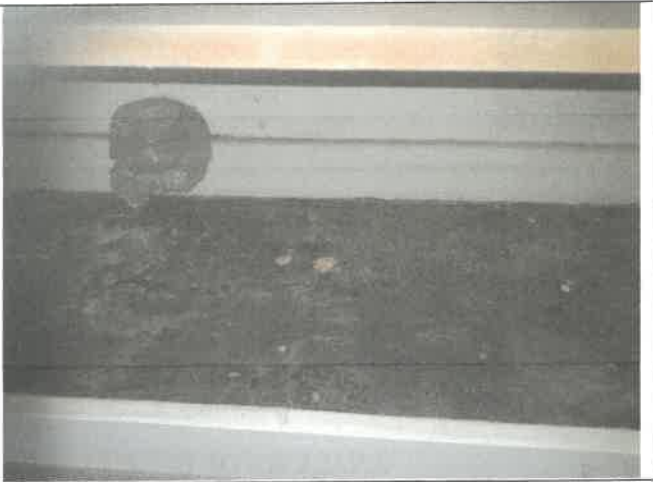
<b>Survey Ref.</b>	AA0491	
<b>Sample No.</b>	BIT/08	
<b>Location</b>	Ground Floor - G04 - To Floor in Cupboard	
<b>Component</b>	Bitumen Adhesive	
<b>Analysis</b>	Non-Asbestos	
<b>Comments</b>	A sample of the material was taken, and analysed.	
<b>Summary of Findings</b>	No asbestos was detected in the sample. No Action Required.

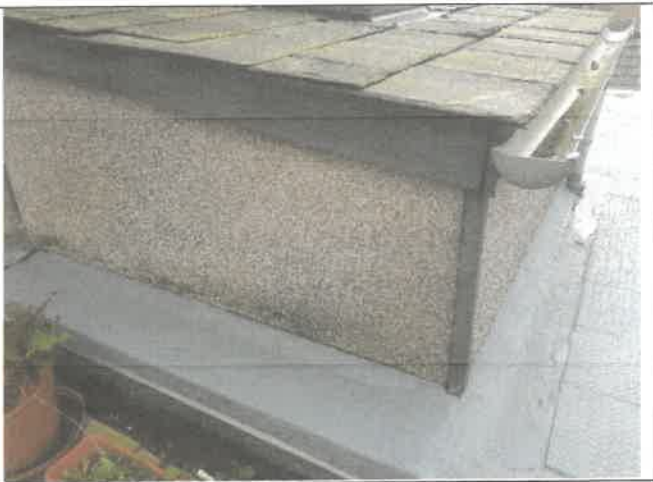
<b>Survey Ref.</b>	AA0491	
<b>Sample No.</b>	COMPOSITE/09	
<b>Location</b>	Ground Floor - Roof Level - Around Skylight	
<b>Component</b>	Composite Boards	
<b>Analysis</b>	Non-Asbestos	
<b>Comments</b>	A sample of the material was taken, and analysed.	
<b>Summary of Findings</b>	No asbestos was detected in the sample. No Action Required.
