# Fells Farm

# Structural Survey

Client: Zara Moon Architects  
Author: Victoria Triay  
Date: 31/03/2025  
Reference: 23375-PWA-ZZ-ZZ-RP-S-3300-A01

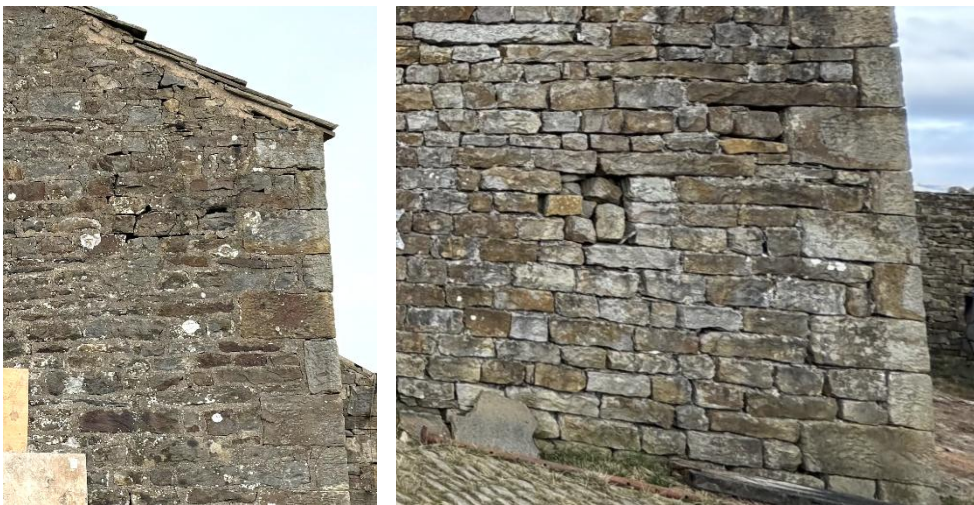
The existing stone walls measured 540mm to 570mm in thickness and generally appear in reasonable condition. There are some areas of loose or missing mortar around the external areas of the property and some areas where individual stones were loose as a result of weathering due to the age of the property.

*Figure 1 Missing mortar and loose stone externally*

There are areas of the external walls that require re-mortaring due to missing mortar and loose stone. This is likely to be more extensive locally than repointing (which will be required throughout) and localised removal of masonry units should be anticipated.

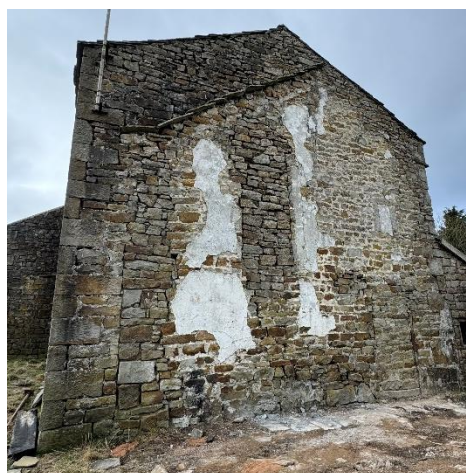
There appears to have been an extension to the side of the building that has been removed. There are still remnants of the internal rendering and the roof tiles remain embedded in the elevation.

*Figure 2 Removed side extension*

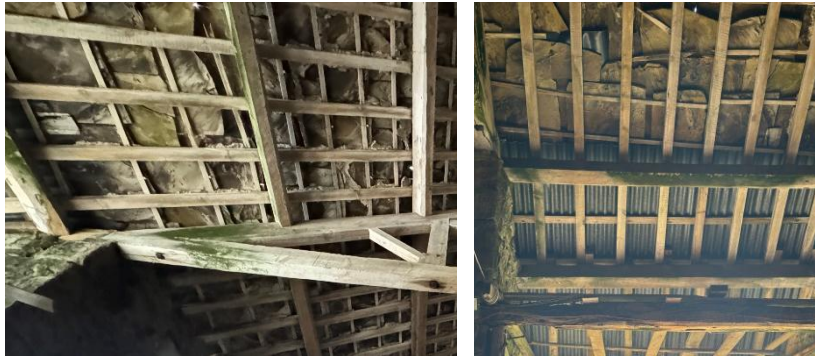
The timber trusses appear to be in a generally good condition with the exception of the area next to the main barn door, in the double height area, which appears weathered due to the barn not being properly sealed and subject to water ingress.

*Figure 3 Weathered timber truss and beam in main entrance*

A full survey of the timber roof should be completed by a timber / damp specialist to ensure no defects have been missed from inspecting the roof from the ground. In particular the weathered timber trusses and timber beams by the barn entrance door should be inspected and may require treatment or repairs subject to the result of the specialist surveys.

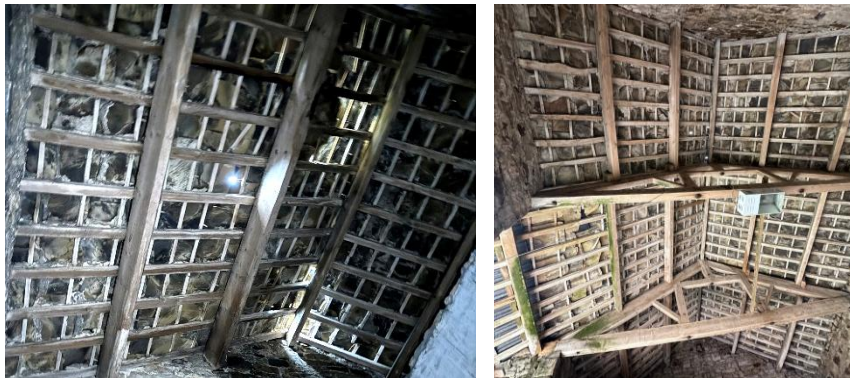
There are areas of the roof where there appear to be missing tiles, observed only due to light shining through. At the time of our inspection, the weather was overcast, so the roof tile defects may be more extensive than is observed/reported.

*Figure 4 Light shining through roof in areas*

The roof tiles will have to be removed to bring the roof to modern standards and properly weatherproofed to ensure no further water damage occurs to the roof structure. The existing tiles could be reused if found in adequate state when removed, with any suitable replacement tiles introduced in line with any planning approval.

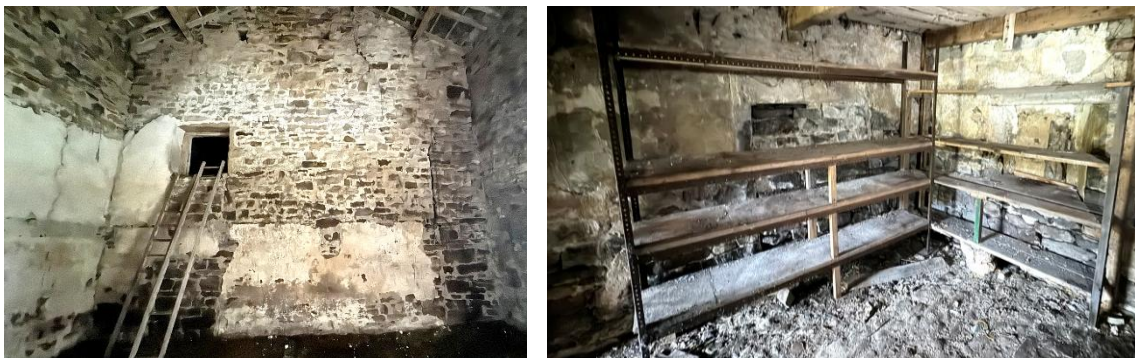
The walls have remnants of rendering/plasterwork throughout most of the internal walls.

*Figure 5 Light shining through roof in areas*

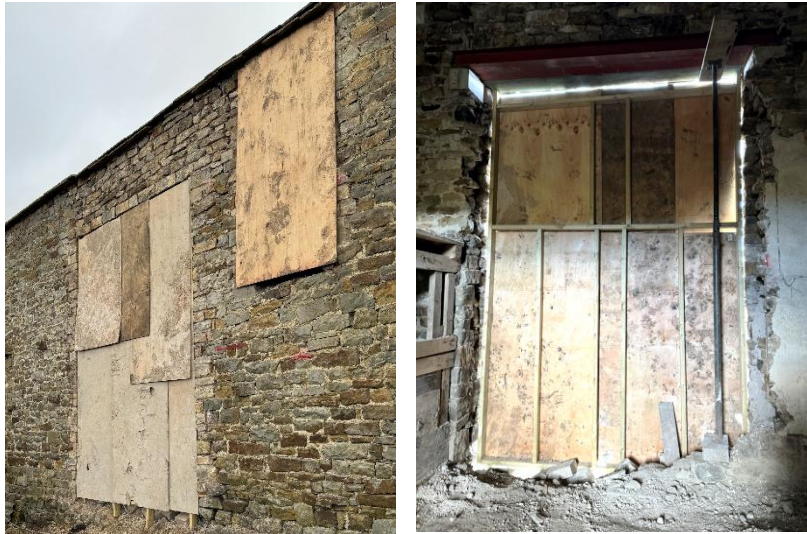
Openings have been undertaken to the property in the past, forming a larger opening at the rear and the side with a couple of small openings formed at high level. The openings have not been dressed formally to the sides and so is subject to degradation over time if left unattended.

*Figure 6 Past openings*

The openings require finishing properly along the sides to ensure a straight wall on either side of each one of the openings. The openings will need to be properly sealed to allow for a habitable space in the barn.
