# Preliminary Roost Assessment

Thornlee  
Whalley Road  
Clitheroe  
BB7 9LG

For  
John Hargreaves

# Gritstone Ecology

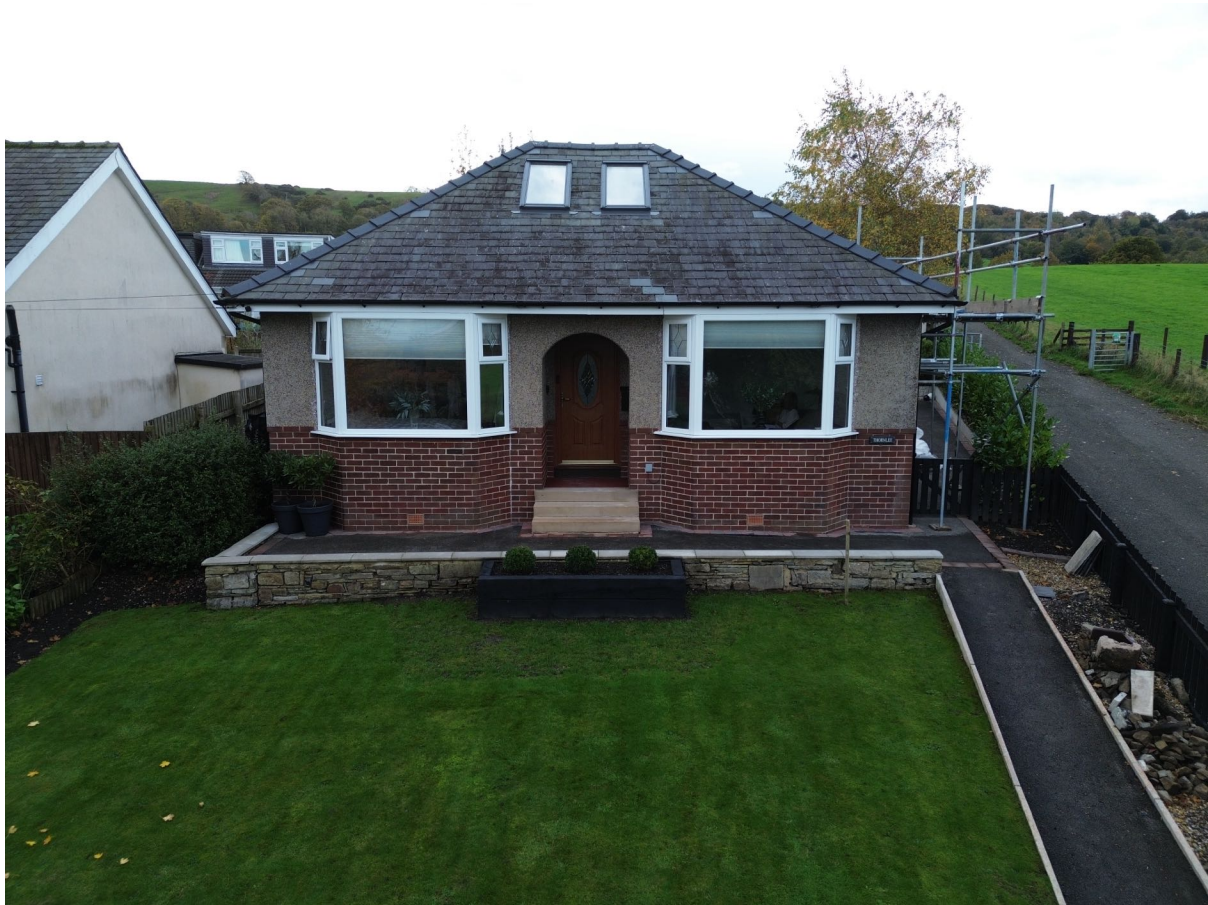
3.1a – The front of the house.

The building is well maintained, and in good condition. Ridge tiles are fixed tightly, there are no damaged or missing ridge tiles. There are no damaged, slipped, or missing roof tiles. Roof tiles are tightly fitted, with no gaps between tiles. Fascia boards and boxed soffits are fitted tightly against the walls gaps are filled with sealant. Walls and render are in good condition, with no missing mortar or cracks.

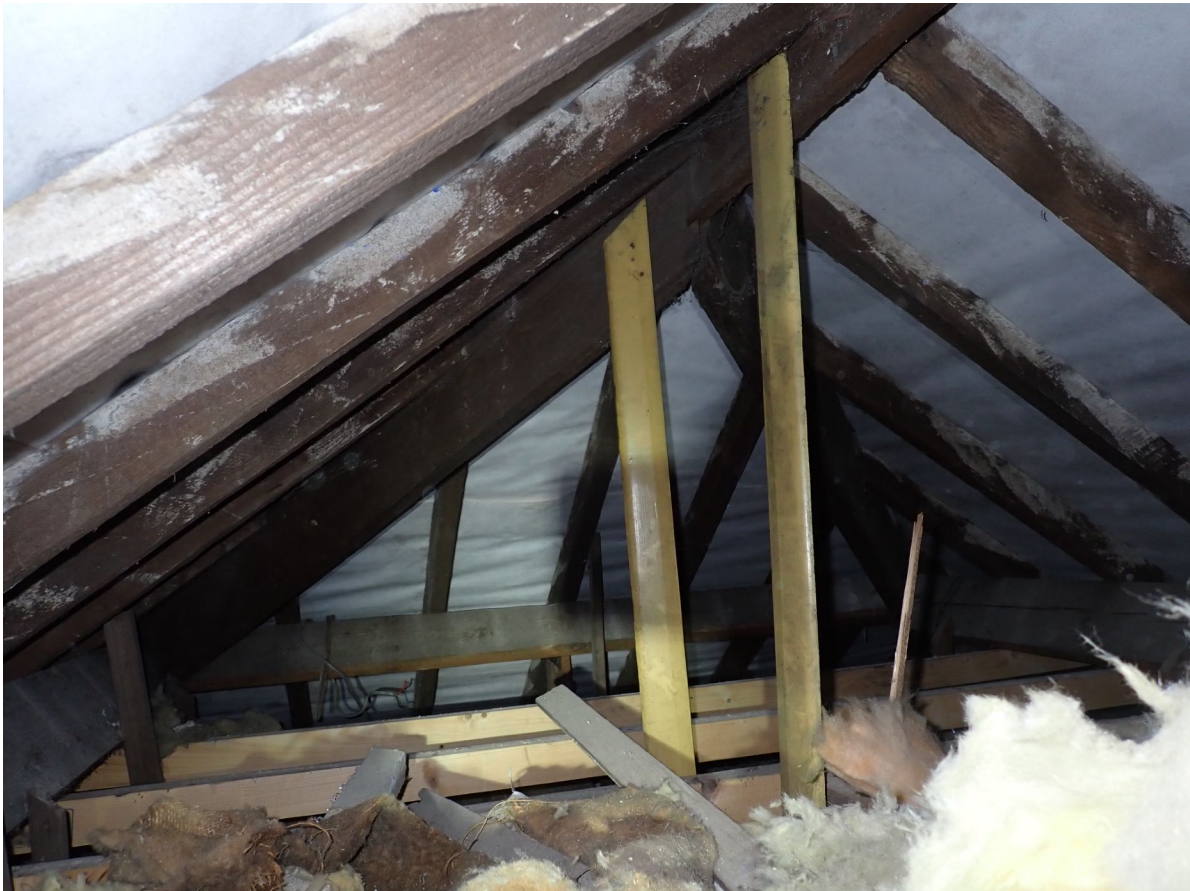
3.2a – The roof void.

The main central area of the roof void has been converted to liveable space. There are small crawl spaces at the eaves, and a small void to the rear of the house, which were inspected in detail. These areas are not used for storage, and are accessed infrequently for essential maintenance works.

The roof has a timber rafter and purlin structure, lined with a modern breathable membrane, and insulated with mineral wool between the ceiling joists. The roof lining is in good condition with no tears, or gaps.

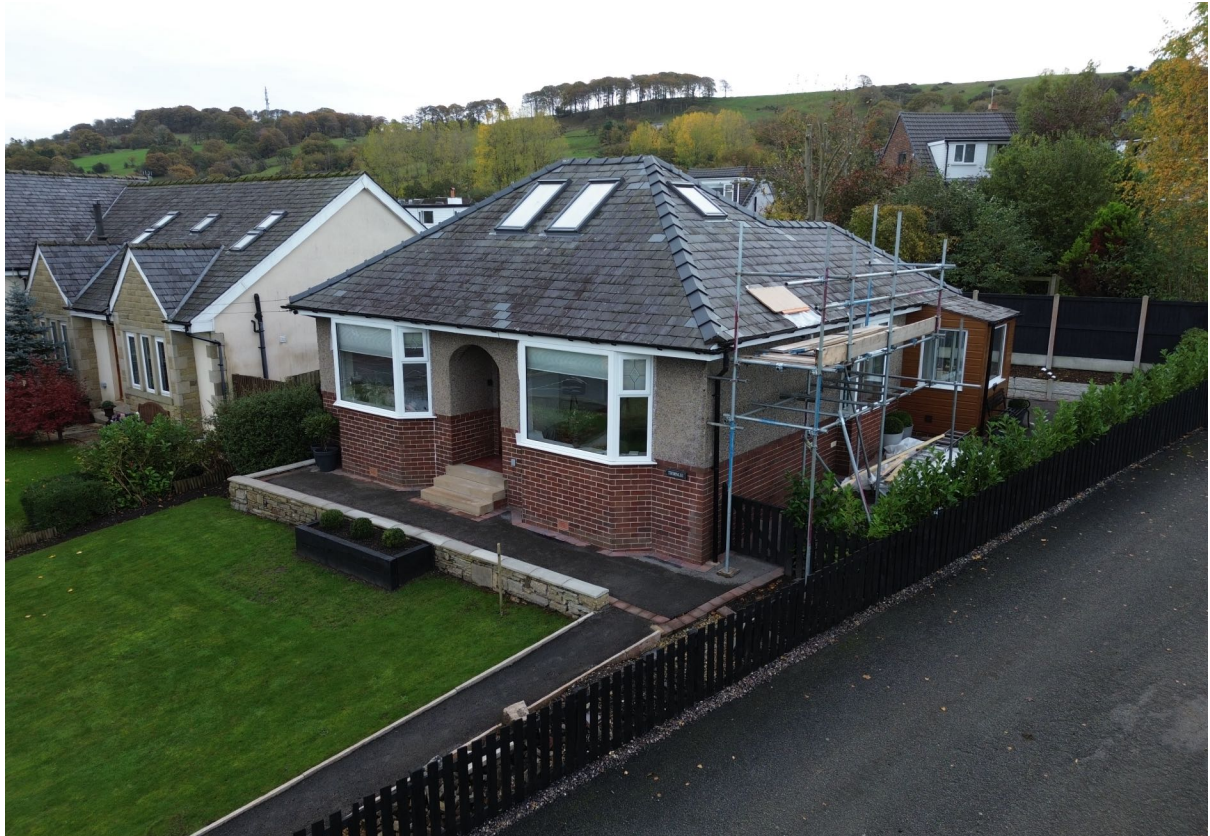
1 – The front of the house.

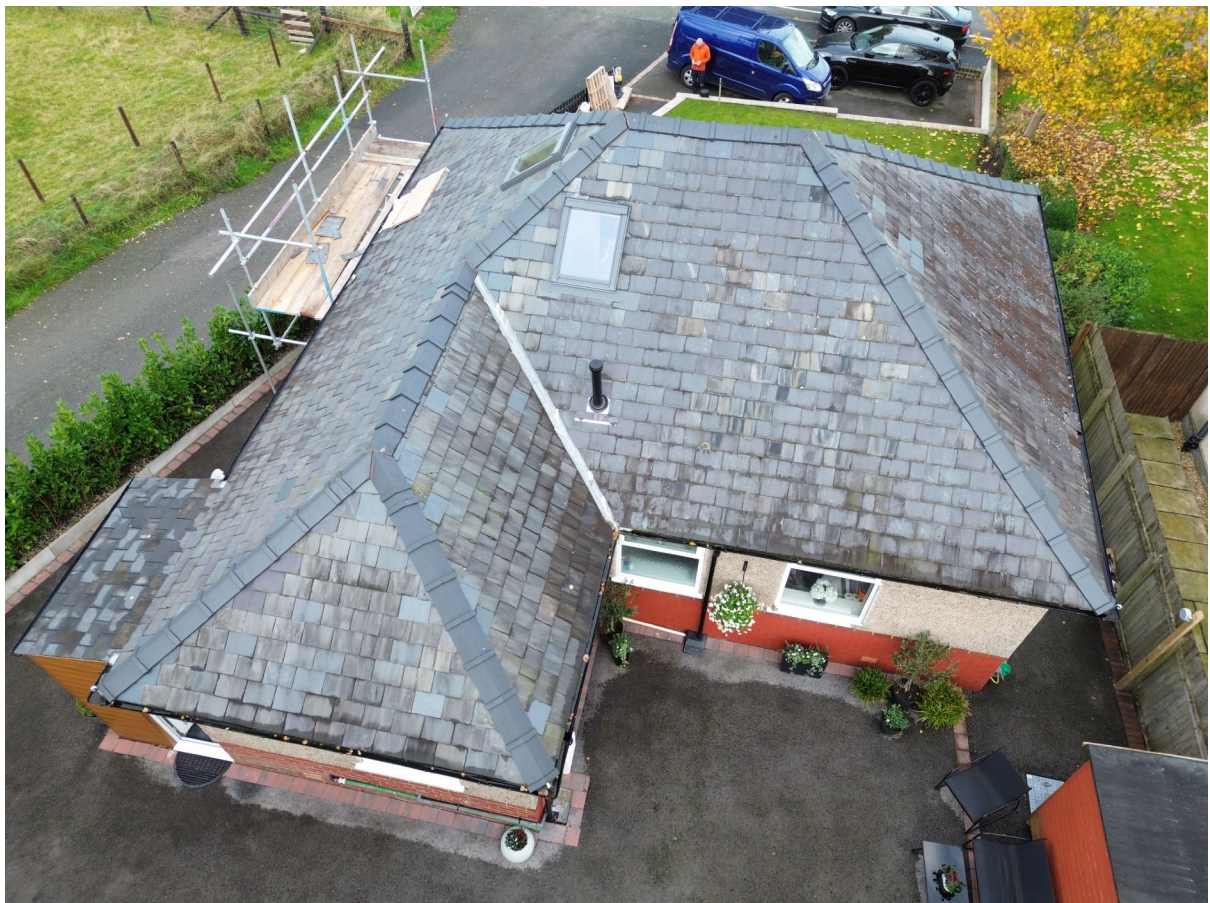
2 – The rear of the house.

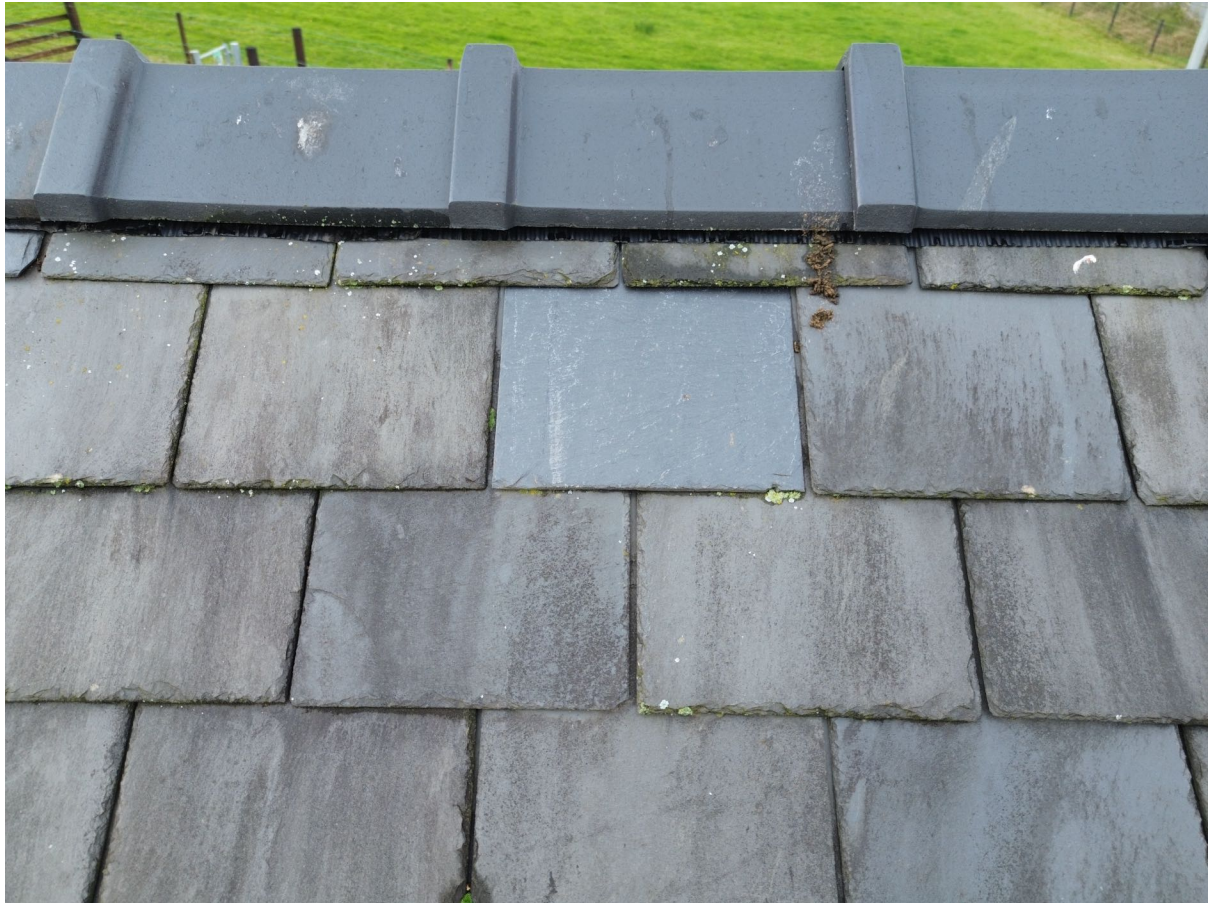
Roof and ridge tiles are in good condition; ridge tiles are mechanically fixed. There are no gaps between roofing materials which could be used by roosting bats.

3 – Roof and ridge tiles are in good condition with no suitable gaps.

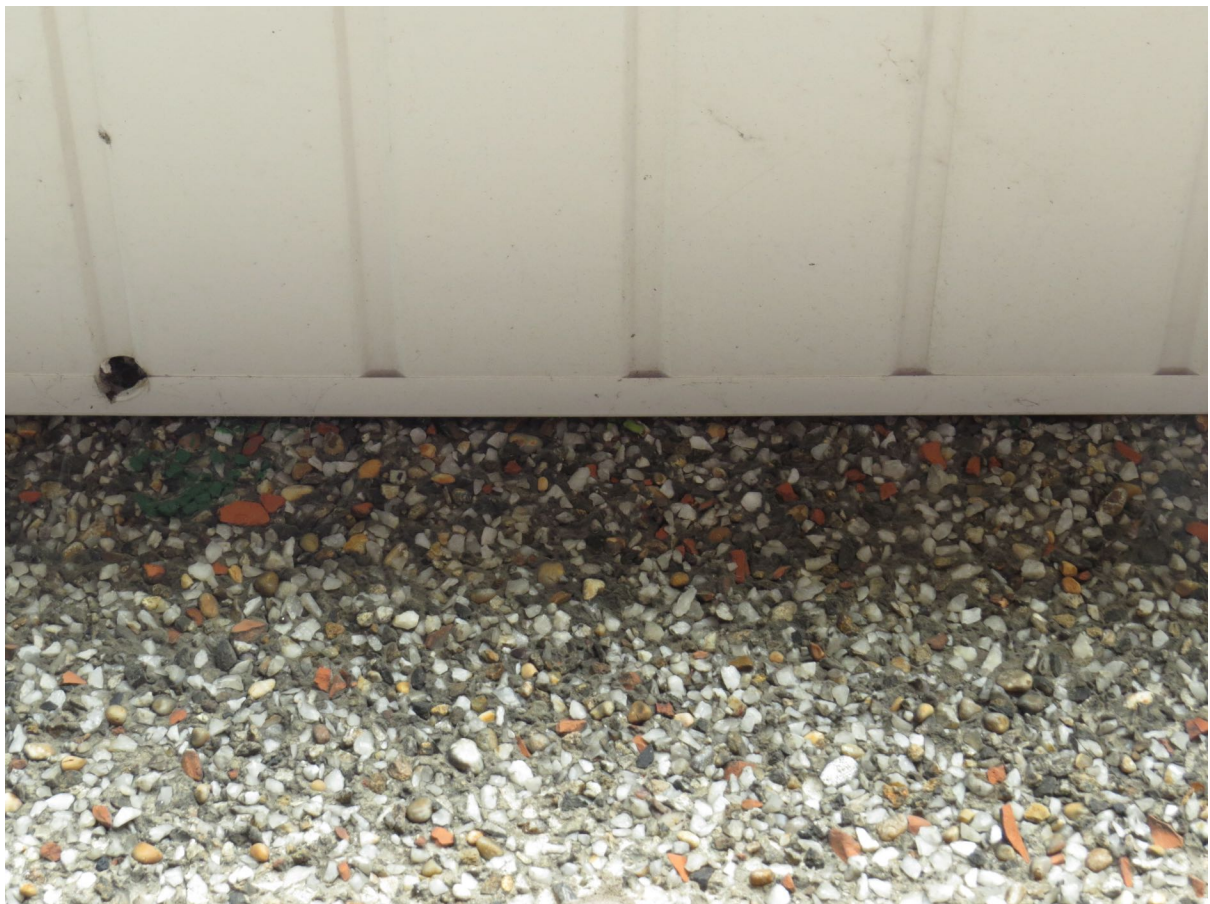
Fascia boards and boxed soffits at the eaves are fixed tightly against brickwork, with no suitable gaps; wall cavities and boxed soffits open into the roof void, and were inspected from above.

4 – Fascia boards and soffits at the eaves are fixed tightly against brickwork.

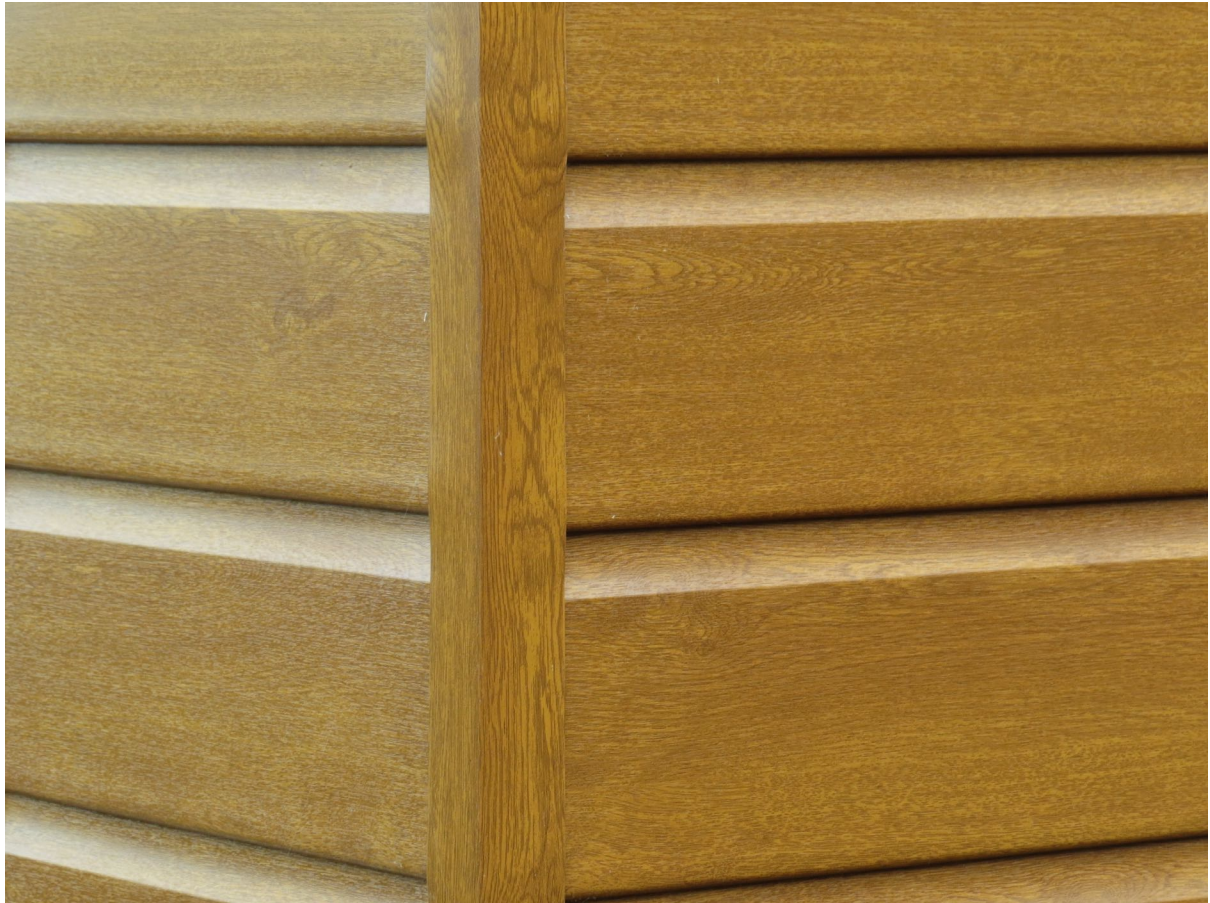
5 – Cladding on the rear extension is fitted tightly with no suitable gaps.

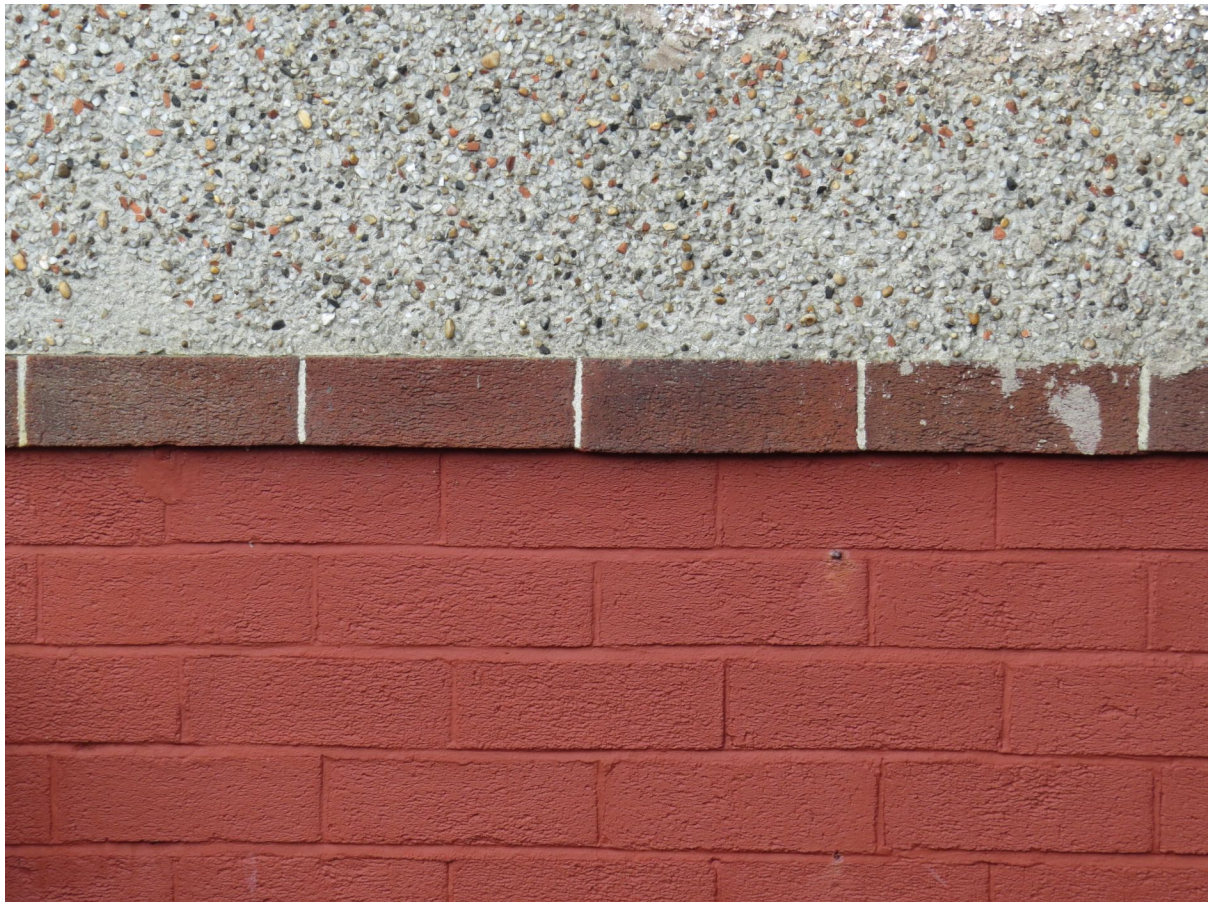
Walls are brick with an insulating cavity, the wall cavity has been filled with insulation. Walls and render are in good condition, with no cracks, or missing mortar which could be used by crevice dwelling bats.

6 – Brickwork and render are in good condition with no suitable gaps.

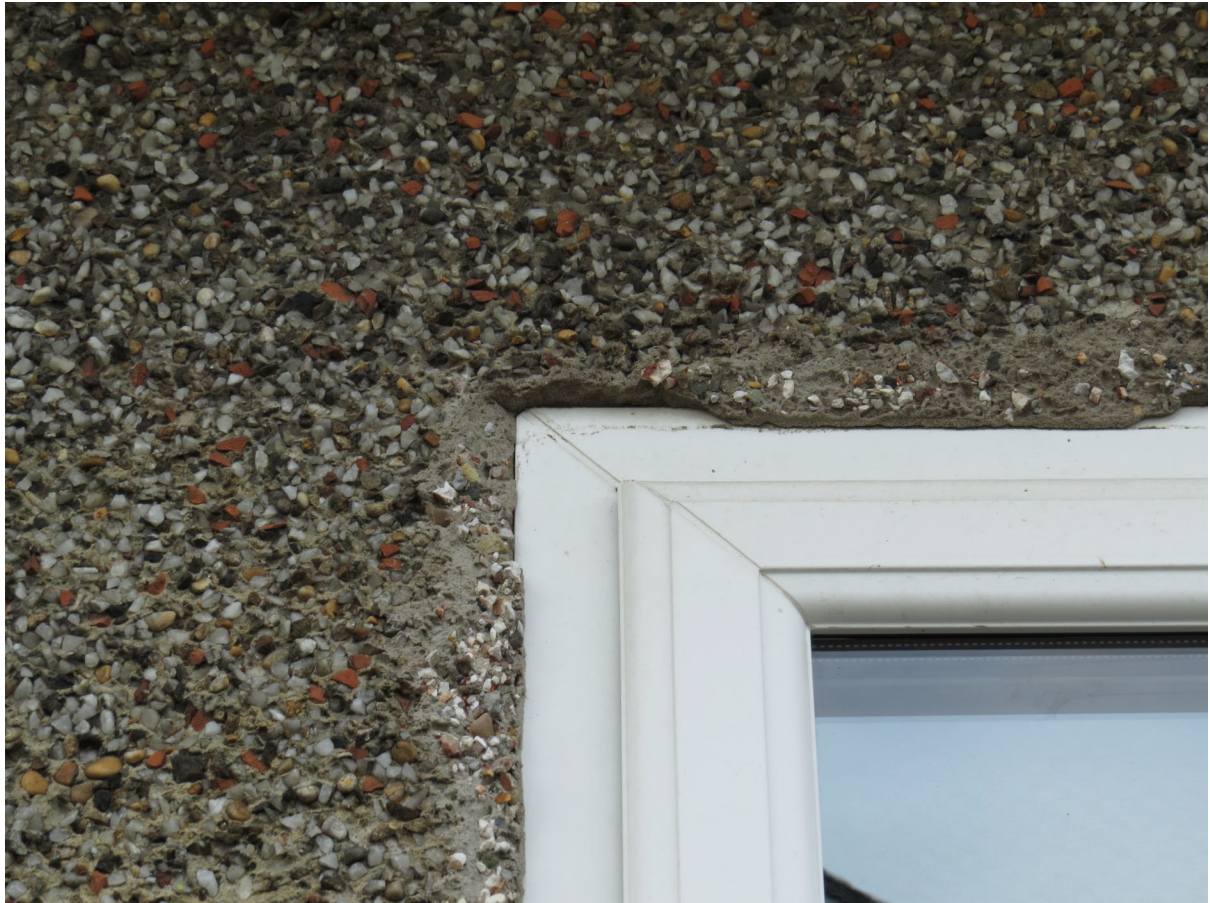
Window and door frames are fixed into the brickwork, gaps are filled with sealant, and offer no suitable roosting opportunities.

7 – Window and door frames are tightly sealed into brickwork with no suitable gaps.

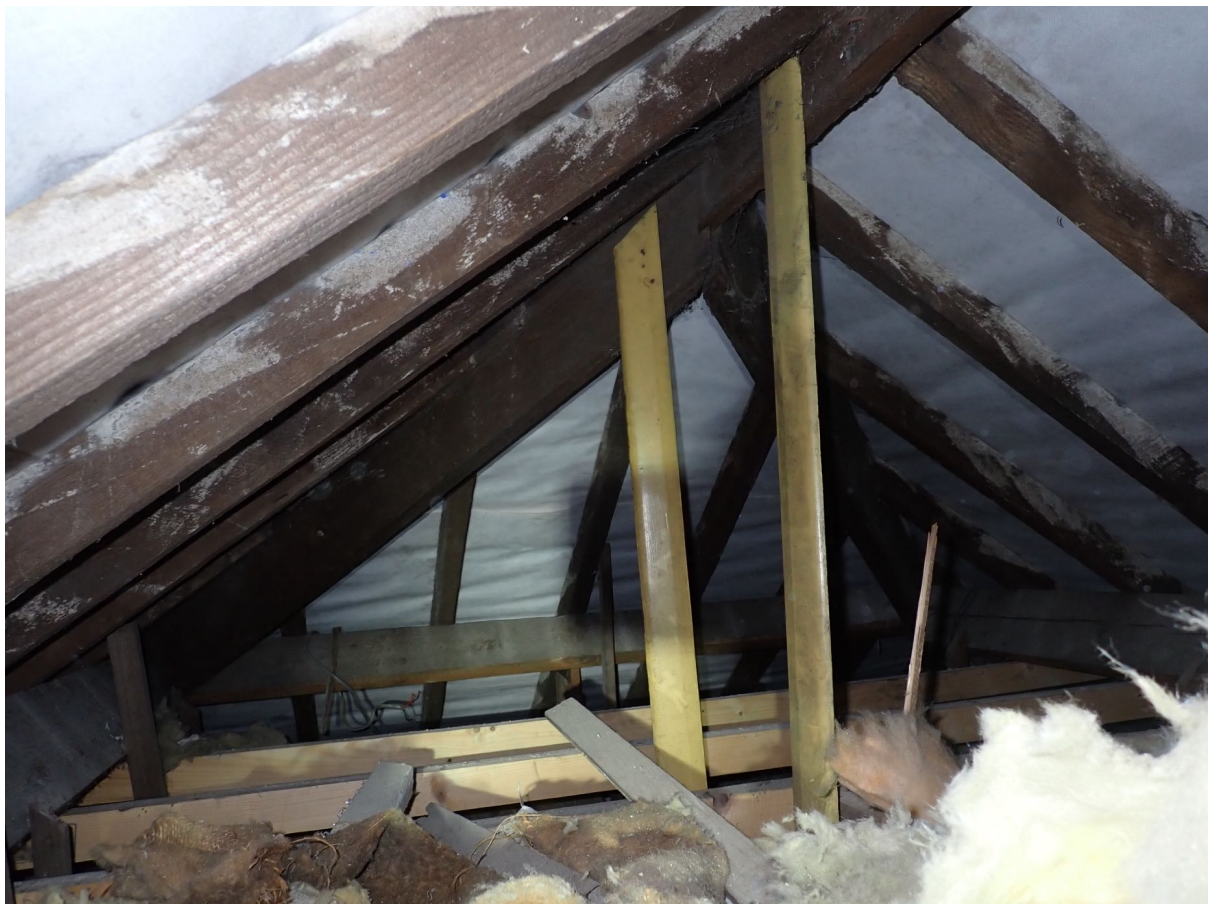
8 – The small roof void to the rear of the house.

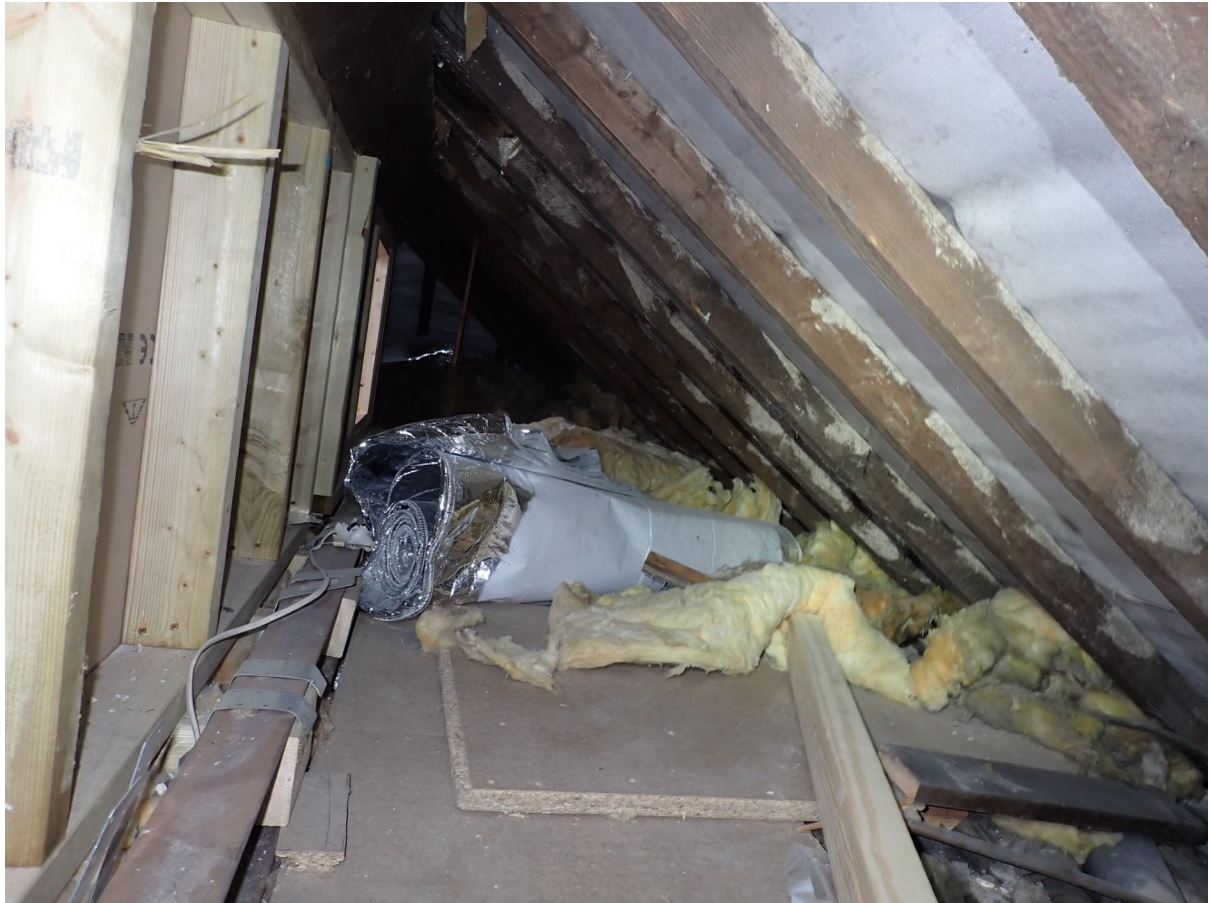
9 – Crawl spaces at the eaves.

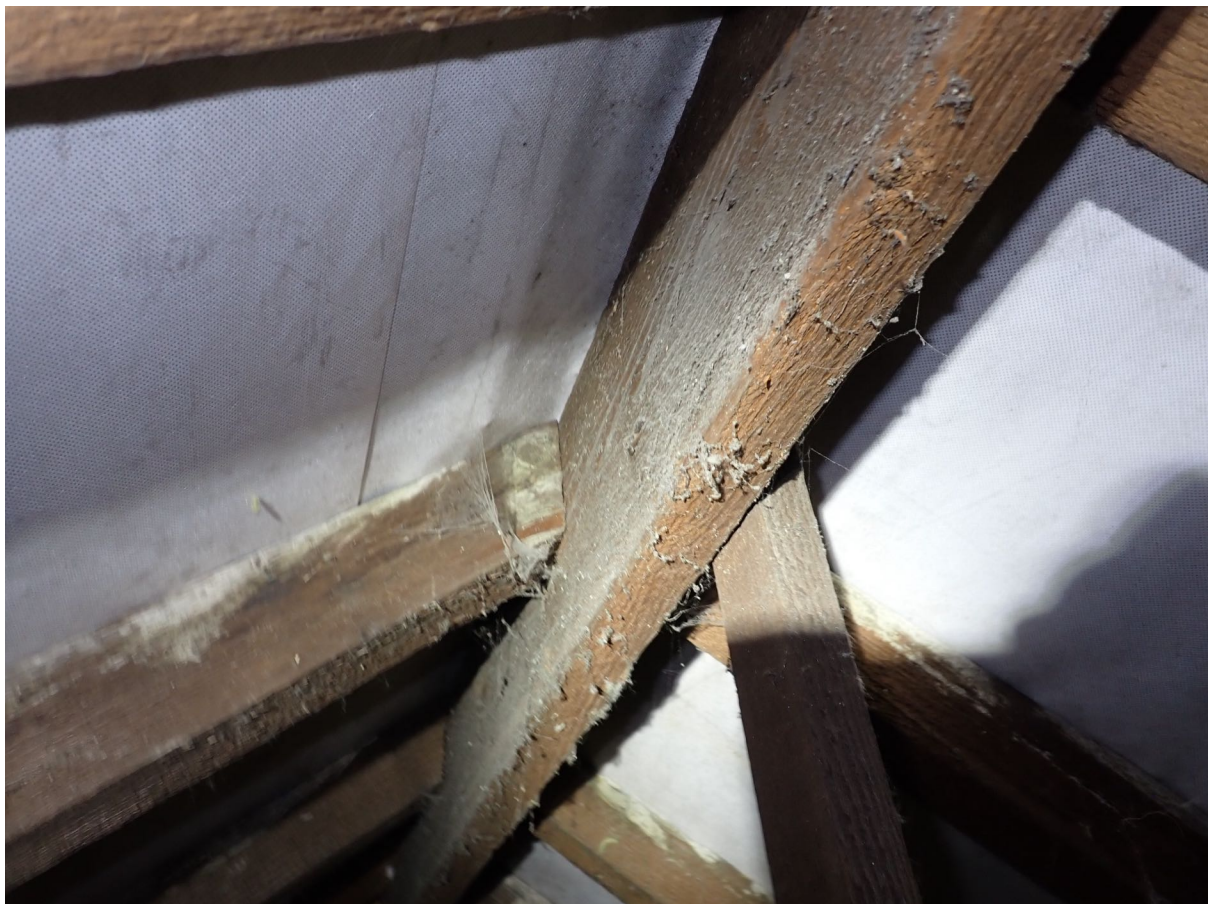
10 – Roof lining is in good condition with no gaps or tears.
