Document name: 19310-EDGE-XX-XX-CO-C-0003_DRAINAGE VERIFICATION AND MAINTENANCE[P01]

Re: 19310 – VERIFICATION REPORT & OPERATION AND MAINTENANCE PLAN FOR SURFACE WATER DRAINAGE SYSTEM

Project**Project Name:** 2023-06-20463 Persimmon Hawthorne Clitheroe**Project Date:** 17/07/2023**Inspection Standard:** MSCC5 Sewers & Drainage GB (SRM5 Scoring)

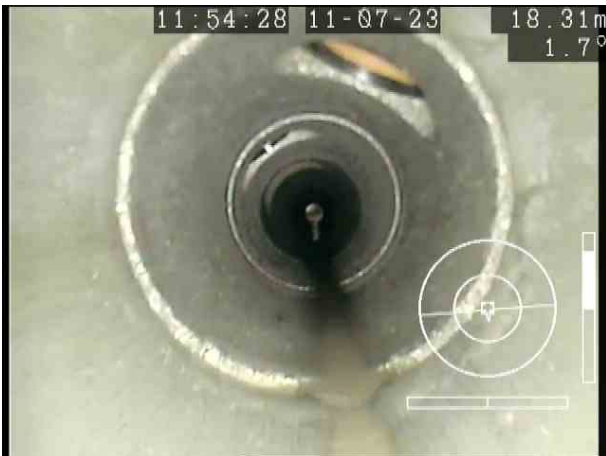
S2X_ffbca896-0bb1-4b80-b5e5-772db8491e15_20230717_12
 2915_899.jpg, 00:00:57, 18.31 m
 Connection other than junction at 01 o'clock, 150mm dia

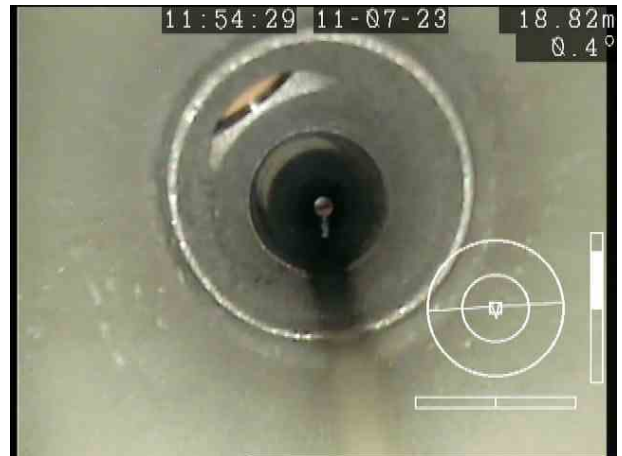
S2X_8f0c81a6-8968-4cf2-b07d-1b411f1828a0_20230717_12
 2925_635.jpg, 00:00:58, 18.82 m
 Connection other than junction at 11 o'clock, 150mm dia

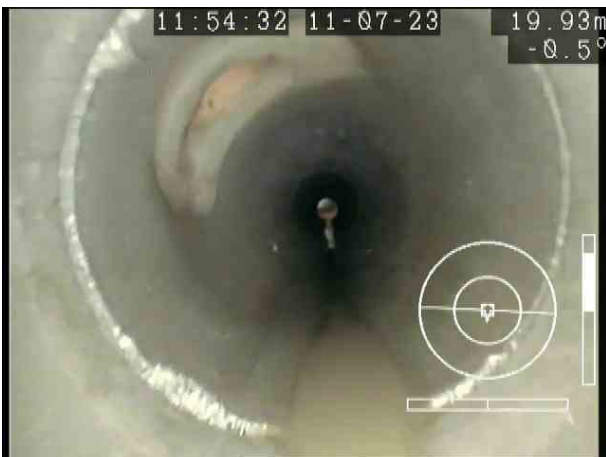
S2X_of3c6b7a-adf1-44ce-ac15-979ad2b0b05e_20230717_12
 2945_776.jpg, 00:01:02, 19.93 m
 Connection other than junction at 11 o'clock, 150mm dia

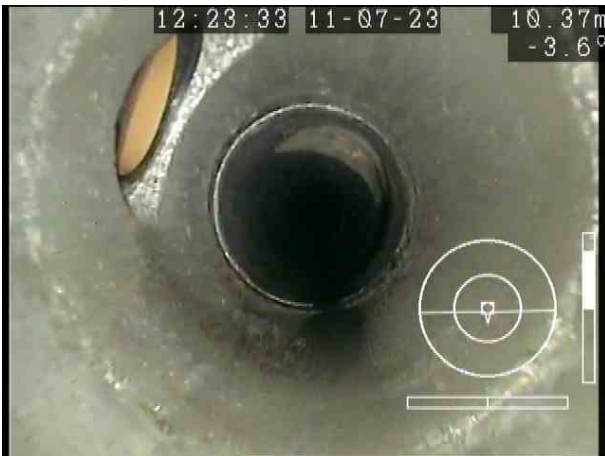
S3X_816e11e9-31f4-4a41-8603-53dc22ac2779_20230717_123231_169.jpg, 00:00:53, 10.37 m
Connection other than junction at 10 o'clock, 150mm dia

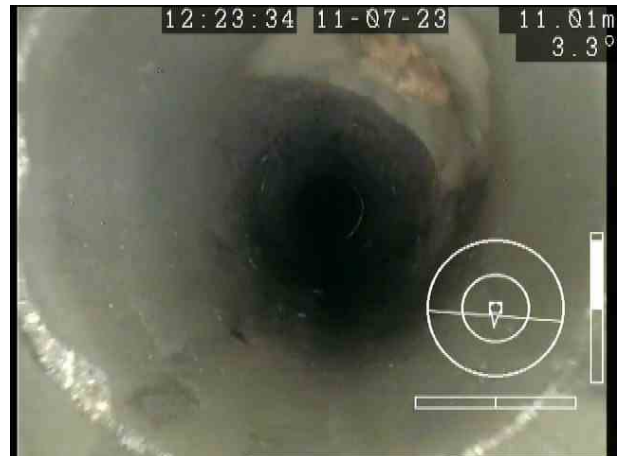
S3X_98c9a4b4-a209-4956-9b42-1767c74ca4a3_20230717_123240_424.jpg, 00:00:55, 11.00 m
Connection other than junction at 01 o'clock, 150mm dia

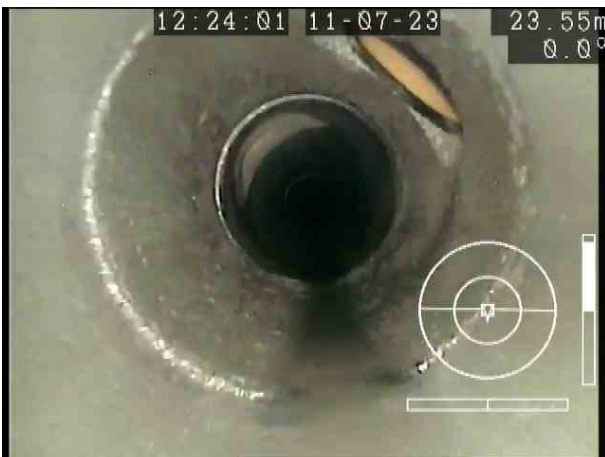
S3X_ee4444db-2ec5-44ed-8ab8-d22c893cef62_20230717_123258_625.jpg, 00:01:20, 23.55 m
Connection other than junction at 02 o'clock, 150mm dia

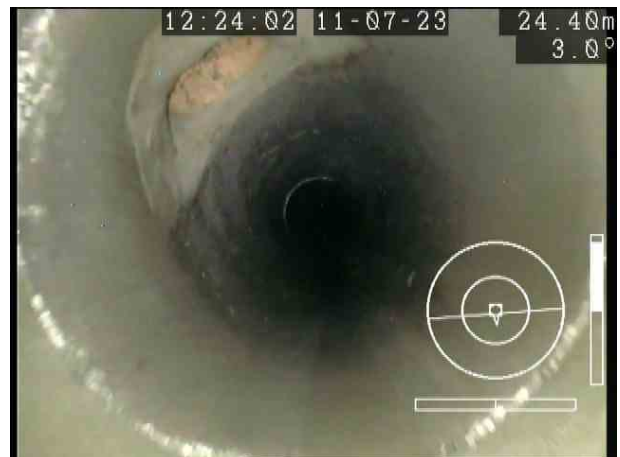
S3X_c6c7fd8f-4725-4563-99ff-85b4c7b35617_20230717_123310_143.jpg, 00:01:22, 24.40 m
Connection other than junction at 10 o'clock, 150mm dia

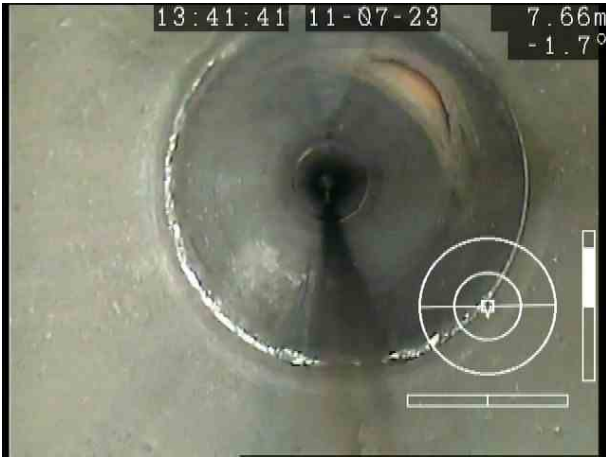
S4X_64431a07-b02a-4f5f-9758-9be73cdd54e8_20230717_123442_232.jpg, 00:00:29, 7.66 m
 Connection other than junction at 01 o'clock, 150mm dia

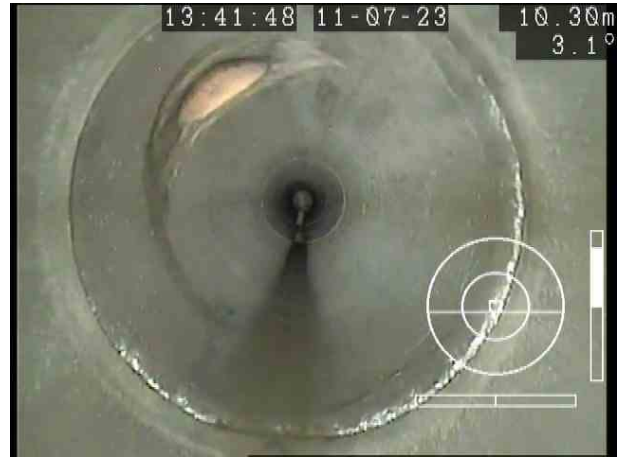
S4X_3fdf9f87-7101-4f60-a99d-2fdb90cd1ef5_20230717_123452_778.jpg, 00:00:36, 10.30 m
 Connection other than junction at 10 o'clock, 150mm dia

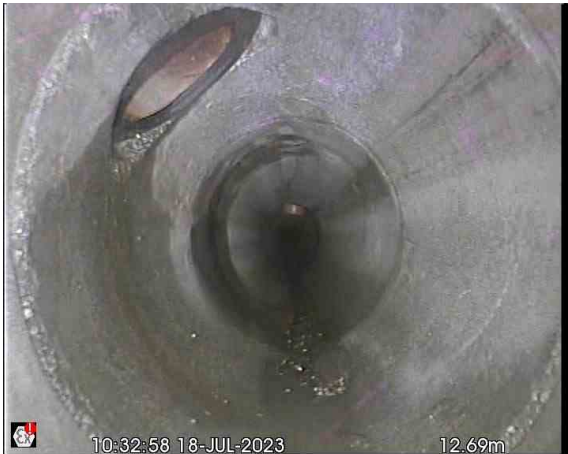
S15X_3e7e19de-77be-4fa0-ac92-c44a97039f94_20230719_083708_111.jpg, 00:01:01, 12.69 m
 Connection other than junction at 10 o'clock, 150mm dia

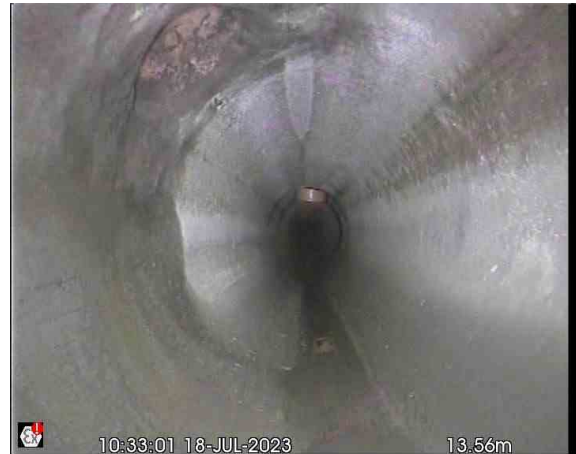
S15X_b453d0a2-4c1b-432a-ad0f-cc587732be68_20230719_083720_022.jpg, 00:01:03, 13.56 m
 Connection other than junction at 11 o'clock, 150mm dia

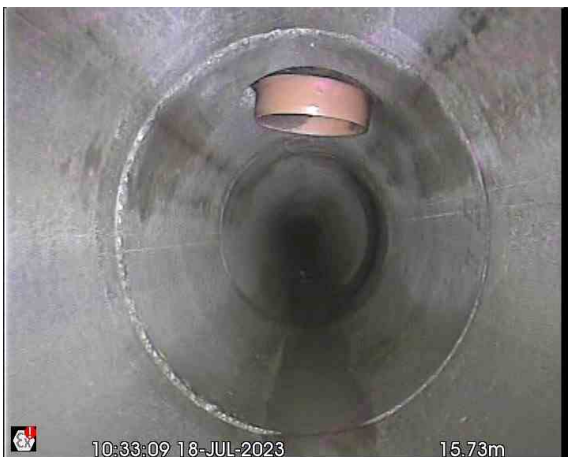
<table><tr> <td>0.00</td> <td>MH</td> <td>Start node, manhole, reference: S15</td> <td>00:00:00</td> <td></td> <td></td> </tr><tr> <td>15.73</td> <td>CXI</td> <td>Connection defective, connecting pipe is intruding at 12 o'clock, 150mm dia, intrusion: 10%</td> <td>00:01:12</td> <td>S15X_83803eba-5f3c-427b-a5</td> <td>3</td> </tr></table>

S15X_83803eba-5f3c-427b-a586-ab6f81f50a07_20230719_083737_463.jpg, 00:01:12, 15.73 m
 Connection defective, connecting pipe is intruding at 12 o'clock, 150mm dia, intrusion: 10%

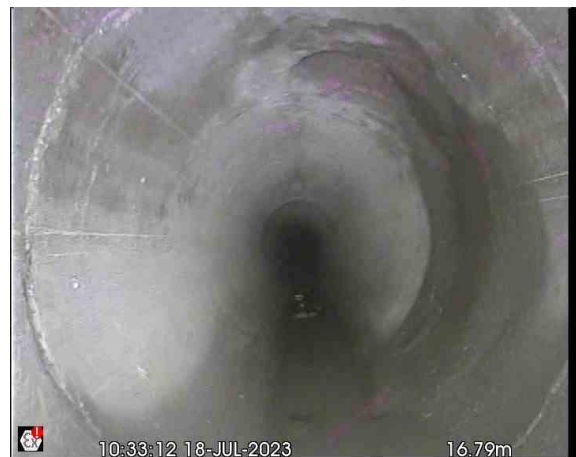
S15X_3a217687-8e4a-422f-986b-ab51f2207361_20230719_083801_945.jpg, 00:01:15, 16.79 m
 Connection other than junction at 01 o'clock, 150mm dia

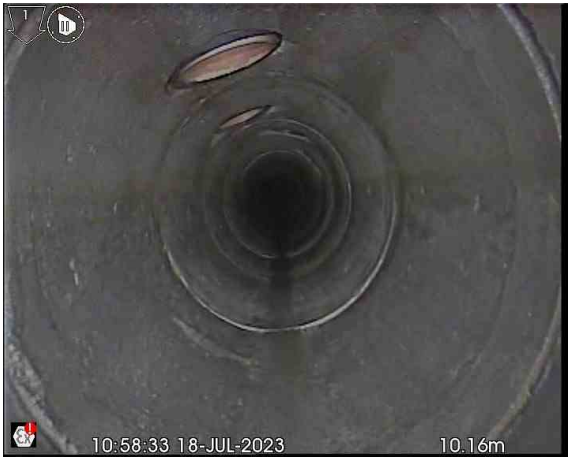
S5X_69482780-32c4-47c2-a862-55adb0e7964c_20230719_083845_973.jpg, 00:00:45, 10.16 m
Connection other than junction at 11 o'clock, 150mm dia

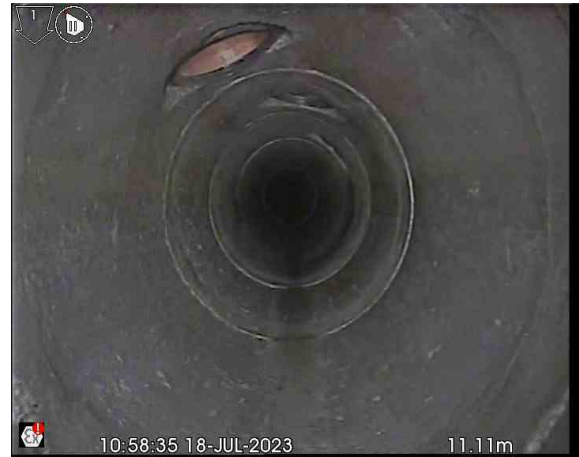
S5X_933ea363-1bea-4514-a186-d870029a2deb_20230719_083855_801.jpg, 00:00:46, 11.11 m
Connection other than junction at 11 o'clock, 150mm dia

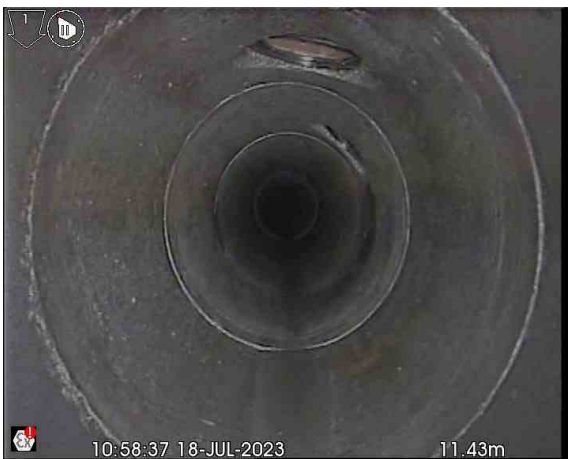
S5X_464e9282-bcda-4122-a6a9-0c10dc12b58a_20230719_083904_800.jpg, 00:00:49, 11.43 m
Connection other than junction at 01 o'clock, 150mm dia

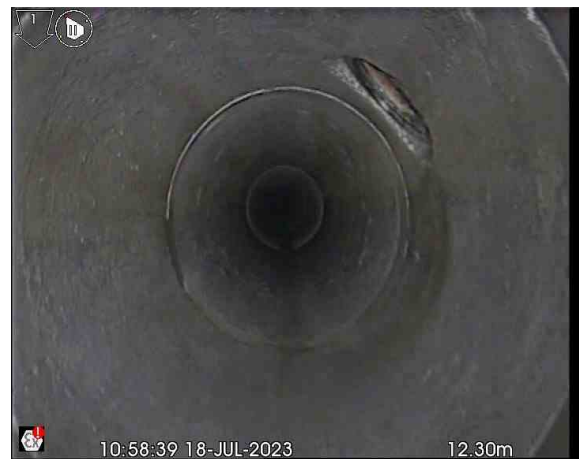
S5X_f910e798-03df-476f-bd0b-94fccaa5d9d2_20230719_083915_260.jpg, 00:00:50, 12.30 m
Connection other than junction at 01 o'clock, 150mm dia

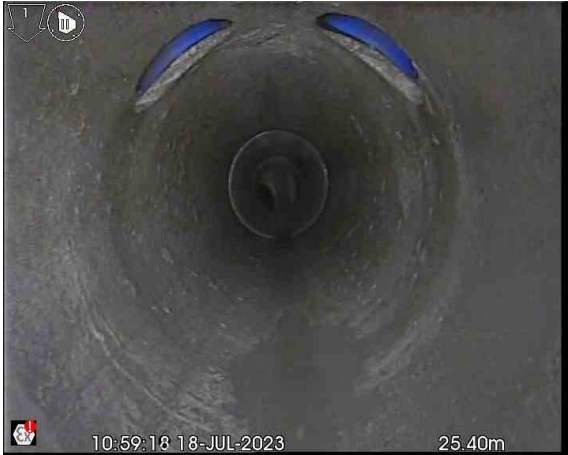
S5X_aa5db9e7-ef72-4a2f-8741-cb38c19b37ec_20230719_083947_037.jpg, 00:01:31, 25.40 m
 Connection other than junction at 01 o'clock, 150mm dia

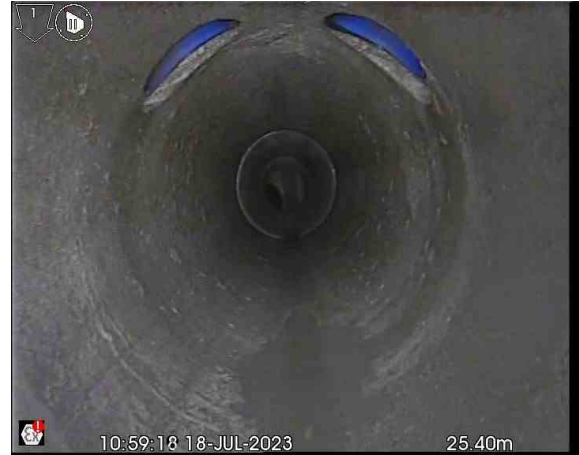
S5X_97b800b8-6e34-46ba-a3b3-74080f5063b7_20230719_083955_518.jpg, 00:01:31, 25.40 m
 Connection other than junction at 11 o'clock, 150mm dia

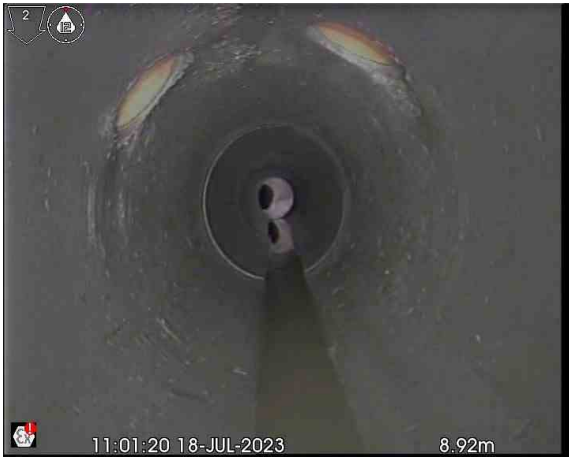
S6X_f8838de4-89cb-4f05-95ca-006372961c53_20230719_084033_836.jpg, 00:00:38, 8.92 m
Connection other than junction at 01 o'clock, 150mm dia

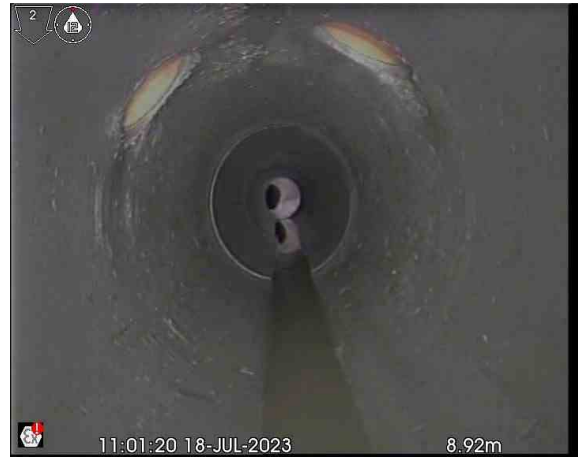
S6X_551f594b-43de-430f-9638-d64102814dd4_20230719_084042_289.jpg, 00:00:38, 8.92 m
Connection other than junction at 10 o'clock, 150mm dia

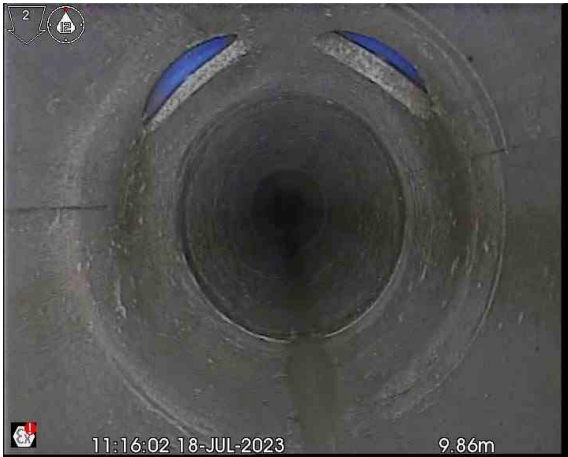
S16X_b406b9c5-5266-463f-8d7f-39144229c92f_20230719_084132_259.jpg, 00:00:42, 9.86 m
 Connection other than junction at 01 o'clock, 150mm dia

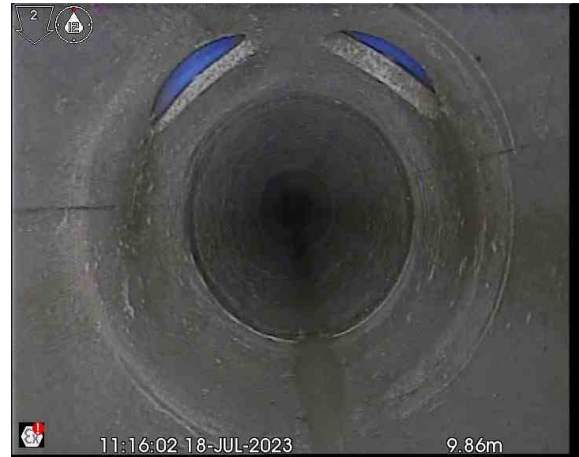
S16X_c7a32aba-50f1-48eb-b9cd-40a971cfac98_20230719_084141_165.jpg, 00:00:42, 9.86 m
 Connection other than junction at 11 o'clock, 150mm dia

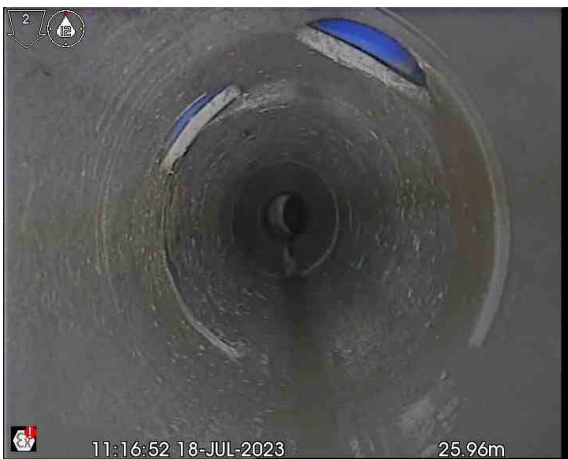
S16X_b6dadf70-05bf-4ba6-aeb6-a05bbb3c8f39_20230719_084200_104.jpg, 00:01:33, 25.96 m
 Connection other than junction at 01 o'clock, 150mm dia

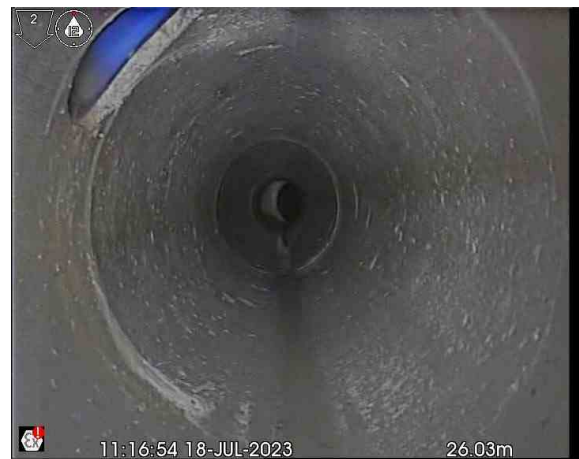
S16X_f207fe33-9c05-4af9-95d4-4b80a2fbc68d_20230719_084225_257.jpg, 00:01:34, 26.03 m
 Connection other than junction at 11 o'clock, 150mm dia

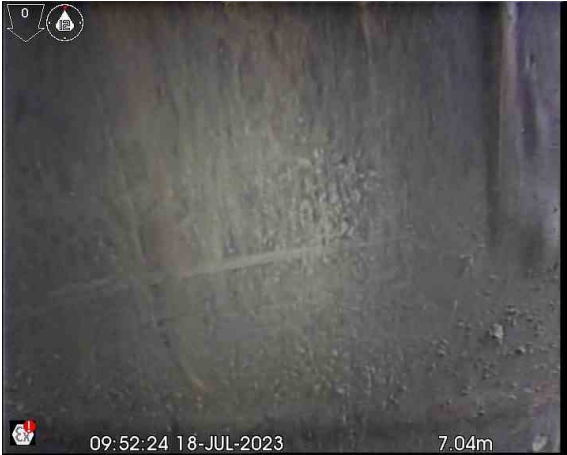
S9X_ec431df6-983c-4457-a810-7f7f1c669aa2_20230719_083516_692.jpg, 00:00:36, 7.04 m
Finish node, manhole, reference: S9, blocked off with timber

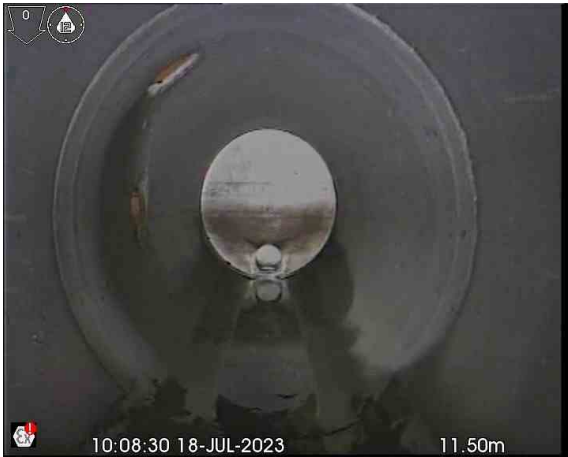
S10X_26fa98fc-5ad2-4dcf-b9d7-36a9c5c48fa0_20230719_083612_351.jpg, 00:00:46, 11.50 m
 Connection other than junction at 10 o'clock, 150mm dia

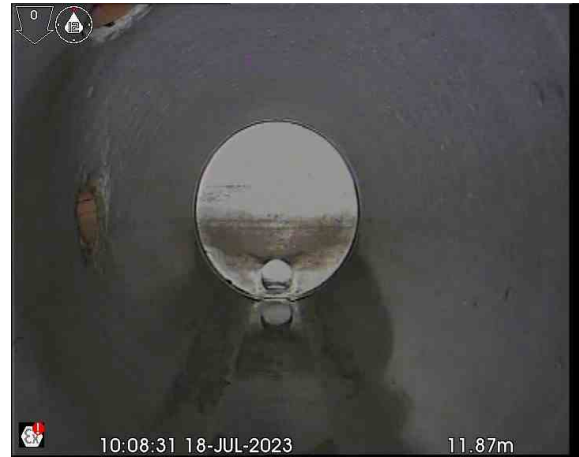
S10X_42a1f004-fcdd-4655-b05e-65b8c754aea6_20230719_083623_583.jpg, 00:00:48, 11.87 m
 Connection other than junction at 09 o'clock, 150mm dia
