Preliminary Roost Assessment

137 Whalley Road

Langho

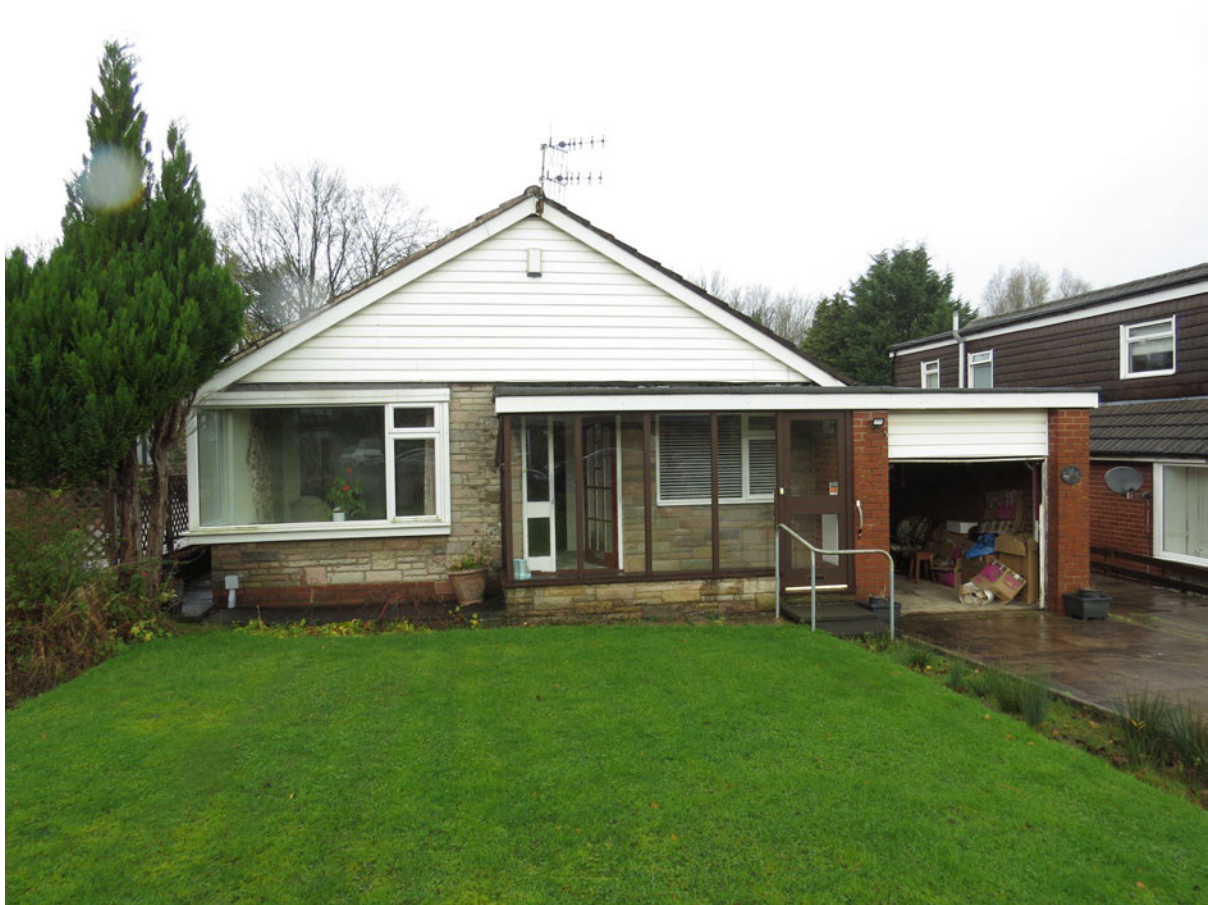
3.1a – The front of the house and attached garage.

Nº137 Whalley Road, Langho, is a 1970's built detached bungalow, which was occupied until recently. It has a pitched roof, covered with concrete roof and ridge tiles. An attached garage to the side, and front porch have a flat felt-covered roof. There is a UPVC and glass conservatory to the rear.

The building is relatively modern, well maintained, and in good condition. Ridge tiles are fixed tightly, there are no damaged or missing ridge tiles. There are no damaged, slipped, or missing roof tiles. Roof tiles are tightly fitted, with no gaps between tiles. Fascia boards and boxed soffits are fitted tightly against the walls with no viable gaps. Walls are in good condition, with no missing mortar or cracks. UPVC cladding is fitted tightly.

There are no features externally which are likely be used by roosting bats, and no indications of use by bats were present during the inspection.

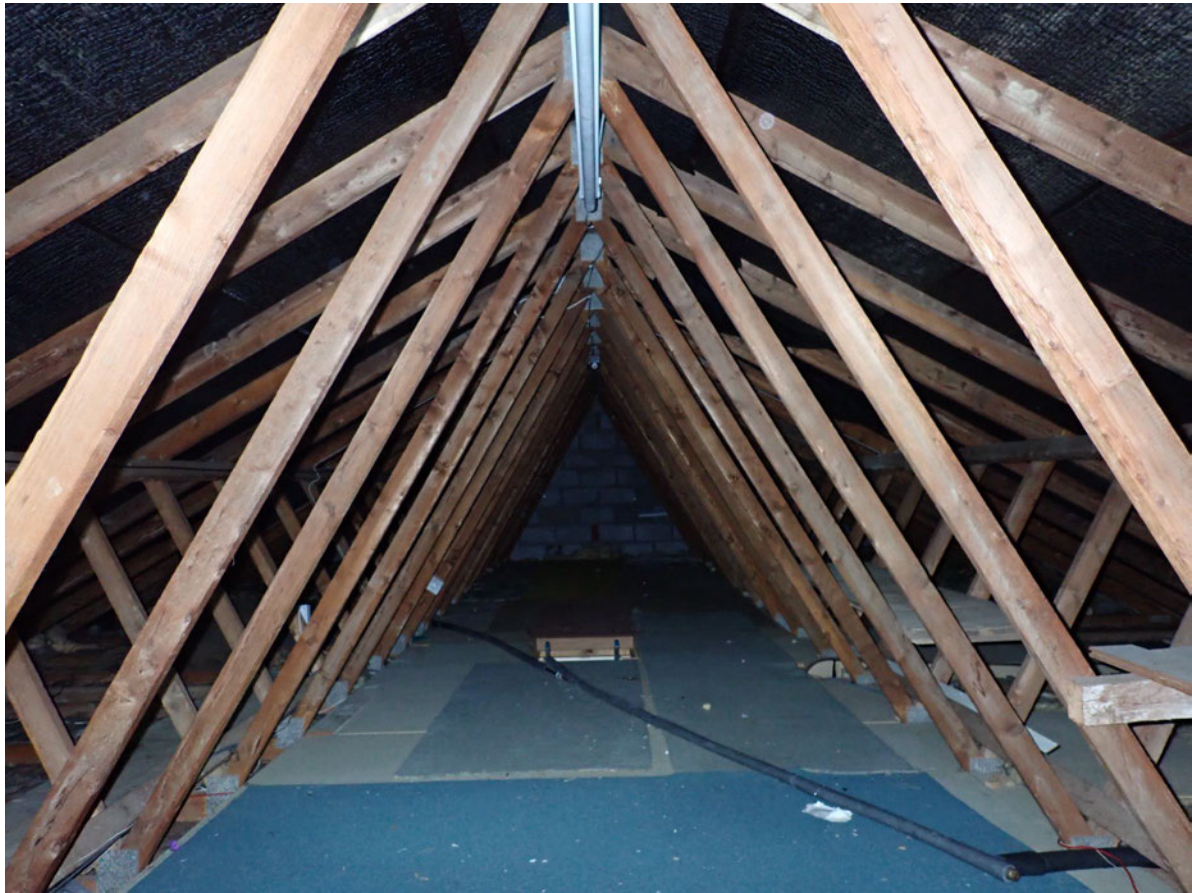
3.2a – The roof void.

The house has a single roof void, which is not used for storage, and is only accessed infrequently for essential maintenance work.

The roof has a trussed timber structure, lined with bitumen felt, and insulated with mineral wool between the ceiling joists. The roof lining is in good condition with no tears, or gaps.

The wall cavity was inspected at the eaves and gable ends using a torch and endoscope, and has been filled with insulation. There are no gaps at the eaves; and there are no gaps which give direct access to the roof void from the outside. Boxed soffits open into the roof void and were inspected from above.

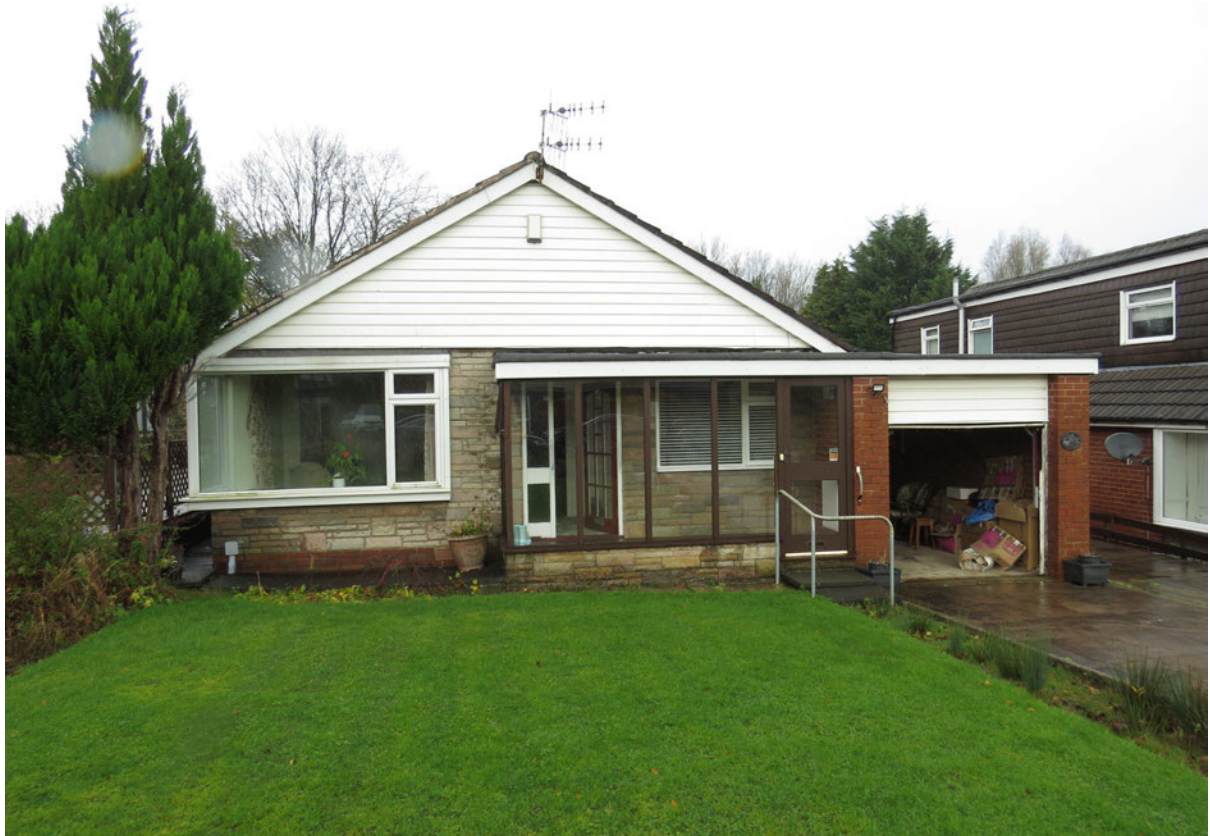
1 – The front of the house.

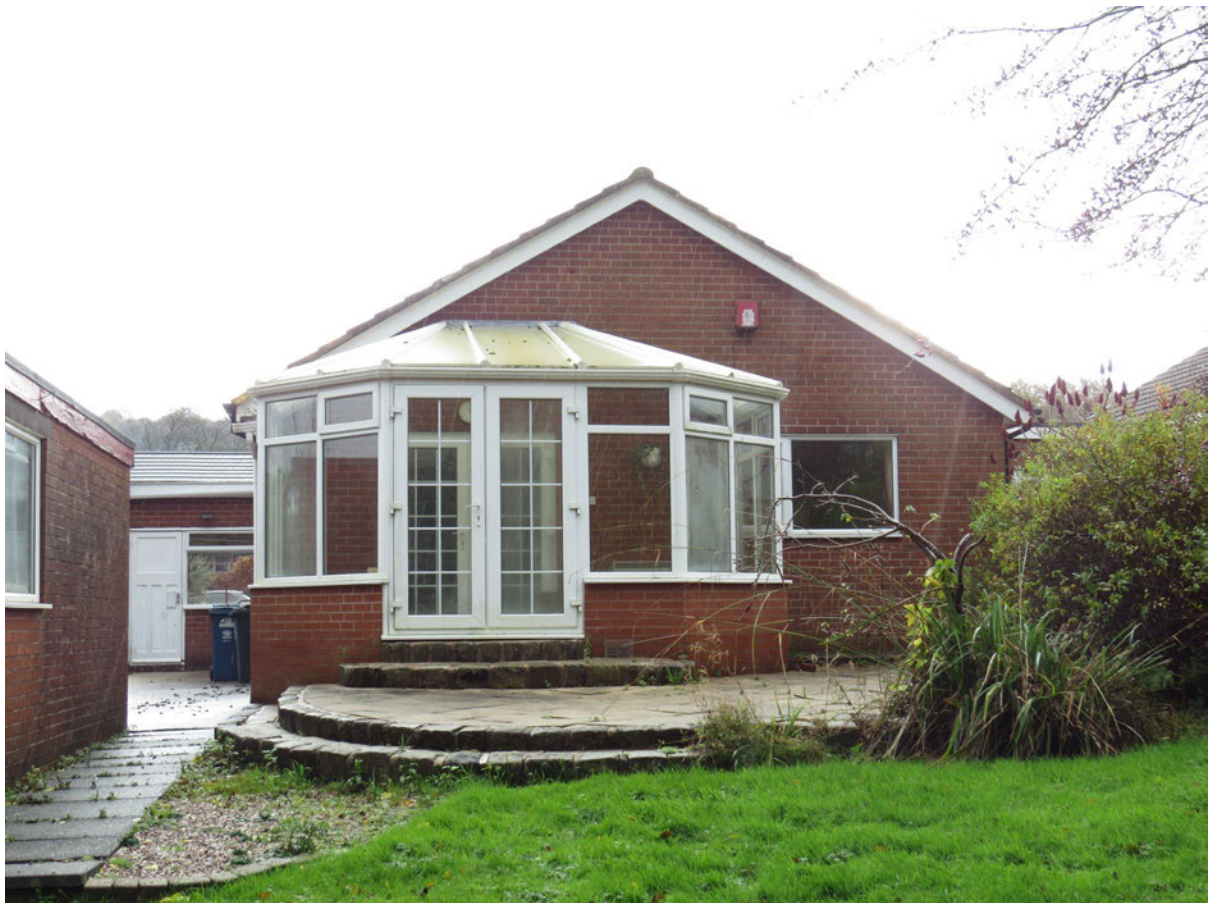
2 – The rear of the house and conservatory.

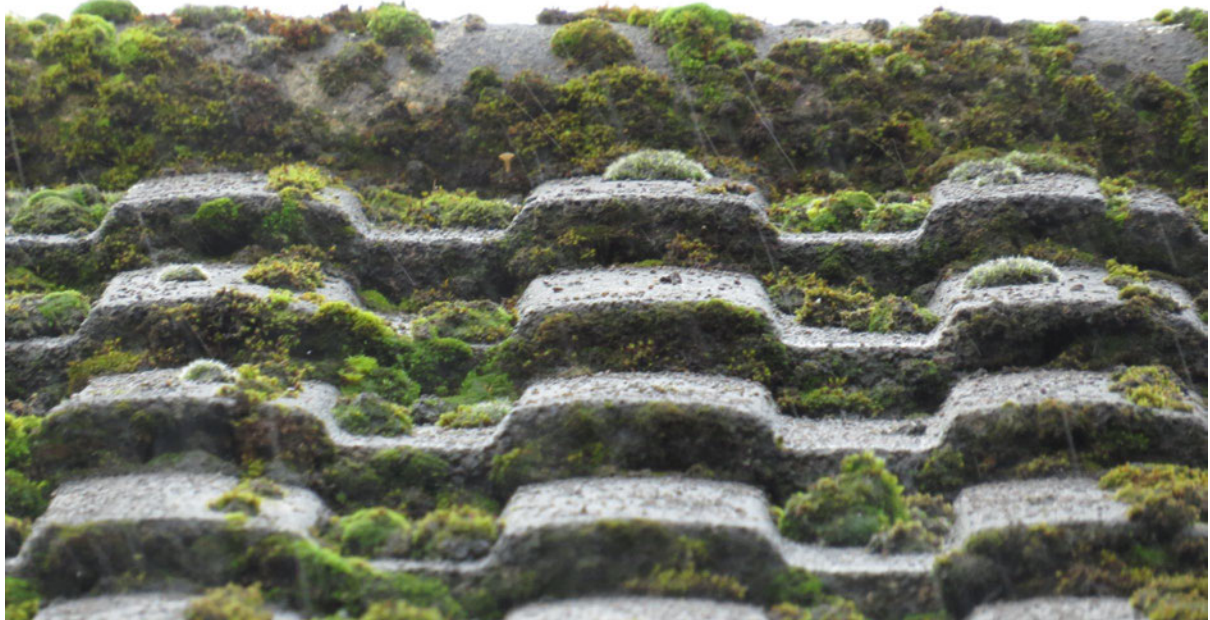
Roof and ridge tiles are in good condition; ridge tiles are sealed with cement. There are no gaps between roofing materials which could be used by roosting bats.

3 – Roof and ridge tiles are in good condition with no suitable gaps.

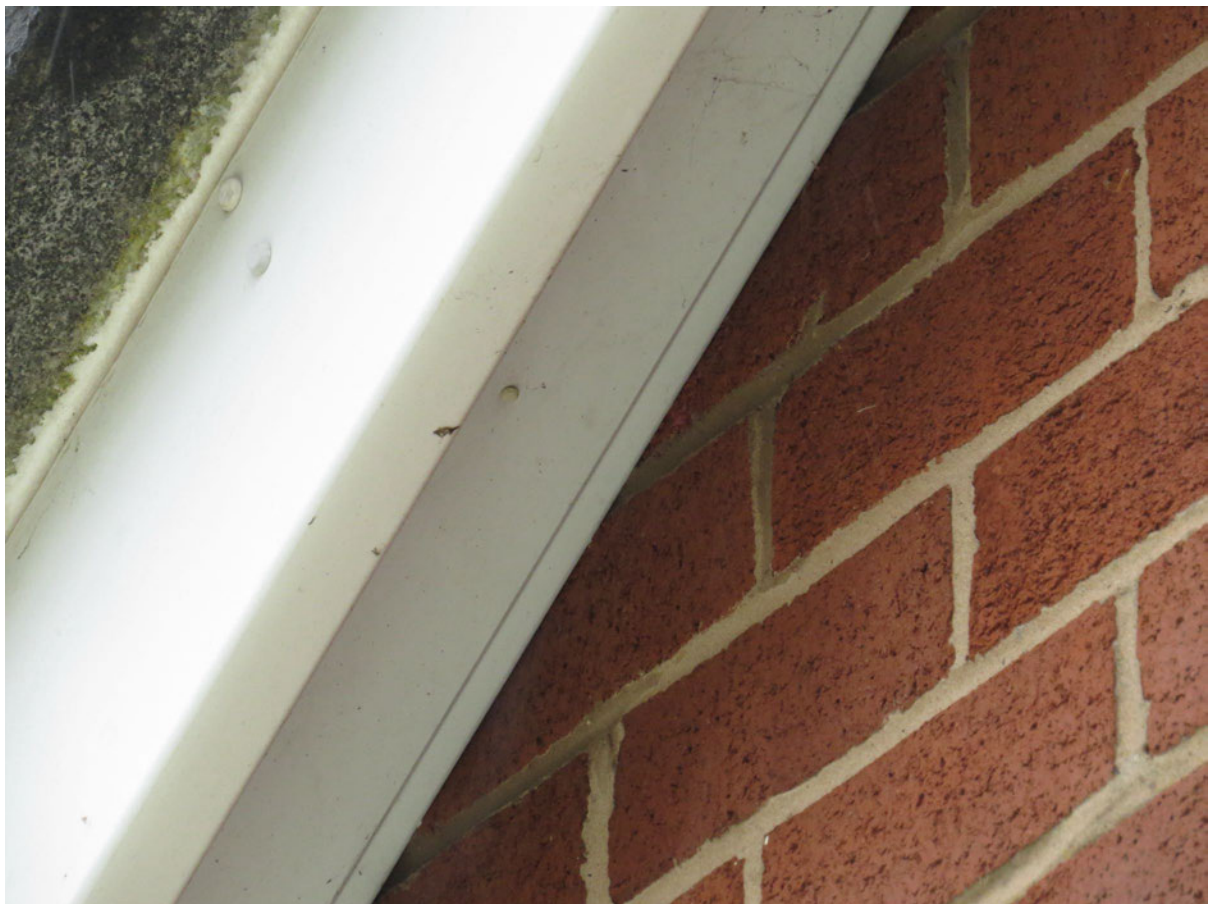
Fascia boards and boxed soffits at the eaves are fixed tightly against brickwork, with no suitable gaps; wall cavities and boxed soffits open into the roof void, and were inspected from above.

4 – Fascia boards and soffits at the eaves are fixed tightly against brickwork.

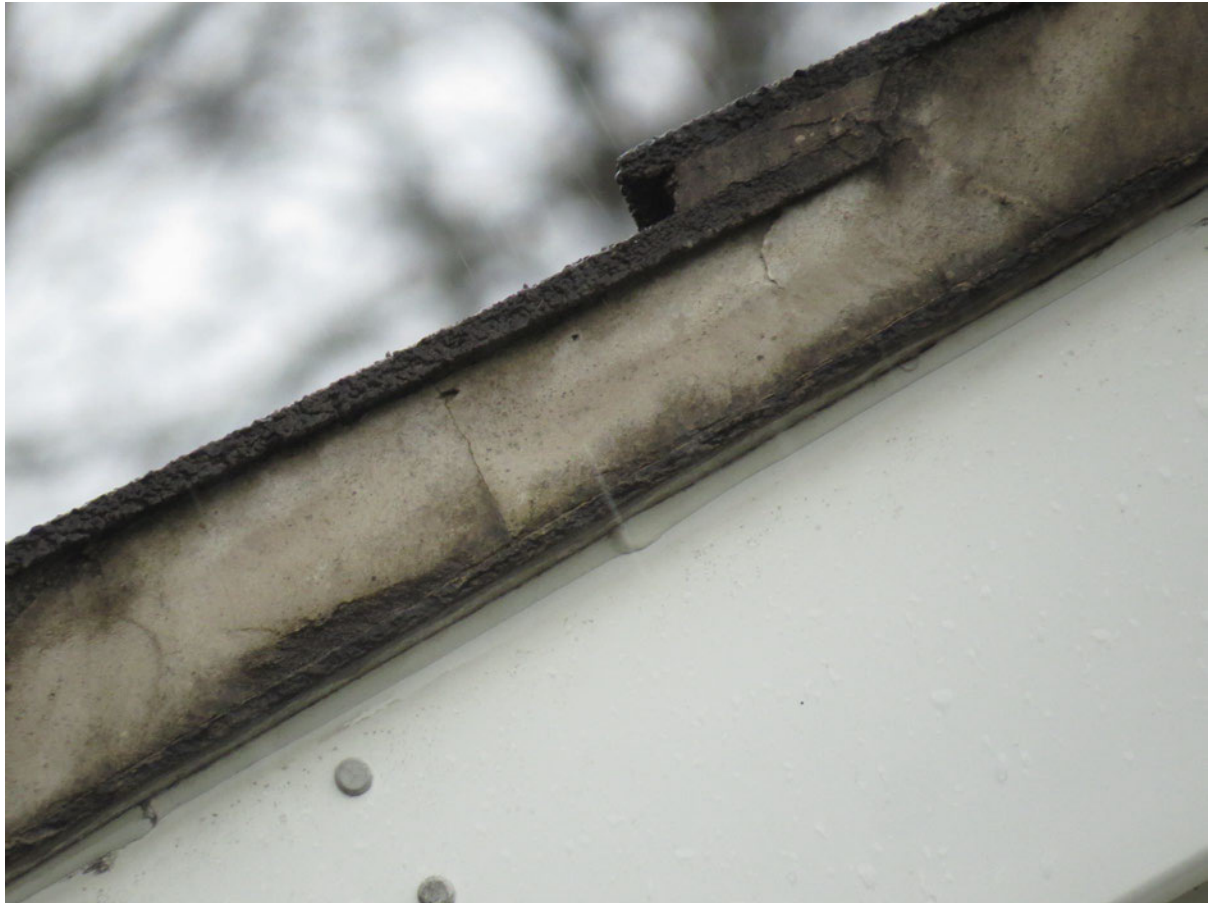
5 – End-tiles at the verges are sealed with cement.

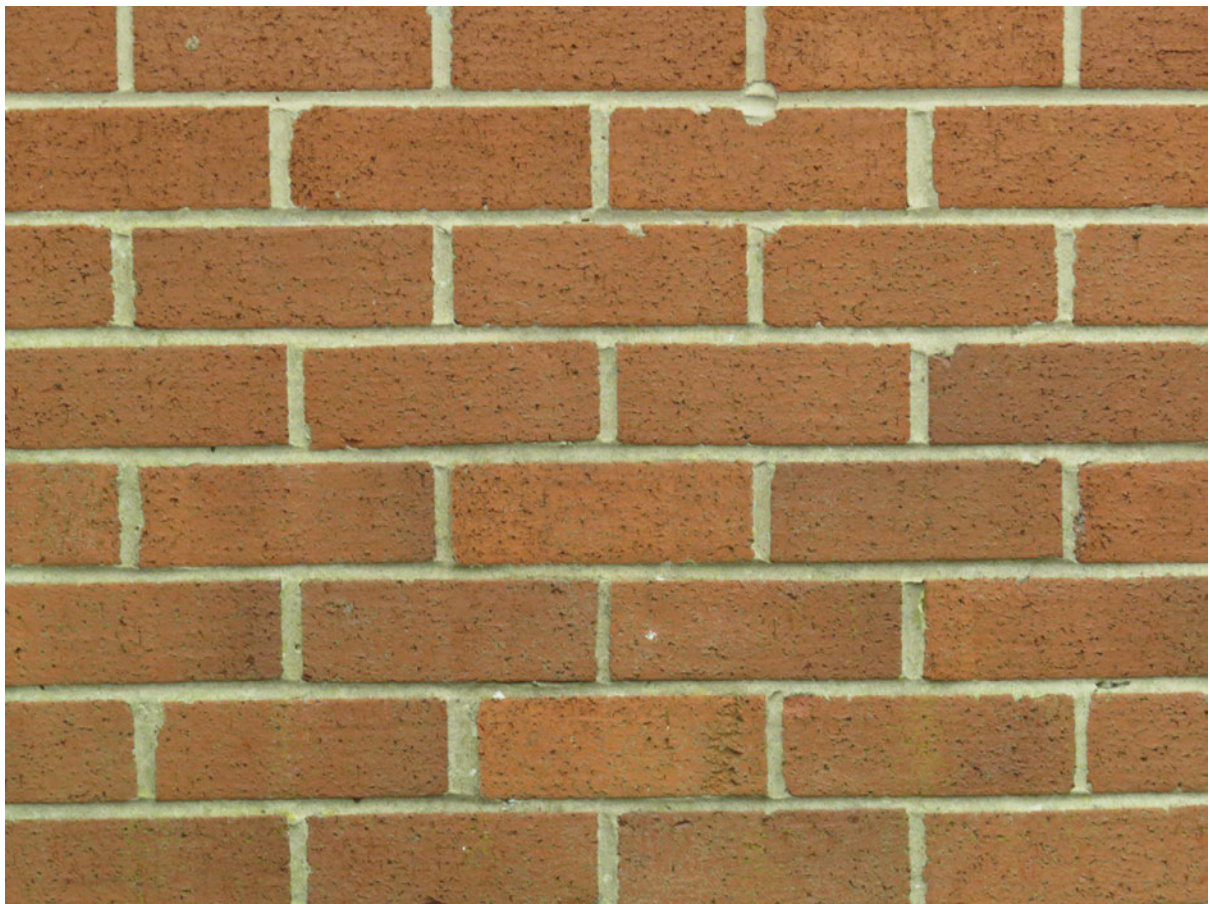
Walls are brick with an insulating cavity; the cavity has been filled with insulation. Walls are in good condition, with no cracks, or missing mortar which could be used by crevice dwelling bats.

6 – Brickwork and mortar are in good condition with no suitable gaps.

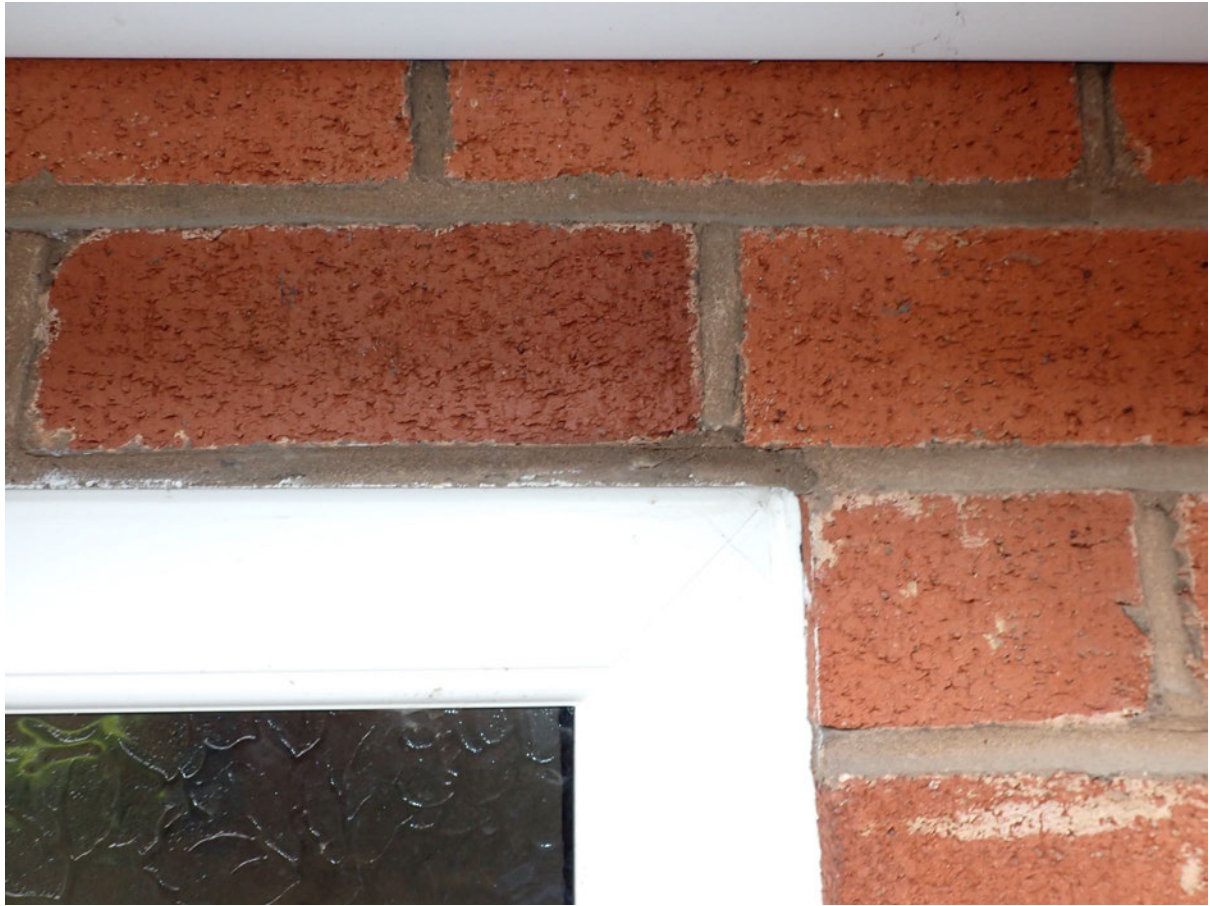
Window and door frames are fixed into the brickwork, gaps are filled with sealant, and offer no suitable roosting opportunities.

7 – Window and door frames are tightly sealed into brickwork with no suitable gaps.

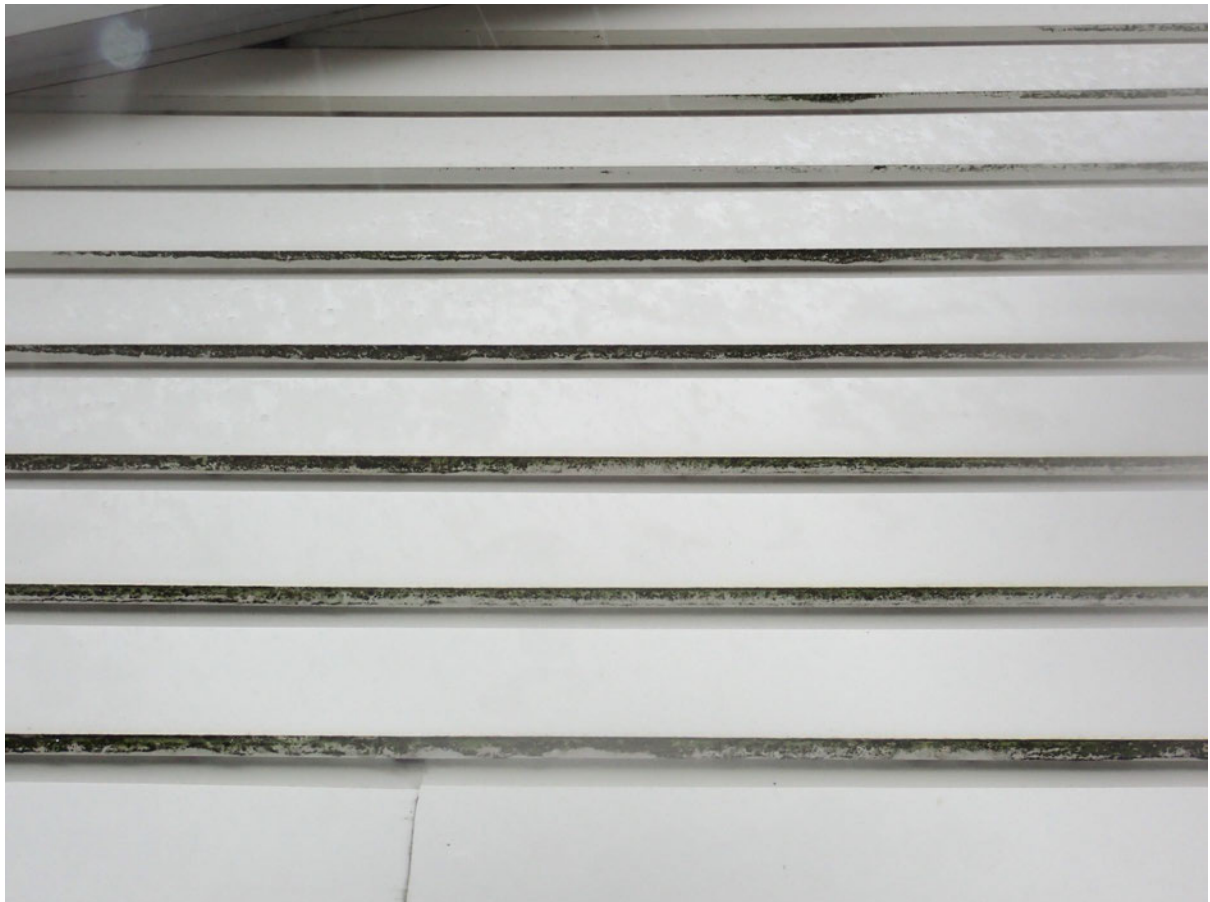
8 – UPVC cladding at the front gable is fitted tightly with no suitable gaps.

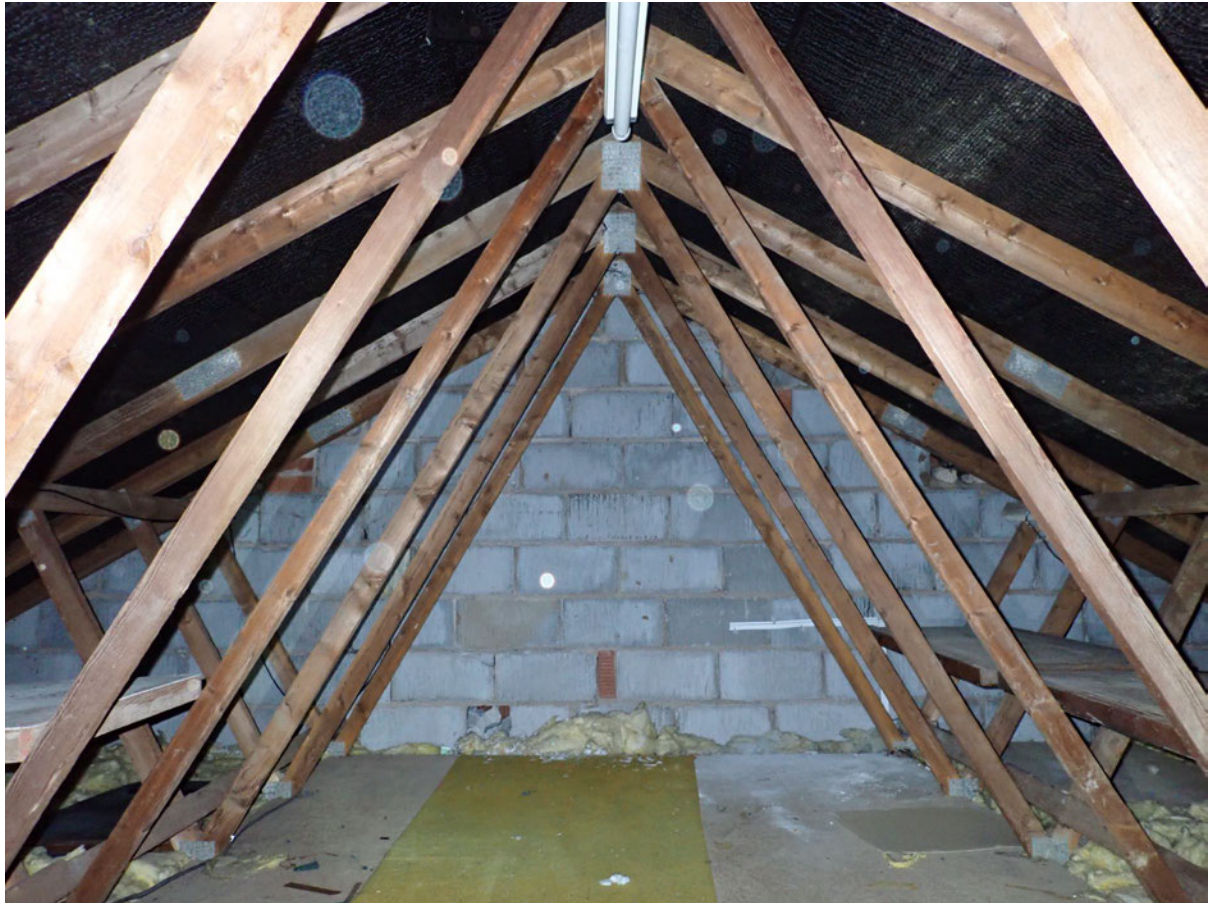
9 – The house has a single roof void.

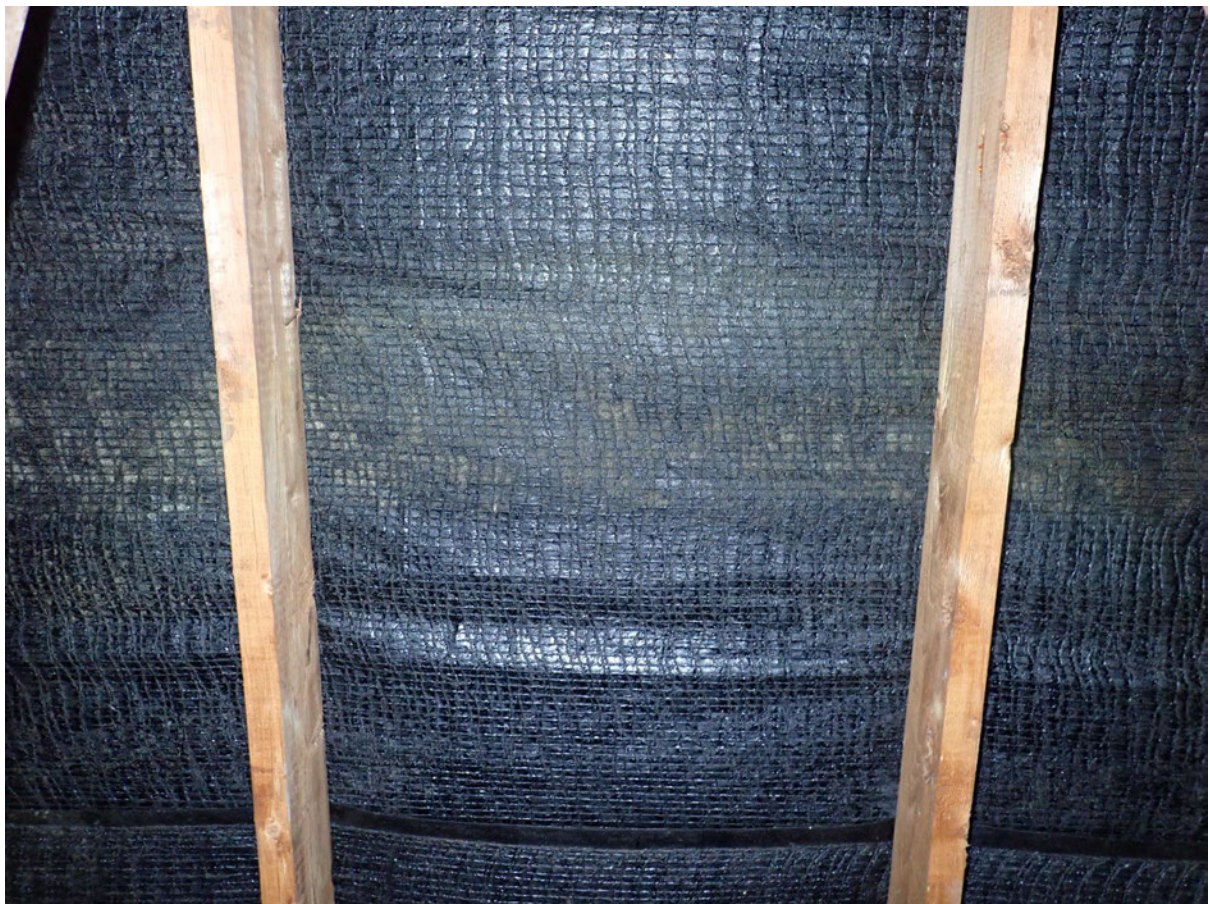
10 – Roof lining is in good condition with no gaps or tears.
