Mark Lincoln  
9 The Dene  
Hurst Green  
BB7 9QF

06/11/25

**Historic Leaded Light Glazing: INSPECTION REPORT WITH PROPOSAL FOR RESTORATION & CONSERVATION**

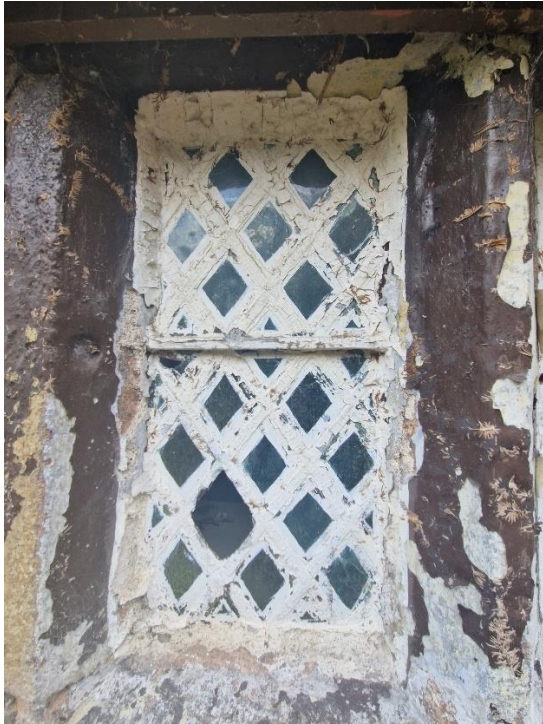
*fig 1. External*

Condition in general is poor/very poor as can be expected. As previously stated, all lead comes are heavily painted over internally and externally which will have provided a degree of protection from continued oxidization/lead corrosion/water ingress. Lead appears extremely thin but the panel remains structurally sound. There are approximately 6# cracked quarries and one is missing entirely. Glass is extremely thin/fragile. External timber saddle bar is heavily weathered and very prone to continued deterioration.

Following completion of studio intervention works, the panel will be returned to site and re-installed into its original setting. Lightworks propose the external timber support bar be replaced with an internally set non-ferrous (manganese bronze) saddle bar matching the profile of the original. The panel will be connected to the bar via its copper ties in the traditional manner. Perimeters internally and externally to be pointed using an NHL 3.5 hydraulic lime mortar and all glass given a final detailed clean to remove any pointing residue.
