Leagram Mill Farm, PR3 2QS

Structural Report

Client: Kim Weld-Blundell
Author: Frazer Clarke
Date: 12/06/2025
Reference: 25039-PWA-00-XX-RP-S-1000-P01

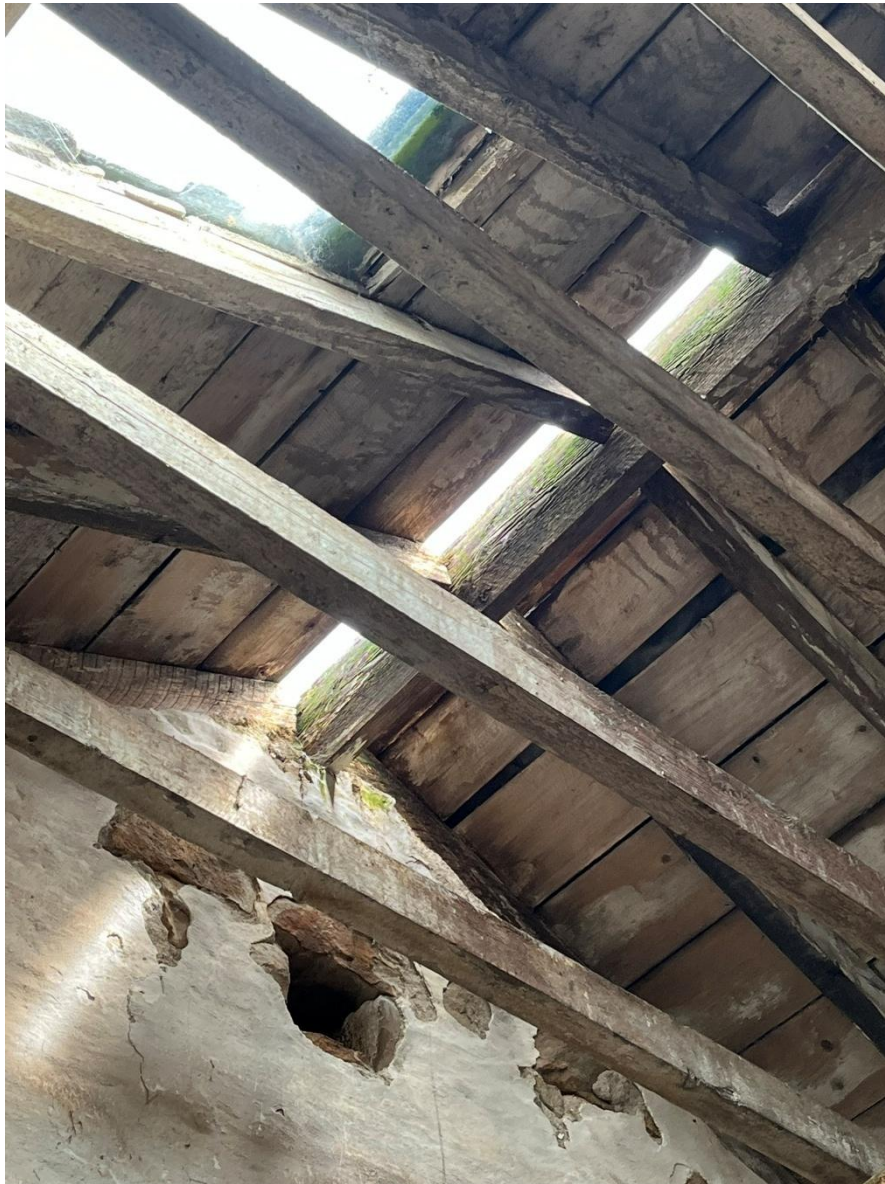
Photo 1

The roof timbers visually appeared damp in areas, it was also noted that the roof has holes in across its length at the ridge and along its pitch. The structure is at risk of degradation from water ingress. (Photo 1 & 2).

A full timber survey must be undertaken to determine whether the timber is suitable for re-use and does not need replacing.

Roof flashings above damp timbers must be repaired to prevent any further water ingress.

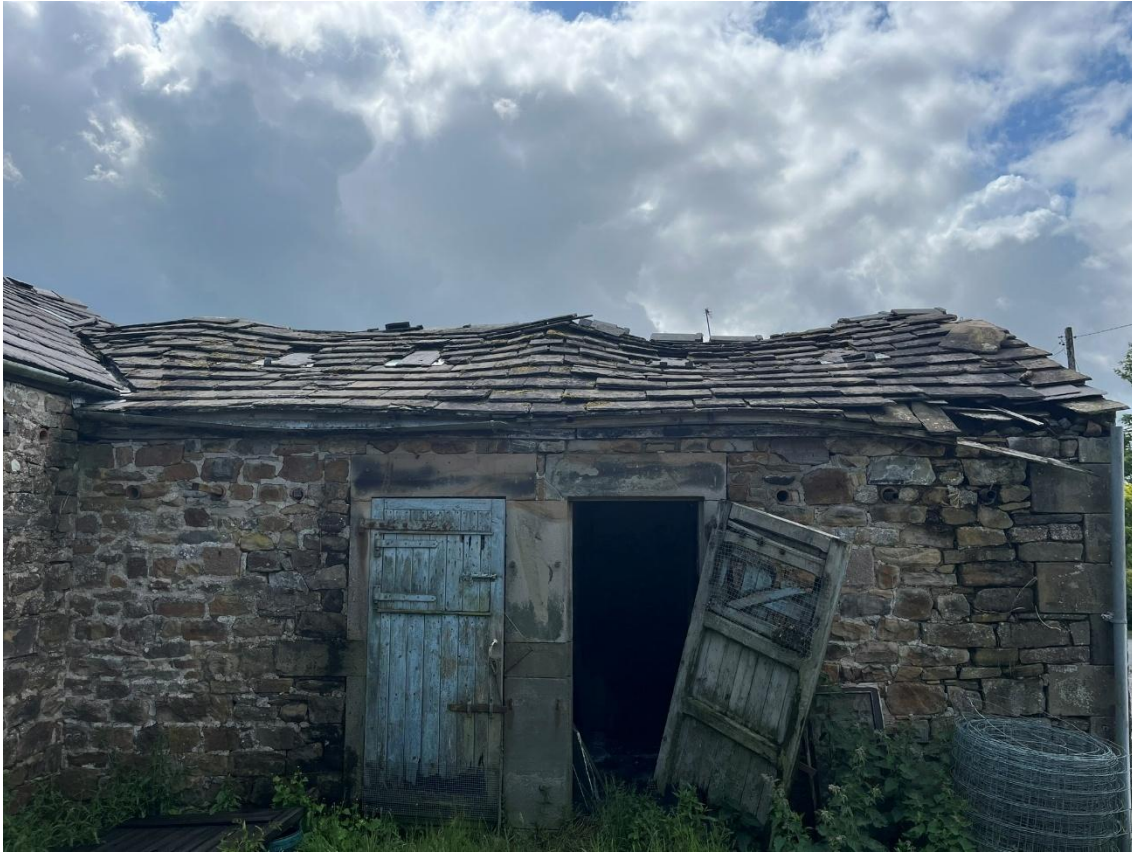
Photo 3

A section of the roof is in a state of disrepair. The roof has collapsed. (Photo 3).

Structurally speaking the building is suitable for conversion, providing the advised remedial works are undertaken, the lack of maintenance to the roof has resulted in the partial collapse and slates slipping therefore holes forming. A scheme of repairs is required to prevent any more collapse which will only accelerate if left unaddressed.

Where the roof has failed, this must be replaced.

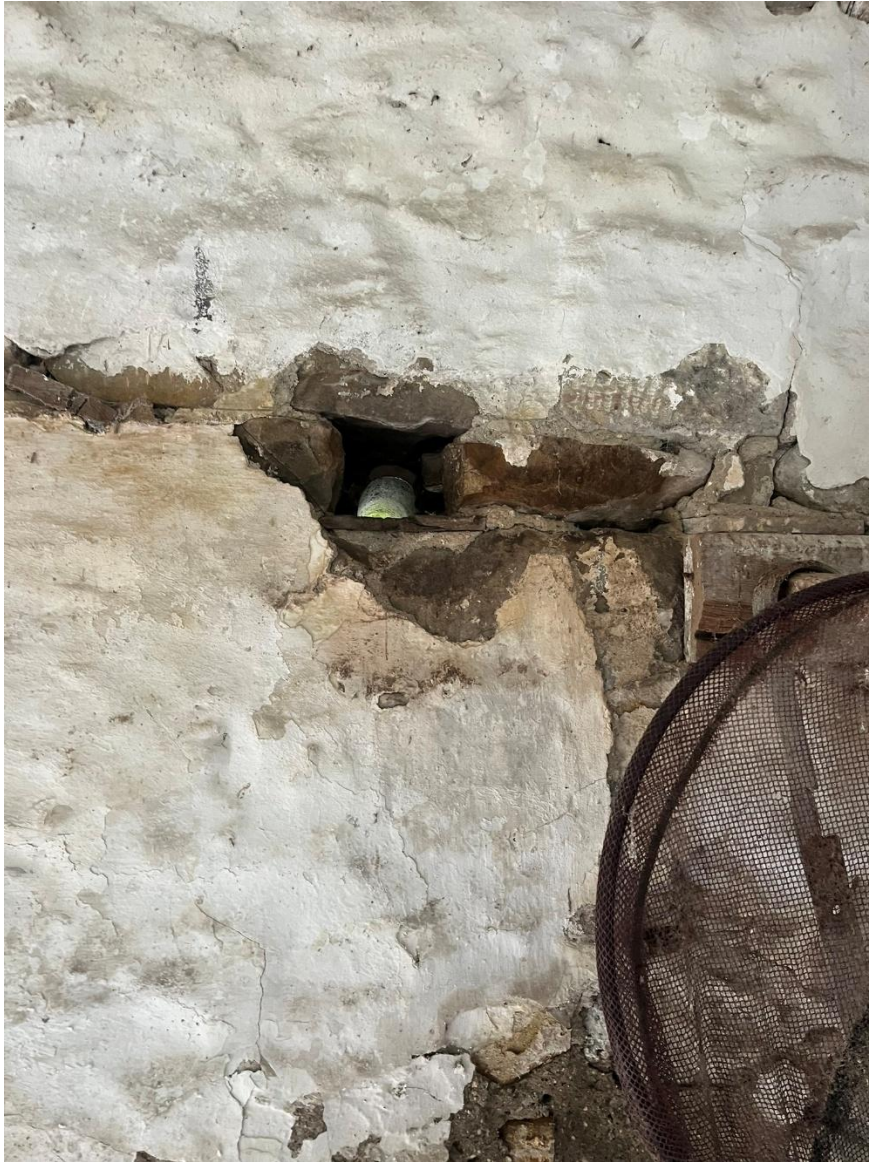
Photo 4

The external and internal walls are missing masonry, and holes are present in the wall. (Photo 4 & 5).

Any loose or missing masonry should be replaced and made good.

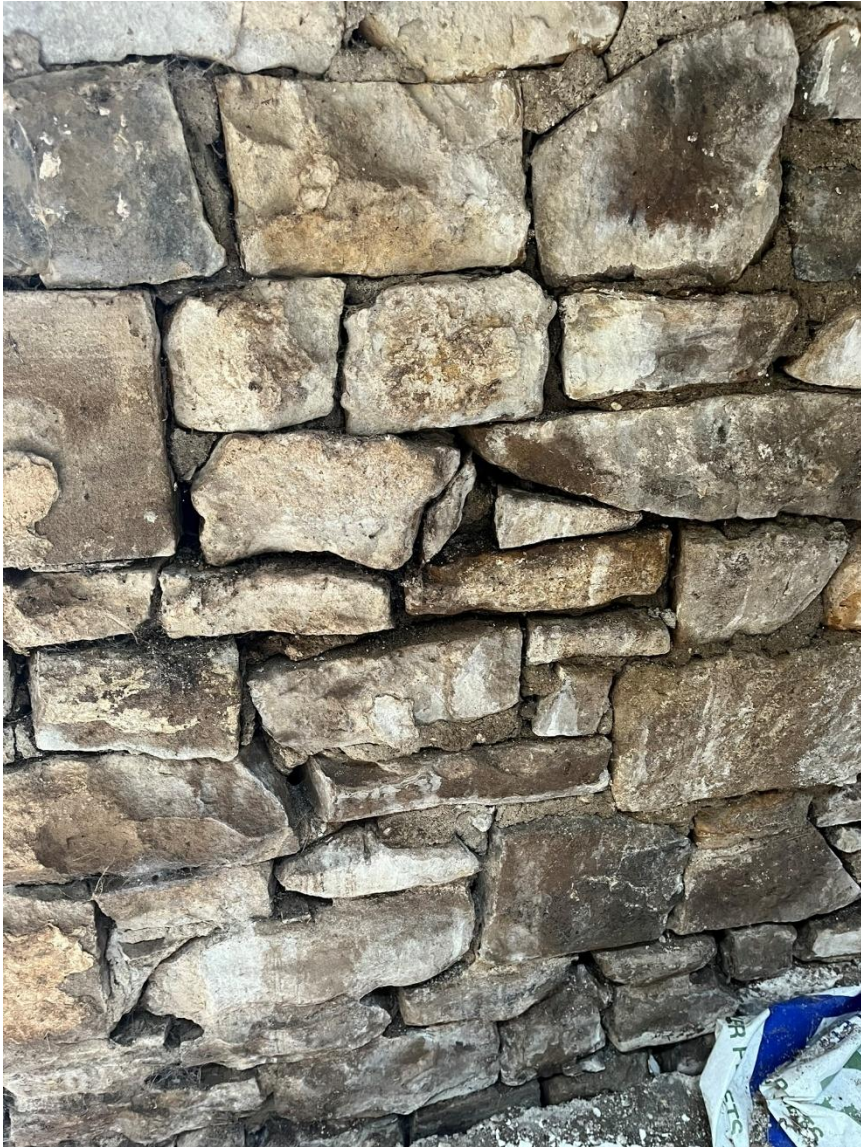
Photo 6

The external and internal walls have missing/loose mortar. (Photo 6).

Any loose or missing mortar should be repointed/replaced and made good.

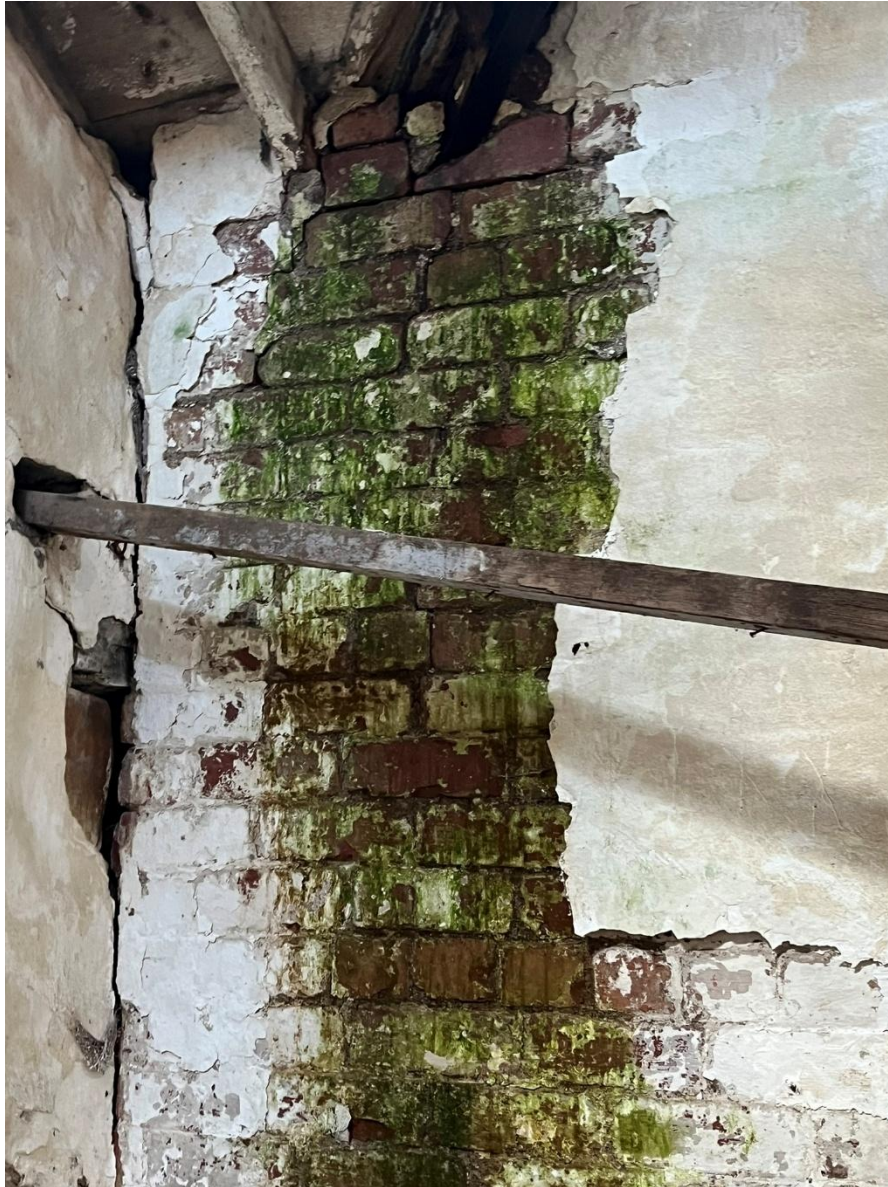
Photo 7

Damp was noted in areas of the building. (Photo 7).

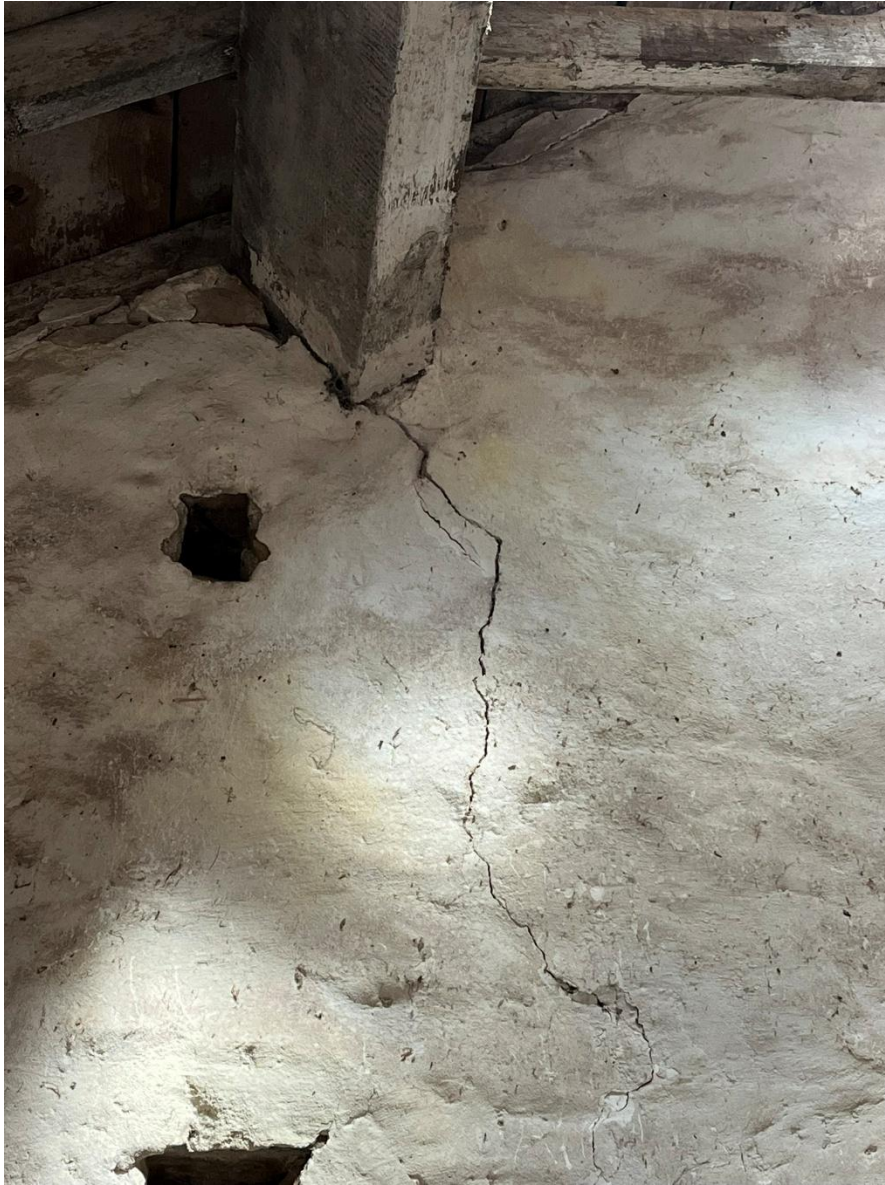
Photo 8

There is a series of small vertical cracks varying in size from 1-5mm, some of these were noted in the finishes, but it was not possible to confirm whether these were present in the masonry. (Photo 8, 9 & 10).

Cracking ranging from 1-5mm should be treated using a suitable lining. Some external repointing may be required to ensure water tightness.

A full scheme for crack repairs should be undertaken.

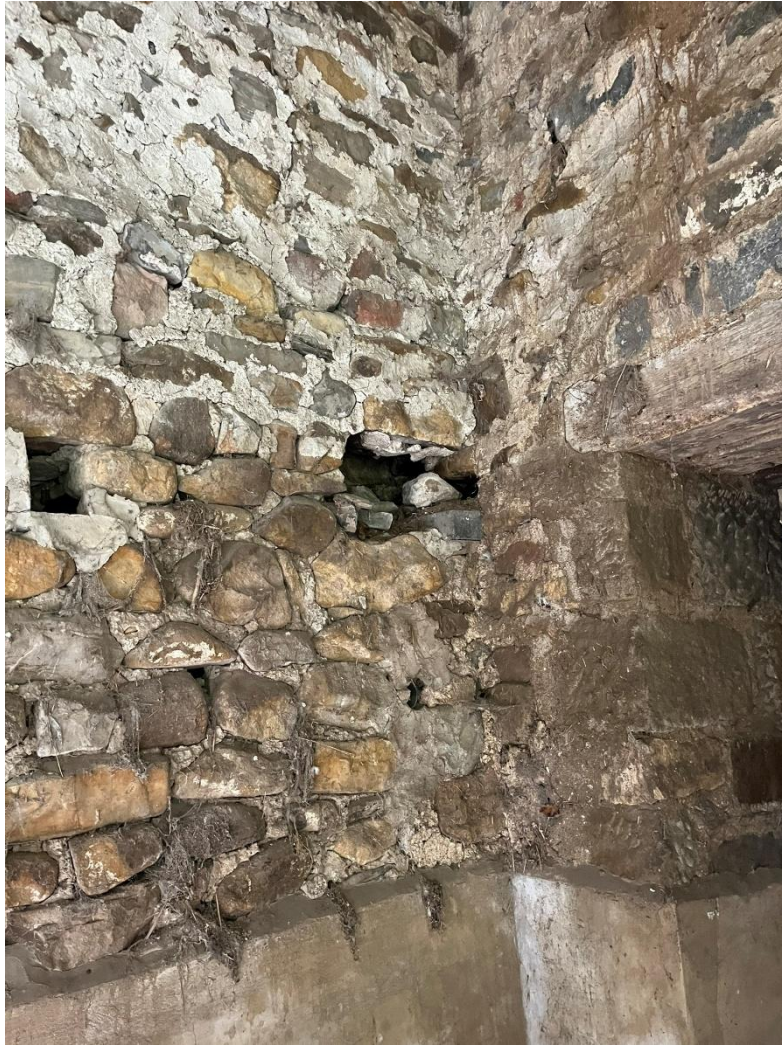
Photo 11

The external and internal walls are missing masonry and holes are present in the wall. (Photo 11 & 12).

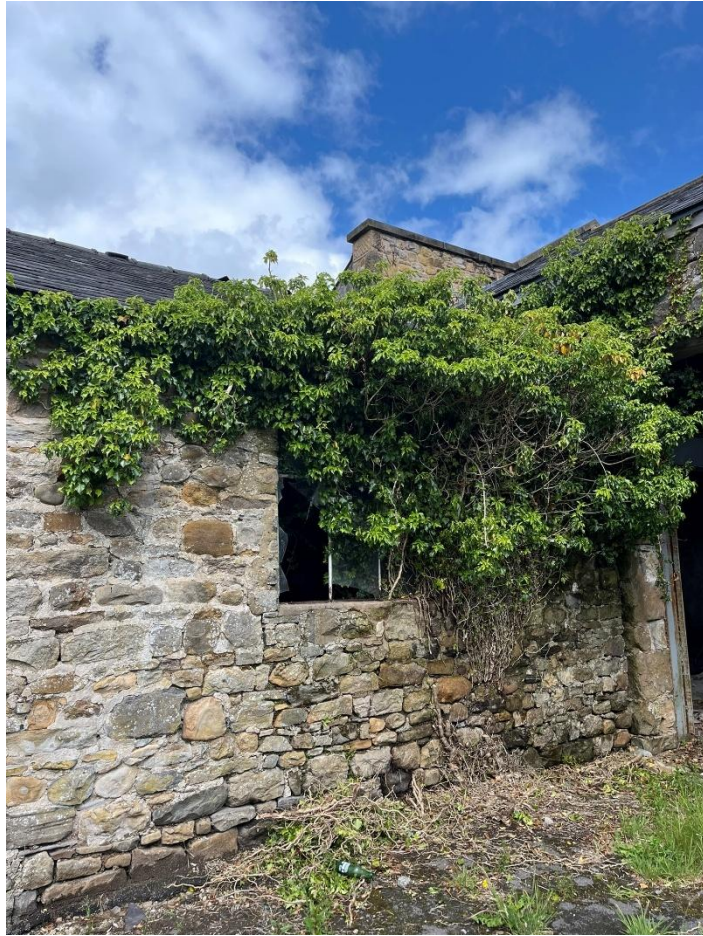
Photo 13

The external and internal walls have missing/loose mortar. (Photo 13).

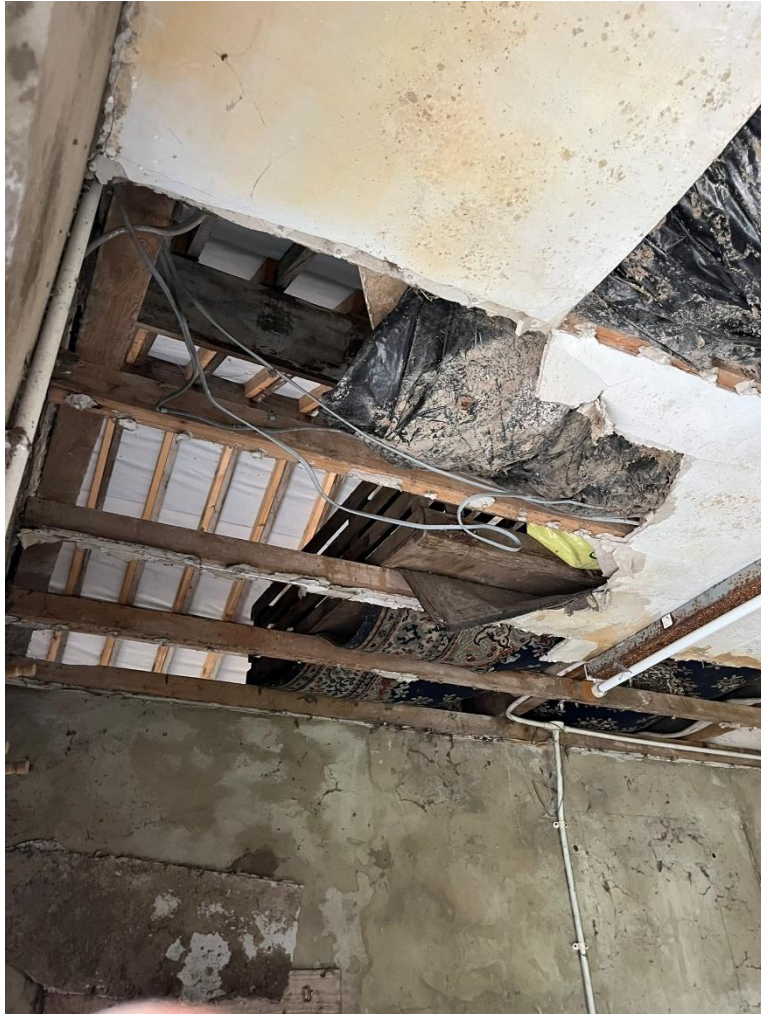
Photo 14

A small area of first floor is in a state of disrepair, it has partially collapsed. (Photo 14).

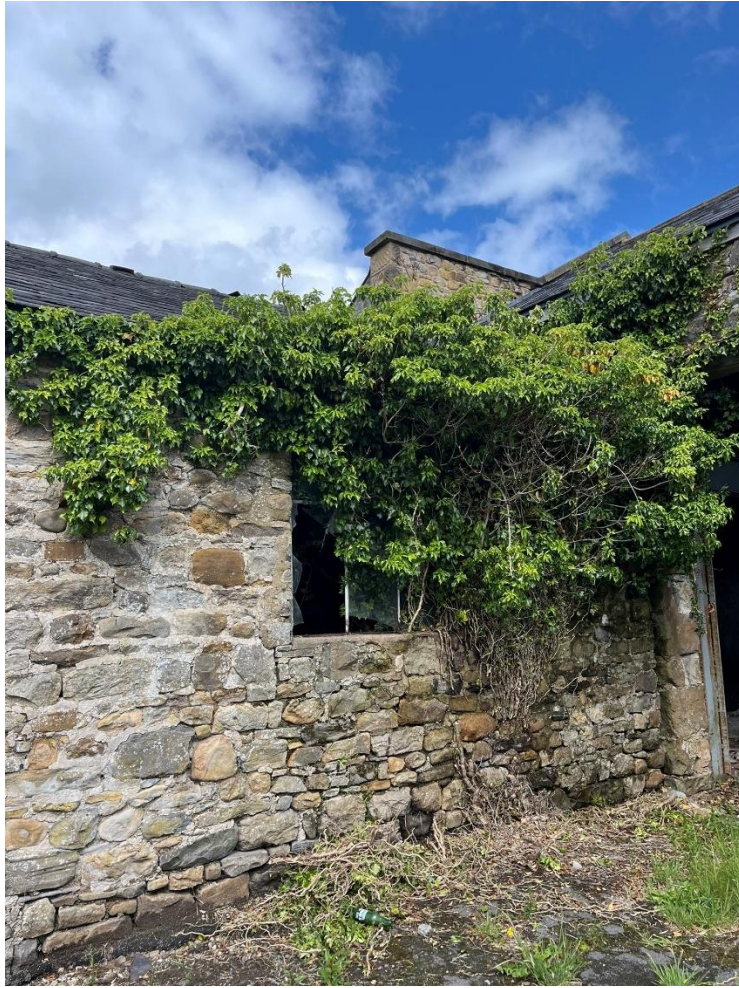
Photo 15

There is vegetation present on the external walls. (Photo 15).

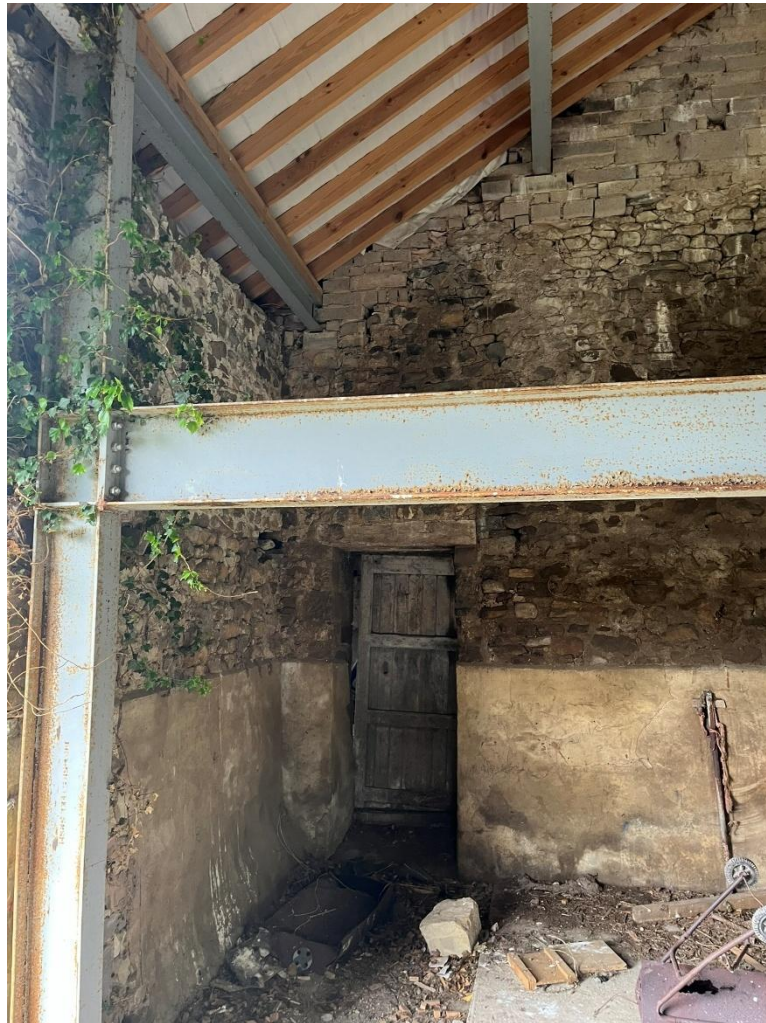
Photo 16

Steelwork is showing signs of rust and oxidation in areas. (Photo 16).

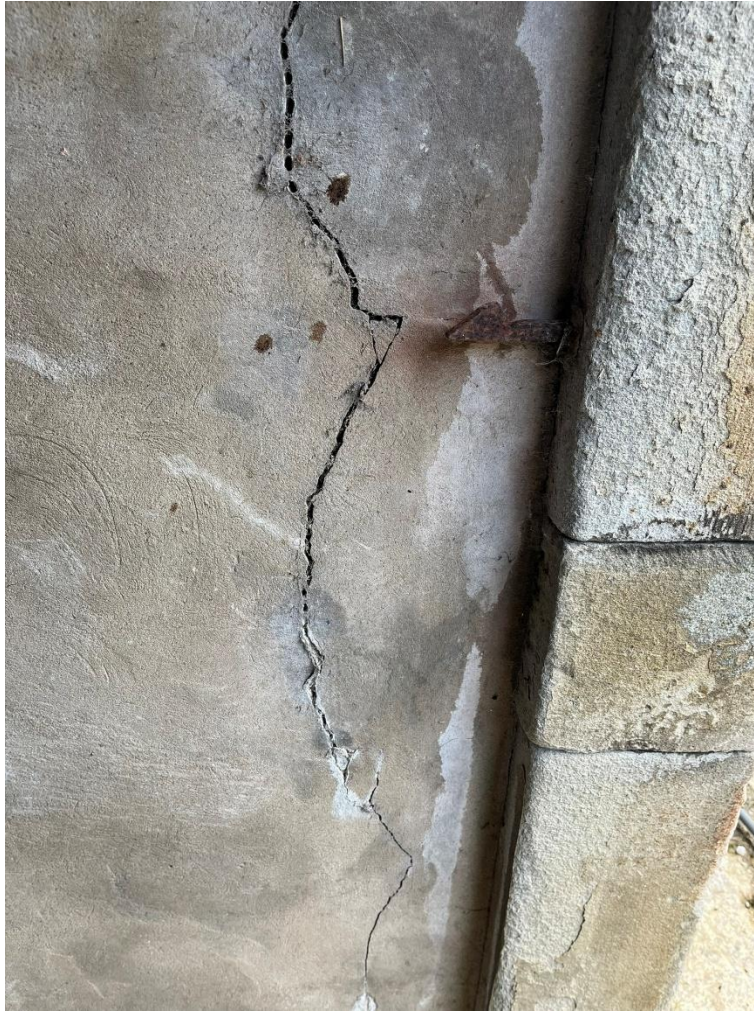
Photo 17

There is a series of small cracks varying in size from 0.1-5mm, some of these were noted in the finishes, but it was not possible to confirm whether these were present in the masonry. (Photo 17, 18 & 19).

Cracking ranging from 0.1-1mm can be treated using normal decoration methods.
