# Tree Condition Report

6 & 7 Nethertown Gardens,  
Whalley, BB7 9GU

10/11/2025

**Job Ref:** 2232

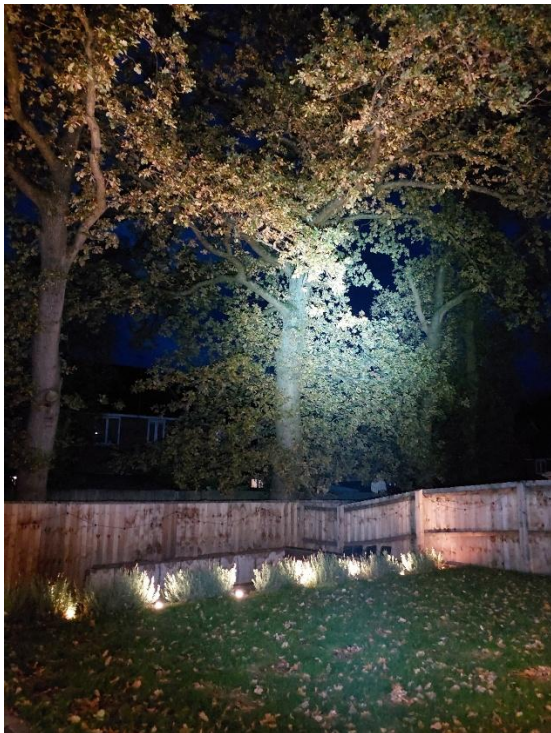
T1

| Job Ref: | 2232 | Survey Date: | 27-Oct-2025 | | Surveyor: | Gary Marsden | | Site Address: | 6 and 7 Nethertown Gardens | | VTA site survey | | | | | | | |
|---|---|---|---|---|---|---|---|---|---|---|---|---|---|---|---|---|---|---|
| Tree | T001 | Oak<br>( <i>Quercus sp.</i> ) | 1 | 60 | 18 | N:8<br>E:8<br>S:8<br>W:8 | Mature | Good | Good | 40+ Years | <ul style="list-style-type: none"><li>_ Tree under 3rd party ownership.</li><li>_ No significant visual root defects.</li><li>_ No significant visual stem defects.</li><li>_ No significant visual branch defects.</li><li>_ Minor deadwood &lt;25 mm diameter.</li><li>_ Grown as part of a group of trees.</li><li>_ Canopy encroaching boundary line.</li><li>_ No significant visual foliage issues.</li><li>_ Seasonal leaf drop has started (normal).</li></ul> | No significant visible fungus present at the time of inspection. | No significant visible Pests or Disease present at the time of inspection. | Owned by neighbour.<br>Target # - Dwelling<br>Target # - Garden<br>Target # - Conservatory<br>Target # - Garage | YES | <ul style="list-style-type: none"><li>_ Remove dead wood greater than 25mm.</li></ul> | 27-Oct-2026<br>(1 Year) | 2 Years |

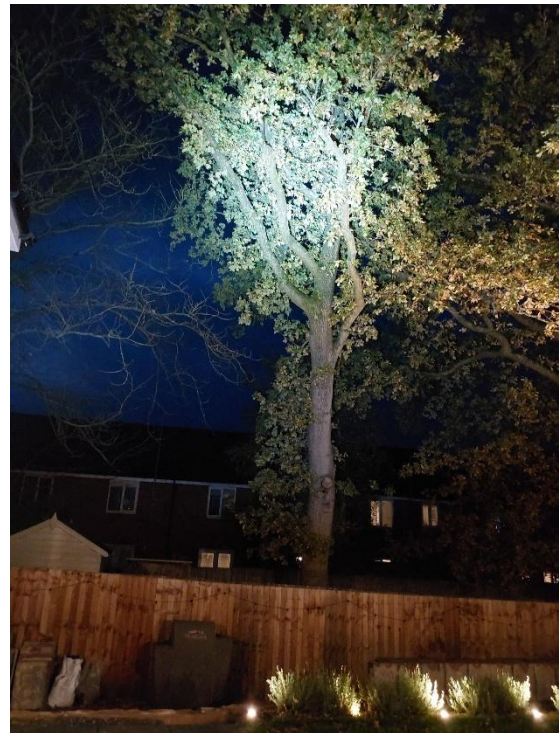
T2

| Job Ref: | 2232 | Survey Date: | 27-Oct-2025 | | Surveyor: | Gary Marsden | | Site Address: | 6 and 7 Nethertown Gardens | | VTA site survey | | | | | | | |
|---|---|---|---|---|---|---|---|---|---|---|---|---|---|---|---|---|---|---|
| Tree | T002 | Oak<br>( <i>Quercus sp.</i> ) | 1 | 50 | 16 | N:6<br>E:6<br>S:6<br>W:6 | Semi Mature | Good | Good | 40+ Years | <ul style="list-style-type: none"><li>_ Tree under 3rd party ownership.</li><li>_ No significant visual root defects.</li><li>_ No significant visual stem defects.</li><li>_ No significant visual branch defects.</li><li>_ Minor deadwood &lt;25 mm diameter.</li><li>_ Suppressed canopy.</li><li>_ Unbalanced canopy.</li><li>_ Grown as part of a group of trees.</li><li>_ Canopy encroaching boundary line.</li><li>_ Pruning history - Crown reduction.</li><li>_ No significant visual foliage issues.</li><li>_ Seasonal leaf drop has started (normal).</li></ul> | No significant visible fungus present at the time of inspection. | No significant visible Pests or Disease present at the time of inspection. | Owned by neighbour.<br>Target # - Dwelling<br>Target # - Garden<br>Target # - Conservatory<br>Target # - Garage<br>Target # - shed / greenhouse / outbuilding | YES | <ul style="list-style-type: none"><li>_ Remove dead wood greater than 25mm.</li></ul> | 27-Oct-2026<br>(1 Year) | 2 Years |

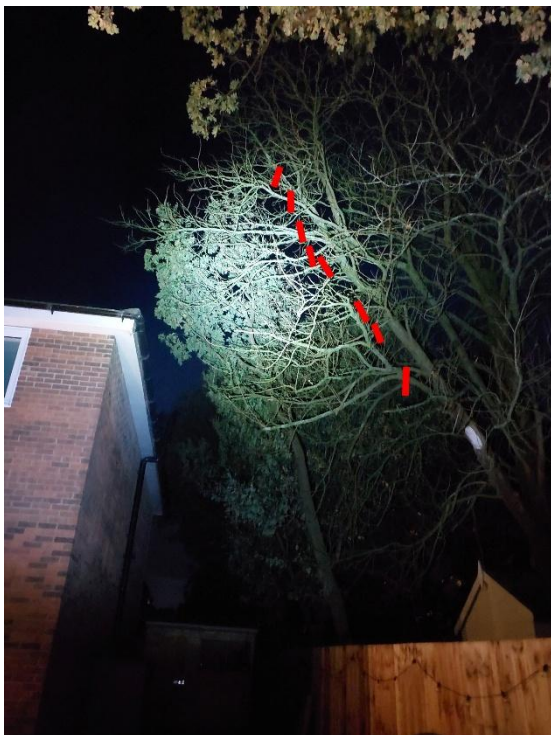
T3

| Job Ref: | 2232 | Survey Date: | 27-Oct-2025 | | Surveyor: | Gary Marsden | | Site Address: | 6 and 7 Nethertown Gardens | | VTA site survey | | | | | | | |
|---|---|---|---|---|---|---|---|---|---|---|---|---|---|---|---|---|---|---|
| Tree | T003 | Horse chestnut<br>( <i>Aesculus hippocastanum</i> ) | 1 | 10 | 16 | N:5<br>E:5<br>S:5<br>W:5 | Semi Mature | Good | Good | 40+ Years | <ul style="list-style-type: none"><li>_ Tree under 3rd party ownership.</li><li>_ No significant visual root defects.</li><li>_ No significant visual stem defects.</li><li>_ No significant visual branch defects.</li><li>_ Minor deadwood &lt;25 mm diameter.</li><li>_ Canopy encroaching boundary line.</li><li>_ Canopy encroaching building.</li><li>_ Seasonal leaf drop has occurred (normal).</li></ul> | No significant visible fungus present at the time of inspection. | No significant visible Pests or Disease present at the time of inspection. | Owned by neighbour.<br>Target # - Dwelling<br>Target # - Garden<br>Target # - Conservatory<br>Target # - shed / greenhouse / outbuilding | YES | <ul style="list-style-type: none"><li>_ Prune to clear building by 2 m.</li><li>_ Prune to clear boundary line.</li></ul> | 27-Oct-2026<br>(1 Year) | 2 Years |

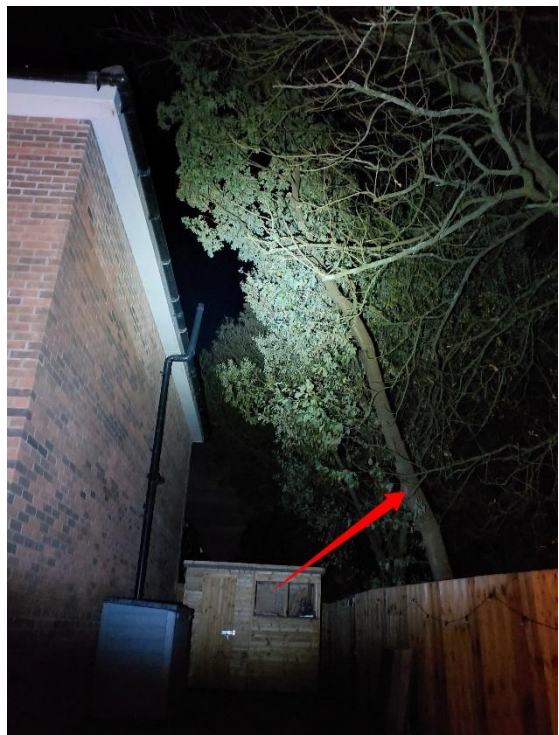
- 19.4. The Oak tree, T4 has a very suppressed form and is growing at an angle from the neighbouring land, over the boundary line and is now over the roof of number 6, the tree will never grow to gain a full balanced canopy due to the surrounding trees and the encroachment over the roof will only get worse over time, therefore it is recommended that this tree is removed to ground level.

| Tree | T004 | Oak ( <i>Quercus sp.</i> ) | 1 | 30 | 10 | N:3<br>E:3<br>S:3<br>W:3 | Semi Mature | Good | Fair | 10+ Years | <ul style="list-style-type: none"><li>_ Tree under 3rd party ownership.</li><li>_ No significant visual root defects.</li><li>_ Leaning stem 15 degrees.</li><li>_ No significant visual branch defects.</li><li>_ Minor deadwood &lt;25 mm diameter.</li><li>_ Suppressed canopy.</li><li>_ Unbalanced canopy.</li><li>_ Grown as part of a group of trees.</li><li>_ Tree has poor form / shape.</li><li>_ Canopy encroaching boundary line.</li><li>_ Canopy encroaching building.</li><li>_ Seasonal leaf drop has started (normal).</li></ul> | No significant visible fungus present at the time of inspection. | No significant visible Pests or Disease present at the time of inspection. | Owned by neighbour.<br>Target # - Dwelling<br>Target # - Garden<br>Target # - shed / greenhouse / outbuilding | NO | <ul style="list-style-type: none"><li>_ Remove tree to ground level for arboricultural management reasons.</li></ul> | 27-Apr-2026 (6 Months) | Not Applicable |

- 19.5. As the trees are covered by a TPO and on land not owned by the clients, an application to the council will have to be made and the landowner contacted to gain permission for the works to be undertaken.

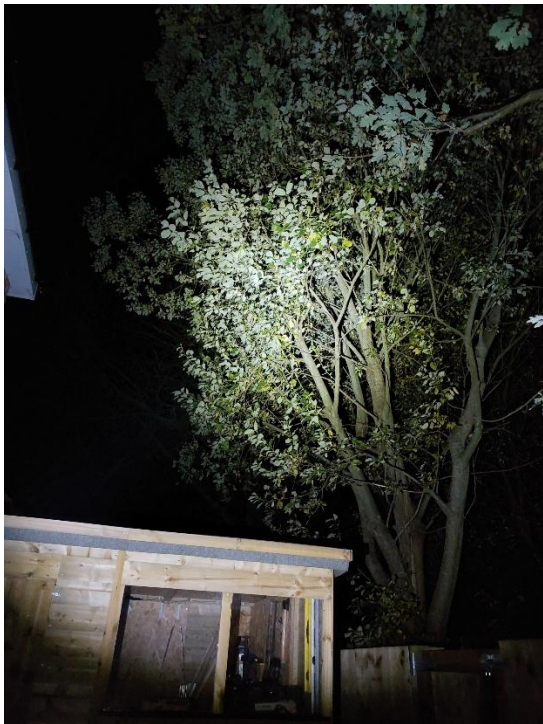
T5

| Tree | T005 | Willow ( <i>Salix sp.</i> ) | 1 | 40 | 13 | N:4<br>E:4<br>S:4<br>W:4 | Semi Mature | Good | Good | 40+ Years | <ul style="list-style-type: none"><li>_ Bark damage on stem.</li><li>_ No significant visual branch defects.</li><li>_ No significant visual crown defects.</li><li>_ No significant visual foliage issues.</li></ul> | No significant visible fungus present at the time of inspection. | No significant visible Pests or Disease present at the time of inspection. | Owned by neighbour.<br>Target # - Dwelling<br>Target # - Garden<br>Target # - shed / greenhouse / outbuilding | YES | <ul style="list-style-type: none"><li>_ No work required at time of inspection.</li></ul> | No Action | 2 Years |

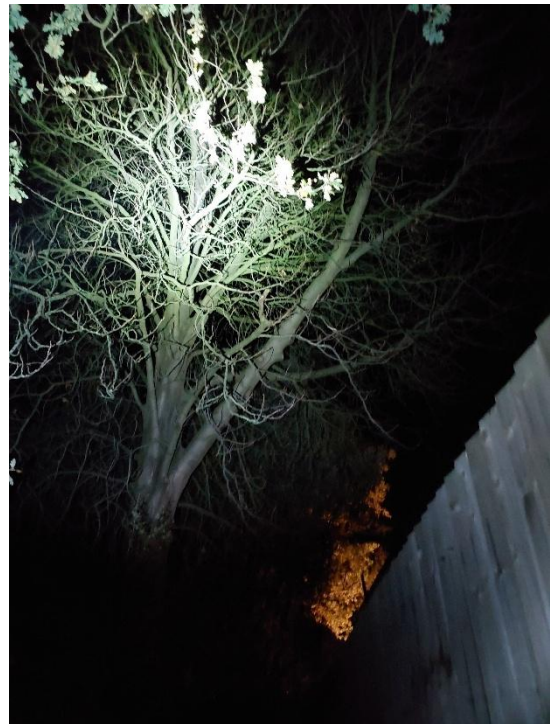
T6

| Tree | T006 | Horse chestnut ( <i>Aesculus hippocastanum</i> ) | 1 | 50 | 18 | N:6<br>E:6<br>S:6<br>W:6 | Mature | Good | Good | 40+ Years | <ul style="list-style-type: none"><li>_ No significant visual root defects.</li><li>_ No significant visual stem defects.</li><li>_ No significant visual branch defects.</li><li>_ Canopy encroaching boundary line.</li><li>_ Seasonal leaf drop has occurred (normal).</li></ul> | No significant visible fungus present at the time of inspection. | No significant visible Pests or Disease present at the time of inspection. | Owned by neighbour.<br>Target # - Dwelling<br>Target # - Garden<br>Target # - Parking / driveway<br>Target # - Open Space | YES | <ul style="list-style-type: none"><li>_ No work required at time of inspection.</li></ul> | No Action | 2 Years |

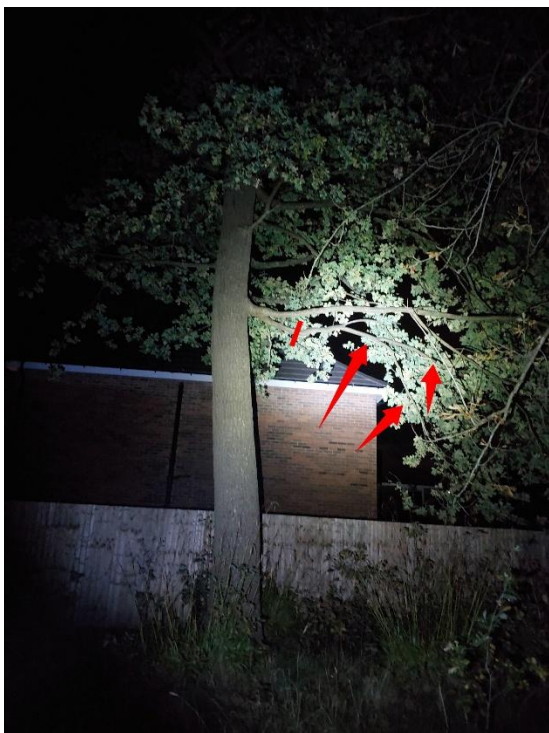
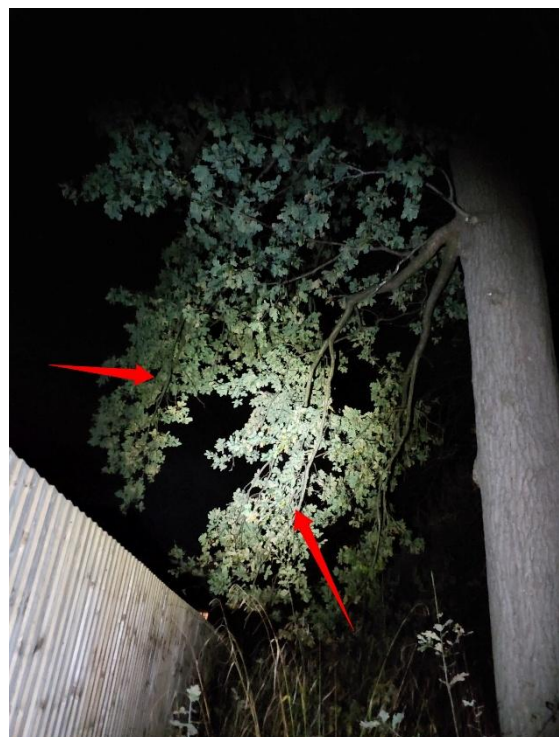
T7

| Tree | T007 | Oak ( <i>Quercus sp.</i> ) | 1 | 60 | 18 | N:6<br>E:6<br>S:6<br>W:6 | Mature | Good | Good | 40+ Years | <ul style="list-style-type: none"><li>_ Tree under 3rd party ownership.</li><li>_ No significant visual root defects.</li><li>_ No significant visual stem defects.</li><li>_ No significant visual branch defects.</li><li>_ Minor deadwood &lt;25 mm diameter.</li><li>_ Grown as part of a group of trees.</li><li>_ Canopy encroaching boundary line.</li><li>_ Canopy encroaching building.</li><li>_ Pruning history - Crown reduction.</li><li>_ Seasonal leaf drop has started (normal).</li></ul> | No significant visible fungus present at the time of inspection. | No significant visible Pests or Disease present at the time of inspection. | Owned by neighbour.<br>Target # - Dwelling<br>Target # - Garden<br>Target # - Open Space | YES | <ul style="list-style-type: none"><li>_ Remove dead wood greater than 25mm.</li><li>_ Prune to clear boundary line.</li></ul> | 27-Oct-2026 (1 Year) | 2 Years |
