**PENDLETON ROAD, WISWELL**

RJP Project No 12327

Urban Future Planning Consultancy Ltd commissioned Reid Jones Partnership Ltd (RJP) to carry out an inspection of the property on land adjacent to Pendleton Road, Wiswell.

Kaye Harrison, BEng (hons) CEng MIStructE, visited the property in January 2026 to carry out an assessment of the suitability of the property for conversion to a residential dwelling from agricultural use.

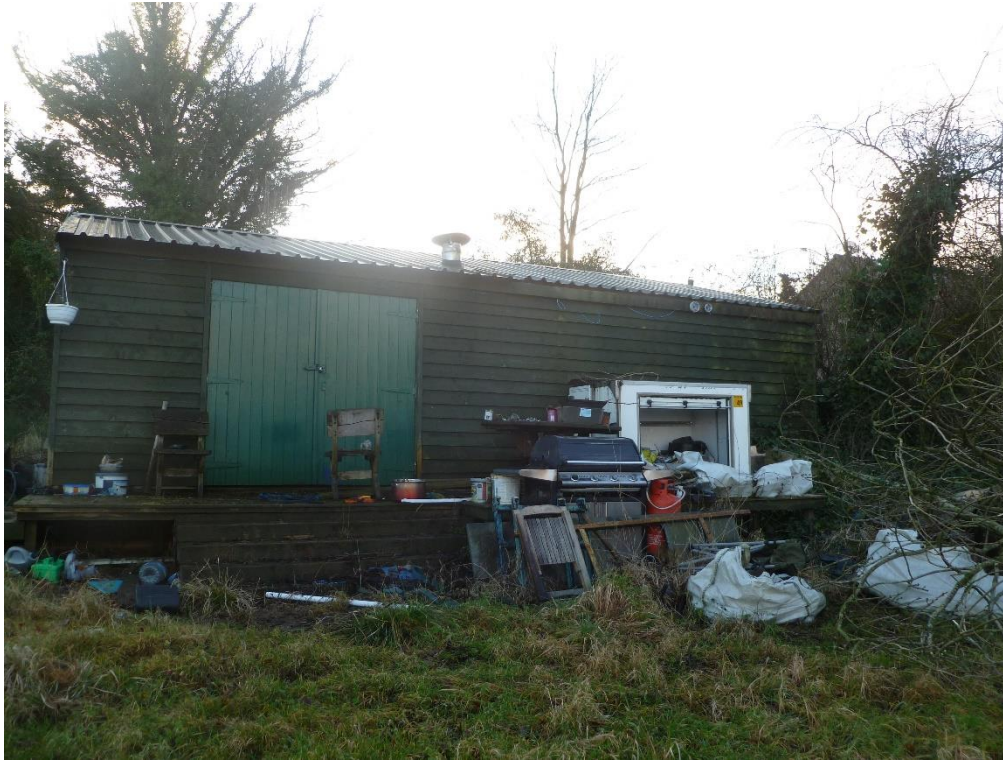
The property is a single storey structure with a pitched roof (photo 1). The external wall is formed of timber studs, clad internally with horizontal timber boarding and externally with lapped horizontal timber boarding. There is insulation between the studs. There is a single internal wall dividing the space, again of timber stud construction. There are timber roof trusses at 1.2m centres supporting timber purlins and profiled metal sheeting (photo 2).

Photo 1 – Front (West) Elevation

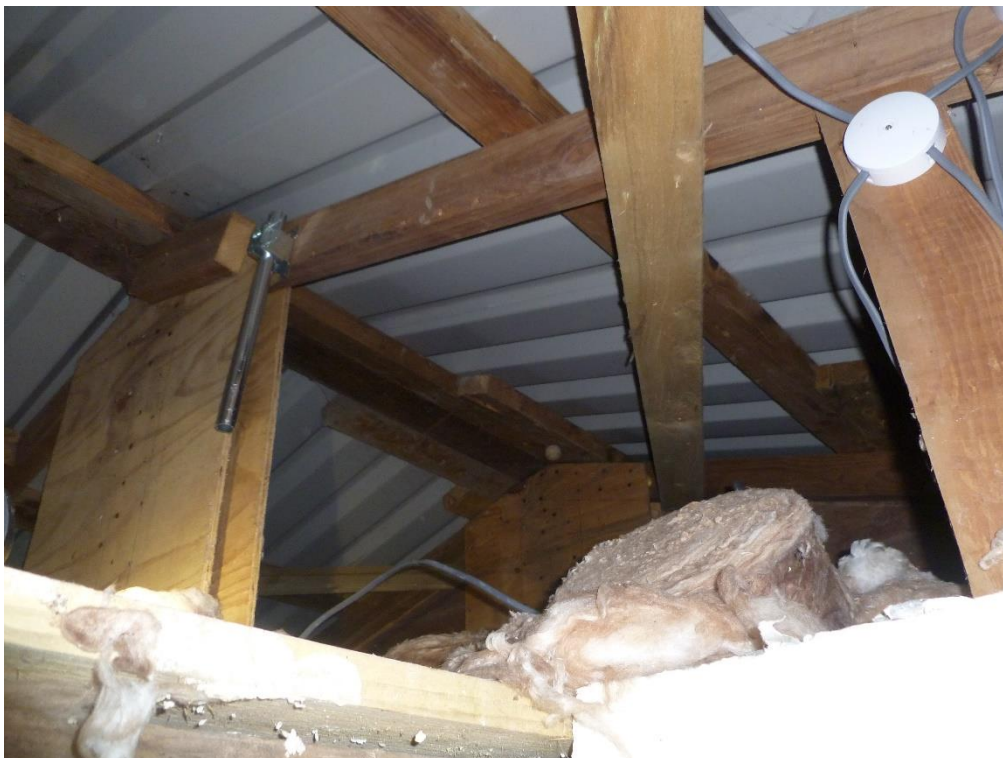
There are timber roof trusses at 1200mm centres. This is suitable to support the lightweight steel sheet roof currently enclosing the building. To support the proposed slate/ tiled roof which is much heavier, roof trusses are likely to be required at 600mm centres to give additional load carrying capacity and appropriate spans for roof battens.

Photo 2 – Roof construction

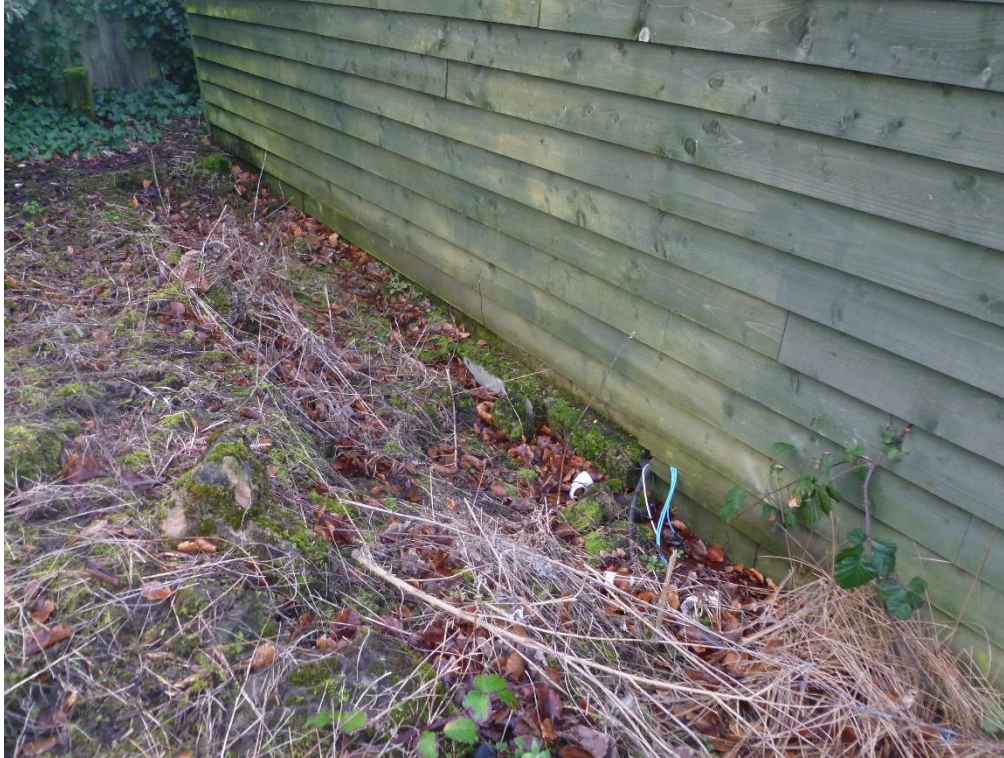
Some external timber cladding at low level is in contact with the ground at the rear of the property, and is damp (photo 3). There is lichen growth on the shaded faces of the cladding.

Photo 3 – High ground levels at the rear of the property

Careful consideration should be given to management of surface water on the site with positive measures employed to divert water running down the slope from Pendleton Road from causing damp problems to the property, and landscaping to ensure appropriate ground levels are maintained around the property. Additionally guttering and downpipes will be required to ensure run off from the roof does not cause damage to the property.
