Tree Condition Report

Somerset Avenue,
Wiltshire,
BB1 9JD

08/11/2024

Job Ref: 2024

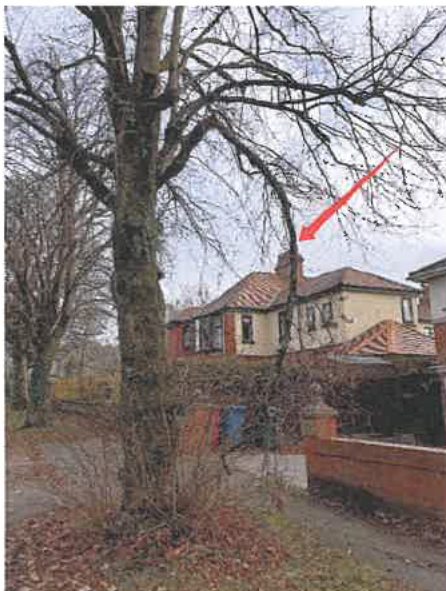
T10 – prune snapped branch

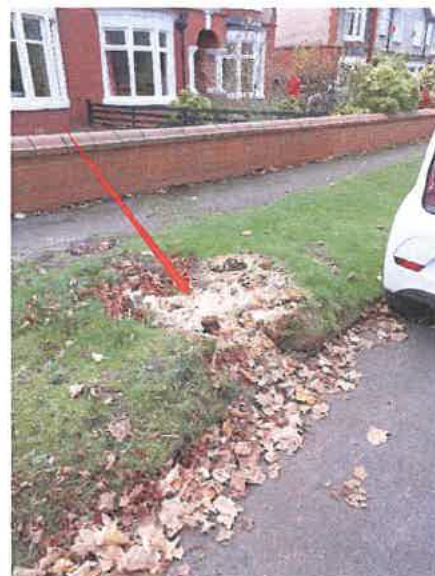
- 18.4. There are 2 tree stumps in the grass verge, T14 and T62, these are a trip hazard, and the stumps need grinding below ground level and the grass reinstating.

- 18.5. T14 has recently failed during a storm resulting in the tree being removed, as the tree was covered under a TPO, and to keep the ongoing aesthetics of the tree lined avenue, a replacement tree will be required once the stump has been removed / ground out.

T14 – stump requiring grinding

Stump	T014	Unknown Species (Unknown Species)	1	70	0.1	N:0.1 E:0.1 S:0.1 W:0.1	Dead	Good	Good	40+ Years	Tree removed. Stem damage.	No significant visible fungus present at the time of inspection	No significant visible pests or disease present at the time of inspection	Owned by the client. Roadside tree. Target # - Footpath - highway	YES	Stump grind. Replacement tree planting required.	08-May-2025 (6 Months)	2 Years
Tree	T015	Lime (<i>Tilia sp.</i>)	1	40	10	N:4 E:4 S:4 W:4	Mature	Good	Good	40+ Years	Seasonal leaf drop has occurred. Low branching. Epicormic growth at base.	No significant visible fungus present at the time of inspection	No significant visible pests or disease present at the time of inspection	Owned by the client. Roadside tree. Target # - Road Target # - Footpath - highway Target # - Garden	YES	Epicormic removal up to 1st limb. Crown lift to 5.2 m for highway clearance.	08-May-2025 (6 Months)	2 Years

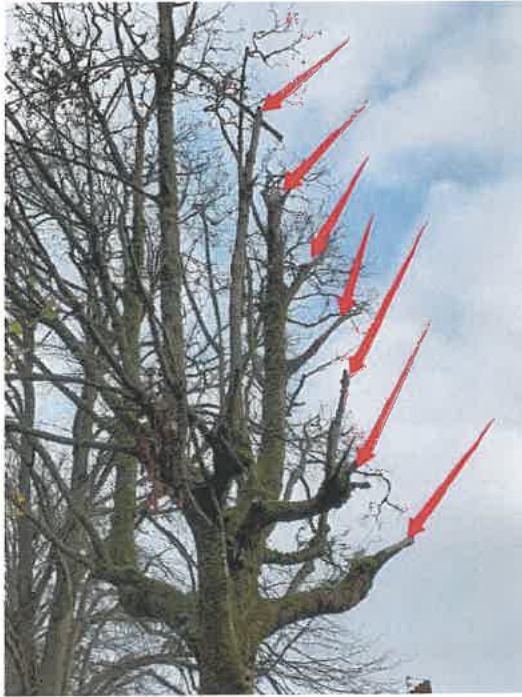
T12 – snapped stubs requiring target pruning and hung-up branches for removal

Tree	T012	Sycamore (Acer pseudoplatanus)	1	40	12	N:4 E:4 S:4 W:4	Mature	Good	Good	40+ Years	<ul style="list-style-type: none"> Low branching. Previous branch damage due to neighbouring tree failure. Hung up branch. 	No significant visible fungus present at the time of inspection.	No significant visible Pests or Diseases present at the time of inspection.	Owned by the client. Roadside tree. Target # - Road Target # - Footpath - highway Target # - Garden Target # - Parking / driveway	YES	No work required at time of inspection.	No action	2 Years

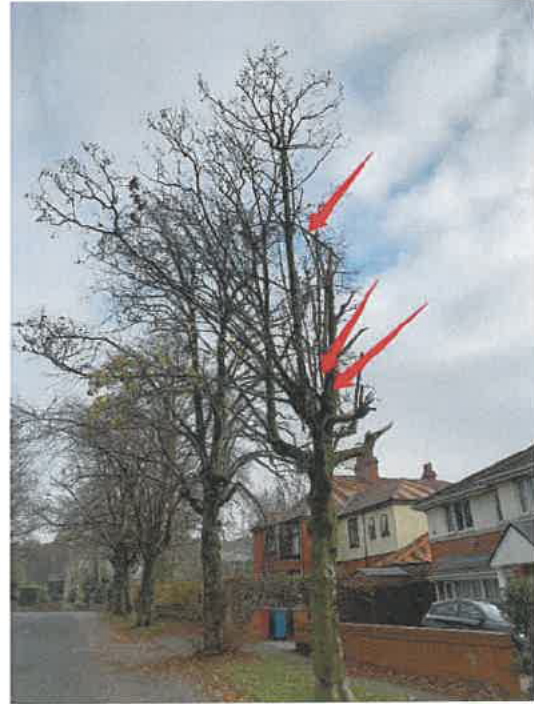
T27 – prune to clear street light

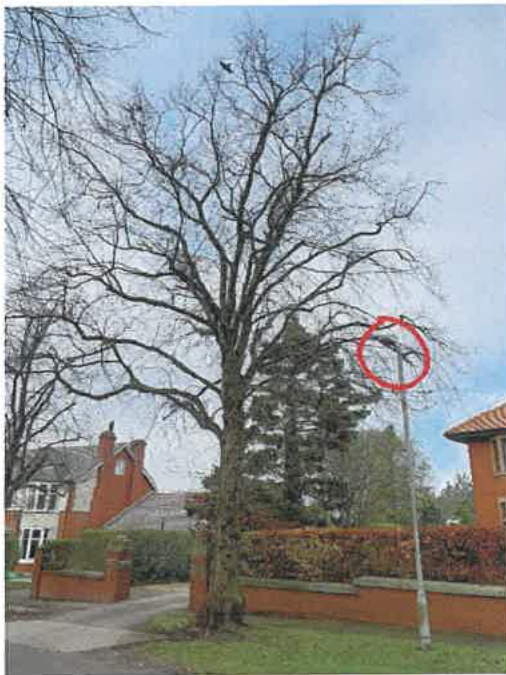
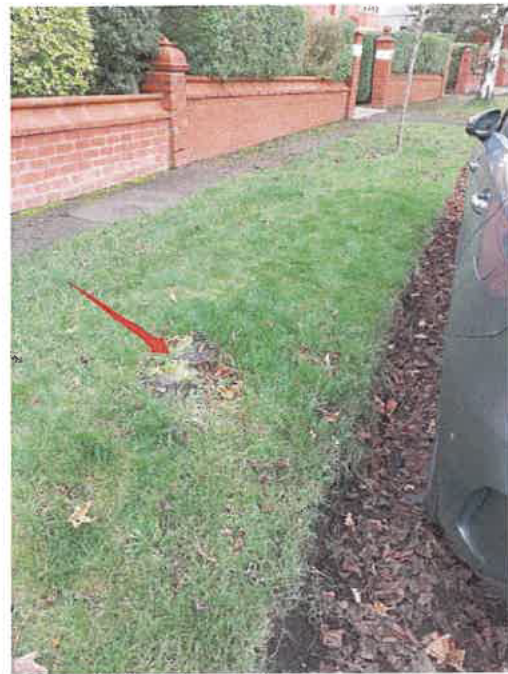
T62 – stump requiring grinding
