**A Report of the Archaeological Recording  
and Watching Brief at  
Cockshotts Farm and Cottage, School Lane, Simonstone, Burnley**

**Part 2 The Watching Brief**

**D J A Taylor, Dip Arch, PhD, RIBA, MIFA  
Chartered Architect, Archaeologist  
2A Higham Road  
Padiham  
Burnley  
BB12 9AP**

**July 2003**

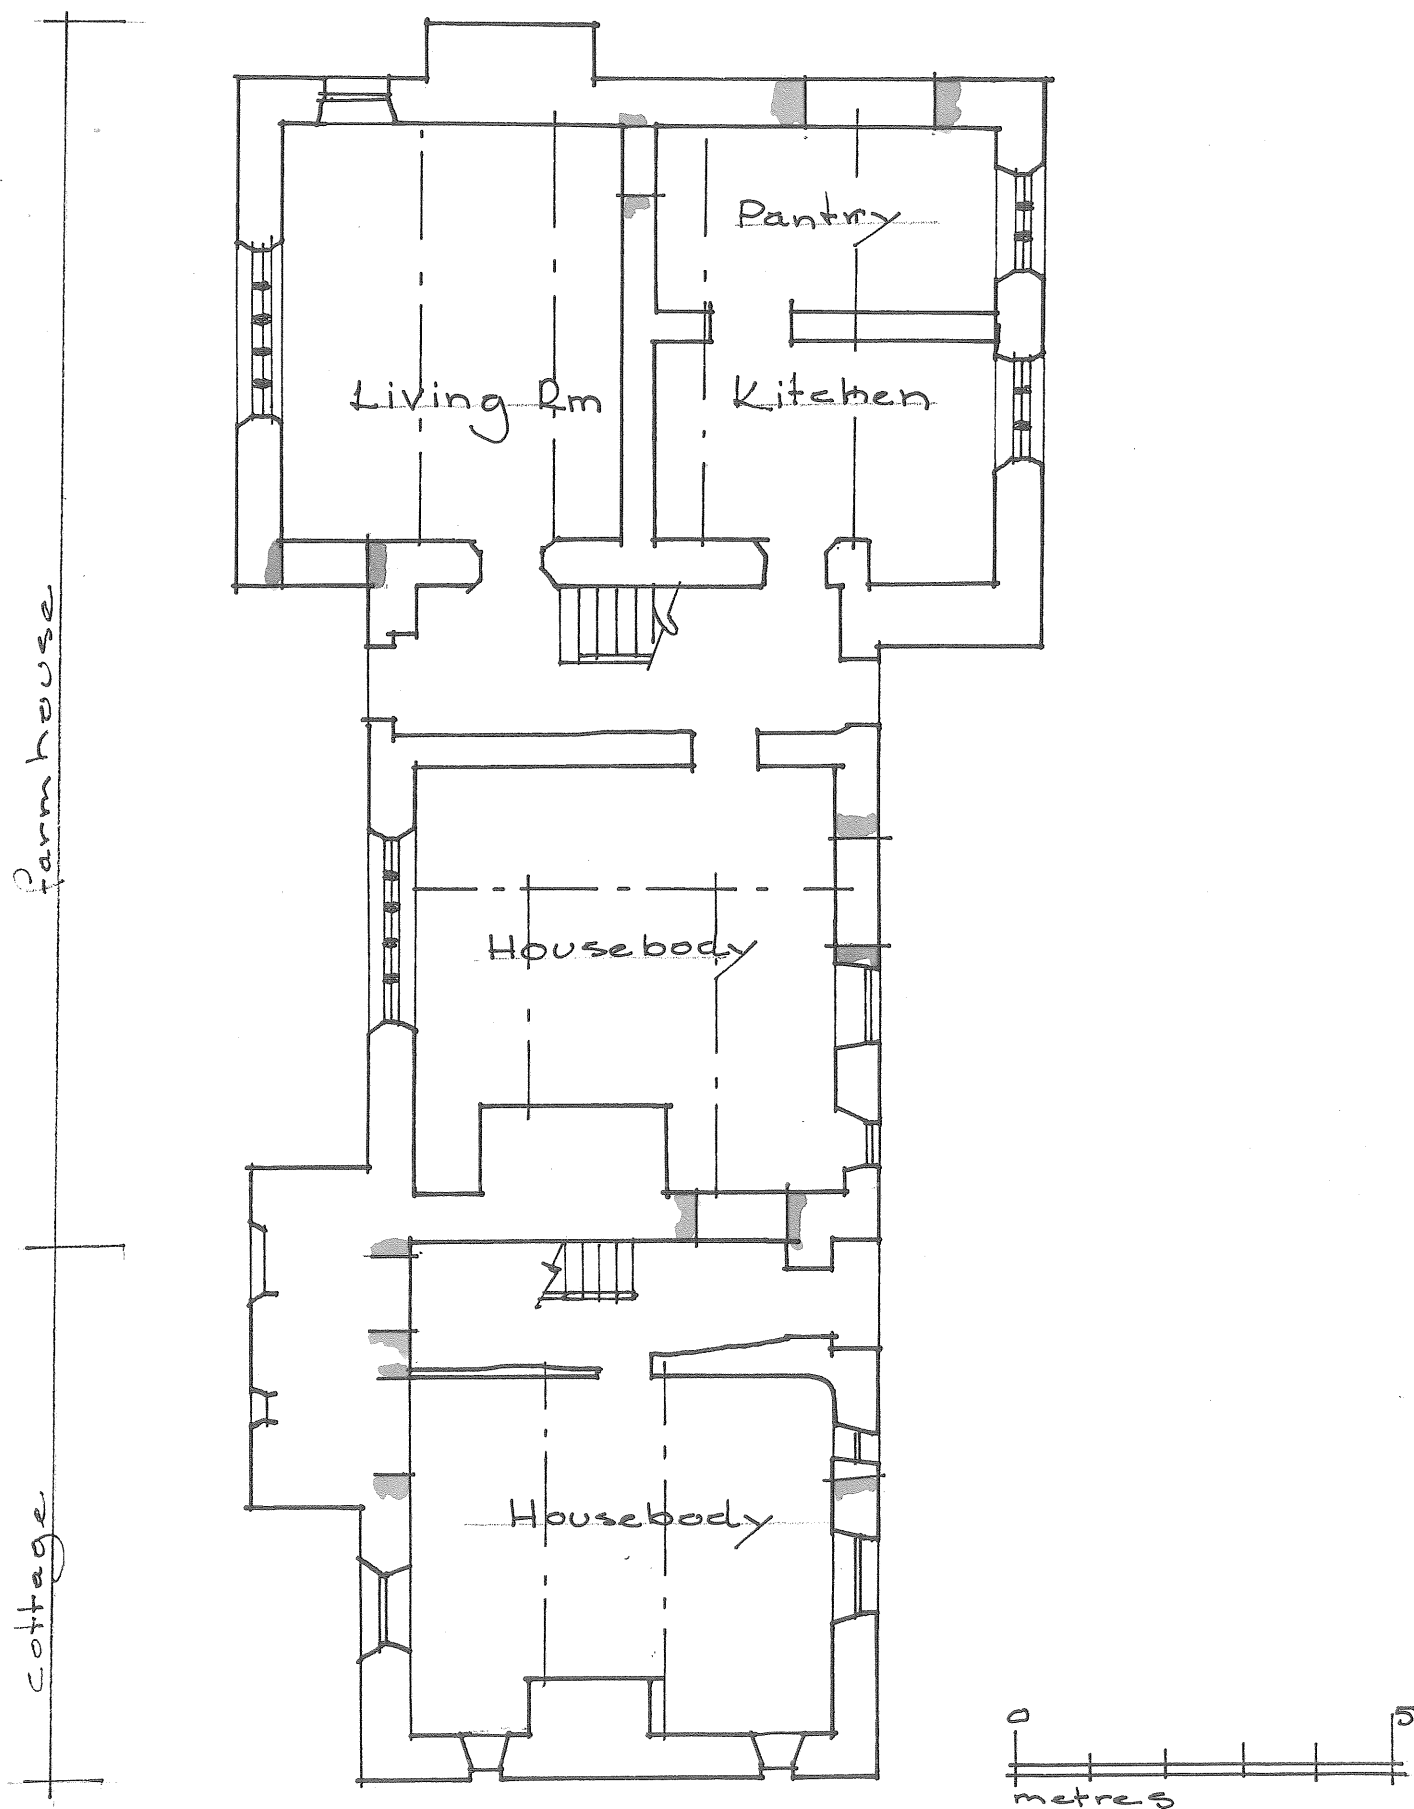
Ground Floor Plan

blocked-up openings shown.

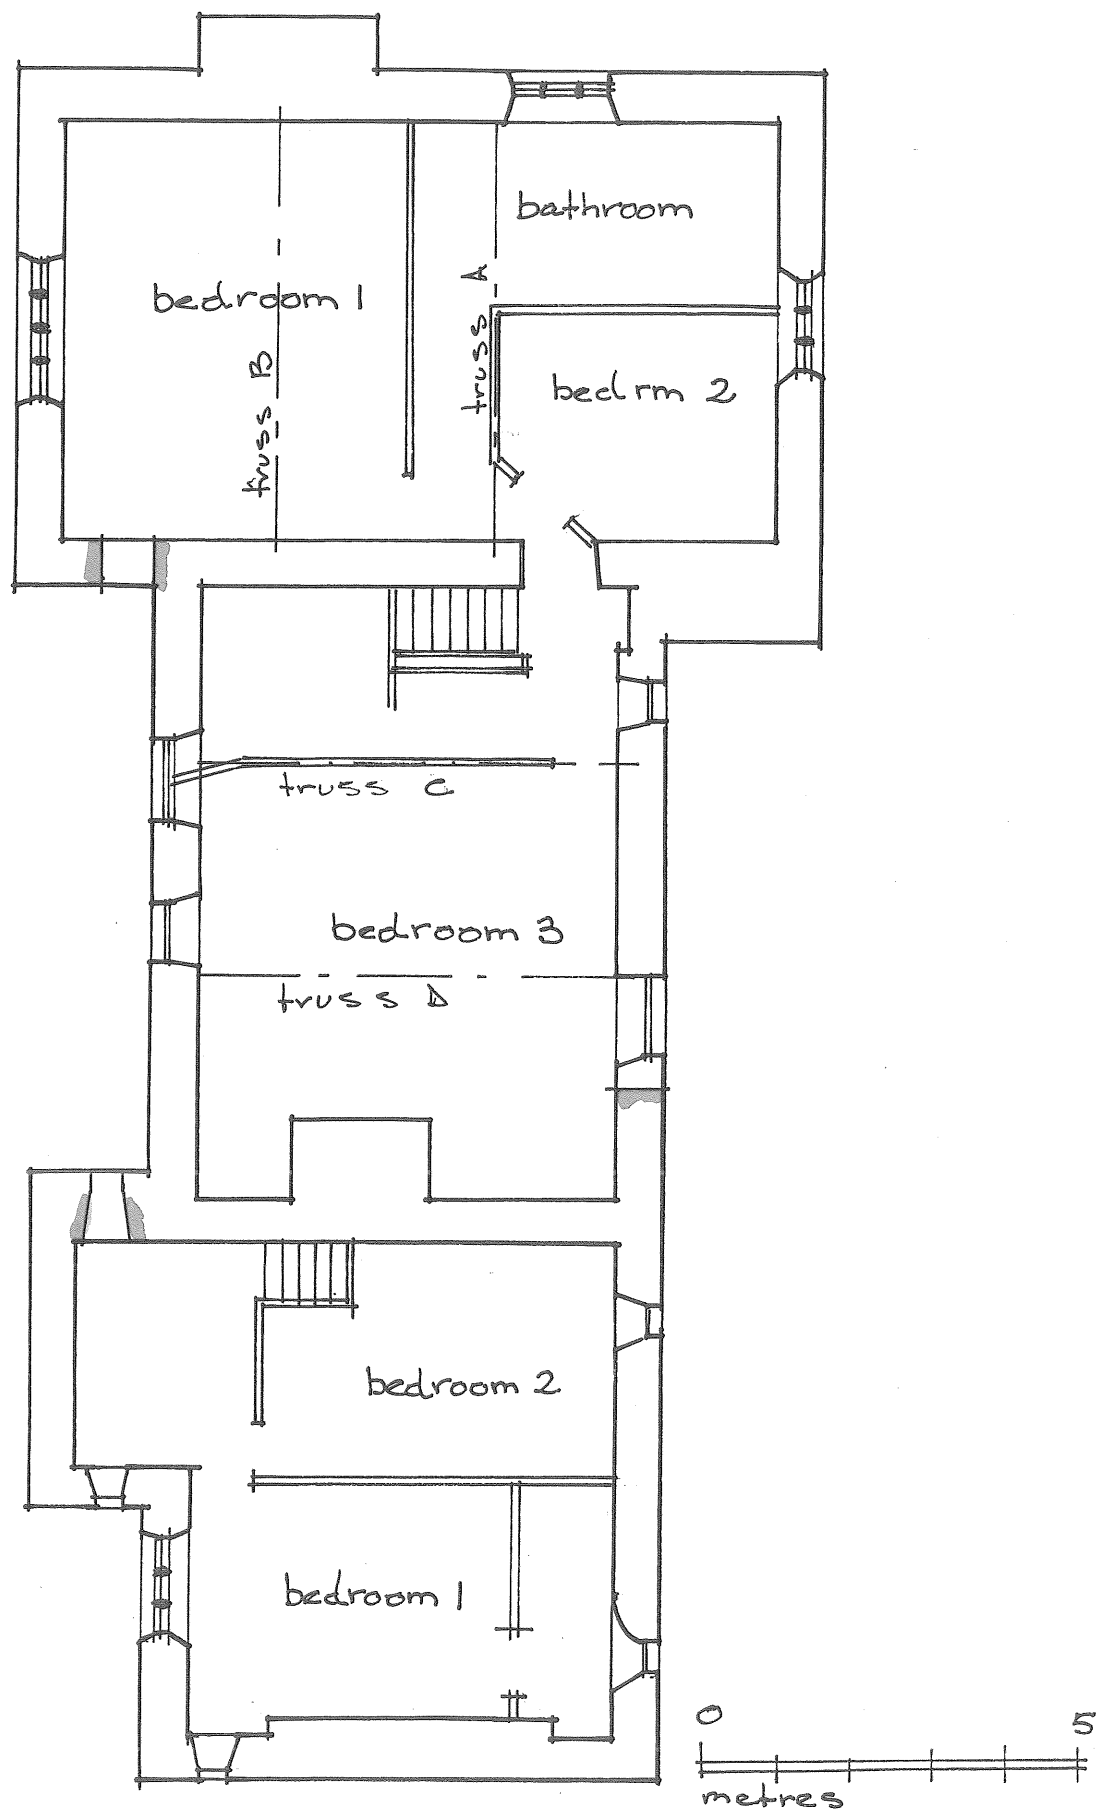
First Floor Plan

- 1 Evidence of mortises and circular holes were seen to the underside of the tie to truss A (fig. 2), with the wattle and daub infill, within the roof space. The corners to the underside are chamfered and there was evidence of limewash on the vertical faces. It was clear that an early full height partition had been formed on the line of the truss.

- 5 The internal face of the south wall to the cross-wing was seen to be plastered within the roof space.
- 6 Truss B (fig. 2) over bedroom 1 had all the external edges chamfered. This contrasts with truss A which had no edges chamfered, except the lower edge of the truss as it formed a partition wall. The implication is that the roof timbers over the cross-wing were intended to be exposed whilst the same degree of finish was not executed over the housebody as trusses C & D do not have chamfered edges.

blocked-up openings shown

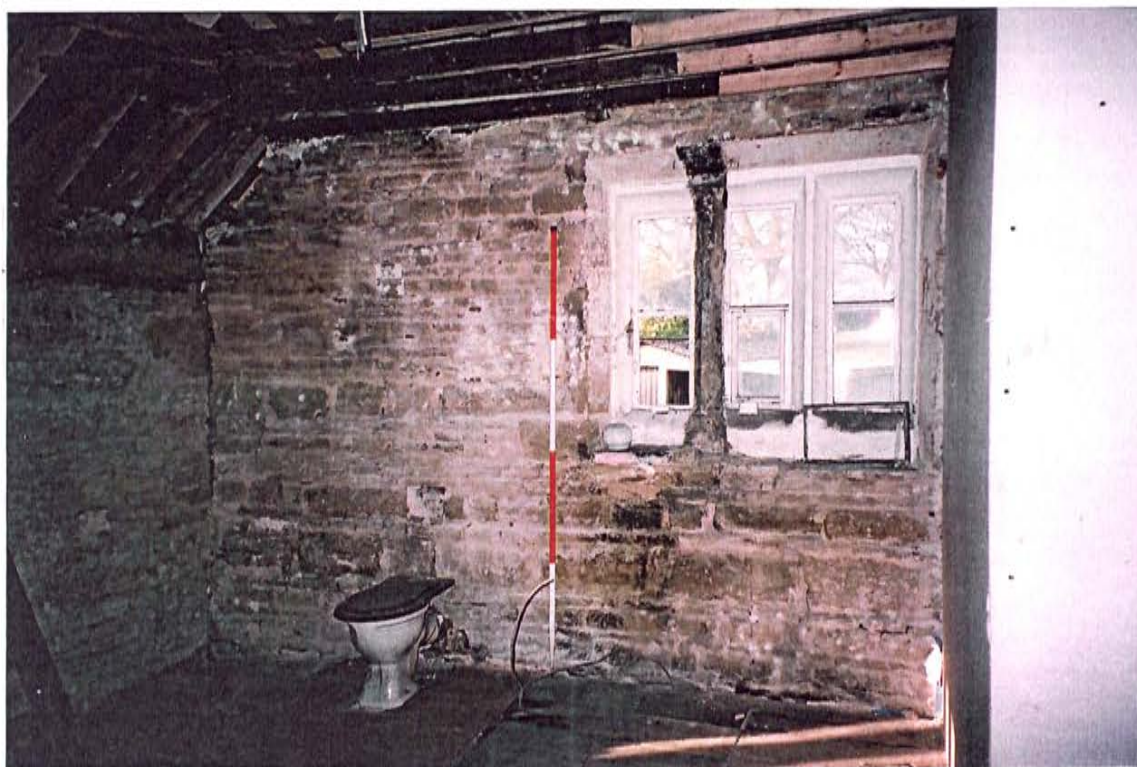
- 2 The masonry to the later cross-wing where seen internally is of very good quality, being largely built of neat shallow courses (pl.1). It is of much higher quality than that of the earlier construction of the farmhouse. A small hole was cut in the south elevation, for drainage purposes, adjacent to the return wall. This showed that the front wall of the cottage was not tied into the cross-wing, there being a straight joint.

Pl. 1 Internal face of external north wall of the cross-wing at first floor level

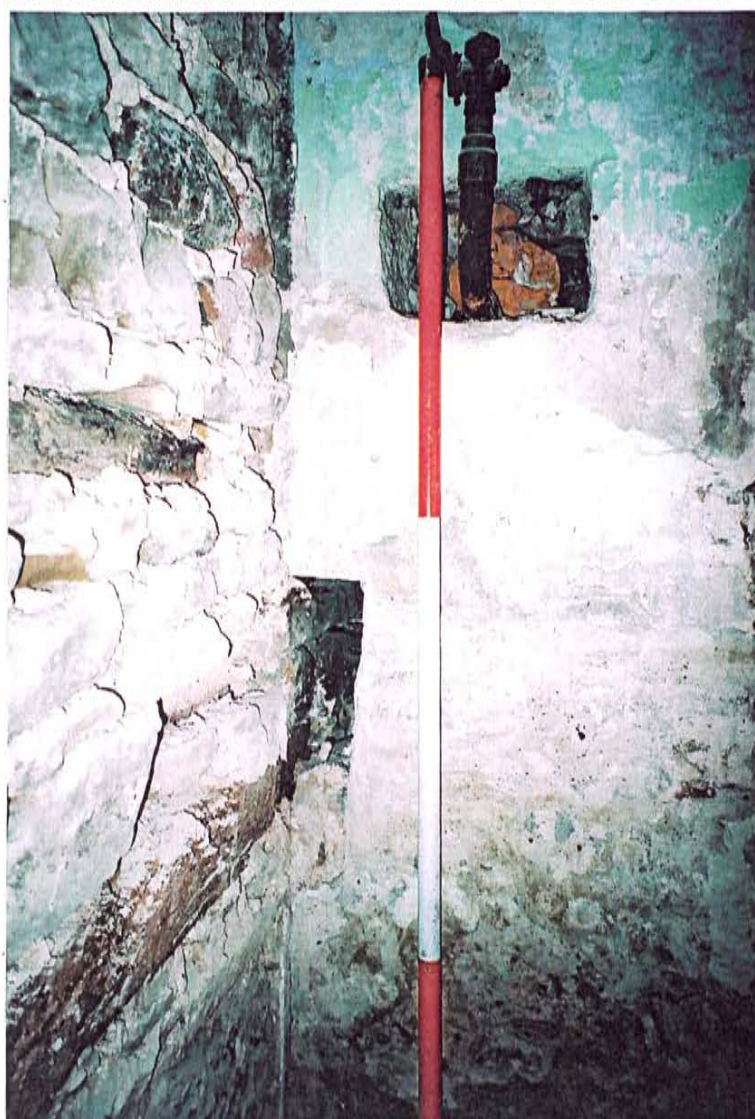
- 4 Small rectangular openings have been built into the external west wall of the kitchen on the line of the dividing wall with the pantry (pl. 2). It would appear that when the doorway 920mm wide was blocked between the two rooms that the new stonework was tied into the openings. No evidence of this doorway can be seen from the pantry. The mortar used to block up the doorway is very light in colour and matches that to the blocked up window opening to the cross-wing at first floor level and also the first floor windows in the east wall of the cottage. A timber beam is built into the internal wall close to the external wall.

Pl. 2 West wall to former pantry of the farmhouse at its junction with the internal wall to the living room

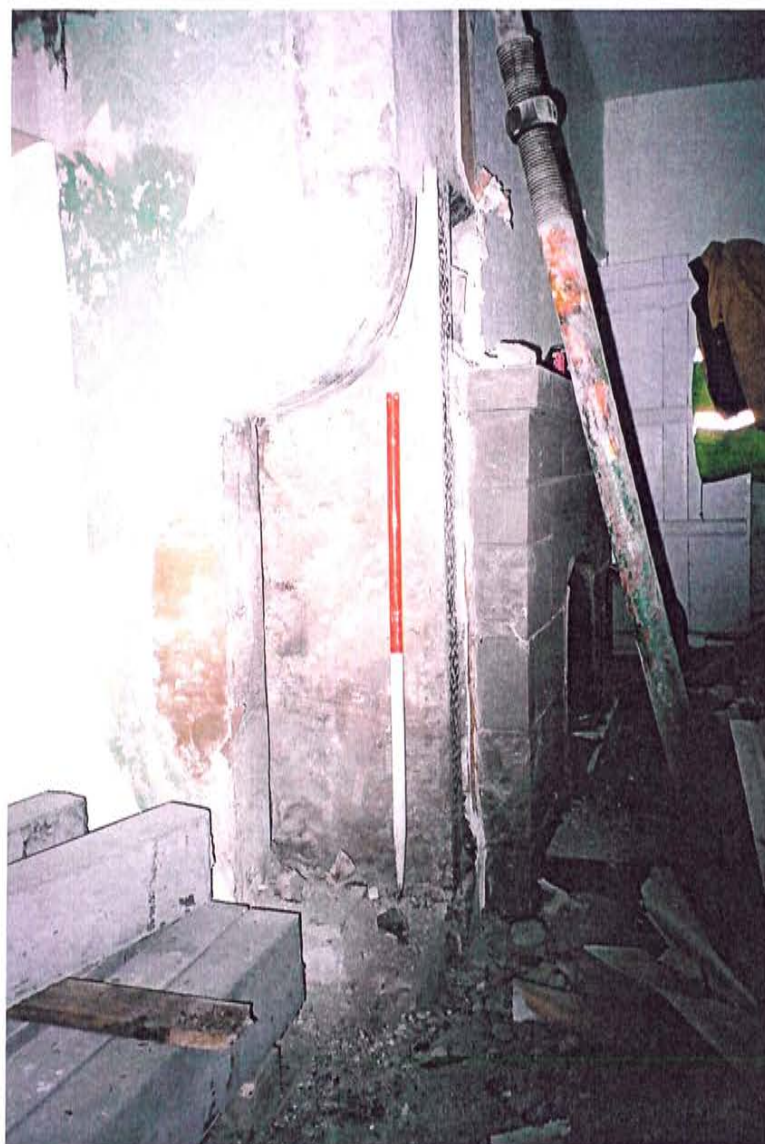
- 7 The left-hand jamb of a large inglenook fireplace was seen in the housebody (pl. 3). The underside of the mantle, with its chamfered lower edge, is 1.450m above floor level and projects on corbels being of one piece with the jambs. The right hand jamb was originally situated to the left hand side of the present cupboard to the right hand side of the fireplace. It would seem that the jamb and corbel have been removed, but the stone to the side of the fireplace to the rear of this is still *in situ* and can be seen within the cupboard. Timbers are built in to the chimney breast, one at high level running across the front just below the ceiling and a further one to the left hand return with the end of the timber being exposed on the front of the breast.

Pl. 3 Left hand jamb to inglenook fireplace to housebody of the farmhouse.

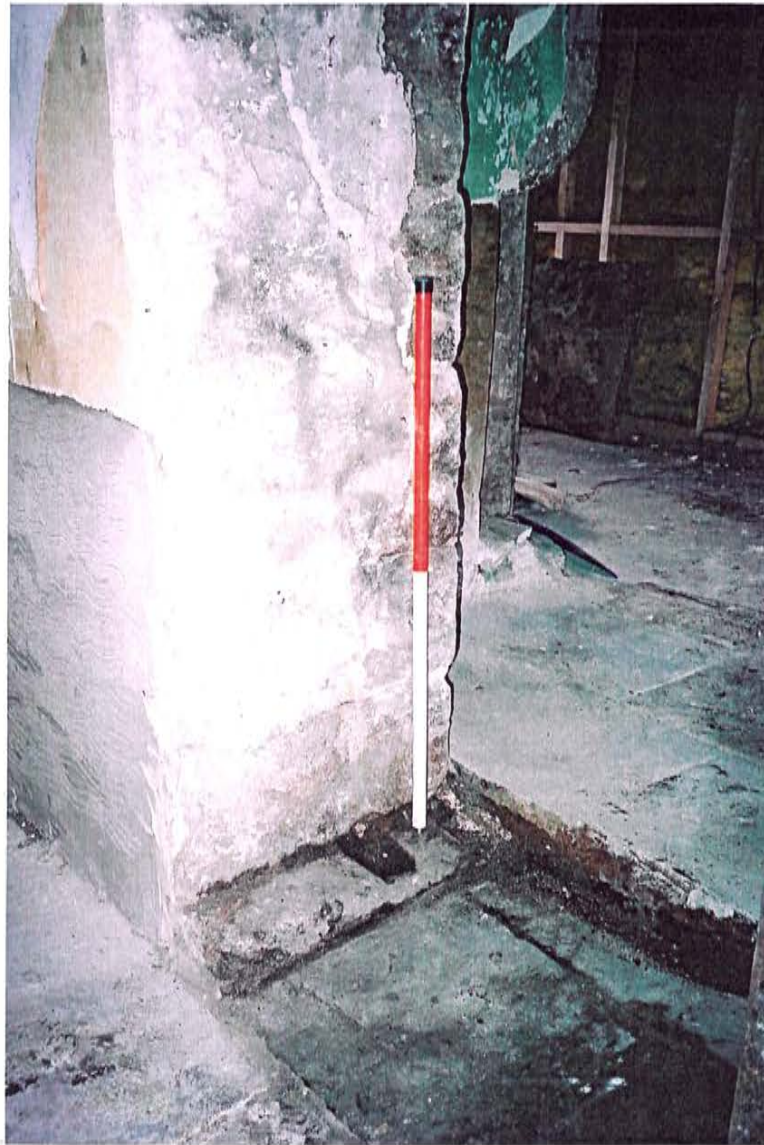
- 8 A blocked window opening 1.360m wide is present in the north wall of the housebody.
- 9 The original external door opening 1.200m wide is positioned to the north side of the fireplace in the living room with jambs of differing height to each side (pl. 4). When this doorway was opened up to provide access into part of the former housebody it could be seen that the flagged floor within the cottage ran beneath a later floor in the farmhouse at the same level. The latest floor of the farmhouse is 130mm above the earlier one. It is evident that there has been some reforming of the door opening on several occasions. Some evidence of this can be seen in the northernmost jamb where there is a suggestion of an earlier rebate having been formed. Two substantial oak timbers act as a lintel over the opening, the inner one 230mm wide and the outer one 210mm set 110mm below the inner one. A late reused timber is positioned behind the outer lintel but this has little or no bearing on the north side of the opening. At floor level two upstands 70mm high with a projection of 100mm are formed with two rebates cut into their upper surface. It is probable that these accommodated a door frame. This at one time would have been the main external doorway

leading into the housebody of the farmhouse and clearly pre-dates the erection of the cottage.

Pl. 4 Doorway in east wall of the housebody to farmhouse, formerly an external entrance.

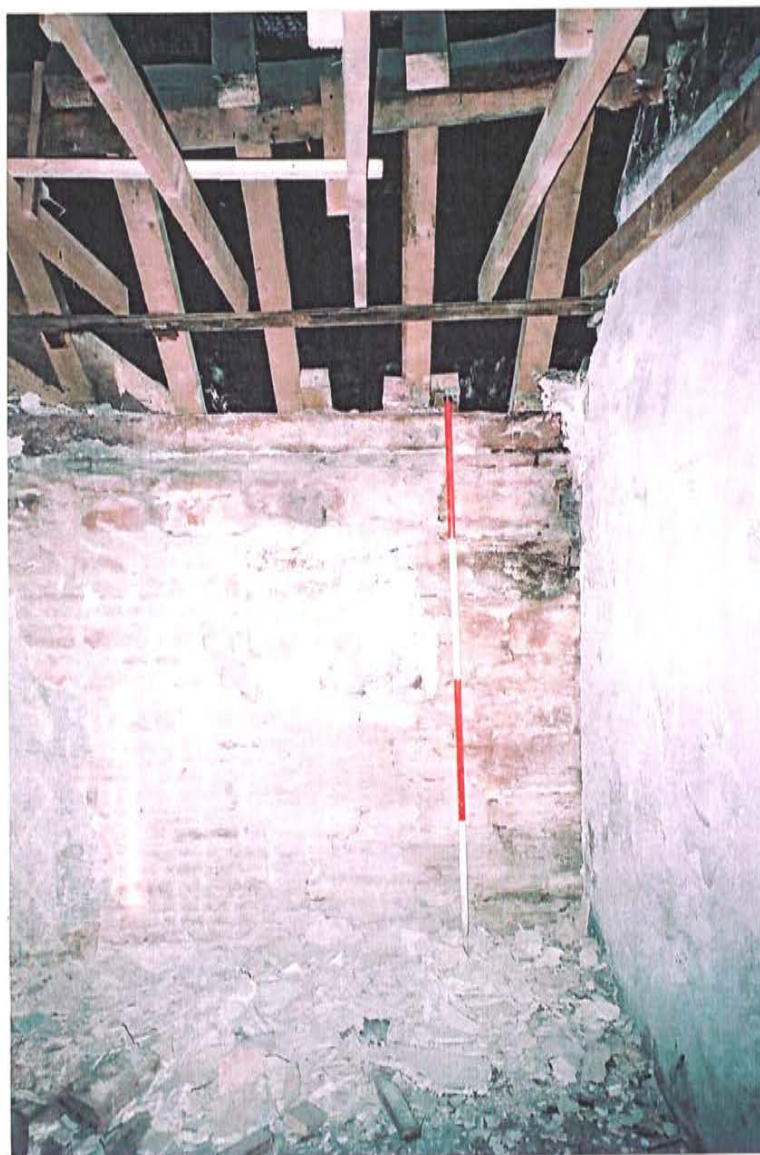
- 10 The exposed floor joists over the housebody have chamfered edges to their lower corners.
- 11 A blocked up window opening 640mm wide is present at first floor level in the east external wall of the cross-wing over the living room (pl. 5). This is clearly seen in the different coloured mortar to the stonework. The mortar to this former opening is identical to that used in the blocking of the east windows to the gable wall of the cottage and the doorway between the living room and pantry.

Pl. 5 Blocked up window opening to first floor room above the living room to cross-wing.

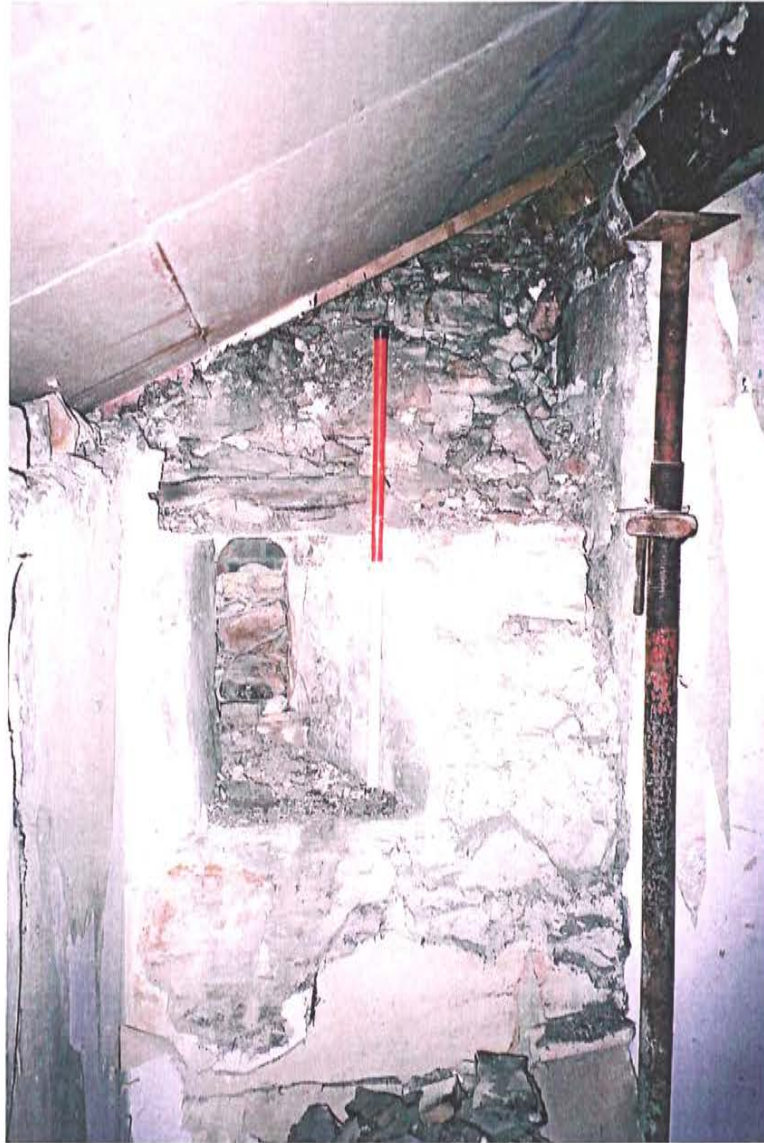
- 1 A round-headed opening with splayed reveals was uncovered on the first floor landing in the return wall on the line of the party wall of the farmhouse (pl. 6). The overall size of the opening was 520mm wide by 610mm high and is visible externally. The opening was subsequently closed up and not retained.

Pl. 6 Former blocked up window to landing of cottage – now reblocked.

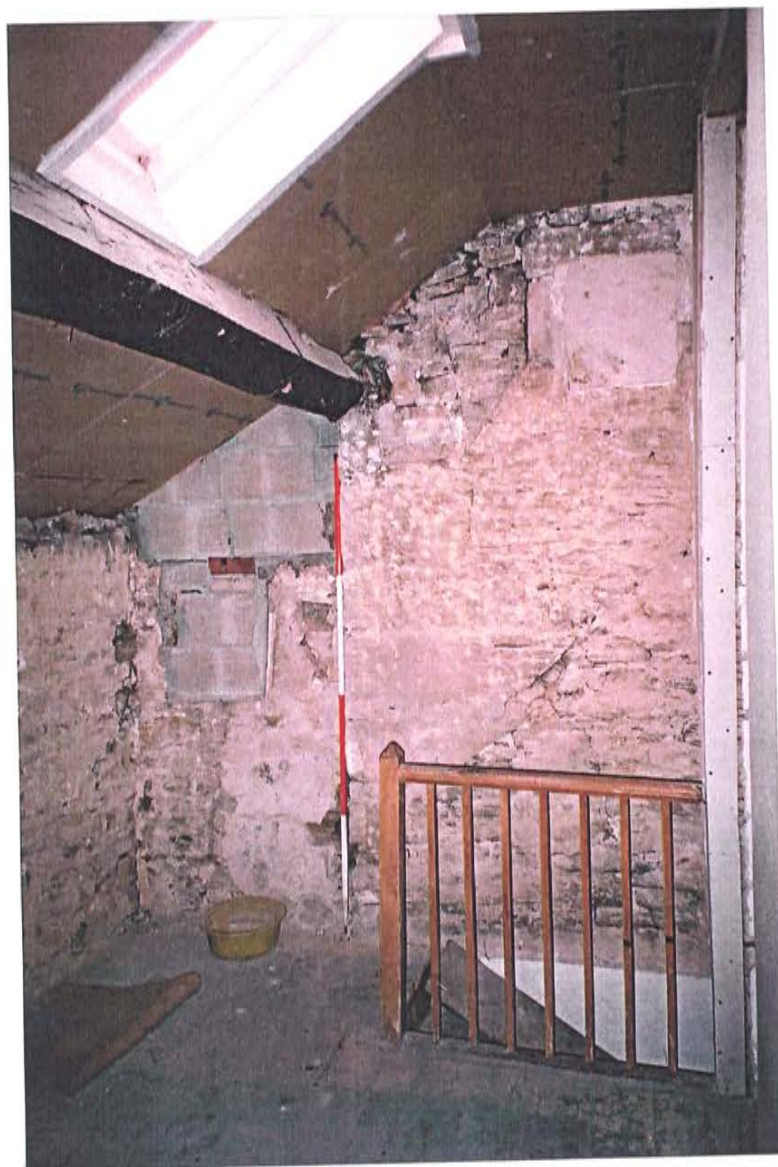
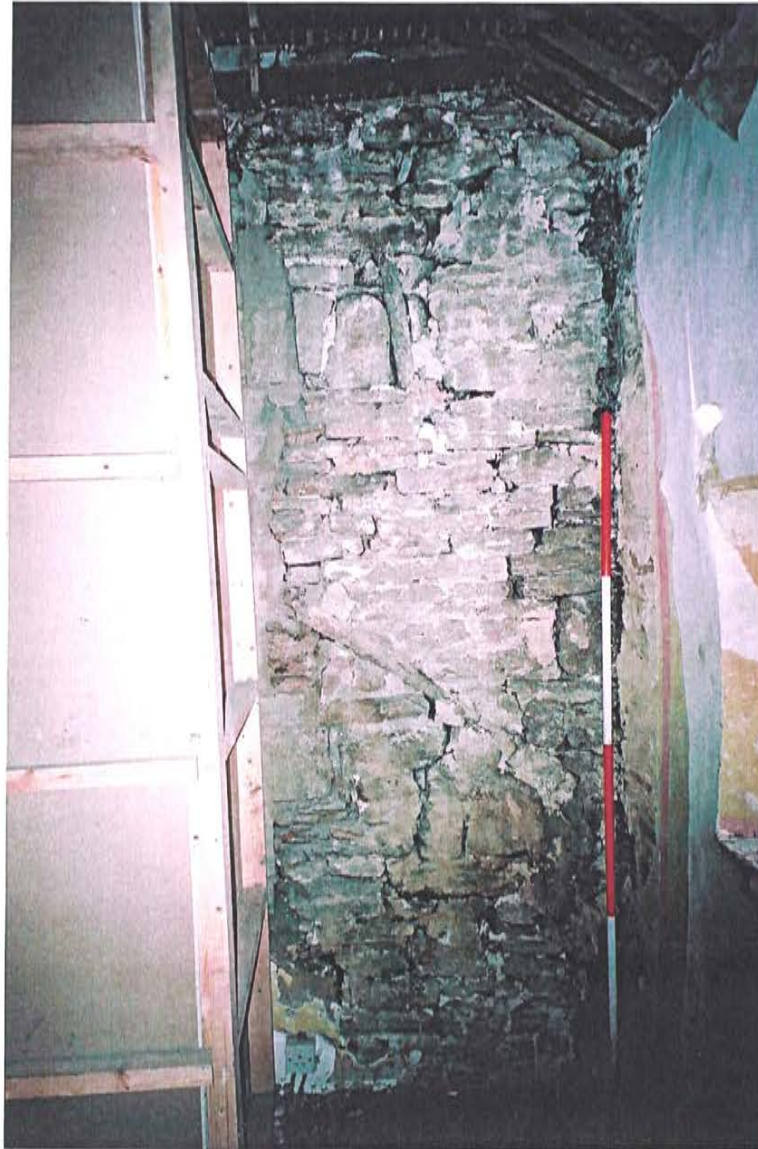
- 3 The stonework to the party wall of the farmhouse was revealed at first floor level and showed that at one time the house had been single-storey, and later raised to two-storey height (pl. 7 & 8). Evidence of the earlier roofline was clearly visible, with some remnants of roofing slates still *in situ*. The later masonry is of inferior quality to the earlier work. Two vents were formed at high level with stone heads, sills and jambs 300mm by 460mm and 230mm by 290mm. The roofline on the face of the party wall was 690-860mm above floor level in the cottage, with the angle of pitch being *c.* 32 degrees. An access has been formed through this wall and the difference in floor levels is 720mm with the floor level of the farmhouse being the higher.

Pl. 7 Gable wall to farmhouse at first floor level in the cottage. The former line of the roof to the farmhouse is visible above floor level.

Pl. 8 Gable wall to farmhouse at first floor level in the cottage.
