# Tree Condition Report

Wilpshire Golf Club

15/01/2026

**Job Ref: 2244**

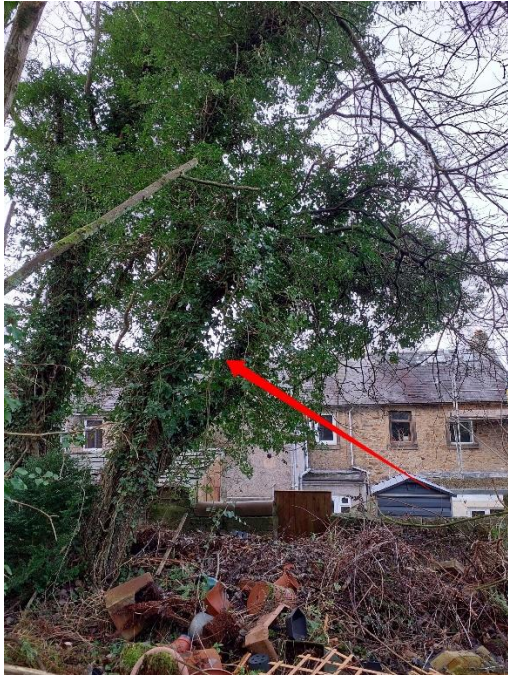
T285 - removal

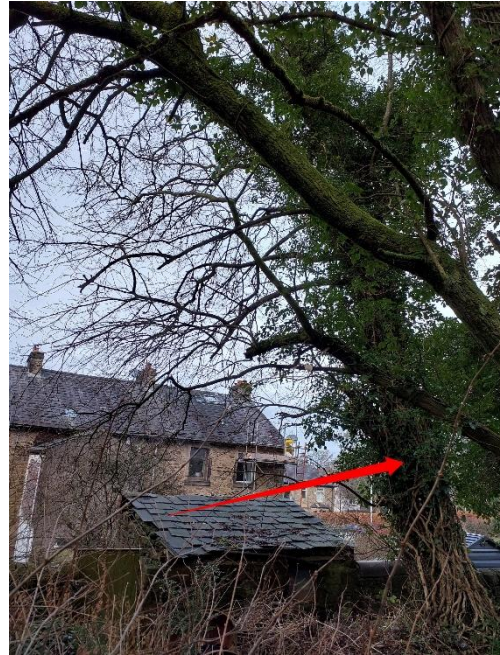
T286 - removal

Tree	T286	Willow ( <i>Salix sp.</i> )	1	30	12	N:4 E:4 S:4 W:4	Semi Mature	Good	Fair	10+ Years	<ul style="list-style-type: none"> <li>_ Restricted rooting volume.</li> <li>_ Tree growing in close proximity to wall / building.</li> <li>_ Dense ivy clad on stem.</li> <li>_ Canopy encroaching boundary line.</li> <li>_ Seasonal leaf drop has occurred (normal).</li> </ul>	No significant visible fungus present at the time of inspection.	No significant visible Pests or Disease present at the time of inspection.	Owned by the client. Target # - Footpath - highway Target # - Garden Target # - shed / greenhouse / outbuilding	YES	_ Remove tree to ground level for arboricultural management reasons.	08-Jul-2026 (6 Months)	Not Applicable
Tree	T287	Willow ( <i>Salix sp.</i> )	1	30	14	N:4 E:4 S:4 W:4	Semi Mature	Good	Fair	10+ Years	<ul style="list-style-type: none"> <li>_ Dense ivy clad on stem.</li> <li>_ Canopy encroaching boundary line.</li> <li>_ Seasonal leaf drop has occurred (normal).</li> <li>_ Leaning stem 15 degrees.</li> </ul>	No significant visible fungus present at the time of inspection.	No significant visible Pests or Disease present at the time of inspection.	Owned by the client. Target # - Footpath - highway Target # - Garden Target # - shed / greenhouse / outbuilding	YES	_ Limb – Remove (see photo).	08-Jul-2026 (6 Months)	2 Years

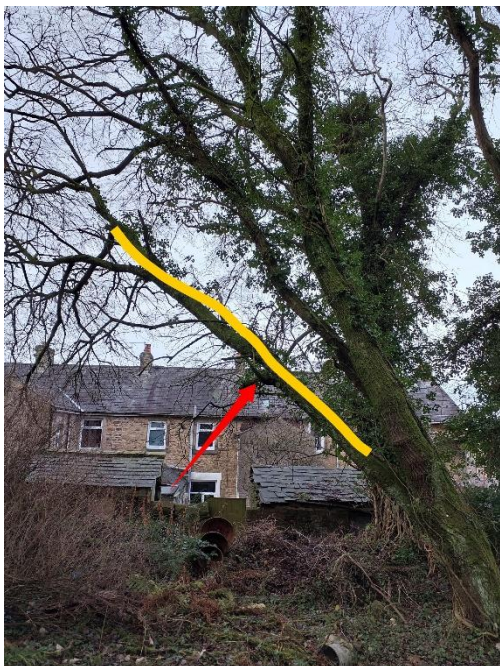
T287 – limb removal

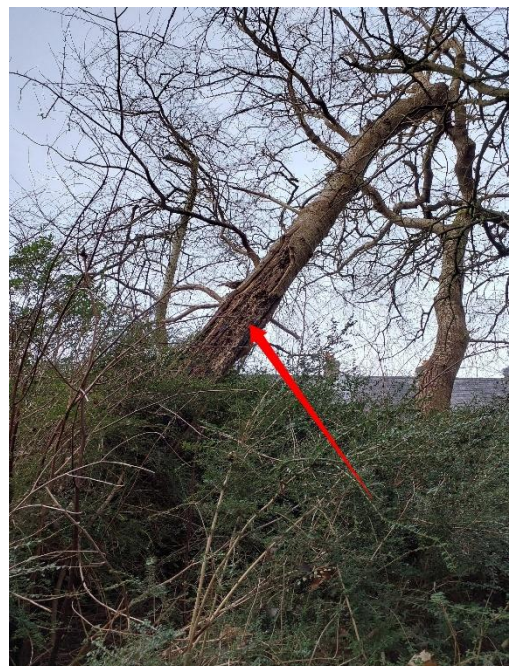
T287 – removal

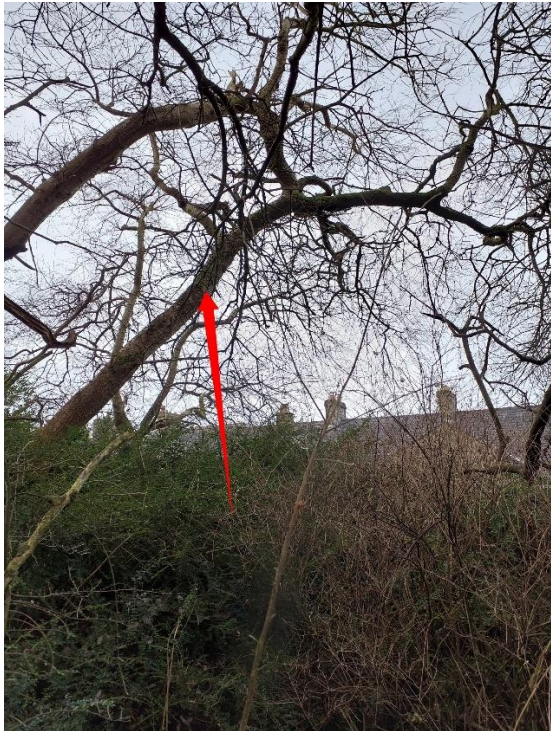
T289 - removal

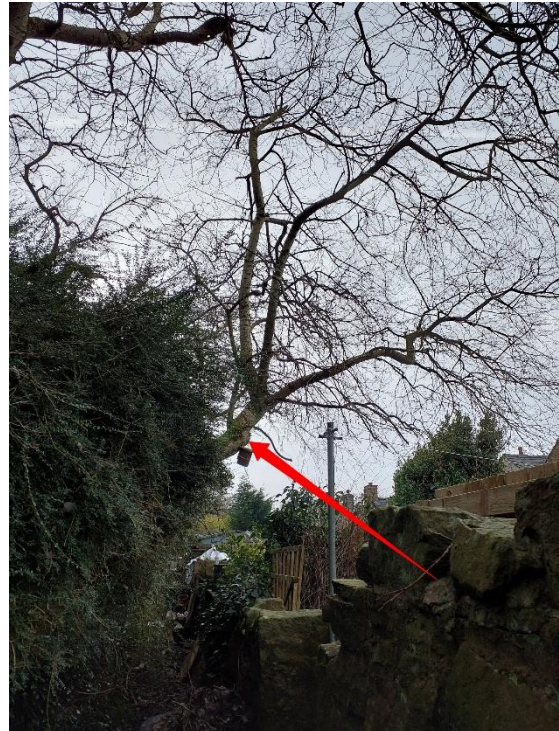
T290 - removal
