Front Boundary Wall at 70 Mellor Brow, Mellor, BB2 7EX

Proposed Repairs and Alterations

Approval in Principle Structural Report

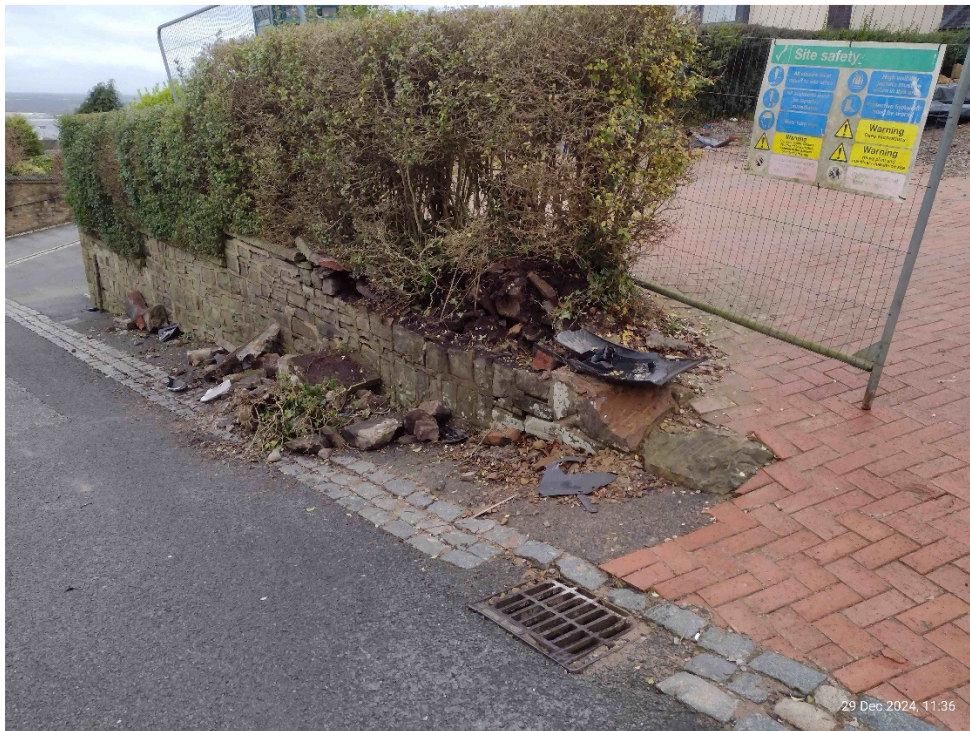
The wall was damaged by a vehicle impact in December 2024 and needs partial rebuilding. The opportunity is being taken to carry out repointing works and minor alterations to the wall.

The wall after the vehicle damage December 2014

1. The section of wall damaged by the vehicle will be re-built using the existing stone, but to a lower height than before (to improve visibility when exiting the property). This is illustrated on the Elevation from Roadway – Proposed.

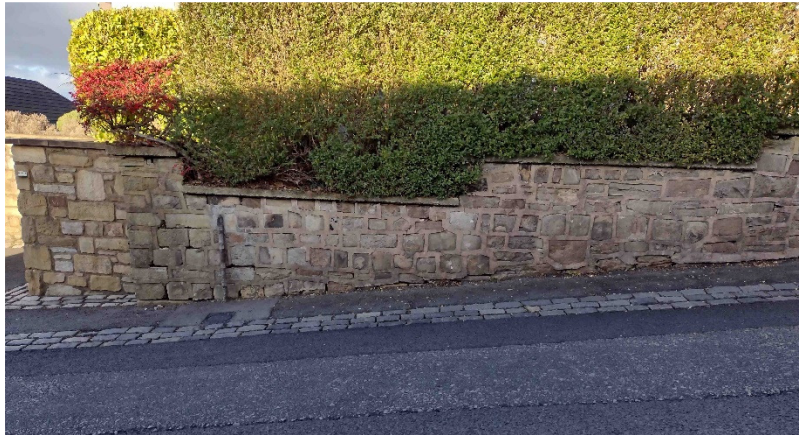
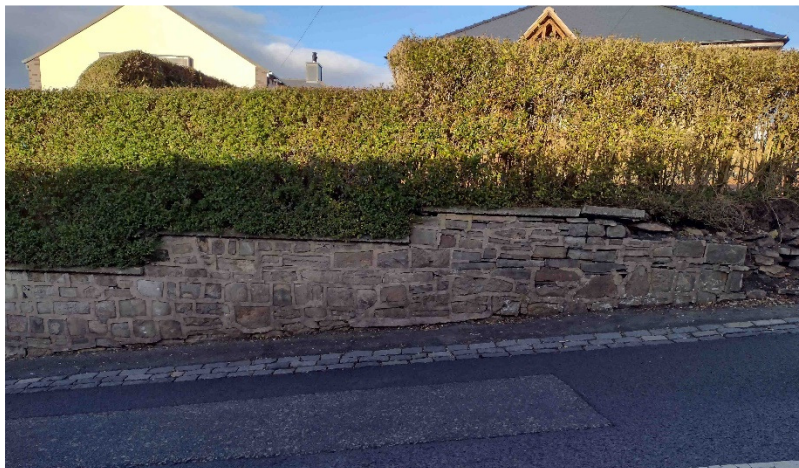
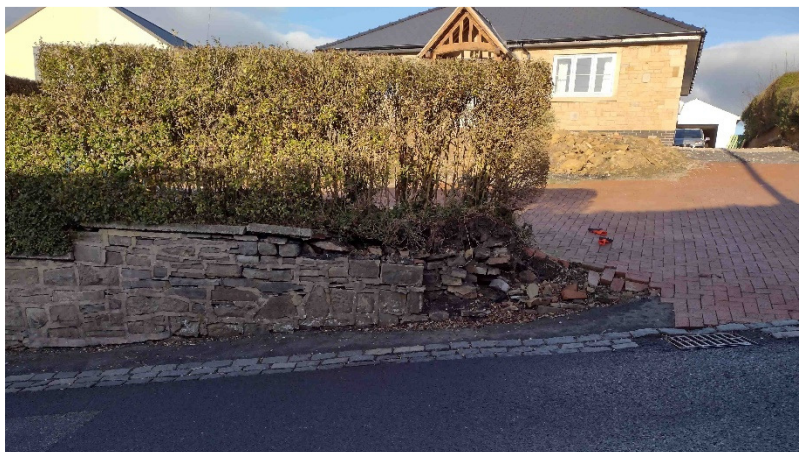
Condition of existing wall January 2026

Other than the area of damage by vehicle impact, the wall is in good condition. It is straight and vertical, with no lean towards the highway. It has however been previously repointed with raised ribbon cement pointing which is now starting to break away in places and does not provide sufficient protection to the stonework.

3. A new 450mm wide flat natural stone coping will be installed throughout.
4. The entire wall will be repointed using a lime-based mortar with a slightly recessed finish.
