Toward Tree Consultancy

RVBC Conservation Area - Tree Works Application Supporting Information

Site: Slaidburn Estate, Slaidburn, BB7 3EP

TTC Survey Ref: TTC004.2 (extract from TTC0042025)

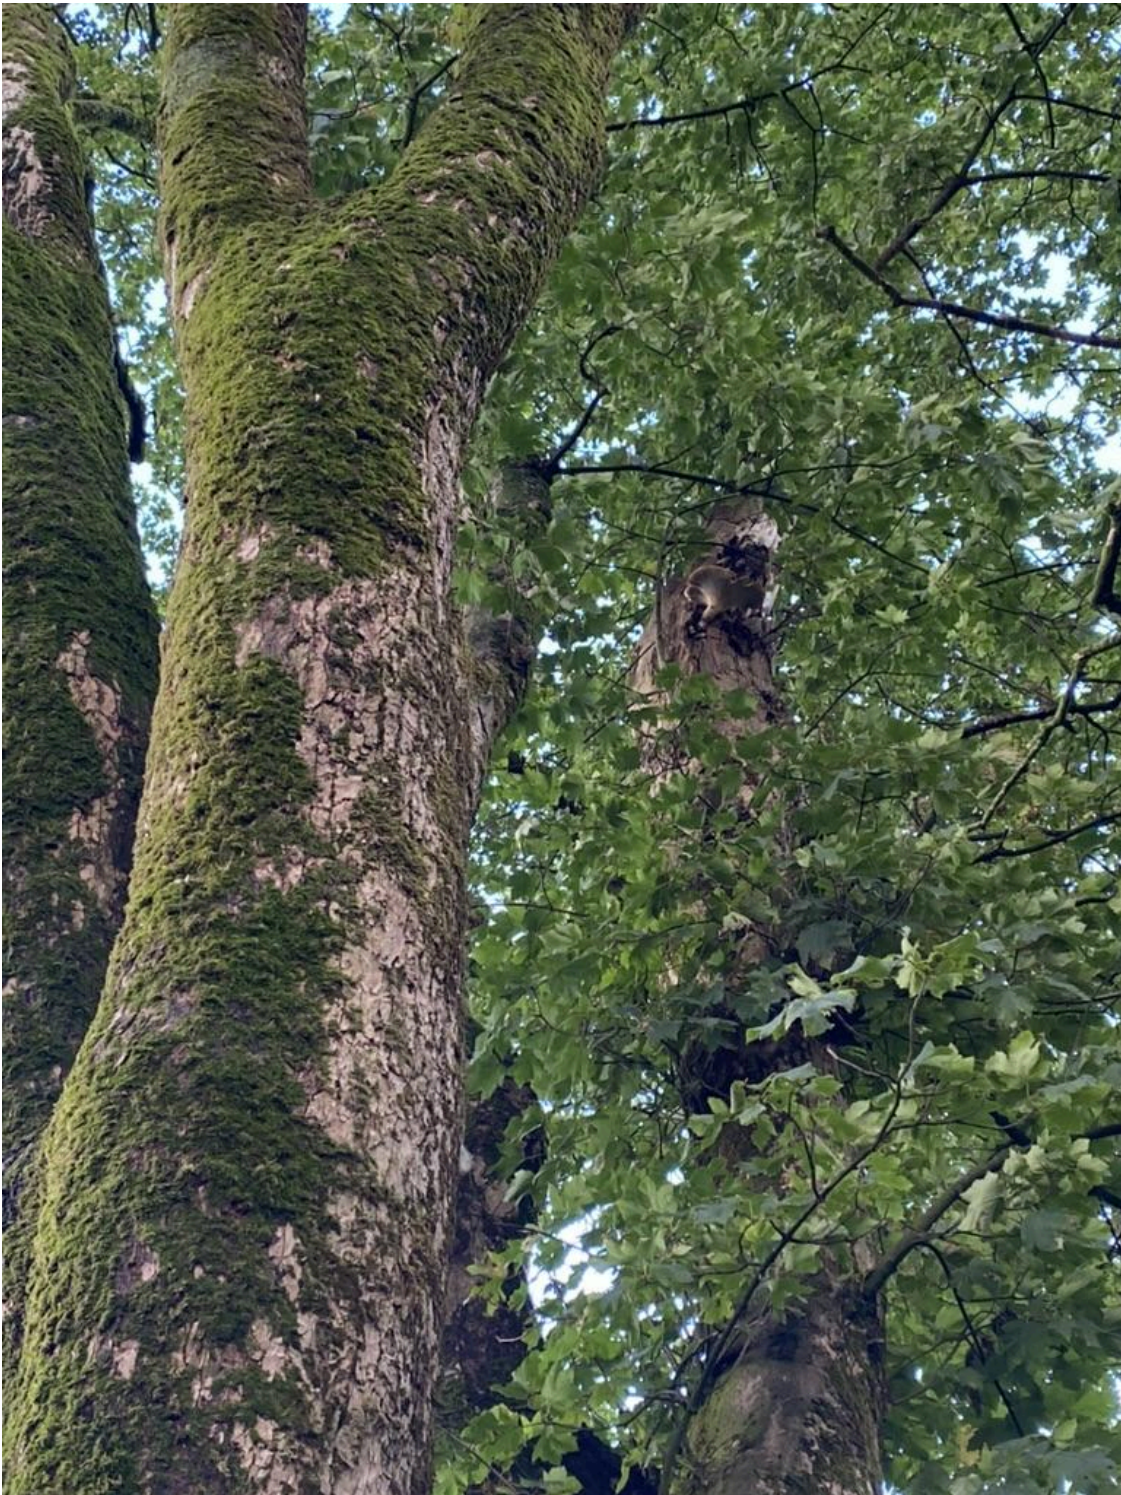
Photo 1

A012	T022	Tree	Sycamore (<i>Acer pseudoplatanus</i>)	27	Mature	SD 7125 5234	Owned by the estate. Woodland tree. Targets: - building - car park - dwelling - footpath - overhead wires - wall/fence - road - bowls area - street lights Within 1x tree height	Previous pruning wounds, some reactive growth. Mid Crown large branch failures, fungi observed on limb (<i>Cerioporus squamosus</i>). Several areas of Deadwood throughout the structure. Fungus: <i>Cerioporus squamosus</i> (Dryad's saddle)	Poor	Moderate	Mitigation Actions 1: Remove deadwood Remove damaged limbs above road Timescale: 12-Mar-2026 (6 Months) Mitigation Actions 2: Monitor Timescale: 12-Sep-2028 (3 Years)
A012	T023	Tree	Sycamore (<i>Acer pseudoplatanus</i>)	22	Semi Mature	SD 7125 5233	Owned by the estate. Woodland tree. Targets: - car park - footpath - overhead wires - bowls area - road - street lights Within 1x tree height	Tree has large areas of Deadwood, and previous failure points.	Poor	Moderate	Mitigation Actions 1: Fell tree. Timescale: 12-Mar-2026 (6 Months) Mitigation Actions 2: Replant Timescale: 12-Sep-2027 (2 Years)

Note: Area 0121 - Showing T022 Sycamore (*Acer pseudoplatanus*) presence of *Cerioporus squamosus* (Dryad's saddle)

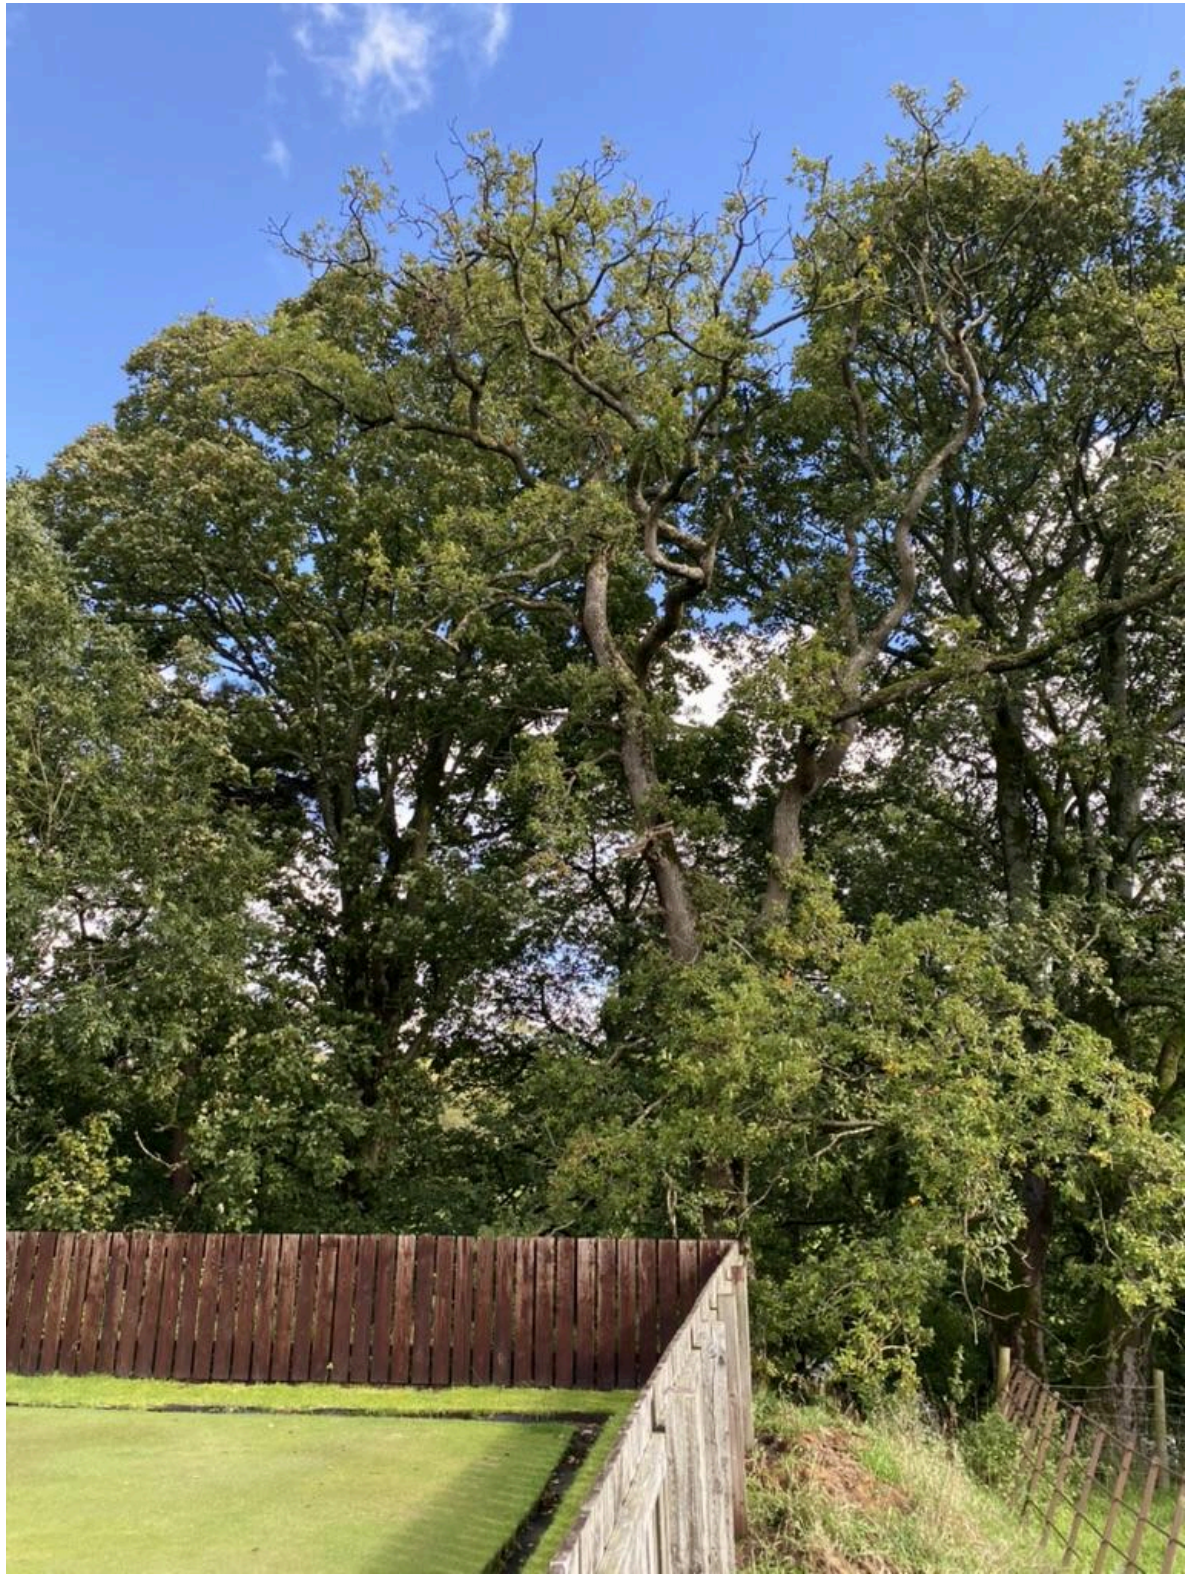
Photo 2

A012	T024	Tree	Oak (<i>Quercus robur</i>)	22	Mature	SD 7125 5225	Owned by the estate. Woodland tree. Targets: - footpath - bowls area - fence - light Within 1x tree height	Tree structural collapsing with large amounts of Deadwood throughout	Poor	Moderate	<p>Mitigation Actions 1: Fell tree. Timescale: 12-Sep-2026 (1 Year)</p> <p>Mitigation Actions 2: Replant Timescale: 12-Sep-2027 (2 Years)</p>
A012	T025	Tree	Horse chestnut (<i>Aesculus hippocastanum</i>)	34	Mature	SD 7127 5229	<p>Query owned by the estate or by local council. Woodland tree. Targets: - building - car park - footpath - playground Within 1x tree height</p>	<p>Bleeding cankers observed. A large amount of decay around the base with some fissuring of bark. Several previous failures and pruning wounds. Deadwood throughout the structure. Main weight of tree is away from high risk targets into woodland but there is a large limb overhanging the village hall</p> <p>Pests and Diseases: Bleeding Canker/Phytophthora</p>	Poor	Moderate	<p>Mitigation Actions 1: Remove limb overhanging village hall Timescale: 12-Sep-2026 (1 Year)</p> <p>Mitigation Actions 2: Monitor Timescale: 12-Sep-2028 (3 Years)</p>

Note: Area 012 - Showing T024 Oak (*Quercus spp.*) in decline and collapsing on boundary of Lawn Bowls area and over footpath

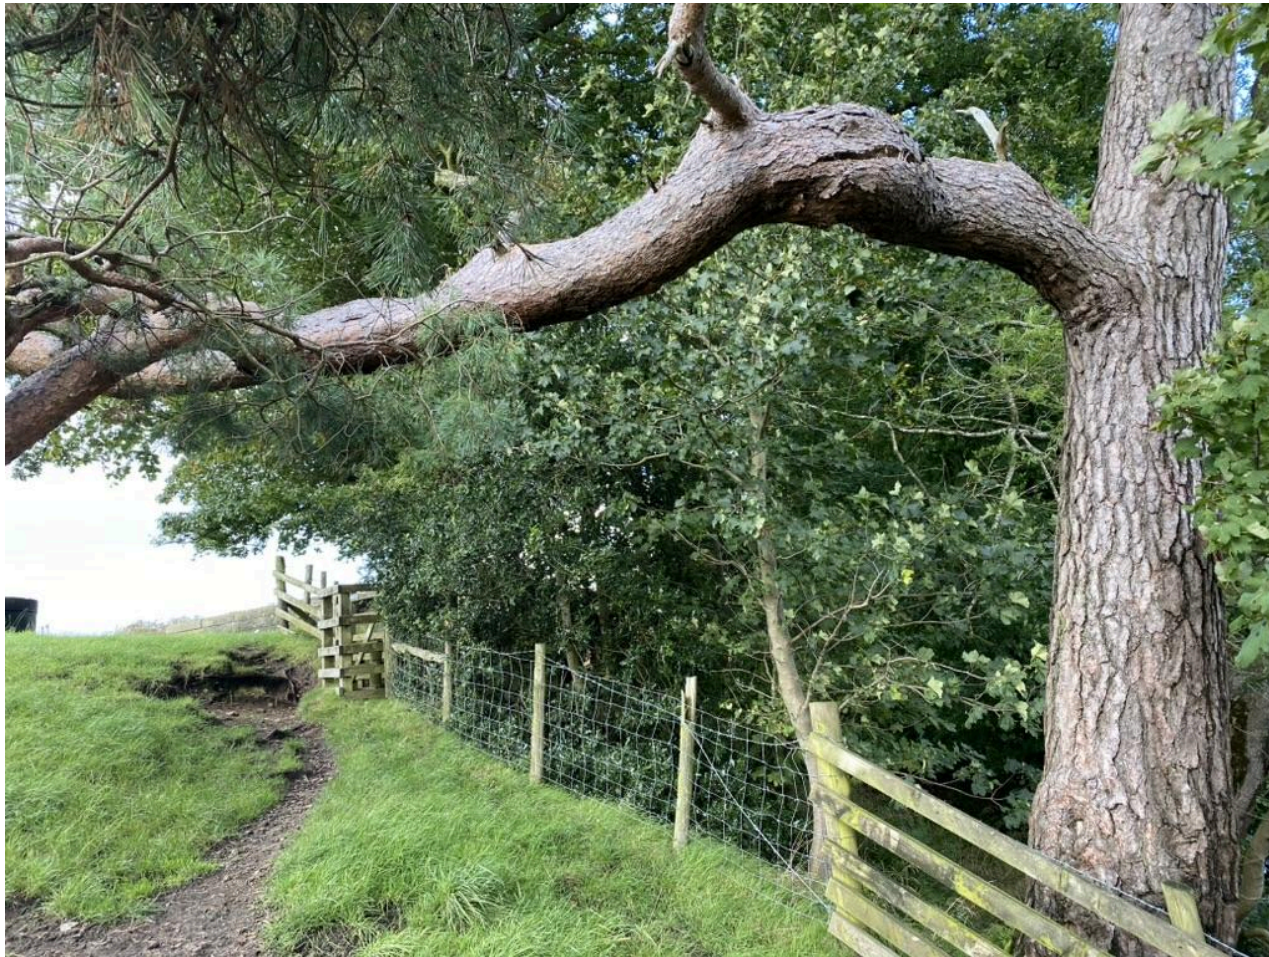
Photo 3

A012	T026	Tree	Scots pine (<i>Pinus sylvestris</i>)	16	Mature	SD 7124 5220	Owned by the estate. Woodland tree. Targets: - footpath - fence - river Within 1x tree height	Several failure points throughout the structure. Low hazard beam/failed limb grounded over footpath	Poor	Low	<p>Mitigation Actions 1: Remove limb (hazard beam/failed) over footpath Timescale: 12-Sep-2026 (1 Year)</p> <p>Mitigation Actions 2: Monitor Timescale: 12-Sep-2028 (3 Years)</p>
A012	T028	Tree	Common lime (<i>Tilia x europaea</i>)	0	Dead	SD 7106 5225	Owned by the estate. Parkland tree.	Dead and fallen tree	Dead	Low	<p>Mitigation Actions 1: Clear fallen tree Timescale: 12-Sep-2027 (2 Years)</p> <p>Mitigation Actions 2: Replant with suitable guarding Timescale: 12-Sep-2028 (3 Years)</p>
A012	T029	Tree	Common lime (<i>Tilia x europaea</i>)	31	Mature	SD 7109 5230	Owned by the estate. Parkland tree. Targets: - building - car park - dwelling - footpath - overhead wires - wall - road	Tree in Fair condition. Some Deadwood throughout the structure, some over road/parking. Signs of grazing/stock damage around base. Small number of low hanging branches over road/parking	Fair	Low	<p>Mitigation Actions 1: Crown lift to 5.2 m for highway clearance. Remove deadwood Install suitable guarding around base Timescale: 12-Sep-2026 (1 Year)</p> <p>Mitigation Actions 2: Monitor Timescale: 12-Sep-2028 (3 Years)</p>

Note: Area 012 - Showing T026 Scots Pine (*Pinus sylvestris*) with large failed hazard beam limb over footpath

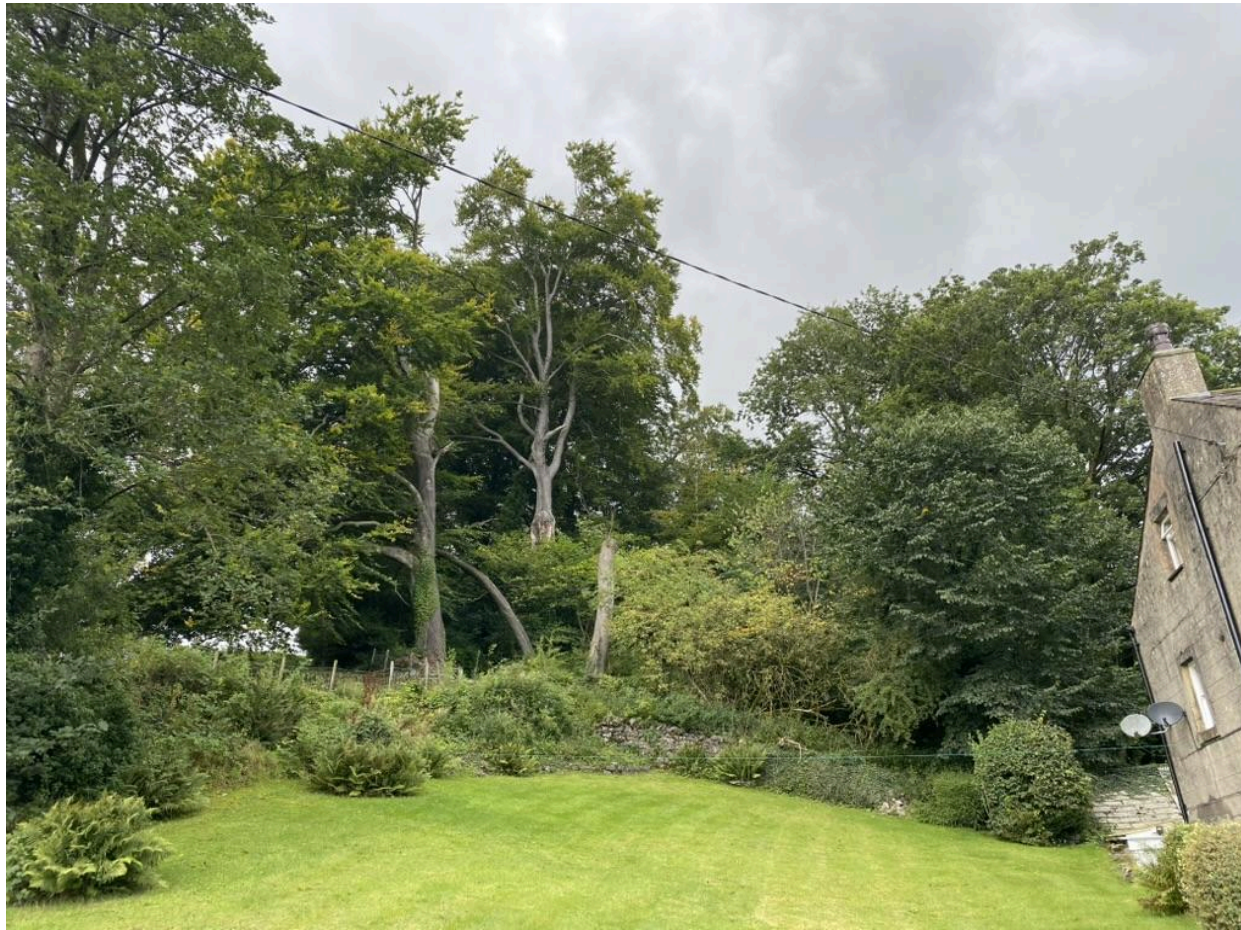
Photo 4

Woodland tree. Limited public access, main issue is weight on T047/safe working area				
A013	T047	Tree	Common beech (<i>Fagus sylvatica</i>)	35	Mature	SD 7093 5248	Owned by the estate. Woodland tree. Targets: - building - oil tank - dwelling - overhead wires Within 1x tree height	Marked RED X. Large tree with several areas of previous branch failures. Some Deadwood in the remaining Crown. Tree is structurally in Poor condition, large decay site mid Main Stem. Fungal fruiting bodies observed across Main Stem (<i>Ganoderma</i> spp) Fungus: <i>Ganoderma</i> spp	Poor	Moderate	Fell tree. Timescale: 13-Sep-2026 (1 Year) Mitigation Actions 2: Replant Timescale: 13-Sep-2027 (2 Years)
A013	T048	Tree	Common beech (<i>Fagus sylvatica</i>)	15	Early Mature	SD 7093 5247	Owned by the estate. Woodland tree. Target: - fence Within 1x tree height	Tree with large arch and lean out of woodland. Fair condition but is obstructing access/safe working area for T047	Fair	Low	Mitigation Actions 1: Arbs will potentially have to Fell tree for T047 access/safe working area. Otherwise monitor Timescale: 13-Sep-2026 (1 Year) Mitigation Actions 2: Replant Timescale: 13-Sep-2027 (2 Years)

Note: Area 013 - Showing T047 (centre photo) Beech (*Fagus sylvatica*) with large wounding from previously failed limb mid stem and declining vigour and proximity to dwelling and other targets

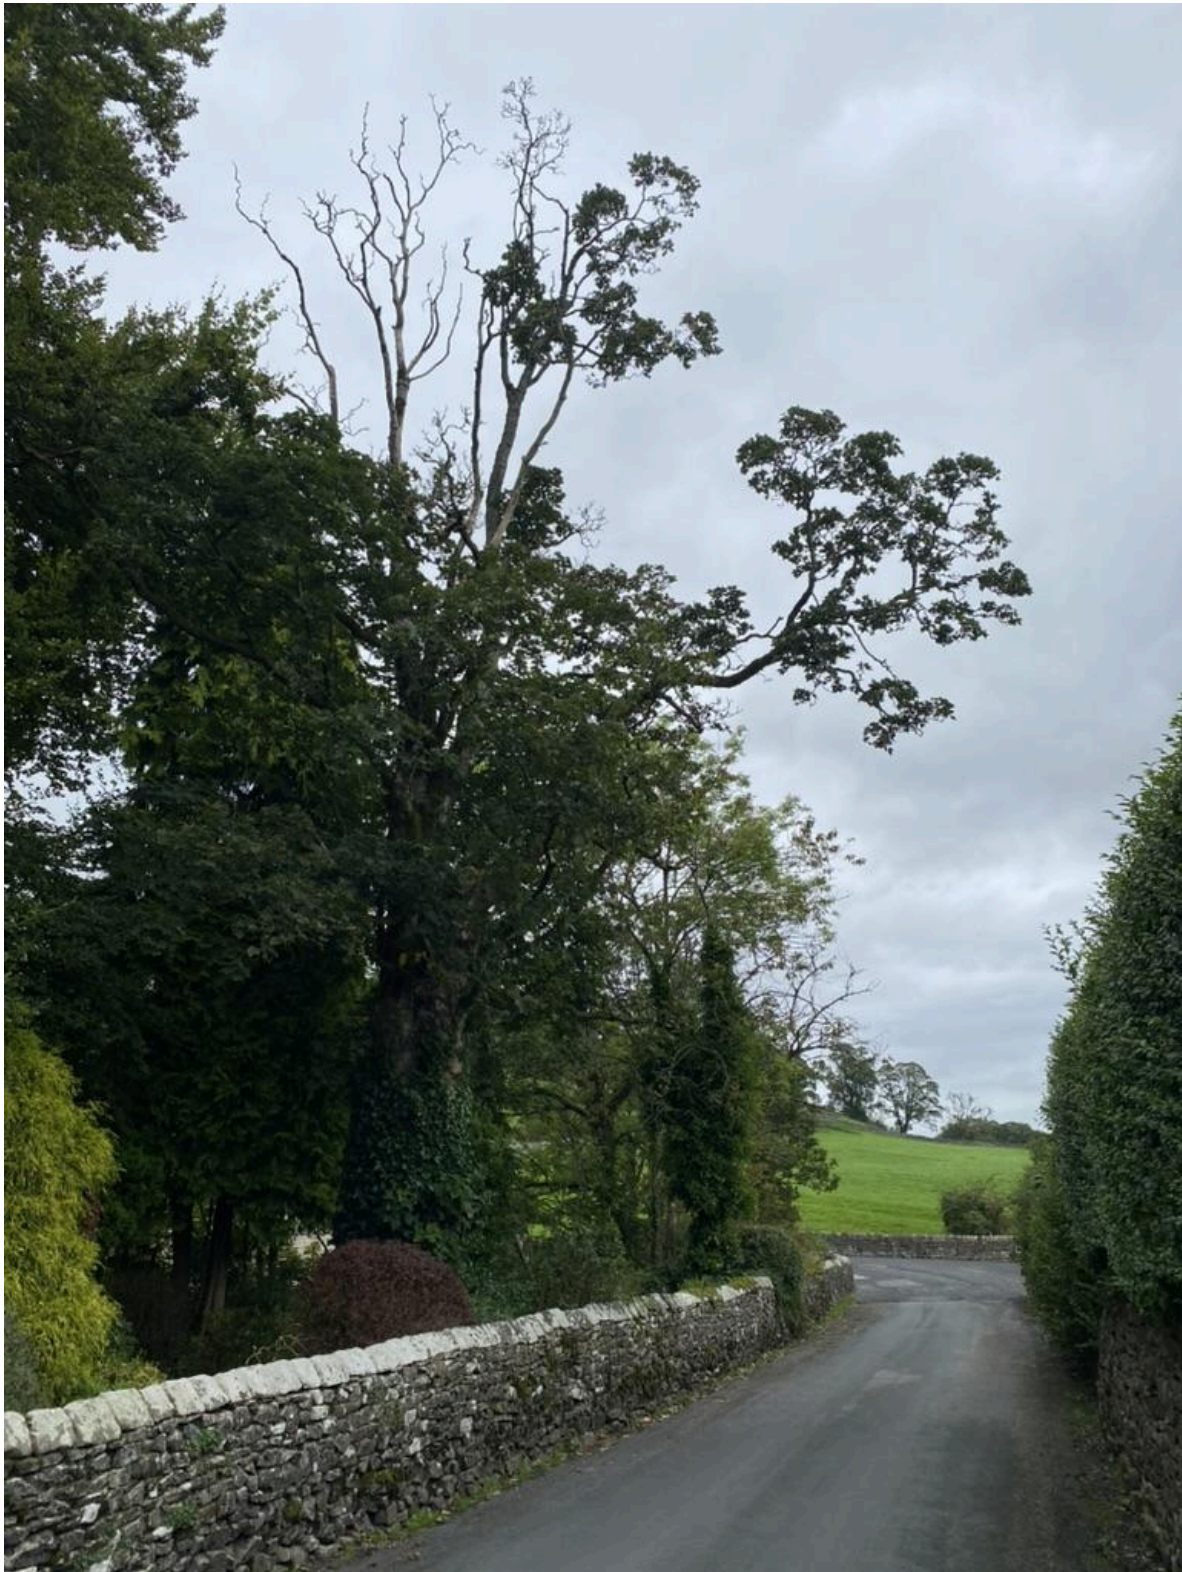
Photo 5

A017	T059	Tree	Cherry (<i>Prunus sp.</i>)	9	Semi Mature	SD 7120 5246	Owned by the estate. Parkland tree. Targets: - building - car park - dwelling - wall - road Within 1x tree height	Tree is in a poor condition with a very sparse Crown. Deadwood throughout the structure. Ivy throughout structure	Poor	Moderate	Mitigation Actions 1: Fell tree. Timescale: 13-Mar-2026 (6 Months) Mitigation Actions 2: Replant Timescale: 13-Sep-2026 (1 Year)

A017	T060	Tree	Sycamore (<i>Acer pseudoplatanus</i>)	16	Semi Mature	SD 7119 5244	Owned by the estate. Parkland tree. Target: - building - car park - dwelling - overhead wires - wall - road Within 1x tree height	Tree in Poor condition with large amounts of decline. Deadwood throughout the structure and several previous failure points. Ivy from base into mid Main stem	Poor	High	<p>Mitigation Actions 1: Fell tree. Timescale: 13-Dec-2025 (3 Months)</p> <p>Mitigation Actions 2: Replant Timescale: 13-Sep-2026 (1 Year)</p>
------	------	------	--	----	----------------	-----------------	---	---	------	------	--

Note: Area 017 - Showing T059 Cherry (*Prunus spp.*) and T060 Sycamore (*Acer pseudoplatanus*) in memorial garden with Poor condition and decline within proximity to highway and other targets
