### REPORT ON A STRUCTURAL INSPECTION

**Barn at Spring Head Farm  
Hellifield Road  
Bolton-by-Bowland  
Clitheroe  
BB7 4LU**

**Project No. 10392**

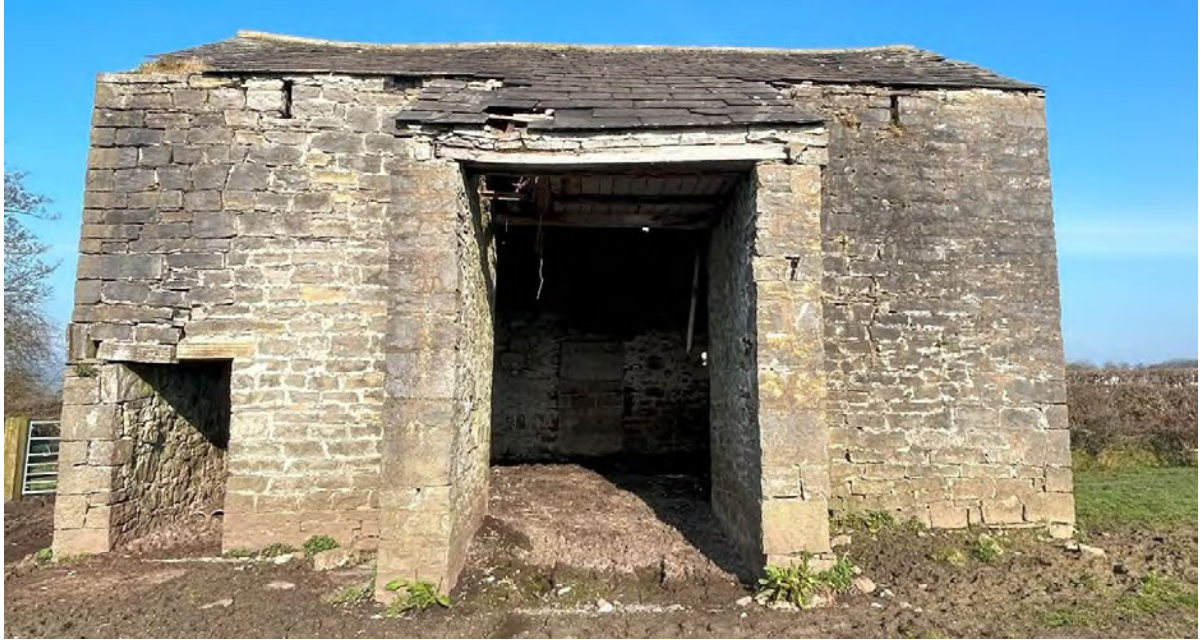
**PHOTOGRAPH 1 –Front elevation**

This barn is constructed from Limestone and built as a solid wall 400 wide. The stones are fairly large and rectangular in shape. (See photograph 1).

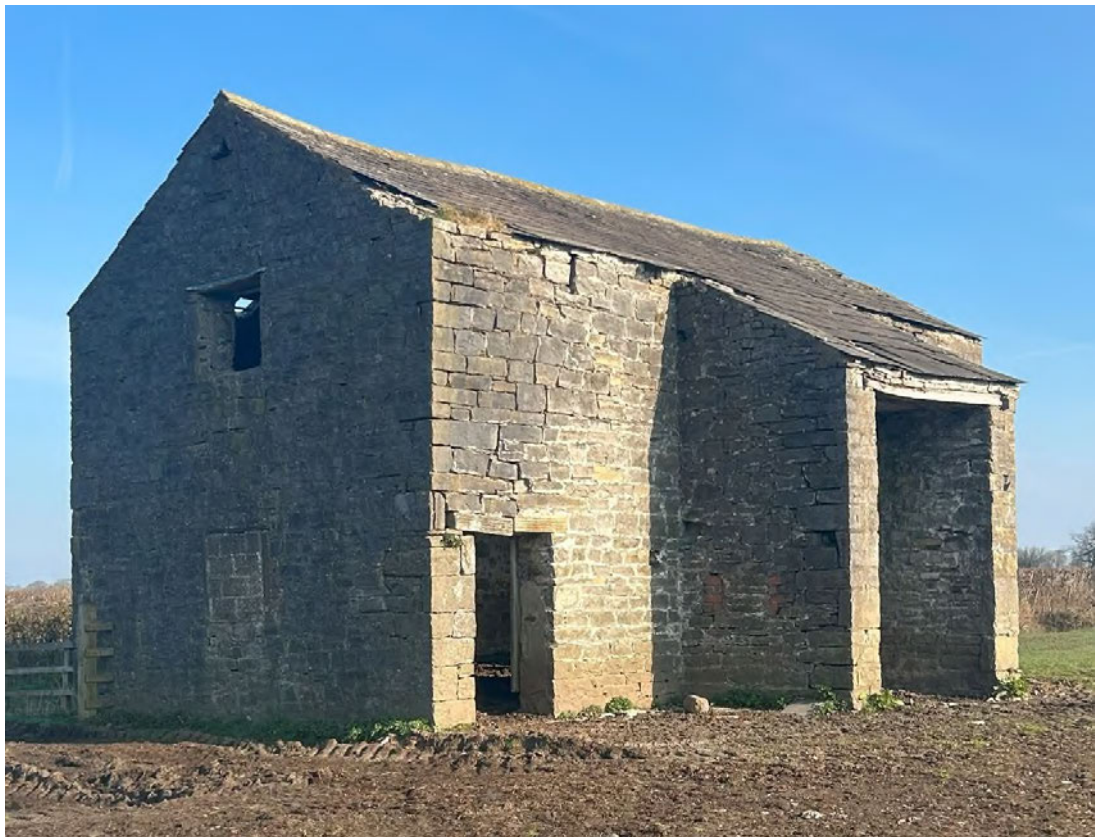
**PHOTOGRAPH 2 – Front elevation**

Alongside the gable wall there is a doorway, there is a stone lintel above this opening and this has cracked. Because of this there is a vertical crack in the wall which runs up to 1.4m. The wall to the left side of the crack has moved laterally deforming the side wall and this area of wall needs to be re-built. (See photographs 2 & 11).

The intention is to convert this building into a dwelling. The building is in a reasonable structural condition. The front left corner of the barn is suffering from cracking and movement mainly due to the stone lintel above the doorway being cracked. This area of wall will need to be rebuilt, and this is shown on figure 1.

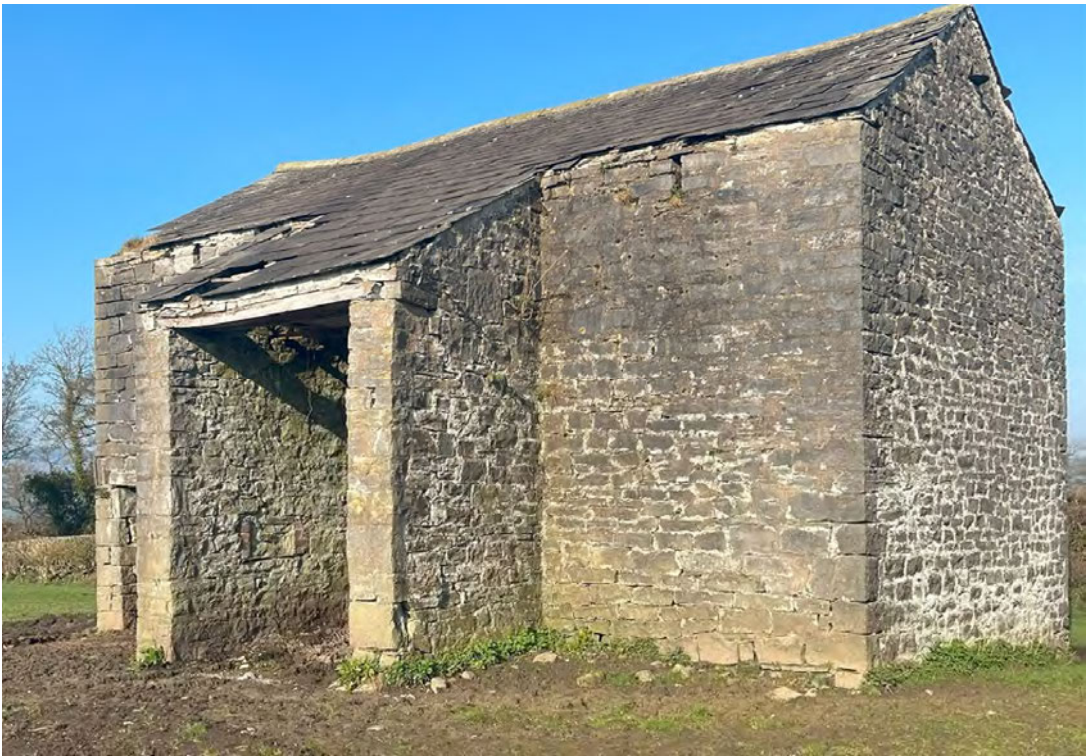
**PHOTOGRAPH 3 – Front elevation**

This wall is constructed from a stone and built as a solid wall 400 wide. This wall is on the right hand side of the barn entrance and is perpendicular to the front wall (See photographs 3).

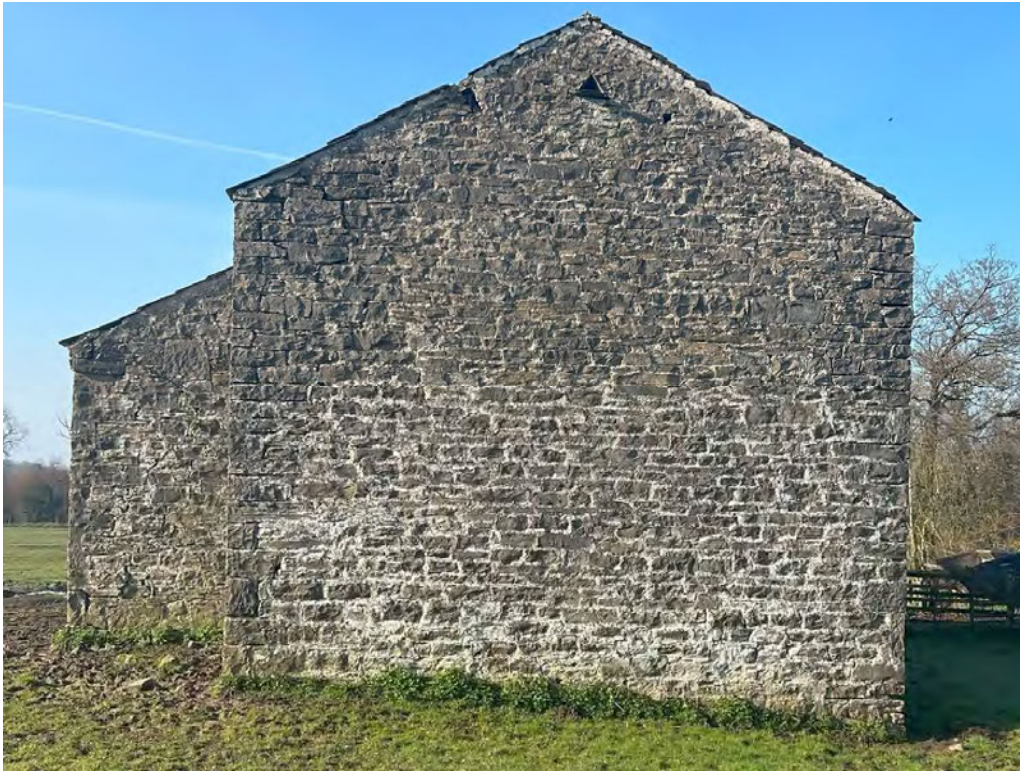
**PHOTOGRAPH 5 –Side elevation**

This gable wall is constructed from a stone and built as a solid wall 400 wide. The stones are fairly large more rectangular in shape. (See photographs 5 & 6).

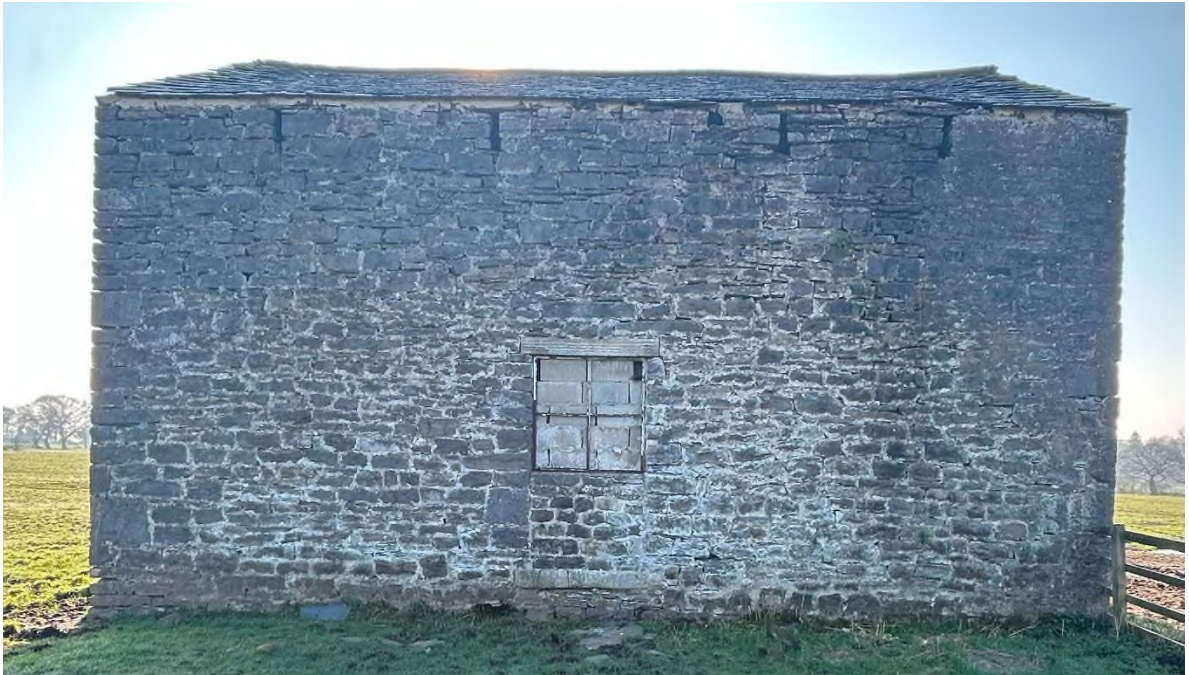
**PHOTOGRAPH 7 – Rear elevation**

This wall is constructed from a stone and built as a solid wall 400 wide. The stones are fairly large more rectangular in shape. (See photograph 7). Areas of this wall need to be pointed.

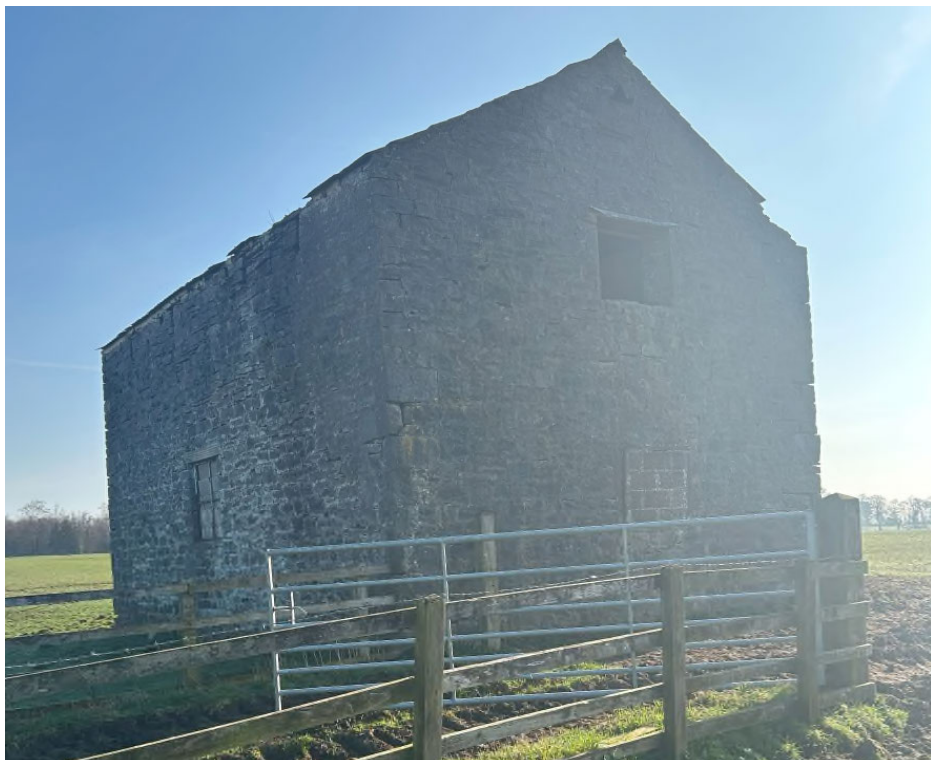
**PHOTOGRAPH 8 – Side elevation**

Reporting from the front wall there are stone quoins to the corner of the wall. (see photographs 8 & 9). The front corner of this wall has bulged out and needs to be re-built. There are various cracks in the wall. (See photograph 16).

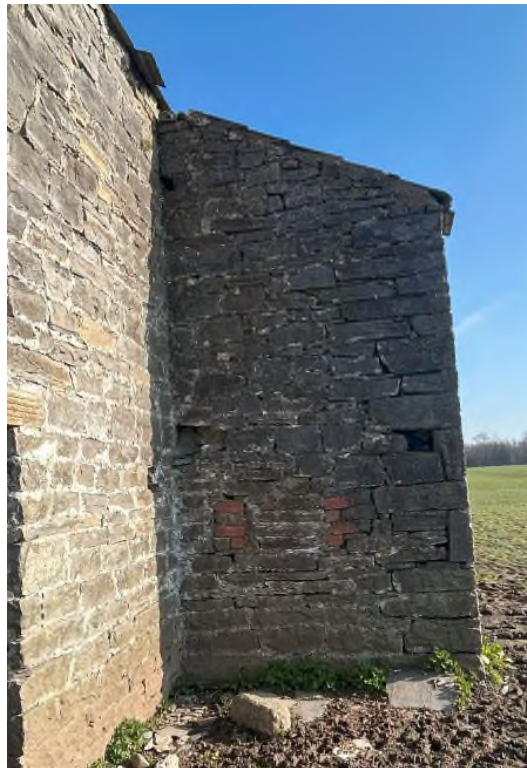
**PHOTOGRAPH 10 – Side elevation**

This wall is constructed from a stone and built as a solid wall 400 wide. This wall is on the right hand side of the barn entrance and is perpendicular to the front wall (See photographs 10).

There have been some previous holes, and these have been infilled with brickwork.

There is a missing stone which needs to be replaced.

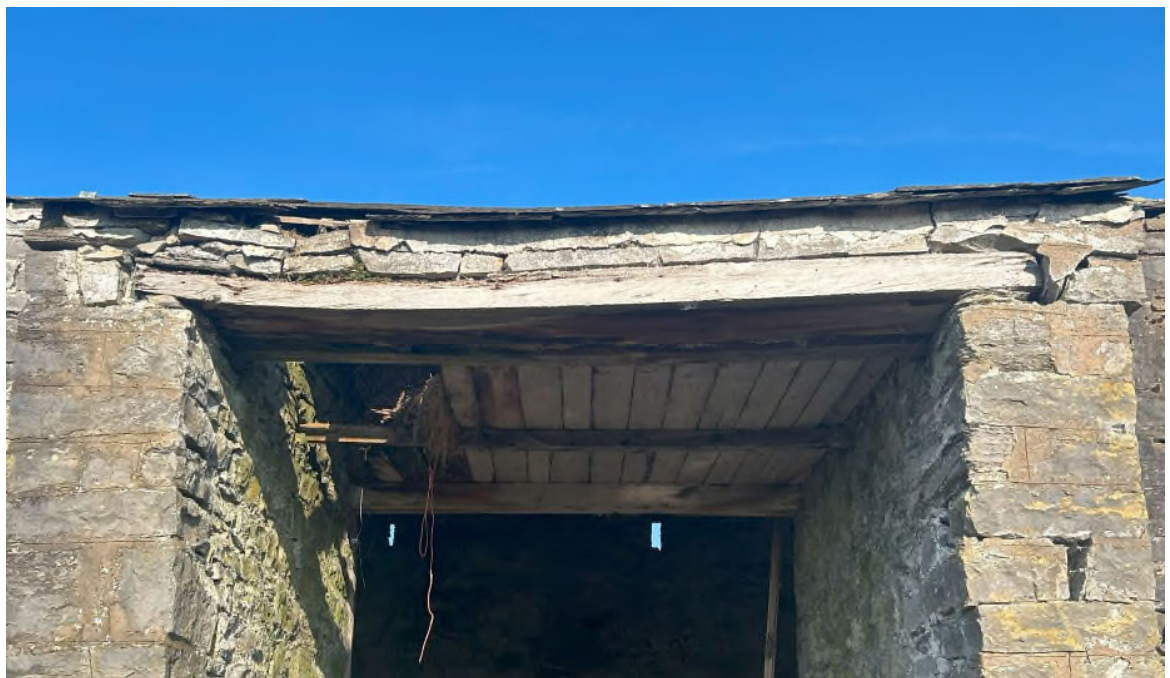
**PHOTOGRAPH 12 – Front elevation**

To the left of this wall panel, there is a projecting wall which flanks barn door opening. This wall is constructed from stone and built as a solid wall 400 wide. Then there is a large barn door opening. There is a timber lintel above this opening. This has deflected considerably and needs to be replaced. This lintel is bearing on a similar flanking wall on the other side of the opening. (See photograph 12).

The roof above the projecting barn door flanking walls, has an unacceptable deflection and this will need to have new structure fitted. Slates are missing to the rear roof slope and these need to be replaced along with any timbers damaged by damp.

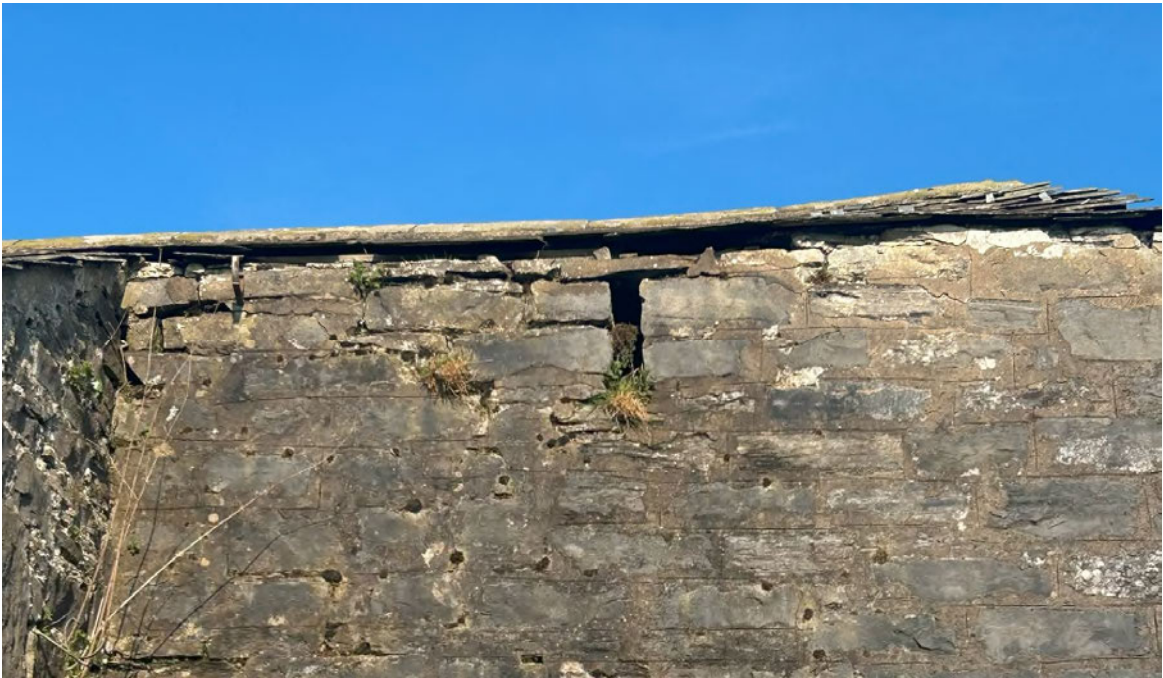
**PHOTOGRAPH 13 – Front elevation**

Reporting from the right gable of the barn there are quoins in the corners of the wall. There is a panel of stonework with ventilation opening at the top of the wall. There is some disturbance in the stone along the eaves line in this area. (See photograph 13).

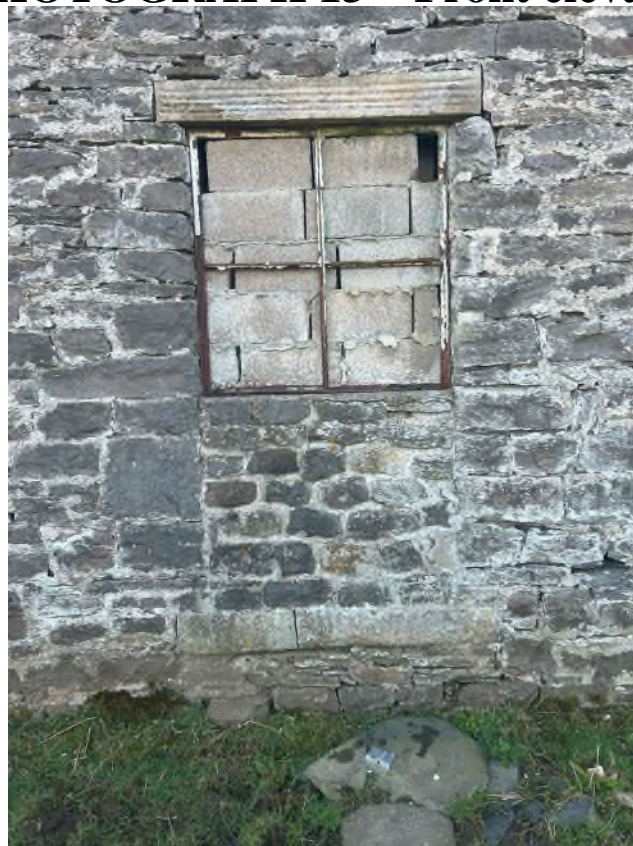
**PHOTOGRAPH 14 – Rear elevation**

There is a window opening with a stone lintel over. This appears to have been a doorway, but the lower part has been blocked up. (See photograph 14).

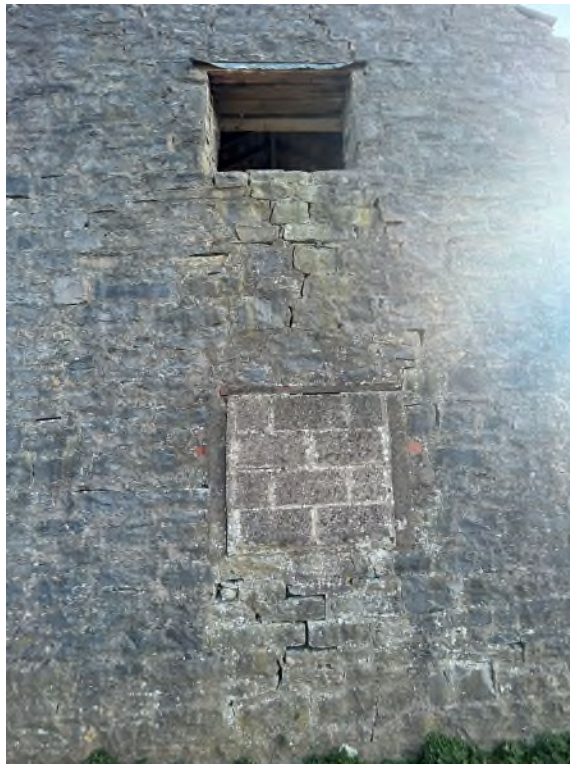
**PHOTOGRAPH 15 –Side elevation**

There is a crack in the wall running from the top right corner of the window this is 4mm wide and runs for 1m. There is a 3mm. wide crack running down the wall from the cill of the upper window for 1.5m. (See photograph 15).

There are some cracks to the external walls, and these need the bonding of the stone improving and then pointing.

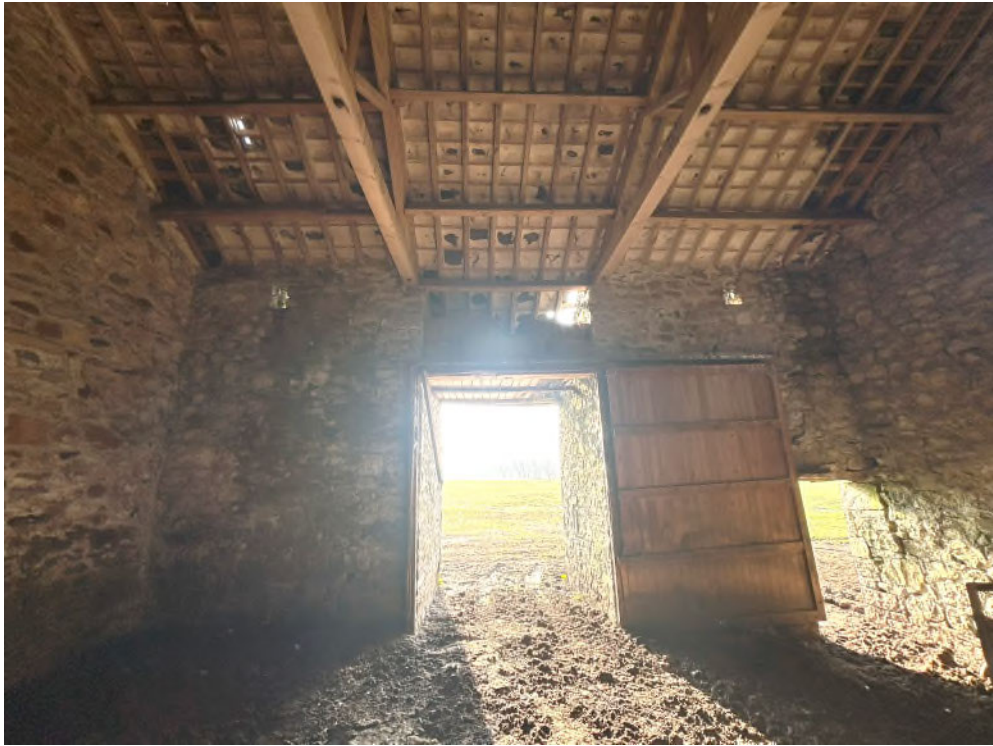
**PHOTOGRAPH 17 –Front Wall**

The front of the barn is shown in photograph 17, there is a central large barn door and a doorway close to the side wall. The lintel above this doorway has failed and there is cracking the wall above (see photograph 18)

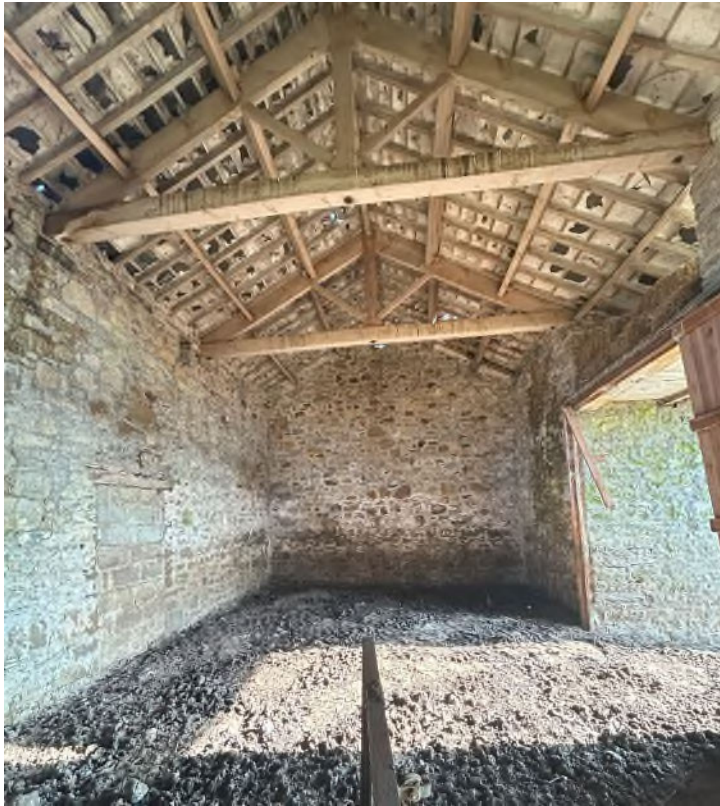
**PHOTOGRAPH 19 – Side Wall**

The roof is a conventional double pitched roof with a ridge running from side to side. The roof consists of 2 timber trusses (See photographs 19 and 21). There are two timber purlins to each roof slope.

The right hand gable wall is show in photograph 19. There is a vertical joint between the gable and rear wall and there is a crack along this vertical joint 3mm wide, see photograph 20.

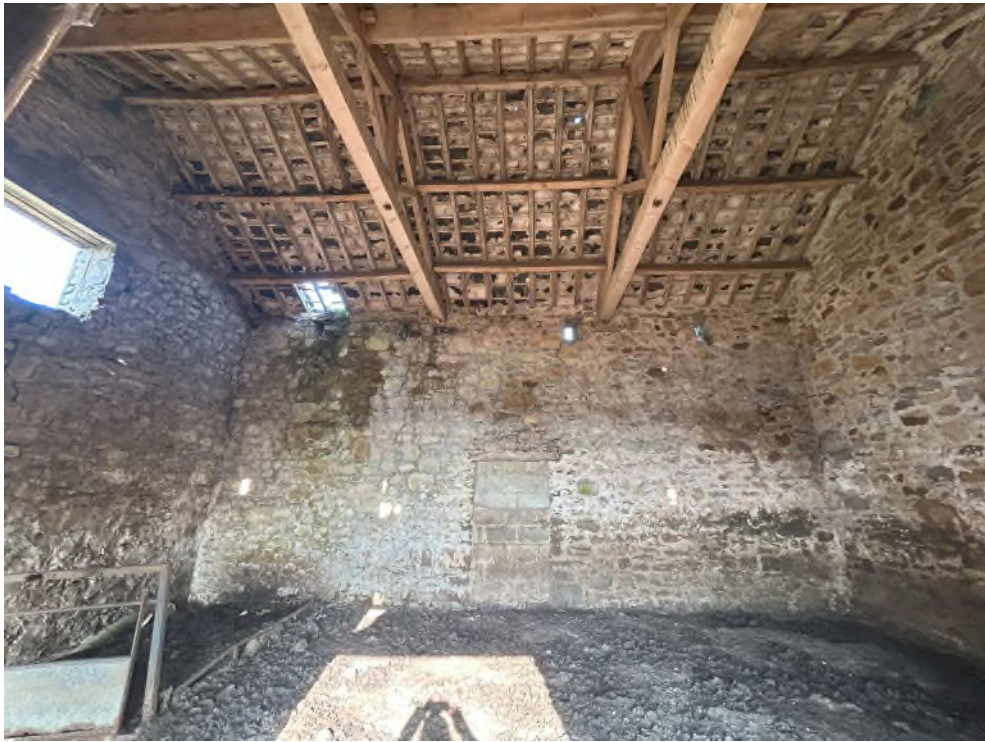
**PHOTOGRAPH 21 –Rear Wall**

The rear wall is shown on photograph 21. This shown the blocked-up doorway. The timber lintel has been retained but this should be removed. The top left hand corner of this wall has been affected by damp because of missing slates to the roof above.

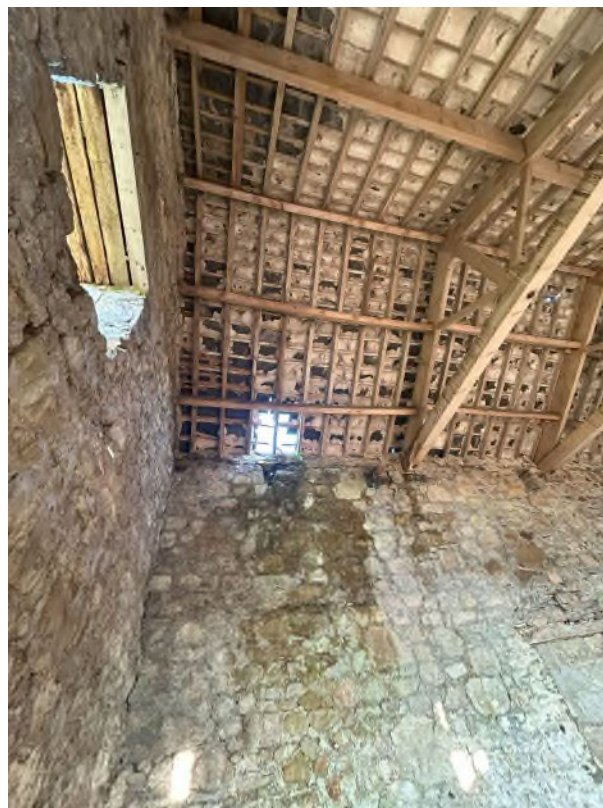
**PHOTOGRAPH 22 – Rear Wall**

The roof is clad with slates. There are areas in the roof that slates are missing, and the supporting timbers have been accepted by damp and need to be replaced. (See photograph 22).

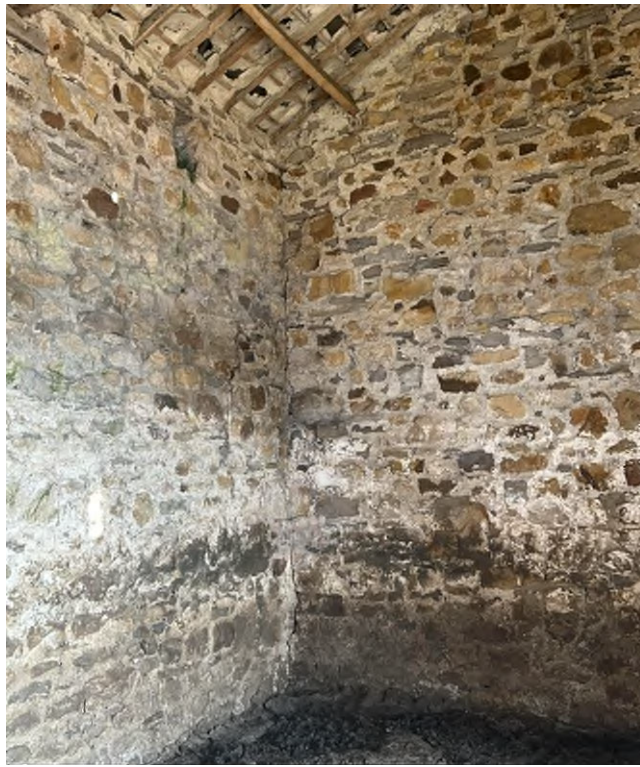
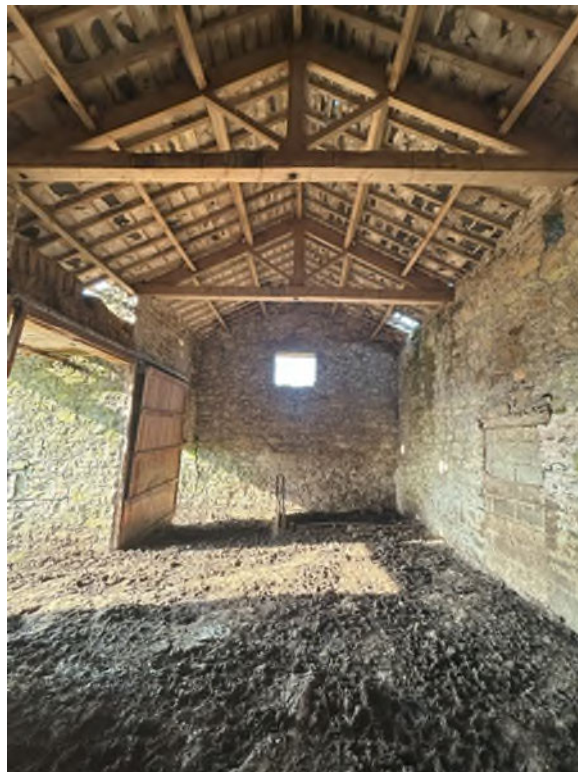
The left hand gable wall is show in photographs 23 & 24. There is a vertical joint between the gable and rear wall and there is a crack along this vertical joint 3mm wide, see photograph 20. There is a blocked up window to the lower part of the wall. Above this there is a window opening and there is a 5mm wide crack running down from the cill of this window (see photograph 25).
