**STRUCTURAL INSPECTION**

**STONE BARNs AT WINKLEY HALL FARM,  
STONYHURST, CLITHEROE**

**STANTON ANDREWS**

| Project No.: 11342 | | | | |

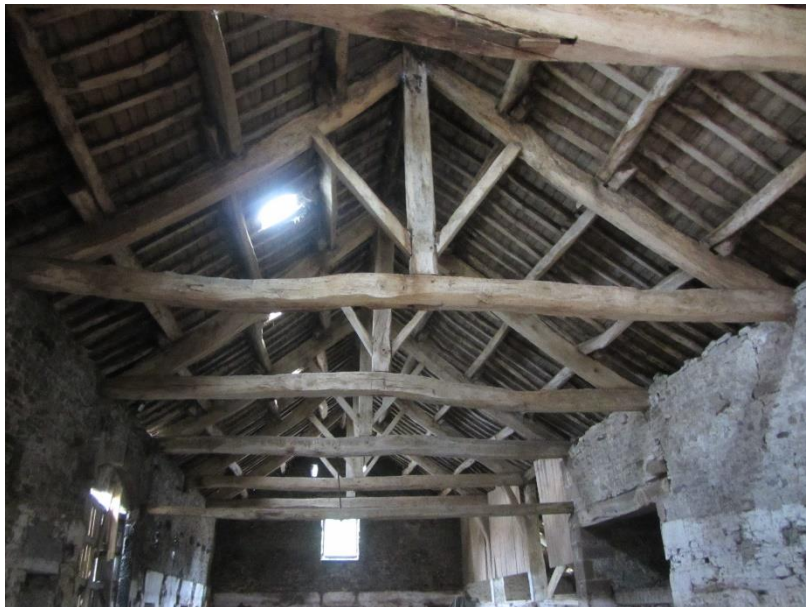
**Photo 10 – Barn 1 – main roof structure**

- The roof structure of the main part of the barn was inspected from ground level (photo 10). Some decay due to wet-rot was noted in the sarking boards and rafters near eaves level on the south side, with widespread signs of insect infestation noted elsewhere. Some rafters and purlins are warped (photo 11), and most show signs of insect infestation and decay. The timber trusses all show signs of insect infestation, with one king post significantly reduced in cross-section (photo 12). Some water staining and possible wet-rot decay was noted on the truss bottom tie beams which rest on the south wall (photo 13). Two trusses are supported on bifurcated timber posts on the north side, and both posts show signs of insect infestation (photo 14).

The original oak purlins and roof trusses show signs of decay due to insect infestation and localised wet-rot at their bearings. The purlins, rafters and boarding are similarly decayed. Warping noted in some timber rafters and purlins is a result of uneven moisture movement of the natural hardwood timber.

- The sarking boards, rafters, purlins, trusses and posts should be fully inspected by a timber conservation specialist. The trusses should have their end-bearings exposed where they meet the external walls. Each timber element should be inspected and the extent of wet-rot decay and decay due to insect infestation recorded, allowing a detailed evaluation of each item to be made. Additional sarking should be provided on top of the existing in decayed areas; decayed or excessively warped timber rafters should be retained and if necessary augmented by additional rafters; decayed or excessively warped purlins should be strengthened with stainless steel plating or new timber sections provided alongside the existing; excessively decayed parts of the roof trusses should be strengthened with stainless steel plating.

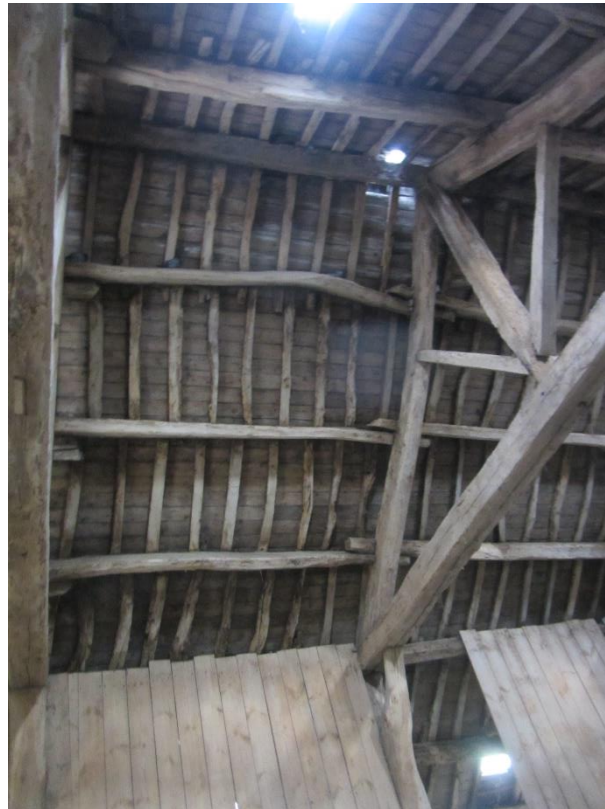
**Photo 11 – Barn 1 – warped rafters and purlins**

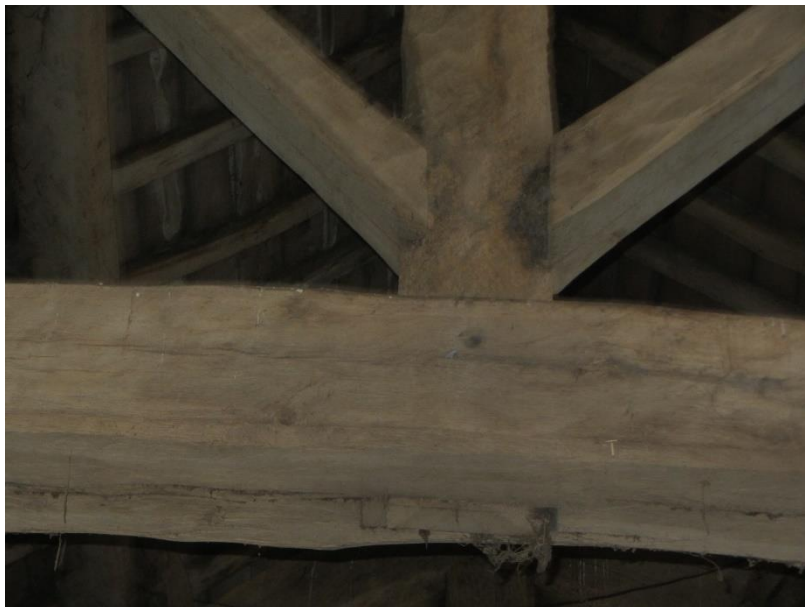
**Photo 12 – Barn 1 – insect decay to roof truss**

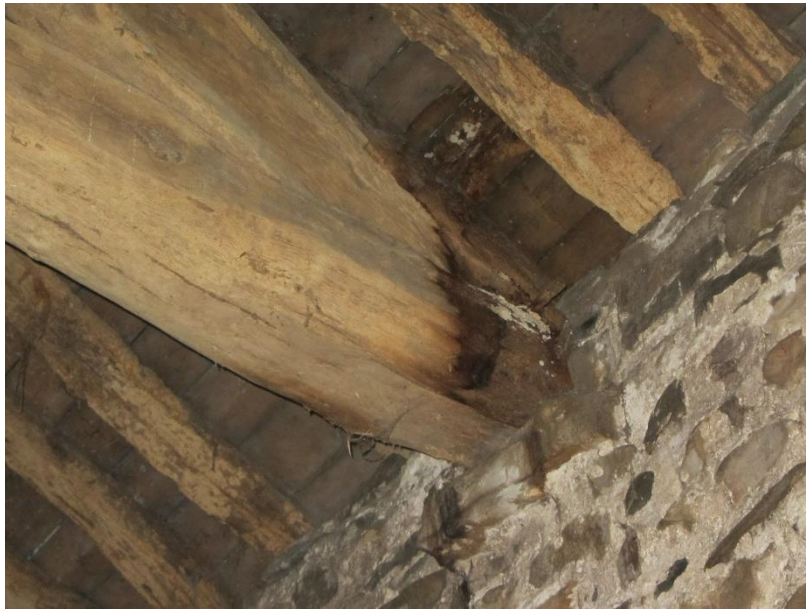
**Photo 13 – Barn 1 – wet-rot at truss bearing**

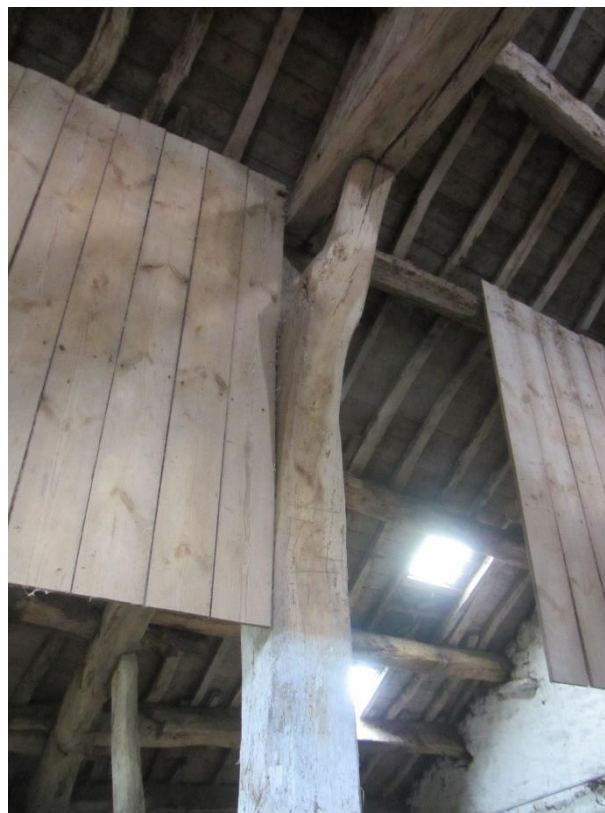
**Photo 14 – Barn 1 – insect decay to timber post**

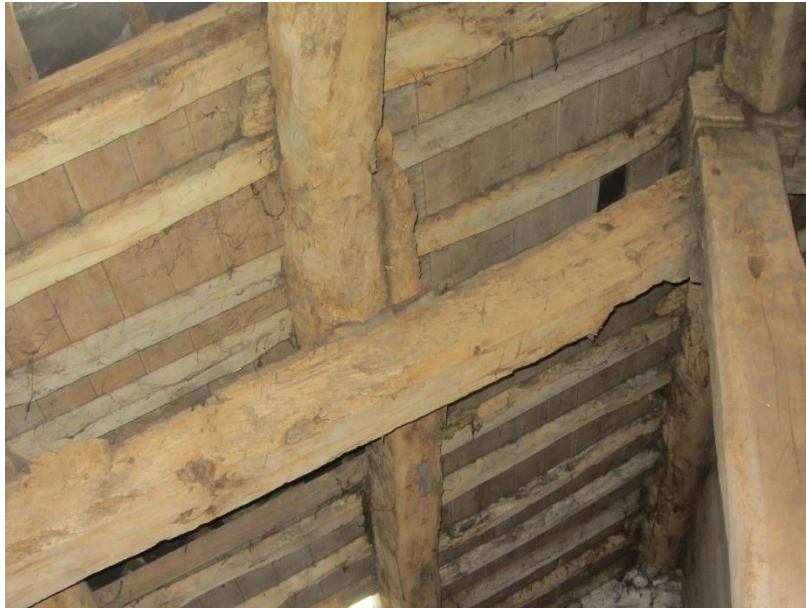
- The roof structure of the shippon was inspected from ground level. Widespread decay due to insect infestation was noted (photos 15 & 16).
- The south wall of the main barn is reasonably straight and vertical, but the western part shows a slight outward lean (photo 17). The west wall is reasonably straight and vertical but bulges outward at around mid-height (photo 18). No significant structural defects were noted in the east or north walls.

**Photo 15 – Barn 1 – insect decay to shippon roof timbers**

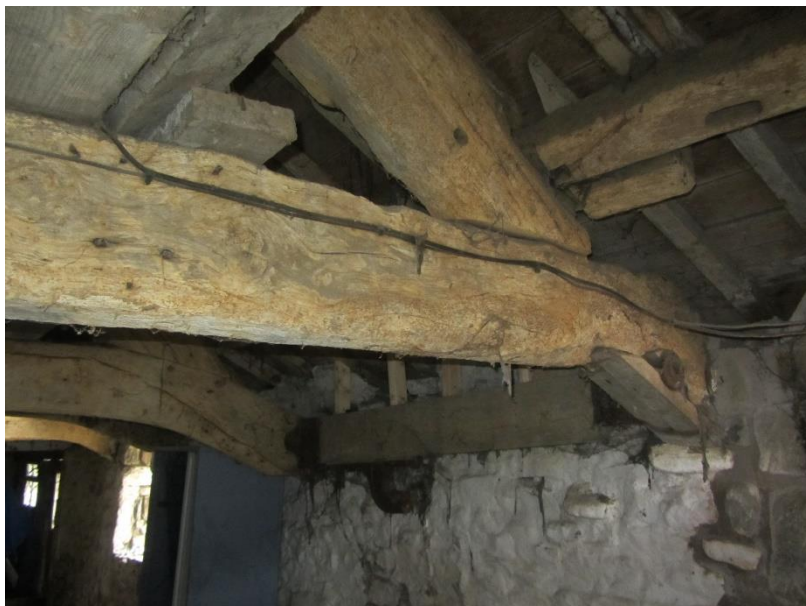
**Photo 16 – Barn 1 – insect decay to shippon roof truss**

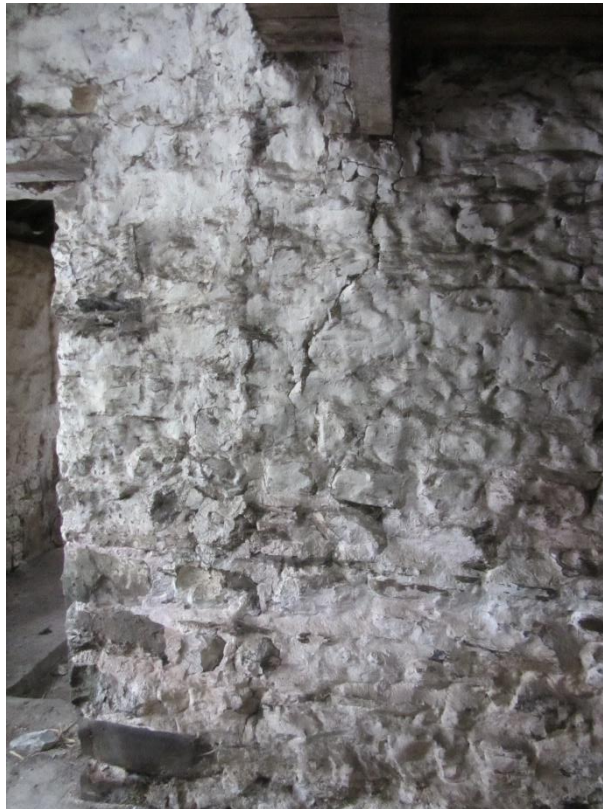
- Minor vertical cracking was noted in the internal walls each side of the north wagon entrance (photo 19). Decaying timber lintels in the internal and external walls has caused the stonework to crack (photo 20).

**Photo 19 – Barn 1 – crack in internal wall**

- Cracks in the stone walls should be repaired by local rebuilding, ensuring sufficient bonding across the cracks is provided. Surface-fixed straps could be used internally, where these will be hidden by new lining walls.

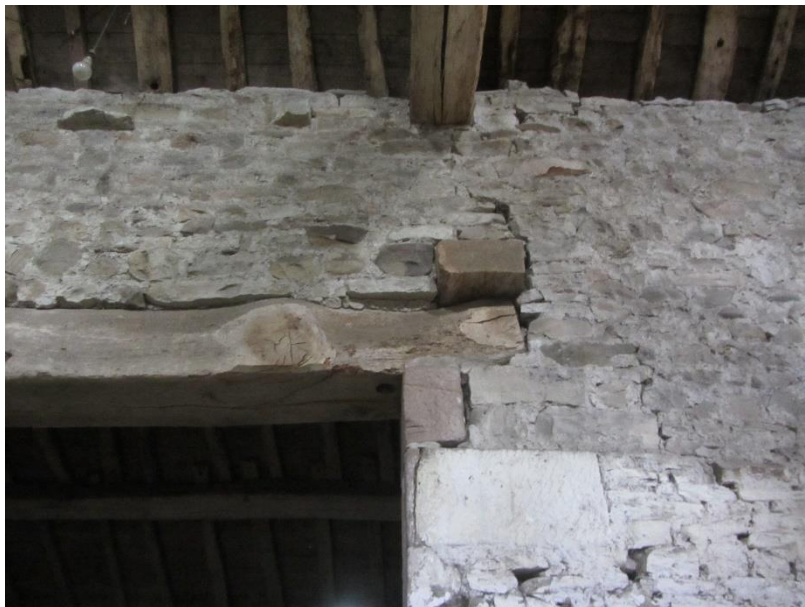
**Photo 20 – Barn 1 – decayed lintel and cracks in wall**

- Internal walls that are unbonded to external walls should be tied with stainless steel bars or straps.
- Decayed timber lintels should be inspected and evaluated. Those excessively decayed should be repaired, strengthened or new relieving lintels provided above the originals.

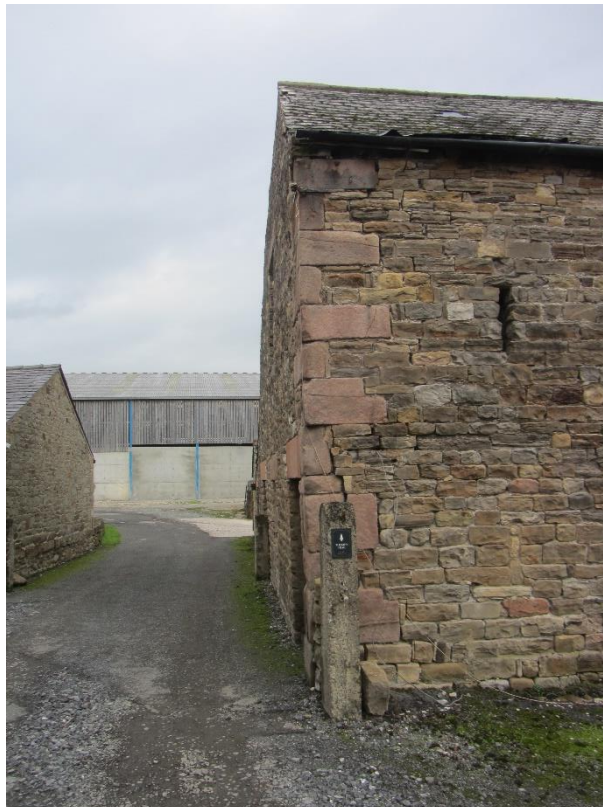
- The north and south roof pitches are reasonably straight and true, and no excessive irregularity or sagging was noted.
- At the south west corner, the stonework is poorly bonded and a quoin has cracked (photo 21). Some distortion and irregularity can be seen towards the top of the south wall.
- There is a noticeable outward bulge in the west wall at around mid-height (photo 22).

The four main external walls are generally straight and vertical, with relatively minor distortion in the upper part of the south wall and some outward bulging of the west wall at around mid-height. The barn has been constructed to a good standard and the sarking boards have increased the rigidity of the roof, holding the walls in position. Cracking noted on the inside face of the external walls and on the internal walls has been caused mainly by thermal movement, possible de-lamination of the inner and outer skins due to lack of bonding through the rubble infill, and decay of timber lintels.

**Photo 22 – Barn 1 – outward bulge in west wall**

- Should a detailed verticality survey reveal that the outer and inner skins of rubble-filled walls are separating, the two leaves should be tied together with stainless steel ties, drilled from the inside.

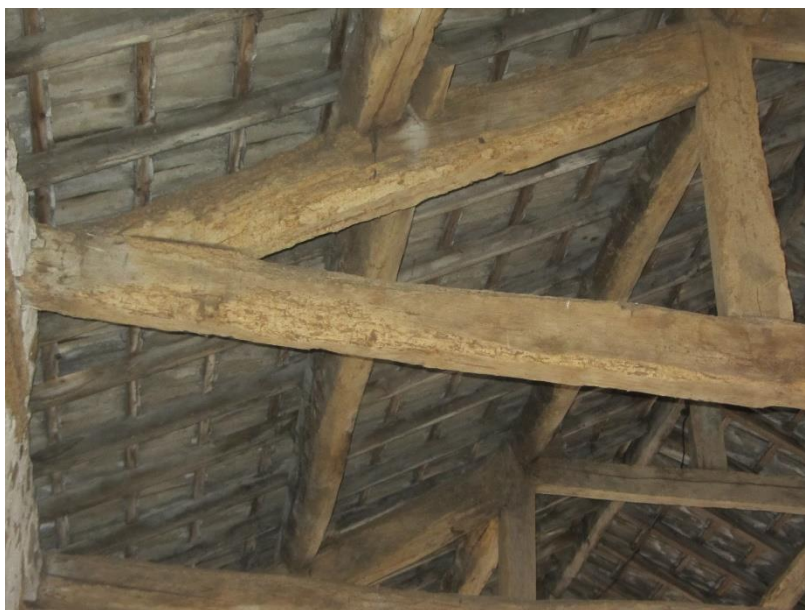
- The roof structure and the south wall have been propped by a steel scaffold structure (photo 23). The timber purlins and trusses show signs of widespread and significant insect infestation (photos 24 & 25). The timber rafters are more recent replacements.
- The first floor joists and boarding have been removed (photo 26), leaving only the original timber beams (and one newer concrete beam).
- Vertical cracks were noted on the inside face of the north wall (photo 27) and west wall (photo 28).

The original oak purlins and roof trusses show signs of severe decay due to insect infestation and localised wet-rot. The timber rafters are relatively new.

**Photo 24 – Barn 2 – decayed roof timbers**

- The whole of the roof timbers should be inspected by a timber specialist and then evaluated for residual strength and the need for repair or strengthening.

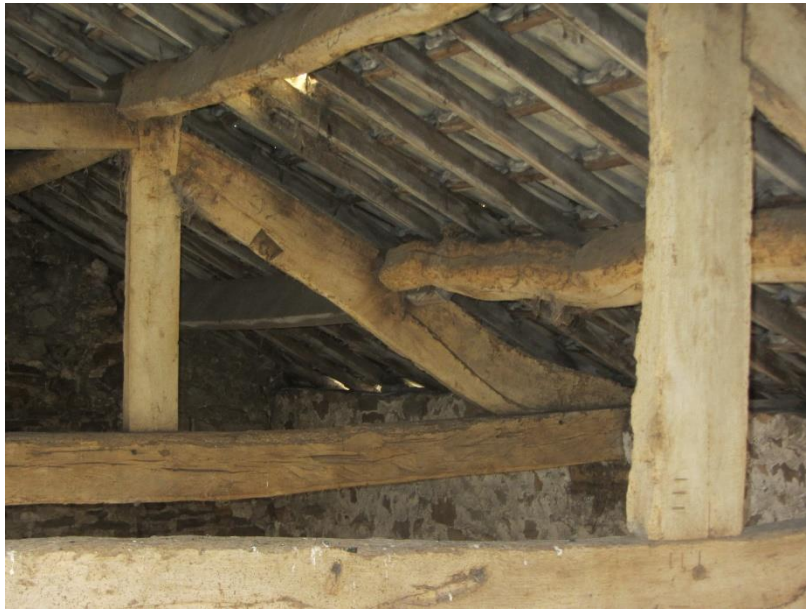
**Photo 25 – Barn 2 – decayed roof timbers**

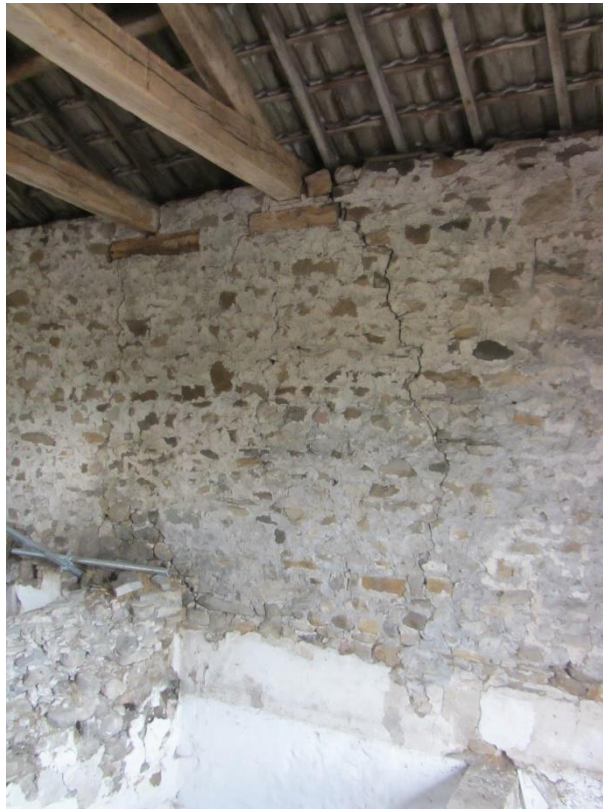
The east and west walls are generally straight and vertical. Cracking noted on the inside and outside faces has been caused mainly by thermal movement. These walls require only minor repairs such as pointing of the open-jointed stonework and filling and stitching of vertical cracks.

**Photo 27 – Barn 2 – cracking in north wall**

- Cracks in the stone walls should be cross-bonded with matching stones or stitched with surface-fixed straps on the inner face. Open joints should be pointed.

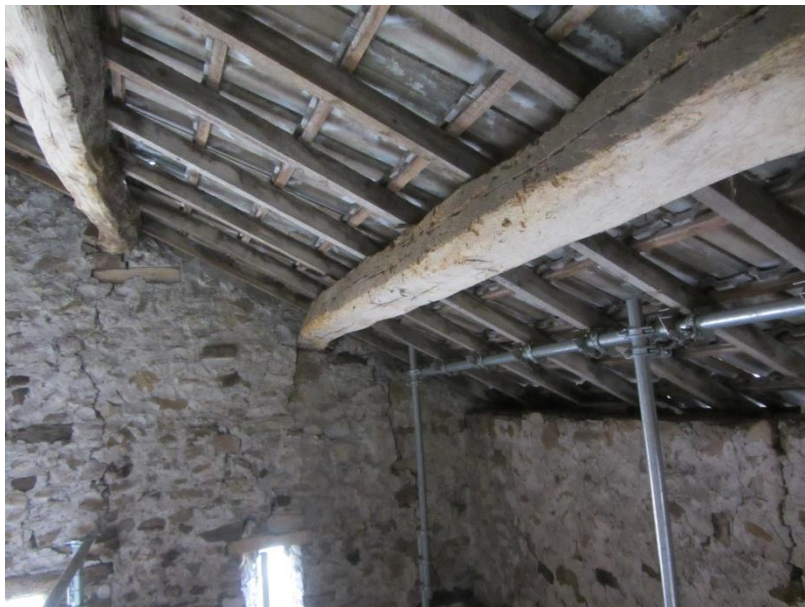
**Photo 28 – Barn 2 – cracking in north and west walls**

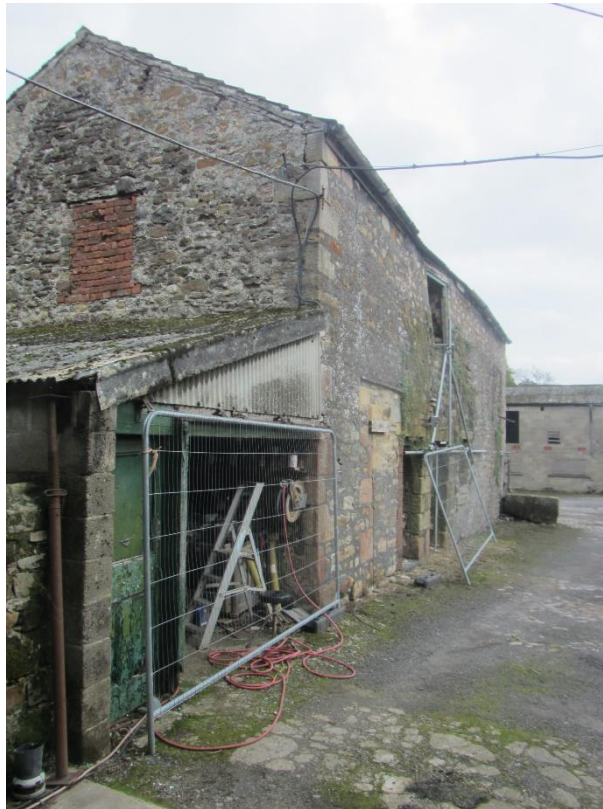
- The south wall is severely distorted and leans outwards. It has been stabilised by steel scaffolding (photo 29). The upper part has been re-built and there is a horizontal step between the old and more recent masonry (photo 30). There is cracking in the wall at multiple locations and one stone lintel has cracked (photos 31 & 32).
- There are cracks in the north wall in multiple locations, and a significant outward bulge at mid-height on the west side (photos 33, 34 & 35).
- One vertical crack was noted in the east wall (photo 36). The west wall is relatively straight and vertical, but with open-jointed stonework.

The central part of south wall, particularly above first floor level, is in extremely poor condition and would collapse in the absence of the support provided by the scaffold system. This section of the wall should be taken down and re-built, leaving those parts close to the east and west corners that are straight and vertical, which should be repaired as described below.

The distortion and near collapse of parts of the south wall has been caused by lack of buttressing from internal walls, in particular above first floor level, partial or complete removal of the first floor, and lack of rigidity in the roof. Some separation of the internal and external leaves of the rubble-filled walls may be taking place.

**Photo 29 – Barn 2 – distorted and propped south wall**

- The central part of the south wall should be rebuilt. Only parts at low level that are straight and vertical should be retained. The bulged upper part of the north wall close to the north west corner should be taken down and rebuilt.

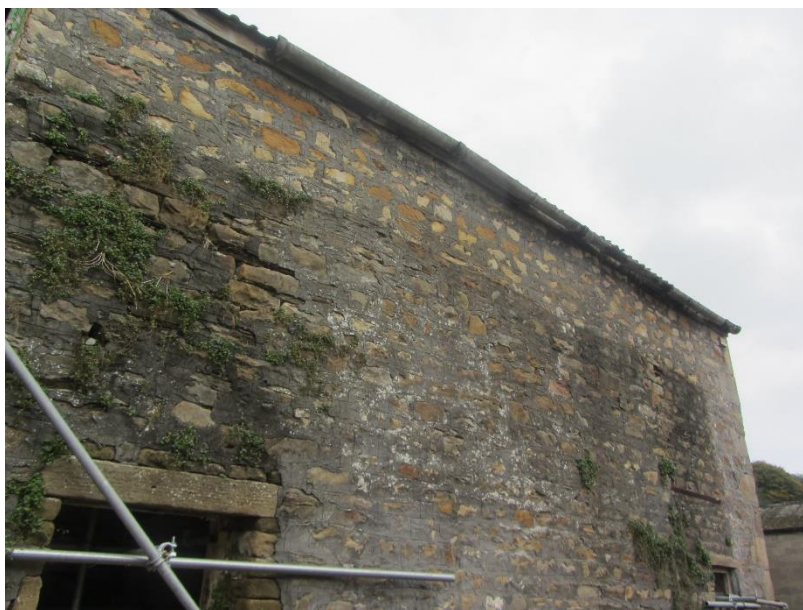
**Photo 30 – Barn 2 – cracks and step in south wall**

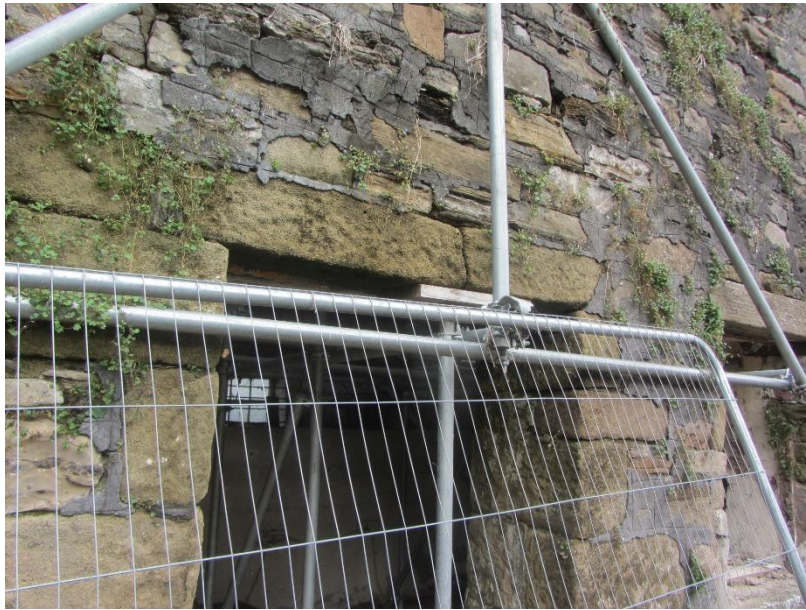
**Photo 31 – Barn 2 – cracked lintel in south wall**

- Loose and damaged areas of masonry should be consolidated by localised re-building using the original stones and traditional sand:lime mortar. Cracked stone lintels should be replaced, or new relieving lintels provided above.

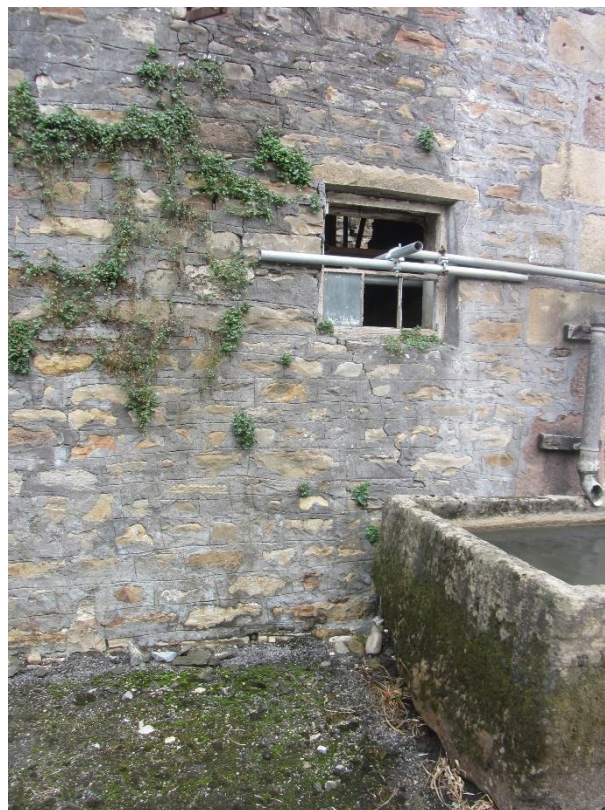
**Photo 32 – Barn 2 – cracking in south wall**

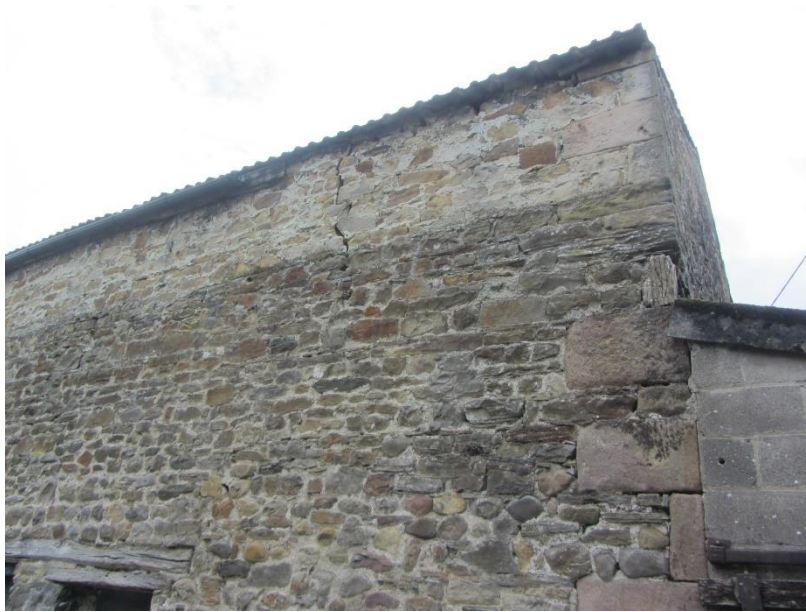
**Photo 33 – Barn 2 – cracking in north wall**

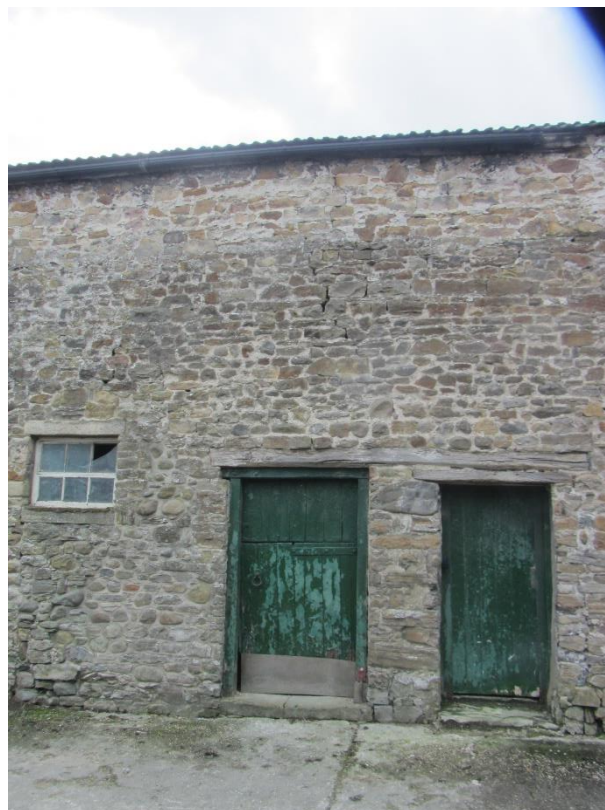
**Photo 34 – Barn 2 – cracking in north wall**

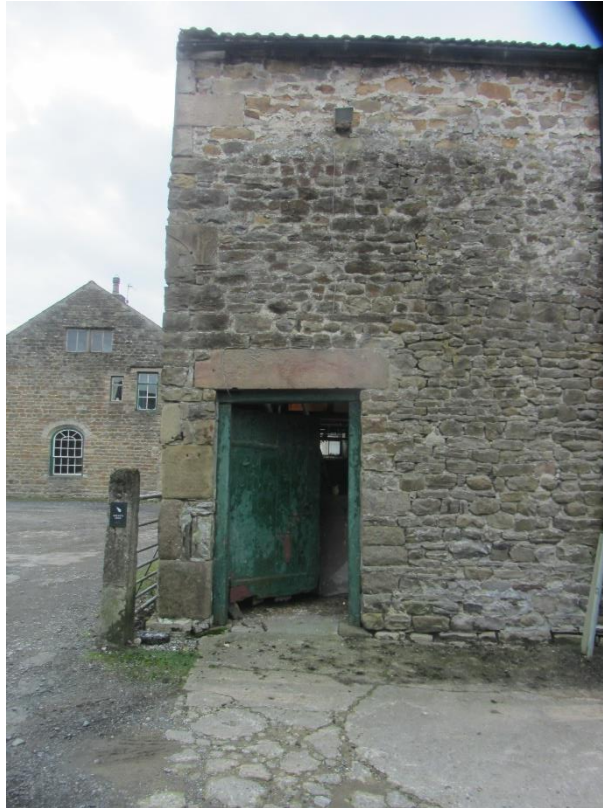
Most of the north wall is reasonably straight and vertical, except for the upper part near the north west corner which bulges significantly.

**Photo 35 – Barn 2 – cracking in north wall**

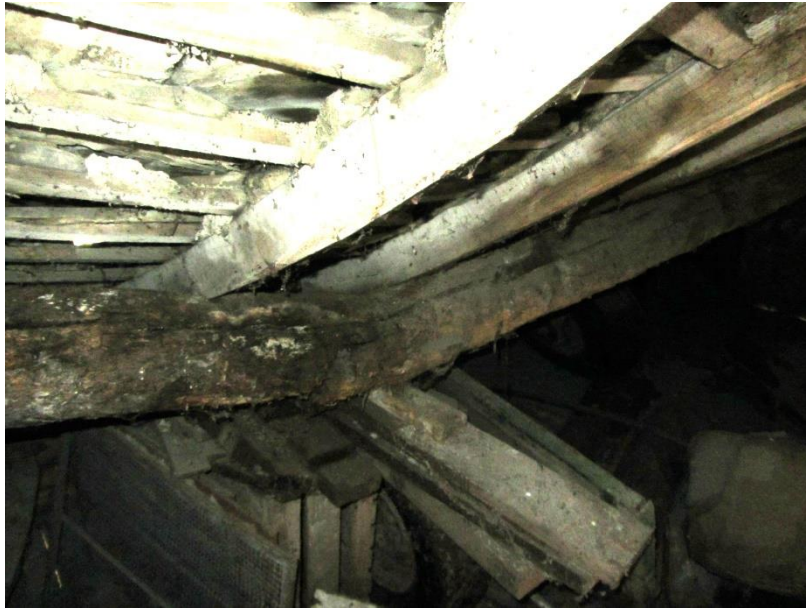
- The upper floor was accessed via the external stone steps. A purlin on the southern roof pitch has fractured causing localised collapse (photo 37). The roof in general shows widespread signs of decay due to insect infestation (photo 38).
- The timber first floor is badly decayed and was unsafe to access.
- The ground floor was full of farm stores and equipment and was unable to be inspected.

**Photo 37 – Barn 3 – fractured purlin**

It is our view that this building is beyond economic repair. We would recommend that it should be taken down completely and rebuilt from new foundations, re-using the existing stones and as much of the existing roof structure as possible.
