## **STRUCTURAL INSPECTION**

### **STONE BARNs AT WINKLEY HALL FARM, STONYHURST, CLITHEROE**

### **STANTON ANDREWS**

| Project No.: 11342 | | | | |

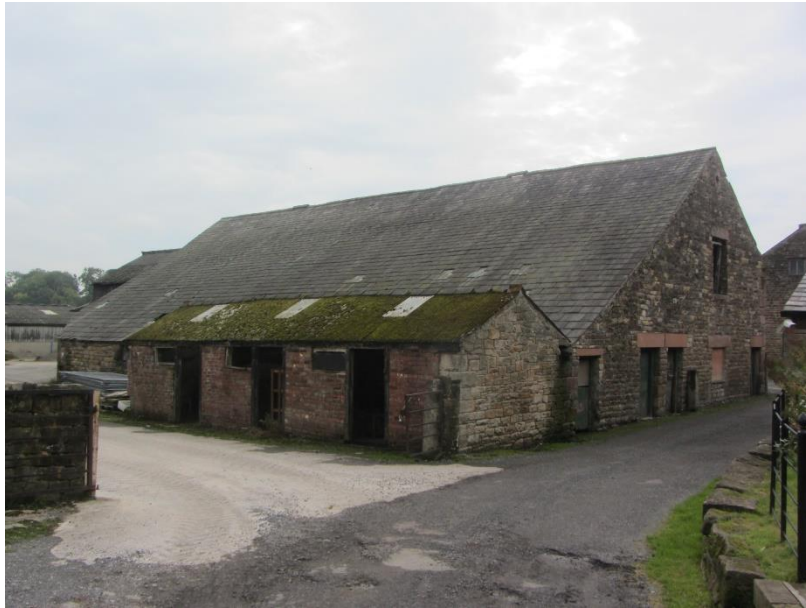
Barn 1 is two storeys high, and most likely originally had a hay-loft which has now been removed (photos 1-4). A single-storey lean-to shippon lies to the north. The barn walls are stone and the roof is of Welsh thin slate or asbestos-cement slate, on timber sarking boards, rafters, purlins and king-post trusses. The shippon is of similar construction, but with mono-pitch timber roof trusses. The building has been extended to the east and south with modern brick, block additions with asbestos-cement sheeted roofs. A relatively modern brick-built pigsty is attached to the north wall of the shippon.

**Photo 1 – Barn 1 - View from north west**

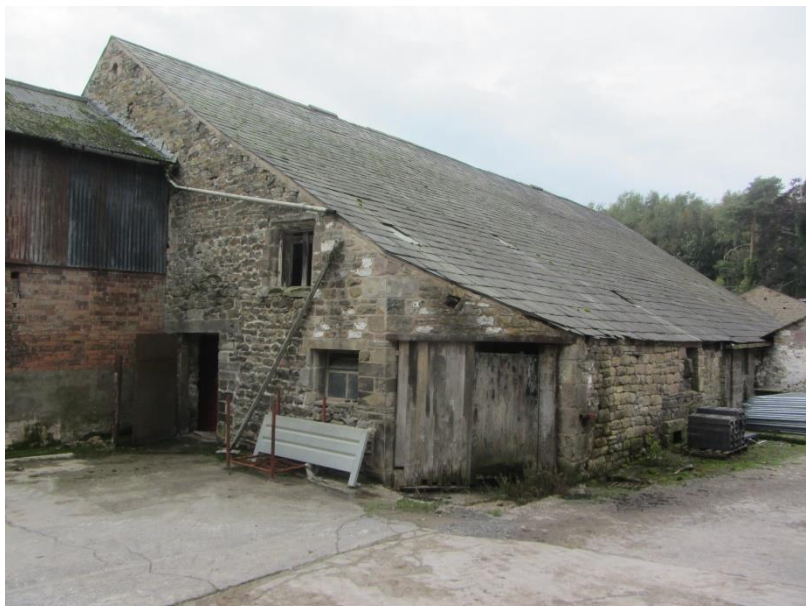
**Photo 2 – Barn 1 - view from north east**

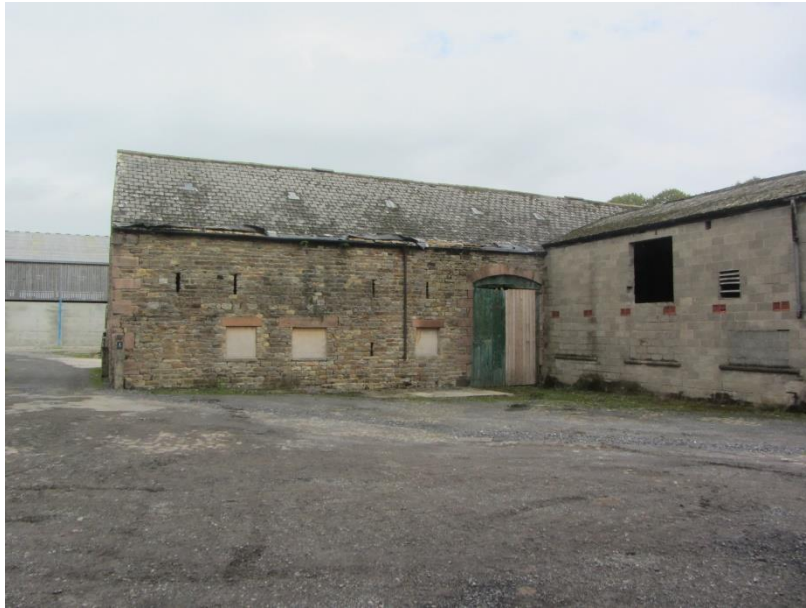
**Photo 3 – Barn 1 – view from south**

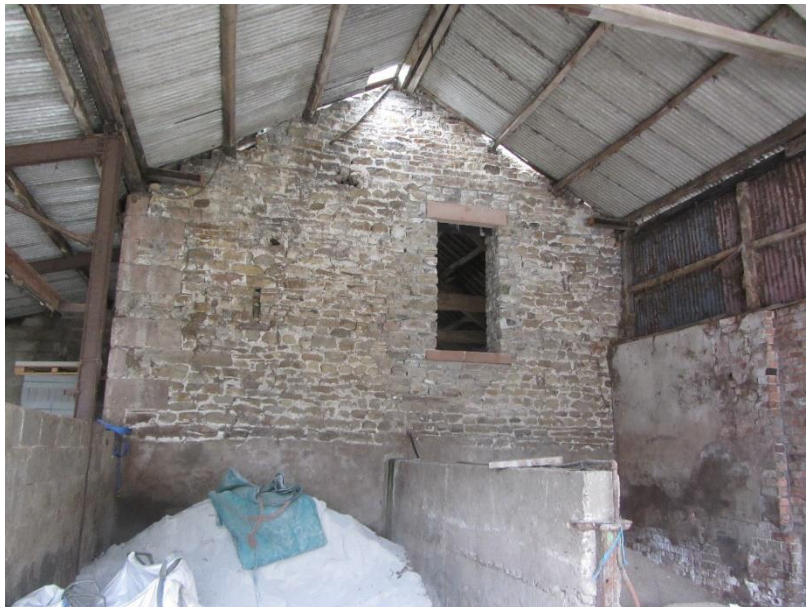
**Photo 4 – Barn 1 – view from east (from within extension)**

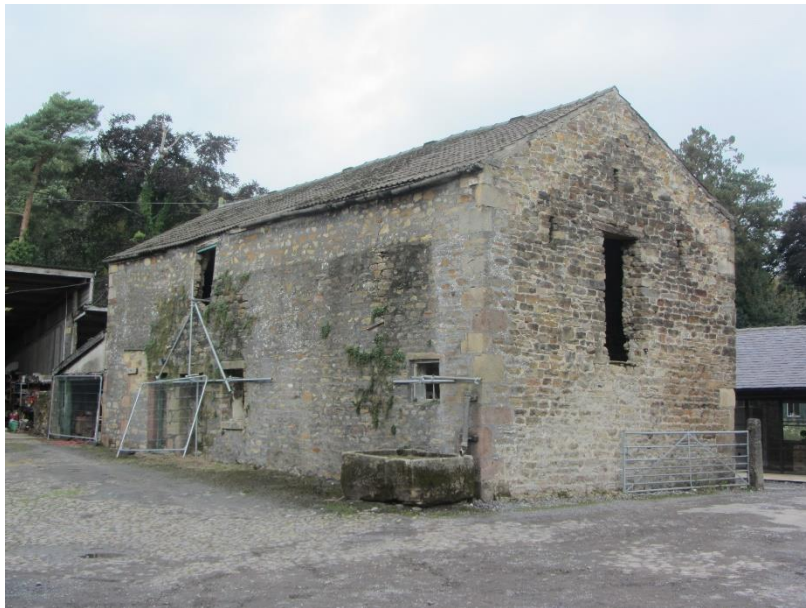
Barn 2 is a two-storey building, the upper floor of which has been removed (photos 5 & 6). It has stone walls and a roof of concrete tiles on timber rafters, purlins and queen post trusses. A relatively modern workshop with concrete block walls and an asbestos-cement sheeted roof has been added to the east.

**Photo 5 – Barn 2 – view from south east**

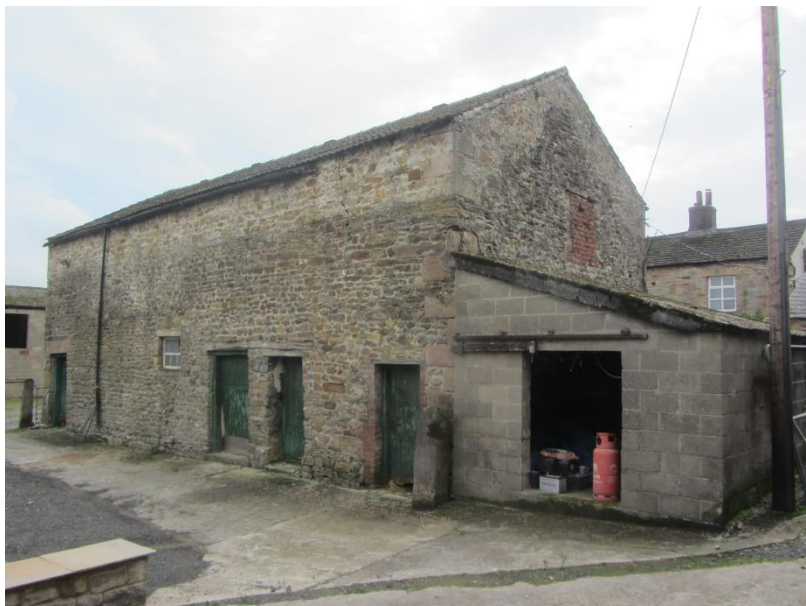
**Photo 6 – Barn 2 – view from north west**

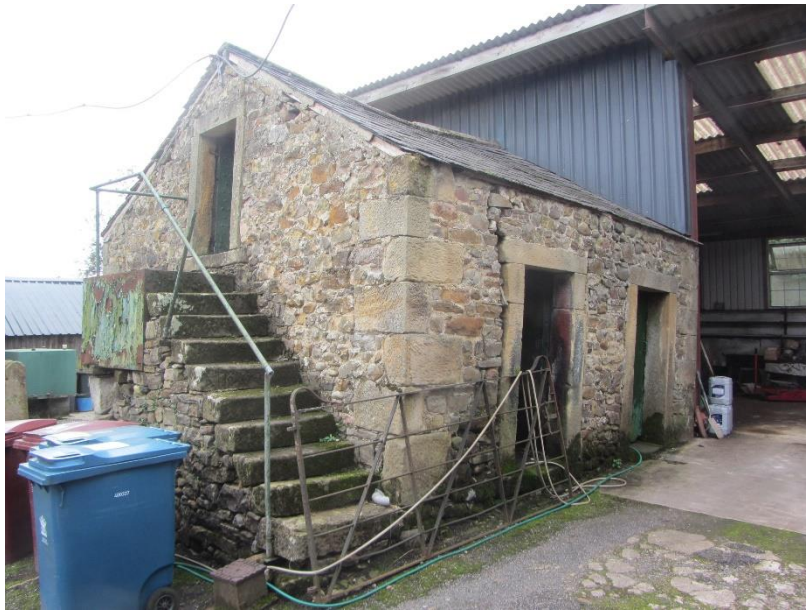
Barn 3 is a small two-storey building, with stone walls and a roof of stone slates on timber rafters and purlins (photos 7, 8 & 9). The roof has partially collapsed and the building leans significantly.

- The building tilts significantly to the west, with wide cracks forming in the north and south wall (photos 7 & 8).

**Photo 7 – Barn 3 – view from north east**

Barn 3 has been severely damaged by timber decay and foundation movement and is beyond repair. It should be taken down completely and re-built from new foundations.

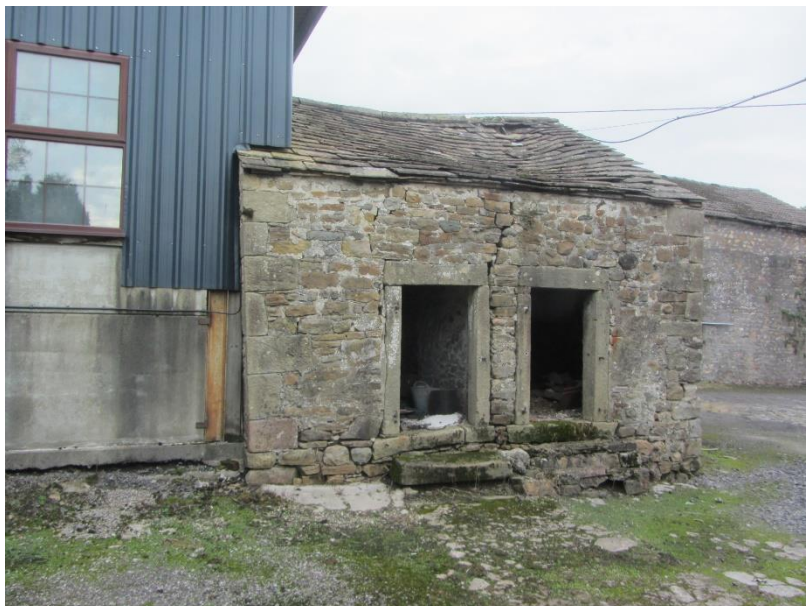
**Photo 8 – Barn 3 – view from south**

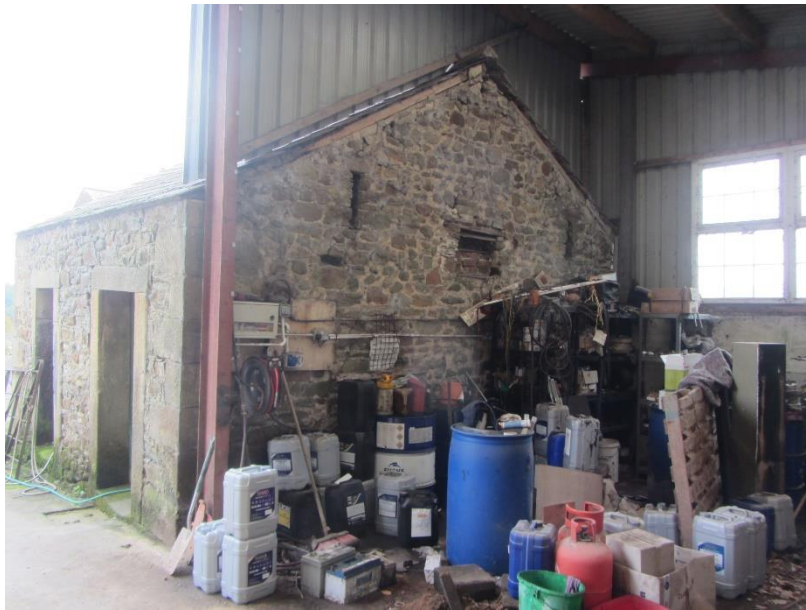
**Photo 9 – Barn 3 – view from north west**

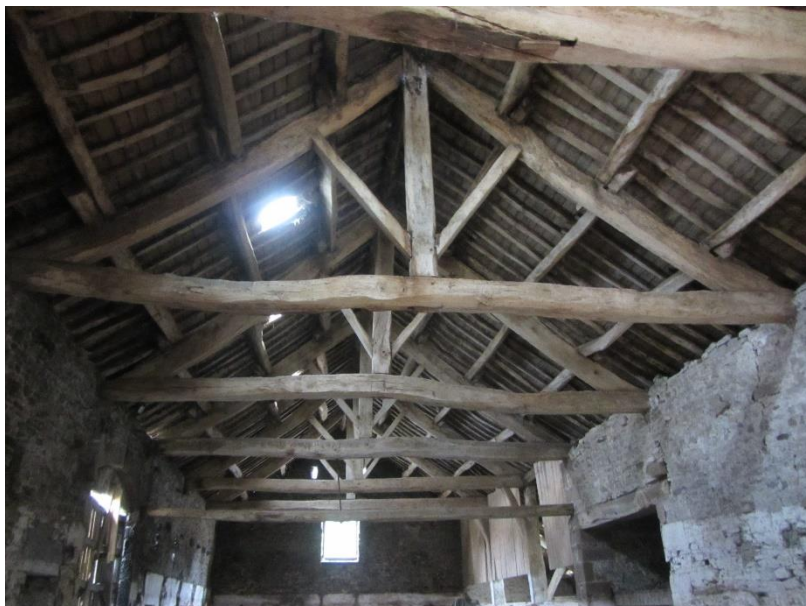
- The roof structure of the main part of the barn was inspected from ground level (photo 10). Some decay due to wet-rot was noted in the sarking boards and rafters near eaves level on the south side, with widespread signs of insect infestation noted elsewhere. Some purlins are excessively warped (photo 11), and most show signs of insect infestation and decay. The timber

The original oak purlins and roof trusses show signs of decay due to insect infestation and localised wet-rot at their bearings. The rafters and boarding are similarly decayed.

**Photo 10 – Barn 1 – main roof structure**

- The sarking boards and rafters should be removed. The purlins and trusses should be de-frassed of insect decay and their bearings exposed, then they should be fully inspected and their residual strength confirmed: if found inadequate, they should be repaired and strengthened. It may be possible to re-use some rafters, subject to detailed inspection and evaluation. The sarking boards should be replaced with plywood, hidden above new ceilings.

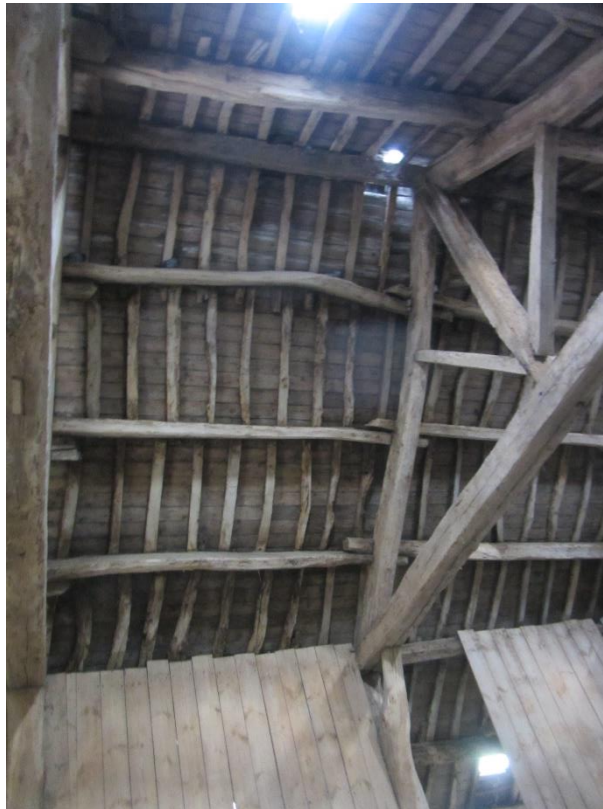
**Photo 11 – Barn 1 – warped rafters and purlins**

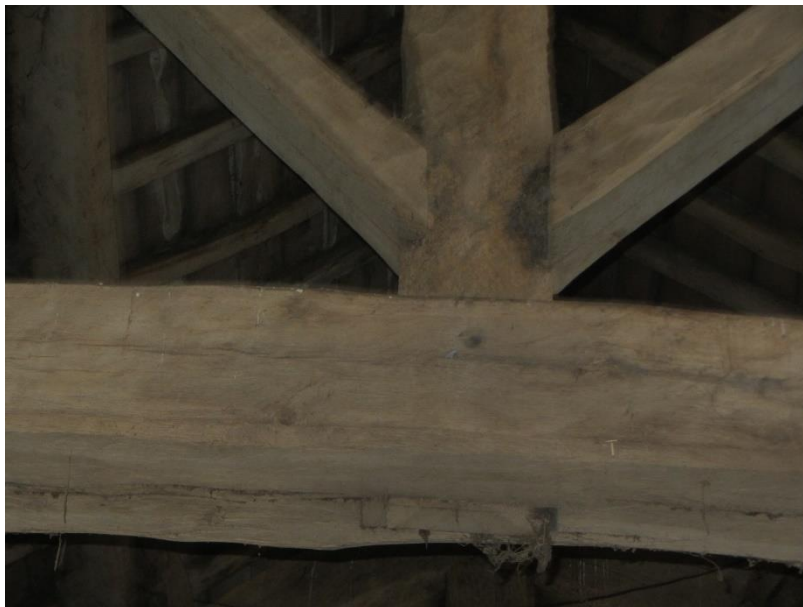
trusses all show signs of insect infestation, with one king post significantly reduced in cross-section (photo 12). Some water staining and possible wet-rot decay was noted on the truss bottom tie beams which rest on the south wall (photo 13). Two trusses are supported on bifurcated timber posts on the north side, and both posts show signs of insect infestation (photo 14).

**Photo 12 – Barn 1 – insect decay to roof truss**

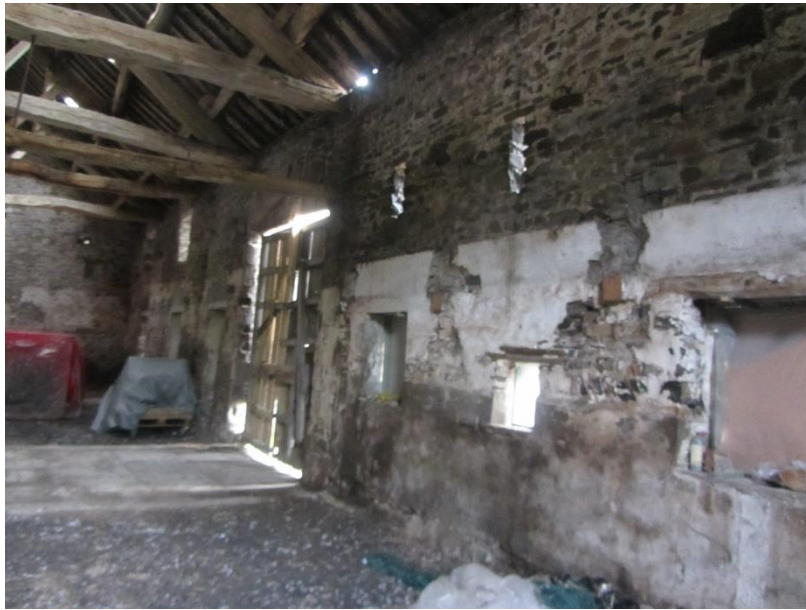
- The roof structure of the shippon was inspected from ground level. Widespread decay due to insect infestation was noted (photos 15 & 16).
- The south wall of the main barn is reasonably straight and vertical, but the western part shows a slight outward lean (photo 17). The west wall is reasonably straight and vertical but bulges outward at around mid-height (photo 18). No significant structural defects were noted in the east or north walls.
- Minor vertical cracking was noted in the internal walls each side of the north wagon entrance (photo 19). Decaying timber lintels in the internal and external walls has caused the stonework to crack (photo 20).

**Photo 17 – Barn 1 - south wall**

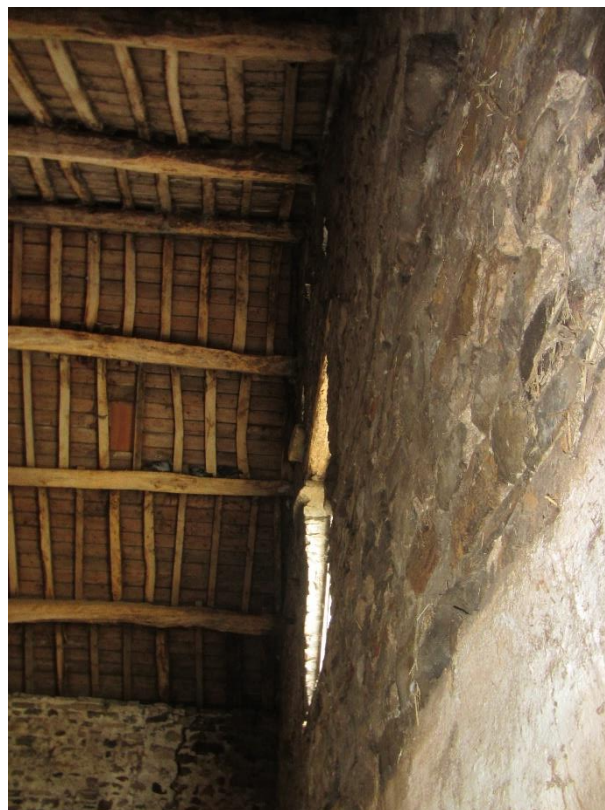
**Photo 18 – Barn 1 – west wall**

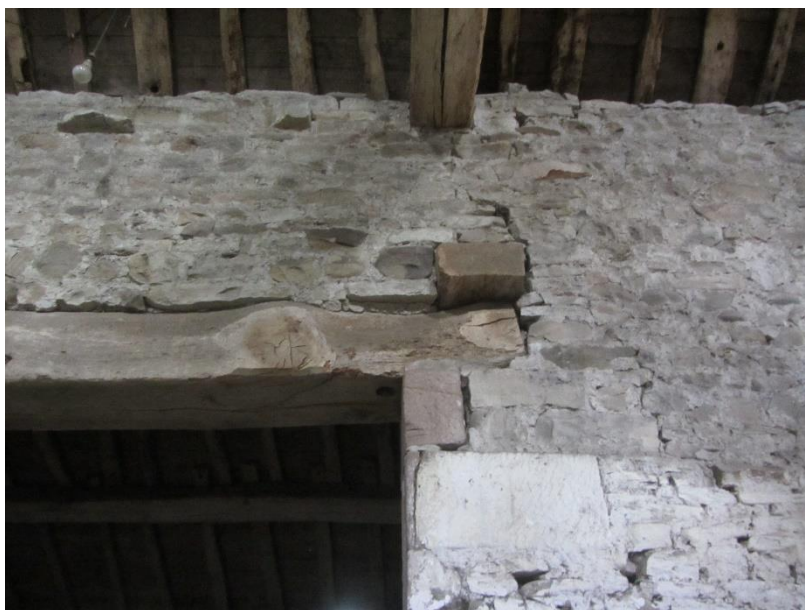
**Photo 20 – Barn 1 – decayed lintel and cracks in wall**

- Decayed timber lintels should be removed and replaced with new pre-cast concrete items.
- Loose and damaged areas of masonry should be consolidated by local re-building.

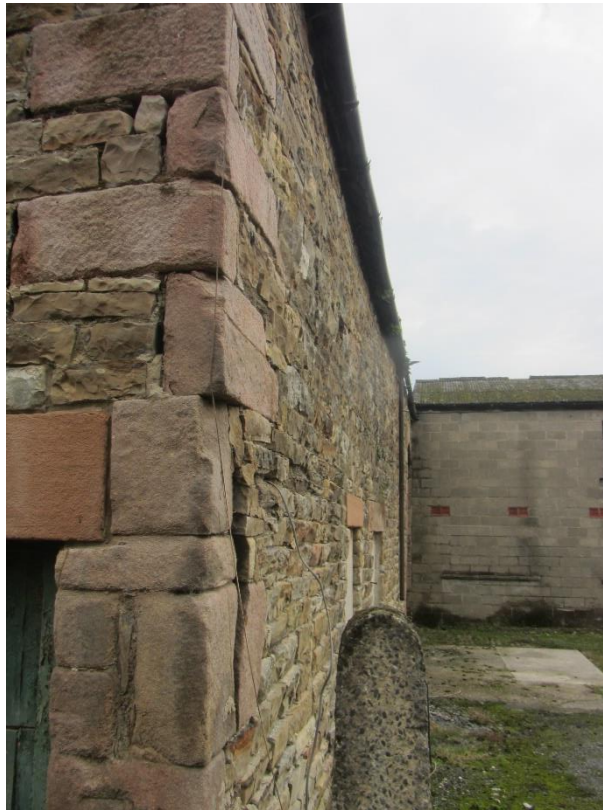
- The north and south roof pitches are reasonably straight and true, and no excessive irregularity or sagging was noted.
- At the south west corner, the stonework is poorly bonded and a quoin has cracked (photo 21). Some distortion and irregularity can be seen towards the top of the south wall.
- There is a noticeable outward bulge in the west wall at around mid-height (photo 22).

**Photo 21 – Barn 1 - south west corner**

- Cracks in the stone walls should be stitched using stainless steel helical bars epoxy-grouted into the stone bedjoints, or at corners, drilled and grouted into the stones. Surface-fixed straps could be used internally, in areas where new lining walls will be provided.

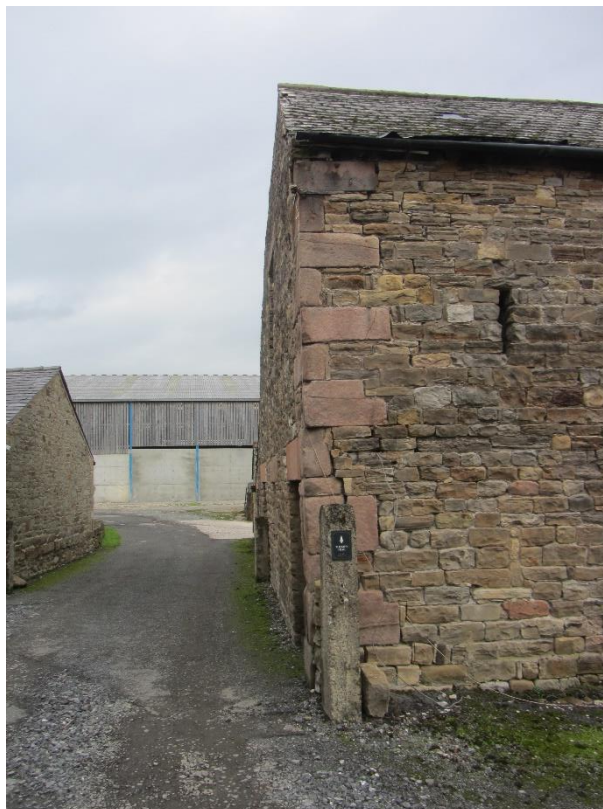
The four main external walls are generally straight and vertical, with relatively minor distortion in the upper part of the south wall and some outward bulging of the west wall at around mid-height. The barn has been constructed to a good standard and the sarking boards have increased the rigidity of the roof, holding the walls in position. Cracking noted on the inside face of the external walls and on the internal walls, has been caused mainly by thermal movement and decay of timber lintels.

**Photo 22 – Barn 1 – outward bulge in west wall**

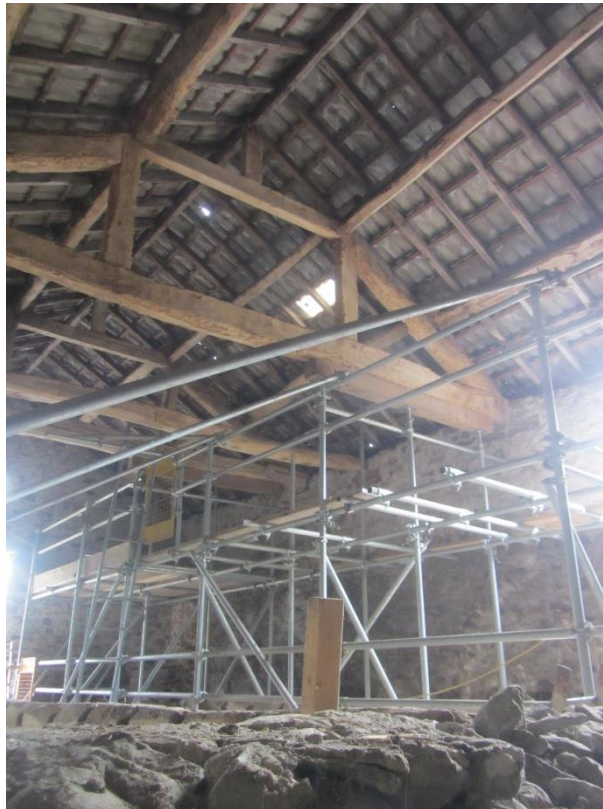
- The roof structure and the south wall have been propped by a steel scaffold structure (photo 23). The timber purlins and trusses show signs of widespread and significant insect infestation (photos 24 & 25). The timber rafters are more recent replacements.
- The first floor joists and boarding have been removed (photo 26), leaving only the original timber beams (and one newer concrete beam).
- Vertical cracks were noted on the inside face of the north wall (photo 27) and west wall (photo 28).

**Photo 23 – Barn 2 – roof structure**

- The roof structure should be removed and replaced in its entirety.

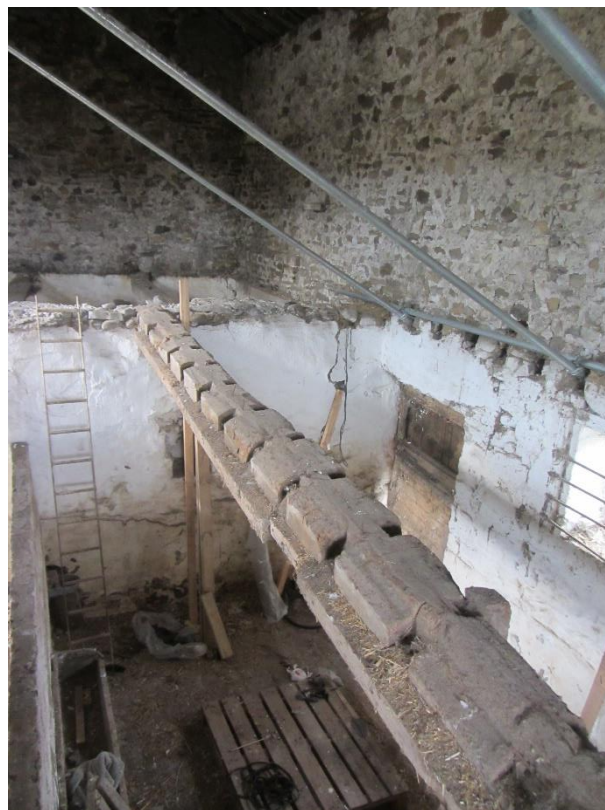
**Photo 26 – Barn 2 – original floor beam**

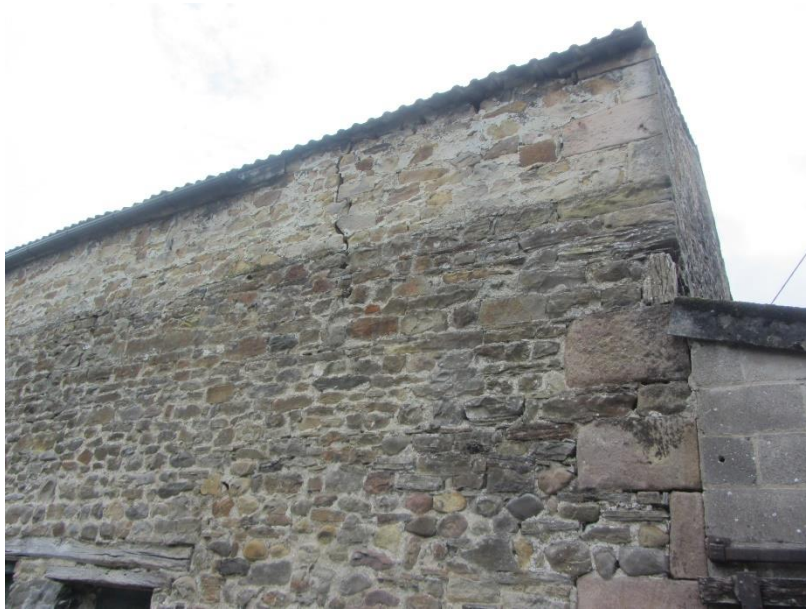
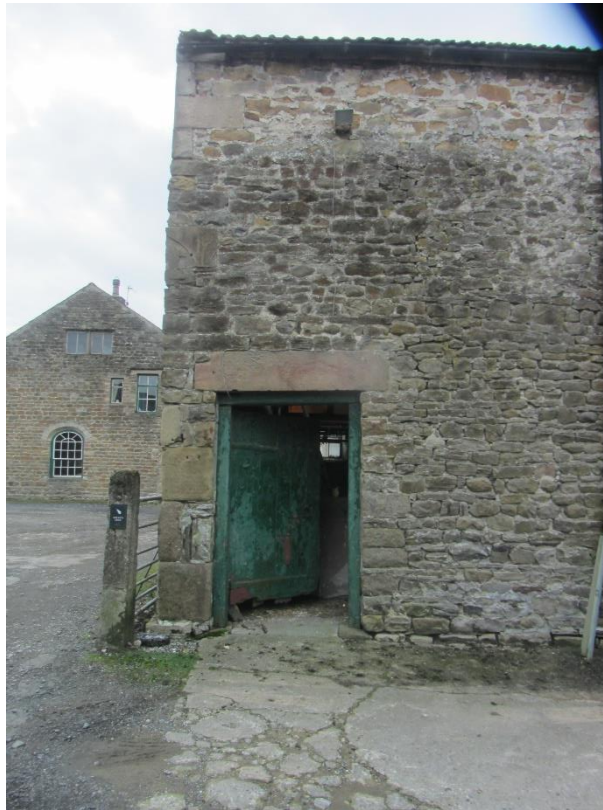
Most of the north wall is reasonably straight and vertical, except for the upper part near the north west corner which bulges significantly. Cracks should be stitched, open joints pointed, and decayed timber lintels replaced. The bulged part should be locally rebuilt, ensuring sufficient through-thickness bonding of the stonework to prevent future delamination.

**Photo 33 – Barn 2 – cracking in north wall**

**Photo 34 – Barn 2 – cracking in north wall**

**Photo 35 – Barn 2 – cracking in north wall**

- Cracks in the stone walls should be stitched using stainless steel helical bars epoxy-grouted into the stone bedjoints, or at corners, drilled and grouted into the stones. Surface-fixed straps could be used internally, in areas where new lining walls will be provided.

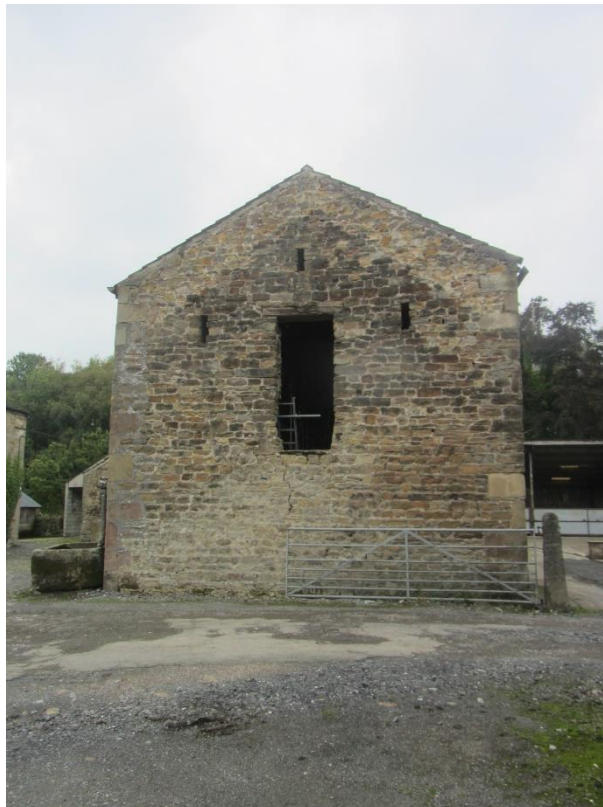
- The south wall is severely distorted and leans outwards. It has been stabilised by steel scaffolding (photo 29). The upper part has been re-built and there is a horizontal step between the old and more recent masonry (photo 30). There is cracking in the wall at multiple locations and one stone lintel has cracked (photos 31 & 32).
- There are cracks in the north wall in multiple locations, and a significant outward bulge at mid-height on the west side (photos 33, 34 & 35).
- One vertical crack was noted in the east wall (photo 36). The west wall is relatively straight and vertical, but with open-jointed stonework.

**Photo 36 – Barn 2 – cracking in east wall**

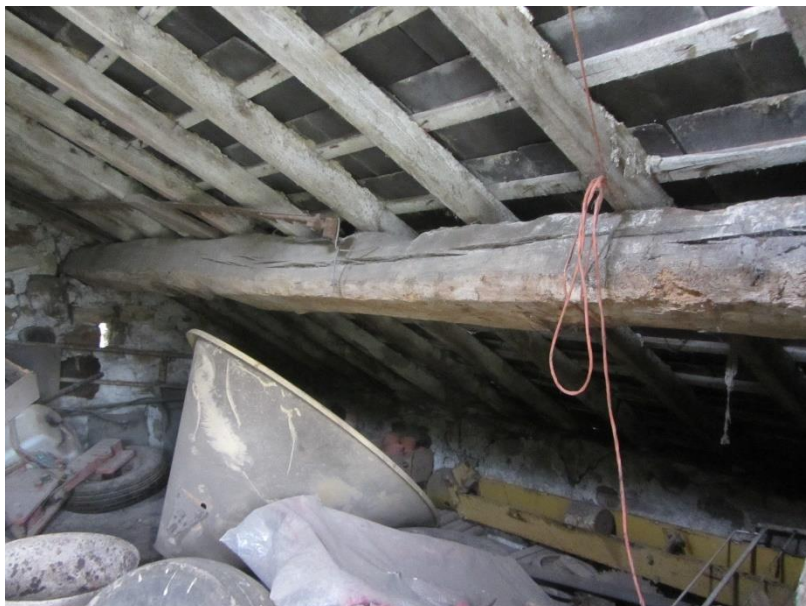
- The upper floor was accessed via the external stone steps. A purlin on the southern roof pitch has fractured causing localised collapse (photo 37). The roof in general shows widespread signs of decay due to insect infestation (photo 38).
- The timber first floor is badly decayed and was unsafe to access.
- The ground floor was full of farm stores and equipment and was unable to be inspected.

**Photo 38 – Barn 3 – decayed roof timbers**
