**THE OLD RECTORY**  
**BOLTON BY BOWLAND**

**STRUCTURAL INSPECTION REPORT**

OCTOBER 2025

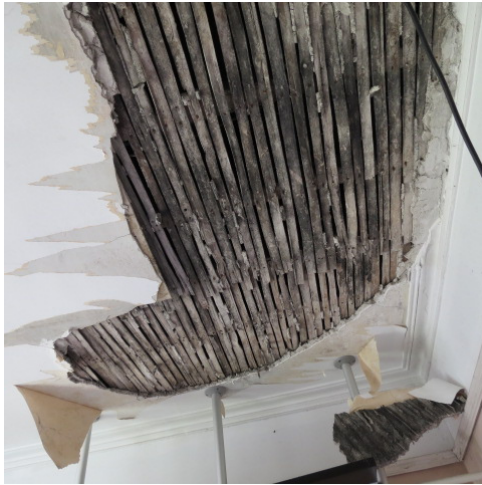
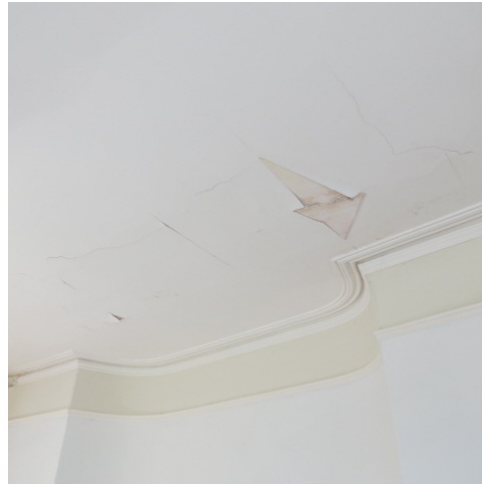
3.1.1 The water damage was caused by severing of a pipe above the en suite to the principal bedroom at the south east corner. There is severe damage to the ceiling above the en suite with saturated plaster debonding from timber laths. Ceiling joists at the east end of the house generally span front-back (north south)

#### **Damage to Bed 1 En Suite Ceiling and Principal Bedroom adjacent**

3.1.2 The principal bedroom at the south east corner has cracking and normal age related damage to the ceiling as well as typical shearing at the junction of the en suite studwork to the rear external wall.

4.1. Flood damage has badly affected plaster finishes to walls and lath and plaster ceilings in parts of the property. Decorative timber floor finishes have also been damaged by the flooding and will need to be removed due to warping etc. All wall and ceiling finishes will need to be stripped to allow the structure to dry out. Timbers should be assessed once exposed but should generally be serviceable once dry. Timber lintels can be assessed once exposed. Historic timbers in external walls in particular are vulnerable to rot and should be replaced as necessary using precast concrete lintels or similar for long term durability.

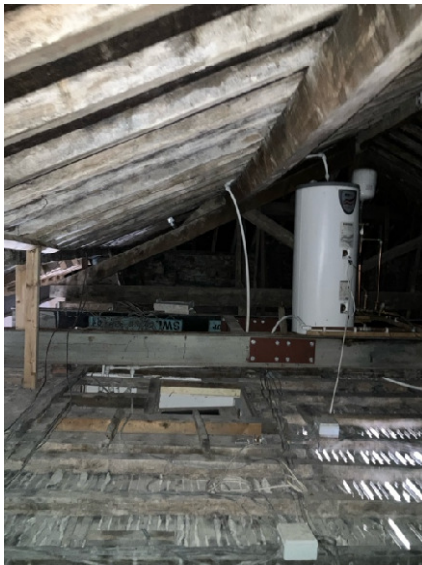
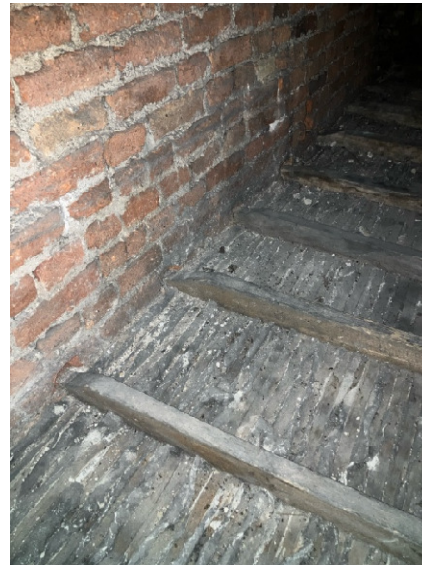
3.1.3 To the west of the original masonry cross wall the ceiling joists span east-west. Support at the masonry cross wall is poor with timbers angled off (probably repurposed rafters) and with minimal bearing onto the masonry.

#### **Ceiling over En Suite and West End minimally supported Ceiling at Cross Wall**

4.4 The poorly supported first floor ceiling joists in the west end of the Georgian extension can be picked up at the masonry cross wall using a timber running along above the ceiling joists and fixed down into each joist. The timber can be bolted into the masonry cross wall. This should be done before general access for workers is allowed.

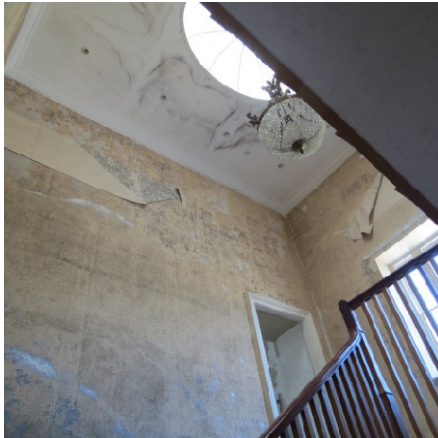
#### **Stairwell**

3.1.5 The ceiling over the stairwell is damp stained and the timber finish to the staircase below has warped and lifted.

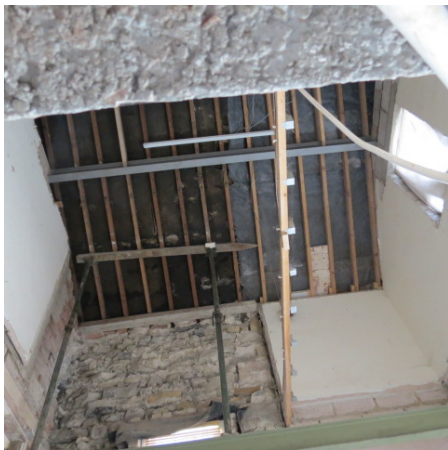
#### **Roof Structure over Void**

3.1.6 Over the void to the east of the stairwell there are two steel purlins believed to be part of the modern extension works. Rafters seem to be propped off another steel beam which has a lifting mechanism attached to it. The rafters only span around 2m on plan so standard 150mm deep timbers would be adequate.

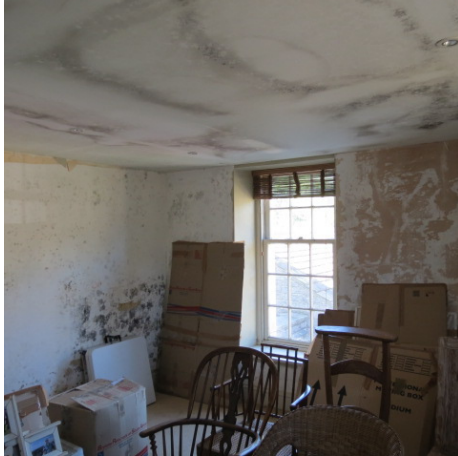
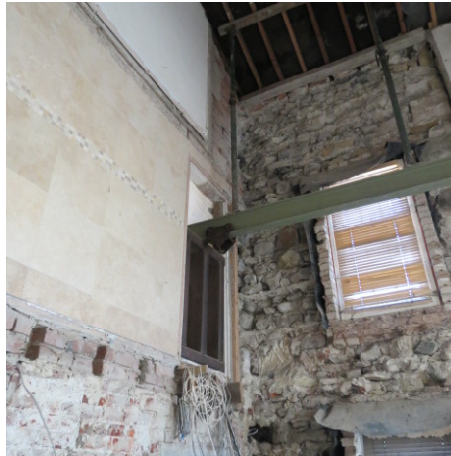
3.2.1 Ceiling finishes are generally affected by the flooding and age related cracking with joists having inadequate support, noted at the cross wall. At lower first floor the ceiling of the coach room bedroom is badly affected by black mould and will need replacing. To the east of the stairwell the upper and lower first floors have been stripped out.

#### Coach Bedroom and Void with removed floors

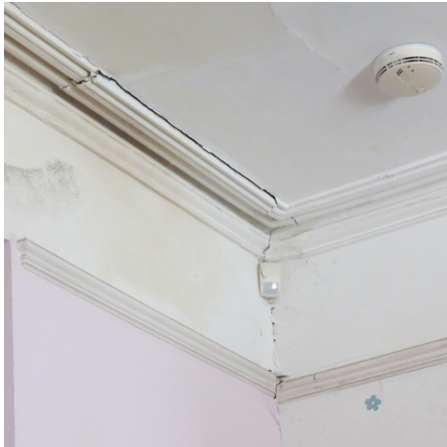
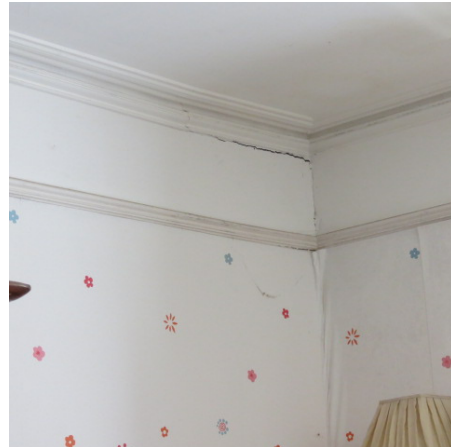
3.2.2 The first floor joists span east west in the Georgian addition. Due to the substantial spans there must be timber span breaker beams to support the joists over the large reception rooms at ground floor level. There is a slope evident in the first floor towards the west end of the house. Movement around the stud partition/masonry junctions and deformation of door openings is evidence of deflection of timbers supporting the partition and general floor loading. Timbers subject to saturation lose capacity and will deflect further. Ceilings have been lowered in areas to the east of the cross wall and a corridor formed by the addition of a studwork partition.

#### Typical Damage at Junctions of Stud Partitions to Masonry

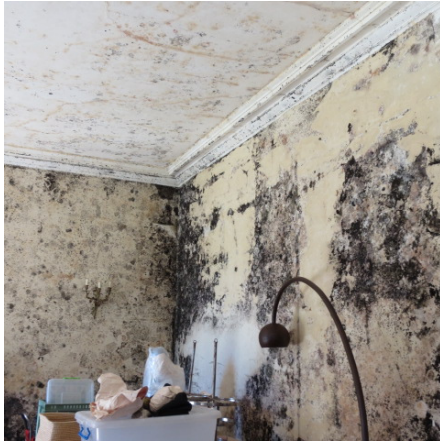
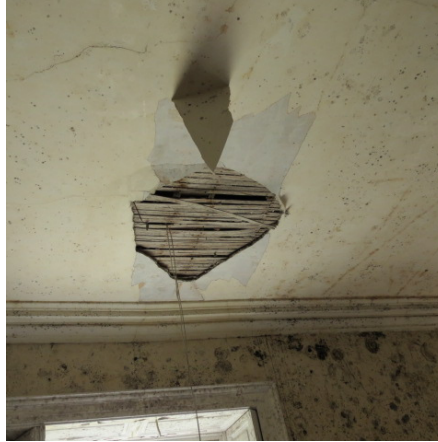
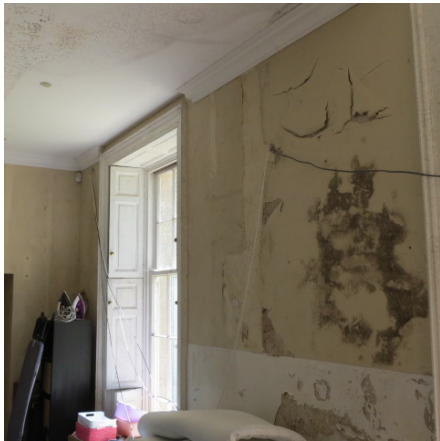
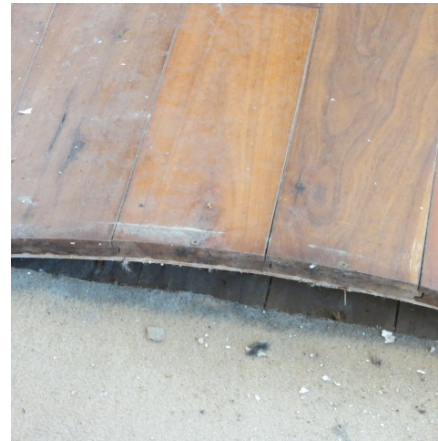
3.3.1 The ground floor is warped directly beneath the principal bedroom en suite due to flooding. Walls at ground floor in the two main reception rooms are badly affected by surface mould caused by the flooding.

#### Reception Rooms Floor Damage

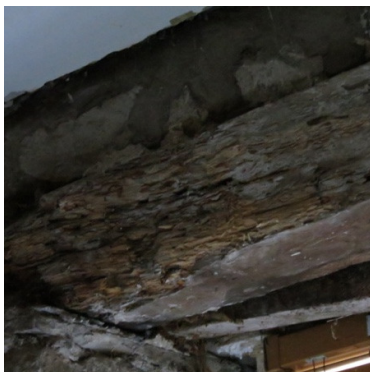
3.3.2 At the north west corner unlawful alterations have been undertaken forming wc cubicles etc. These are all to be removed. An exposed timber purlin on the west end wall was noted to be in poor condition and it is recommended that it be replaced with a pre cast concrete lintel for long term durability.

#### Rotten Lintel

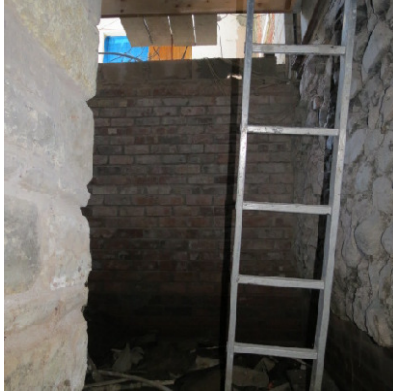
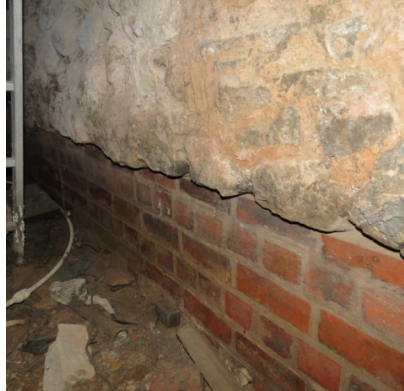
3.3.3 The ground floor to the east of the stairwell has also been removed/alterd unlawfully with significant amounts of excavation having been carried out to lower levels. The ground has been reduced to lower than the foundations of the original part of the house with underbuilding and underpinning appearing to have been carried out. Whilst there are no indications that the excavation and underbuilding has caused problems the removal of the intermediate floors is an issue, as is the stripping of the inner leaf masonry to the north wall.

#### **Cross wall in Excavated area and underbuilding of original North Elevation**

4.2. Stability has been affected by the removal of the inner masonry on the north elevation where the void has been excavated. The remaining masonry is too slender, particularly with the stiffening effect of the intermediate floors having been removed. The single skin of stonework is uncoursed random masonry which has little intrinsic strength in bending due to the lack of continuity of bond. A new inner leaf should be constructed and tied to the original stone outer to reinstate the robustness of the original construction. It is recommended that specialist advice be sought regarding appropriate ties etc. Helifix have a range of specialist products for use in historic properties and should be able to provide advice. I anticipate that a full scaffold will be required for both access and to provide temporary stability/restraint to the slender masonry. The reinstatement of the upper and lower first floors can be undertaken in traditional timber and these floors will act as restraint to the north wall once in situ.

4.3 It is understood that the owner would be happy for the void to be left with a new suspended ground floor introduced. A ground bearing floor would not be possible due to the depth of controlled fill that would be required beneath any slab. A precast concrete floor would be suitable supported at masonry walls. Some backfilling could be undertaken to bring levels up to closer to the original ground levels. If done in a controlled manner this could provide a platform for temporary supports during the works.

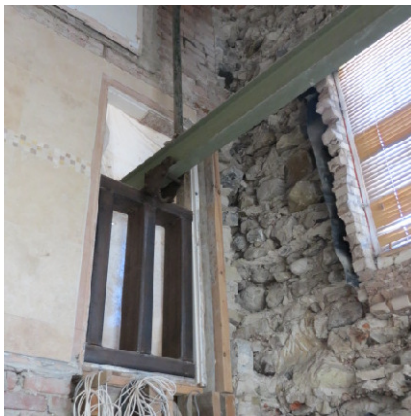
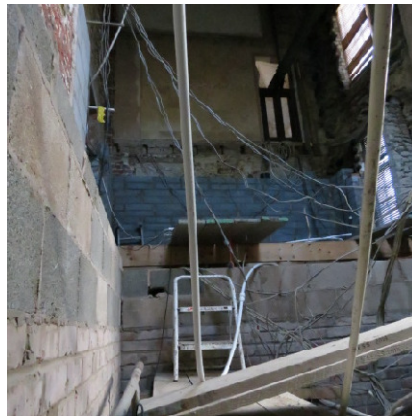
3.3.4 A new masonry cross wall has been added to the unlawfully formed basement and this will help to stabilize the external masonry. The north wall outer leaf is formed in rendered random uncoursed stone with little continuity. The brick reveals to the window openings have also been cut back further reducing the stability of the masonry. New masonry has been added to the construction at the lower levels of the excavation.

#### **North Elevation Inner Leaf Removed and Void showing crosswall**

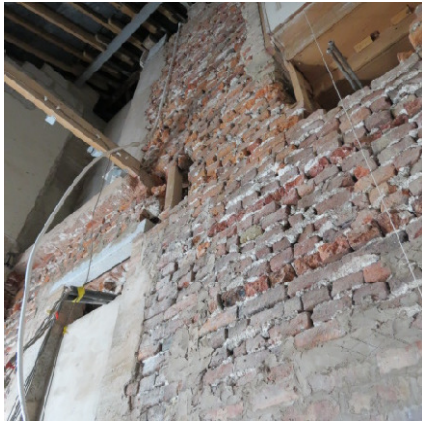
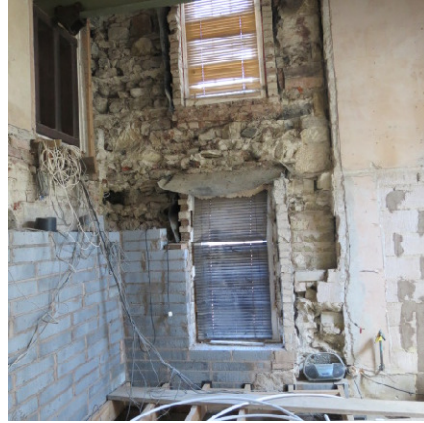
3.3.5 A leaf of masonry also appears to have been removed from what the wall between the original construction and the Georgian extension exposing poor quality brickwork. New masonry has been constructed from the excavated levels. Some floor joists have also been introduced above the void.

**Wall with Masonry Leaf Removed and 1950s North Elevation with Inner Masonry Removed**

4.3 Where the internal wall has had masonry removed to expose poor quality brickwork the missing masonry can be reinstated and tied into the remaining wall. This will allow historic openings at higher levels to be retained full depth.
