Tree Condition Report

St Mary's Church,
A59, Gisburn
BB7 4HB

Ribble Valley Borough Council

Job Ref: 2060

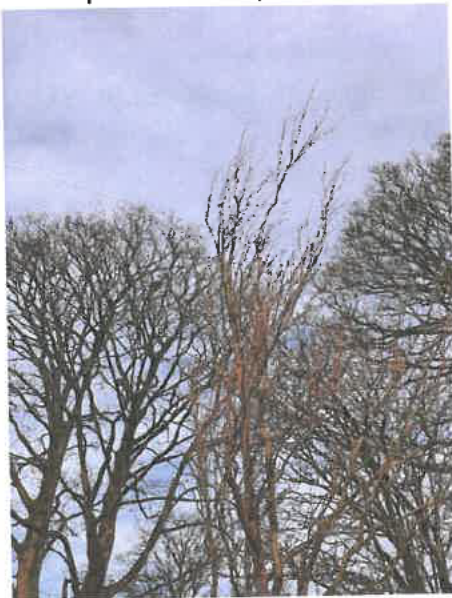
T201 – prune to clear phone lines

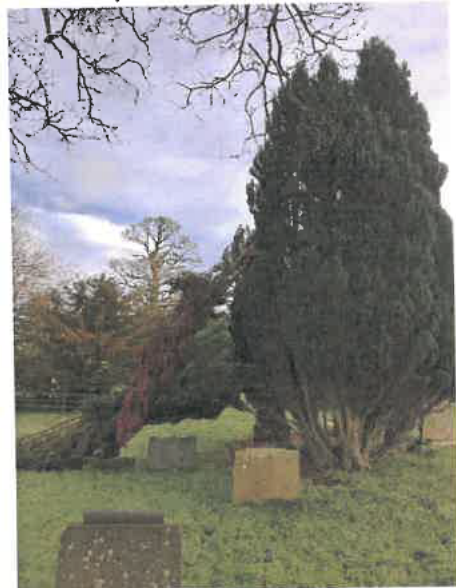
T207 – prune failed branches

Tree	T207	Oak (<i>Quercus sp.</i>)	1	40	16	N:4 E:4 S:4 W:4	Semi Mature	Good	Good	40+ Years	The tree has no significant visual defects. Seasonal leaf drop has occurred (normal).	No significant visible fungus present at the time of inspection.	No significant visible Pests or Diseases present at the time of inspection.	Owned by the client. Target # - graveslones / statue Target # - Parking / driveway	YES	No work required at time of inspection.	No Action	1 Year

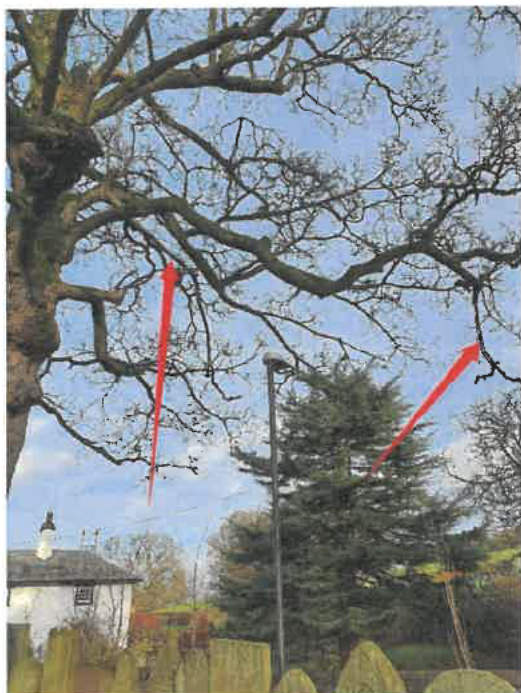
T206 – remove deadwood over road

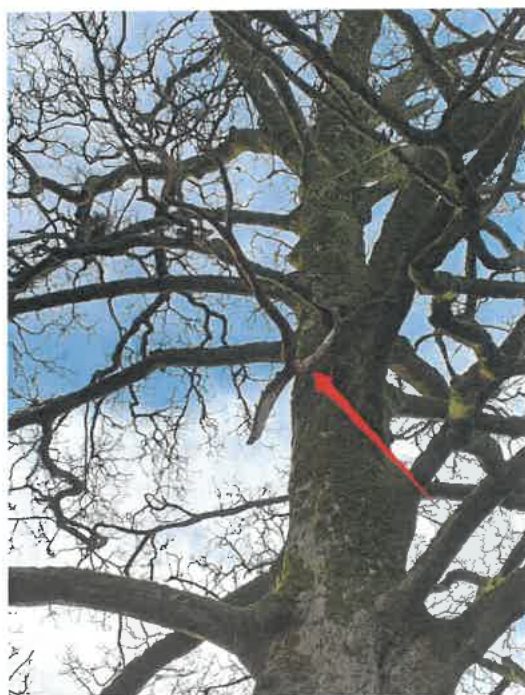
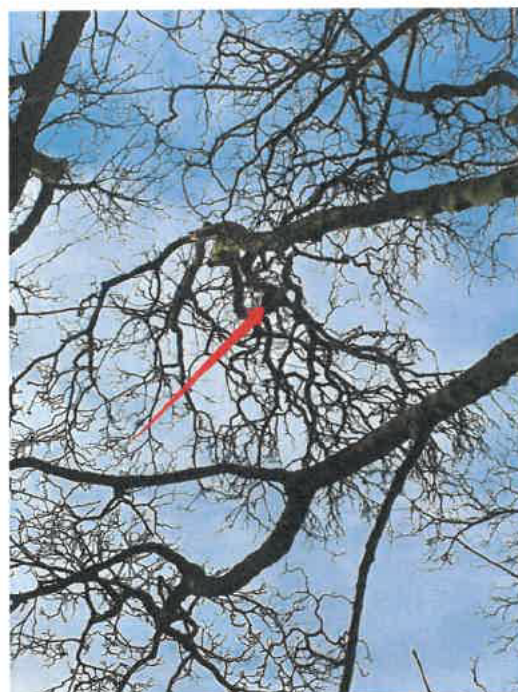
T208 – remove hung up branches

Tree	T208	Sycamore (<i>Acer pseudoplatanus</i>)	1	100	25	N:3 E:3 S:3 W:3	Mature	Good	Good	40+ Years	<ul style="list-style-type: none"> Seasonal leaf drop has occurred (normal). Hanging limbs in upper canopy x2. 	No significant visible fungus present at the time of inspection.	No significant visible Pests or Diseases present at the time of inspection.	Owned by the client. Target #- gravestones / statue Target #- Road Target #- Footpath - highway	YES	<ul style="list-style-type: none"> Make safe storm damage - see photo. 	11-Mar-2026 (3 Months)	1 Year
Tree	T209	Cherry (<i>Prunus</i> sp. 'Cherry')	1	40	5	N:5 E:5 S:5 W:5	Semi Mature	Good	Fair	40+ Years	<ul style="list-style-type: none"> Seasonal leaf drop has occurred (normal). Suppressed canopy. Unbalanced canopy. 	No significant visible fungus present at the time of inspection.	No significant visible Pests or Diseases present at the time of inspection.	Owned by the client. Target #- gravestones / statue Target #- Road Target #- Footpath - highway	YES	<ul style="list-style-type: none"> No work required at time of inspection. 	No Action	1 Year

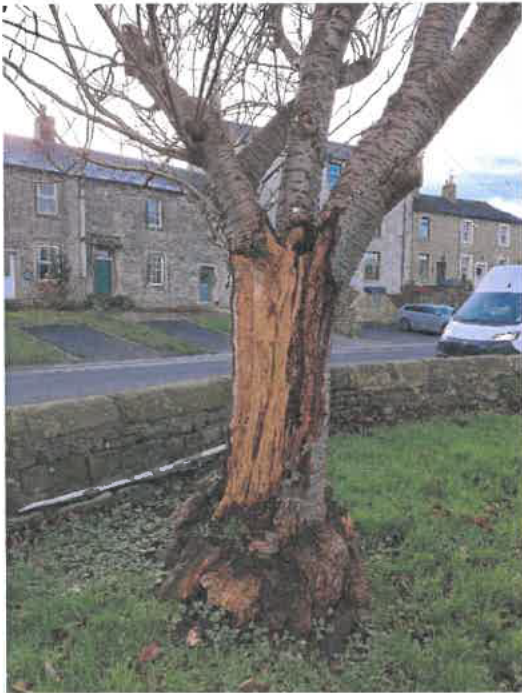
T217 – remove tree

Tree	T217	Cherry (<i>Prunus</i> sp. 'Cherry')	1	50	6	N:4 E:4 S:4 W:4	Mature	Good	Poor	<10 years	<ul style="list-style-type: none"> Stem decay. Failed co-dominant stem. Seasonal leaf drop has occurred (normal). 	No significant visible fungus present at the time of inspection.	No significant visible Pests or Diseases present at the time of inspection.	Owned by the client. Target # - Road Target # - Footpath - highway	YES	Remove tree to ground level for arboricultural management reasons.	11-Jun-2026 (6 Months)	1 Year				
Tree	T218	Cherry (<i>Prunus</i> sp. 'Cherry')	1	40	4	N:4 E:4 S:4 W:4	Mature	Good	Fair	10+ Years	<ul style="list-style-type: none"> Seasonal leaf drop has occurred (normal). Pruning history - Topped. 	No significant visible fungus present at the time of inspection.	No significant visible Pests or Diseases present at the time of inspection.	Owned by the client. Target # - Road Target # - Footpath - highway	YES	No work required at time of inspection.	No Action	1 Year
