Tree Condition Report

St Joseph's RC Cemetery,
Waddington Road,
Clitheroe

26/02/2026

Job Ref: 22280

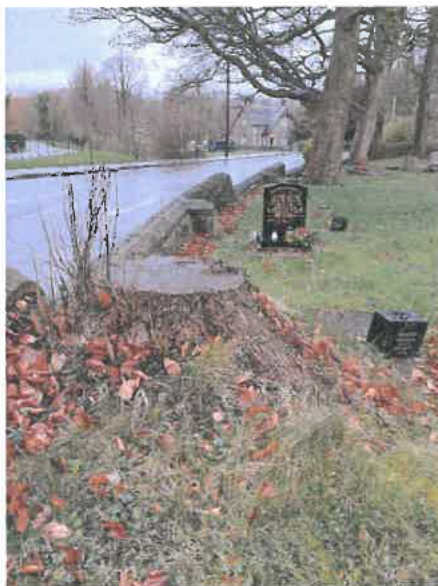
T69 – Ash tree removed as recommended

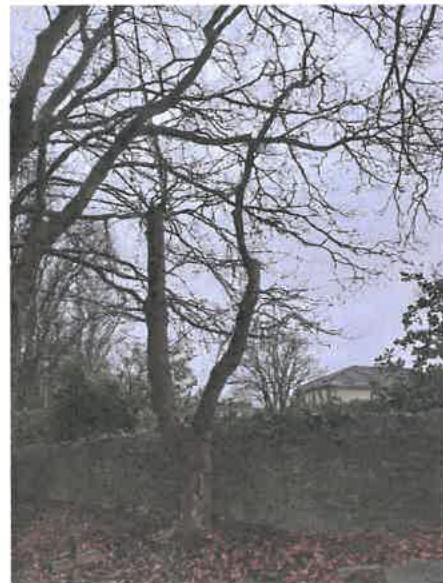
T83 – recommended for removal

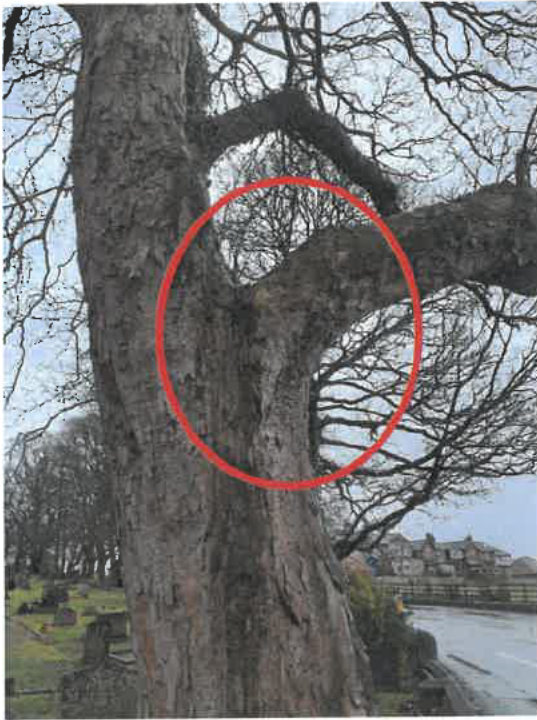
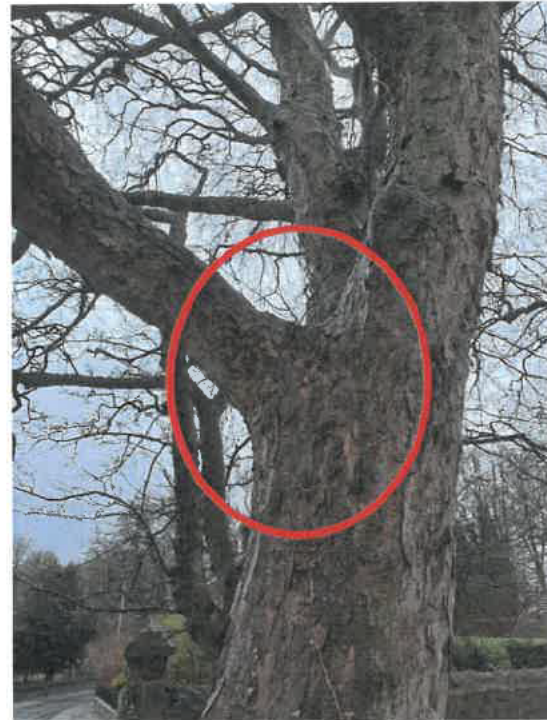
19.3. The client did have concerns over the branch union of the limb going over the road – see photos – this was found to be free from any significant visual defects and at the time of inspection no additional work is required on the tree.

T71 – clients concern over branch union – photos of both sides of the branch union

Tree	T071	Sycamore (Acer pseudoplatanus)	1	70	20	N6 E6 S6 W6	Mature	Good	Good	40+ Years	<ul style="list-style-type: none"> Restricted Rooting Volume. 	No significant visible fungal presences at the time of inspection.	No significant visible pests or disease present at the time of inspection.	Owned by the client. Roadside tree. Target # - Road Target # - Footpath - highway Target # - gravestones / statue	YES	No work required at time of inspection.	No Action	2 Years			
Tree	T072	Sycamore (Acer pseudoplatanus)	1	50	20	N6 E6 S6 W6	Mature	Good	Good	40+ Years	<ul style="list-style-type: none"> Restricted Rooting Volume. Suppressed canopy. Canopy unbalanced. Tree not in leaf (normal). 	No significant visible fungal presences at the time of inspection.	No significant visible pests or disease present at the time of inspection.	Owned by the client. Roadside tree. Target # - Road Target # - Footpath - highway Target # - gravestones / statue	YES	No work required at time of inspection.	No Action	2 Years
