# Preliminary Roost Assessment

79 Mitton Road  
Whalley  
Clitheroe  
BB7 9JN

For  
Thorpe Design

# Gritstone Ecology

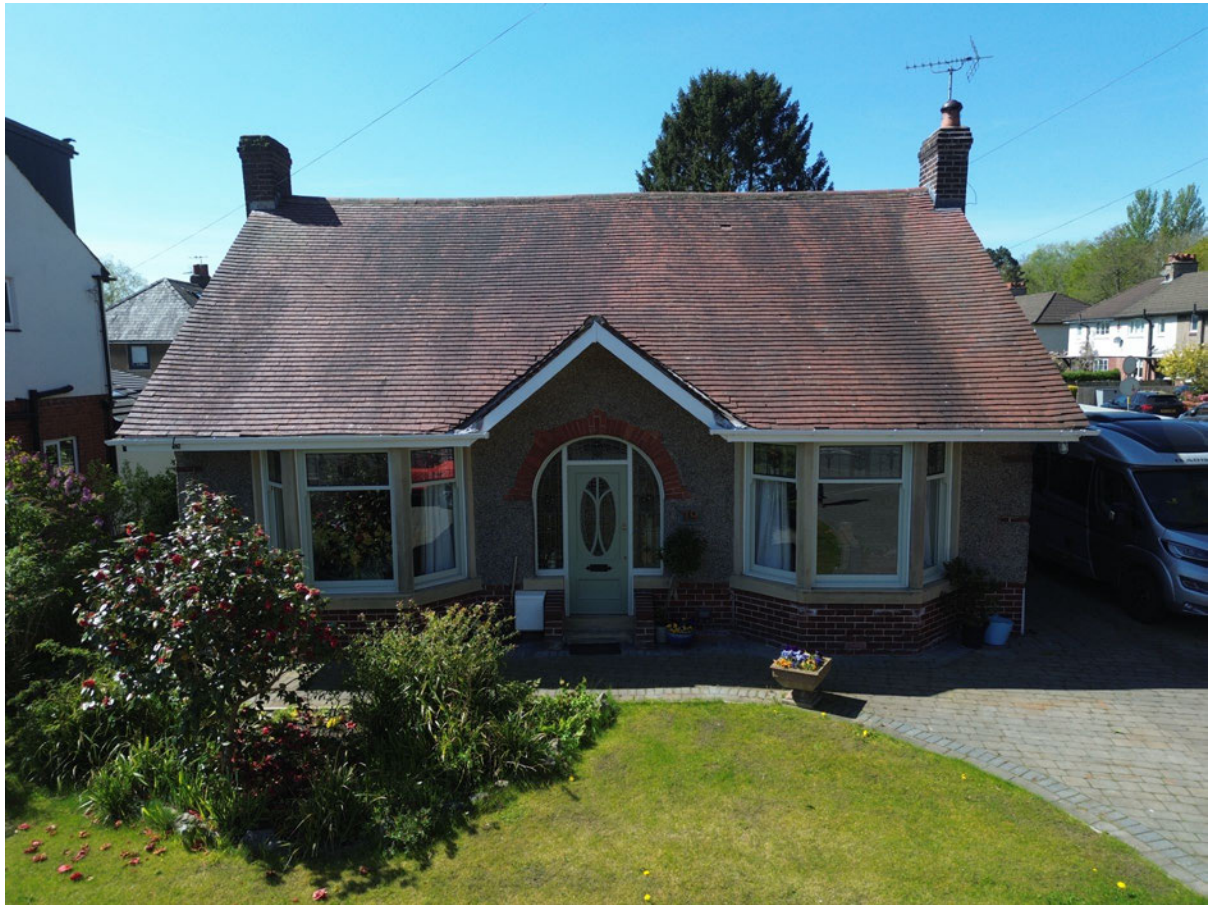
3.1a – The front of the house.

The building is well maintained, and in good condition. Ridge tiles are fixed tightly, there are no damaged or missing ridge tiles. There are no slipped, or missing roof tiles. Roof tiles are tightly fitted, with no gaps between tiles. End tiles at the verges are sealed with cement. Fascia boards and boxed soffits are fitted tightly against the walls with no viable gaps. Walls and render are in good condition, with no missing mortar or cracks.

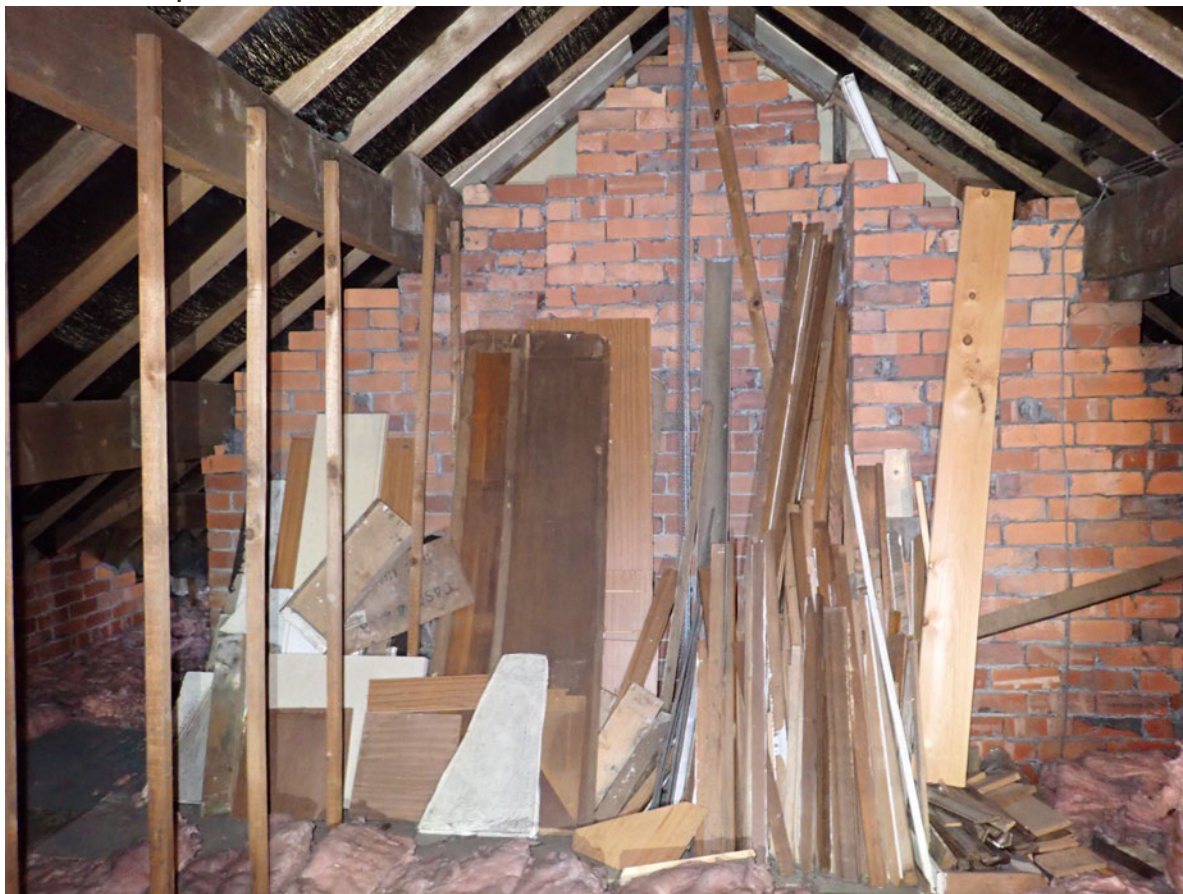
3.2a – The roof void.

The roof has a timber rafter and purlin structure, lined with bitumen felt, and insulated with mineral wool between the ceiling joists. The roof lining is in good condition with no tears, or gaps.

The wall cavity was inspected at the wall plate using a torch and endoscope, and has been filled with insulation. There are no gaps at the eaves or gables; and there are no gaps which give direct access to the roof void from the outside. Boxed soffits open into the roof void and were inspected from above.

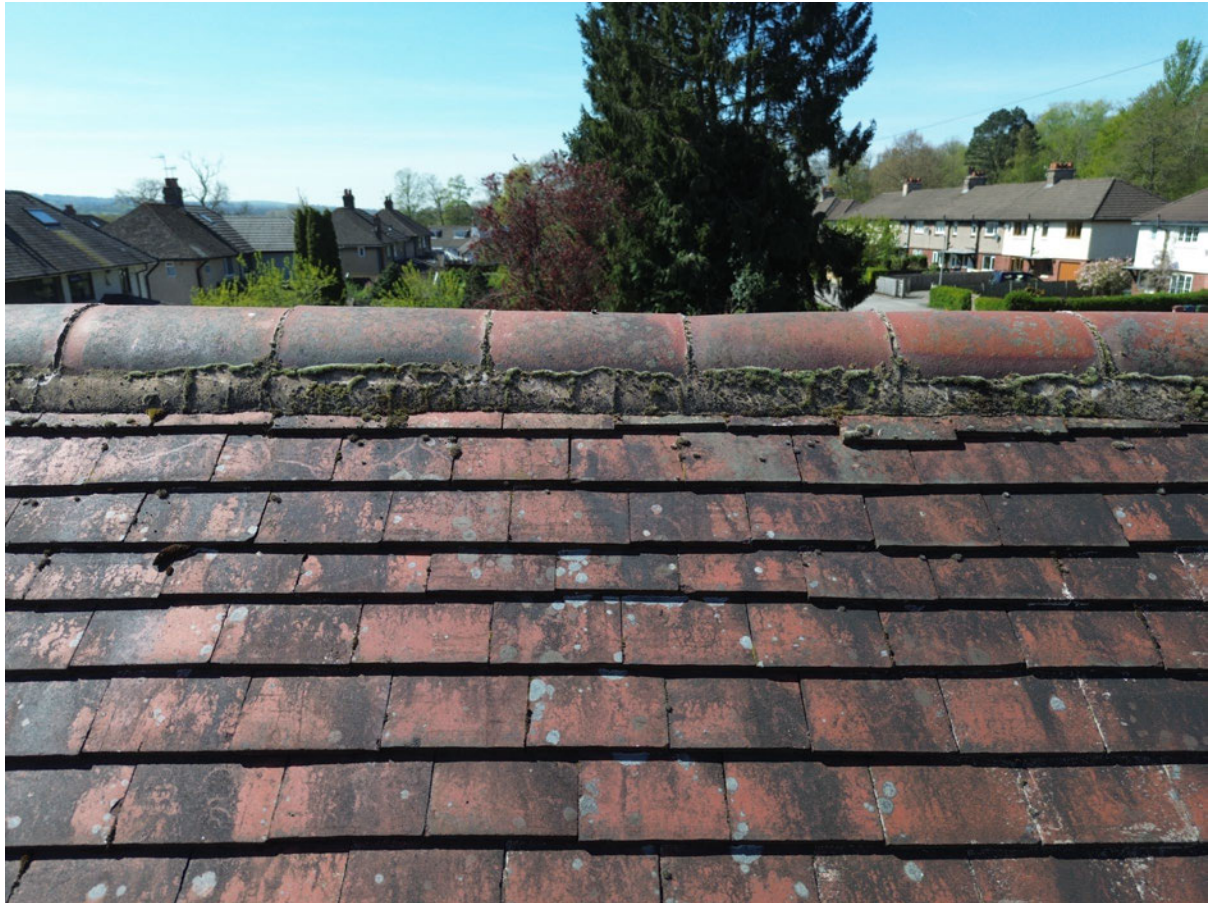
Roof and ridge tiles are in good condition; ridge tiles are sealed with cement; end tiles at the verges are sealed with cement. There are no gaps between roofing materials which could be used by roosting bats.

3 – Roof and ridge tiles are in good condition with no suitable gaps.

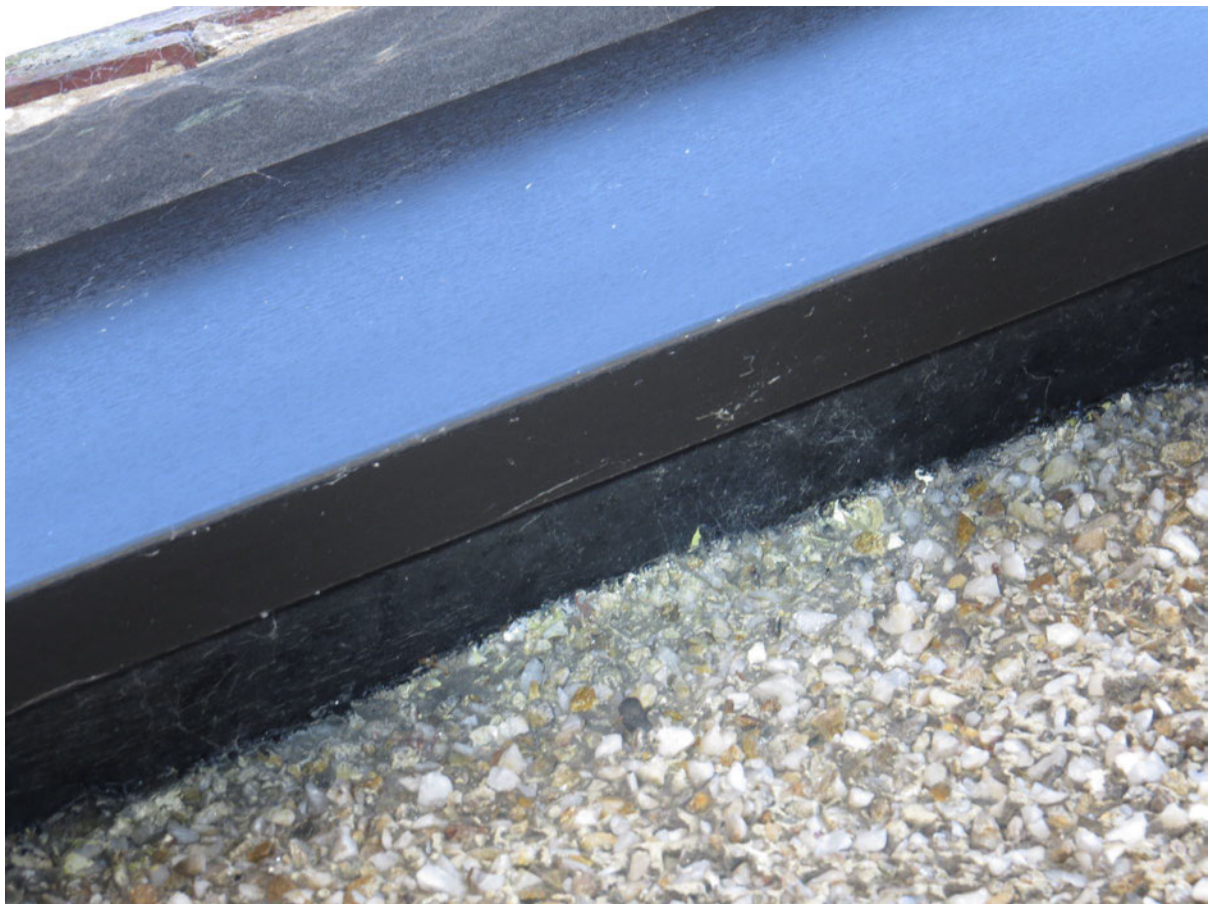
Fascia boards and boxed soffits at the eaves are fixed tightly against brickwork, with no suitable gaps; wall cavities and boxed soffits open into the roof void, and were inspected from above.

4 – Fascia boards and soffits at the eaves are fixed tightly against brickwork.

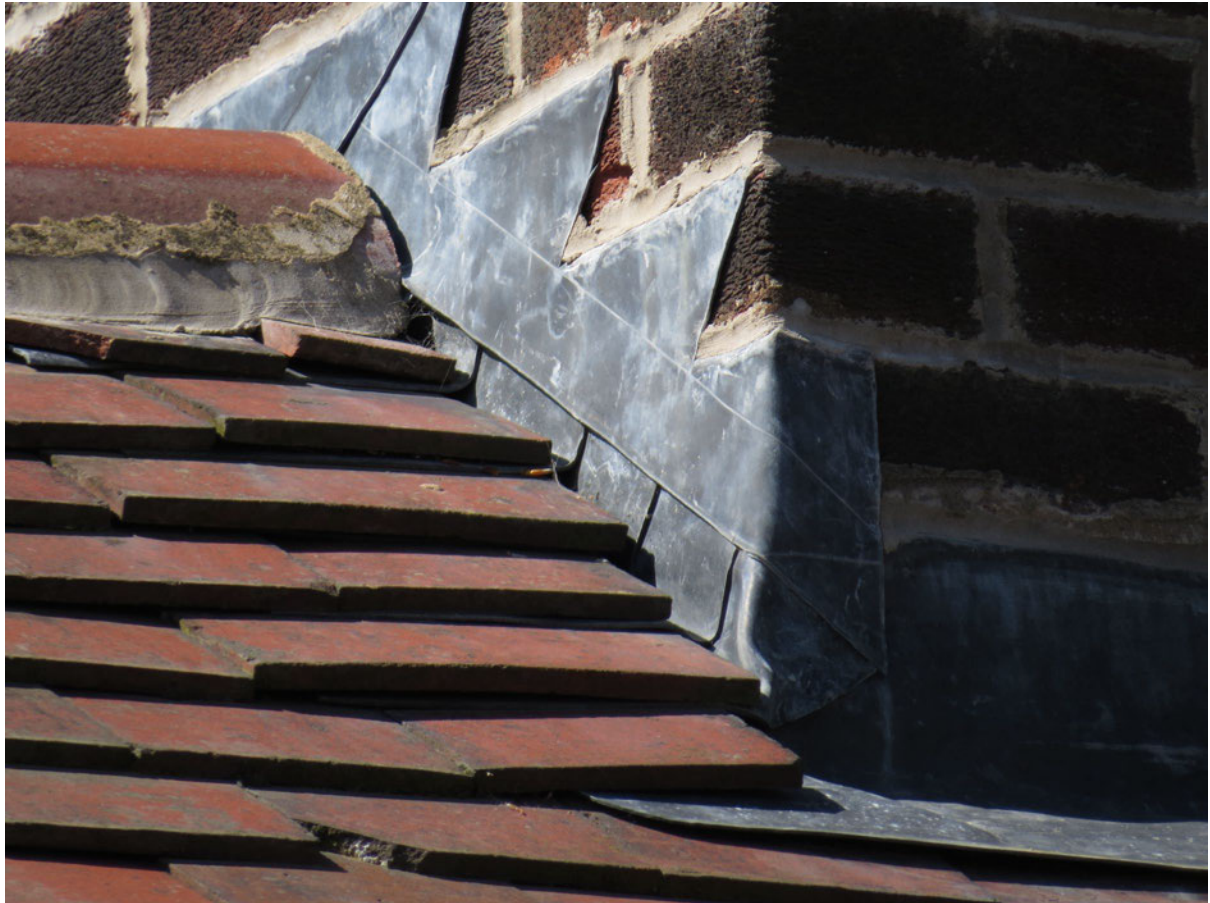
5 – Lead flashing is fitted tightly with no suitable gaps.

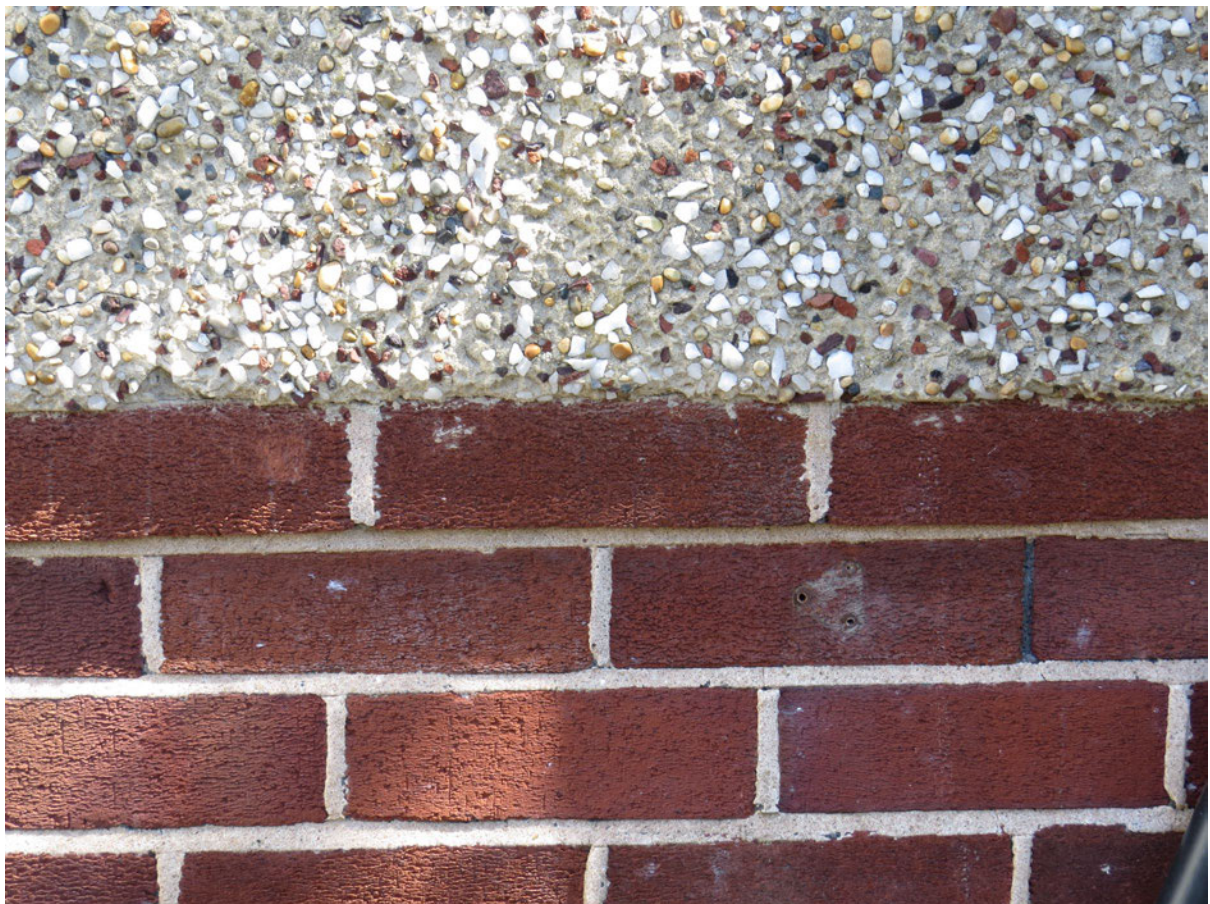
Walls are brick with an insulating cavity. Walls and render are in good condition, with no cracks, or missing mortar which could be used by crevice dwelling bats.

6 – Brickwork and render are in good condition with no suitable gaps.

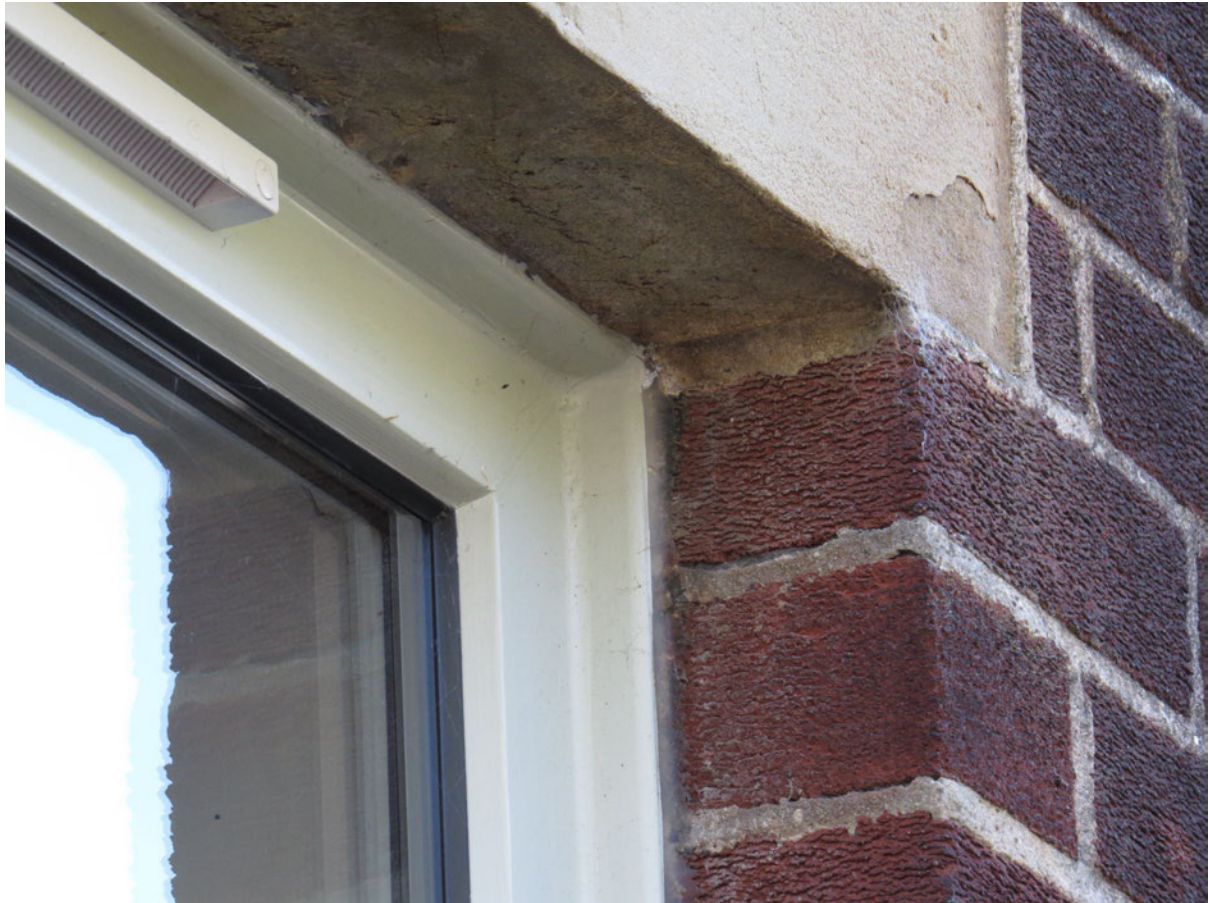
Window and door frames are fixed into the brickwork, gaps are filled with sealant, and offer no suitable roosting opportunities.

7 – Window and door frames are tightly sealed into brickwork with no suitable gaps.

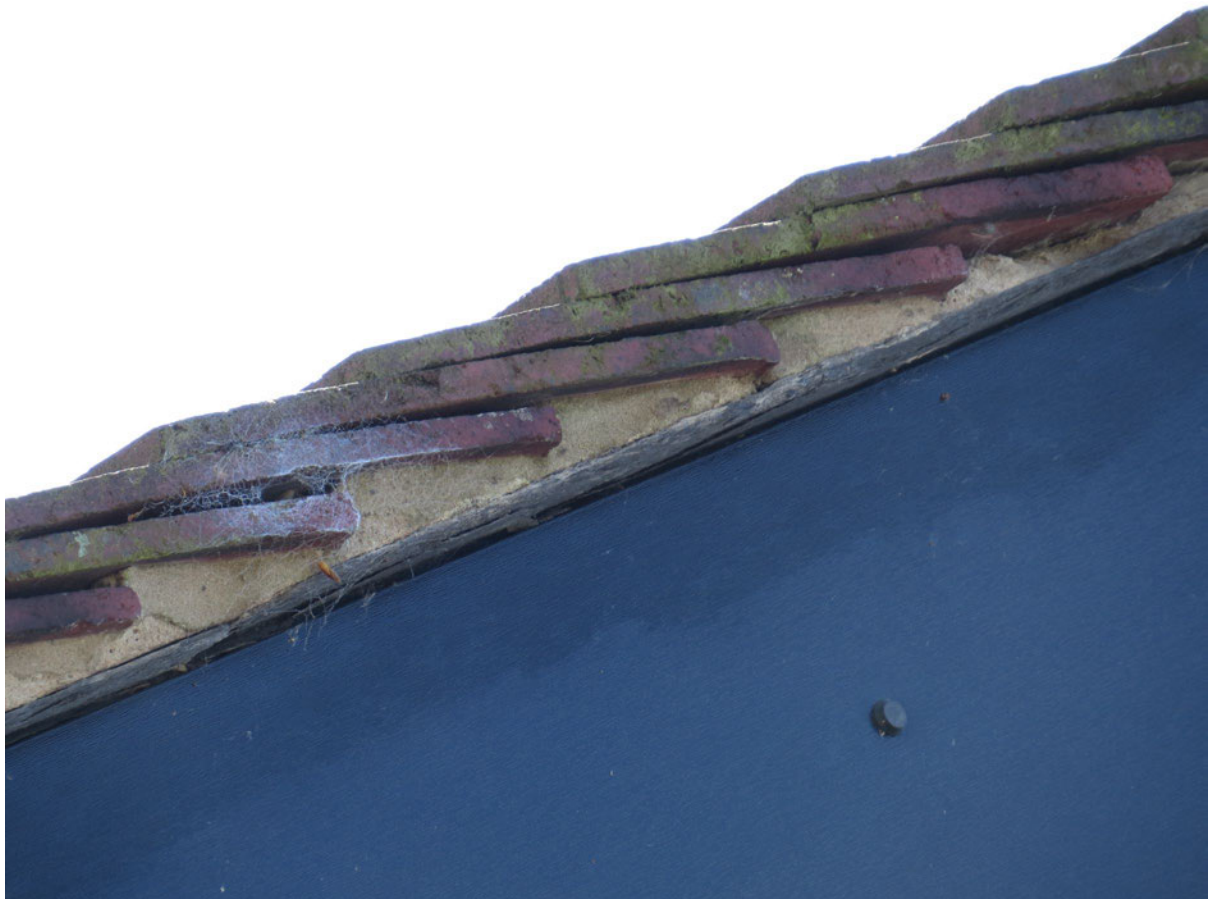
8 – End tiles at the verges are sealed with cement.

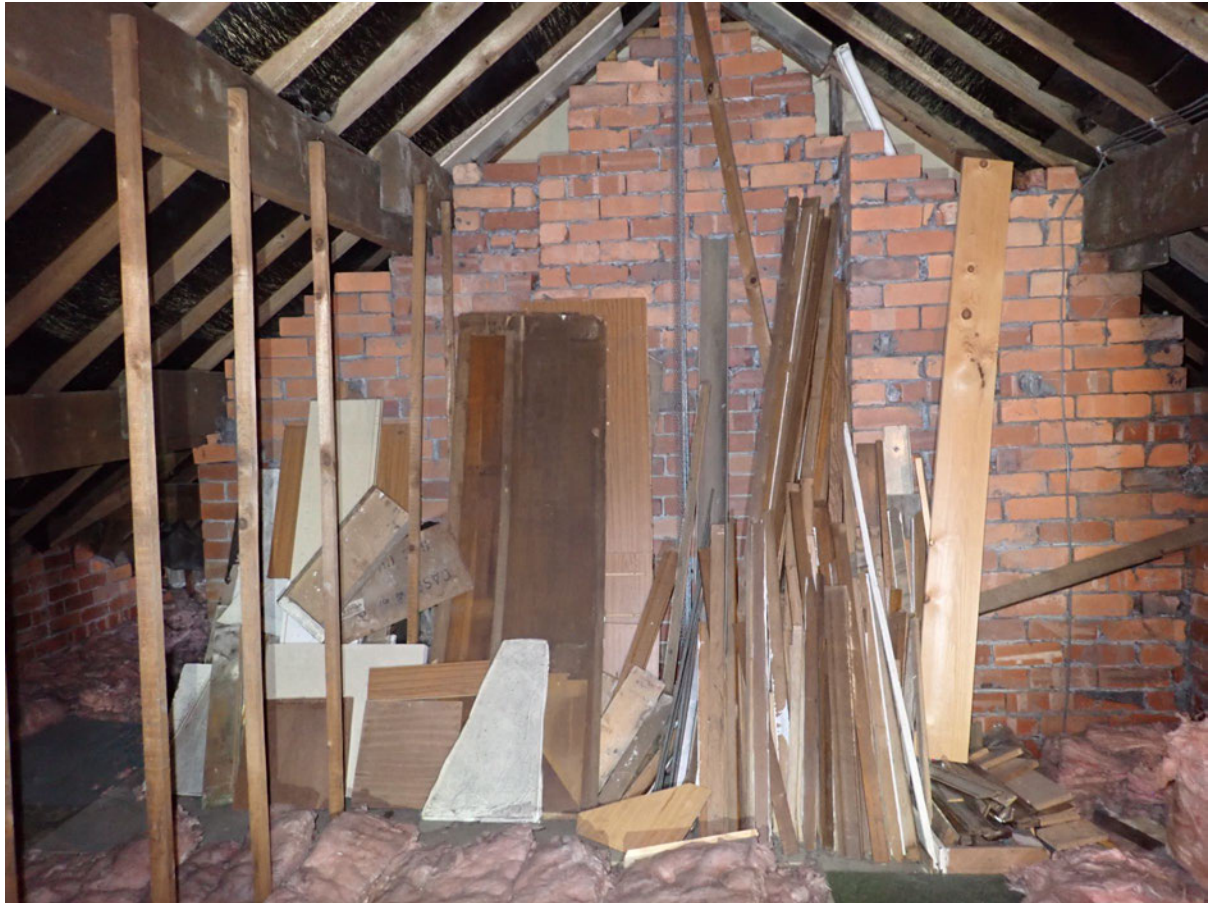
9 – The house has a single roof void.

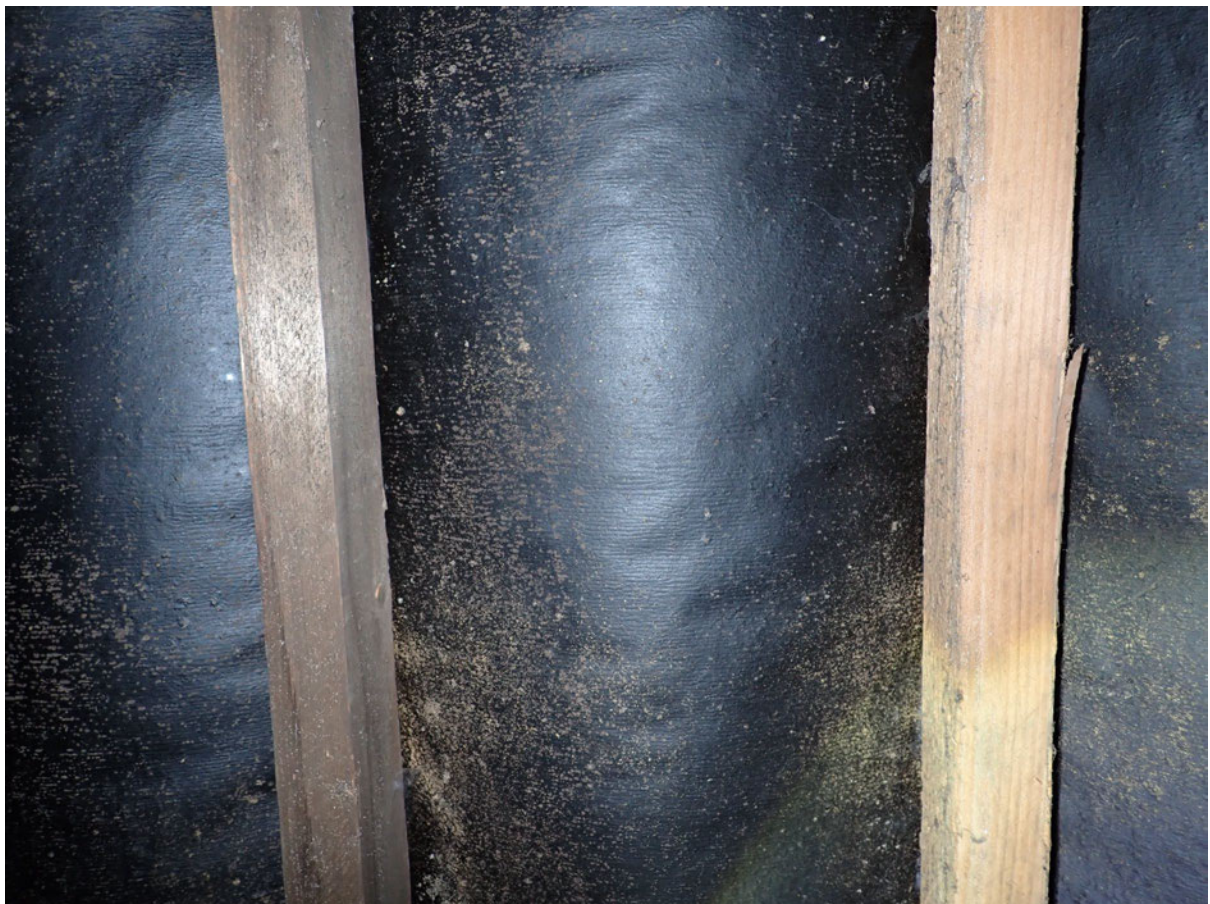
10 – Roof lining is in good condition with no gaps or tears.
