Tree Condition Report

4 + 6 Brooklands,
Chipping,
Preston,
PR32QU

25/03/2026

Job Ref: 2294

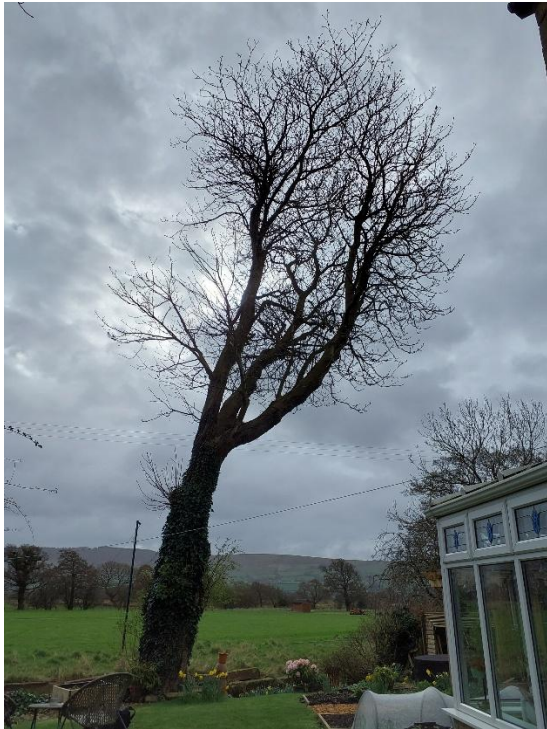
T1

19.3. Tree 1 has an unbalanced canopy it is recommended that a crown reduction of 3 m is undertaken to prevent end loading of canopy towards the summer house.

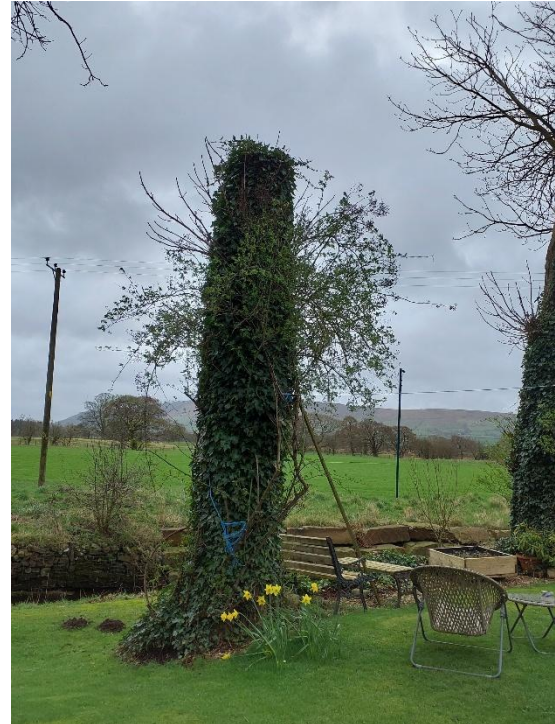
T2

- 19.4. Tree 2 has been reduced to a monolith prior to this survey, the stem is covered in ivy so any defects can't be seen, the resistograph showed adequate structural wood at 1m above ground. No work needed at the time of inspection.

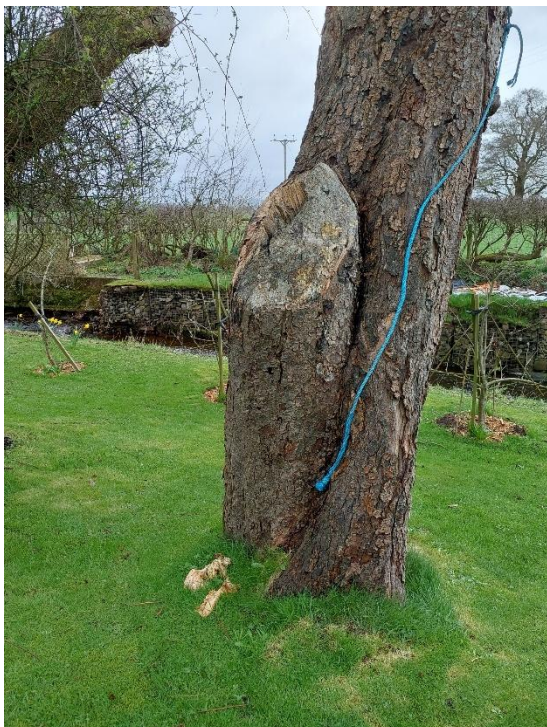
T3

- 19.5. Tree 3 has a previously removed stem to the west that has now decayed, at present this has not affected the main remaining stem. There is an unidentifiable fungal bracket evident at the base of the tree that is not identifiable due to degradation. The tree will need reassessing again within 12 months when in full leaf to fully assess the vigour and vitality of the tree. No work needed at the time of inspection.

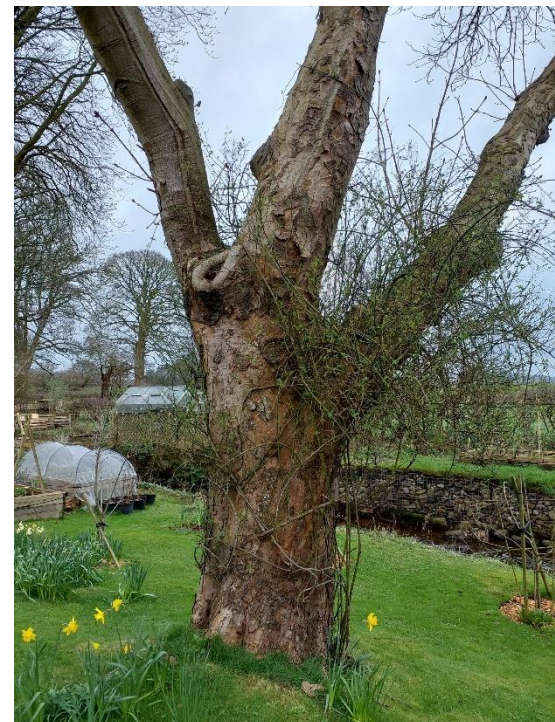
T4

- 19.6. Tree 4 has no significant defects found. Tree does have three codominant leaders but no significant risk of failure.
- 19.7. Tree 5 is located on the boundary line with the properties at number 4 and 6. Part of the main internal stem structure has branch decay that extends into the upper 5m of branch structure. The main branches do have helical twist growth with evidence of bacterial cancer, but the tree is coping with these associated stresses. At the time of inspection this tree can be managed by carrying out a canopy reduction of 3m all over to reduce and loading on the unions and stem, this will retain the aesthetics of the site in the short term. In the long term (10+ years), it is foreseen that this tree will need removing.

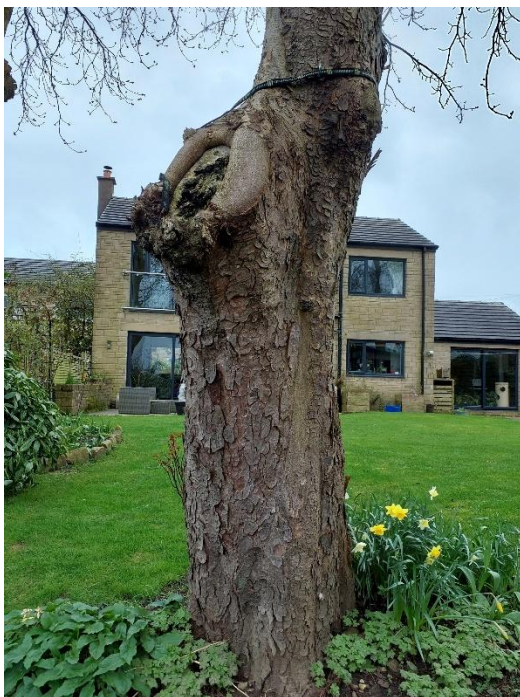
T6

- 19.8. Tree 6 has an open wound on the stem at 2m, but the wound is gradually occluding. There is no sign of significant spread of decay into the main stem from resistograph test and with hammer resonance test. There are no visible issues with the upper canopy.

Tree	T006	Horse chestnut (<i>Aesculus hippocastanum</i>)	1	60	16	N:6 E:6 S:6 W:6	Mature	Good	Good	20+ Years	<ul style="list-style-type: none"> _ Restricted rooting volume. _ Tree growing on edge of watercourse. _ Failed co-dominant stem. _ Minor deadwood <25 mm diameter. _ Suppressed canopy. _ Unbalanced canopy. _ Grown as part of a group of trees. _ Bud burst has started. 	No significant visible fungus present at the time of inspection.	No significant visible Pests or Disease present at the time of inspection.	Owned by the client. Target # - Garden Target # - Conservatory Target # - shed / greenhouse / outbuilding Target # - Dwelling	YES	_ No work required at time of inspection.	No Action	18 Months

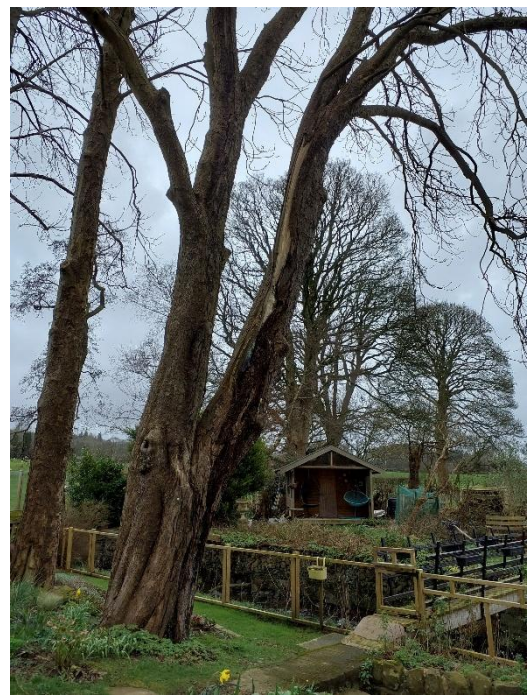
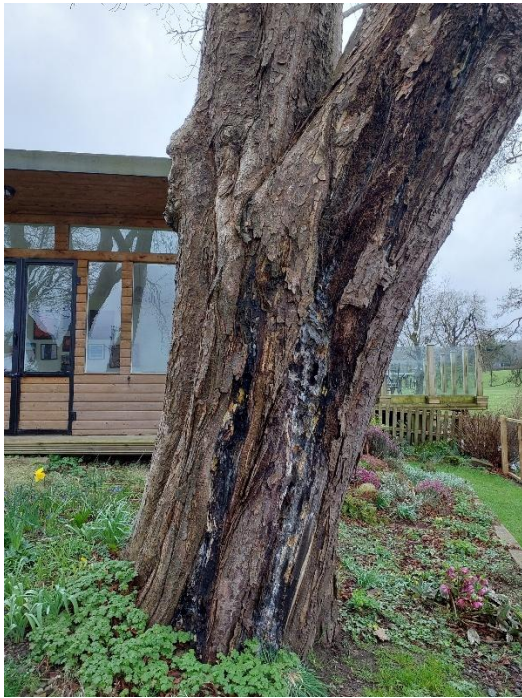
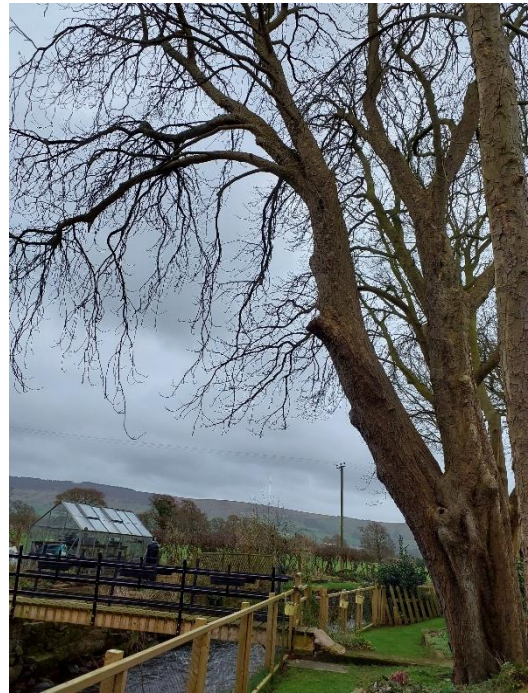
- 19.9. Tree 7 has significant decay within the main stem, and this then extends into the upper branch structure that spans towards the stream and the summer house on the other side of the stream, there is a high potential for failure due to the heavy end loading and weight imposed on the weakened branch union and stem. Whole tree removal is recommended due to internal decay at base of the tree and extending into the main limb.

- 19.12. Resistograph testing has been carried out on all 9 trees. At the time of testing on the in screen digital display only T7 showed significant internal disfunction that warranted removal. Due to an unknown technical issue with the device the transmission of the collected data to my PC was lost, so no printable graphs could be produced for this report.

Type	Ref.	Species	Number of stems	Stem diameter @ 1.5m (cm)	Height	Spread	Life Stage	Physiological Condition	Structural Condition	Life Expectancy	Survey Notes	Fungus	Pests and Diseases	Description	Is RISK 'ALARP' As Low As Reasonably Practicable	Recommendations	Timescale for recommended works	Re-inspect within	
Tree	T007	Horse chestnut (<i>Aesculus hippocastanum</i>)	1	60	18	N:6 E:6 S:6 W:6	Mature	Good	Decaying	<10 years	<ul style="list-style-type: none"> _ Restricted rooting volume. _ Tree growing on edge of watercourse. _ Detailed inspection undertaken - resitograph tests taken on the stem. _ Decay at base of tree. _ Stem has co-dominant fork. _ Multi stemmed leaders. _ Stem decay. _ Heavy branch loading. _ Included bark of main branches. _ Occluded pruning wounds on main branches. _ Bud burst has started. 	No significant visible fungus present at the time of inspection.	No significant visible Pests or Disease present at the time of inspection.	Owned by the client. Target # - Garden Target # - Conservatory Target # - shed / greenhouse / outbuilding Target # - Dwelling	YES	_ Remove to ground level.	16-Sep-2026 (6 Months)	18 Months

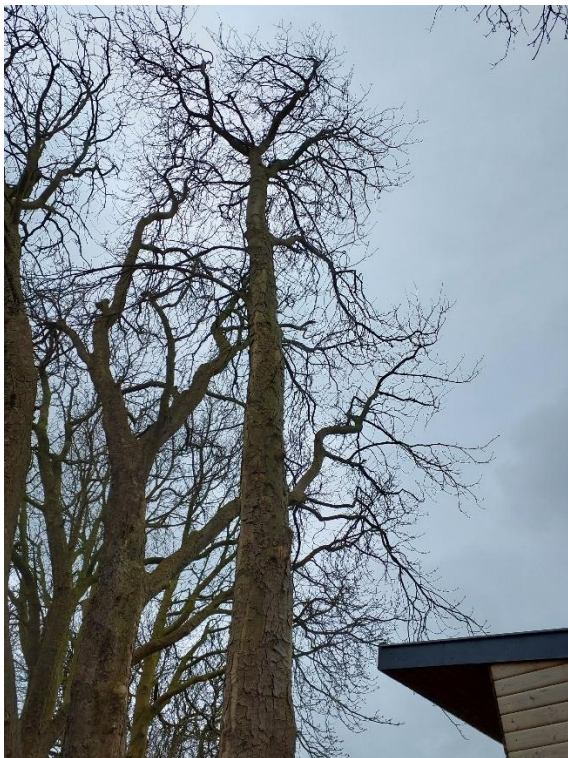
T8

- 19.10. Tree 8 is a tall slender grown tree with a high upper canopy. There is no significant defects on this tree and no work required at the time of inspection

Tree	T008	Horse chestnut (<i>Aesculus hippocastanum</i>)	1	40	18	N:4 E:4 S:4 W:4	Mature	Good	Good	20+ Years	<ul style="list-style-type: none"> _ Restricted rooting volume. _ Tree growing on edge of watercourse. _ The tree has no significant visual defects. _ Bud burst has started. 	No significant visible fungus present at the time of inspection.	No significant visible Pests or Disease present at the time of inspection.	Owned by the client. Target # - Garden Target # - Conservatory Target # - shed / greenhouse / outbuilding Target # - Dwelling	YES	_ No work required at time of inspection.	No Action	18 Months

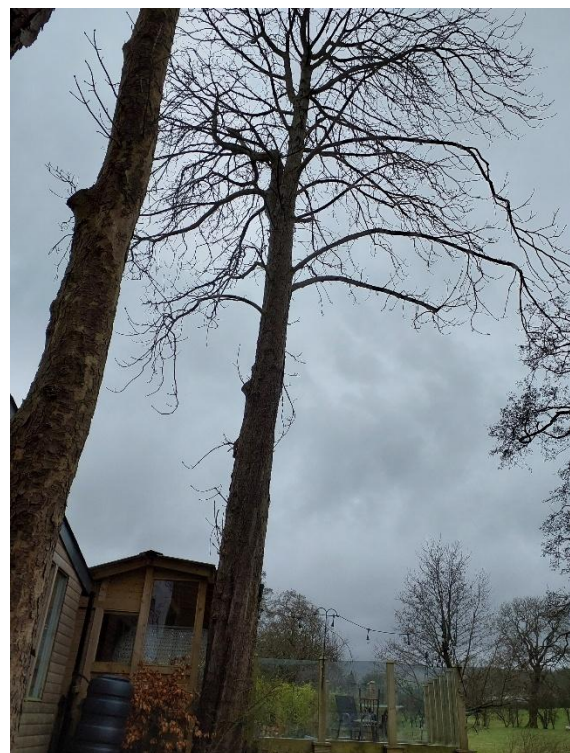
T9

- 19.11. Tree nine is located on the boundary line with the properties at number 6 and 8. No significant visual defects found with the tree and no work needed at the time of inspection.
