# **BUILDING (STRUCTURAL) CONDITION SURVEY**

PROPOSED CONVERSION OF EXISTING BARN AT

FOODEN HALL FARM

GISBURN ROAD

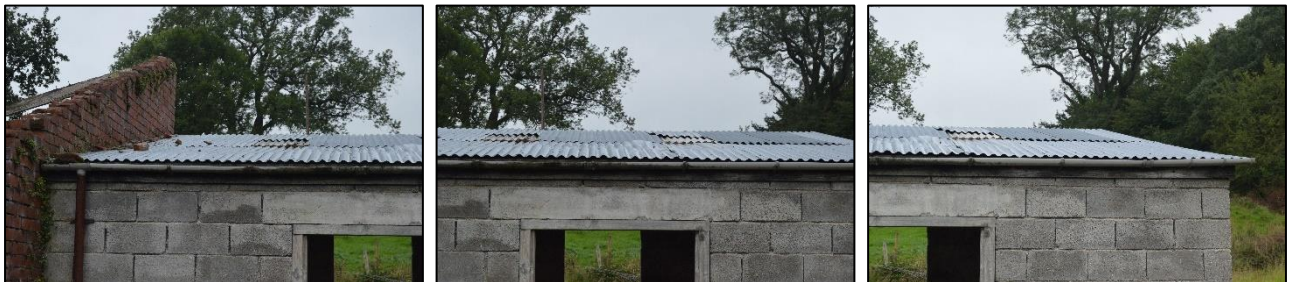
The roof covering to the north lean – to structure was in poor condition at the time of inspection. The sheets were generally deformed and not correctly installed resulting in large gaps between the sheets, when combined with the shallow pitch of the roof increase the risk of water ingress through wind driven rain. No leadwork / flashings are present to the abutment with the adjoining brickwork wall to the south further increasing the risk of water ingress.

PL05: View of the metal profiled sheet roof covering to the north lean-to structure.

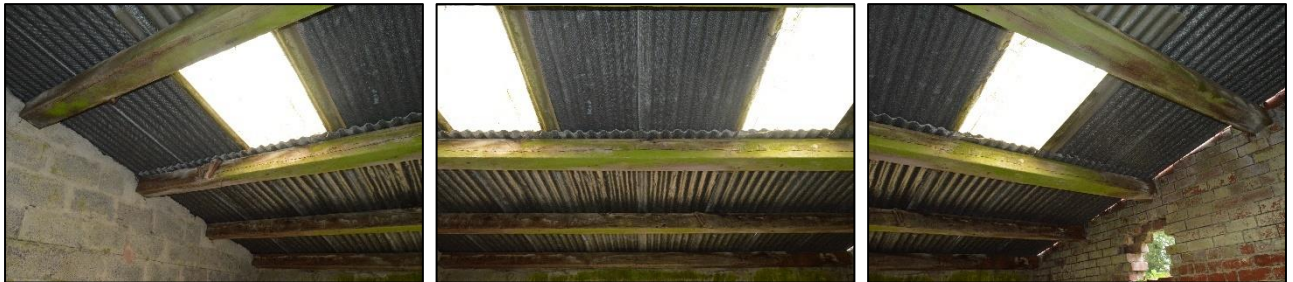
Dampness, staining and minor decay was noted to the internal roof structure of the north lean-to structure, likely resulting from water ingress, which is also suggested by the presence of algal growth to the roof timbers. No significant decay was noted to the roof timbers at the time of inspection; however, the condition of the roof timbers will likely worsen over time in the buildings current condition. Some minor shakes were noted to the roof timber but were not considered to be significant at the time of inspection.

*PL06: View of the timber roof structure to the roof of the north lean-to structure.*

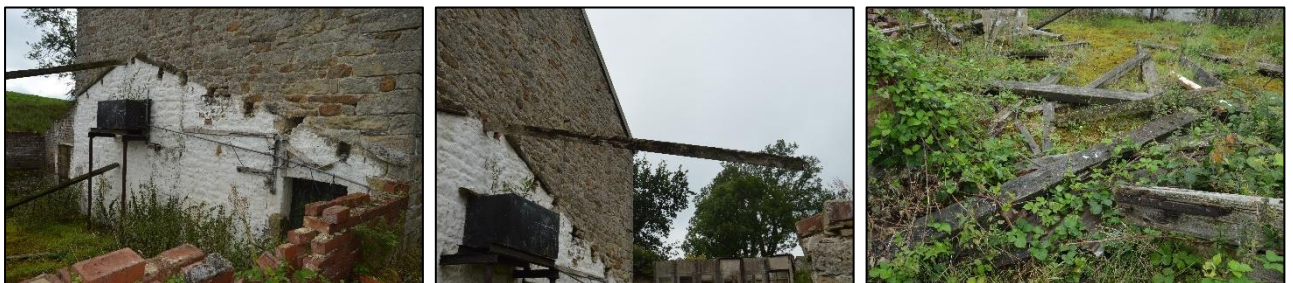
The roof structure to the brick built north addition has fully collapsed. An overhanging roof timber remained in-situ at the time of inspection and is unsafe and requires removal. The collapsed roof structure requires removal from site.

*PL07: View of the now dilapidated and collapsed roof structure to the brick-built north addition.*

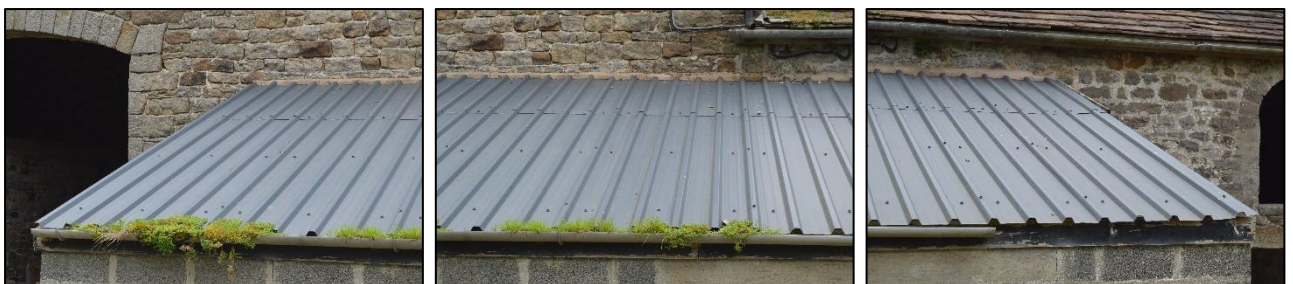
The metal sheet roof overing to the west lean-to structure appeared to be in good condition at the time of inspection, with no obvious specific issues of note. A cement fillet was noted to the roof / wall abutment and whilst this appeared to be sound at the time of inspection it will be subject to decay and periodic renewal will be required.

*PL08: View of the profiled sheet roof covering to the west lean-to structure.*

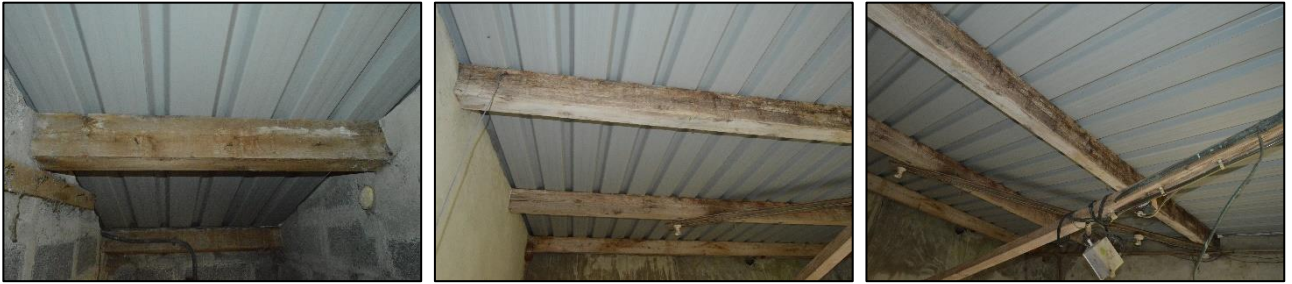
The roof structure to the west lean-to structure appeared to be sound at the time of inspection, however the exposed ends of the roof timbers were significantly decayed. Some minor staining was noted to the roof timbers but could be related to past water ingress. The roof did appear to be quite shallow which can increase the risk of water ingress through wind driven rain but the type of roof covering, with limited roof joints) will reduce this risk. Some minor shakes were also noted to the roof timbers but were again not considered to be significant at the time of inspection. Evidence of wood-boring insect attack was noted to the roof timbers at the time of inspection, i.e. insect flight holes, however it could not be confirmed if any active infestation was present at the time of inspection and further investigations are recommended to confirm this.

PL09: View of the timber roof structure to the west lean-to structure.

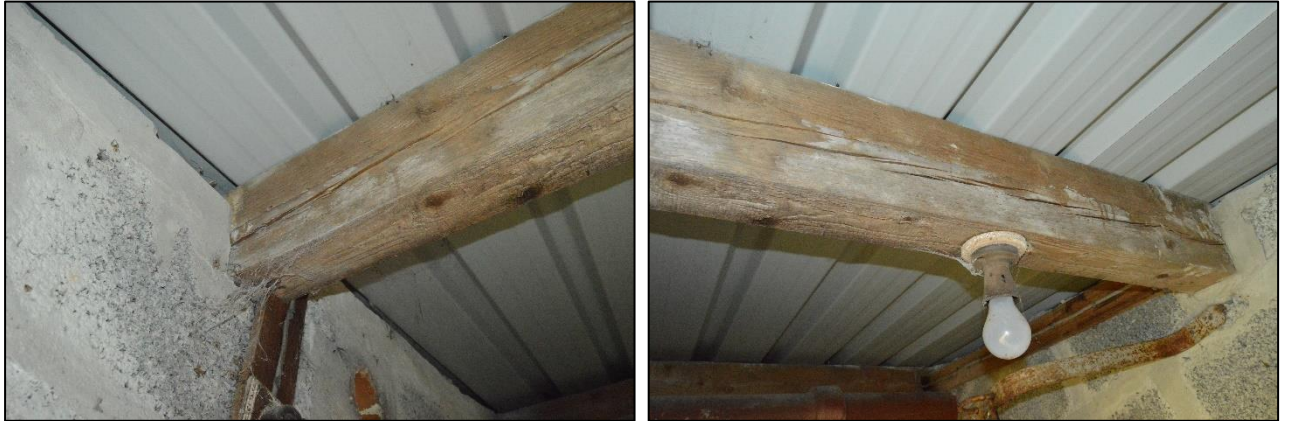
PL10: View of minor shakes noted to the timber roof structure to the north side of the west lean-to structure.

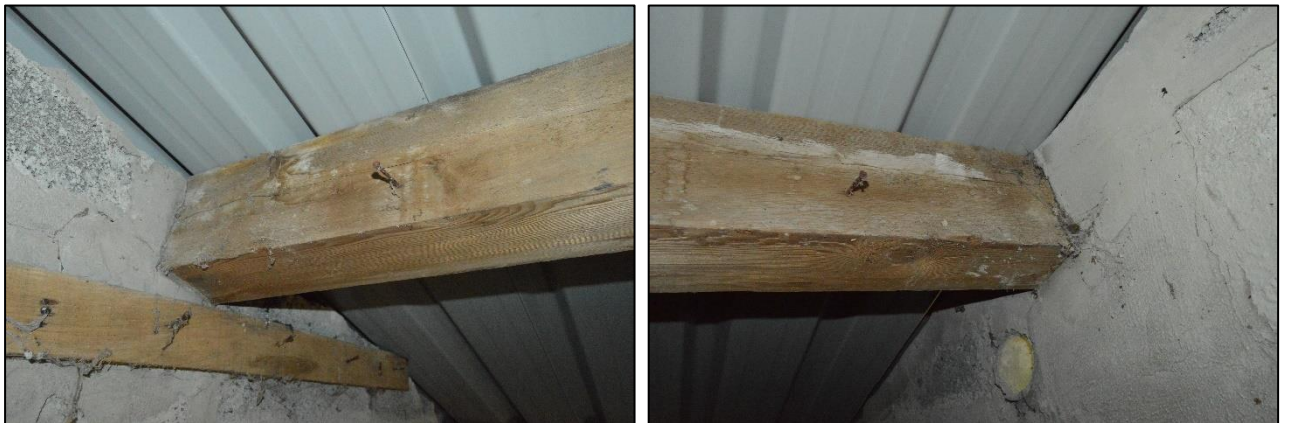
PL11: View of minor staining noted to the timber roof structure to the north side of the west lean-to structure.

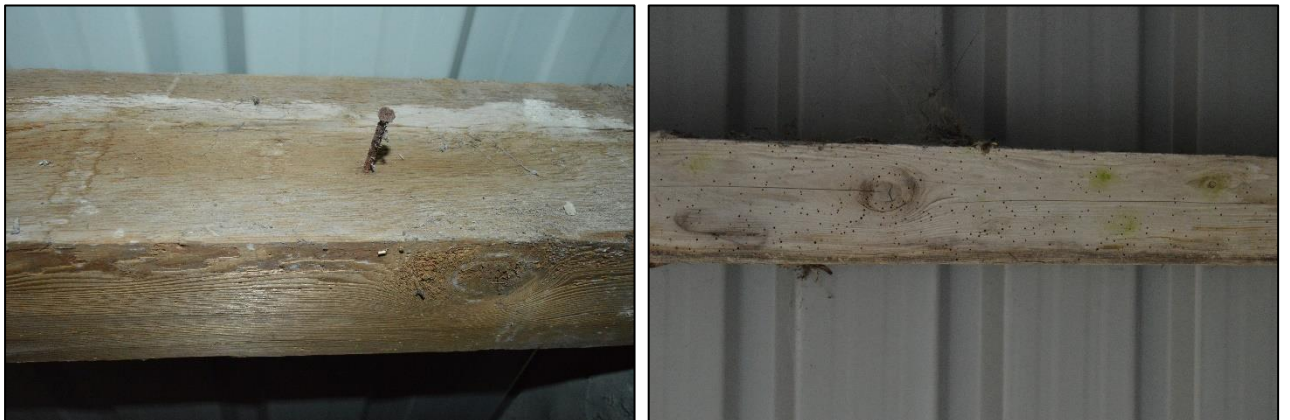
PL12: View of evidence of wood-boring insect attack i.e. insect flight holes, noted to the timber roof structure of the west lean-to structure.

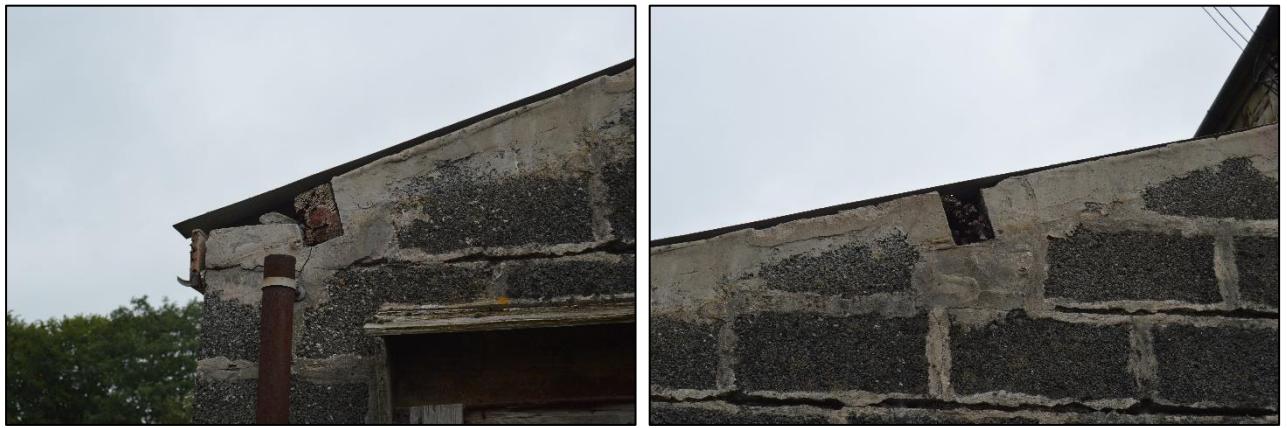
PL13: View of exposed and decayed purlin ends to the west lean-to structure.

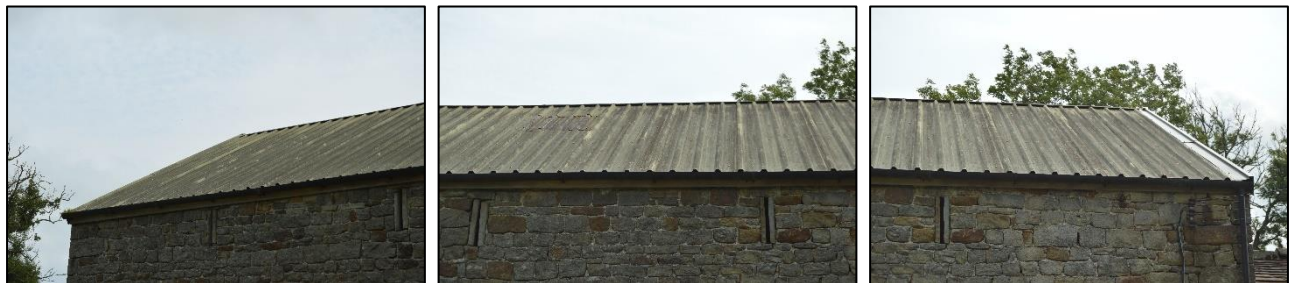
The sheet roof covering to the roof of the main core of the barn appeared to be in good condition at the time of inspection albeit with a slightly aged and weathered appearance but with no obvious significant issues of noted identified at the time of inspection. No significant undulations were noted to the roof at the time of inspection as well as any evidence of potential roof spread. All ridge and verge cappings were present at the time of inspection.

PL14: View of the profiled metal sheet roof covering to the west roof slope of the main core of the barn.

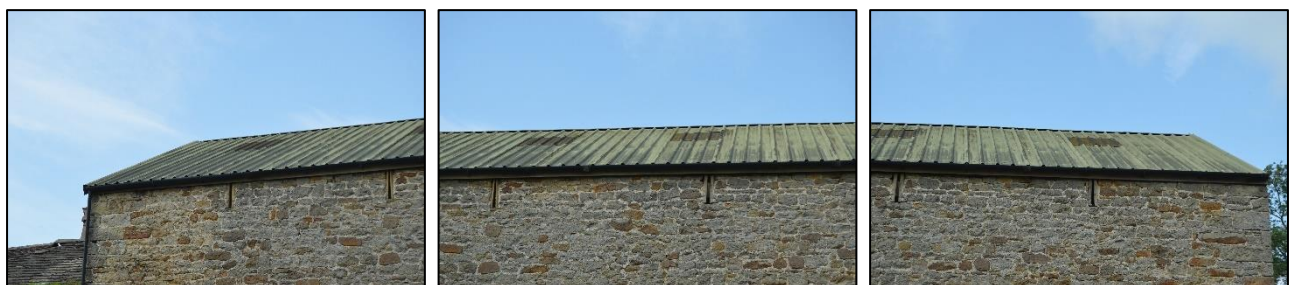
PL15: View of the profiled metal sheet roof covering to the east roof slope of the main core of the barn.

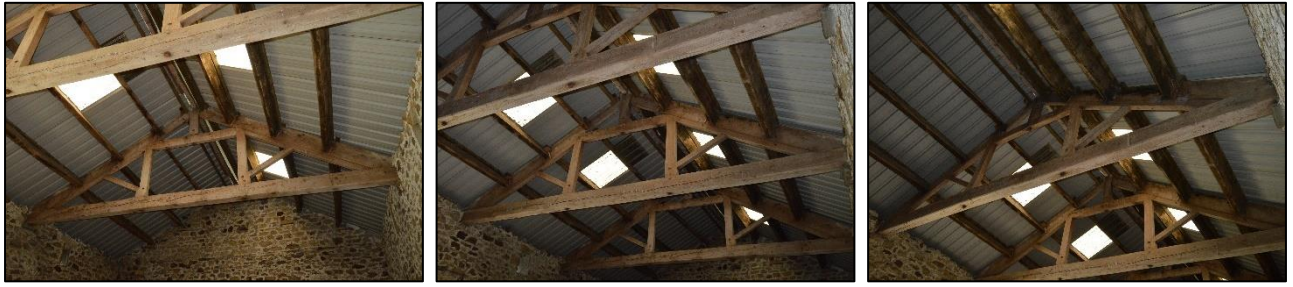
The roof structure to the main core of the barn appeared to be in fair condition at the time of inspection and free from obvious significant decay and defects. The trusses and purlins were built into the existing external walls and is considered to be traditional practice. However, where there is localised moisture penetration / water ingress, this can leave the timbers susceptible to decay. However, there was no significant decay noted to the ends of the trusses or purlins (where built into walls) at the time of inspection, with only staining noted to the roof timbers. This is likely to have been caused by past water ingress. The purlins to the roof appeared to have a slight curvature which has likely occurred due to 'creep' over a long period of time as opposed to a more recent significant structural issue / defect. However, a closer assessment of the roof timbers is recommended to the exact condition of the timber roof structure. It was also noted that additional timbers have been installed to the top of the timber purlins. The exact purpose of this could not be confirmed at the time of inspection. It may be that they were installed to facilitate the installed of the sheet roof covering as opposed to any sort of strengthening works, however further investigations are recommended to confirm this.

PLI 6: View of the timber queen post roof trusses and associated roof structure to the main core of the barn.

A closer inspection of the roof structure is recommended on erection of a safe working platform to confirm the exact condition of the roof structure and its suitability for retention. This should also provide an opportunity to asses for the extent of any decay present not visible from ground level and any evidence of wood-boring insect attack to the roof

timbers. It is also recommended that all elements of the existing timber roof structures which are to be retained are treated with a suitable preservative to ensure their longevity.

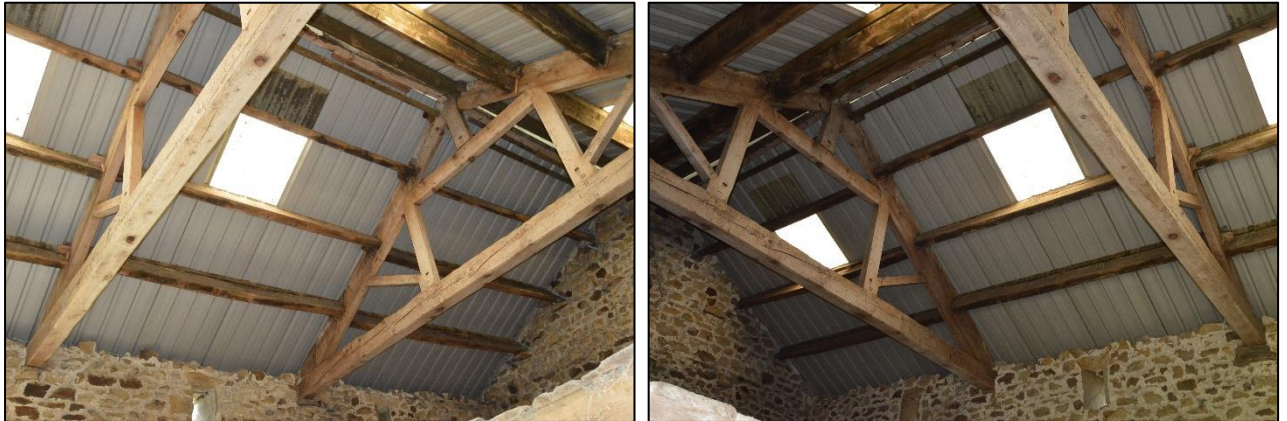
PLI 7: View of timber purlins to the roof of the main core of the barn. It was noted that additional timbers have been installed to the top of the timber purlins to the roof of the main core of the barn. The exact purpose of this could not be confirmed at the time of inspection. It may be that they were installed to facilitate the installation of the sheet roof covering as opposed to any sort of strengthening works, however further investigations are recommended to confirm this.

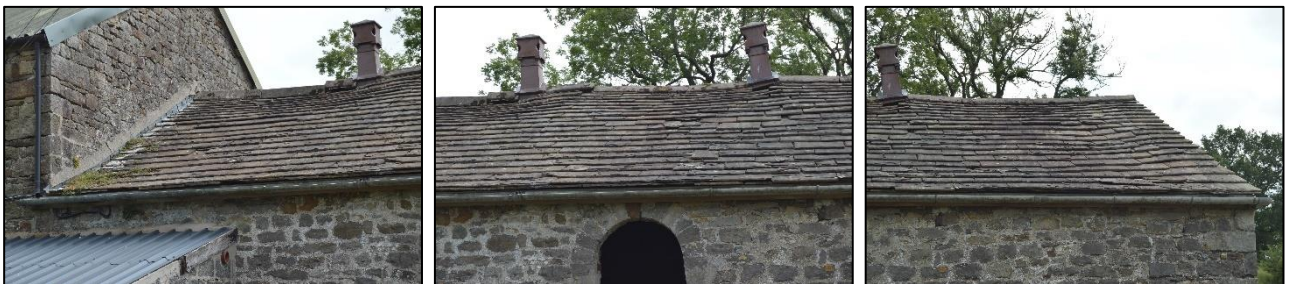
The roof to the south addition was in poor condition at the time of inspection. The roof covering had numerous broken, dislodged and missing slates. Obvious undulations were noted to the roof slopes and ridge at the time of inspection, in between the locations of the stonewalling and roof trusses, however no evidence of roof spread was noted at the time of inspection. All ridge tiles were present but breaches were noted. On inspection of the roof structure appeared to be in fair to poor condition. Issues of decay were noted to the ridge beam and crude repairs appear to have been undertaken. Some slight curvature / deflection noted to the timber purlins, likely as a result of 'creep' over time as opposed to over a long period of time as opposed to a more recent significant structural issue / defect. Again, the trusses and purlins were built into the existing external walls and is considered to be traditional

PL19: View of the stone flag roof covering to the west roof slope of the south addition.

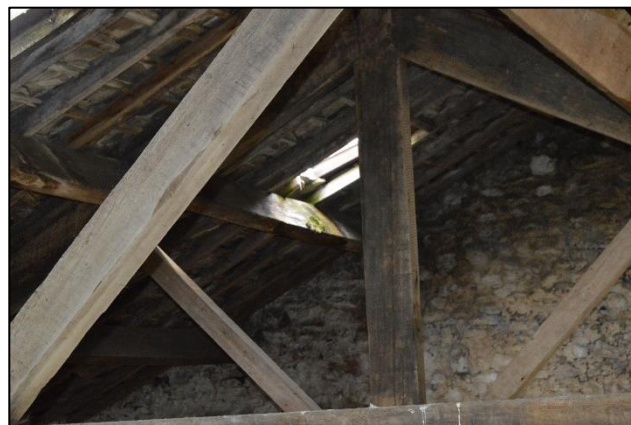
Decay was noted to the timber purlins directly below the roof lights to the east roof slope of the south addition, with associated staining and algal growth suggesting water ingress at the roof light locations. A number of the timber battens to the roof were broken.

PL22: Staining noted to the timber purlins located beneath the roof lights to the east roof slope of the south addition, suggesting potential water ingress at these locations. This has led to some decay of the timbers below the roof light locations and it is recommended that these areas are closely inspected on erection of a safe working platform to confirm condition and full extent of decay.

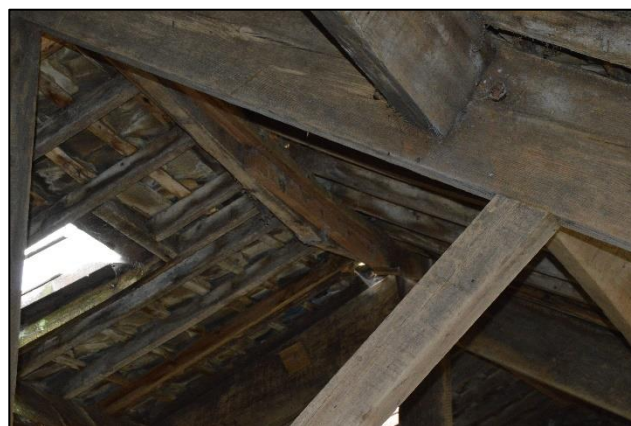
PL23: View of decay and repairs undertaken the ridge beam of the roof to the south addition. It is recommended that these areas are closely inspected on erection of a safe working platform to confirm condition.

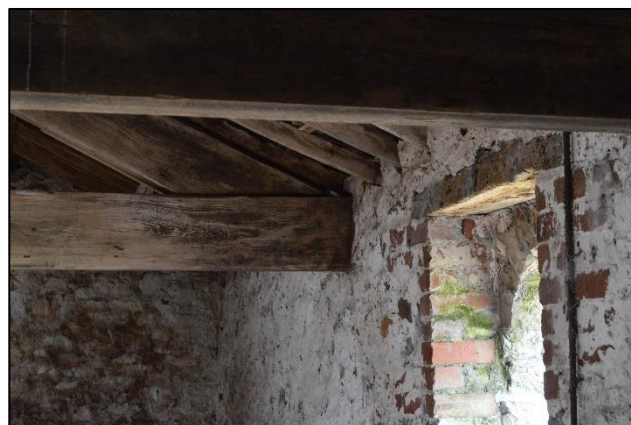
PL24: View of staining noted to the roof timbers of the south addition where the timbers are built into the stone wall fabric.

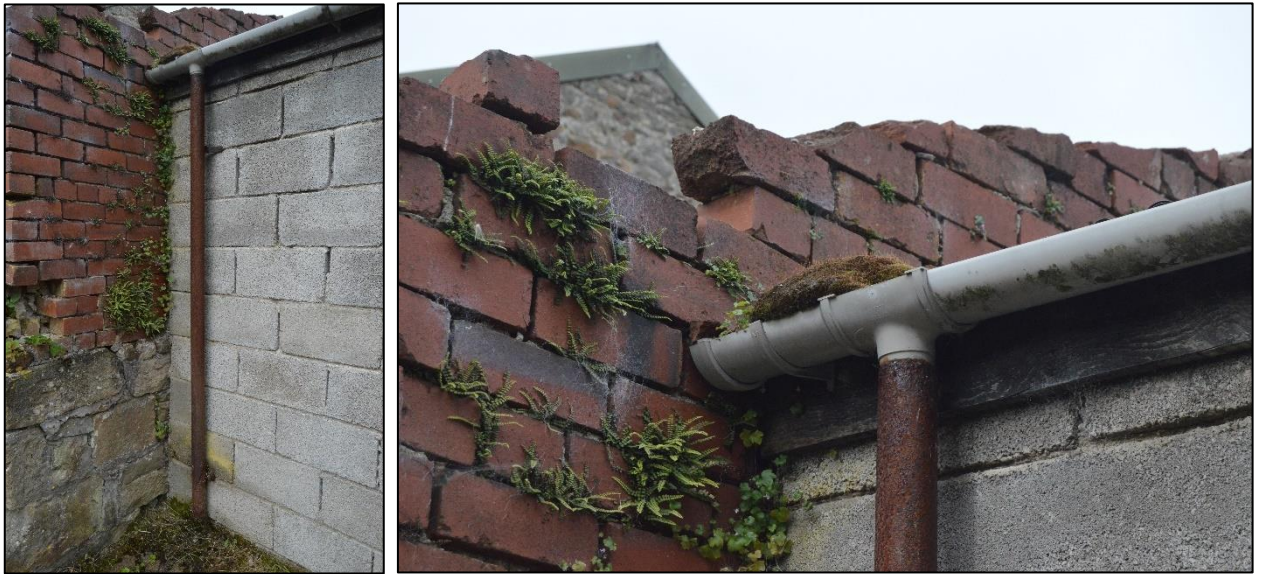
The rainwater goods to the barn were generally in poor condition at the time of inspection. Due to the lack of persistent rain at the time of inspection, it was not possible to confirm the presence of leaks. However, the presence of wall staining and plant growth to the walls, in particular to the east side of the south addition would suggest that leaks are present. Significant moss and plant growth was noted throughout the rainwater goods and are likely causing blockages to the gutters, likely leading to the uncontrolled discharge of surface water from the guttering during periods of rainfall. Missing elements of the rainwater goods were also noted throughout the barn also leading to the uncontrolled discharge of surface water from the barn. Metal elements of rainwater goods were noted as rusted at the time of inspection and replacement is recommended. Full overhaul / replacement of the rainwater goods is recommended. Replacement rainwater goods should be in metal and of a suitable heritage style consistent with the historic nature and context of the barn.

PL26: View of the existing rusted downspout to the east side of the north lean-to structure. Moss / plant growth was noted to the gutter outlet.

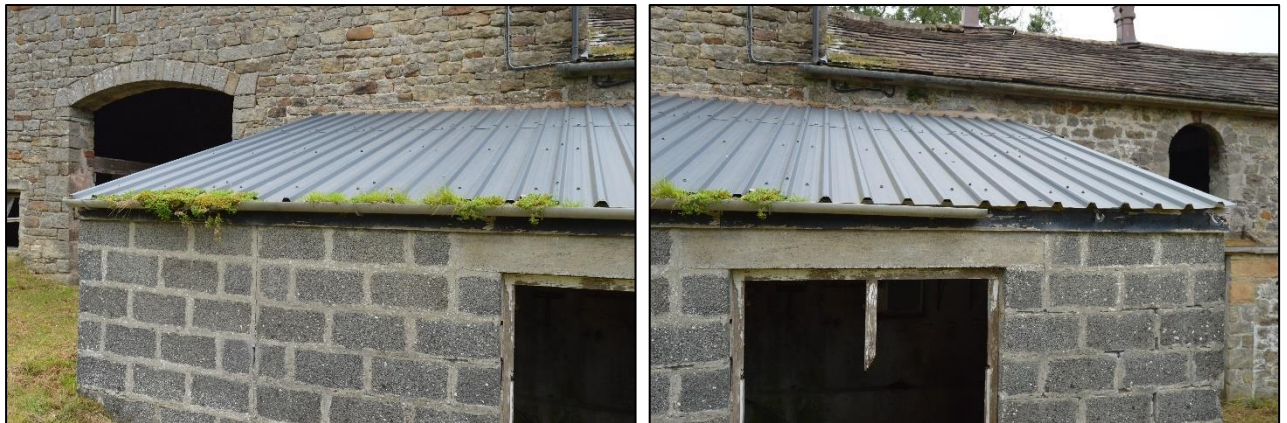
PL27: View of the plant growth to the gutter to the west lean-to structure as well as a missing section of guttering.

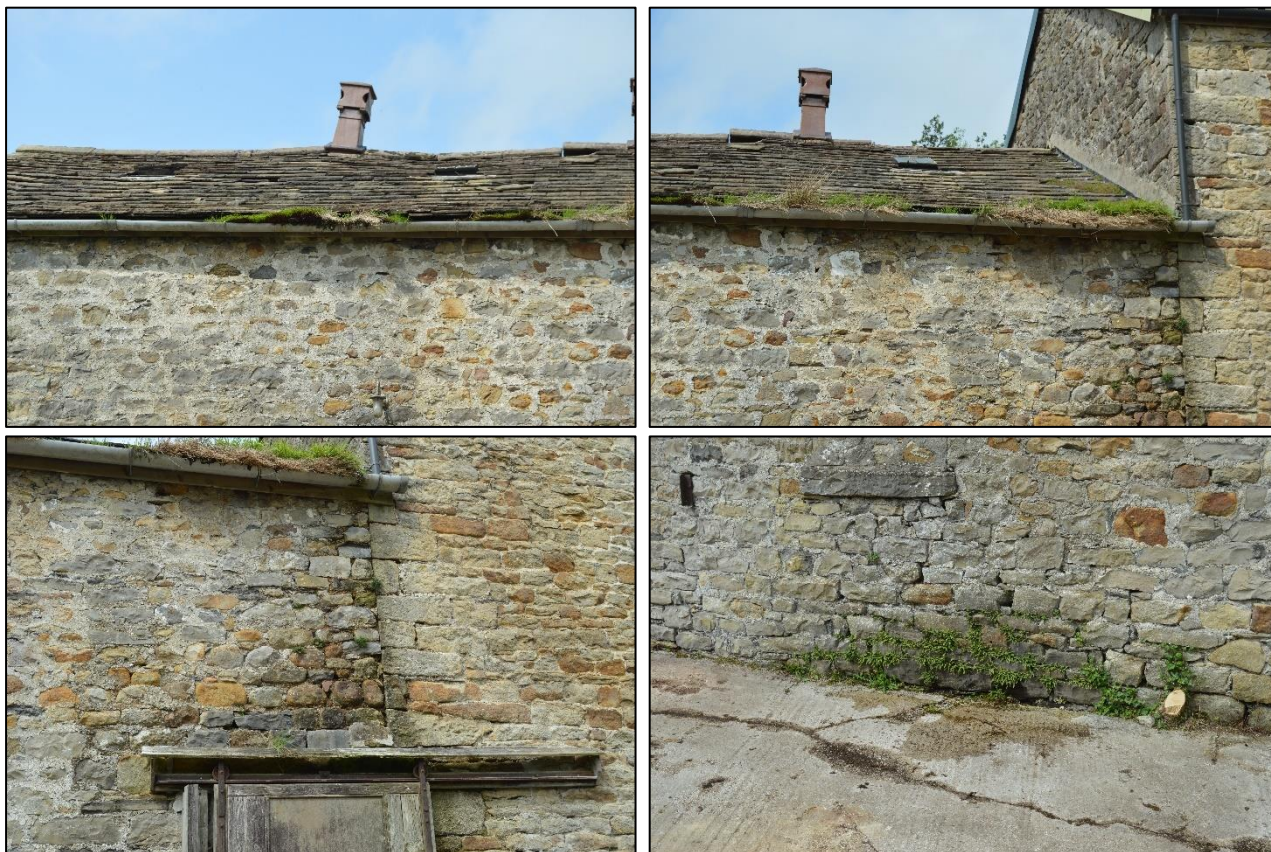
PL29: View of the significant plant growth to the guttering on the east side of the south addition. Wall staining and plant growth suggests the presence of leaks to the guttering as well as overflowing during periods of rainfall.

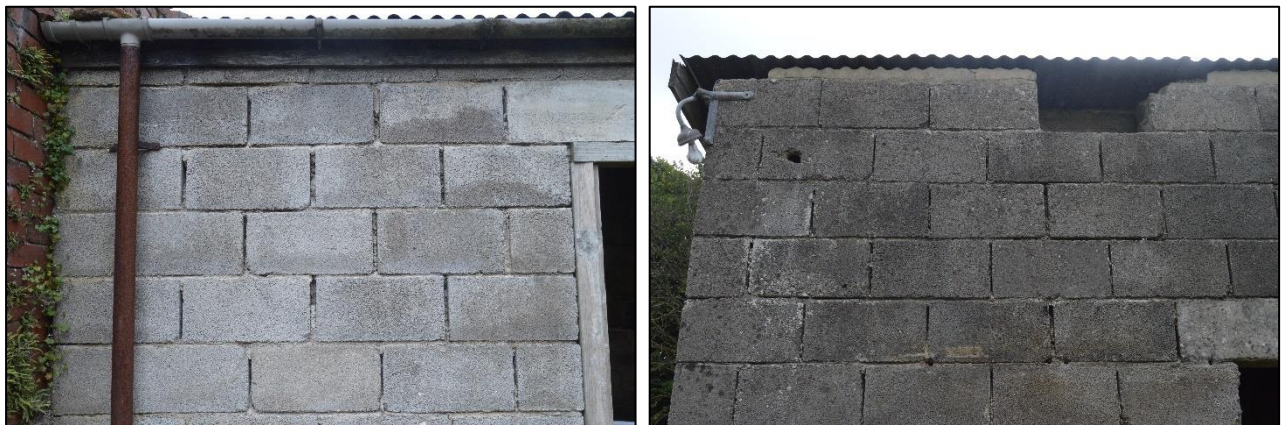
The external walls to the north lean-to addition are built from concrete blockwork, with the south wall being built using red brick. The walls were found to be sound with a true vertical alignment and with no obvious significant evidence of recent structural movement / settlement, or structural cracking to the external walls. The pointing to the external walls was largely degraded. A hole was noted in the brickwork to the south wall, with possible missing blockwork noted at high level to the west wall.

PL31: View of the degraded / missing pointing noted throughout the external walls of the north lean-to structure.

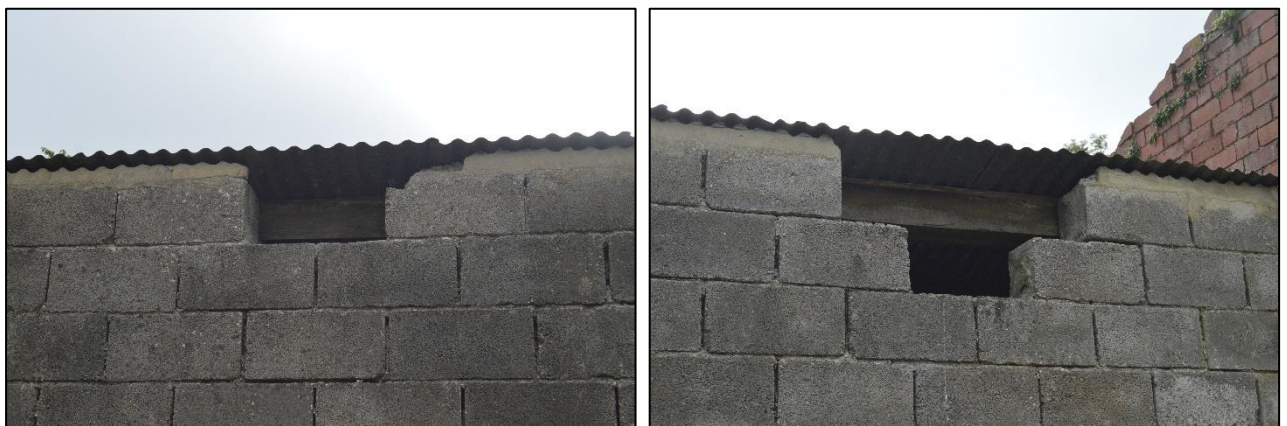
PL32: Missing blockwork noted to the west side of th north lean-to structure. It could not be confirmed if this is intentional but the exact purpose was not known at the time of inspection.

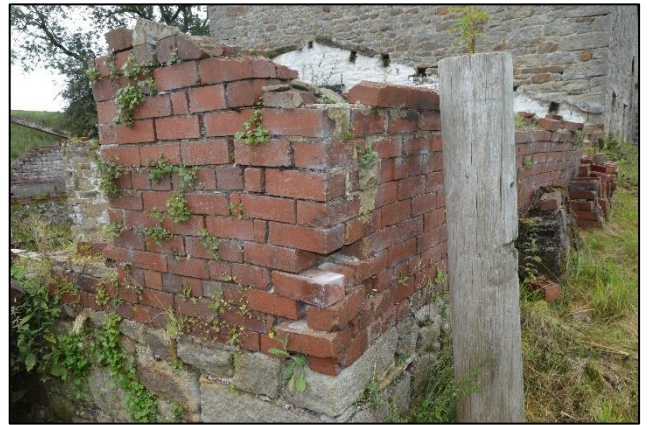
*PL34: The remains of the west wall of the brick built north addition was leaning towards the west at the time of inspection. The masonry was largely loose and unconsolidated and is considered to be unsafe. The pointing to the masonry was largely perished.*

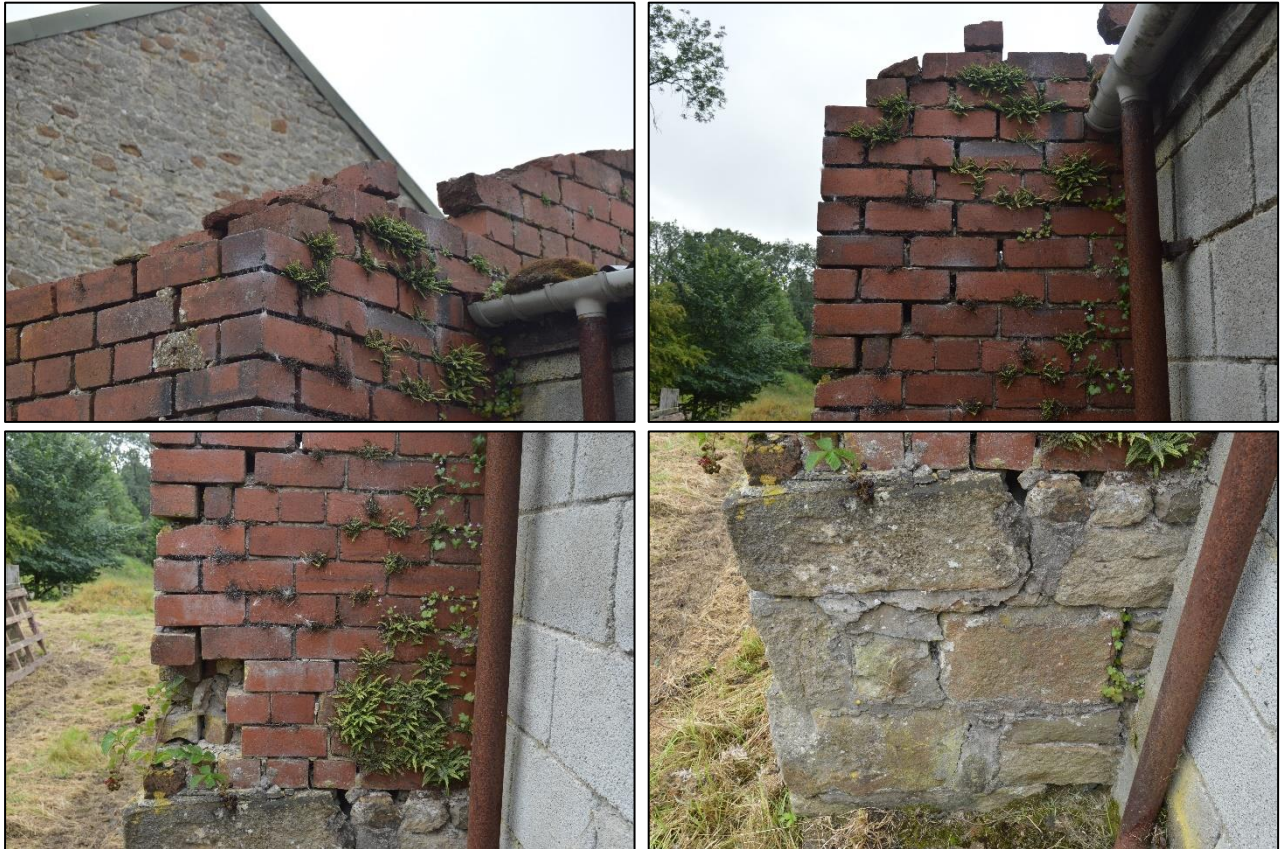
PL35: Loose and unconsolidated masonry noted to the north east corner of the brick built north addition.

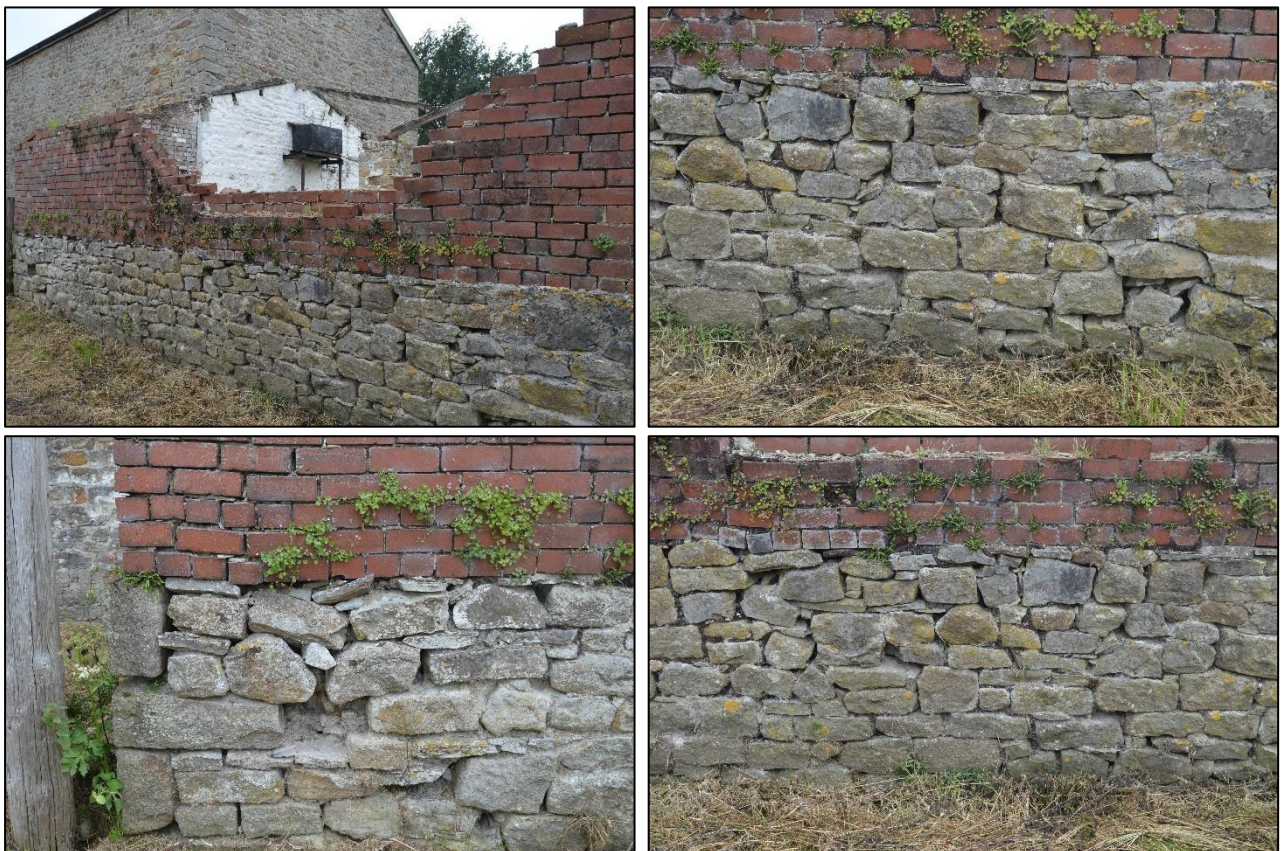
PL36: The remains of the east wall of the brick built north addition was leaning towards the east at the time of inspection. The masonry was largely loose and unconsolidated and is considered to be unsafe. The mortar to the pointing was largely perished.

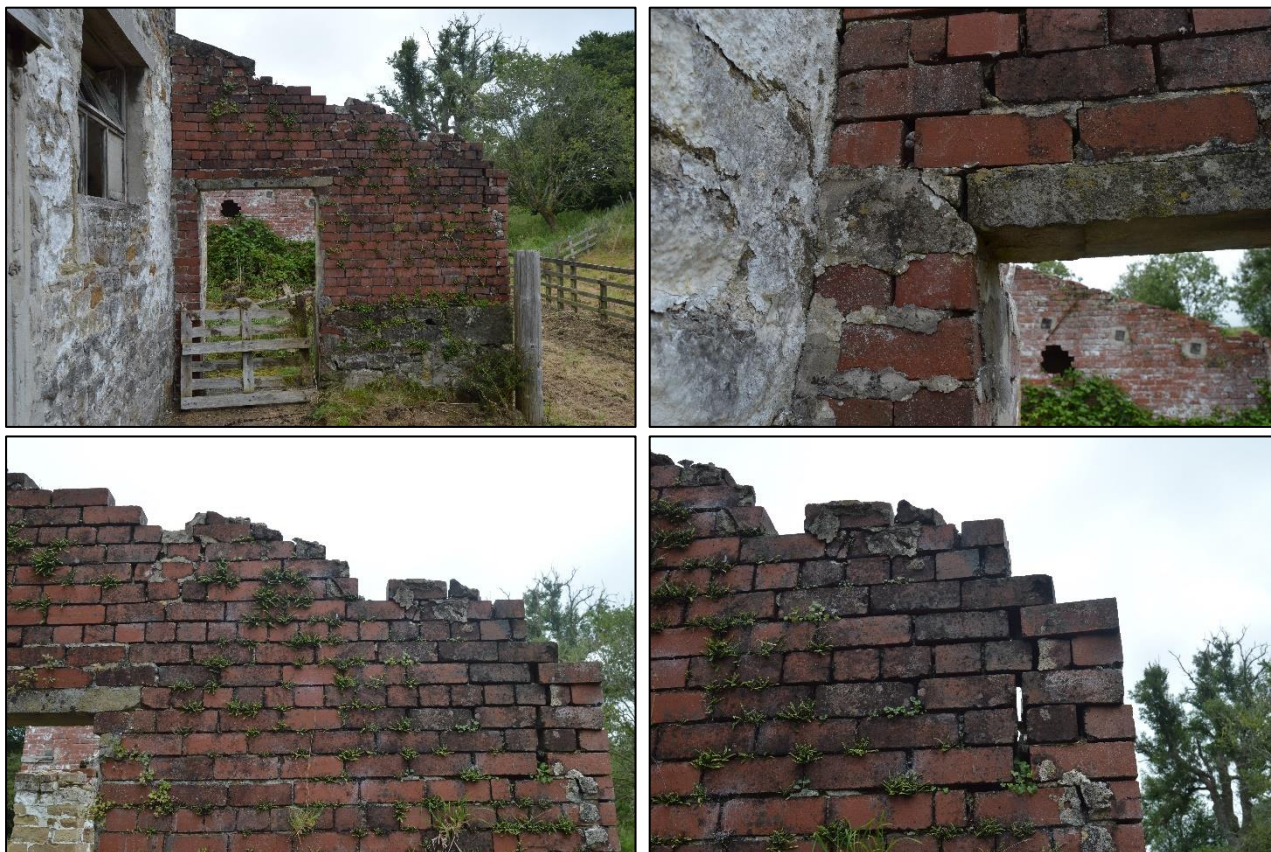
*PL37: The masonry to the south east corner of the brick built north addition was loose and unconsolidated. The lintel to the door opening had virtually no end bearing onto the masonry below. The masonry is considered to be unsafe and is at risk of imminent collapse.*

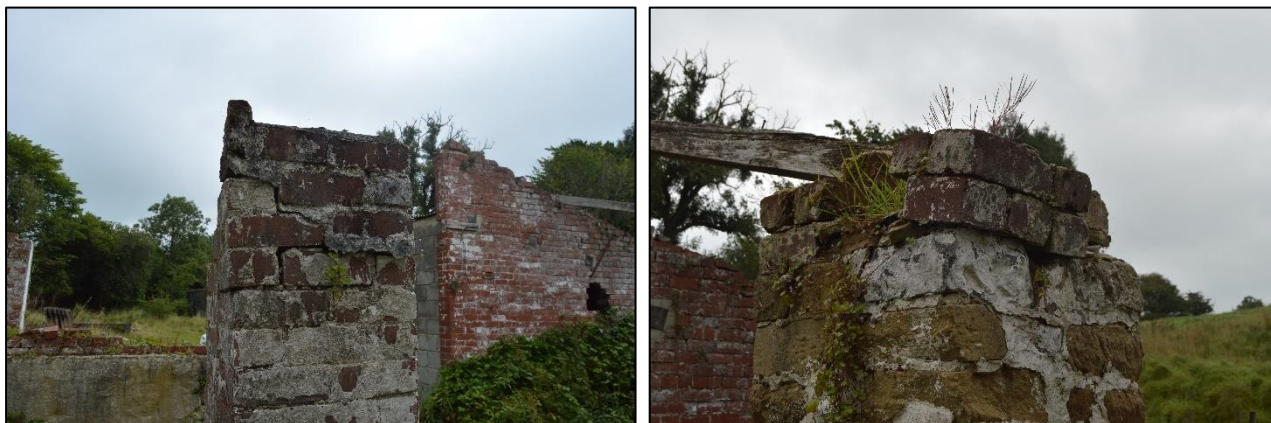
*PL38: Loose masonry not to the top of the freestanding masonry columns within the brick built north addition*

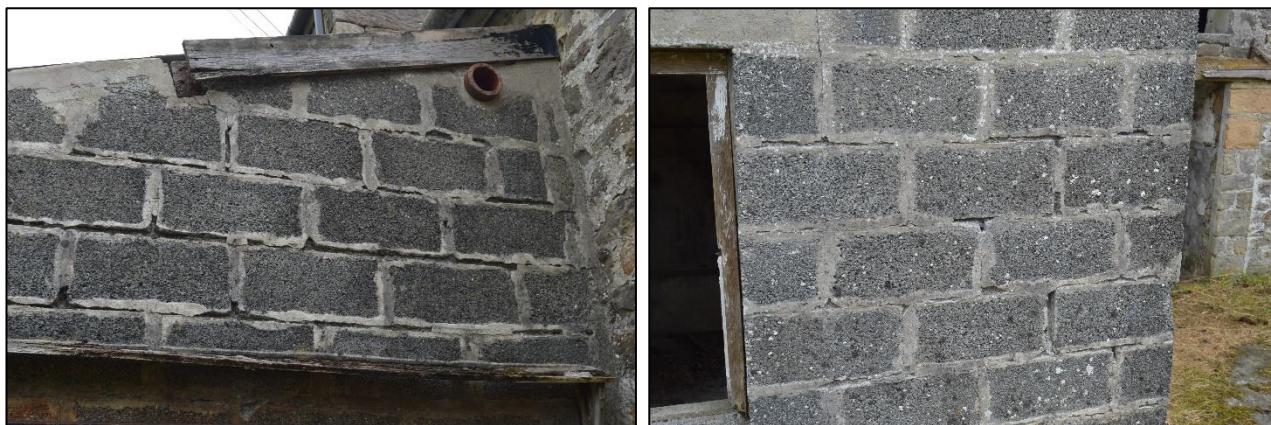
PL39: View of the degraded / missing pointing noted throughout the external walls of the west lean-to structure.

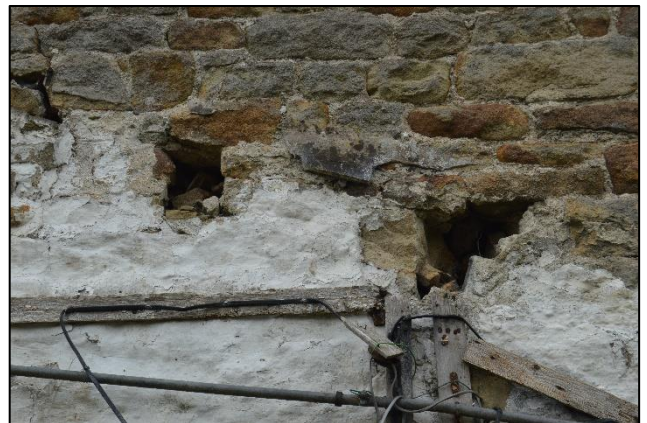
*PL40: Loose / unconsolidated masonry noted to the now relict purlin sockets to the north gable of the main core of the barn. Making good is recommended and the sockets infilled with matching stonework.*

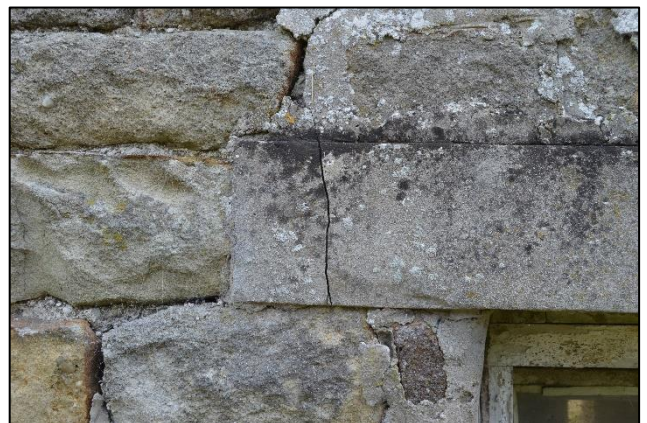
*PL41: A crack noted to the lintel to a window to the ground floor of the west elevation of the main core of the barn. The front of the lintel appeared to be comprised of a cement veneer and it could not be confirmed if it was only the veneer was cracked or if the crack was also present the underlying structural support, the type, condition and adequacy of which could not be confirmed at the time of inspection.*

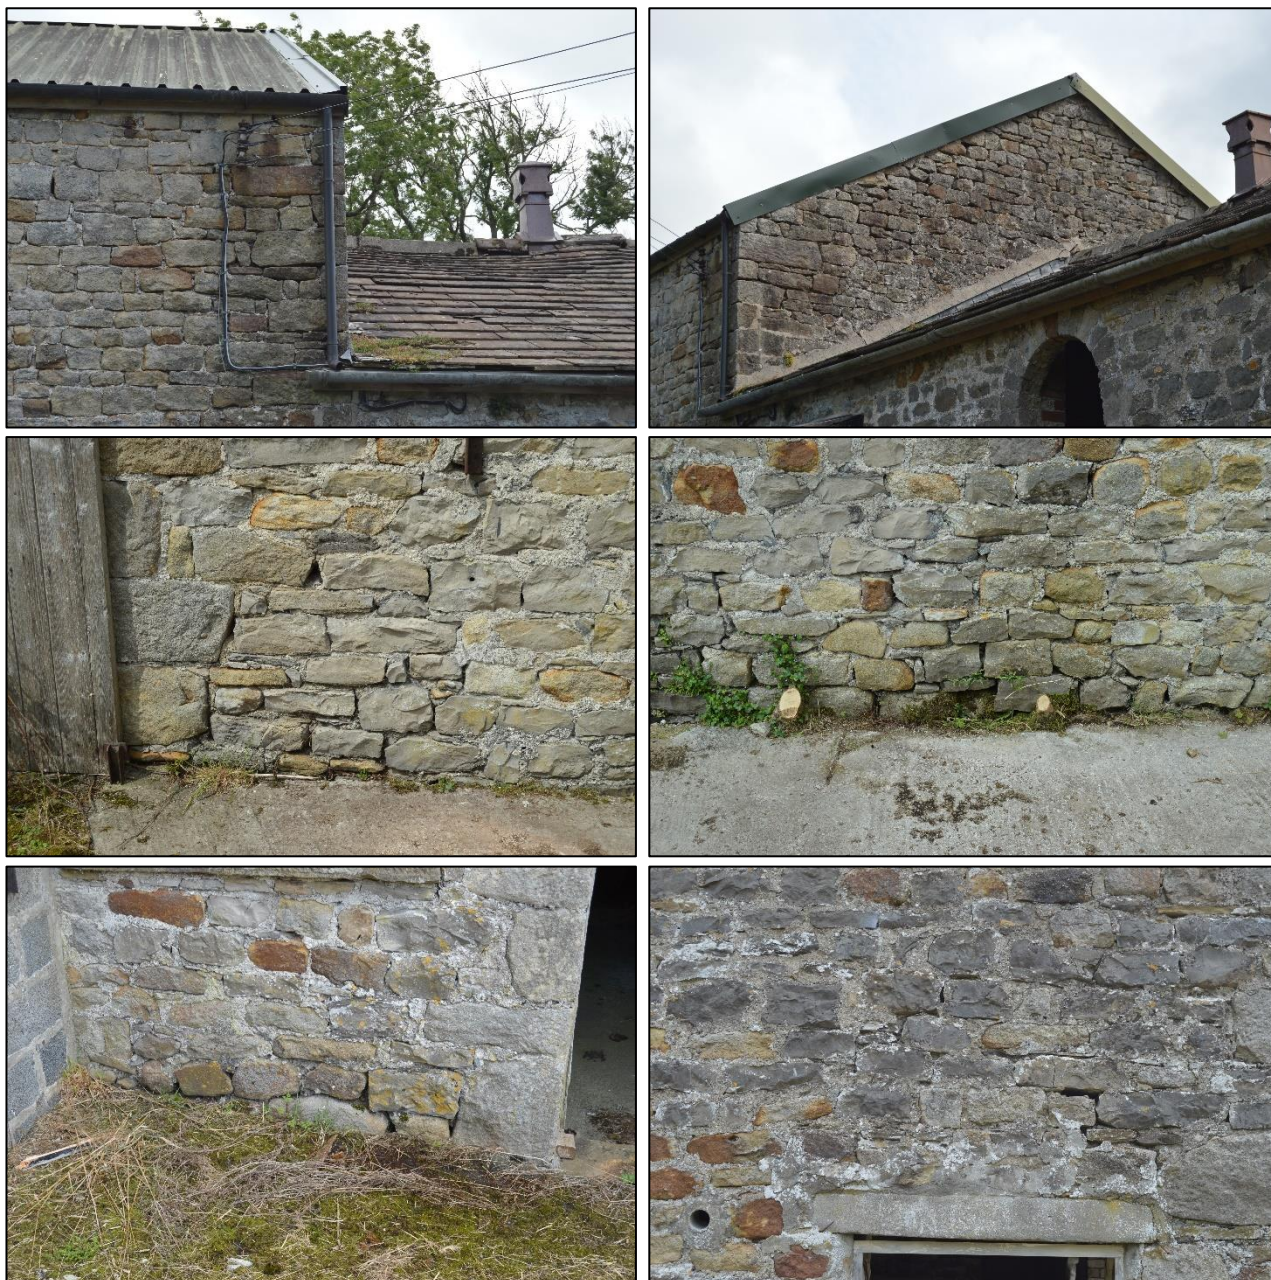
PL42: Areas of perished mortar was widespread throughout the building and repointing is recommended using a lime mortar.

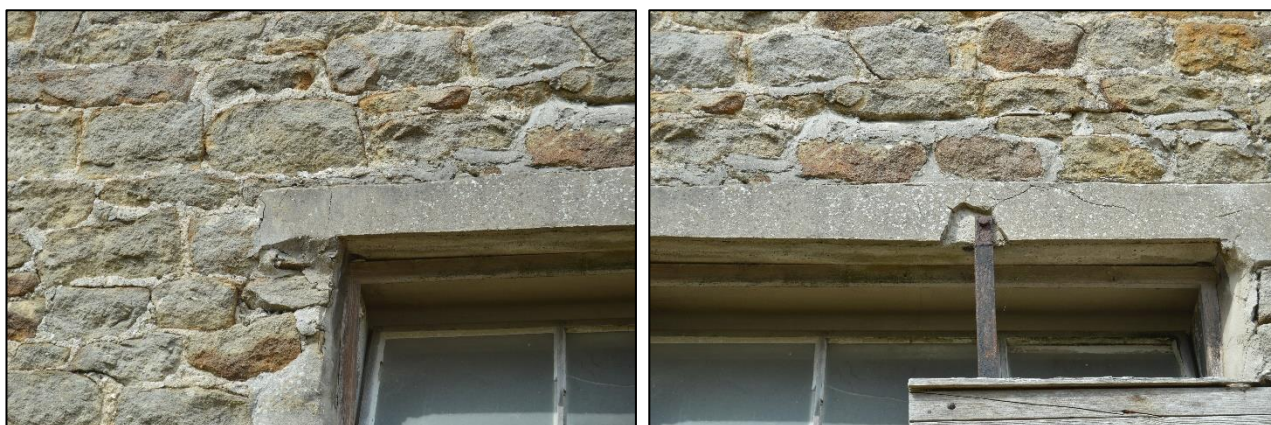
PL43: Cracking noted to the lintel to a window to the ground floor of the east elevation of the main core of the barn. The front of the lintel appeared to be comprised of a cement veneer and it could not be confirmed if it was only the veneer was cracked or if the crack was also present the underlying structural support, the type, condition and adequacy of which could not be confirmed at the time of inspection.

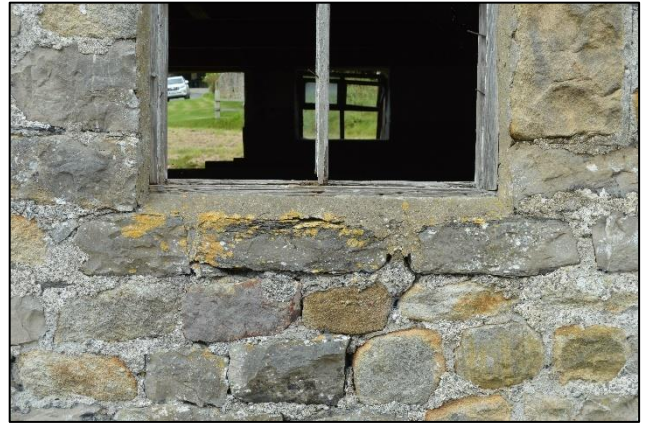
PL44: No cills were largely present to window openings throughout the barn and as a result this will prove to be a poor water shedding detail. It is recommended that all window openings are provided with a throated cill to remove surface water away from the window and wall fabric.

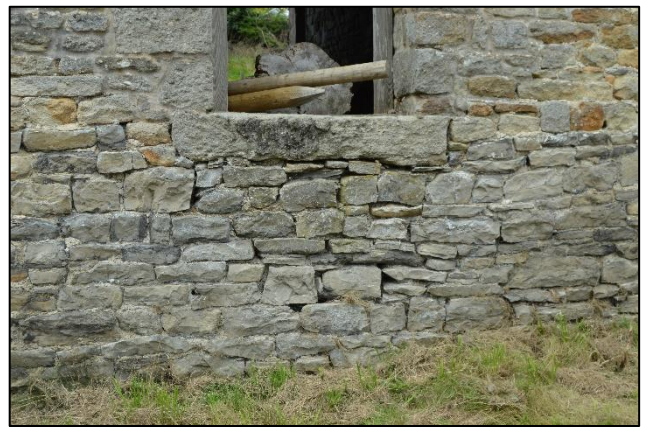
PL45: A lean / bulging was noted around the location of the former winnowing door to the east elevation of the main core of the barn. It was noted that the external walling around the former winnowing door has been rebuilt, however this does not appear to be the case to the walling directly below the opening, likely as the wall is retaining the floor behind. No obvious structural cracking was noted at this location at the time of inspection to suggest any recent / ongoing movement to this location, however it is recommended that this area is regularly monitored for any evidence of recent movement / cracking. Should any further movement / cracking occur then this will require assessment by a Structural Engineer and structural repairs undertaken as required. The stonework beneath the former winnowing door should be repointed / consolidated using a lime mortar.

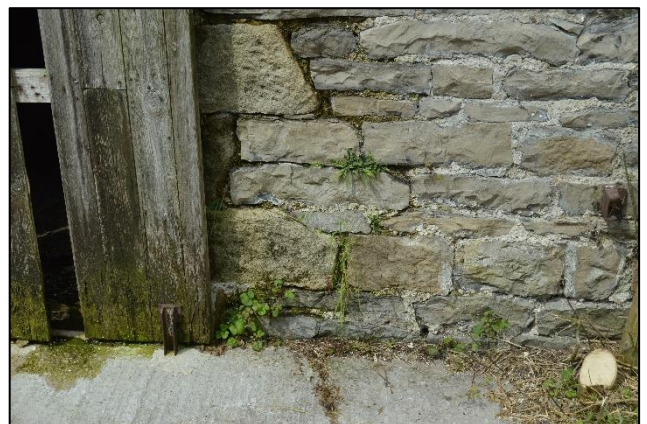
PL46: Areas of plant growth were noted throughout the building and should be removed to prevent further growth.

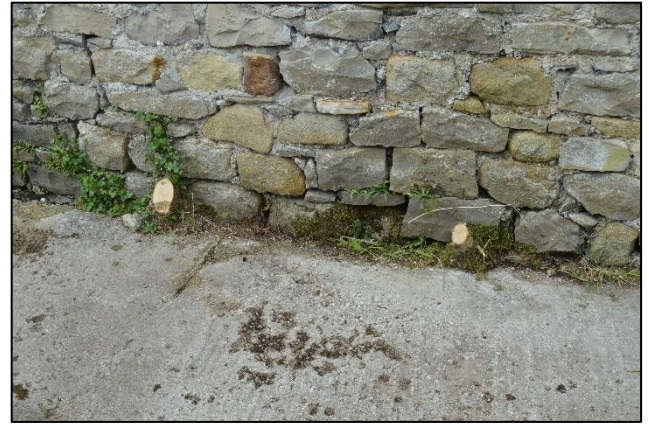
PL47: A number of tree / sapling stumps were noted to the wall base of the east elevation. It is recommended that stumps are fully removed as well as the underlying root matrices.
