# **BUILDING (STRUCTURAL) CONDITION SURVEY**

PROPOSED CONVERSION OF EXISTING BARN AT

FOODEN HALL FARM

GISBURN ROAD

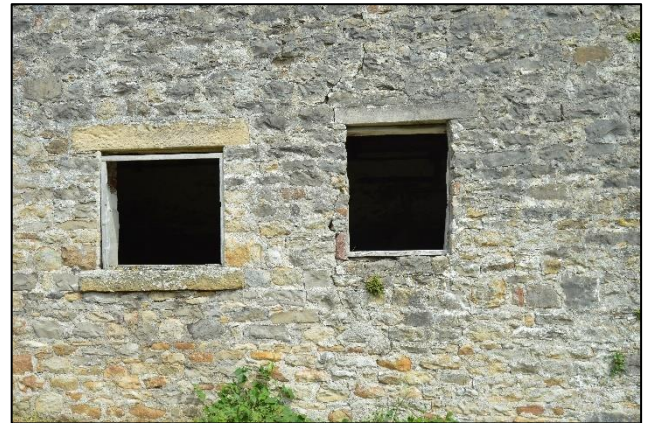
PL48: Isolated vertical cracking was noted over the east window opening to the south gable end of the south addition. The cracking was deemed to be slight (between 1mm and 5mm) to moderate (between 5mm and 15mm). A fall was also noted to the window head at this location. It is recommended that bed joint reinforcement is installed where coursing will allow i.e. stainless steel helical bars and the affected area then repointed using a lime mortar. This should then be monitored for any further evidence / re-occurrence of cracking or movement. Should any further movement / cracking occur then this will require assessment by a Structural Engineer and structural repairs undertaken as required.

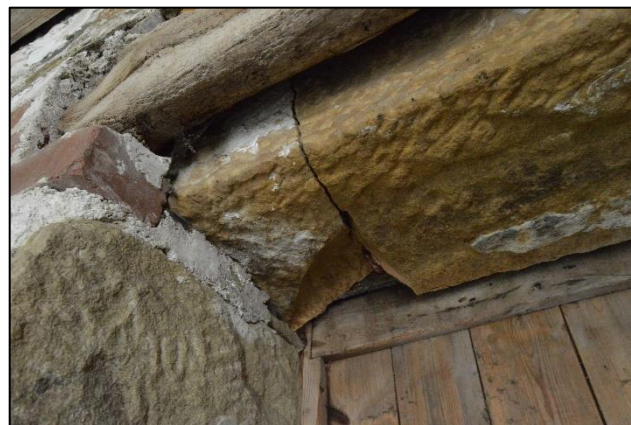
PL50: The stone lintel to the doorway at the south end of the east elevation was cracked and replacement will be required. The internal timber safe lintel was also noted as being slender in profile and was decayed. It also contained evidence of wood-boring insect attack and replacement of the timber lintel is also required.

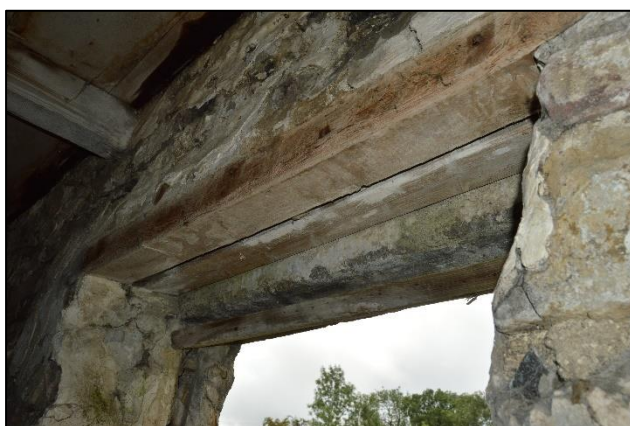
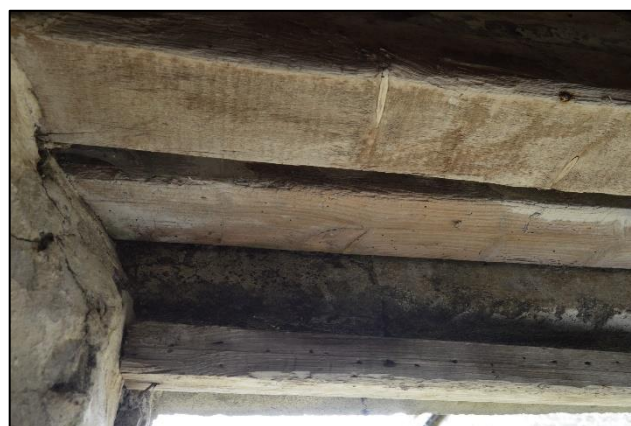
PL51: Minimal end bearings were noted to the internal timber safe lintels over the east opening to the ground floor of the south gable end of the south addition. Evidence of wood-boring insect attack was also noted, i.e. insect flight holes. It is recommended that the lintels are replaced with new lintels with a minimum end bearing of 150mm – 200mm.

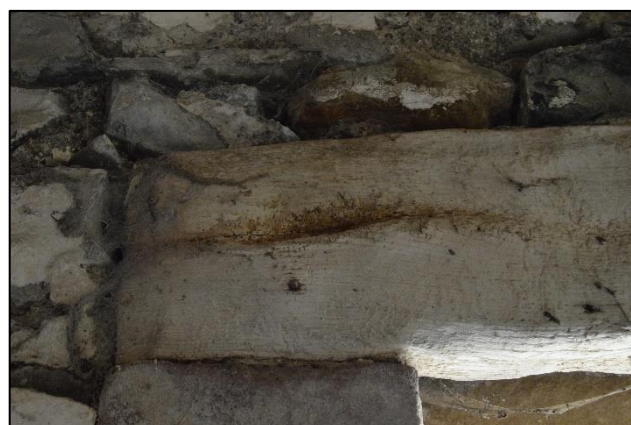
PL52: The timber safe lintel over the west opening to the opening to the ground floor of the south gable end of the south addition was noted as being slender in profile. Evidence of wood-boring insect attack was also noted, i.e. insect flight holes. It is recommended that the timber lintel is replaced.

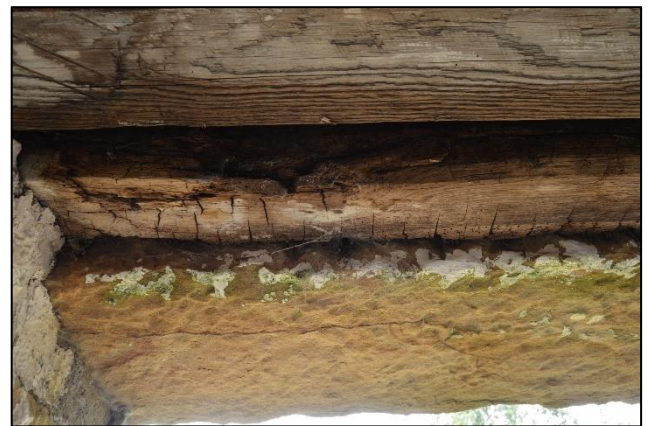
PL54: Decay was noted to the timber safe lintel located over the west elevation personnel door to the south addition. Replacement is recommended.

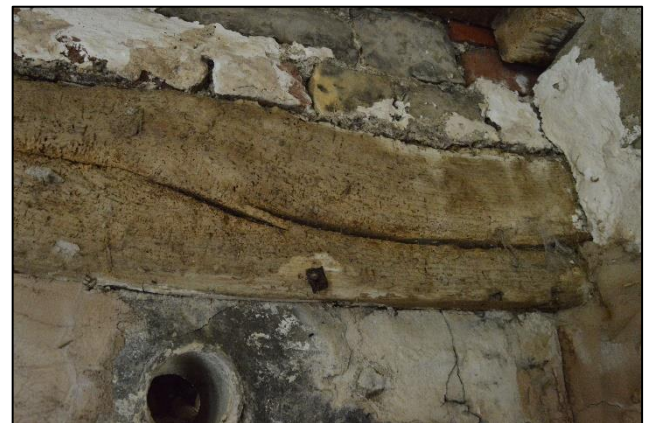
PL55: Evidence of wood-boring insect attack was noted to the internal timber safe lintel over the blocked-up door opening to the west side of the south addition, i.e. insect flight holes. It is recommended that the timber lintel is replaced.

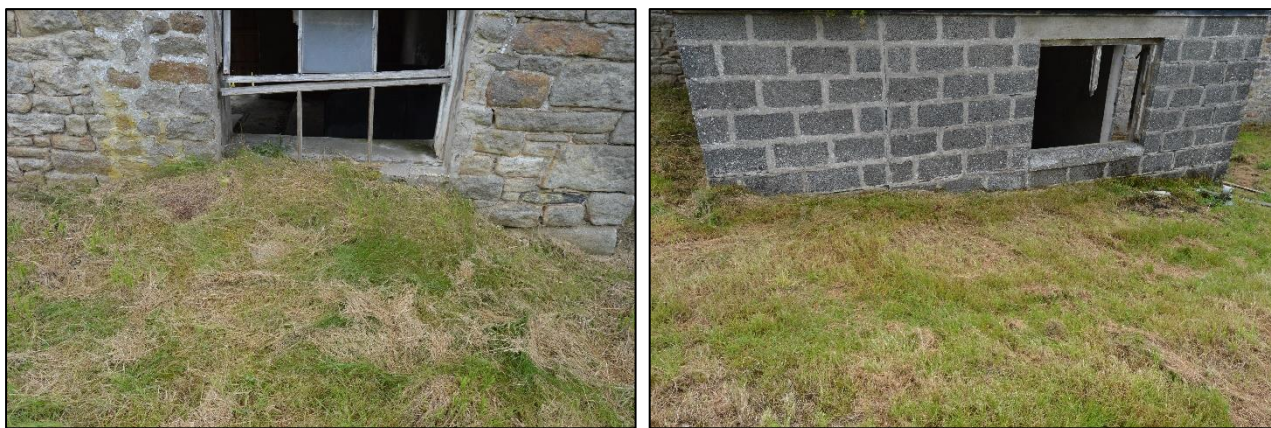
*PL61: View of raised ground levels to the west elevation of the building.*

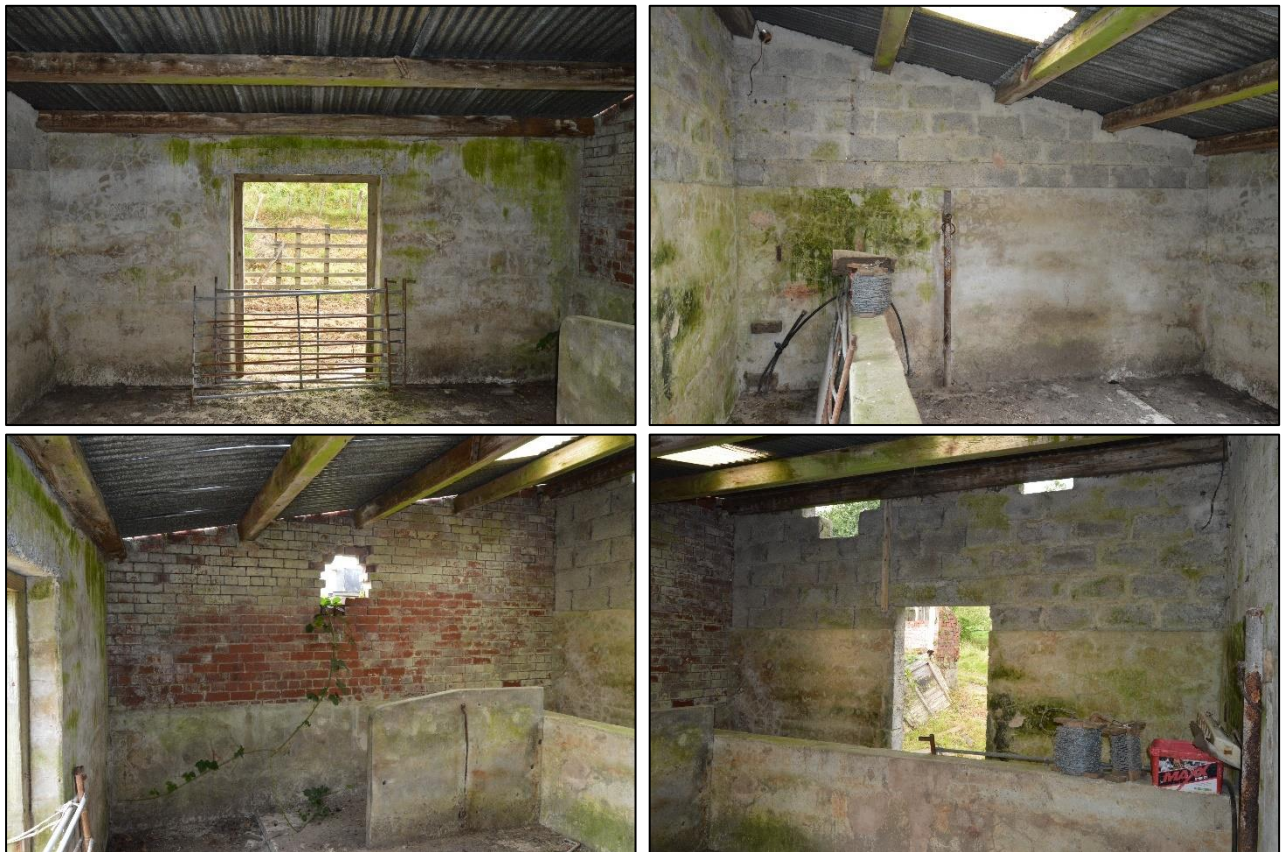
PL63: Internal views within the north lean-to structure. Cracking and staining were widespread as well as algal growth and salt contamination / efflorescence which are suggestive of damp conditions. It is recommended that the plaster finishes are removed throughout the building. This will also allow for an assessment of the underlying wall fabric.

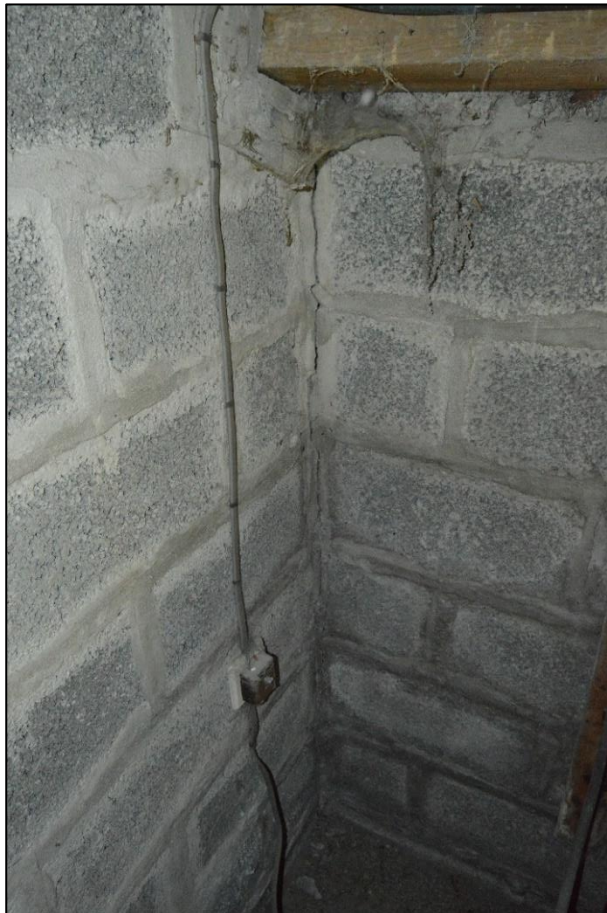
PL65: Isolated cracking noted to the west end of the internal wall within the north unit of the west lean-to. The cracking was deemed to be slight (between 1mm and 5mm) to moderate (between 5mm and 15mm) and likely occurred as a result of some

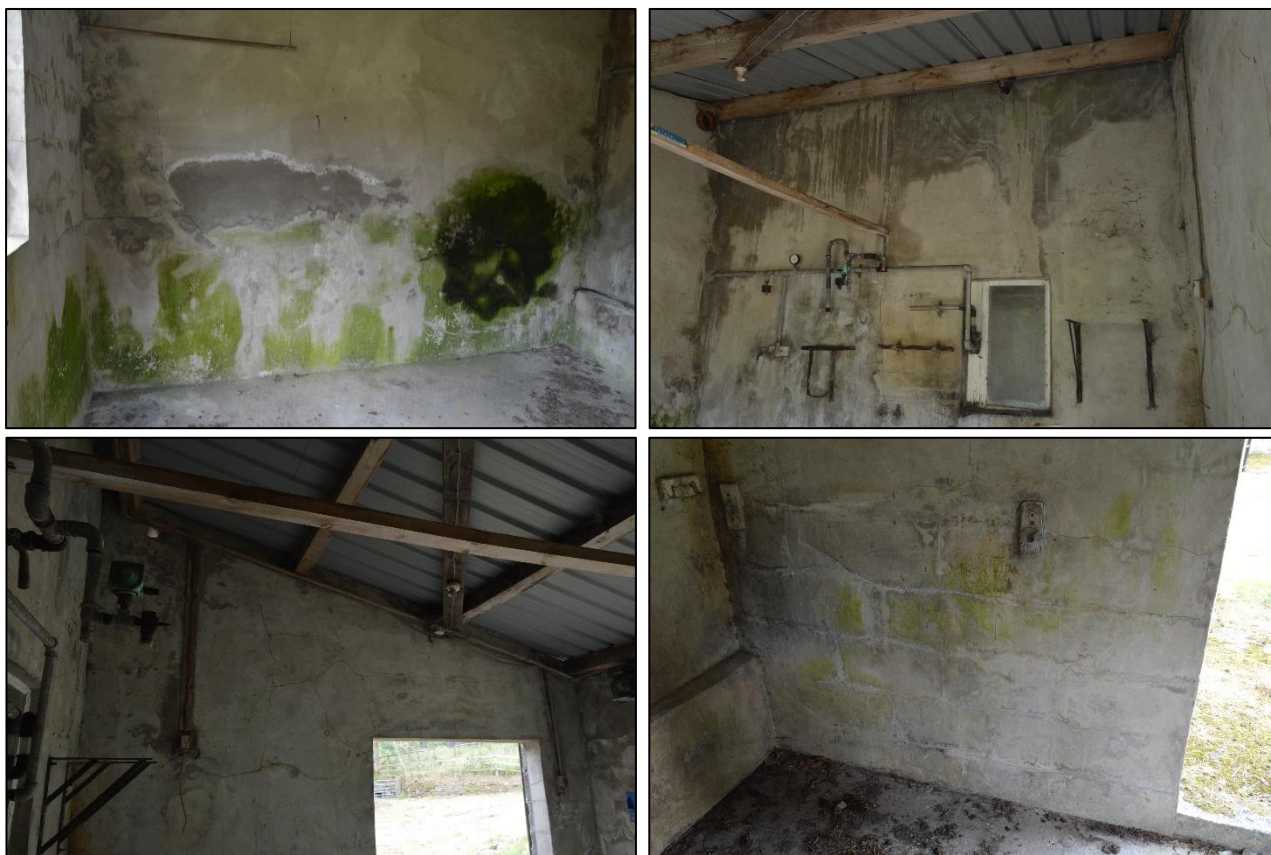
PL66: Views within the south unit of the west lean-to. Cracking and staining were widespread as well as algal growth and salt contamination / efflorescence which are suggestive of damp conditions. It is recommended that the plaster finishes are removed throughout the building. This will also allow for an assessment of the underlying wall fabric.

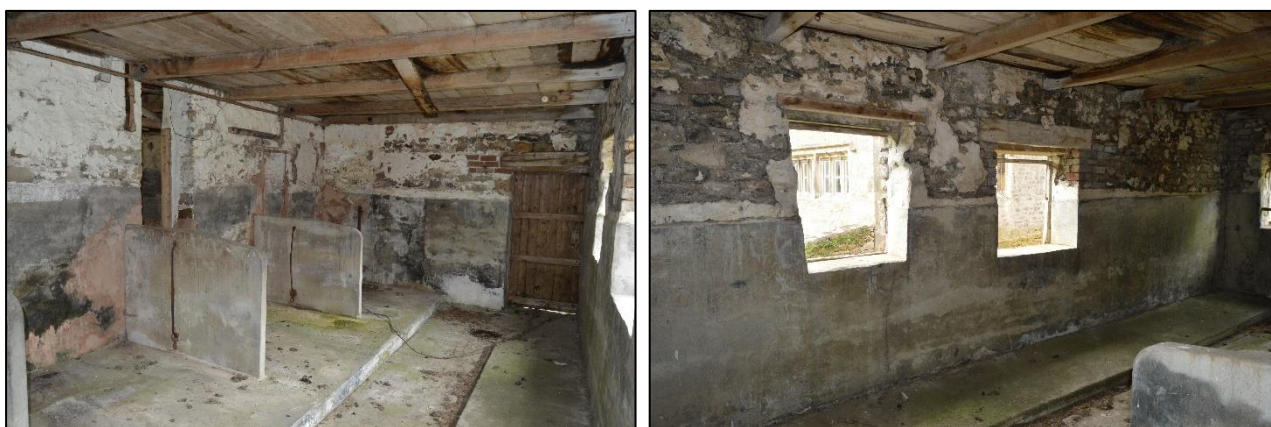
PL67: Views within the south shippon to the south addition. Cracking and staining were widespread as well as algal growth and salt contamination / efflorescence which are suggestive of damp conditions. It is recommended that the plaster finishes are removed throughout the building. This will also allow for an assessment of the underlying wall fabric.

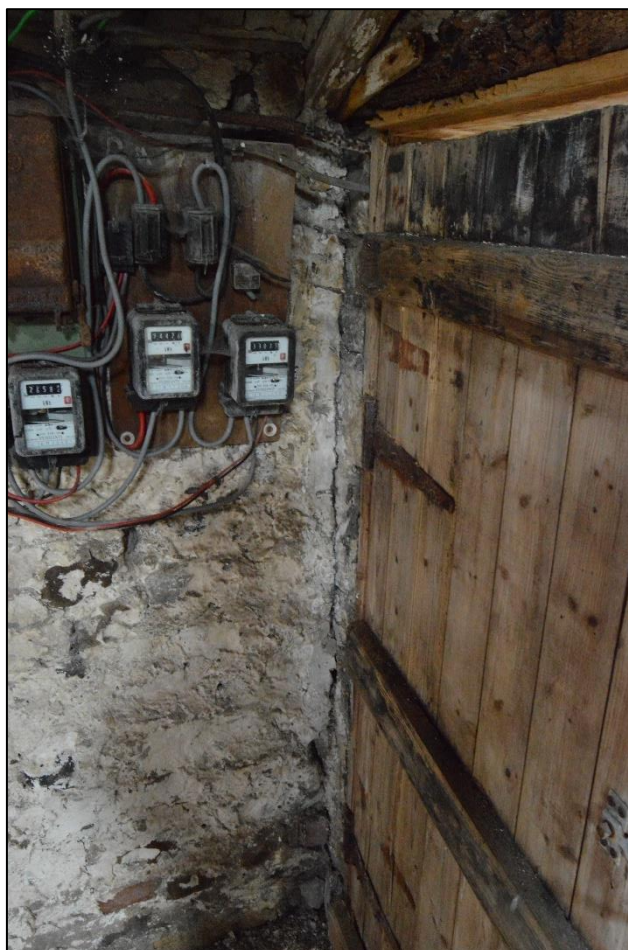
PL72: Isolated cracking was noted adjacent to the internal door to the south hayloft. The cracking was deemed to be slight (between 1mm and 5mm) and it is recommended that the crack is repointed and periodically monitored for any re-occurrence of cracking.

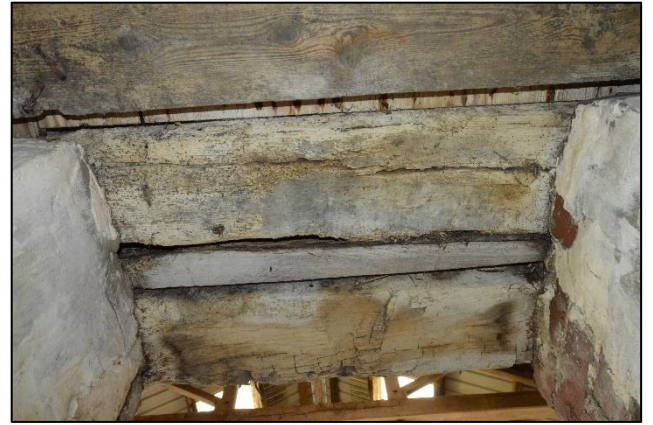
PL73: Decay and evidence of wood-boring insect attack i.e. flight holes, noted to the timber lintels over the wall opening to the north side of the main core of the barn. Replacement of the lintels is recommended.

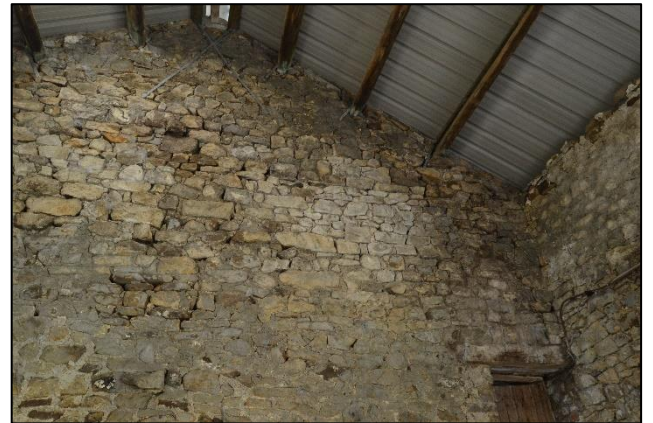
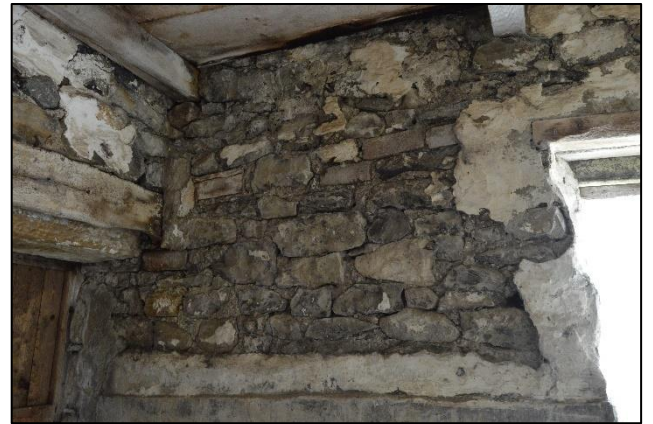
PL74: Areas of perished mortar were widely noted throughout the building and repointing using a lime based mortar is recommended. Any larger voids should be packed with mortar and gallet stones and then repointed.

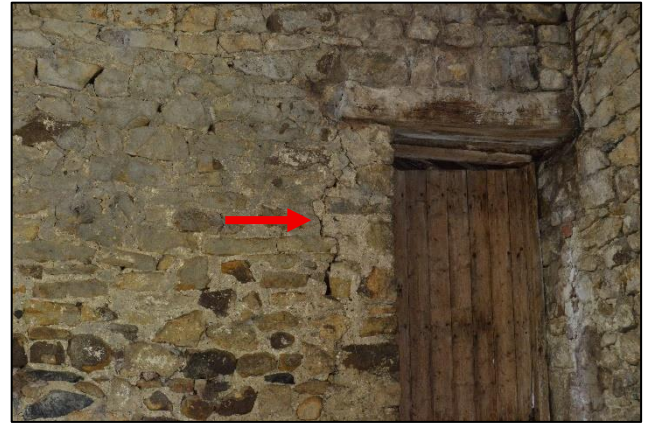
PL75: Cracking was noted internally to the south wall of the main core of the barn, above the doorway to the south hayloft and extending down the LHS of the doorway. The cracking was deemed to be slight (between 1mm and 5mm) to moderate (between 5mm and 15mm). It is recommended that bed joint reinforcement is installed where coursing will allow i.e. stainless steel helical bars, and the affected area then repointed using a lime mortar. This should then be monitored for any further evidence / re-occurrence of cracking or movement. Should any further movement / cracking occur then this will require assessment by a Structural Engineer and structural repairs undertaken as required.

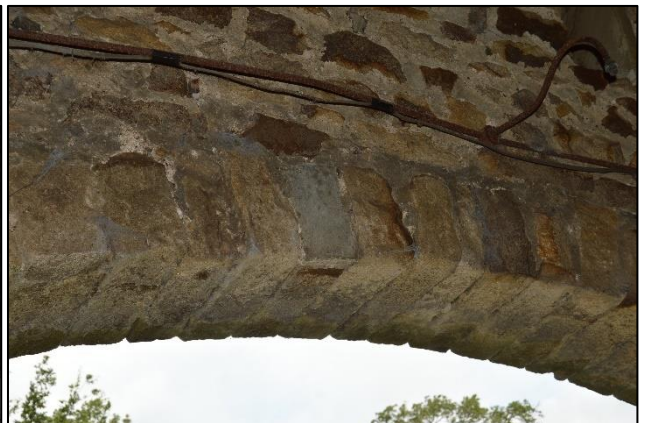
PL77: The internal faces of the stone voussoirs to the west cart entry opening appear to have decayed and have been repaired with a stone / masonry veneer. This was not considered to be significant at the time of inspection.

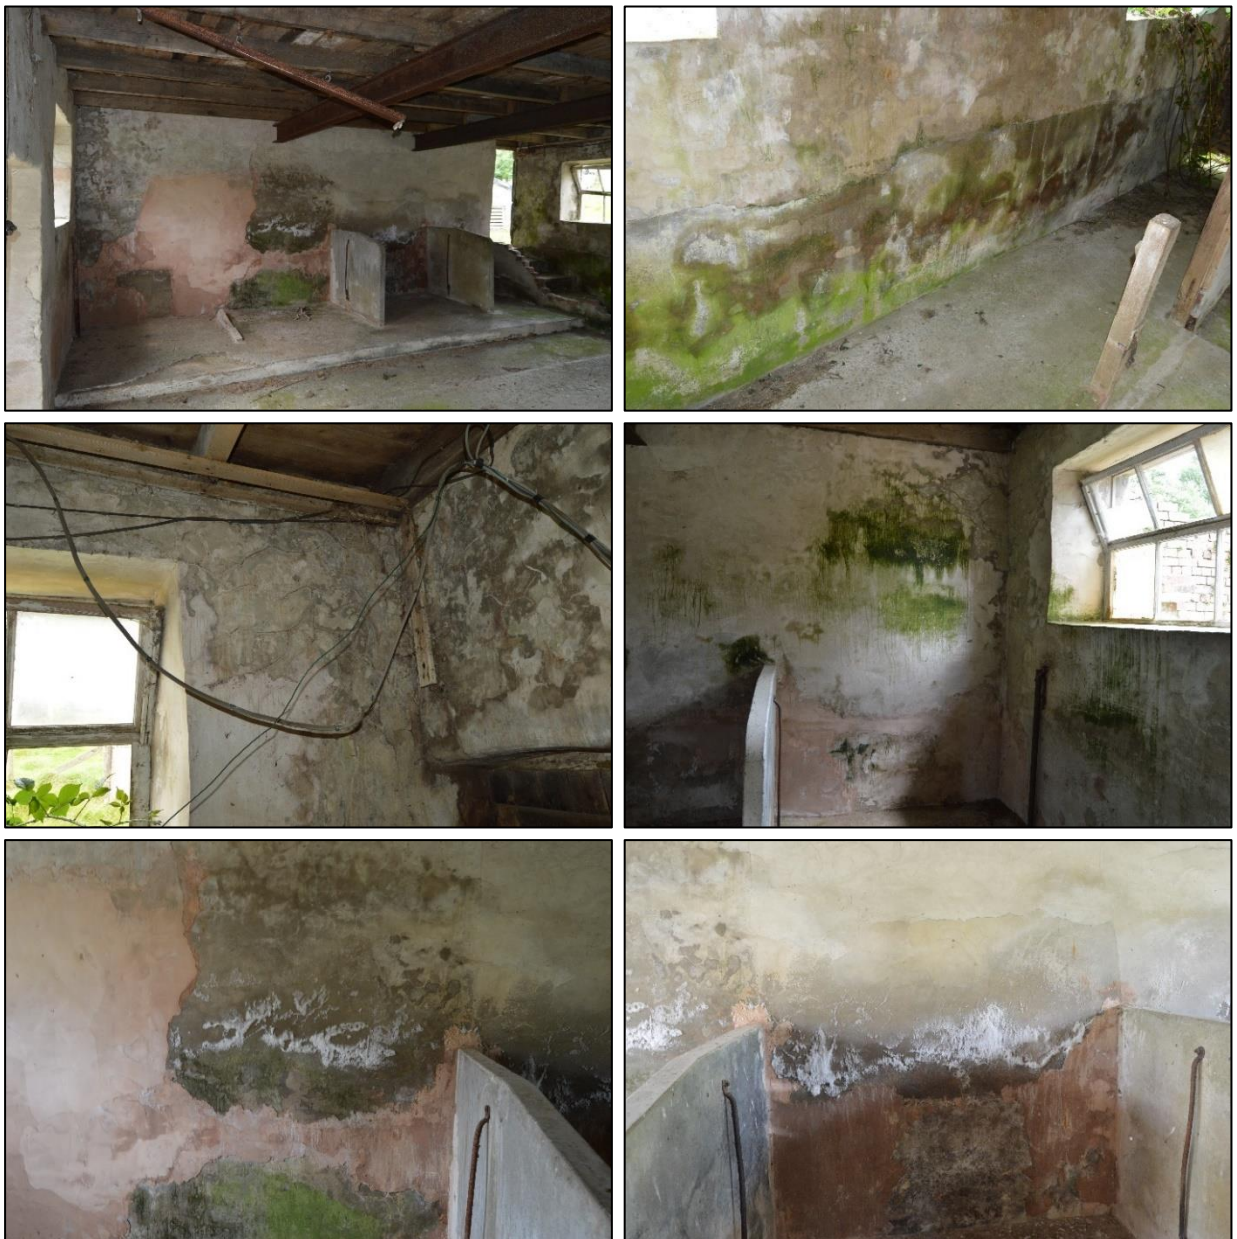
PL79: The wall finishes to the north shippon were in poor condition at the time of inspection. Cracking and staining were widespread as well as algal growth and salt contamination / efflorescence which are suggestive of damp conditions. It is

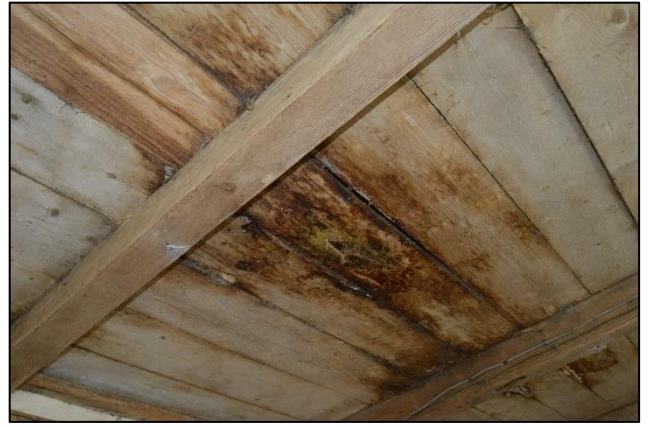
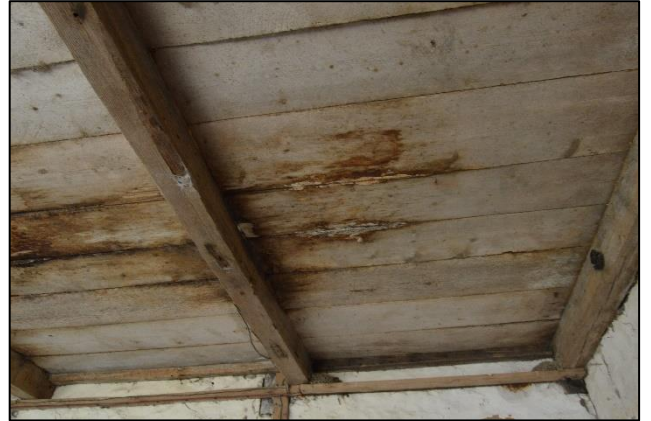
*PL84: View of areas of decayed timber floor boards present to the suspended timber floor to the southern half of the south hayloft, likely caused by past water ingress from the roofing above.*

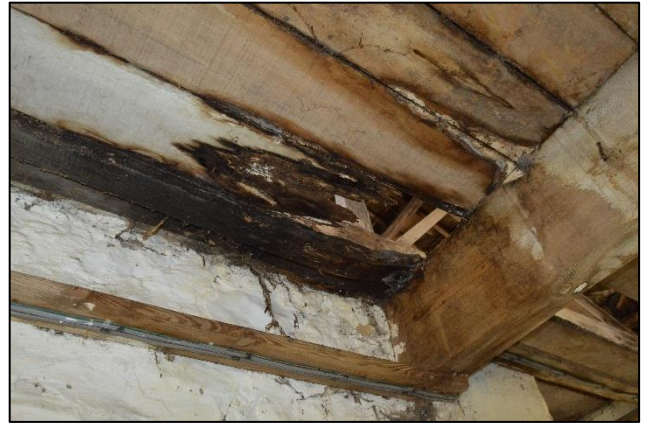
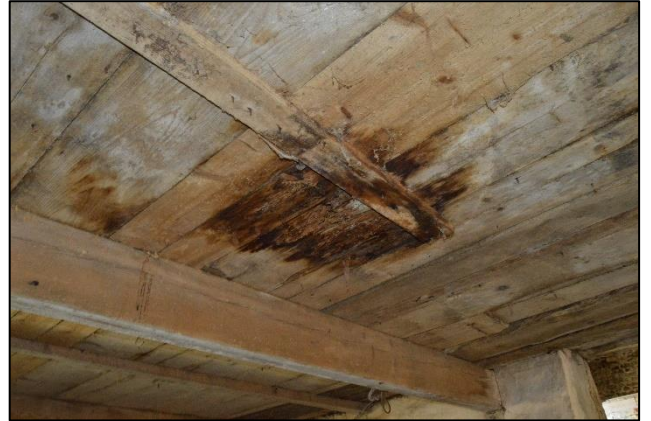
PL86: View of areas of decayed timber floor boards present to the suspended timber floor to the northern half of the south hayloft.

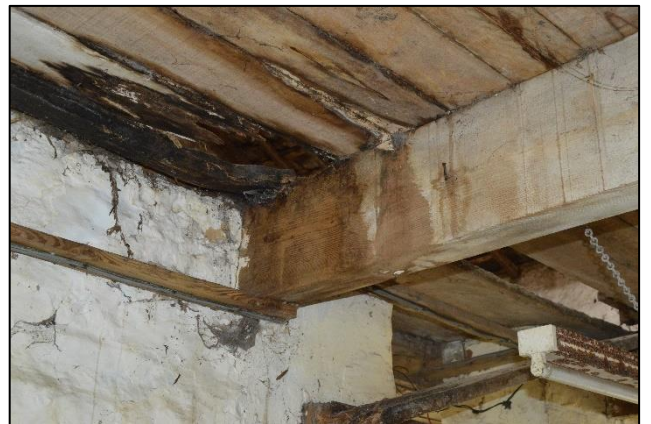
PL87: View of staining noted to isolated floor joists to the northern half of the south hay loft.

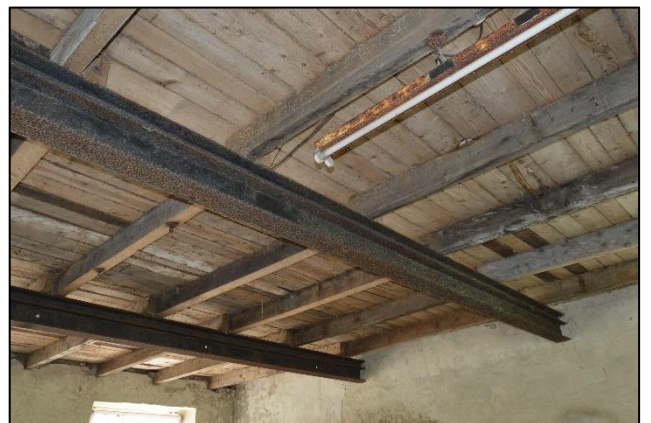
PL88: View of the suspended timber floor structure and steel supporting beams to the north hay loft, likely caused by past water ingress from the roofing above.

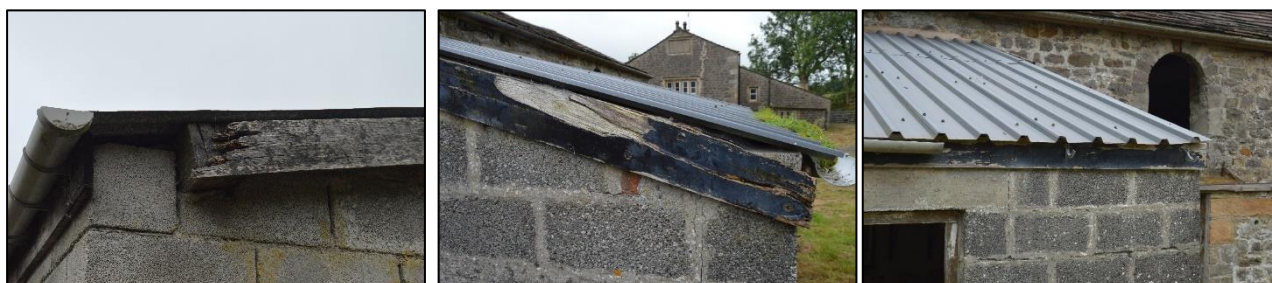
*PL89: Evidence of decay noted to timber fascia boards.*

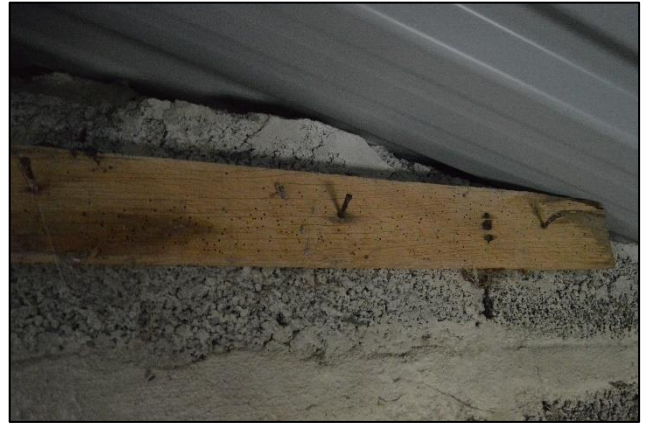
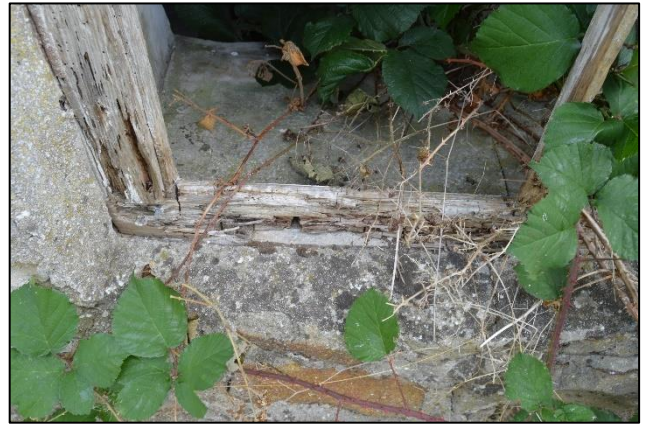
PL90: Evidence of insect attack i.e. insect flight holes and decay noted to joinery items.
